February 2, 2005

CB Consultants
868 Greystone Place
San Luis Obispo, California 93401

**HDPE Penetration Repair Documentation Report
Casmalia Hazardous Waste Management Facility
Casmalia, California**

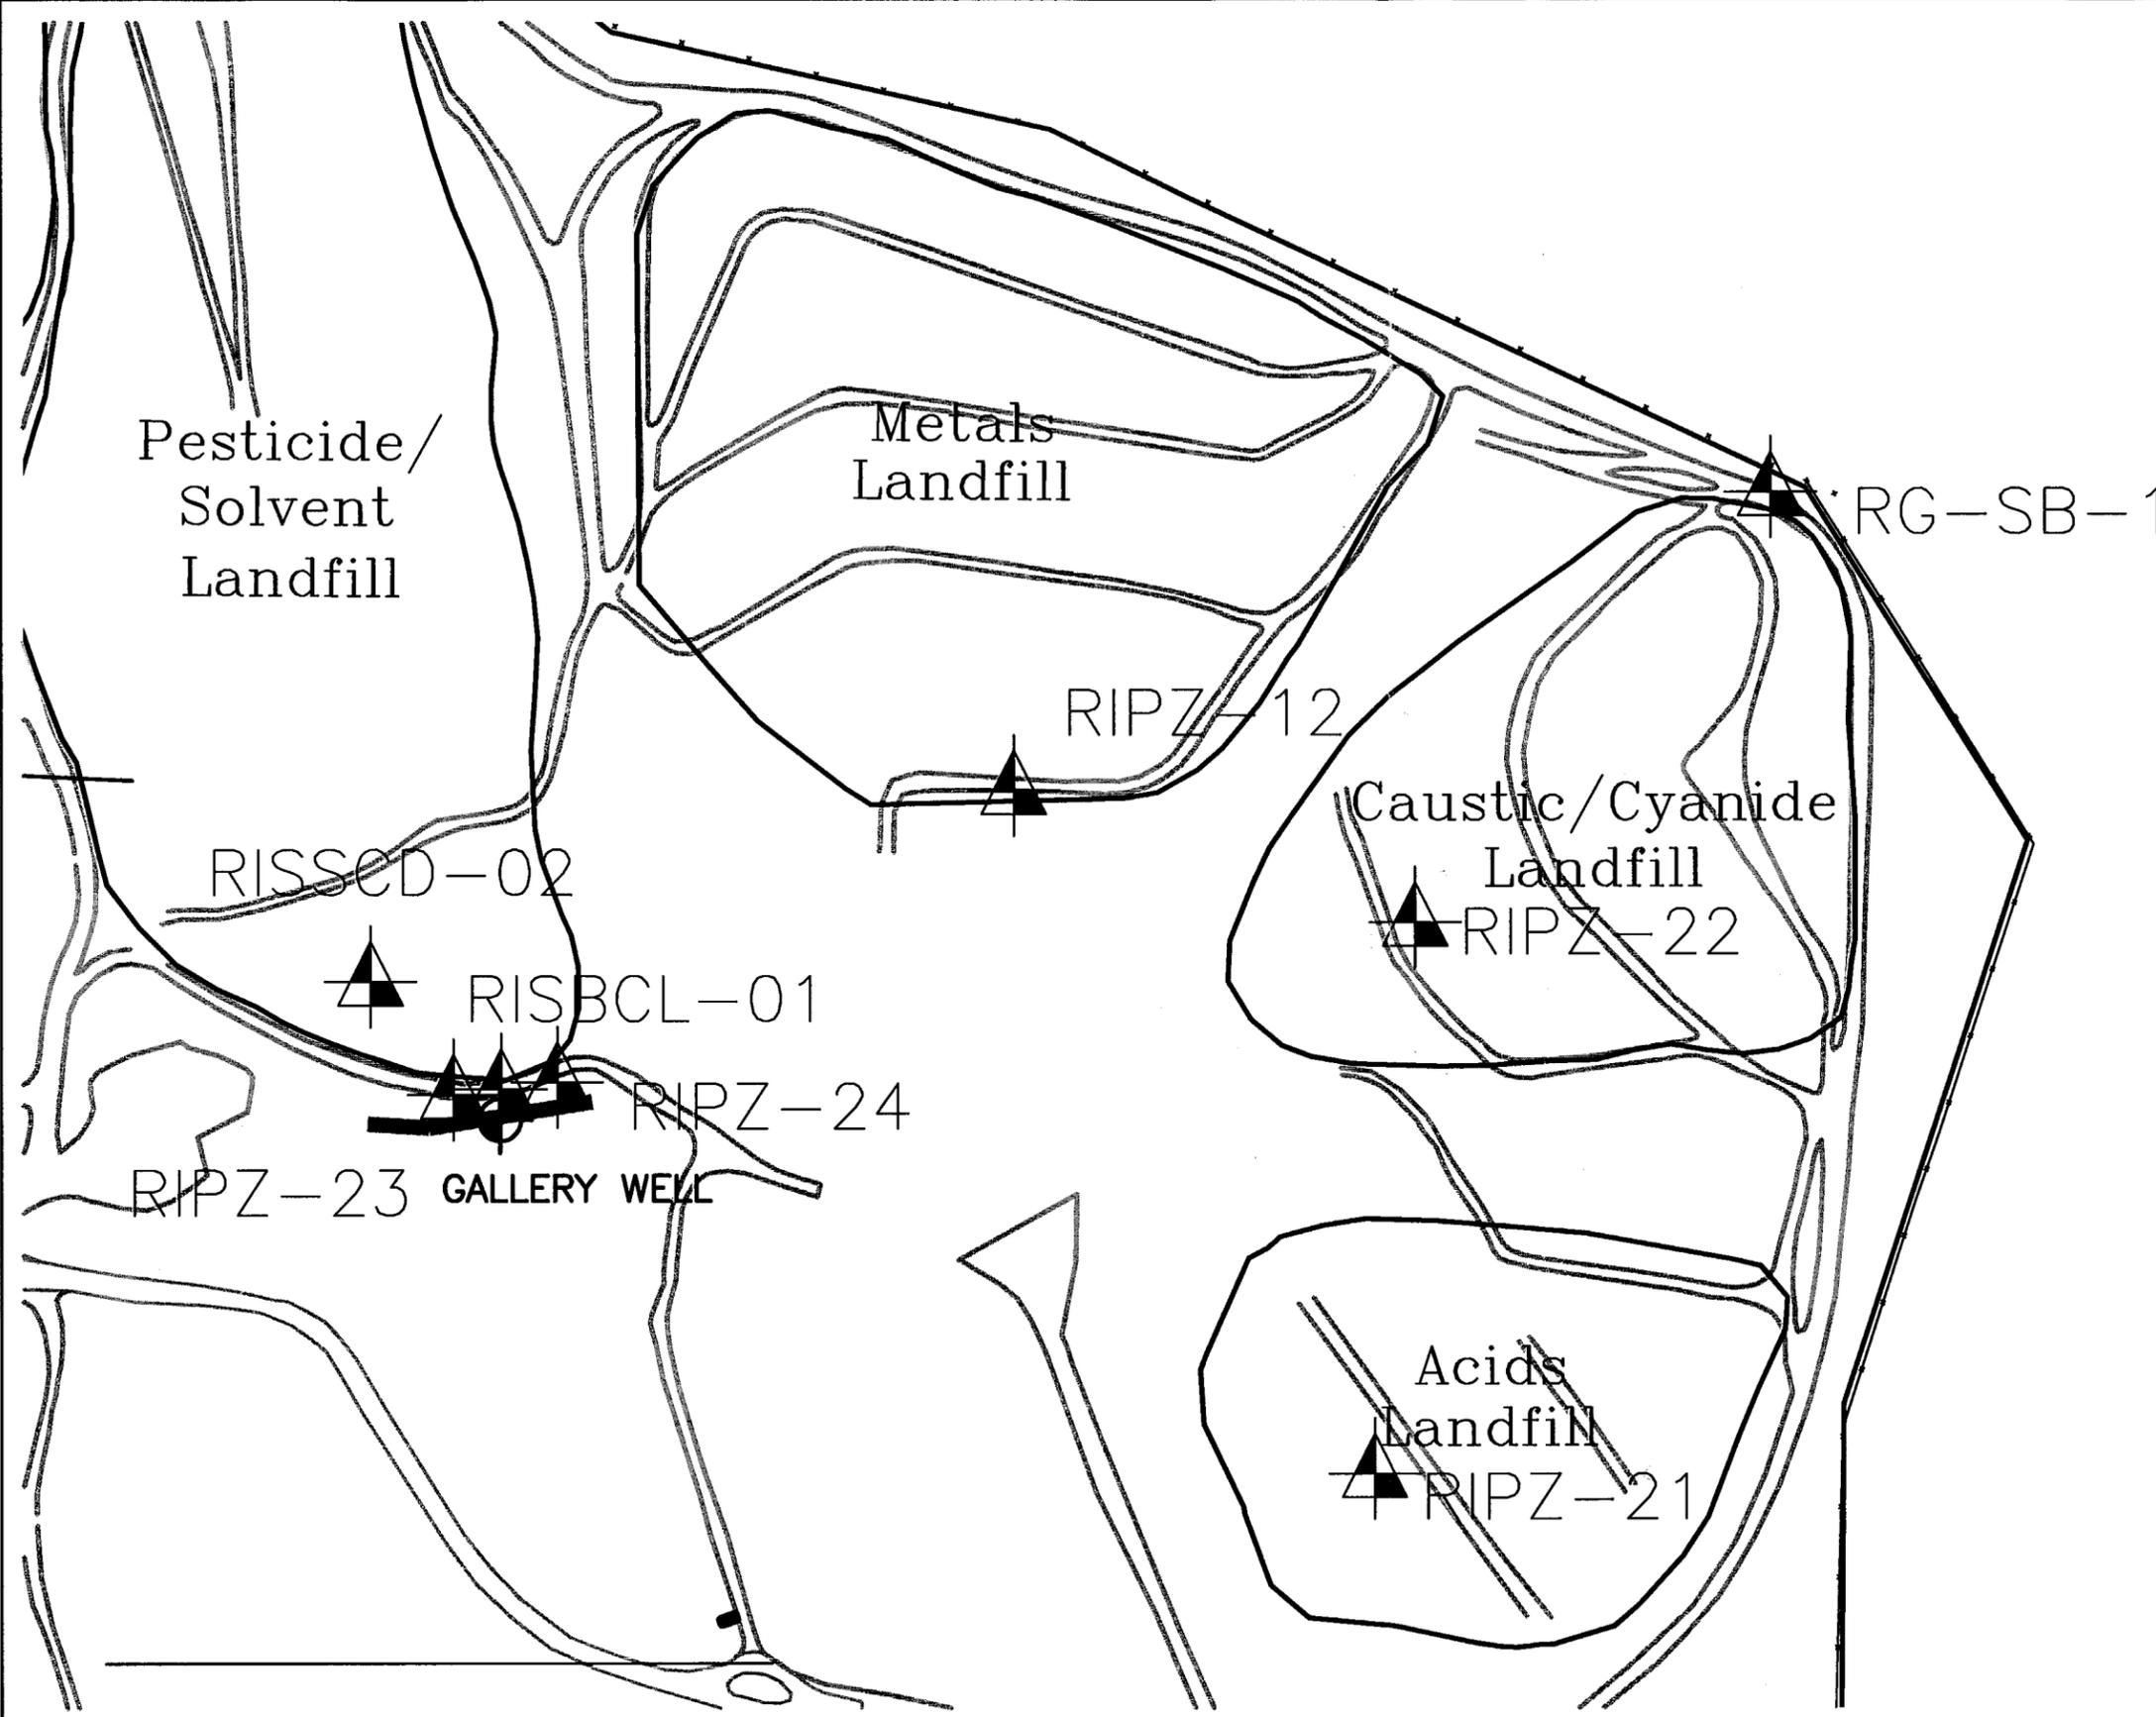
MACTEC ENGINEERING & CONSULTING 4704 Roseville Road, Suite 108 North Highlands, California 95660 (916) 332-5552	FINAL COVER REPAIR LOCATIONS RI/FS WORK PLAN CASMALIA SITE REMEDIATION		PLATE 1
	DRAWN JAT	FILE NAME REPAIRS 2004.DWG	PROJECT NUMBER 47540
		DATE 01/06/05	REVISED DATE

GEOMEMBRANE REPAIR LOG	
REPAIR NUMBER	CORRESPONDING OBSERVATION WELL OR CPT LOCATION
R-1	RIPZ-12
R-2	RIPZ-12
R-3	RIPZ-22
R-4	RIPZ-22
R-5	RIPZ-22
R-6	RIPZ-21
R-7	RIPZ-21
R-8	RIPZ-21
R-9	RG-SB-1
R-10	RISSCD-02
R-11	RIPZ-23
R-12	RISBCL-01
R-13	RISBCL-01
R-14	RISBCL-01
R-15	RISBCL-01
R-16	RISBCL-01
R-17	RIPZ-24

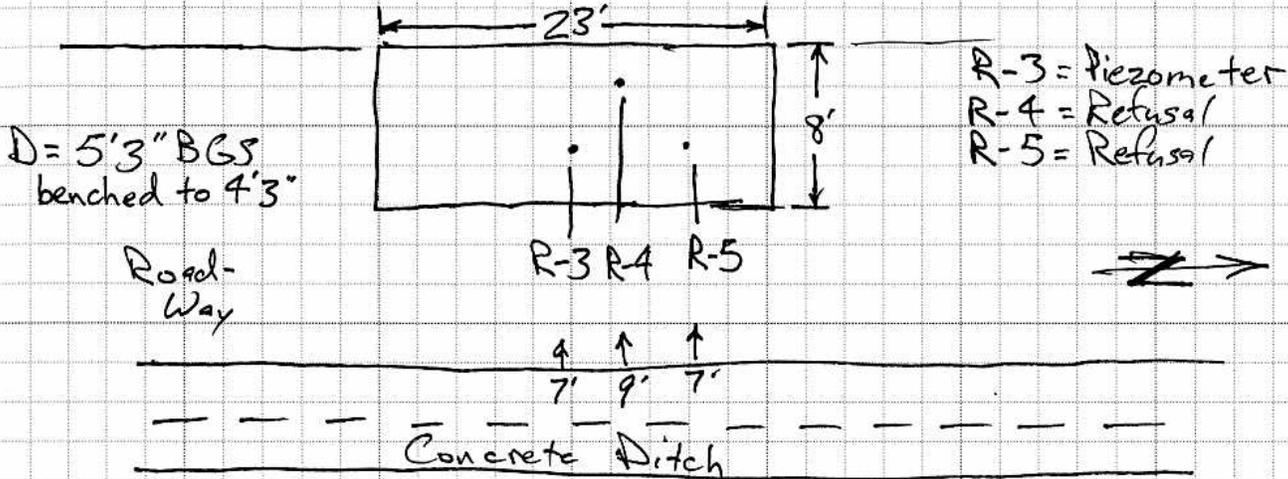
RIPZ-22

Caustics/Cyanide LF

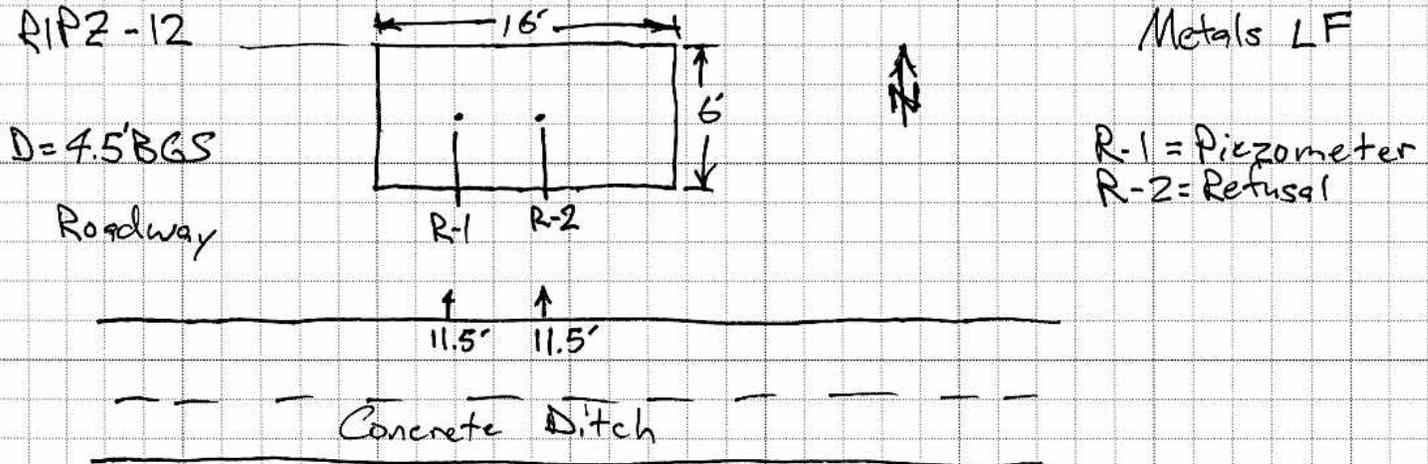
RIPZ-12

Metals LF

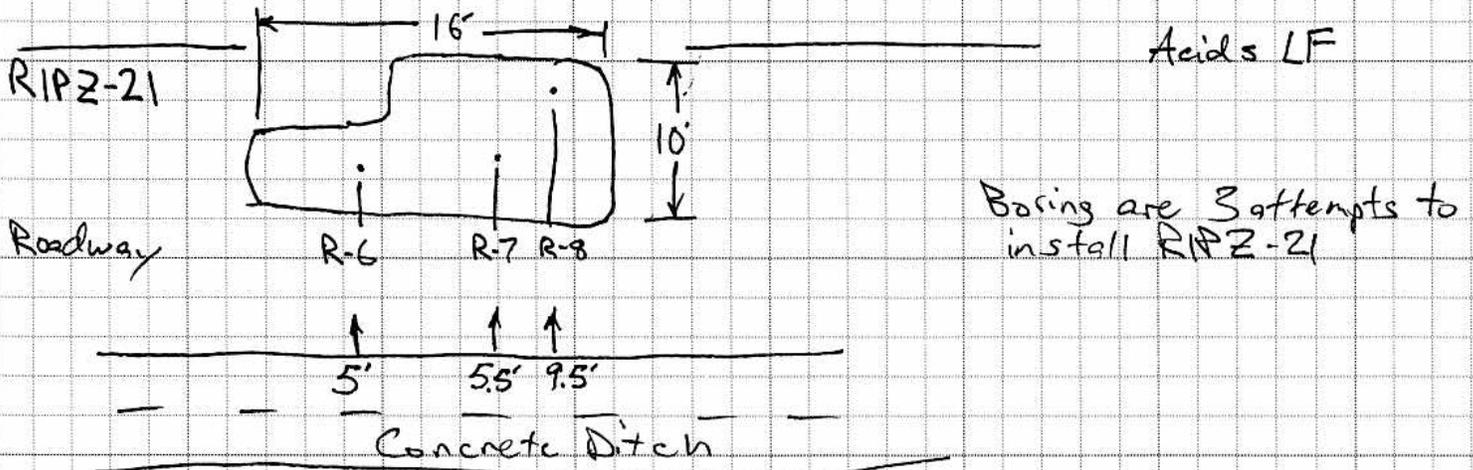
RIPZ-21

Acids LF

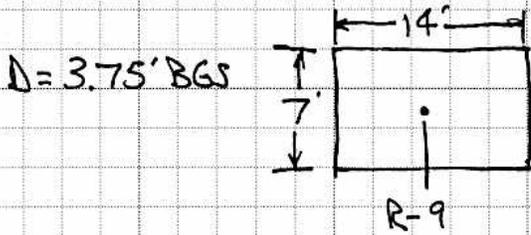
RG-SP-1

Northside of Caustics LF

R-9 = 8" Boring

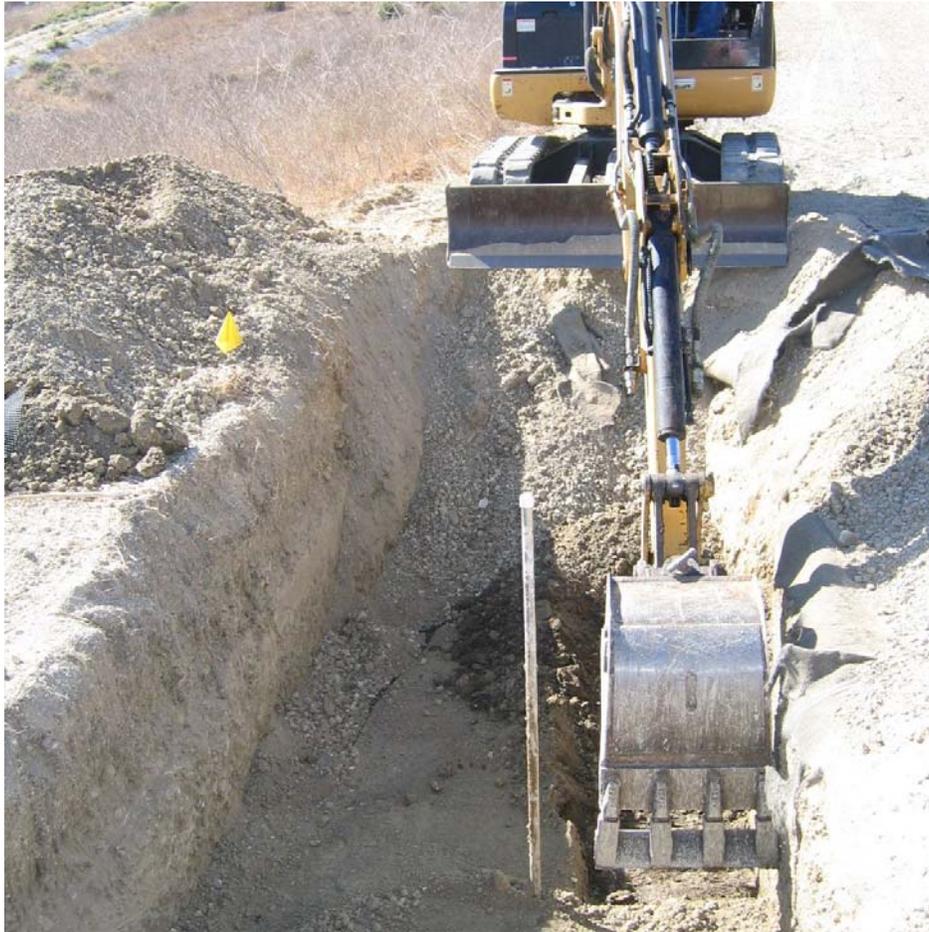
Photograph of Repair No. R-1 and R-2
Excavation at RIPZ-12, using CAT 303.5 mini-excavator

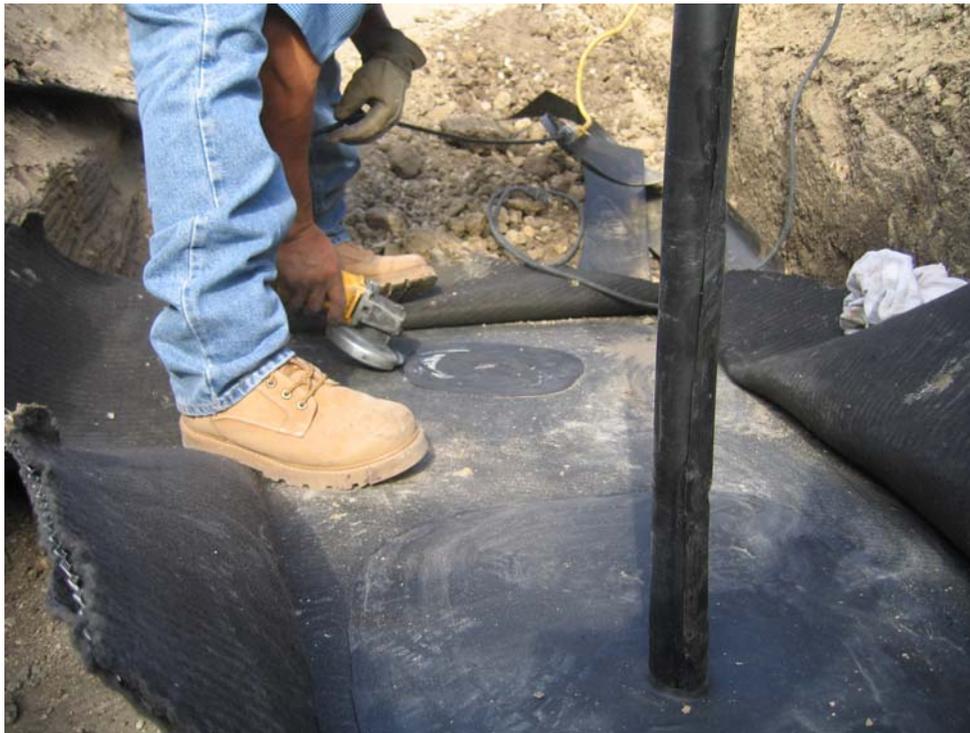
Photograph of Repair No. R-1 and R-2
Preparatory grinding the edges of the patch (R-2) and boot (R-1) at RIPZ-12.

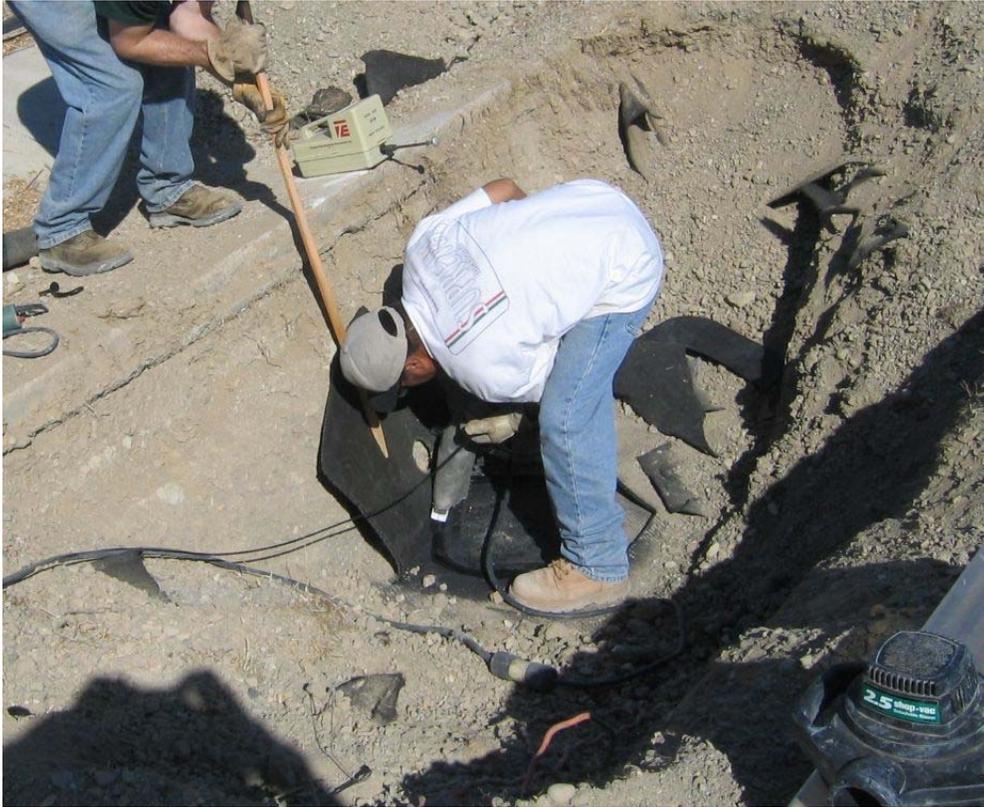
Photograph of Repair No. R-10
Extrusion welding the patch over RISSCD-02.

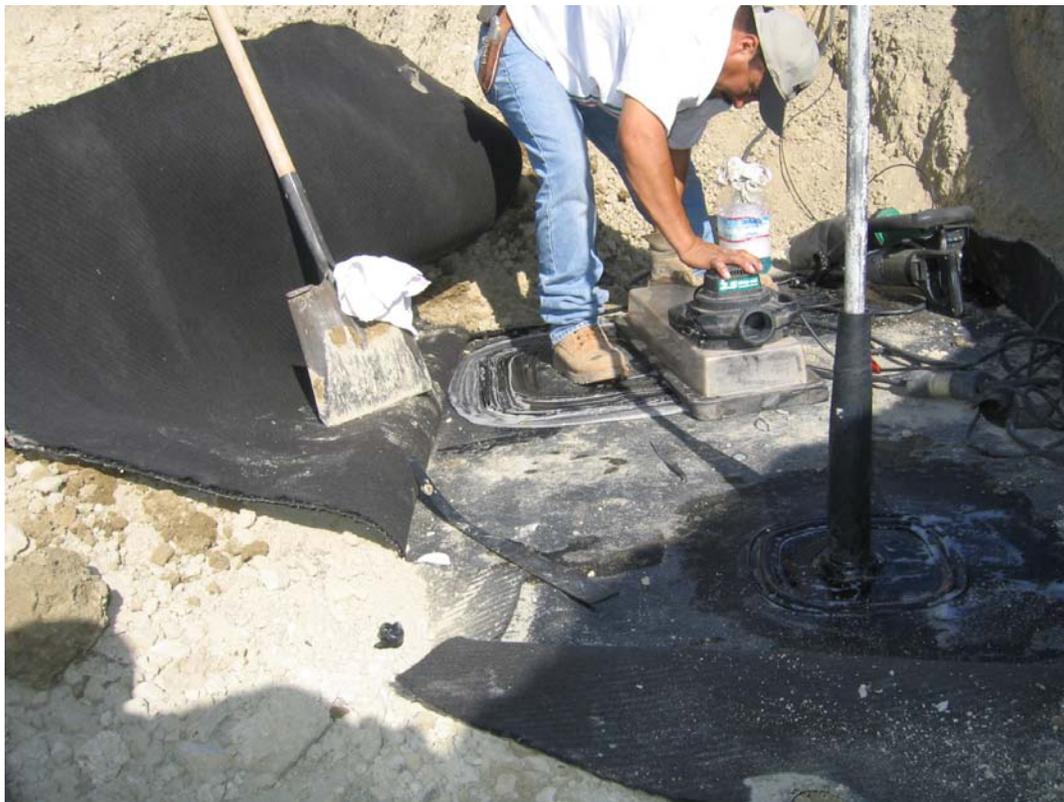
Photograph of Repair Nos. R-3, R-4, and R-5
Vacuum testing repair R-3 at RIPZ-22

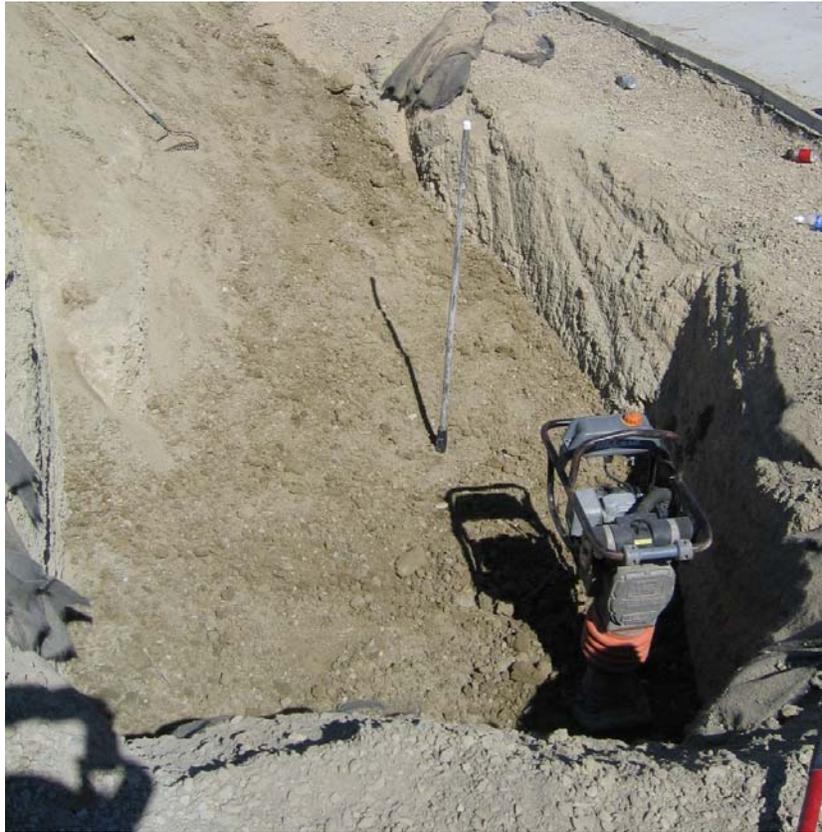
Photograph of Excavation at Repair R-3, R-4, and No. R-5
Backfilling and compacting excavation at RIPZ-22

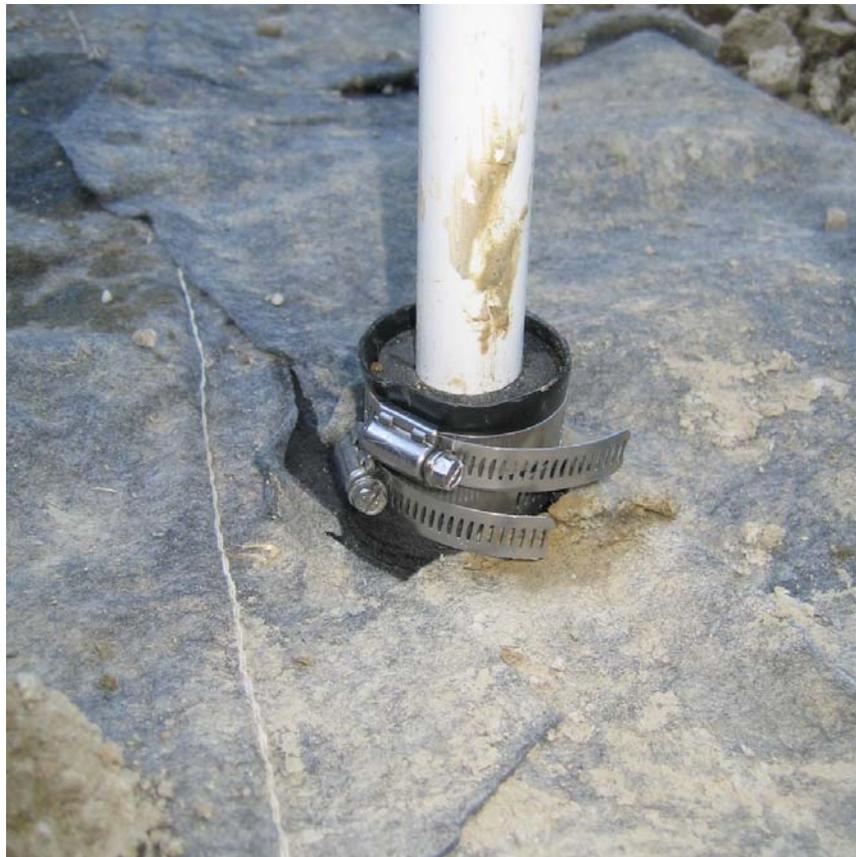
Photograph of Repair No. R-17
Typical boot collar completion with geotextile cushion over geomembrane
