2014 ANNUAL SITE INSPECTION REPORT GROUNDWATER TREATMENT FACILITIES NORTH INDIAN BEND WASH SUPERFUND SITE, SCOTTSDALE, ARIZONA

EPA Contract Number EP-S9-08-03
Task Order 0007

June 2015

Document Control No. 07163.0008.0147

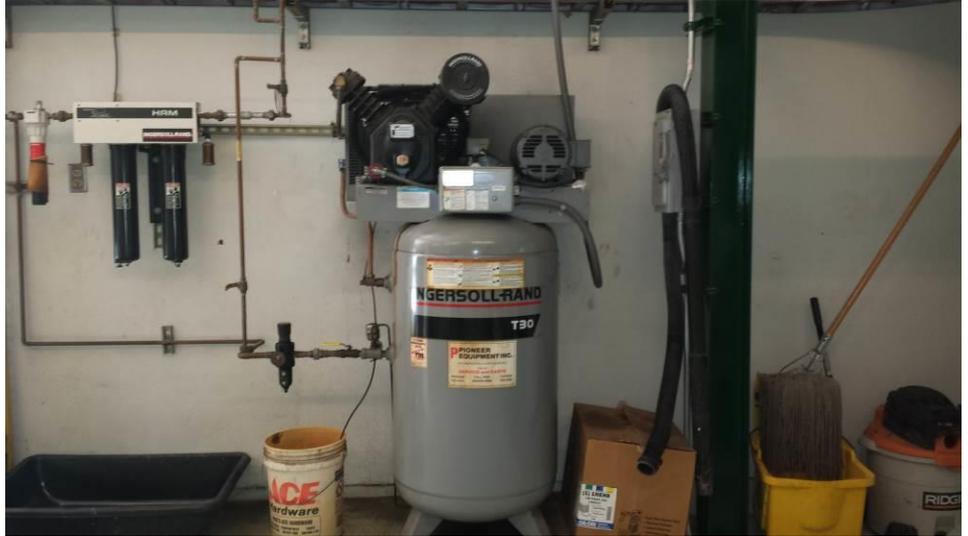
Description: Air compressor in good working condition.

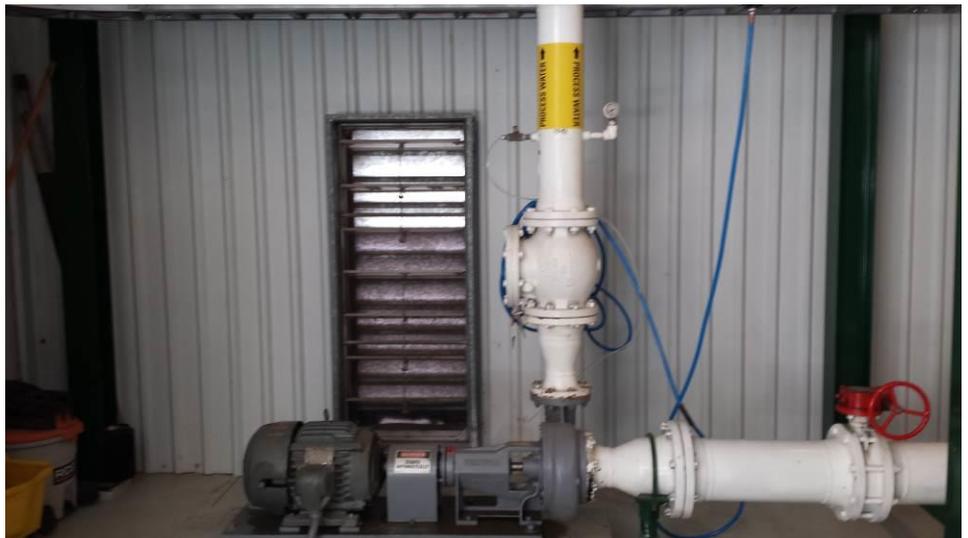
Photograph No. 2

Description: Pump P-1 prior to ultraviolet/chemical oxidation (UV/Ox) treatment. Sample port SP-102-S is shown at the top center of the photo just below the yellow pipe label.

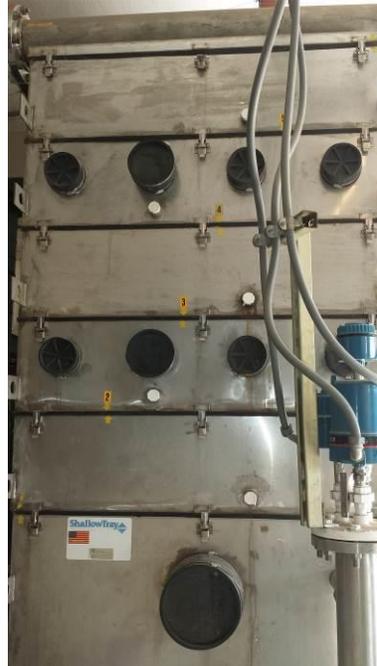
Description: Tray air stripper that was in good working condition during the inspection. Next anticipated cleaning reported to be in early 2015.

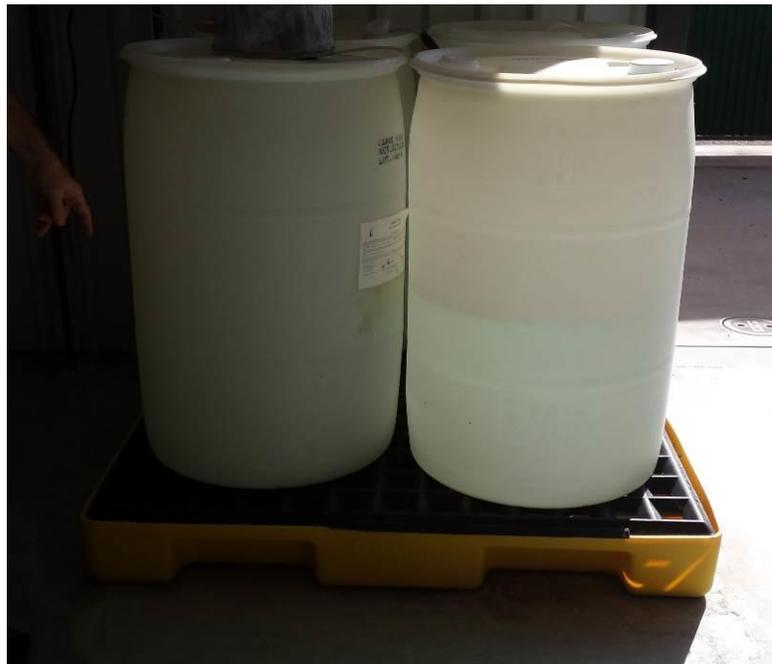
Photograph No. 4

Description: Polyphosphate (anti-scalant) drum storage area with drums on secondary containment.

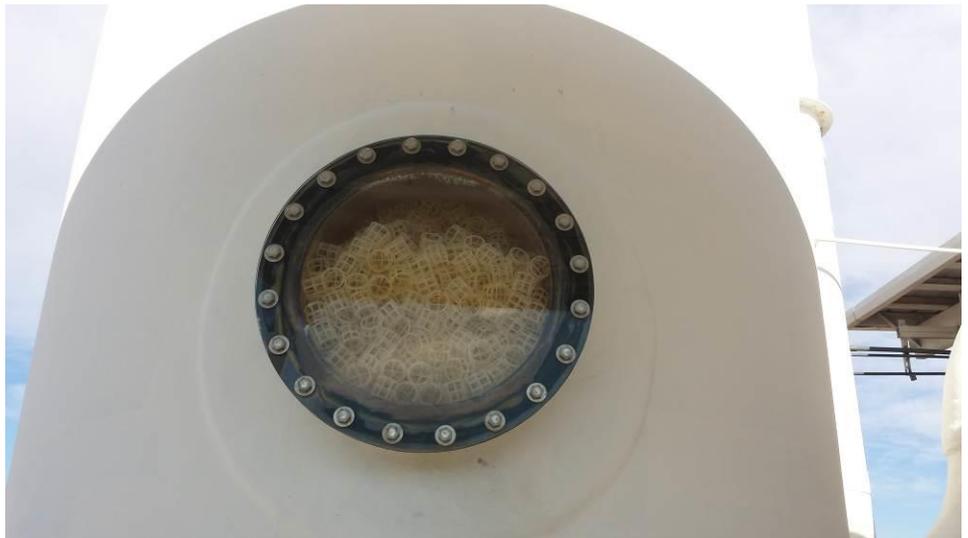
Photograph No. 4

Description: View of packing within the air stripper. Packing is in good condition.

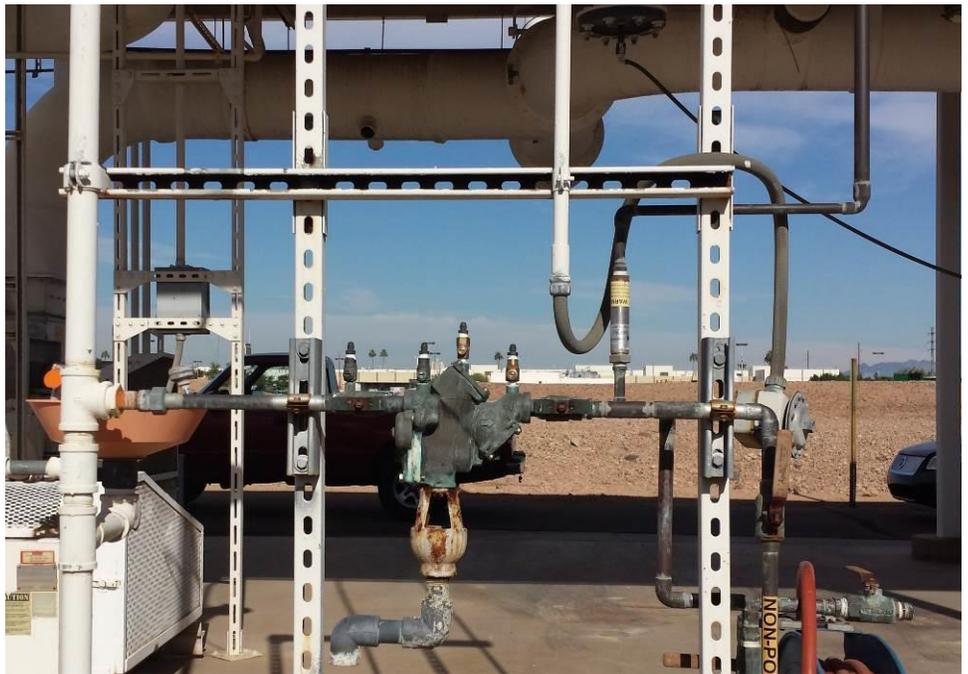
Photograph No. 6

Description: Emergency
eyewash station on the far left.
Note the corroded water
piping in need of replacement.

1. Repair corroded areas of the vGAC vessel.
2. Repair corroded parts of emergency eyewash station.
3. Provide documentation on the air stripper cleaning procedures in a chemical handling plan. This includes hazardous waste procedures and spill containment details.
4. Provide a maintenance plan for activities during the upcoming year. Action items developed during maintenance activities will be confirmed as completed or in progress during the next annual site inspection.
5. Provide written details of the major interlock alarm testing procedures, and include details as to how participating parties are incorporated in each step.
6. A hard copy of the Health and Safety Plan should be kept on site at all times.
7. Provide an updated O&M plan based on agency comments provided in September 2014.

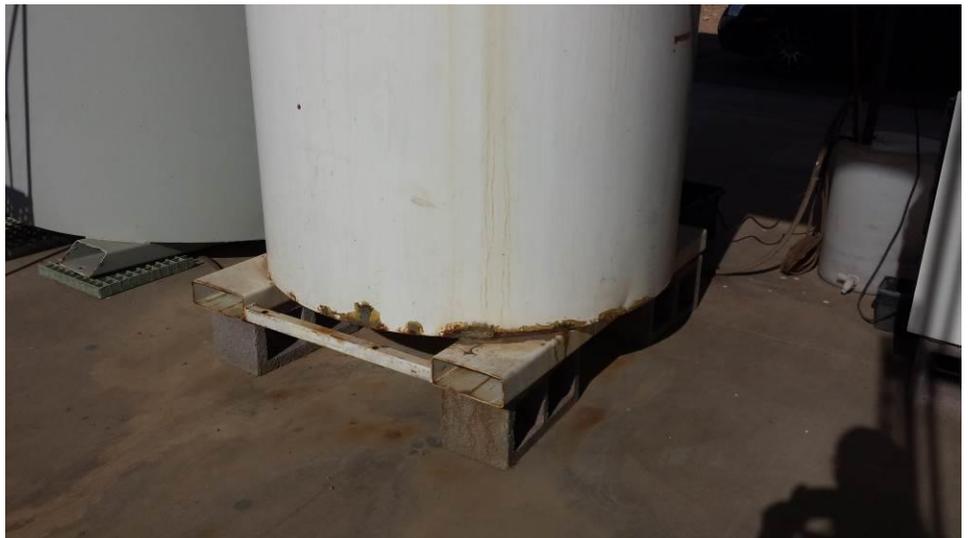
Photograph No. 8

1. Corroded areas of the vGAC vessel still need to be repaired.
2. Tagging of instrumentation to correlate with detailed and accurate Process and Instrumentation Diagrams (P&IDs) was completed.

Description: View of corroded vGAC vessel 2, still in need of repair.

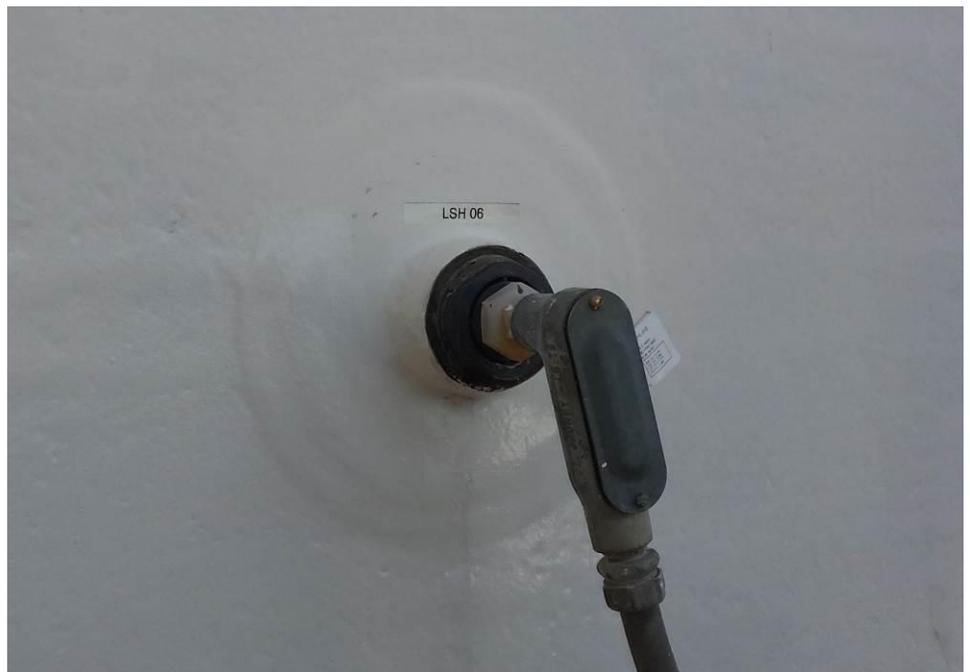
Photograph No. 10

Description: Example of labeling completed at site. This high level switch is located near the bottom of the air stripper containment area.

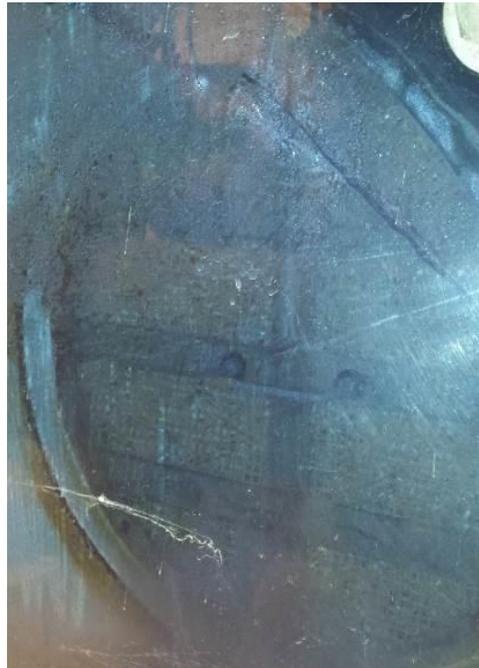
Photograph No. 6

Description: Moderately
scaled packing within air
stripper column 2.

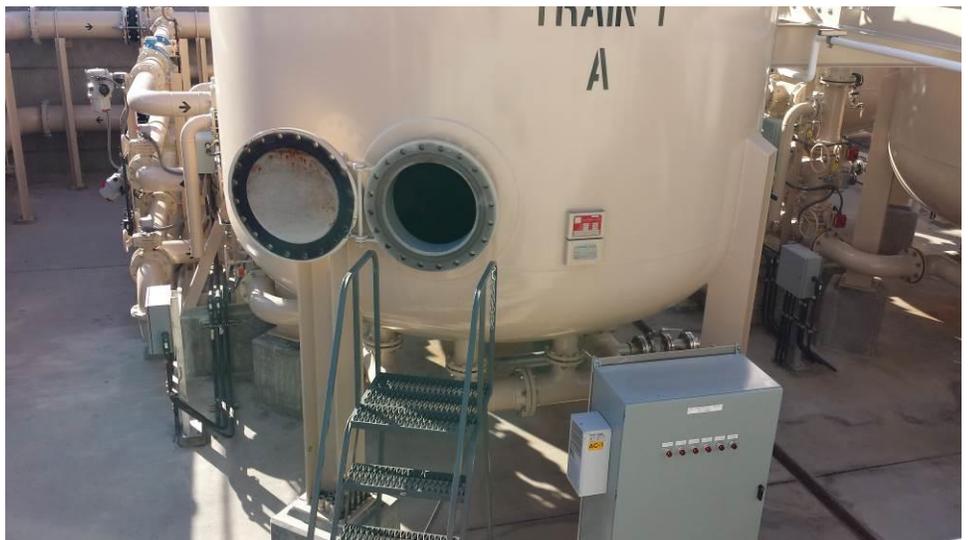
Photograph No. 6

Description: View of the carbon vessel for train 1A. The manhole is open for repairs inside the vessel. The control panel for train 1 is adjacent to the vessel.

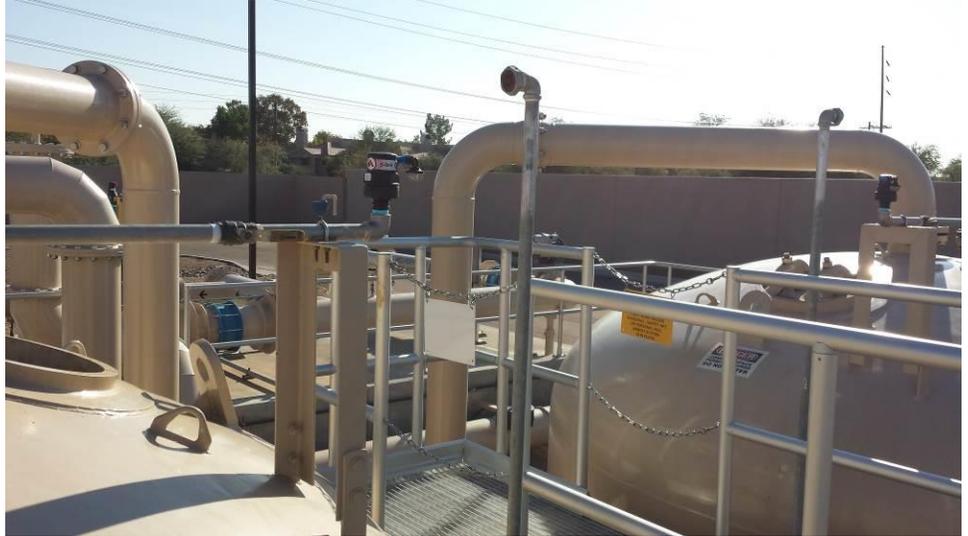
Description: New air relief valves (black instruments in center and on the right side of photo) replaced old valves that would leak.

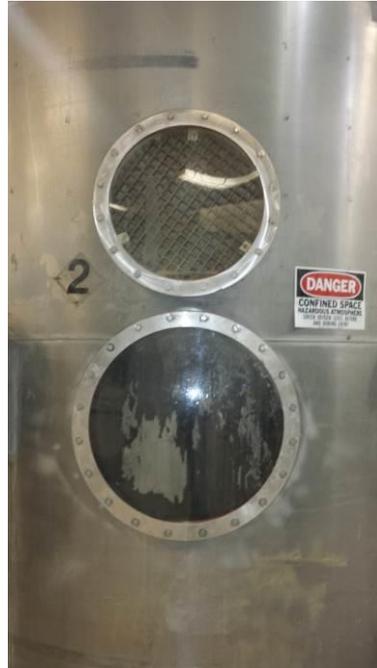
Description: Tower 2 in operation. Packing is in good condition.

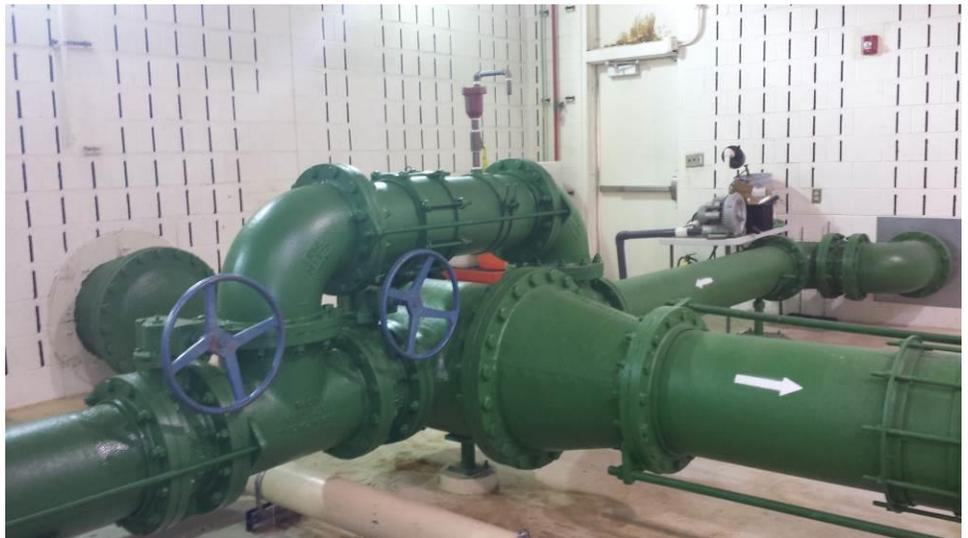
Photograph No. 4

Description: Piping reconfiguration resulting from the disconnection of the pipeline from PCX-1 to the MRTF treatment system.

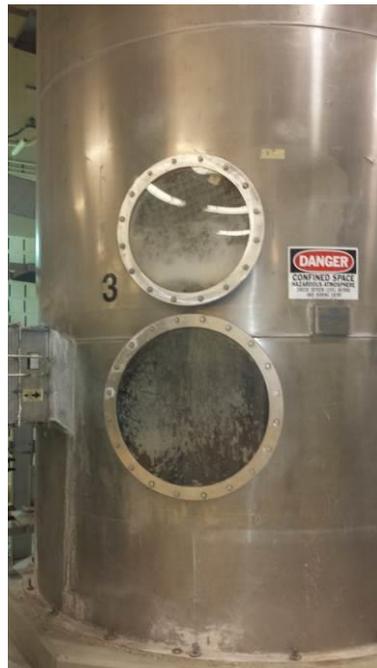
Photograph No. 6

Description: Tower 3 in operation. Packing is in good condition.

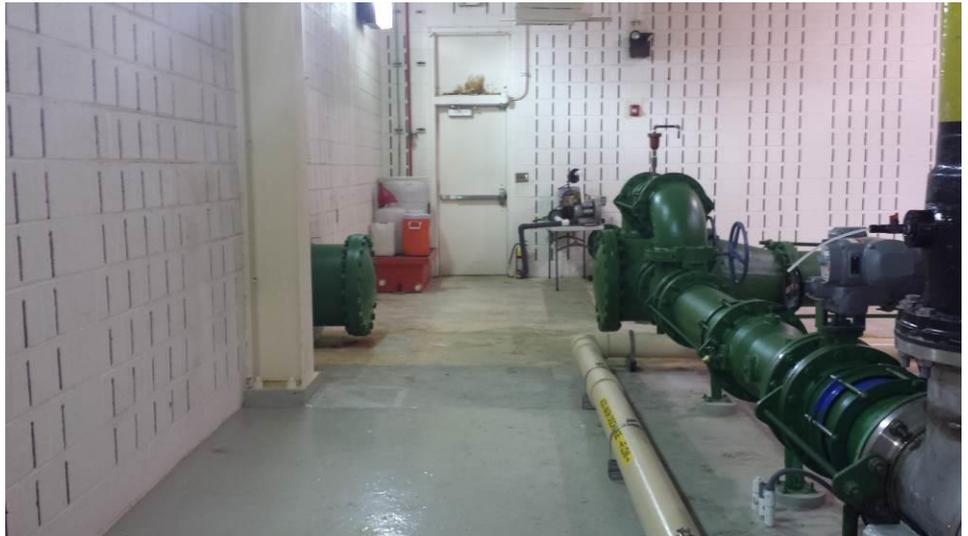
Photograph No. 8

Description: Blind flanges installed on the pipeline from PCX-1 and the connection to treatment system piping (disconnected section of piping having blind flanges in the center of the photo).

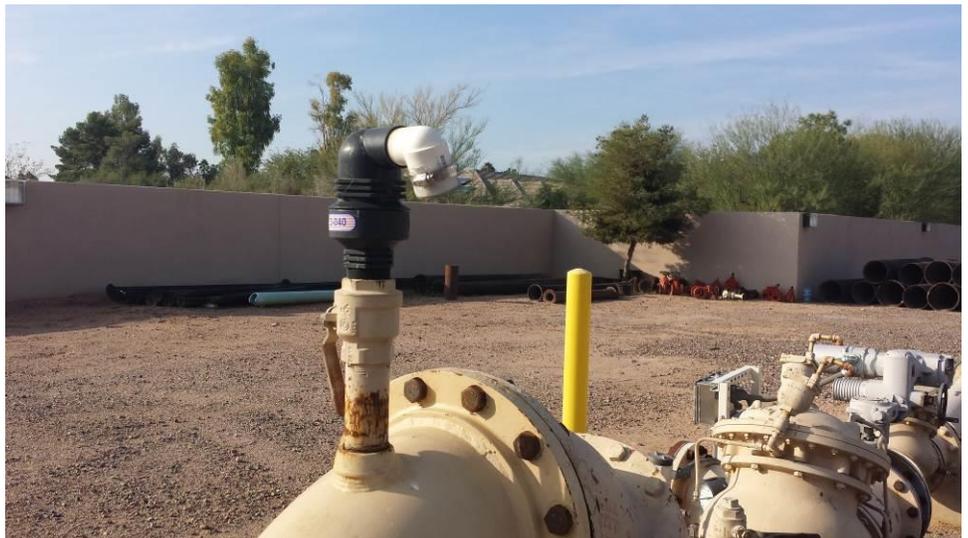
Photograph No. 14

Description: The air relief valve at the PV-15 wellhead has been reconfigured to minimize the potential of bodily harm.
