FINAL FIVE-YEAR REVIEW REPORT

**INSTALLATION RESTORATION SITE 9
OPERABLE UNIT 1
MARINE CORPS BASE
CAMP PENDLETON, CALIFORNIA**

September 12, 2007

Prepared by:
DEPARTMENT OF THE NAVY
Naval Facilities Engineering Command Southwest
1220 Pacific Highway, San Diego, California 92132-5190

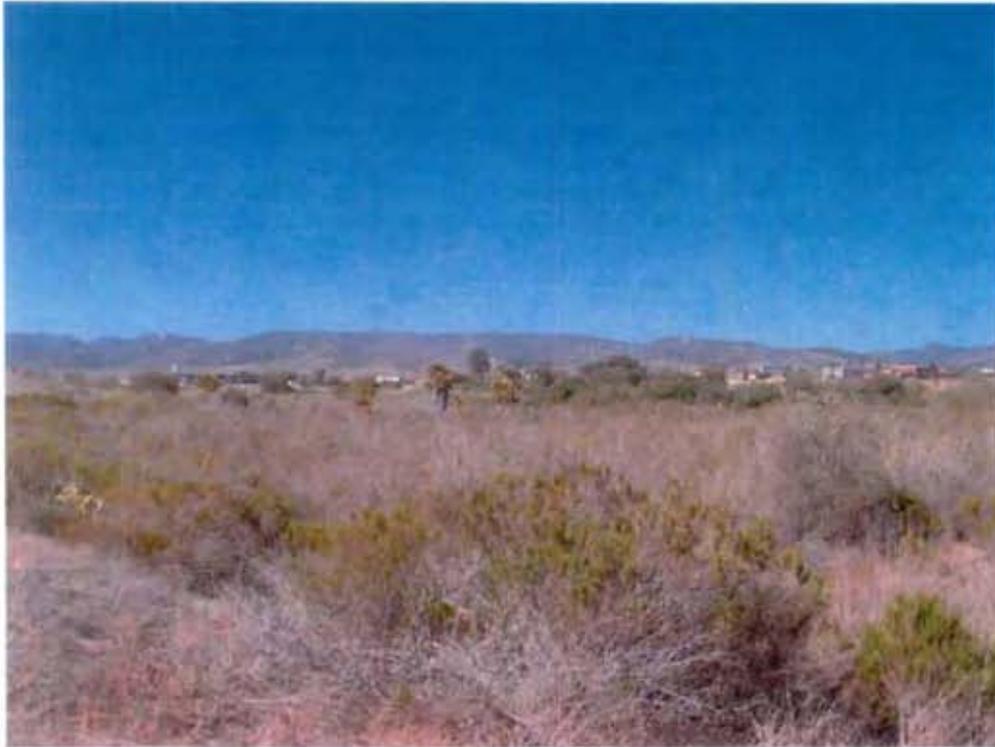
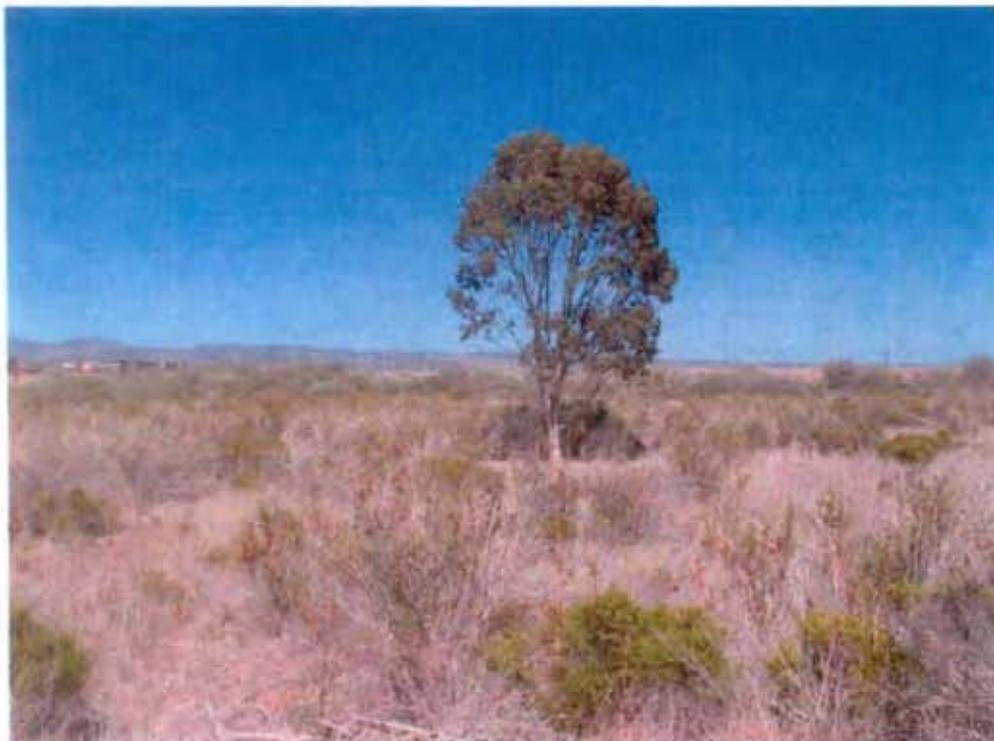
- The site is not used for any purposes. The pond is surrounded by an earthen dike on all sides. The dike is about 8 feet tall as measured from the bottom of the pond, which is relatively flat all across.
- The former disposal areas show no sign of recent disposal activities. The impoundment is dry. The earthen berm surrounding impoundment is intact.
- Most of the site is covered with dense vegetation, with a few bare patches of soil, and shows minimal erosion damage.

**VIEWS TO
NORTHEAST AND SOUTHEAST FROM WESTERN EDGE OF SITE**
