**Five-Year Review Report for
Installation Restoration (IR) Site 9 - Operable Unit 1
Marine Corps Base Camp Pendleton
Camp Pendleton, California**

May 20, 2002

**Five-Year
Review Report**

**Southwest Division
Naval Facilities Engineering Command
San Diego, California**

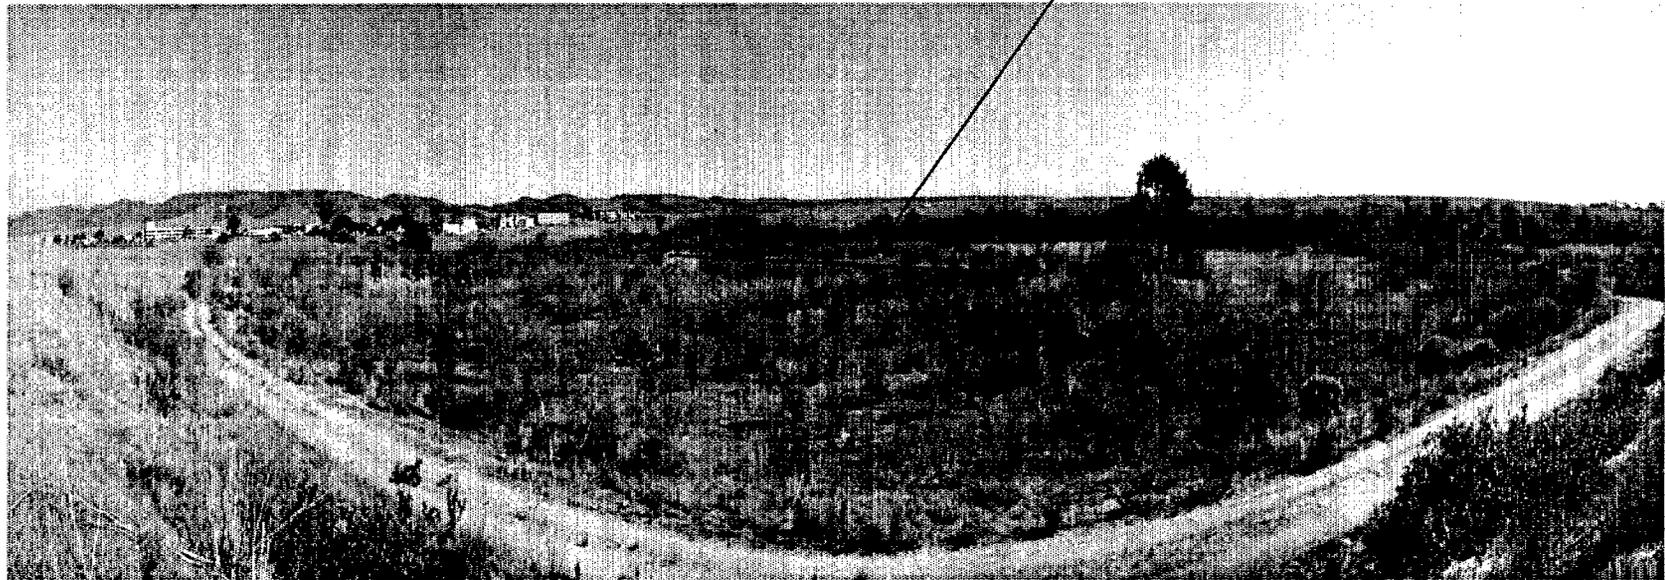
Abandoned above grade sewer pipeline

Photograph No. 1: IR Site 9 – 41 Area Waste Stabilization Pond
Looking Northeast (January 03, 2001)

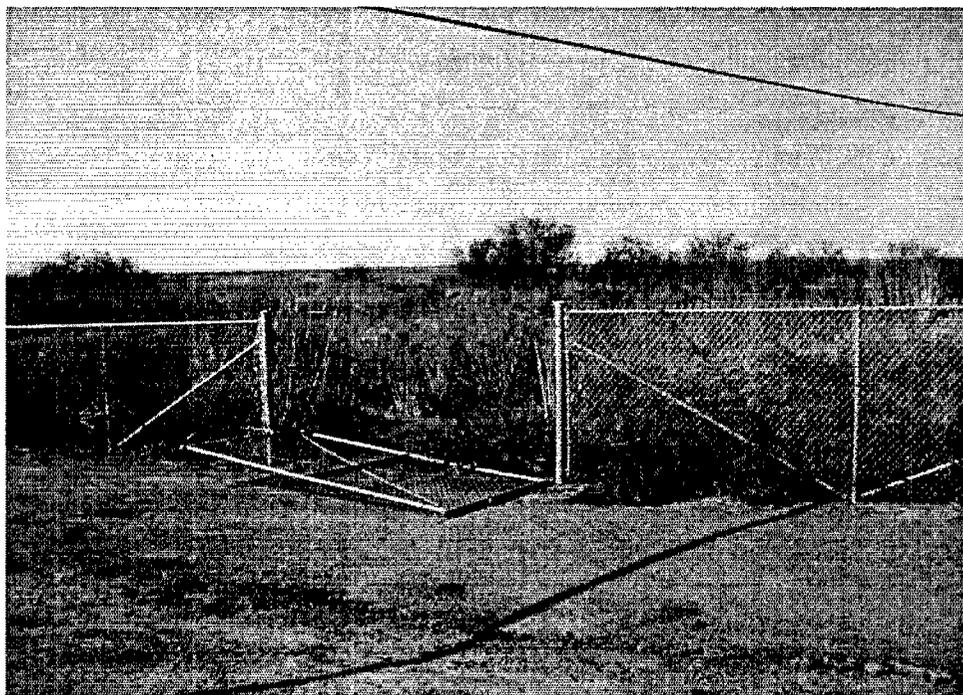
During the interview, Lt. Col. Linder indicated that the gate to the grease pit was down and that the fence did not entirely enclose the grease pit. Lt. Col. Linder also noted that an old sign in the stabilization pond area that was used to direct past disposal activities should be removed. Lt. Green and Mr. Baltikauski indicated that the base is in the process of updating the Capital Improvement Plan (MasterPlan) for 41 Area. IR Site 9 will be noted in this plan and designated similarly to the legend of the constraints map. Lt. Col. Linder would like the site to be used as a critical habitat mitigation area.

- The site is inactive and is not used for any purposes. The former grease disposal pit is partially secured by a chain-linked fence installed along the access road and the west side. One of the fence panels is detached and needs repair. The former waste lagoon area has no fence. The lagoon is surrounded by an earthen dike on all sides. The dike is about 8 feet tall as measured from the bottom of the pond, which was relatively flat all across.

The visual inspection of the site and interviews with base personnel indicated that site conditions and land uses have not changed in the last 5 years. With the exception of one panel of the security fence at the former grease disposal pit, there is no sign of damage that requires repair or maintenance.

Photograph No. 2: Damaged gate in fence for restricting access to the Former Grease Pit.
Looking North (January 03, 2001)

- Repair the security fence panel at the grease disposal pit.
- Repair or replace the dedicated sampling pump in well MW-03S.
- Install signs to reinforce access restrictions to the site and provide contact information.

B.	<p>Adequacy of O&M</p> <p>Describe issues and observations related to the implementation and scope of O&M procedures. In particular, discuss their relationship to the current and long-term protectiveness of the remedy.</p> <p><u>The site is located in an isolated area with limited access. No signs of significant damages were found during this inspection. The broken fence panel should be repaired.</u></p> <hr/>

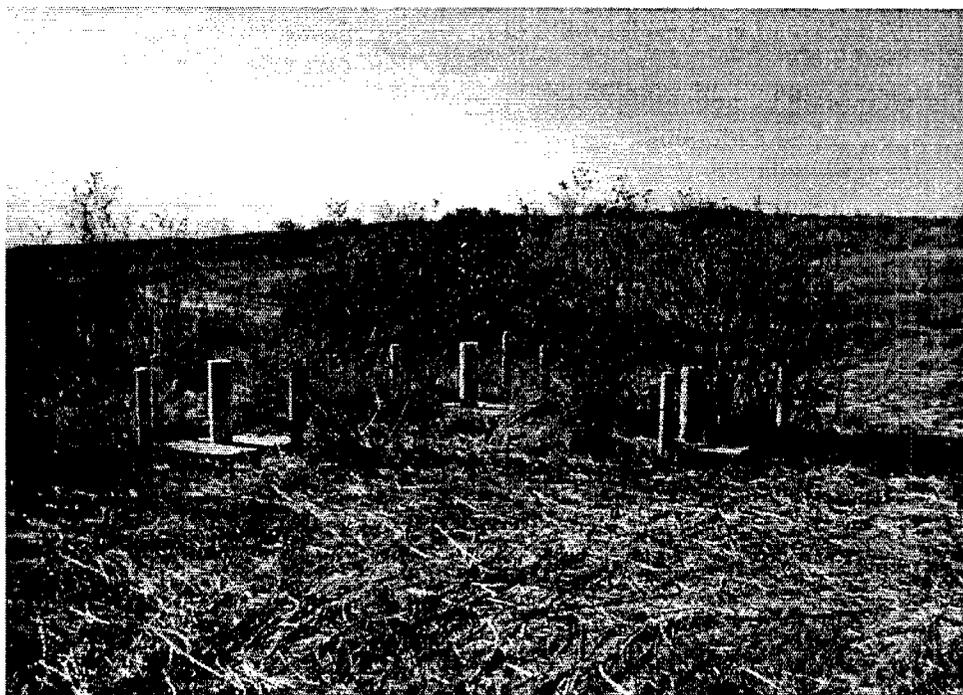
Groundwater level data indicates that the most recent groundwater level at the site was generally about 2 feet lower than the 1997 level (9W-6A, 6B, 6C). This is likely due to the relatively dry weather experienced in 1999 and 2000. However, such fluctuation of groundwater levels is not uncommon and was also noted in the RI report (SWDIV, 1993). The groundwater gradient and flow directions have not changed significantly. Because PCE was detected in only one well, the extent and migration of the PCE could not be fully assessed with the limited data available. See Section 9 for recommended additional action.

Photograph No. 3: Monitoring Well cluster 9W-6A, -6B, & -6C
Looking North (January 03, 2001)

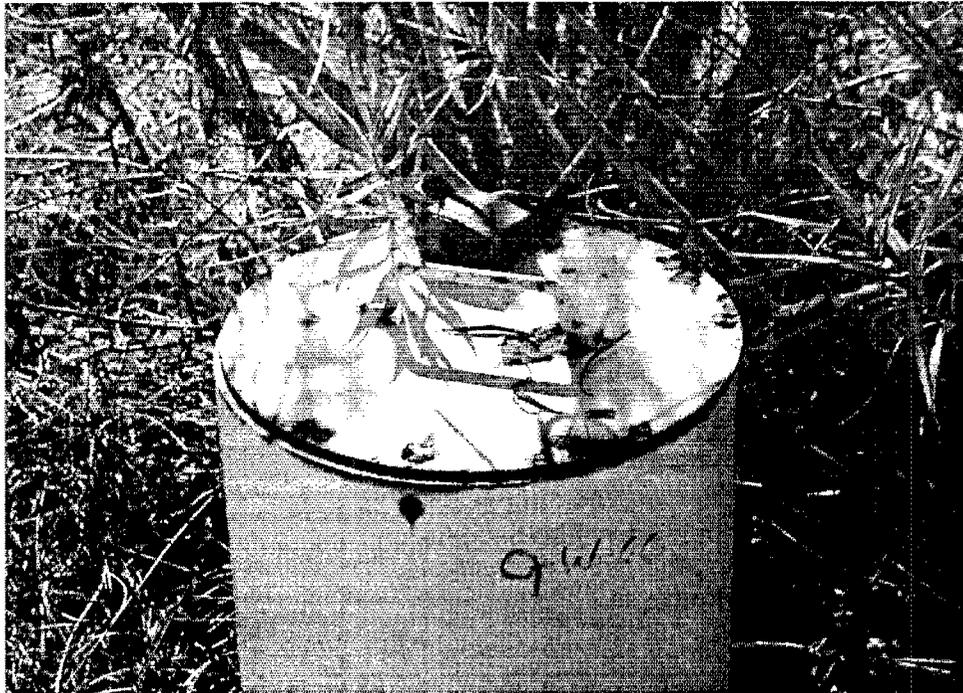
Photograph No. 4: Monitoring Well 9W-6C
(January 03, 2001)

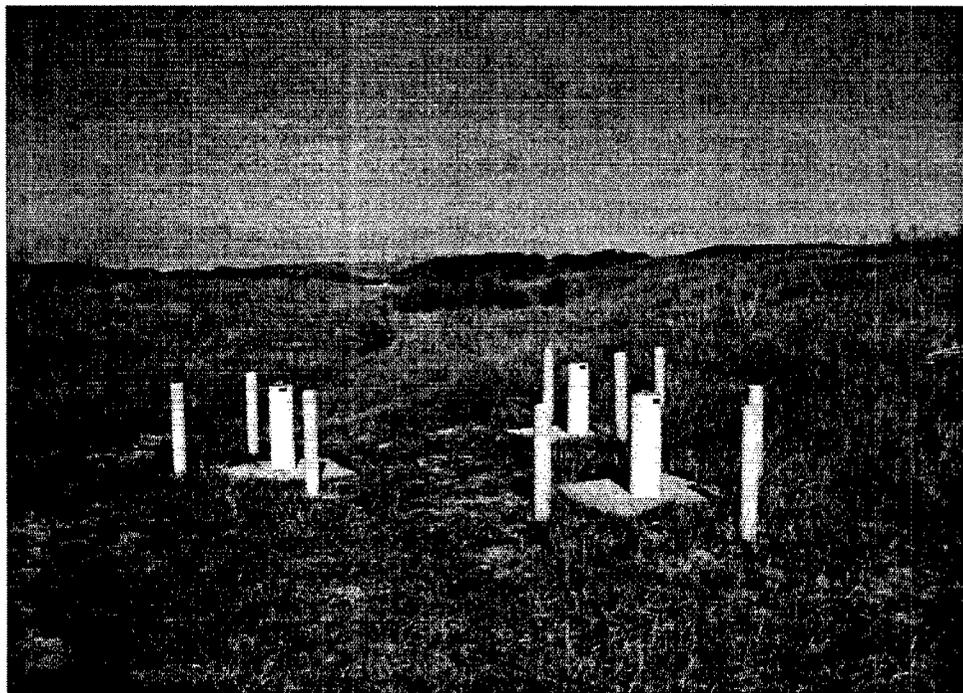
Photograph No. 5: Monitoring Well cluster 9W-7A, -7B, & -7C
Looking East (January 03, 2001)

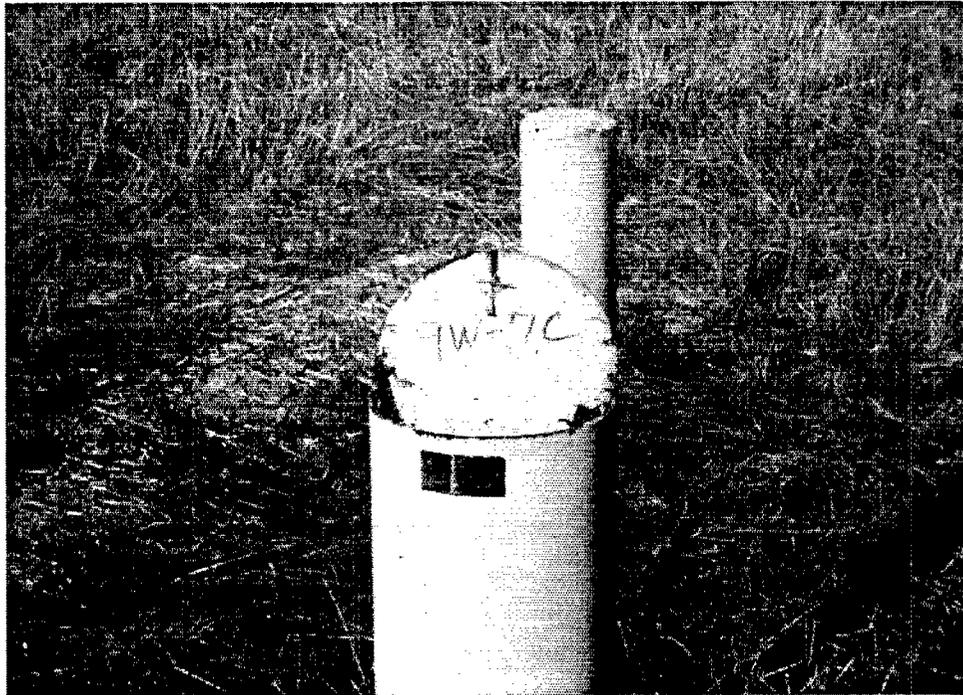
Photograph No. 6: Monitoring Well 9W-7C
(January 03, 2001)

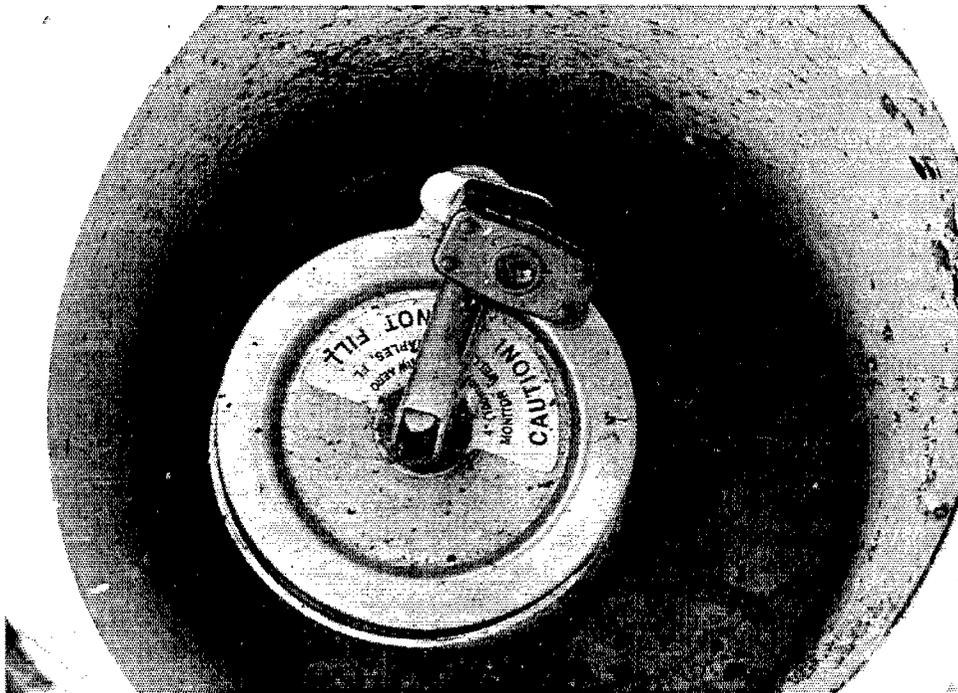
Photograph No. 7: Interior view of Monitoring Well 9W-7C
(January 03, 2001)
