CH2M HILL  
155 Grand Avenue  
Suite 800  
Oakland, CA 94612  
Tel 510.251.2888  
Fax 510.622.9000

October 31, 2014

Subject: Additional Vapor Intrusion Evaluation Report, June/July 2014, Former Synertek Building No. 1, 3050 Coronado Drive, Santa Clara, California, Final Site Cleanup Requirements Order No. 91-051

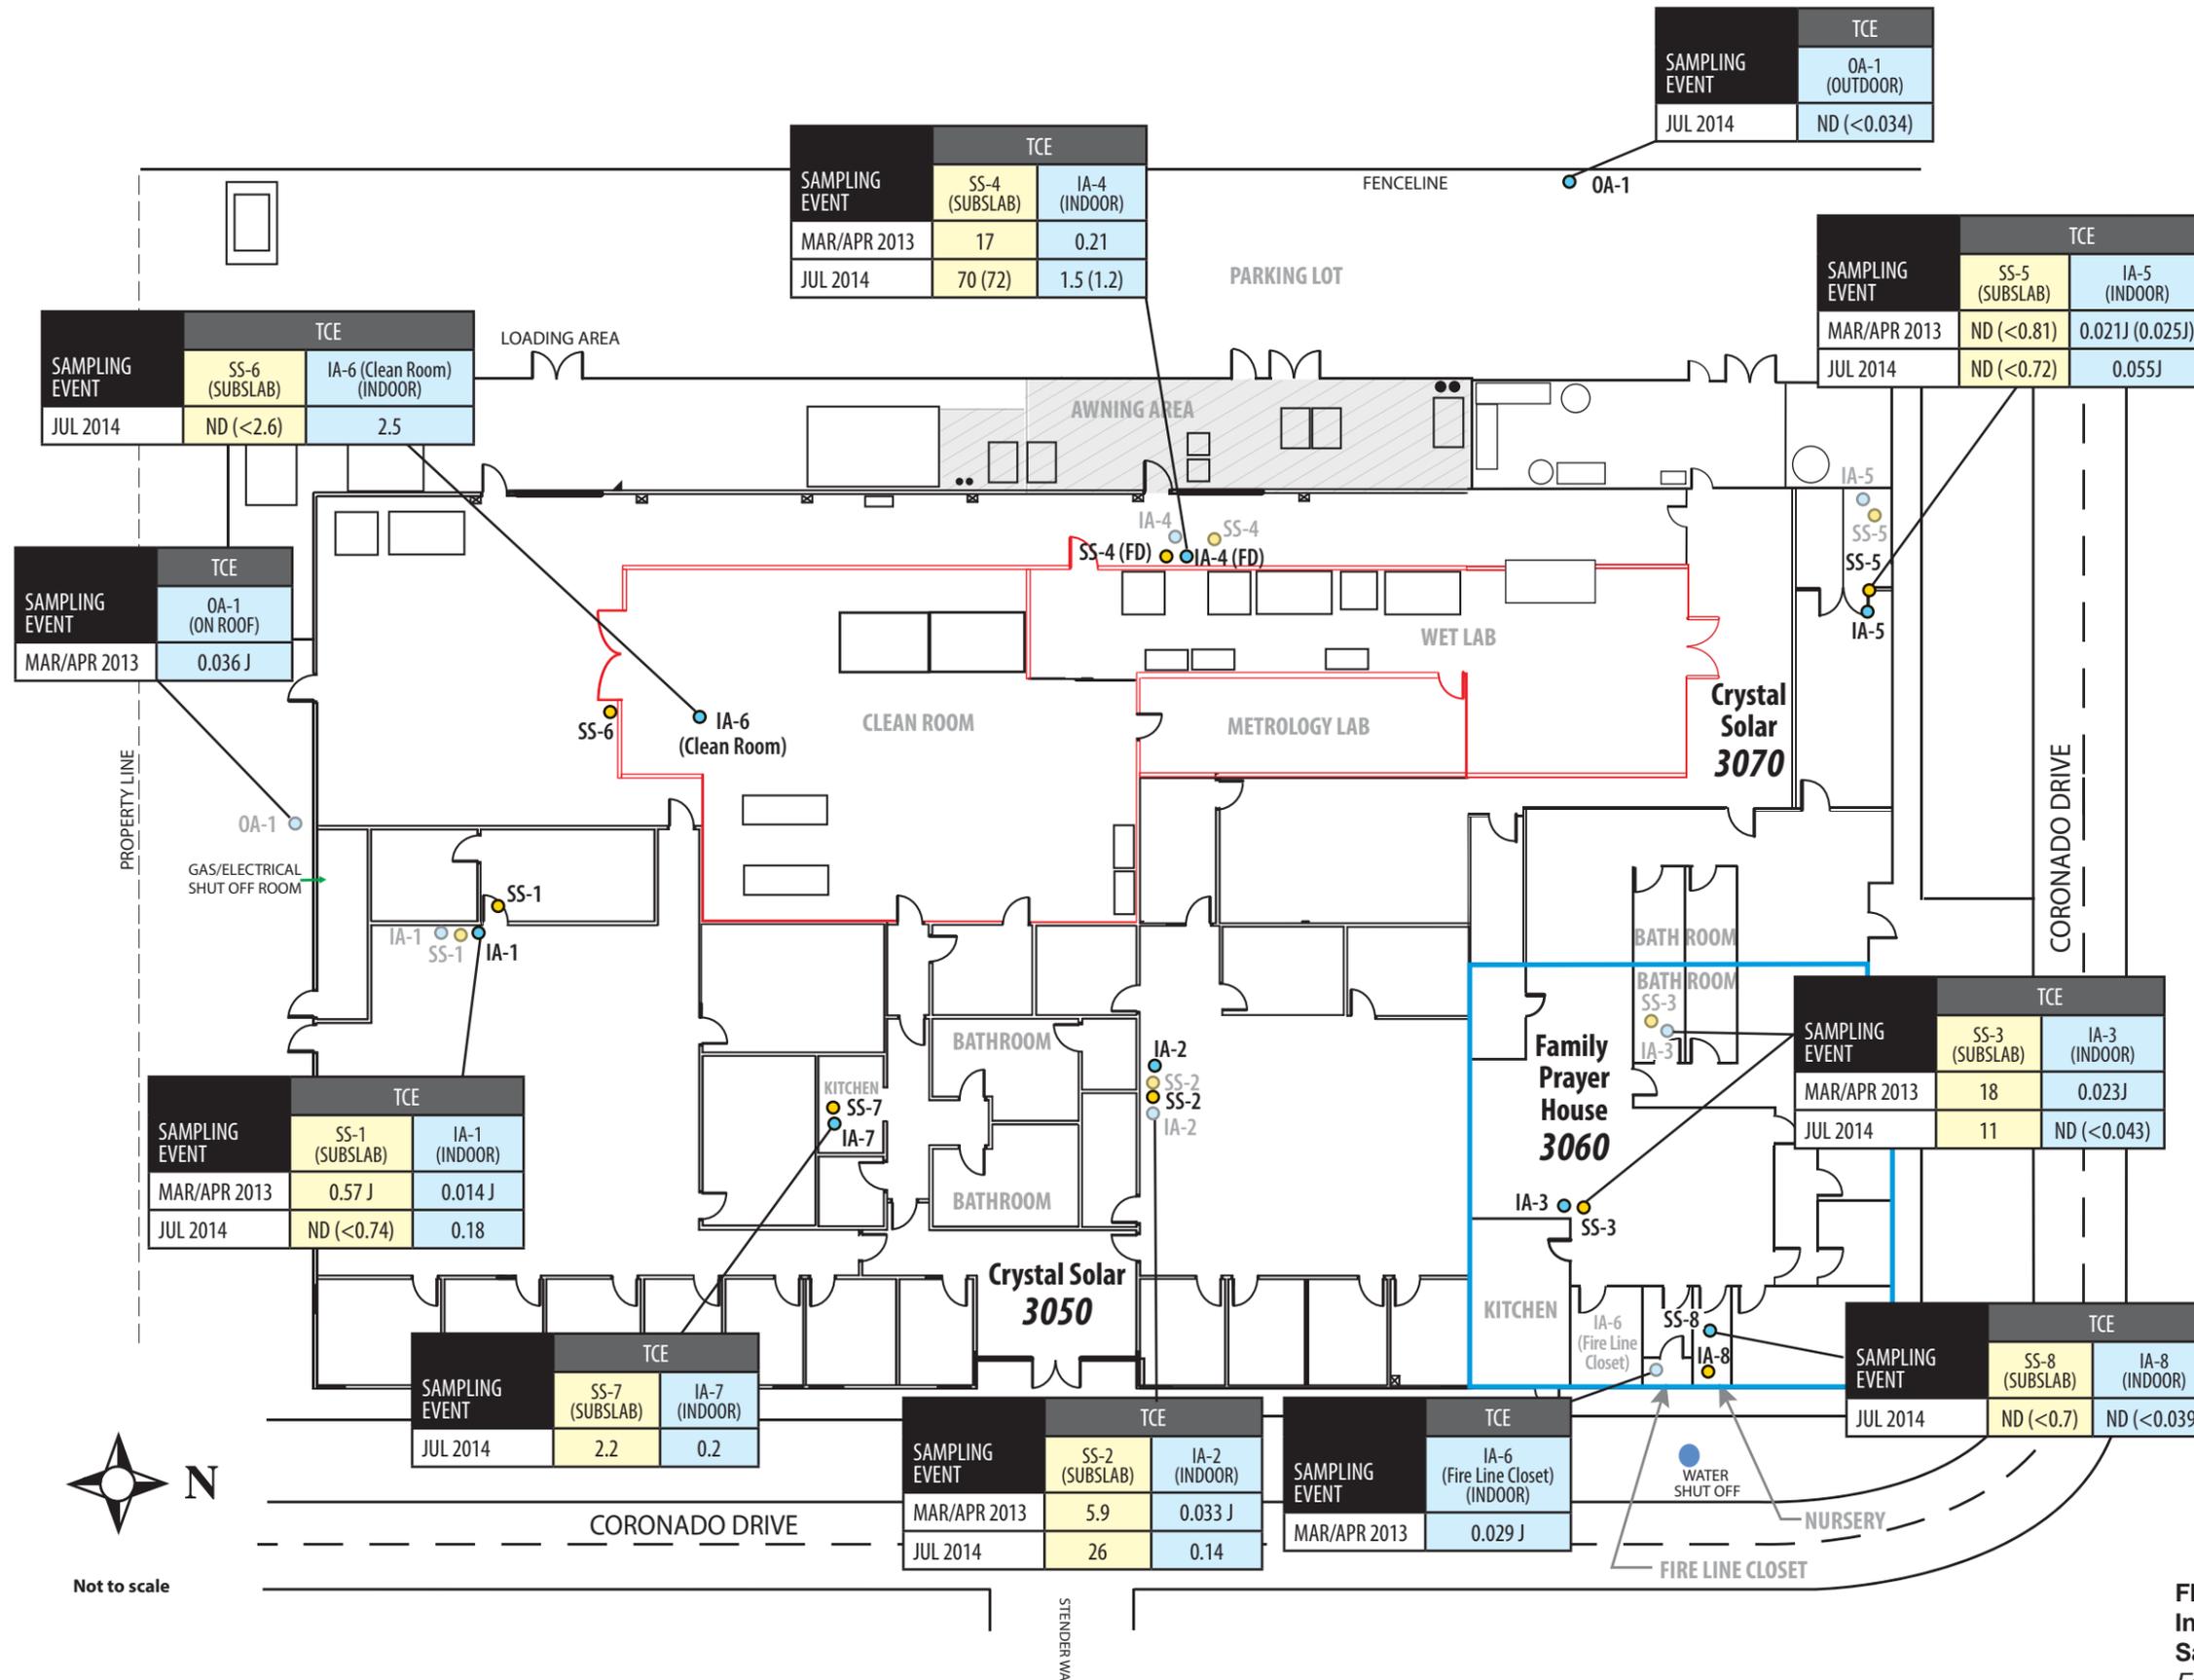
The HAPSITE sample locations and TCE results are shown in Figure 3. A photo log of HAPSITE sampling locations is included in Attachment 4.

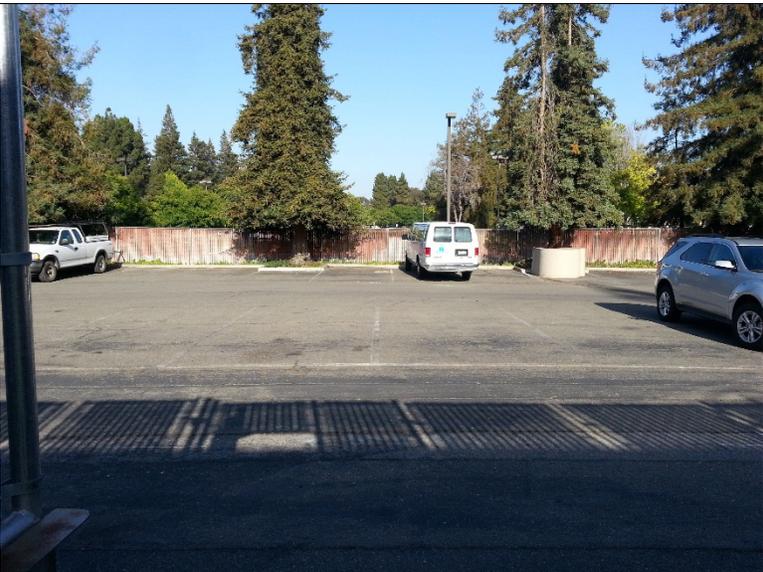
Fence line: Location of Outdoor Air Sample

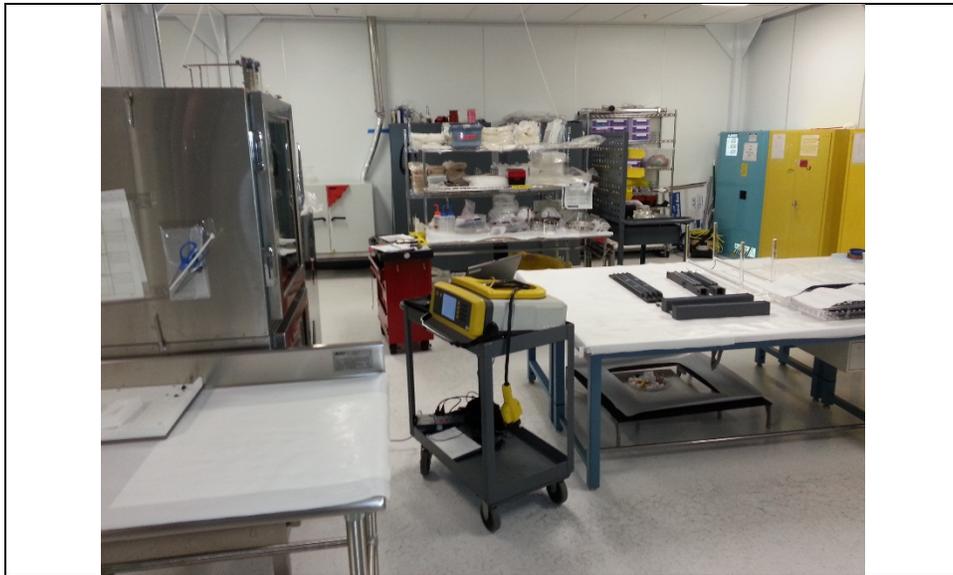
As with the HVAC-on event, the majority of the compounds were largely not detected. The only notable detection was for TCE in a sample taken in the interior of clean room (HAP-12) at approximately 11:00 a.m. After discussion with tenant, it was discovered that an additional background indoor source, two mostly empty 4-L amber jugs of TCE, were located within a cabinet inside the cleanroom. The tenant removed the jugs that afternoon at 12:50 p.m., approximately midway through the indoor SUMMA sampling period. At 6:03 p.m., another sample was taken at the same location in the clean room and TCE was not detected. An additional sample was taken in the wet lab (HAP-14) at 5:31 p.m., and TCE was not detected.

<b>Photo No.</b>	20	<b>Date</b>	07/05/14	<b>View Direction</b>	North
Interior of clean room. Site where duplicate samples were taken to verify TCE detect.

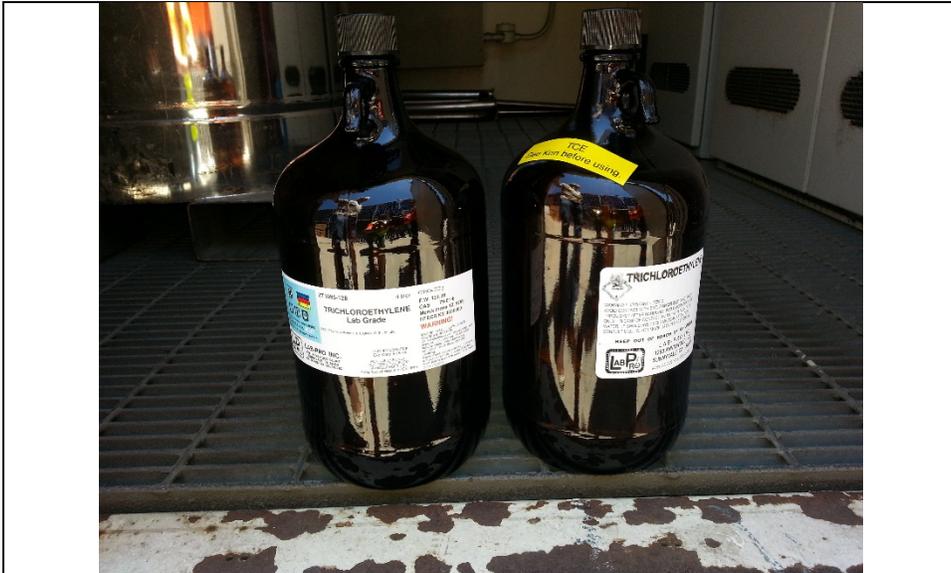
Two bottles of TCE removed from the Clean room.

At least 48 hours prior to sample collection, the known TCE container was removed from the wet lab, and sample collection commenced the morning of July 5, 2014. As discussed in the HAPSITE screening section above, at approximately 12:50 p.m. on July 5, additional TCE containers were identified by the tenant in the clean room and removed. The outdoor air sample (SYN-OA1) was collected on the fence line west of Building 1. The indoor air samples were collected as outlined in the Additional VI Work Plan. The samples were collected from approximately 3 to 5 feet above the building floor to represent the breathing zone. The indoor and outdoor air sampling locations are shown on Figure 4.
