**FOURTH FIVE-YEAR REVIEW REPORT FOR**  
**LIQUID GOLD OIL CORPORATION SITE**  
**CONTRA COSTA COUNTY, CALIFORNIA**

U.S. Army Corps of Engineers, Seattle District

U.S. Environmental Protection Agency  
Region IX  
San Francisco, California

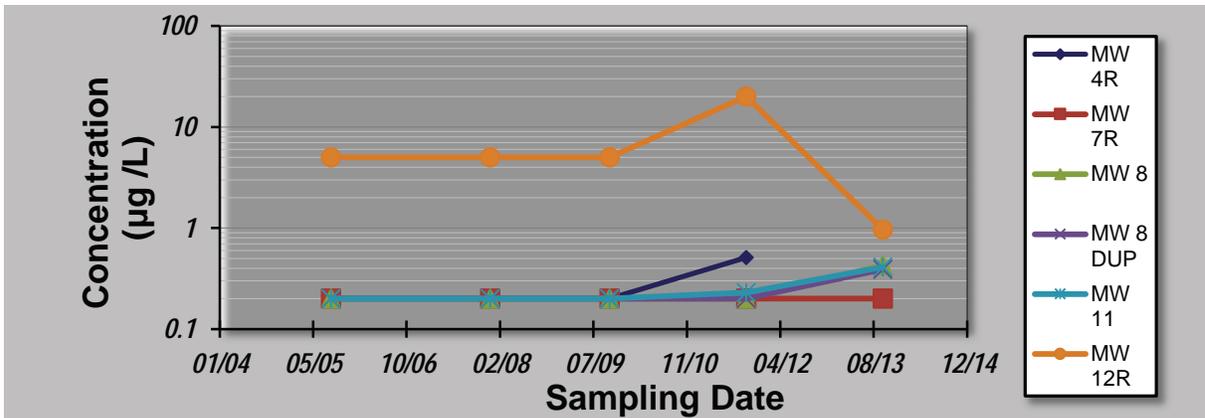
Figure 7: Mercury Trends

MW11 is located upgradient from the Site, so the increasing mercury trend in groundwater at that location could hypothetically indicate on-site migration from another source and should be investigated further if concentrations continue to increase.

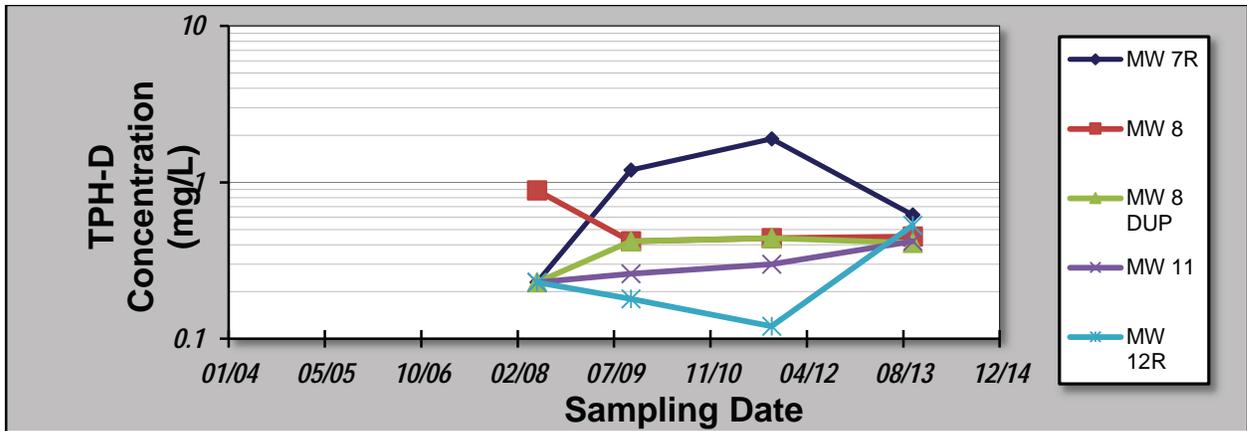
**Figure 10: TPH-D**

TPH-D has historically been detected in all groundwater monitoring wells. The data summary for TPH-D groundwater sampling results is presented in Table 8, and the Mann-Kendall trend analysis is shown in Figure 10. The analysis used TPH-D concentrations from 2008 to 2013. MW-4R and MW-13 were not included in the trend analysis because these wells were dry. For instances where the TPH-D concentration was below the detection limit, half of the detection limit was used in the trend analysis. For MW-7R, MW-8, and MW-12R, the results indicate that the trend is either stable or that no trend was detected. MW-11 showed an increasing trend (95.8 percent confidence factor). However, all levels of TPH-D used in the analysis were below the laboratory detection limit of 0.47 mg/L.

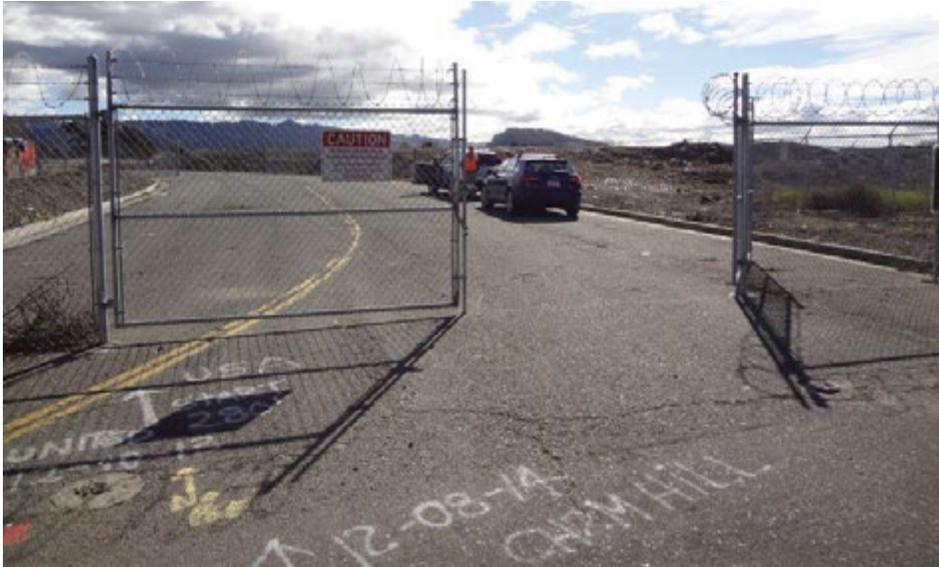
Photograph 1 (taken facing east): Most Exterior Access Gate to the Property from South 51<sup>st</sup> Street

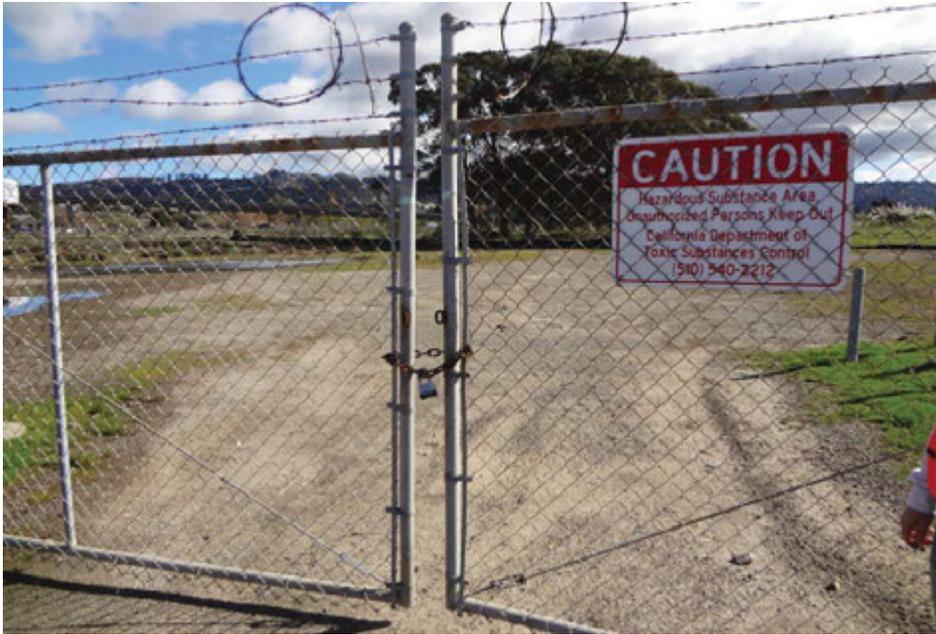
Photograph 2, (taken facing east): Third Locked Gate along the Access Road Sometimes referred to as an interior (nonperimeter) gate to access the Site.

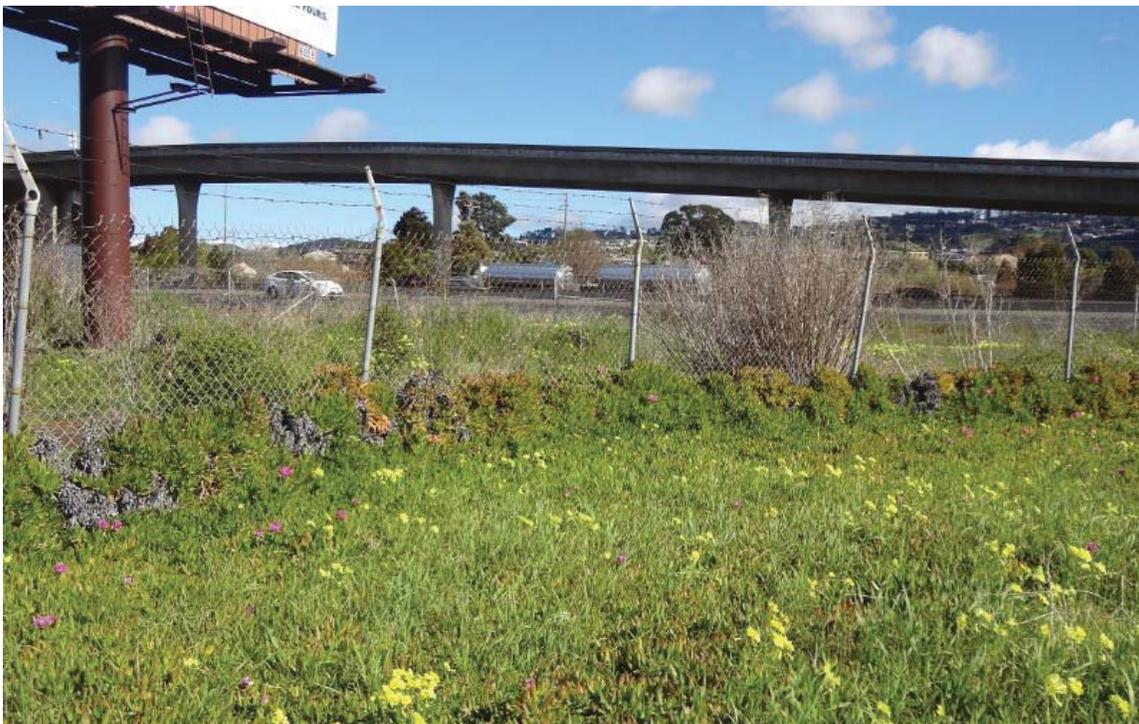
Photograph 3, (taken facing northeast): Sea Fig Plants Growing at the Base of the Fence along Interstate Highway 580

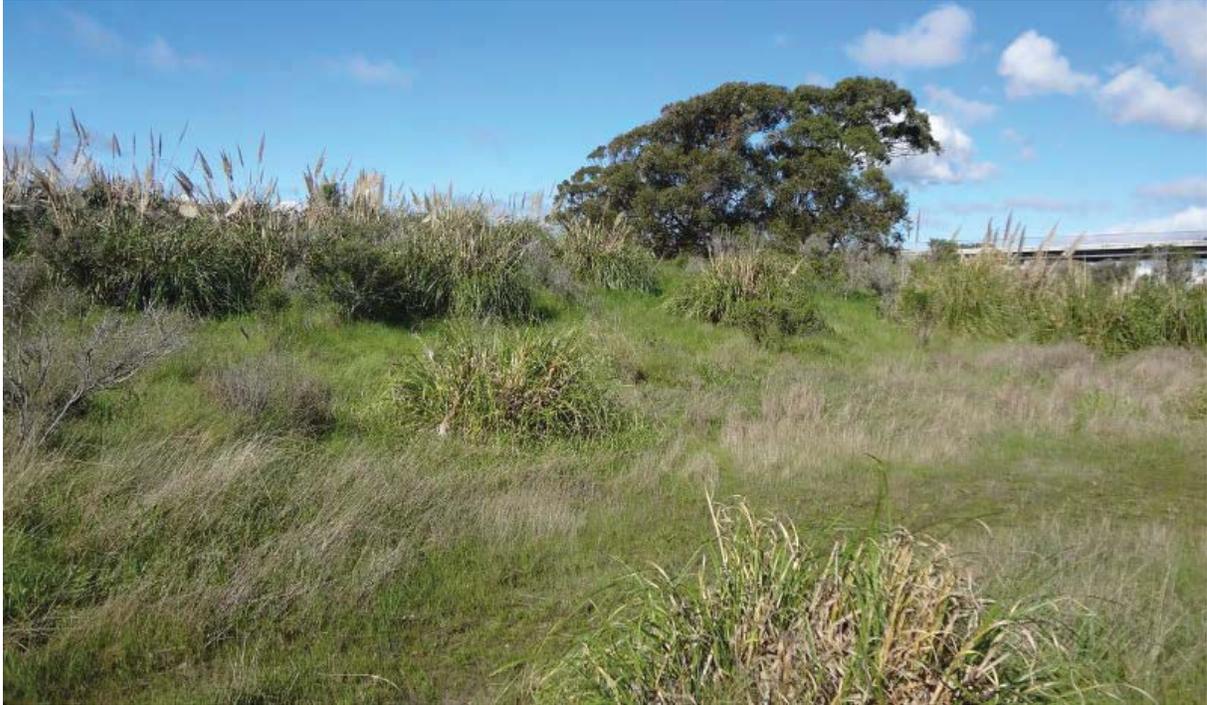
All access gates to the Site were found to be locked and in working condition. The team observed damage to the interior (nonperimeter) fence at the southernmost corner of the Site due to the growth of large pampas grass; however, the exterior (perimeter) fence still prevented access to the Site. The team observed some broken barbed wire at the top of the chain link interior (nonperimeter) fence in the southwest portion of the Site; however, the fence itself was still intact. A small portion of the vegetated cap slope extends beyond the fence. There was one very minor graffiti marking in white paint on the Site access gate. However, the team did not observe any other evidence of vandalism or trespassing such as trash or refuse. The team observed one bare spot in the vegetation covering the central portion of the cap, approximately six feet by six feet in size, but it did not appear to be eroding or depressed. This is a minor issue that does not appear to be negatively impacting the effectiveness of the vegetated cap. All active wells, including wells MW-4R, MW-7R, MW-8, MW-11, MW-12R, and MW-13, were located and inspected.

Photograph 4 (taken facing northwest): Side Slope of the Vegetated Cap  
An example of the pampas plants that have grown throughout cap area.

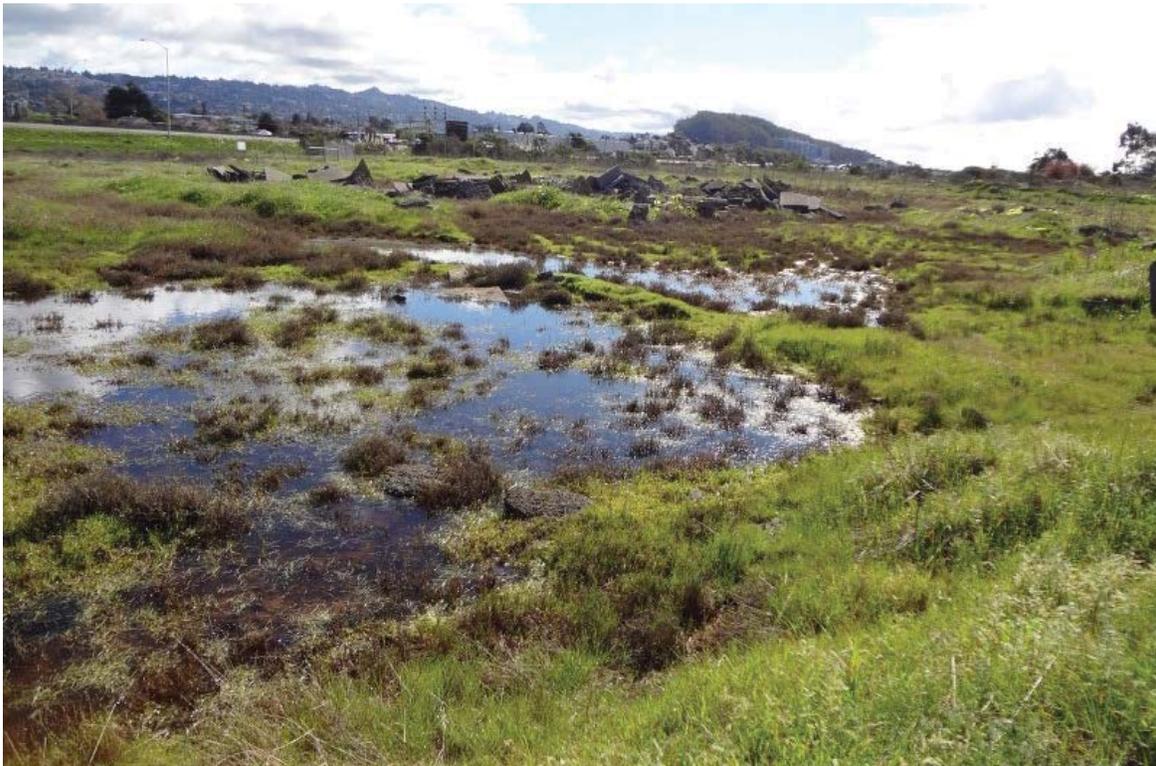
Photograph 5 (taken facing southeast): Ponded Area in the Easternmost Area of the Site,  
Outside of the Vegetated Cap Area

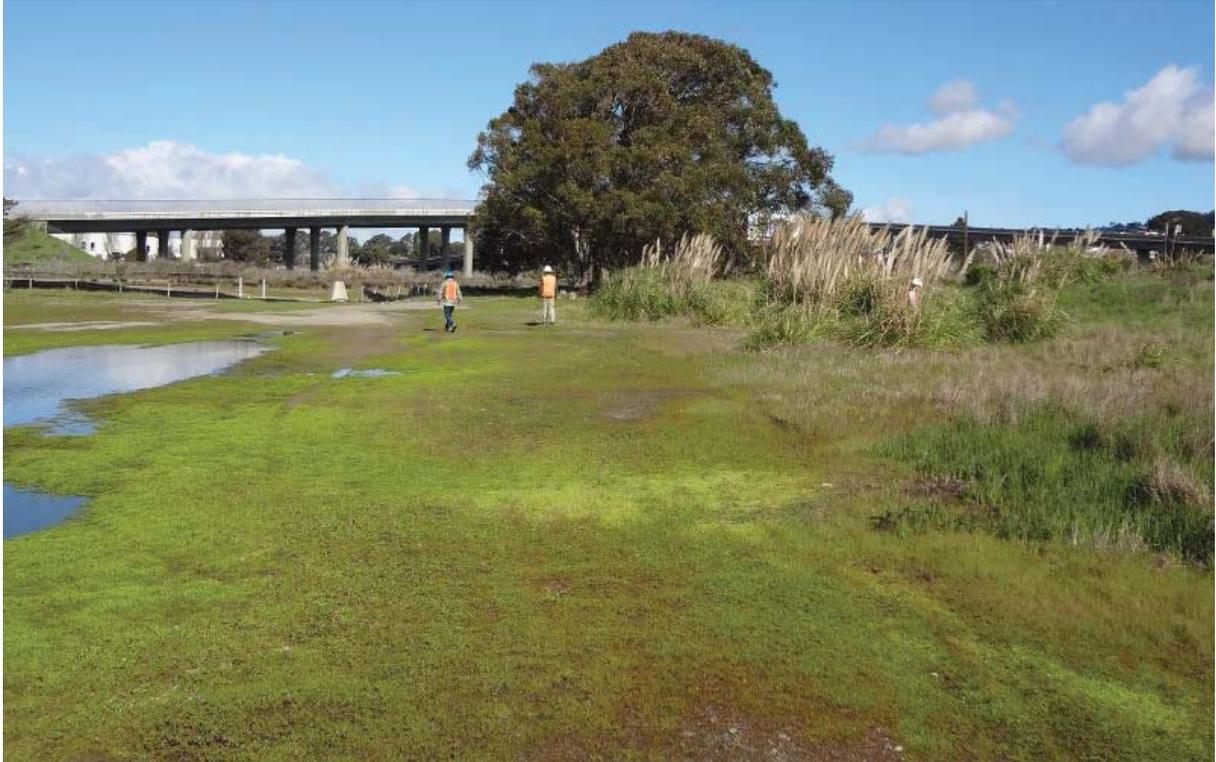
Photograph 6 (taken facing north): Ponding in an Area West of the Vegetated Cap  
This area has been referred to as a low spot in the documentation for previous Five Year Review reports.

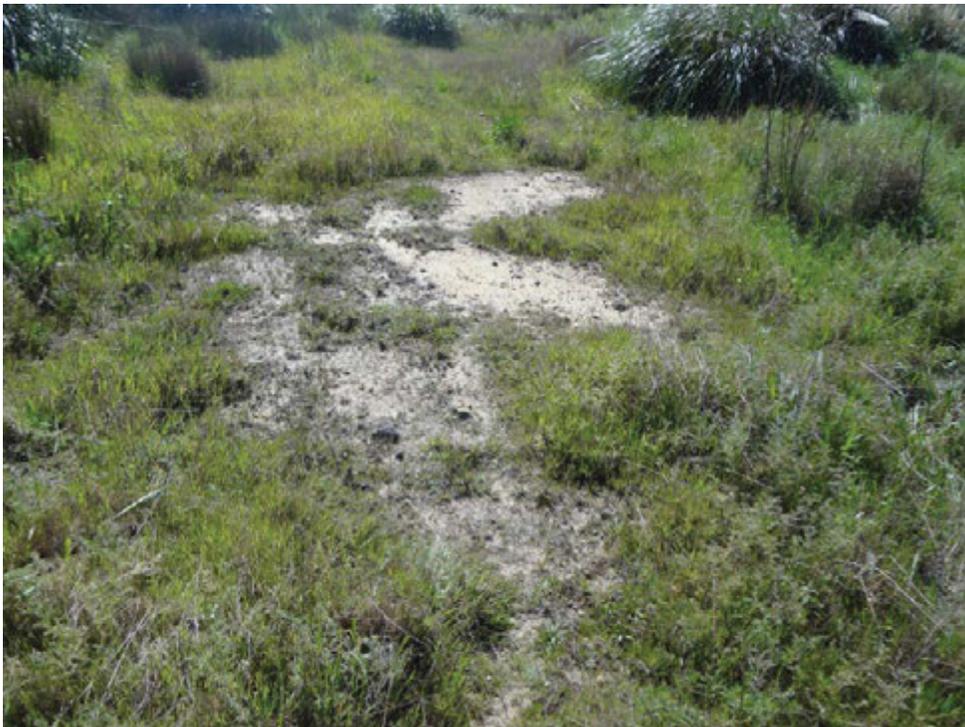
Photograph 7: The Bare Spot in the Central Portion of the Top of the Cap, Measuring Approximately 6 by 6 Feet

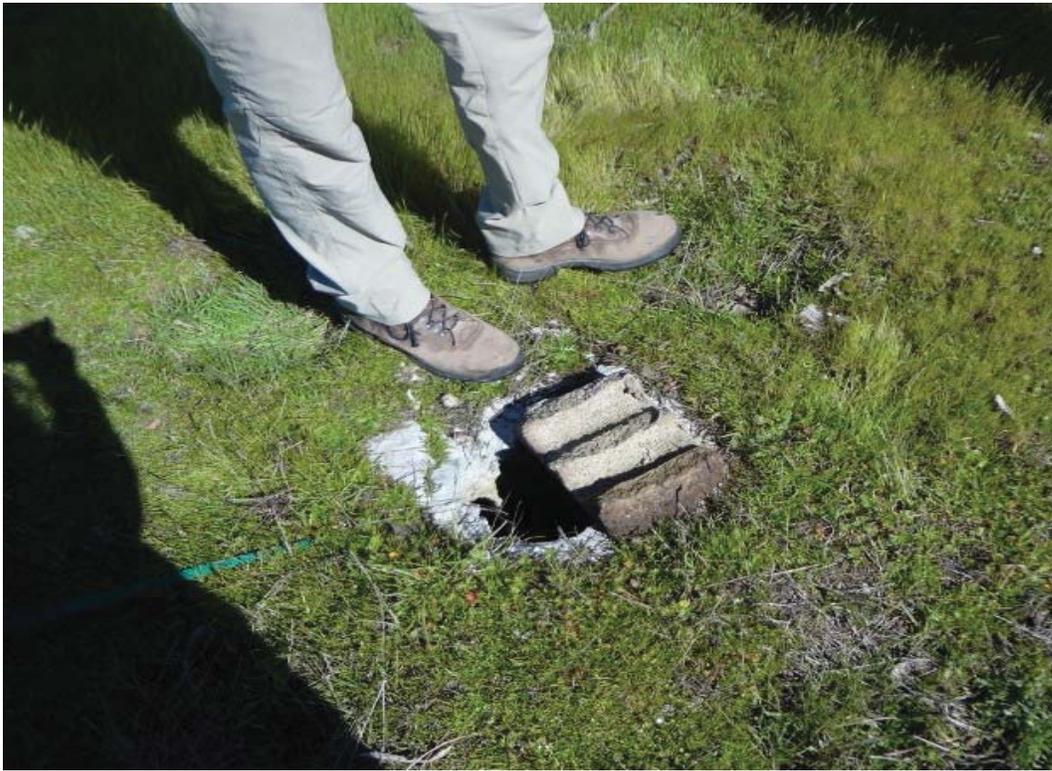
Photograph 8: An Abandoned Site Groundwater Monitoring Well That May Have Caved in Near Well MW-21 Outside of the vegetated cap area.

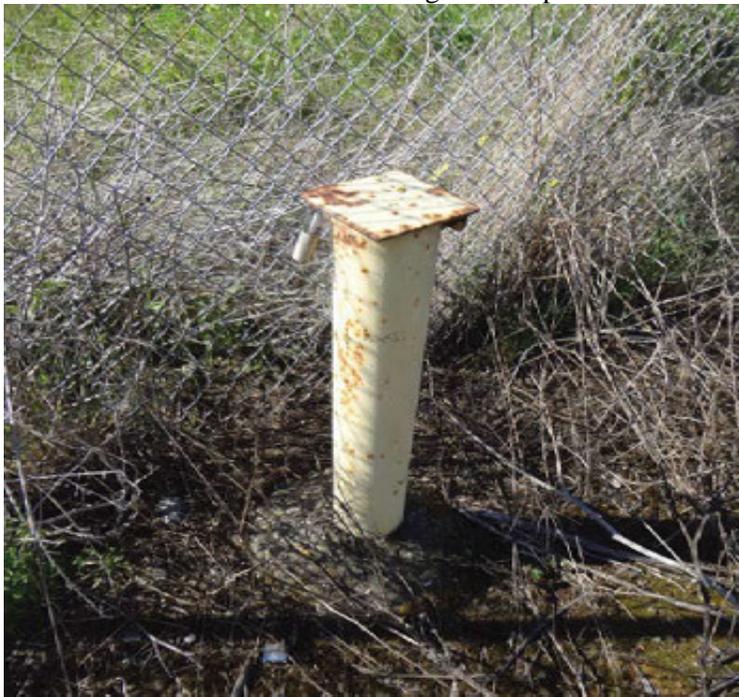
Photograph 9: Well MW-11  
All active wells were observed. All active wells were locked and in good condition.
