**FIVE-YEAR REVIEW REPORT FOR
SOUTH BAY ASBESTOS SUPERFUND SITE
SANTA CLARA COUNTY, CALIFORNIA**

U.S. Environmental Protection Agency

Five-Year Review Summary Form

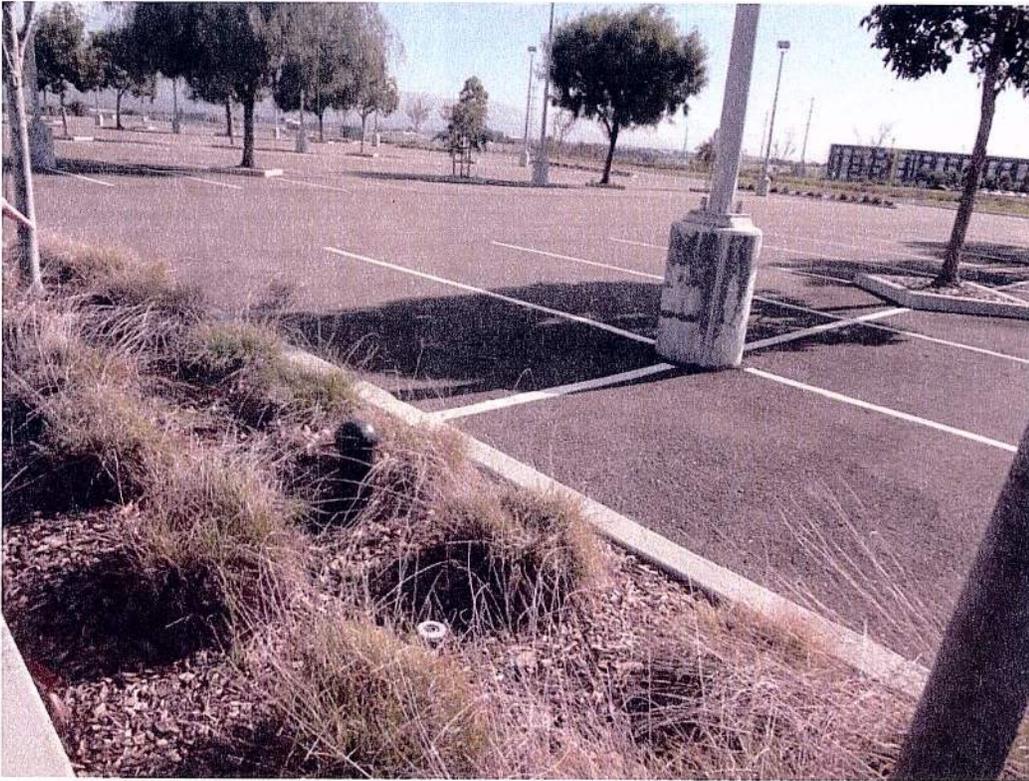
Legacy America Center Photograph 4: Taken facing southeast. Landfill gas venting lines and pipes were installed in the overlying fill material above the landfill and are located in the parking lot areas. No significant cracking or settlement was observed in the parking lot areas. The protruding black pipe in the photograph is the gas vent. All vents appear to be in working order.

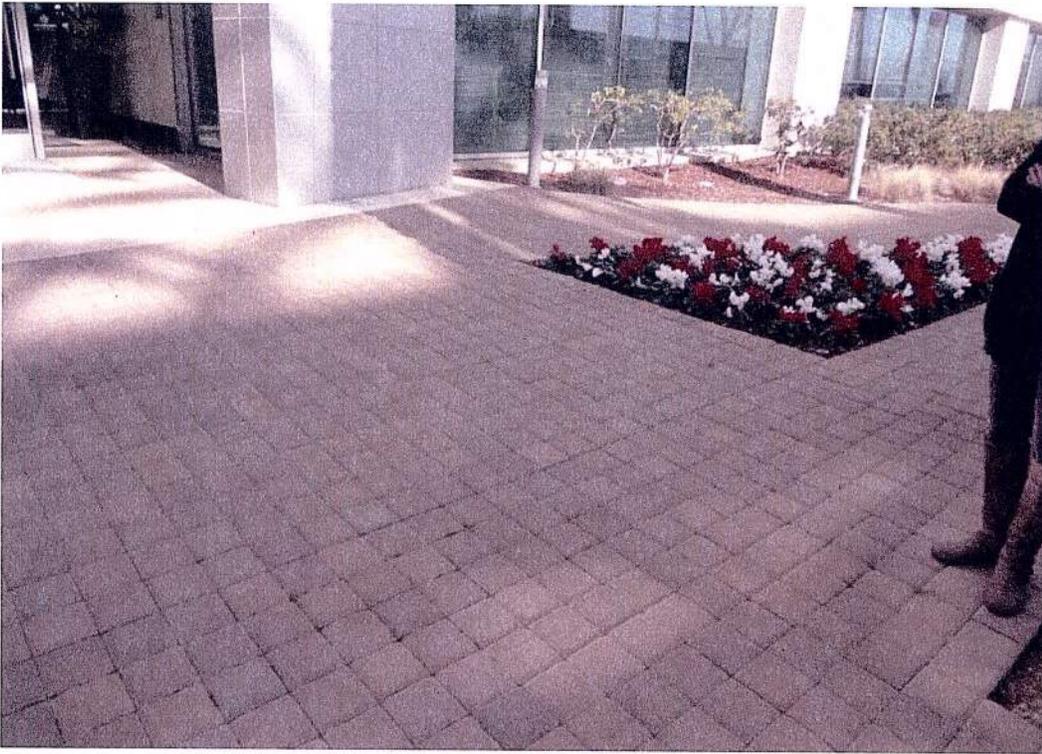
Legacy America Center Photograph 8: Taken facing the entrance to Building 2 (northern direction). According to Mr. Mark Wheeler, pavers are on top of a sand layer to mitigate for settlement adjacent to Buildings 1 and 2 and they are routinely surveyed to prevent the development of tripping hazards.

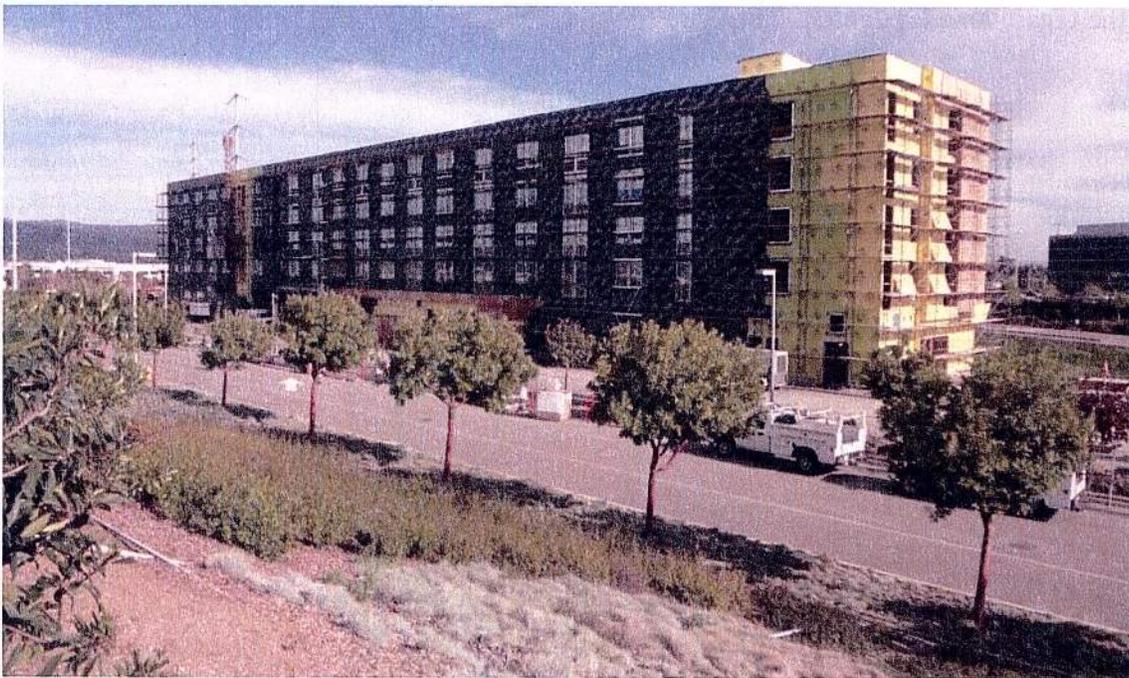
Legacy America Center Photograph 13: Taken facing south. Aloft Hotel construction site overview. The slope of the edge of the Legacy America Center property is also pictured. No signs of slope failures or significant erosion were observed.

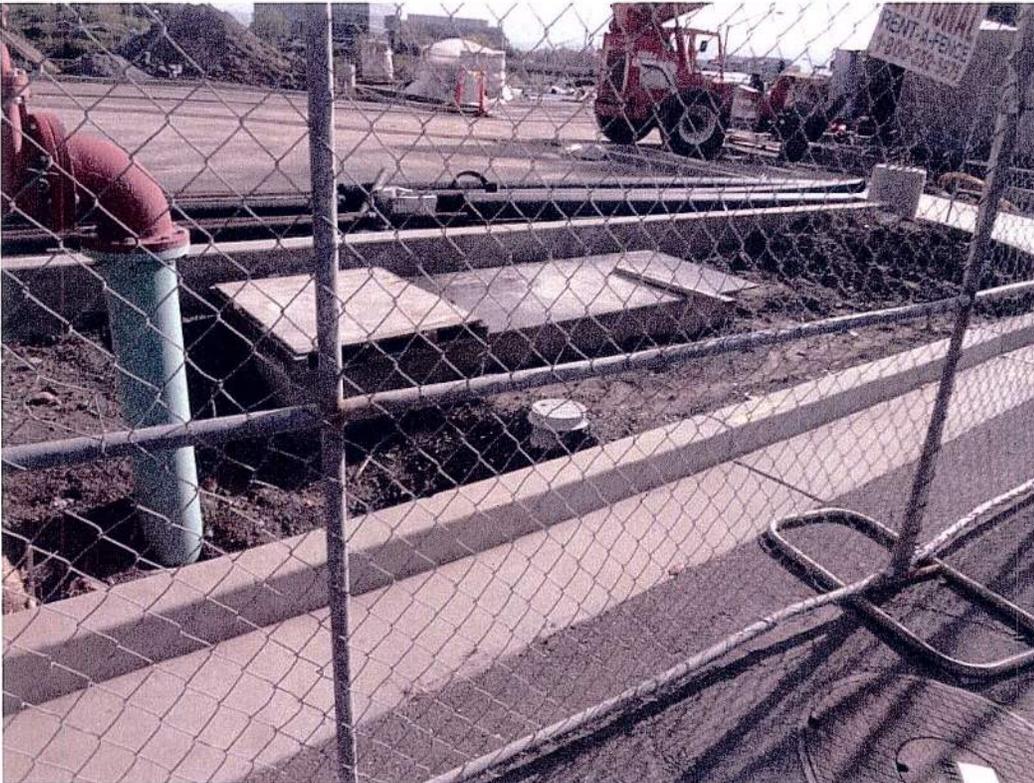
Legacy America Center Photograph 14: Taken facing southeast. This is an example of utility vaults and lines being installed at the Aloft Hotel construction site. At the time of the inspection, it appeared that most of the excavation work is complete, but no digging or holes below the 5-7 foot cover range were observed.

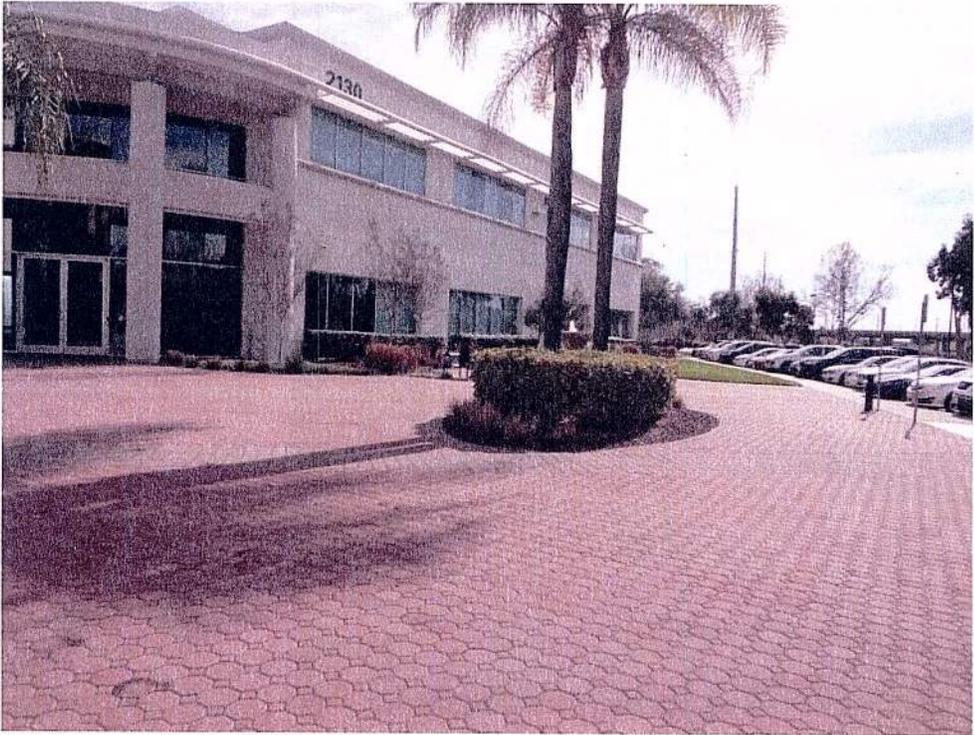
Bixby Technology Center Photograph 1: Taken facing east, toward the entrance of Building 2130. It appears that pavers are installed in sandy base in the areas around some of the buildings to mitigate for any expected settlement adjacent to buildings; however, no notable settlement was observed in these areas during the site inspection.

In addition, pavers on top of sand have been installed in the areas around some of the buildings; however, no notable settlement was observed in these areas during the site inspection.

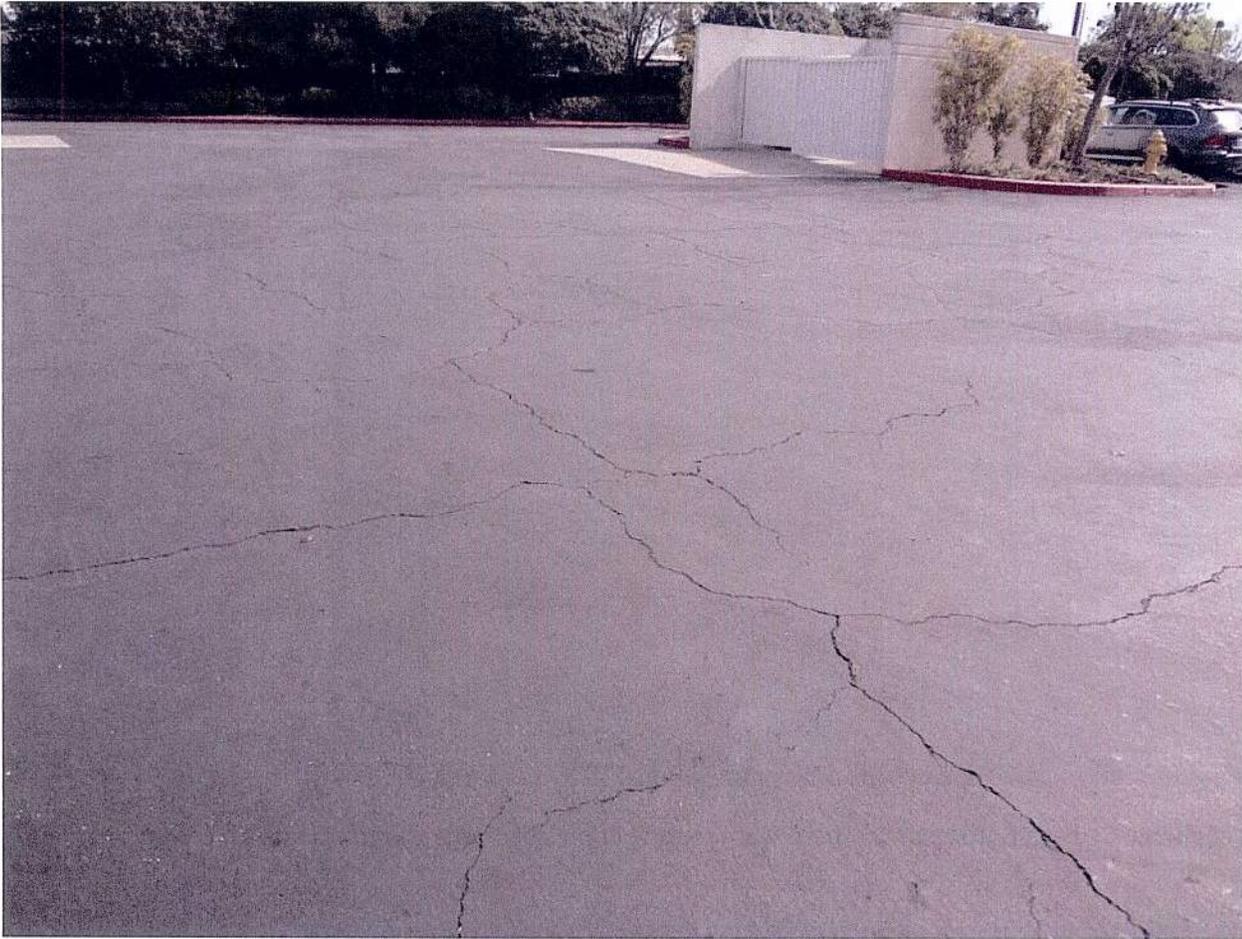
Bixby Technology Center Photograph 3: Taken facing east near the loading area between Buildings 2100 and 2130. There was observed cracking in this area. It was not noted in the attached map because no evidence of white precipitate was observed in this area.

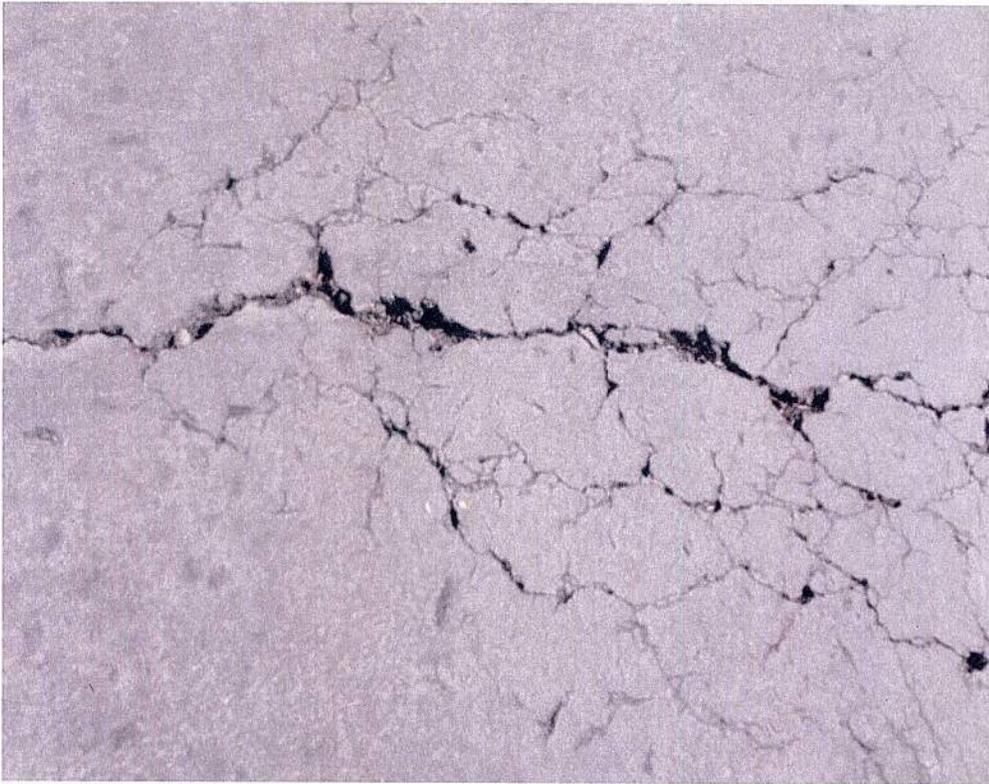
Bixby Technology Center Photograph 5: There was cracking in the road near the southeastern corner of Building 2160.

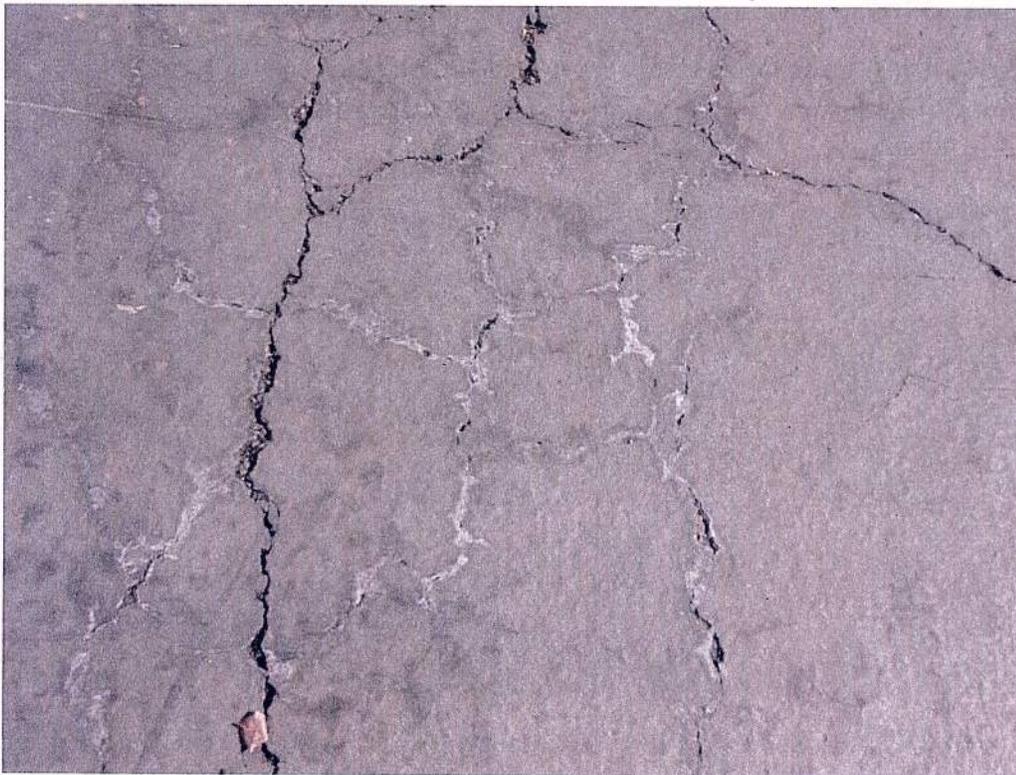
Bixby Technology Center Photograph 6: There was cracking with evidence of white precipitate in the road near the northeastern corner of Building 2190.

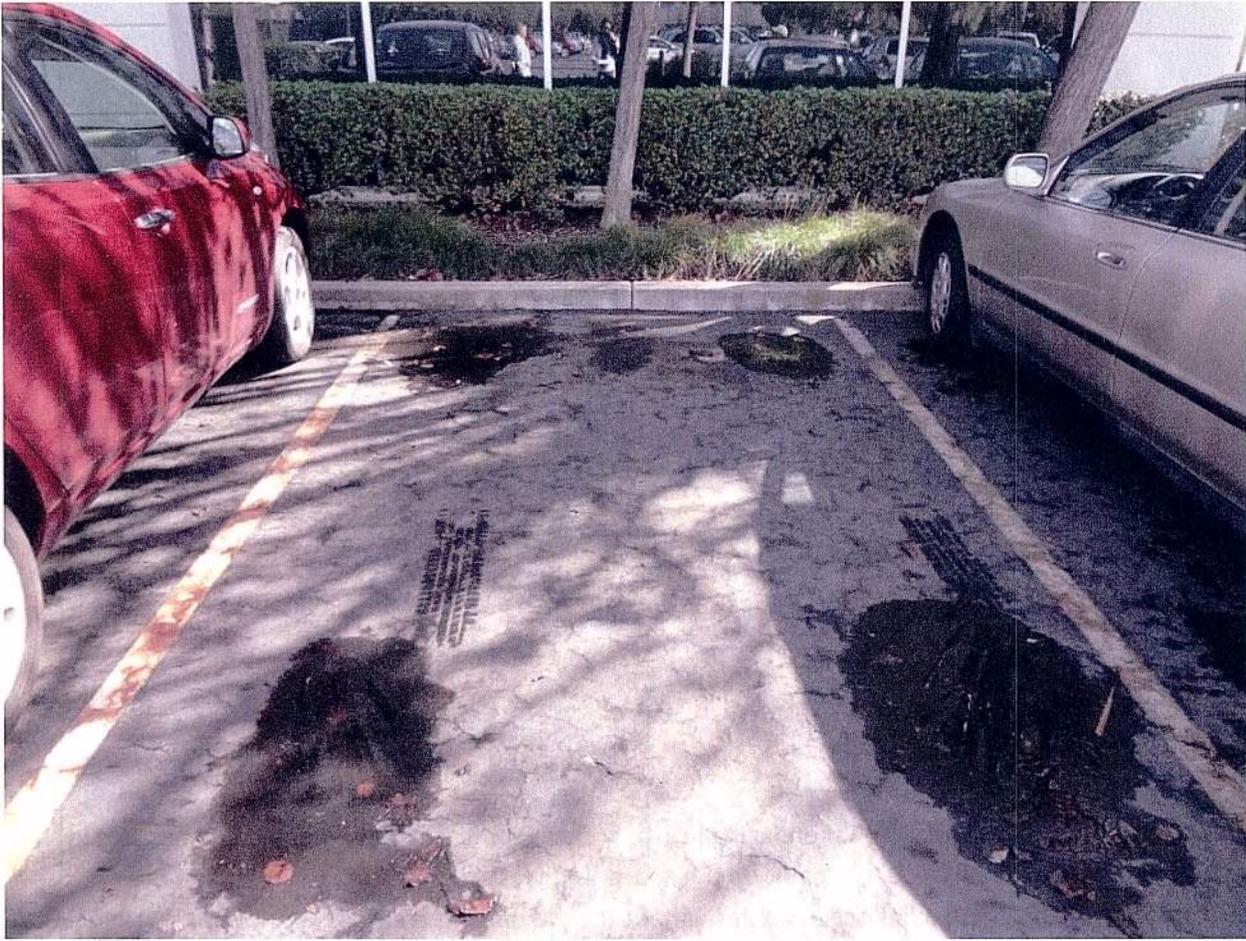
Bixby Technology Center Photograph 7: Taken facing east. No major settlement was observed. However, in the electric vehicle charging parking spots in the southwestern corner of Building 2160, minor ponding was observed in the areas underneath each of the tires of the vehicles in each parking space as noted in the attached map in Appendix B. The ponding was no more than one inch deep.

Remarks: No major settlement was observed. However, in the electric vehicle charging parking spaces on the south west side of Building 2160, some minor ponding was observed in the areas under the tires of the electric vehicles located in each parking space as noted in the attached map in Appendix B. The ponding was approximately one inch deep and the paint in the space that was originally white has turned brown. These parking spaces are adjacent to the building where some minor settlement would be expected.

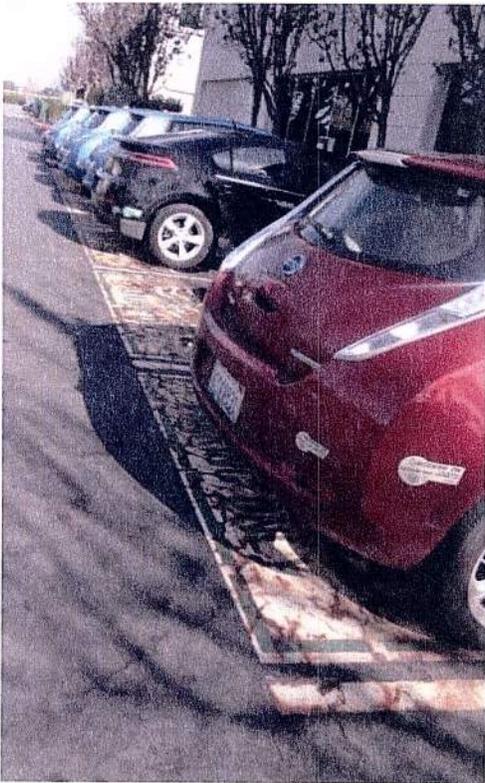
Bixby Technology Center Photograph 8: Taken facing north. In the electric vehicle charging parking spots in the southwestern corner of Building 2160, the paint on the space that was originally white has turned brown. The brown discoloration of the white paint occurred throughout the old parking areas; it was not observed in any of the newly paved parking areas.

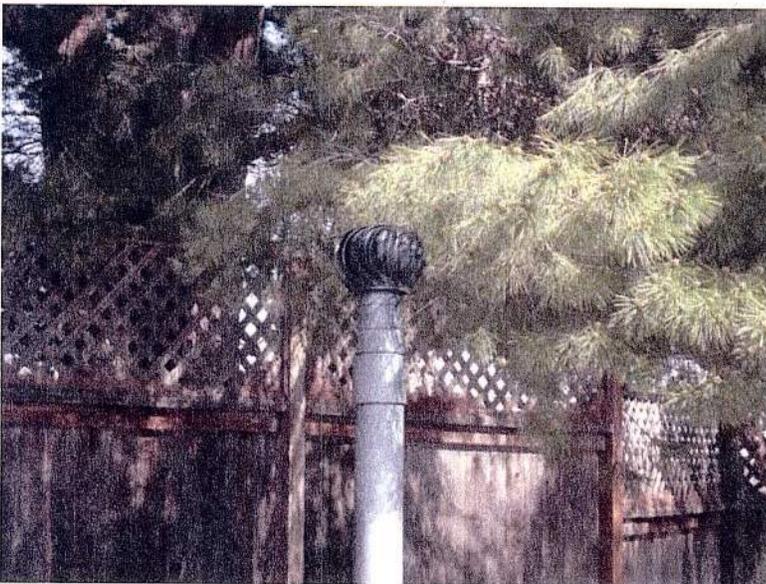
Bixby Technology Center Photograph 9: Taken facing northeast. The landfill gas vent labeled LG-2 in the attached observation map in Appendix B is obstructed by a tree, causing it to not be able to spin freely.

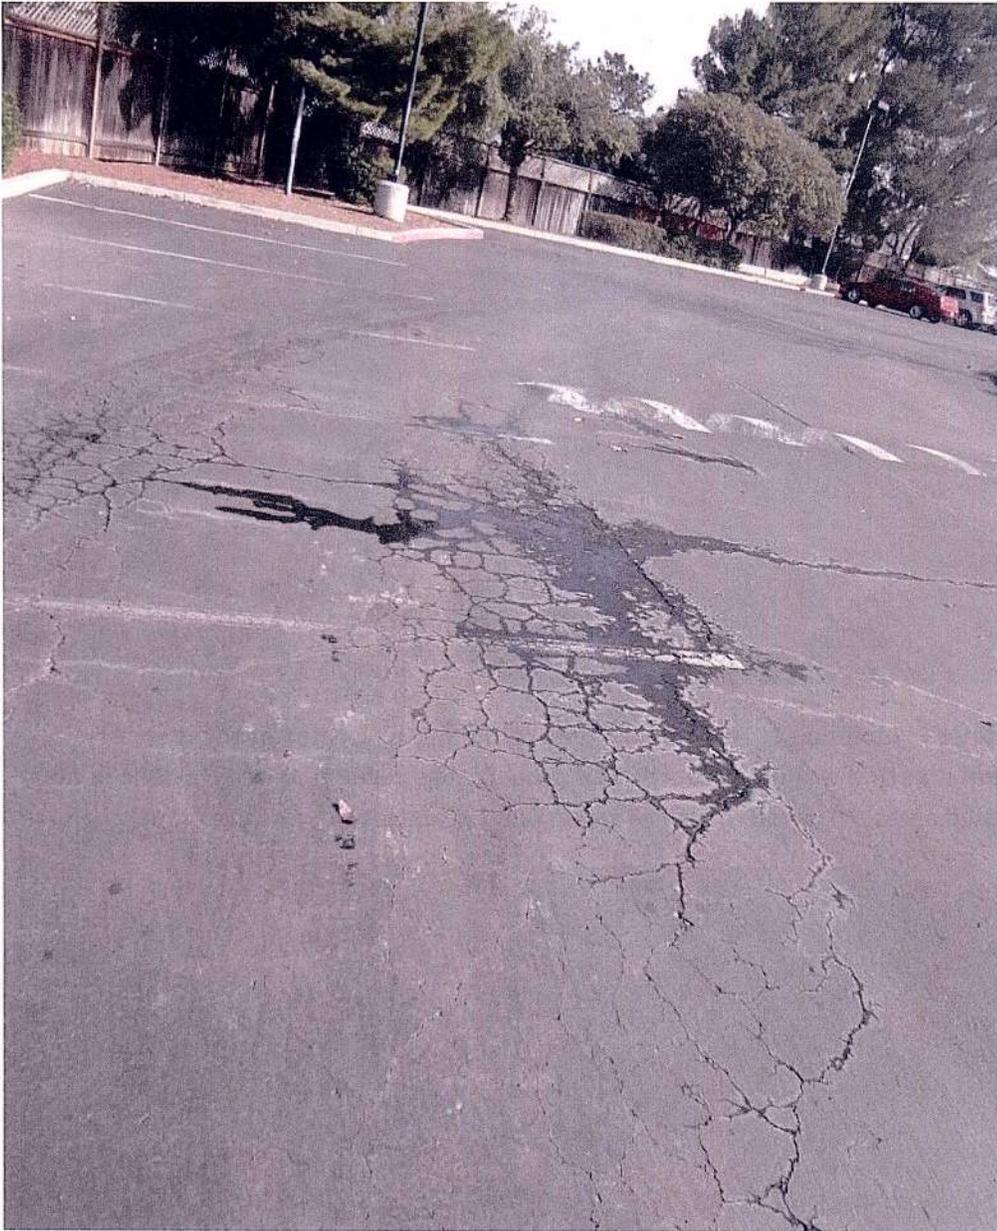
Bixby Technology Center Photograph 10: Taken facing northeast. Cracking and a small wet area was observed in the parking lot north of Building 2100 near the vegetated area.

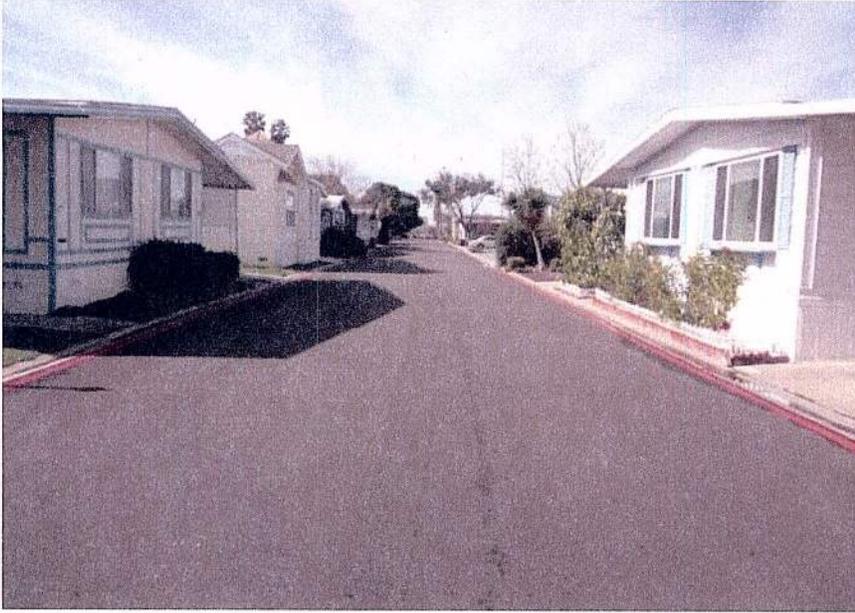
Summerset Mobile Home Estates Photograph 1: This mobile home community is located over the Santos Landfill. This photo is representative of the entire property. This property has paved roadways, mobile homes, driveways, and small landscaped areas. All paved roadways and driveways appear to be in good repair.

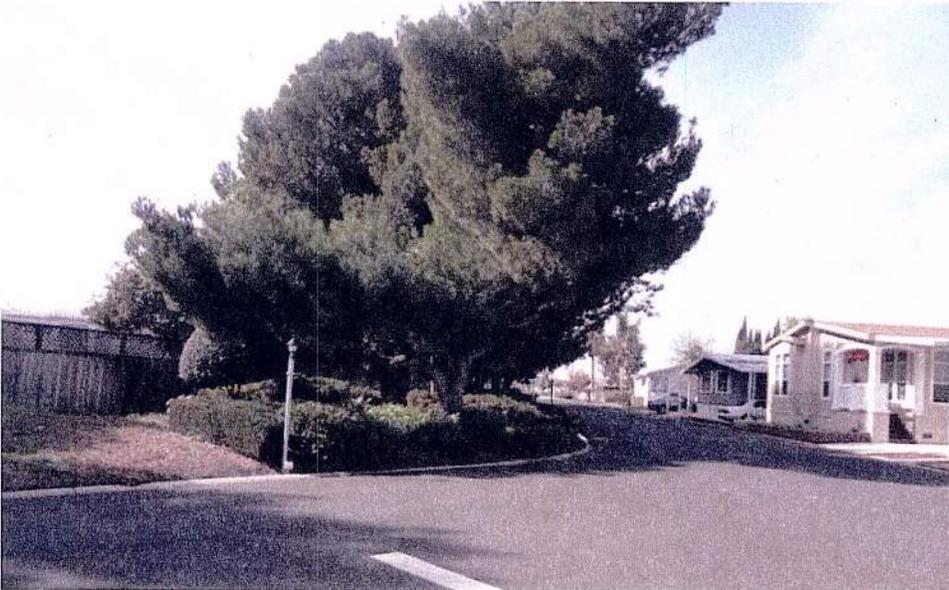
Summerset Mobile Home Estates Photograph 2: Some fairly large trees are located on the property line between the Bixby Technology Center and Summerset Mobile Home Estates. Smaller palm trees and other trees are located throughout the mobile home property and the cap is well maintained in the vegetated areas.

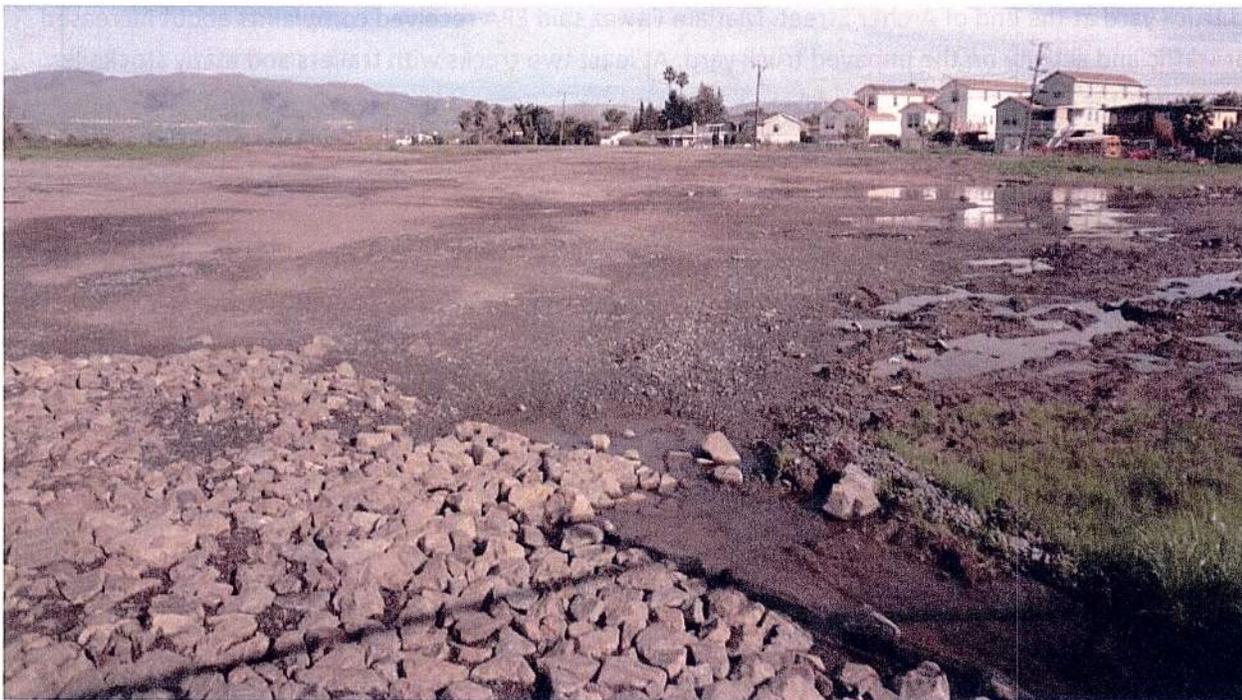
Other Sites – Photograph 1: Taken facing northeast. This is an empty lot located at the intersection of Pacific Avenue and State Street. Mariam Fawaz said EPA received complaints regarding dust in this area. All activity at the site ceased prior to the time of the inspection. A stabilized construction entrance was observed (as pictured). There was one truck with a small excavator in the bed observed on site.

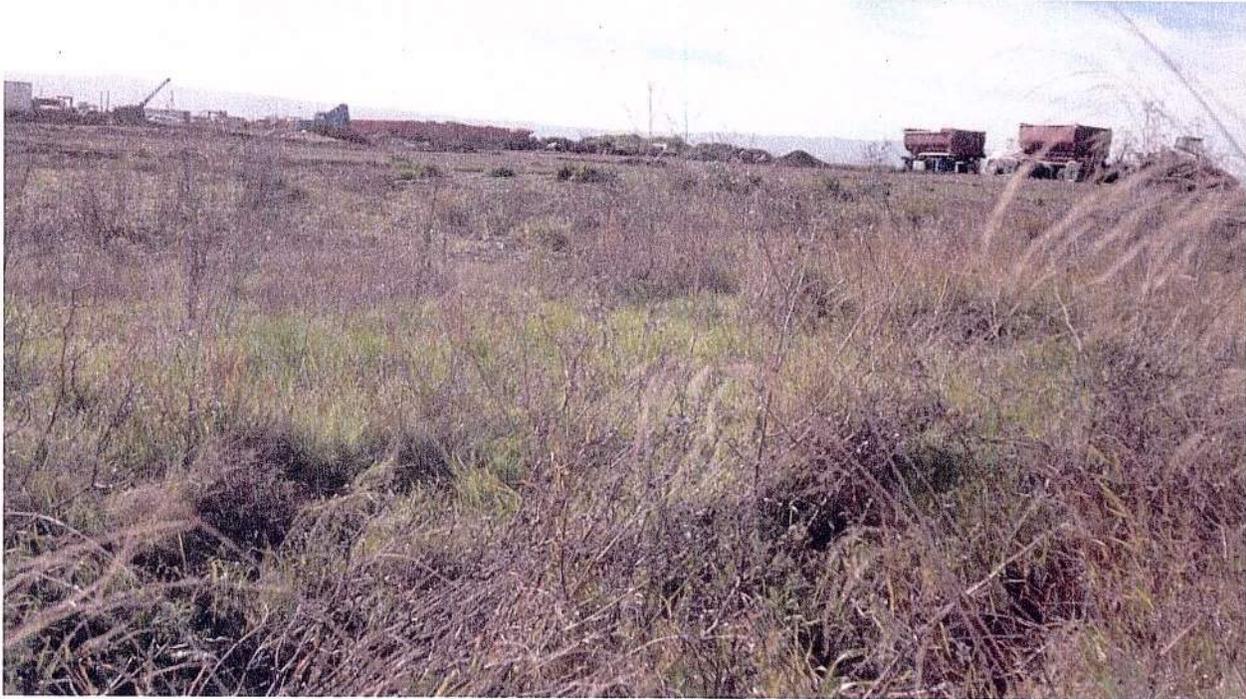
Two properties near the truck yards area appeared to have had recent dust-creating disturbances. At least two trucks with trailers and many stockpiles were observed at an unpaved truck yard at the end of Archer Street. The vacant lot at the intersection of State Street and Pacific Street had evidence of current construction activities, including the presence of a small excavator truck on the property. Mariam Fawaz indicated that EPA received complaints regarding increased vehicular traffic and potential dust in this area in winter 2015.

Other Sites – Photograph 2: Taken facing southwest from a property at the end of Pacific Avenue facing an unpaved truck yard at the end of Archer Street. Mariam Fawaz said EPA received complaints about increased vehicular traffic and activity on the unpaved truck yard. At least two trucks with trailers and many stockpiles were observed at the time of inspection.

- Assess the need for additional work, not specified in the ROD, around the vacant lot and unpaved truck yard where recent soil disturbance was found.
- Based on the observations during the site inspection, some asphalt parking lots and driveways require repair and maintenance. Such activities if conducted will ensure that the remedy is maintained.

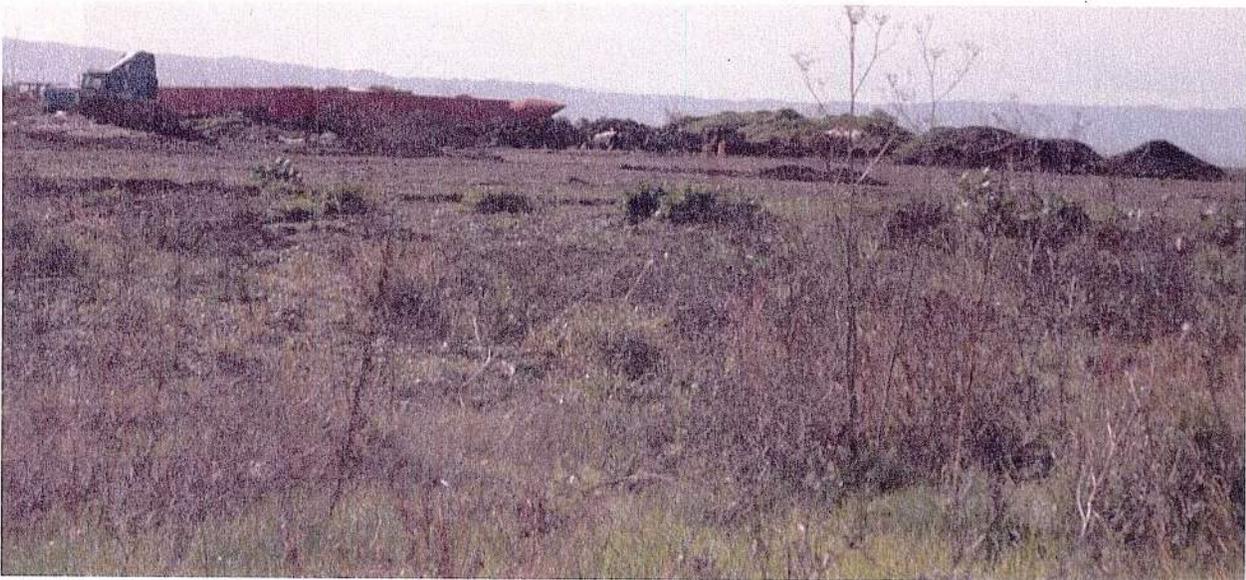
Other Sites – Photograph 3: Taken facing southwest from the property at the end of Pacific Avenue facing the unpaved truck yard on Archer Street. Zoomed in photo of the same site as Other Sites – Photograph 2.

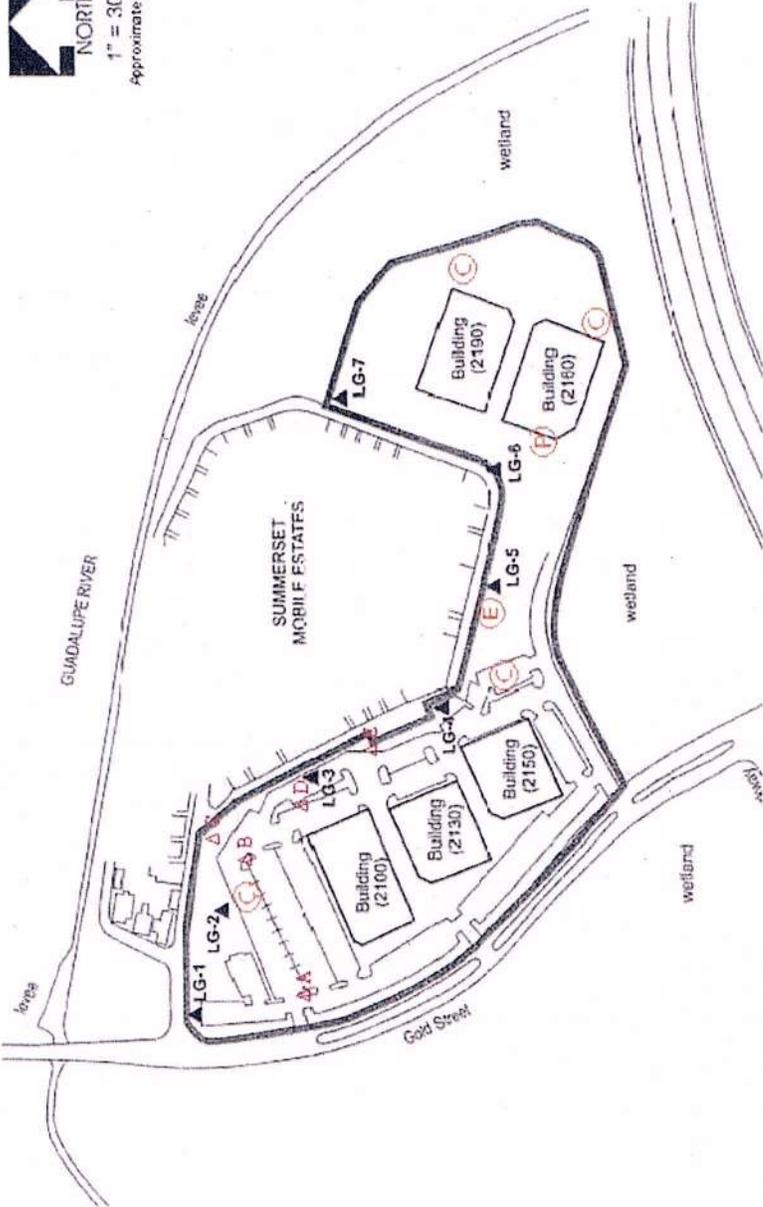
Remarks: Minor cracking was observed throughout all of the parking lot areas. The parking lot area in the northeastern most part of the site near Building 2190 exhibited no cracks. As noted in the 2010 Five Year Review site inspection, some areas exhibited cracks with white precipitate on the asphalt. These areas where evident cracking and white marks on the asphalt were observed are annotated on the attached site map.

Remarks: Nine (9) passive gas vents were observed; however, the locations shown in the last Five Year Review map are incorrect. In the attached map, gas vents labeled LG-5, LG-6, and LG-7 were not found. All vents are located near buildings 2100, 2130 and 2150. In addition, three of the passive gas vents (LG-2, LG-4, and D) were observed to not be able to spin freely as noted in the attached site map.

- 1) Gas vents LG-2, LG-4, and D were not able to spin freely.
- 2) Gas vents LG-5, LG-6, and LG-7 were not found.
- 3) Minor ponding observed in the electric vehicle charging parking spots on the south west side of Building 2180, in the areas where each of the tires of the vehicles normally are located in each parking space.
- 4) A small elevated area (covered with grass) was observed in the recreational area, between the sand volleyball court and the paved basketball court.
