**SUBJECT: Contract Agreement 10-T1114
Cap Repair Summary Report
Brown and Bryant Inc., Site, Arvin, California**

CAP REPAIR SUMMARY REPORT

**BROWN & BRYANT, ARVIN FACILITY
SUPERFUND SITE, FIRST OPERABLE UNIT
REMEDIAL ACTION**

ARVIN, CALIFORNIA

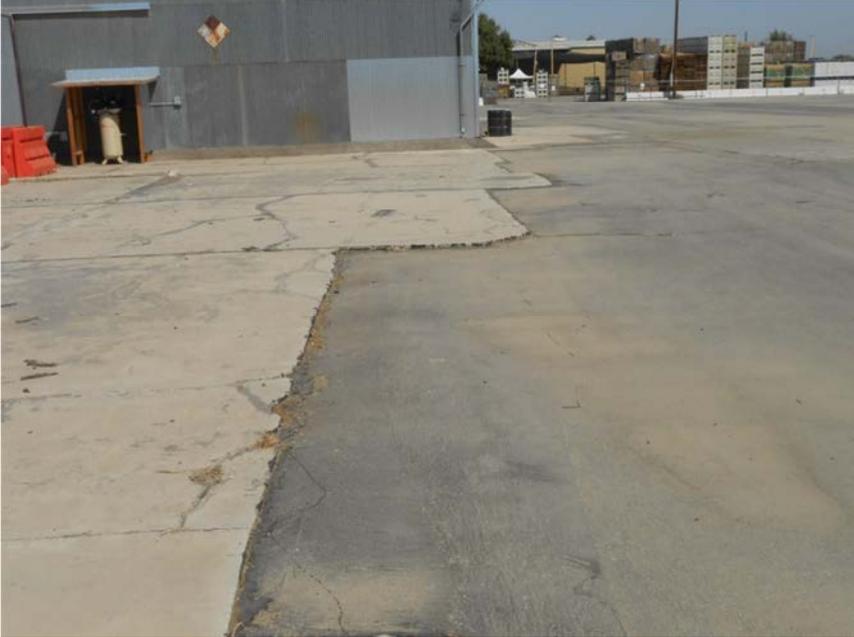
PHOTO: B&B-2014-22 LOCATION: Non-RCRA Cap Area Map Location Number: 1 DESCRIPTION: Removal of weeds growing in asphalt to concrete interface and minor cracks in concrete.

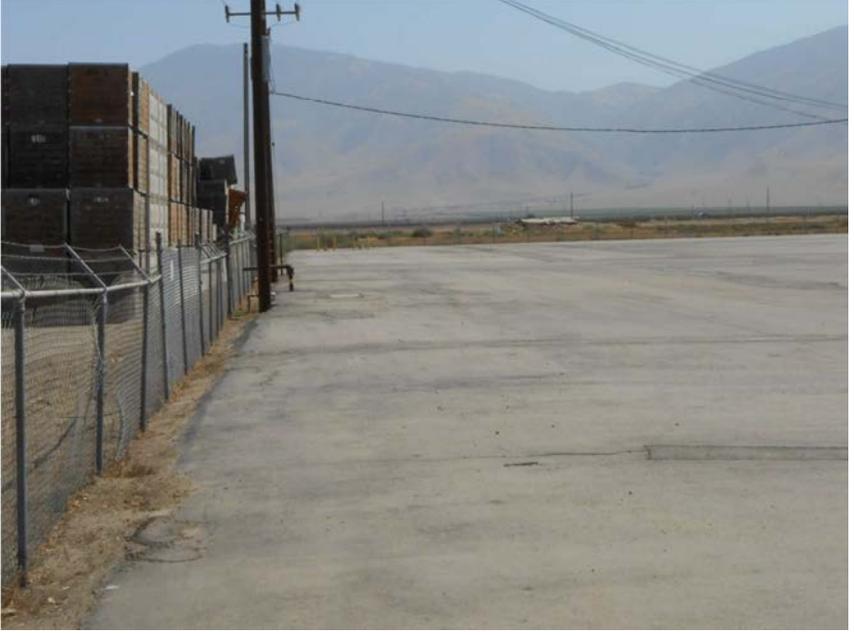
PHOTO: B&B-2014-23 LOCATION: Non-RCRA Cap Area Map Location Number: 1 DESCRIPTION: Removal of weeds growing along fence line.

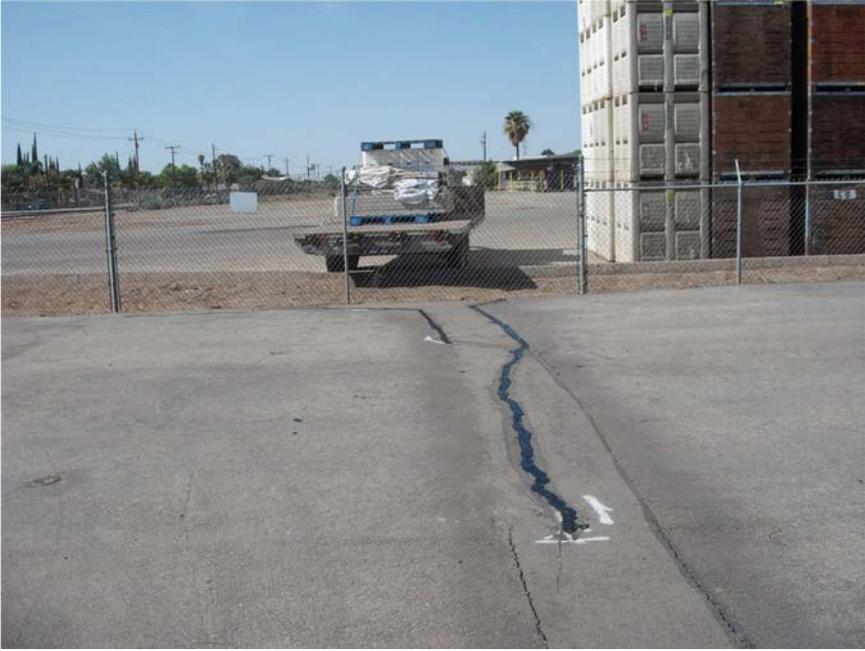
PHOTO: B&B-2014-24 LOCATION: Non-RCRA Cap Area Map Location Number: 2 DESCRIPTION: Repair of asphalt cap cracking; approximately 15 feet long and 1/4 to 3/8 inch wide.

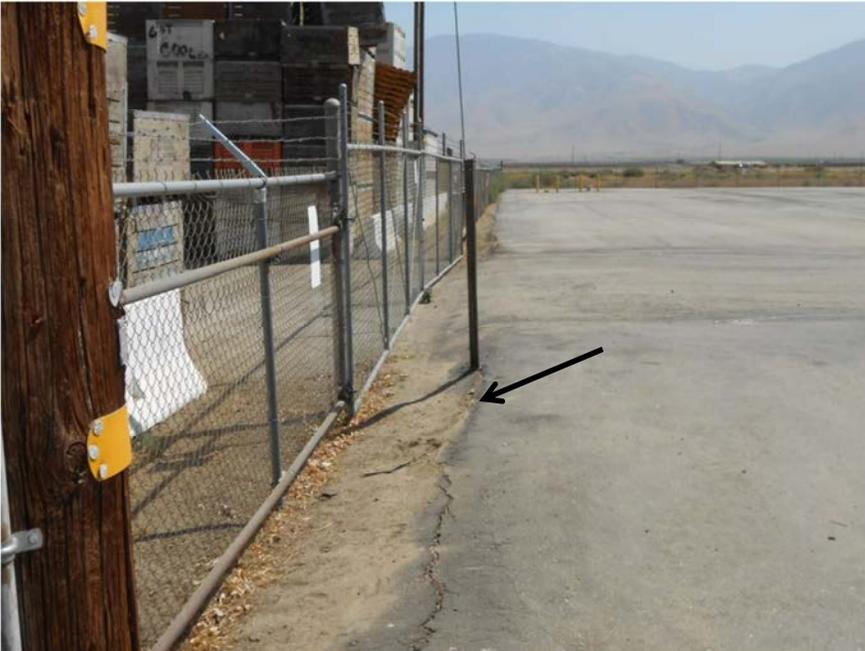
PHOTO: B&B-2014-25 LOCATION: Non-RCRA Cap Area Map Location Number: 3 DESCRIPTION: Repair of asphalt cap cracking; approximately 6 feet long and 3/8 inch wide towards tie-down.

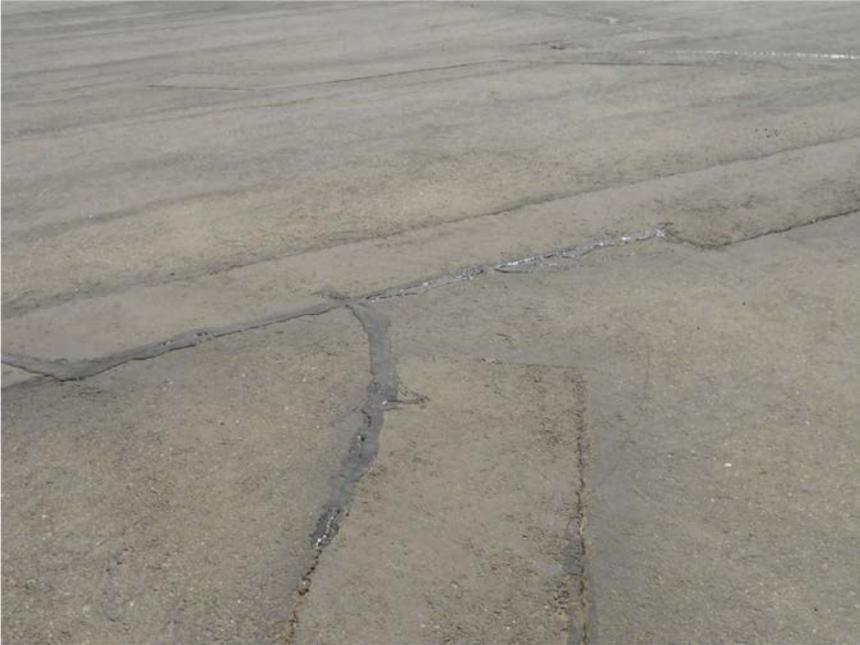
PHOTO: B&B-2014-26 LOCATION: Non-RCRA Cap Area Map Location Number: 4 DESCRIPTION: Repair of asphalt cap cracking; approximately 4 feet long and 1/4 to 3/8 inch wide.

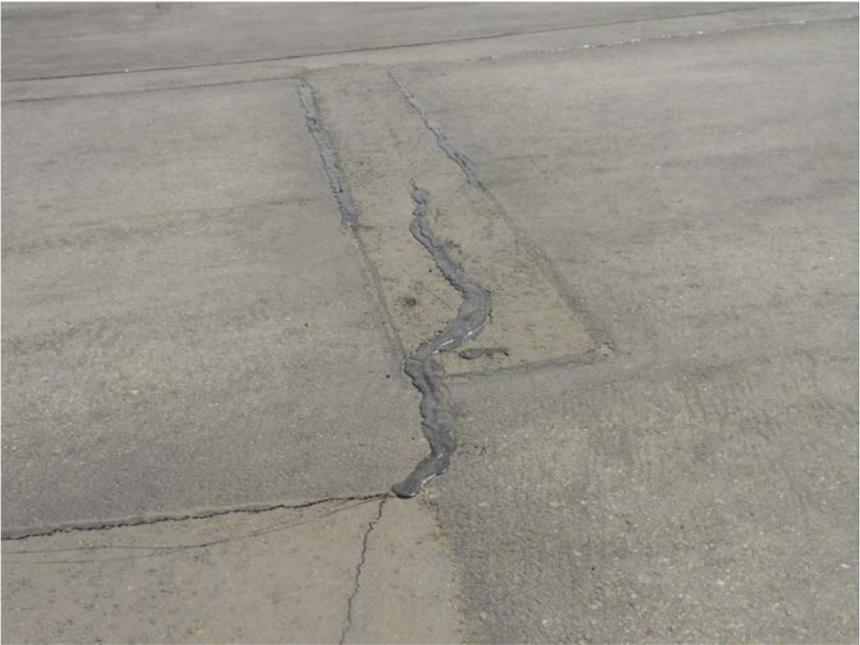
5	Crack approximately 20 feet long and 1/4 inch wide in the asphalt on a patch repair. Crack is near the gate at the northeast corner of the building on the non-RCRA cap.	Sealed crack with sealant that meets Caltrans specifications for crack treatment Section 37-5 (Caltrans, 2010), or equivalent.
6	Crack approximately 4 feet long, 1/2 inch wide, and 3 inches deep in asphalt, east of the building on the non-RCRA cap.	Sealed crack with sealant that meets Caltrans specifications for crack treatment Section 37-5 (Caltrans, 2010), or equivalent.
7	Crack approximately 25 feet long, 1/2 inch wide, and 3 inches deep in asphalt on the northeast area of the non-RCRA cap.	Sealed crack with sealant that meets Caltrans specifications for crack treatment Section 37-5 (Caltrans, 2010), or equivalent.
8	Crack approximately 30 feet long, 5/8 to 7/8 inch wide, and up to 3 inches deep in asphalt near the northeast area of the non-RCRA cap. Crack is along the edge of a previous patch repair.	Sealed crack with sealant that meets Caltrans specifications for crack treatment Section 37-5 (Caltrans, 2010), or equivalent.

PHOTO: B&B-2014-27 LOCATION: Non-RCRA Cap Area Map Location Number: 5 DESCRIPTION: Repair of asphalt cap cracking; approximately 20 feet long and 1/4 inch wide in the asphalt on a patch repair. Crack is near the northeast corner of the building on the non-RCRA cap.

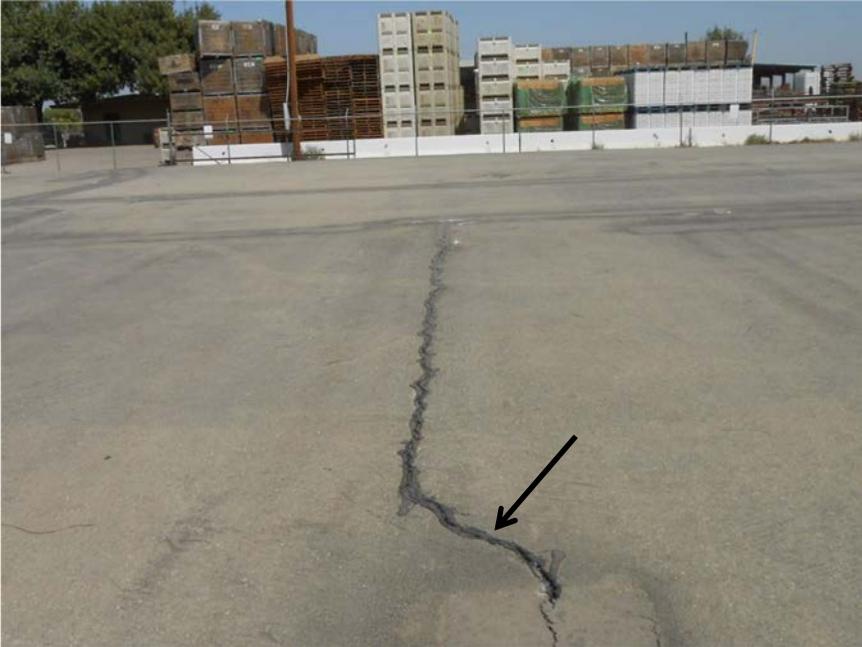
PHOTO: B&B-2014-28 LOCATION: Non-RCRA Cap Area Map Location Number: 6 DESCRIPTION: Repair of asphalt cap cracking; approximately 4 feet long and 1/2 inch wide.

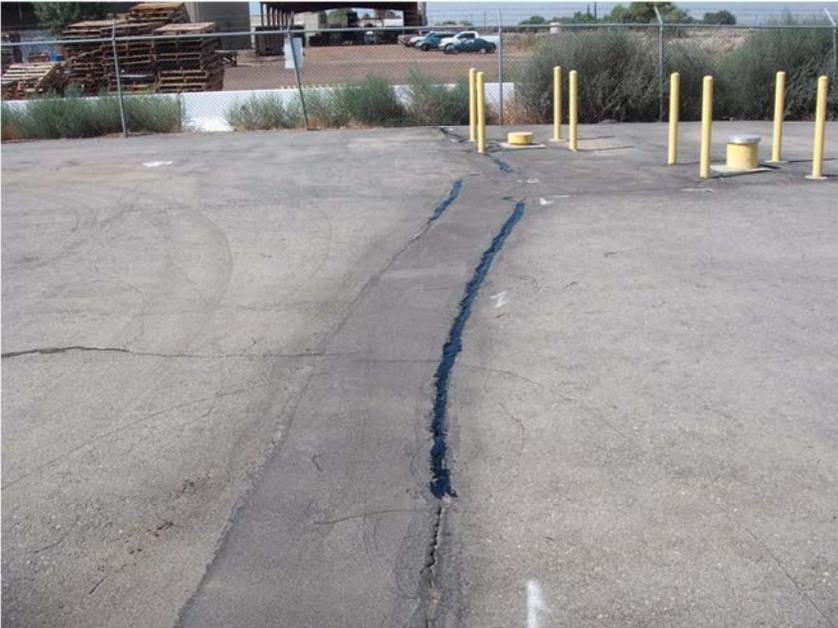
PHOTO: B&B-2014-29 LOCATION: Non-RCRA Cap Area Map Location Number: 7 DESCRIPTION: Repair of asphalt cap cracking; approximately 25 feet long, 1/2 inch wide, and 3 inches deep in asphalt on the northeast area of the non- RCRA cap.

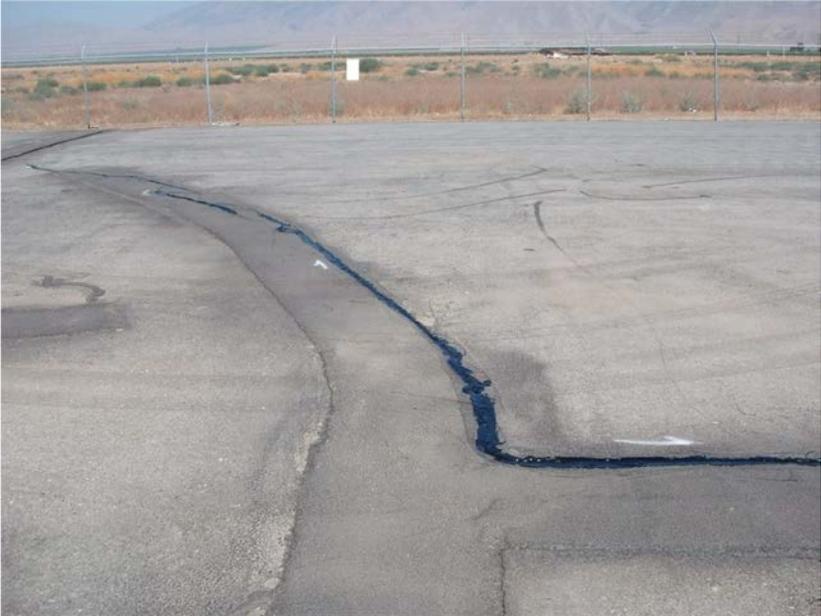
A photograph showing a close-up view of a dark blue repair material applied to a crack in asphalt. The crack runs diagonally across the frame, and the repair material is visible along its length. The surrounding asphalt is light gray and shows some wear and other cracks.		PHOTO: B&B-2014-30 LOCATION: Non-RCRA Cap Area Map Location Number: 8 DESCRIPTION: Repair of asphalt cap cracking; approximately 30 feet long, 5/8 to 7/8 inch wide, and up to 3 inches deep in asphalt on the northeast area of the non-RCRA cap. Crack is along the edge of a previous repair.

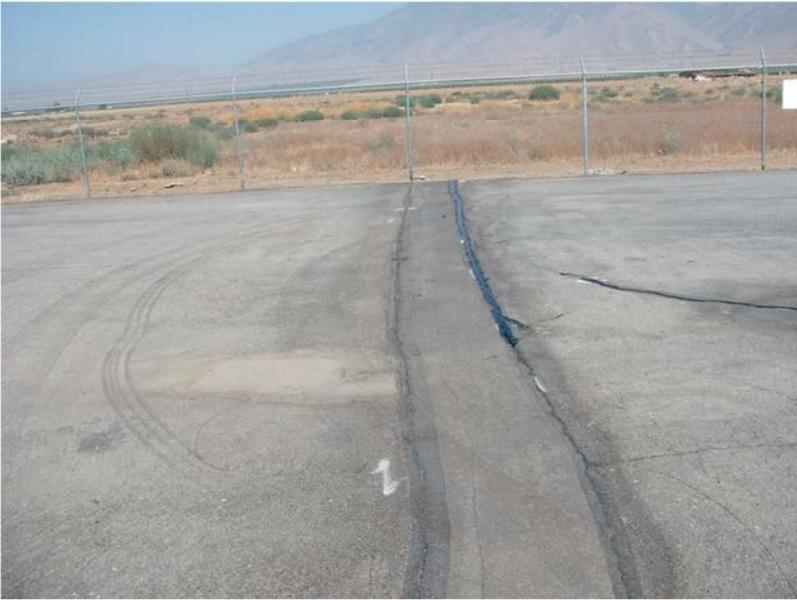
A photograph showing a wider view of an asphalt surface. A dark blue repair material is applied to a crack that runs vertically through the center of the frame. The asphalt surface is light gray and shows some tire tracks and other cracks. The background shows a fence and some vegetation.		PHOTO: B&B-2014-31 LOCATION: Non-RCRA Cap Area Map Location Number: 9 DESCRIPTION: Repair of asphalt cap cracking; two cracks approximately 25 and 40 feet long and 3/8 to 1 inch wide in asphalt leading to the northeast corner of the non-RCRA cap. Crack is along the edge of a previous patch repair.

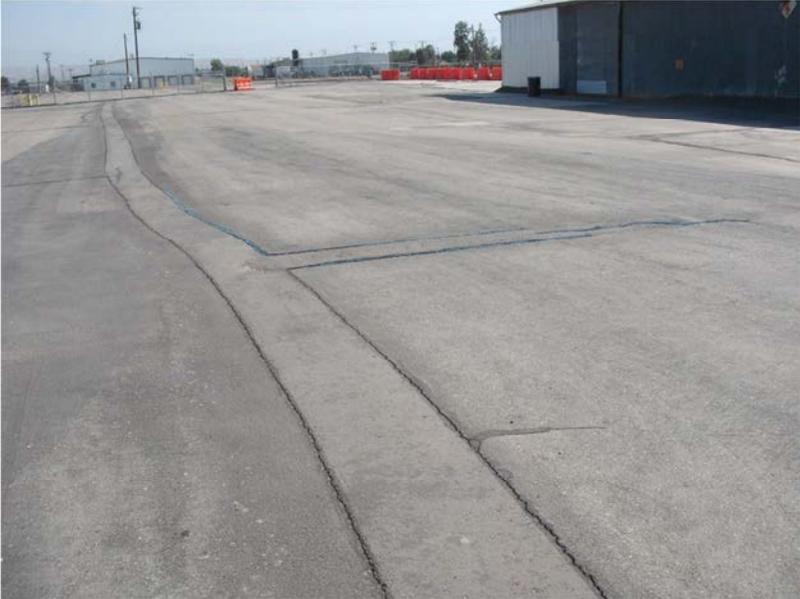
PHOTO: B&B-2014-32 LOCATION: Non-RCRA Cap Area Map Location Number: 10 DESCRIPTION: Repair of asphalt cap cracking; approximately 40 feet long and 3/8 to 5/8 inch wide in asphalt east of the building on the non-RCRA cap.

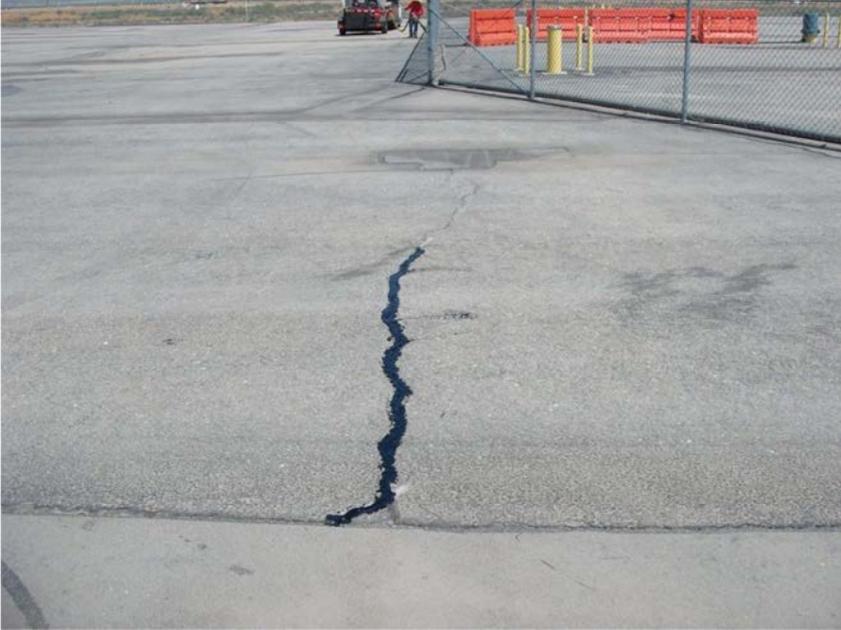
PHOTO: B&B-2014-33 LOCATION: RCRA Cap Area Map Location Number: 11 DESCRIPTION: Repair of asphalt cap cracking; approximately 8 feet long, 5/8 inch wide, and 2 to 3 inches deep in asphalt along the fence near the southern border of the non-RCRA cap.

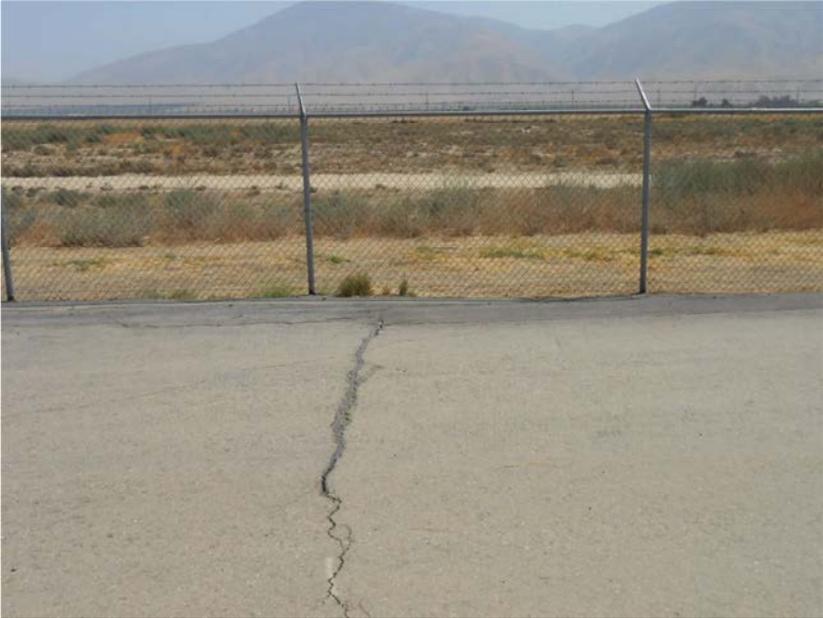
Finding Identifier	Description of Finding	Completed Repairs
12	Crack approximately 8 feet long and 1/2 inch wide in asphalt near the northeast corner of the RCRA cap.	Sealed crack with sealant that meets Caltrans specifications for crack treatment Section 37-5 (Caltrans, 2010), or equivalent.
13	Crack approximately 55 feet long and 1/4 inch wide in asphalt near the east-facing fence of the RCRA cap.	Sealed crack with sealant that meets Caltrans specifications for crack treatment Section 37-5 (Caltrans, 2010), or equivalent.
14	Burrow with a 3-inch-diameter hole, 45 feet north of the southeast corner of the RCRA cap and 8 feet from the east-facing fence.	Filled hole with a cement grout or equivalent.
15	Burrow with a 3-inch-diameter hole, 55 feet north of the southeast corner of the RCRA cap and 4 feet from the east-facing fence.	Filled hole with a cement grout or equivalent.
16	Crack approximately 35 feet long and 1/4 inch wide in asphalt near the south-facing fence of the RCRA cap.	Sealed crack with sealant that meets Caltrans specifications for crack treatment Section 37-5 (Caltrans, 2010), or equivalent.

PHOTO: B&B-2014-34 LOCATION: RCRA Cap Area Map Location Number: 12 DESCRIPTION: Repair of asphalt cap cracking; approximately 8 feet long and 1/2 inch wide in asphalt near the northeast corner of the RCRA cap.

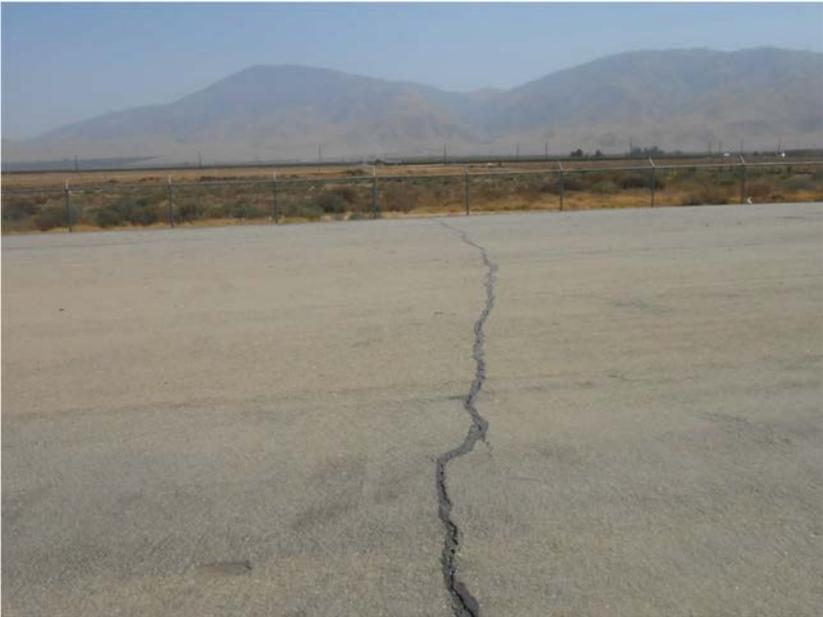
PHOTO: B&B-2014-35 LOCATION: RCRA Cap Area Map Location Number: 13 DESCRIPTION: Repair of asphalt cap cracking; approximately 55 feet long and 1/4 inch wide.

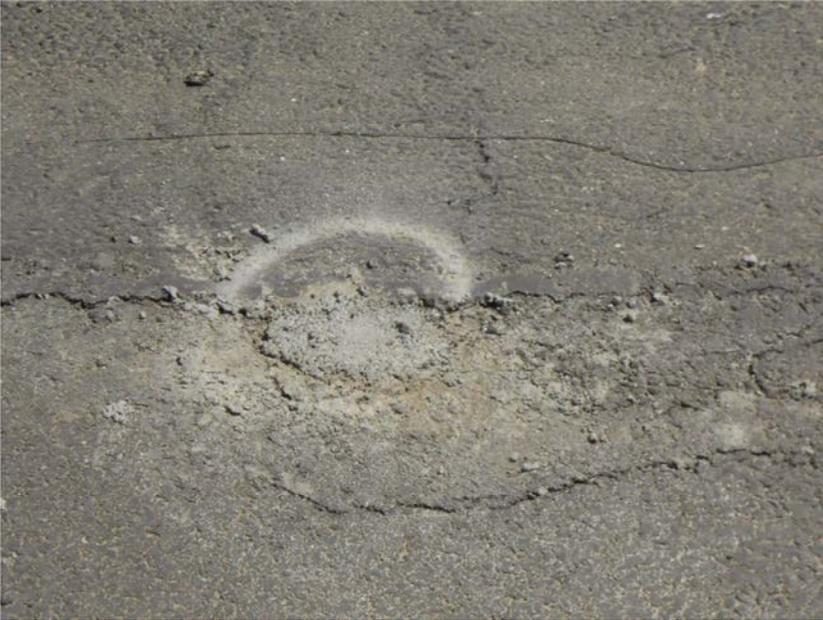
PHOTO: B&B-2014-36 LOCATION: RCRA Cap Area Map Location Number: 14 DESCRIPTION: Repair of burrow hole, filled with cement grout.

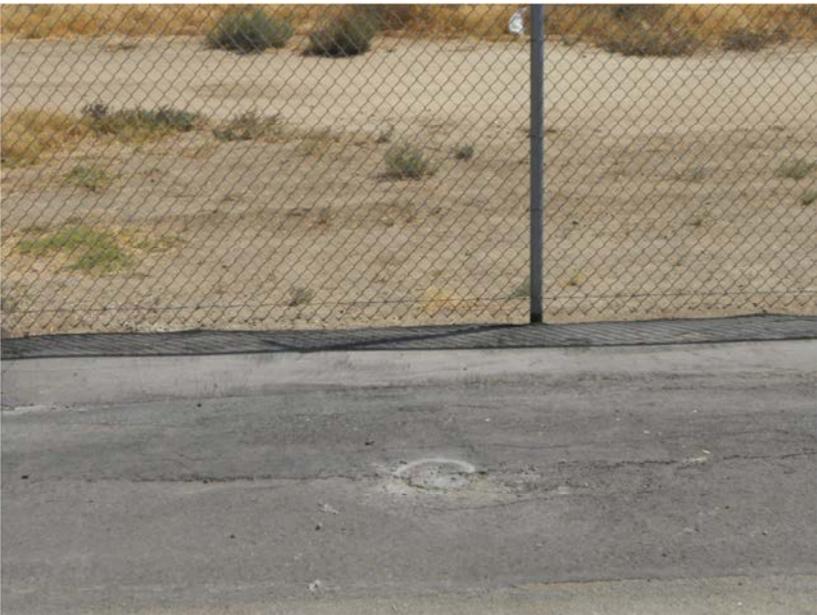
PHOTO: B&B-2014-37 LOCATION: RCRA Cap Area Map Location Number: 15 DESCRIPTION: Repair of burrow hole, filled with cement grout.

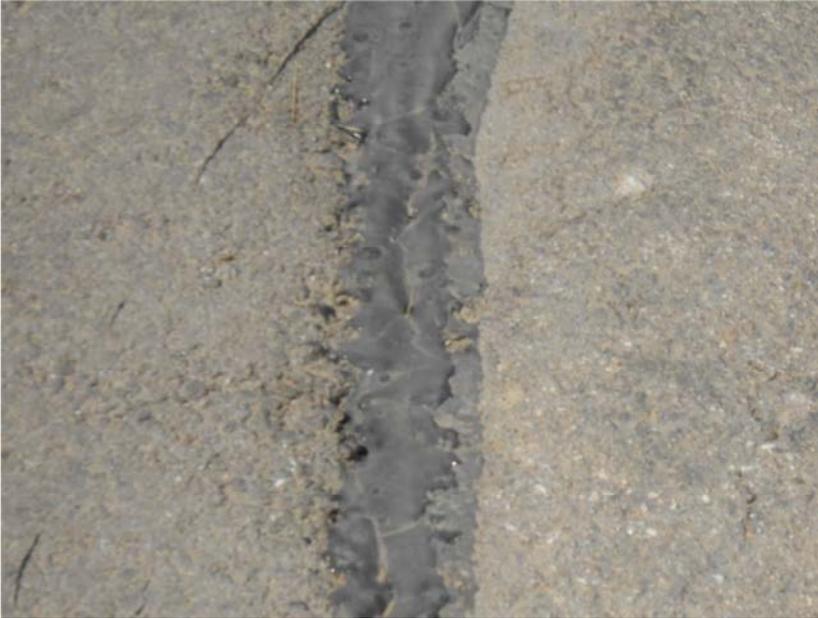
PHOTO: B&B-2014-38 LOCATION: RCRA Cap Area Map Location Number: 16 DESCRIPTION: Repair of asphalt cap cracking; approximately 35 feet long and 1/4 inch wide in asphalt near south-facing fence of the RCRA cap.

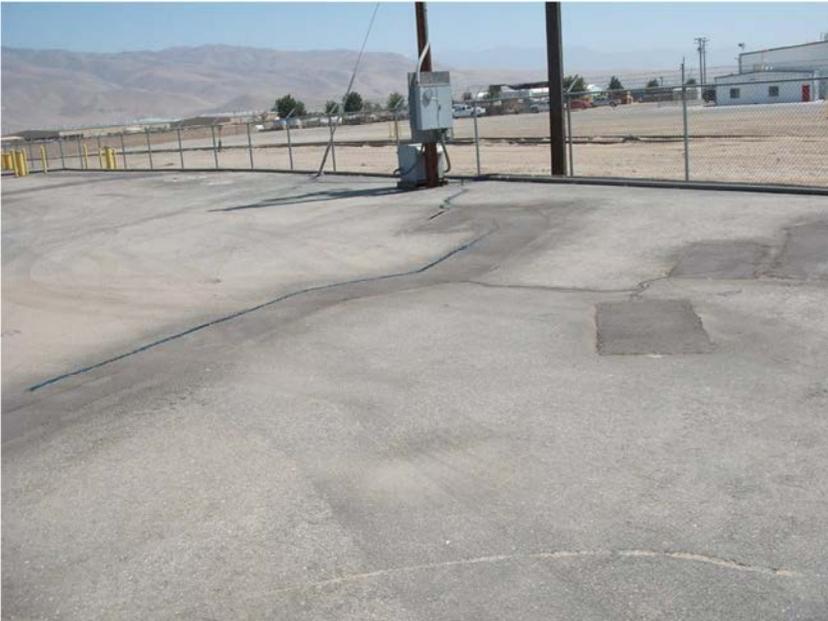
17	Crack approximately 10 feet long and 1/4 inch wide in asphalt near the south-facing fence of the RCRA cap.	Sealed crack with sealant that meets Caltrans specifications for crack treatment Section 37-5 (Caltrans, 2010), or equivalent.
18	Two cracks approximately 25 and 40 feet long, and 1/8 to 3/8 inch wide in asphalt in the northwest area of the RCRA cap.	Sealed crack with sealant that meets Caltrans specifications for crack treatment Section 37-5 (Caltrans, 2010), or equivalent.
19	Crack approximately 20 feet long and 1/4 to 3/8 inch wide in asphalt in the southwest area of the non-RCRA cap. Crack is along the edge of a previous patch repair.	Sealed crack with sealant that meets Caltrans specifications for crack treatment Section 37-5 (Caltrans, 2010), or equivalent.
20	Crack approximately 55 feet long and 5/8 inch wide in the asphalt southwest of the building on the non-RCRA cap. Crack intersects a patch repair with a 1/4 inch crack on both edges approximately 50 feet long.	Sealed crack with sealant that meets Caltrans specifications for crack treatment Section 37-5 (Caltrans, 2010), or equivalent.

PHOTO: B&B-2014-39 LOCATION: RCRA Cap Area Map Location Number: 17 DESCRIPTION: Repair of asphalt cap cracking; approximately 10 feet long and 1/4 inch wide in asphalt near the south-facing fence of the RCRA cap.

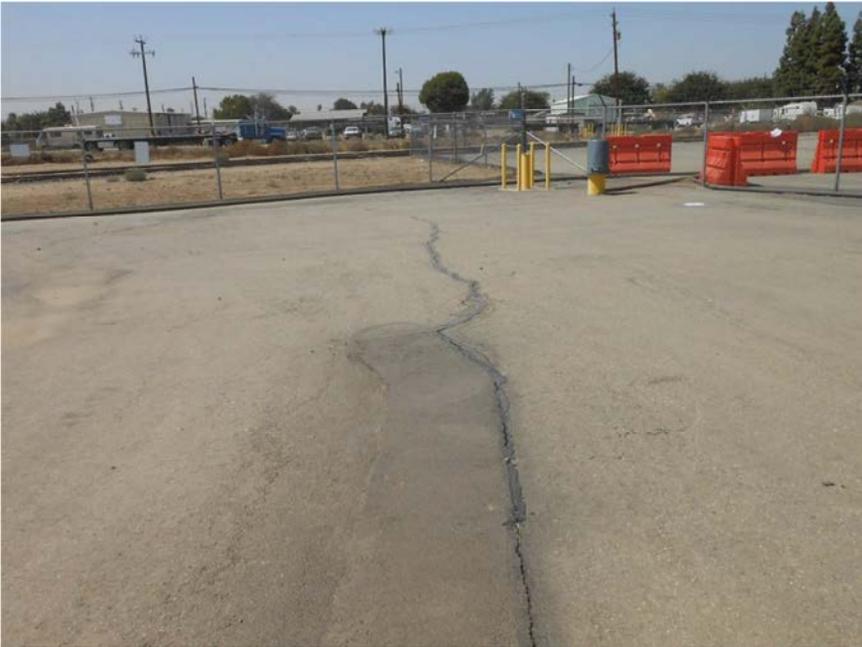
PHOTO: B&B-2014-40 LOCATION: RCRA Cap Area Map Location Number: 18 DESCRIPTION: Repair of asphalt cap cracking; approximately 25 and 40 feet long, 1/8 and 3/8 inch wide in asphalt.

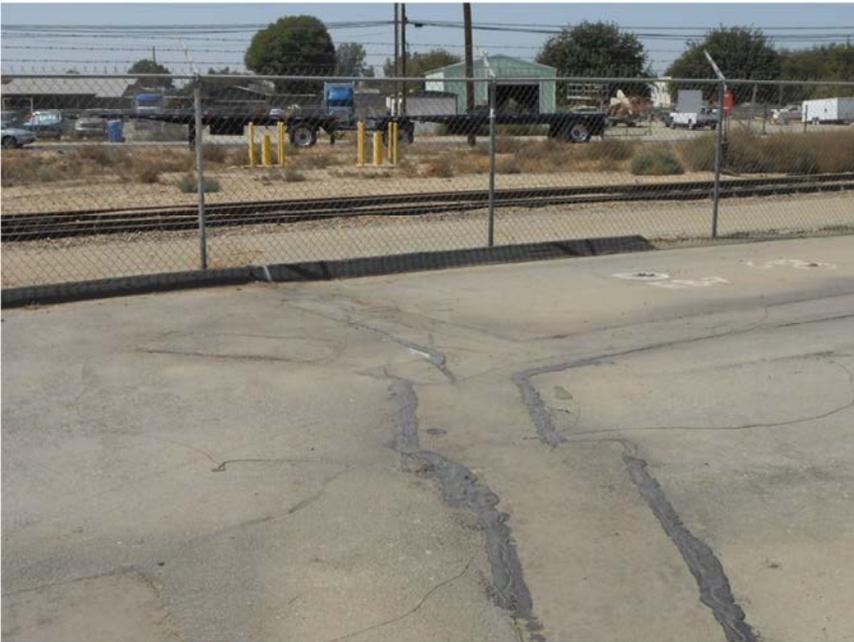
PHOTO: B&B-2014-41 LOCATION: Non-RCRA Cap Area Map Location Number: 19 DESCRIPTION: Repair of asphalt cap cracking; approximately 20 feet long and 1/4 to 3/8 inch wide in asphalt near the southwest corner of the non- RCRA cap.

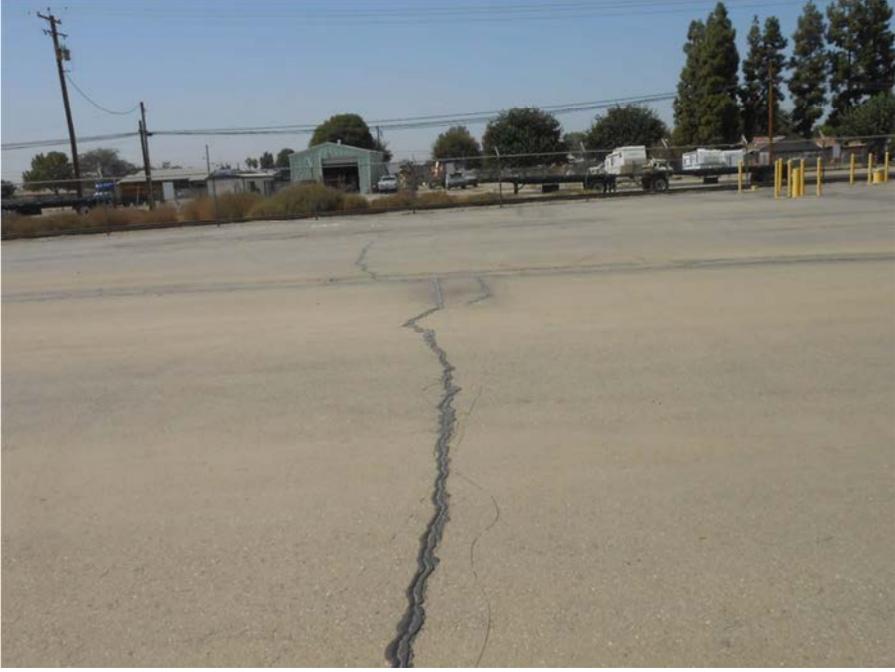
PHOTO: B&B-2014-42 LOCATION: Non-RCRA Cap Area Map Location Number: 20 DESCRIPTION: Repair of asphalt cap cracking; approximately 25 and 40 feet long, 1/8 and 3/8 inch wide in asphalt.

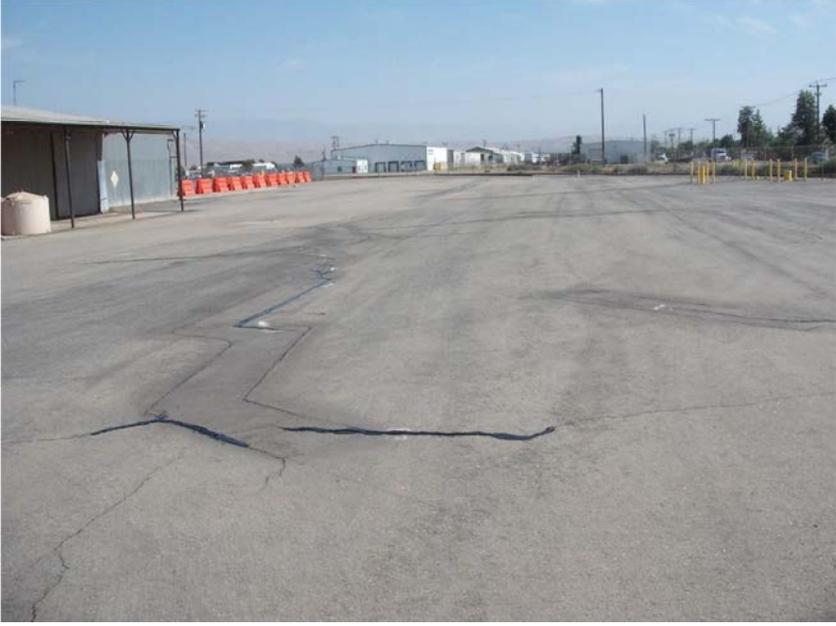
PHOTO: B&B-2014-43 LOCATION: Non-RCRA Cap Area Map Location Number: 22 DESCRIPTION: Repair of asphalt cap cracking; approximately 20 feet long and 5/8 inch wide in the asphalt west of the building on the non-RCRA cap.

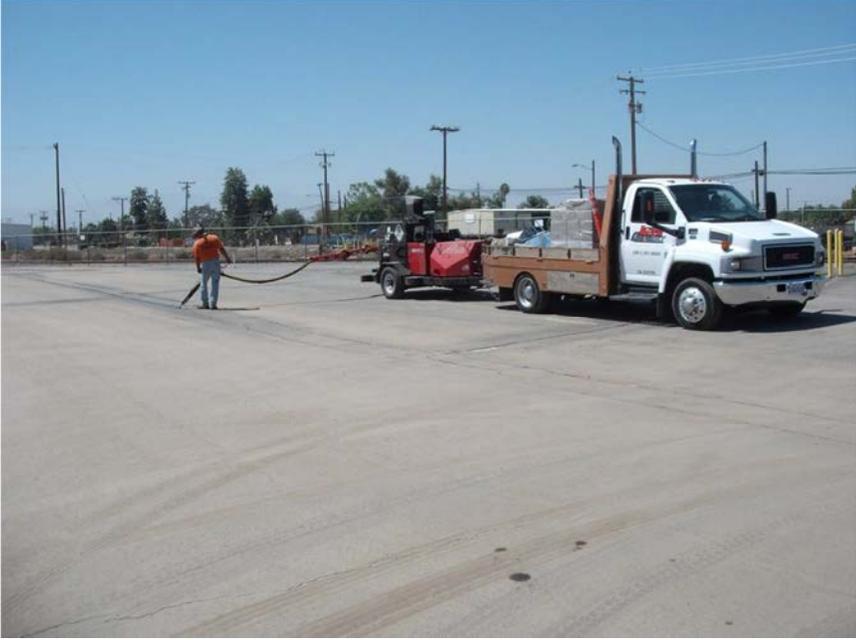
PHOTO: B&B-2014-44 LOCATION: Non-RCRA Cap Area Map Location Number: 23 DESCRIPTION: Repair of asphalt cap cracking; two cracks approximately 70 feet long and 1/8 to 1/4 inch wide in the asphalt southwest of the building on the non-RCRA cap. Cracks are along the edge of a previous patch repair.

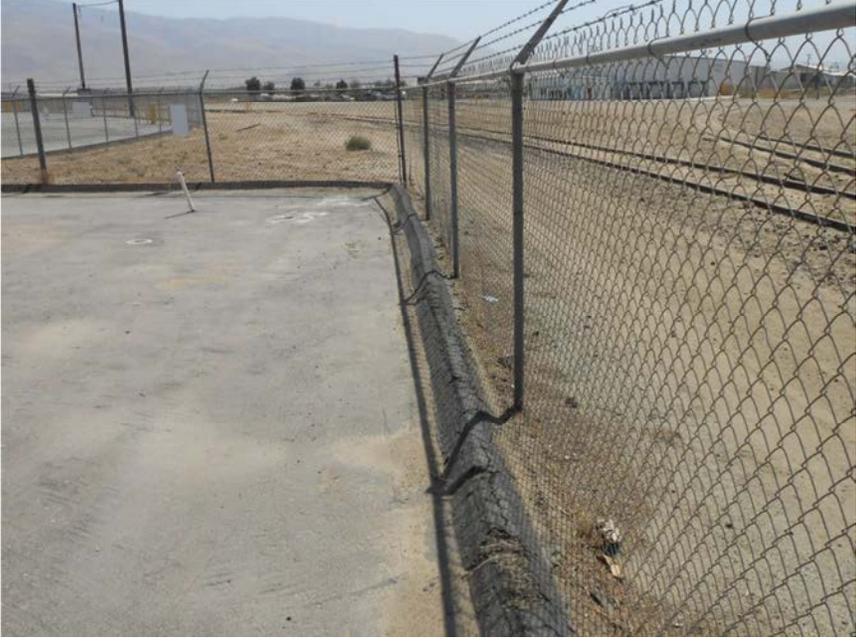
PHOTO: B&B-2014-44 LOCATION: Non-RCRA Cap Area Map Location Number: 13-1 DESCRIPTION: Remove weeds.

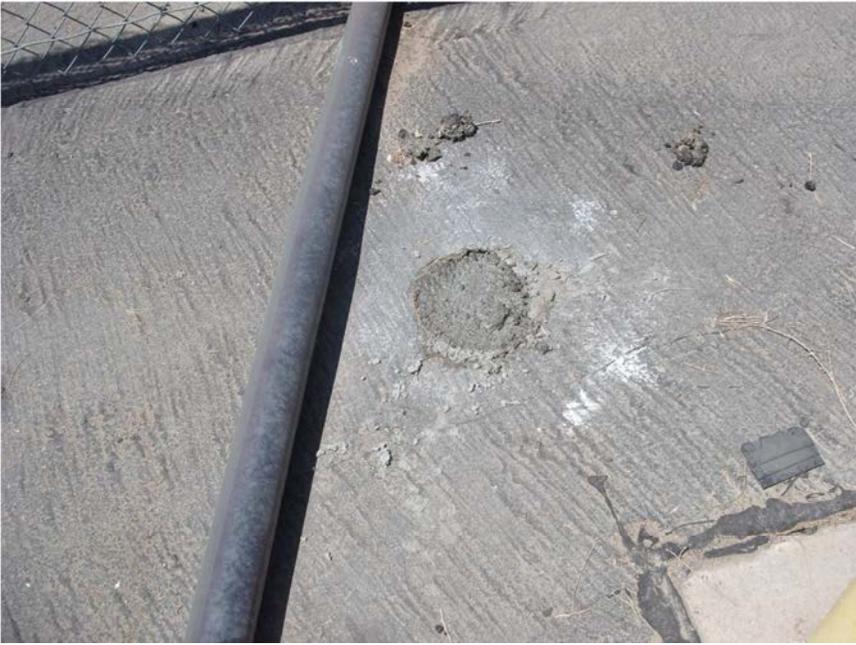
<p>PHOTO: B&B-2014-45</p> <p>LOCATION: RCRA Cap Area Map Location Number: 13-02</p> <p>DESCRIPTION: Repair of hole in asphalt, a shallow hole, approximately 6 inches in diameter, identified in western edge of RCRA cap at center of western property line.</p>

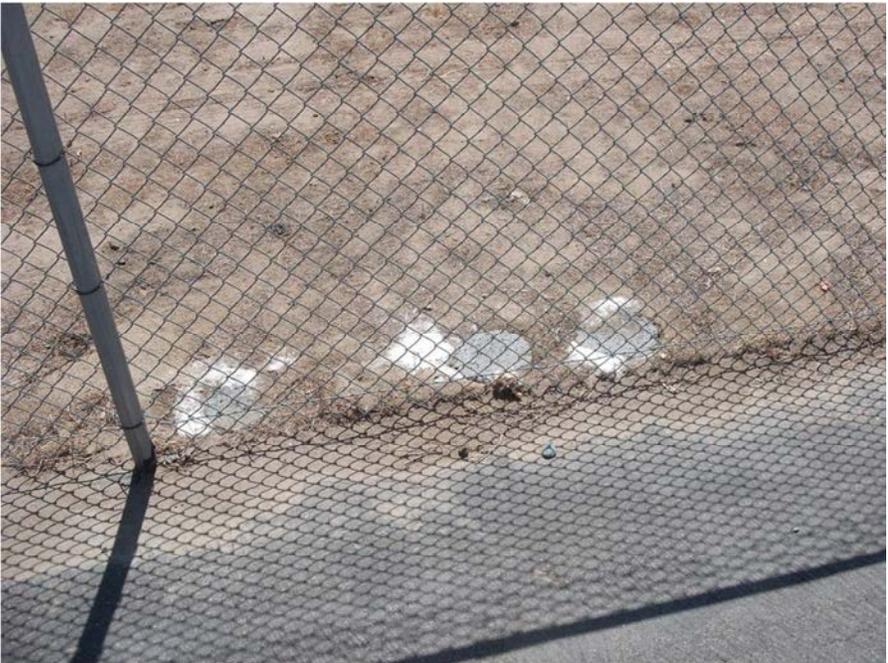
<p>PHOTO: B&B-2014-46</p> <p>LOCATION: RCRA Cap Area Map Location Number: 13-3</p> <p>DESCRIPTION: Grouting of several small squirrel holes at center of western property line of the RCRA cap.</p>

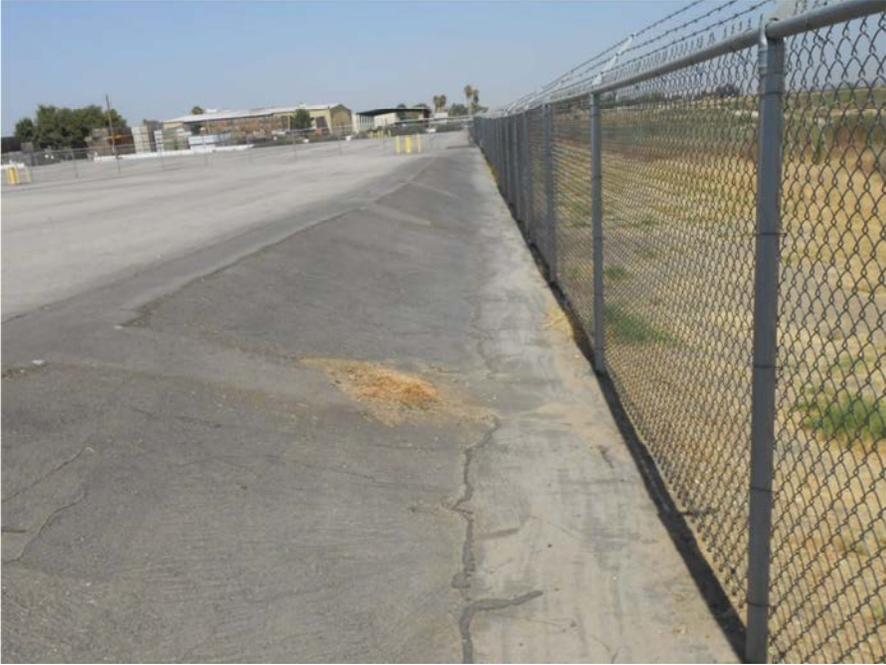
<p>PHOTO: B&B-2014-47</p> <p>LOCATION: RCRA Cap Area Map Location Number: 13-5</p> <p>DESCRIPTION: Mowed weeds growing on cap.</p>

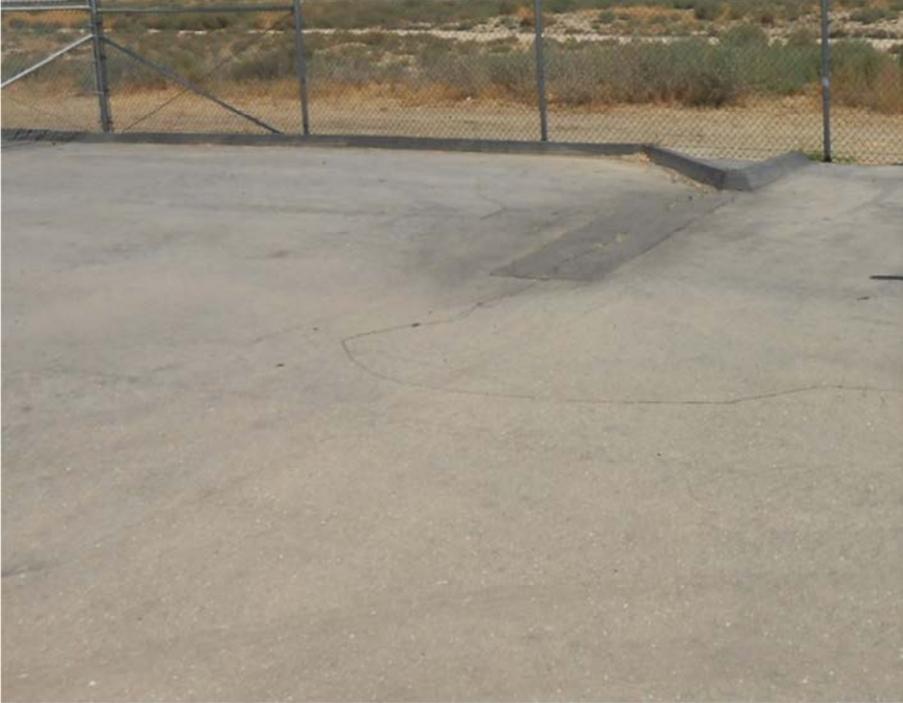
13-6	Small crack, approximately 1/8-inch wide, noted in RCRA cap at center of eastern property line.	Cracking is considered low severity; recommend further monitoring.
13-7	Hairline crack, approximately 60 feet long, 1/8-inch wide, in RCRA cap beginning at previous patch and orientated eastwards at southern end of eastern property line.	Cracking is considered low severity; recommend further monitoring.
13-8	Hairline crack, approximately 30 feet long, 1/8-inch wide, in RCRA cap between previous patches in southern portion of site.	Cracking is considered low severity; recommend further monitoring.
13-9	Three small cracks, each less than 20 feet long and approximately 1/8-inch wide, in RCRA cap near bollards at center of site.	Cracking is considered low severity; recommend further monitoring.
13-10	Hairline crack, approximately 10 feet long, 1/8-inch wide, in RCRA cap at center of site.	Cracking is considered low severity; recommend further monitoring.

<p>PHOTO: B&B-2014-48</p> <p>LOCATION: RCRA Cap Area Map Location Number: 13-6</p> <p>DESCRIPTION: Continue to monitor crack, approximately 1/8-inch wide.</p>

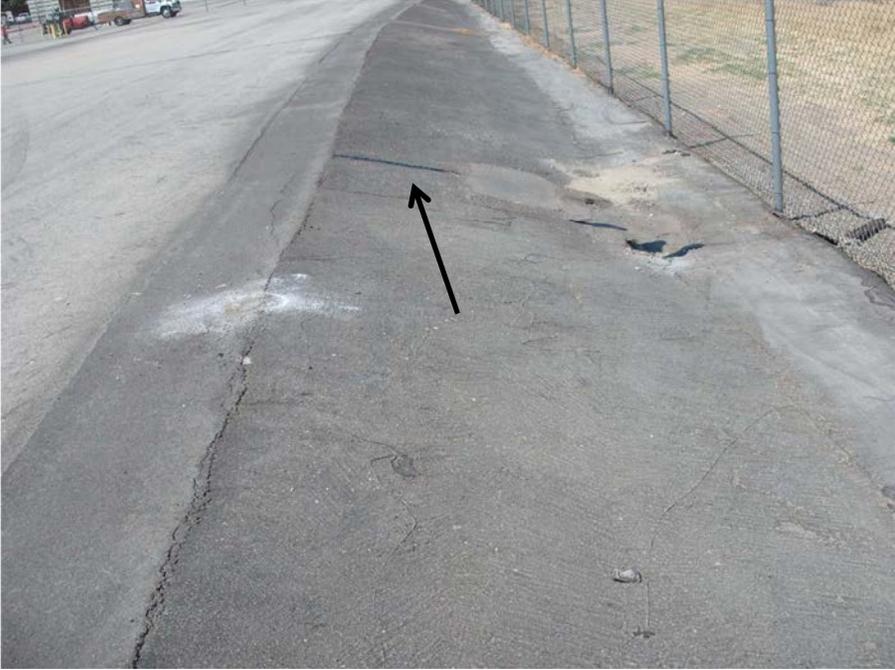
<p>PHOTO: B&B-2014-49</p> <p>LOCATION: RCRA Cap Area Map Location Number: 13-7</p> <p>DESCRIPTION: Continue to monitor crack, approximately 1/8-inch wide.</p>

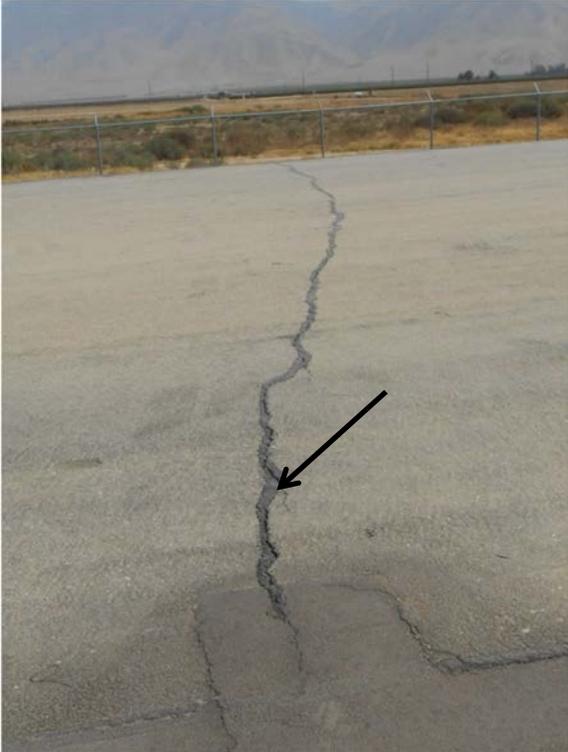
<p>PHOTO: B&B-2014-50</p> <p>LOCATION: RCRA Cap Area Map Location Number: 13-8</p> <p>DESCRIPTION: Continue to monitor crack, approximately 1/8-inch wide.</p>

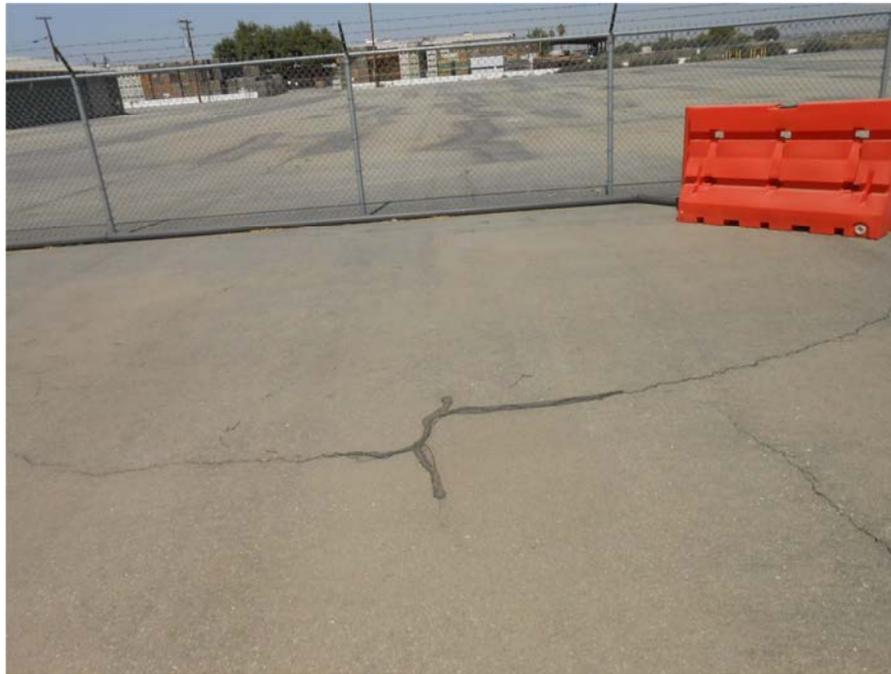
PHOTO: B&B-2014-51

DESCRIPTION:
 Continue to monitor crack,
 approximately 1/8-inch wide.

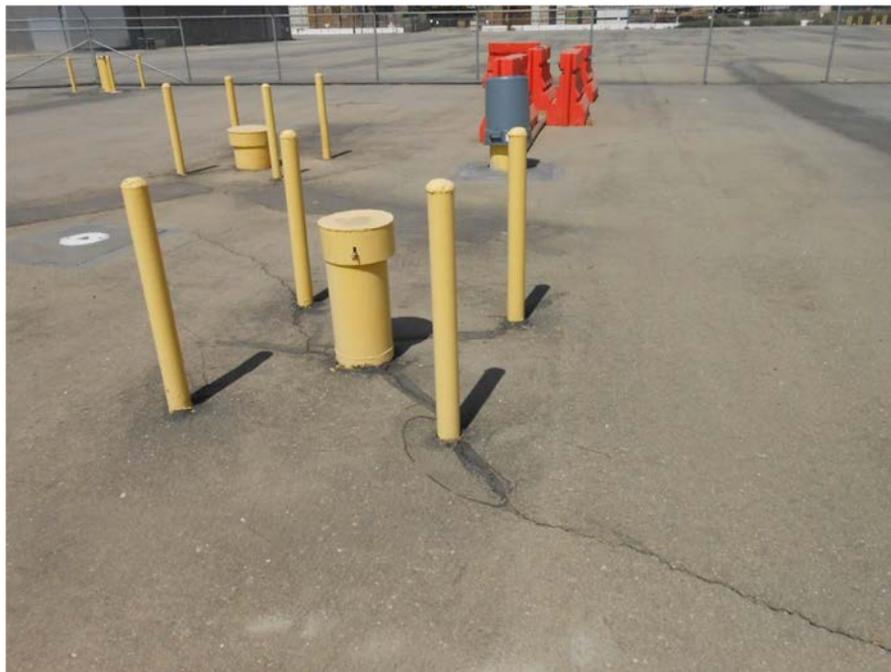
PHOTO: B&B-2014-52

DESCRIPTION:
 Continue to monitor crack,
 approximately 1/8-inch wide.

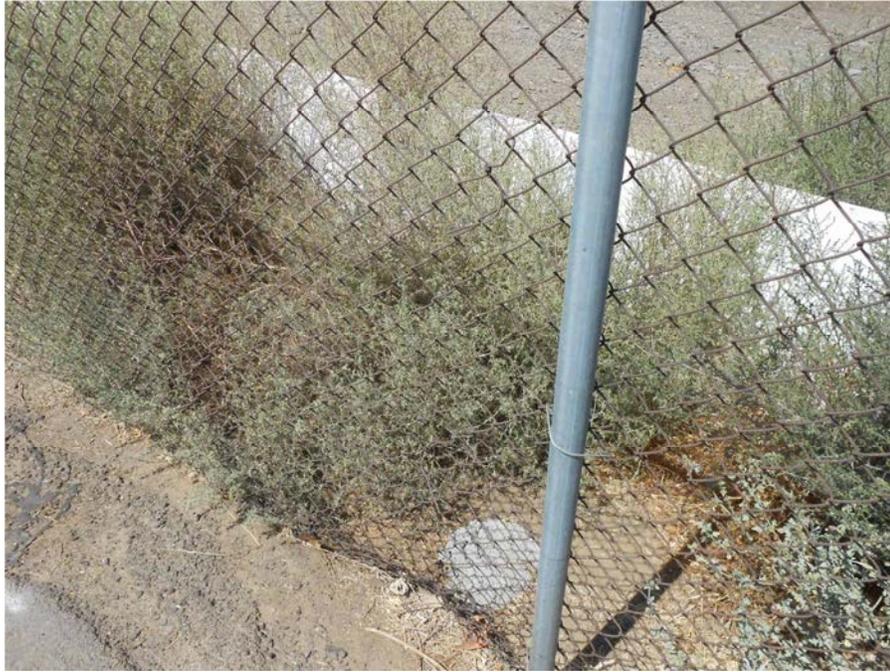
PHOTO: B&B-2014-53

DESCRIPTION:
 Grout hole on the outside of the
 Non-RCRA cap.

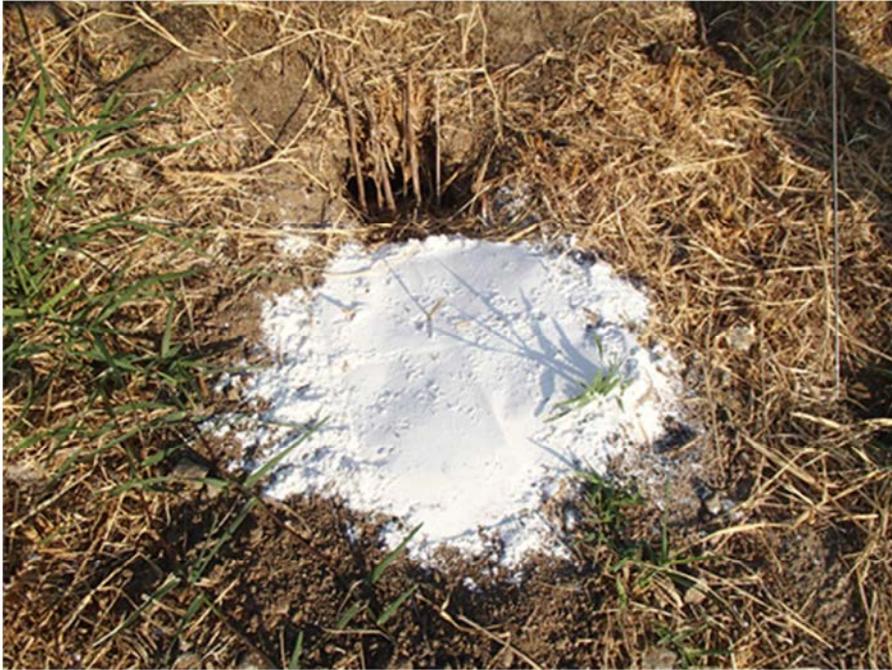
PHOTO: B&B-2014-54

Burrow with sticks and flour dust at entrance. Ant tracks in flour.

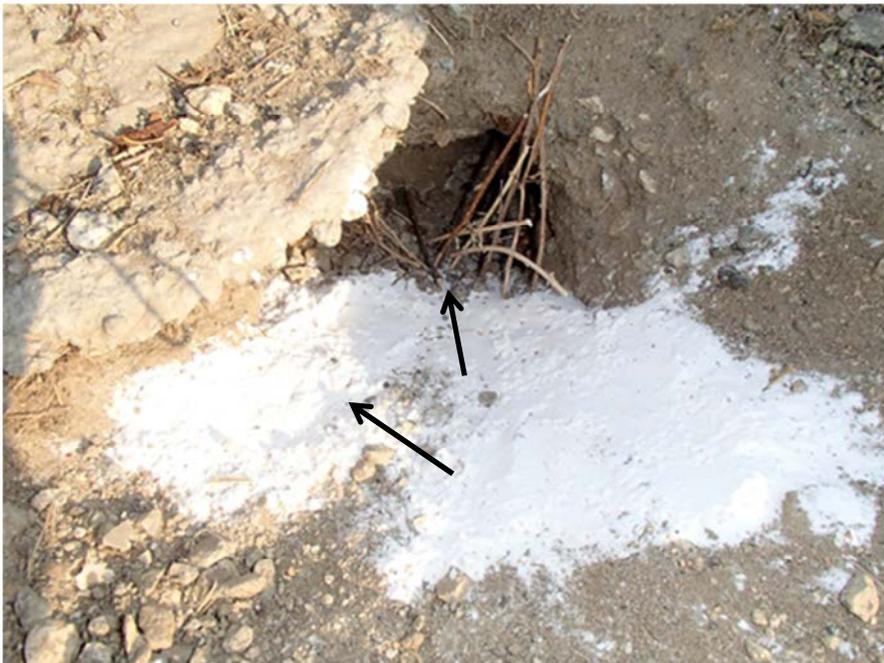
PHOTO: B&B-2014-55

Burrow with disturbed sticks and bird print on left side of entrance (see arrows).

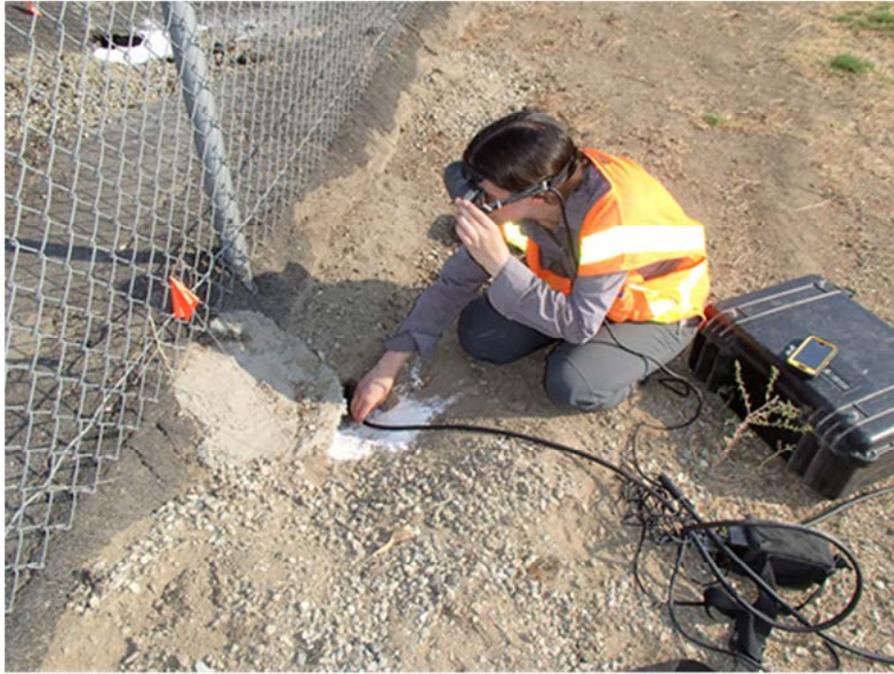
PHOTO: B&B-2014-56

DESCRIPTION:
 Biologist scoping burrow.
