**SUBJECT: Contract Agreement 10-T1114
Cap Repair Summary Report
Brown and Bryant Inc., Site, Arvin, California**

CAP REPAIR SUMMARY REPORT

**BROWN & BRYANT, ARVIN FACILITY
SUPERFUND SITE, FIRST OPERABLE UNIT
REMEDIAL ACTION**

ARVIN, CALIFORNIA

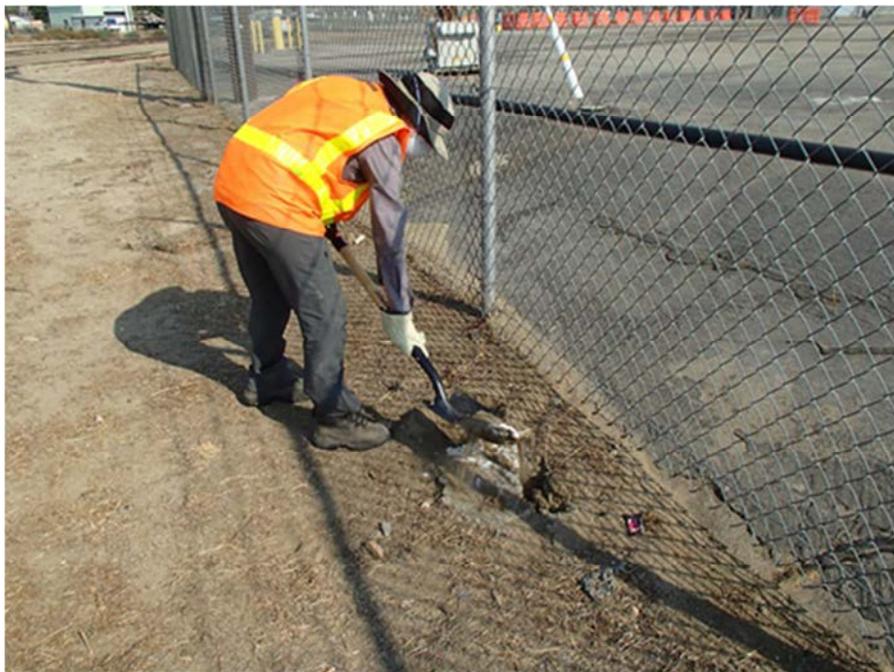
PHOTO: B&B-2014-57

DESCRIPTION:
 Biologist collapsing burrow outside perimeter fence of RCRA cap.

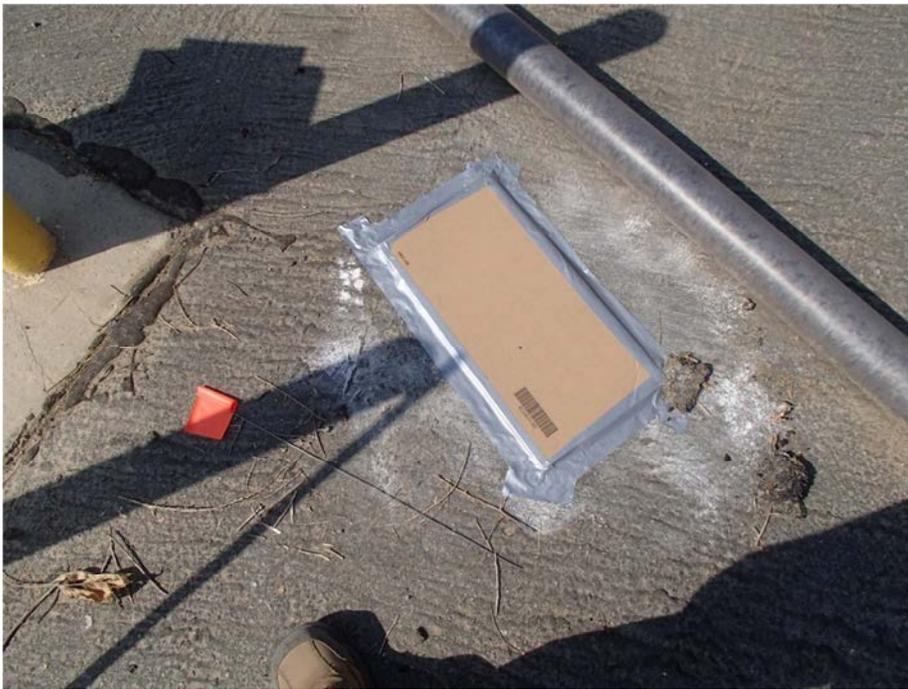
PHOTO: B&B-2014-58

DESCRIPTION:
 Covered burrow with cardboard and secured with duct tape in northwest portion of RCRA cap until grouting was performed.

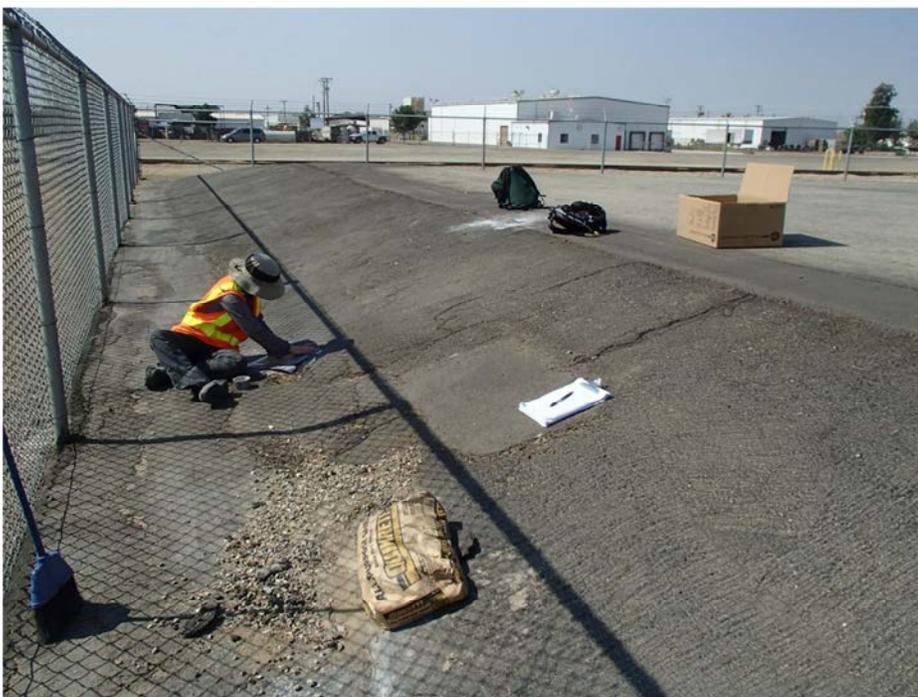
PHOTO: B&B-2014-59

DESCRIPTION:
 Survey of three burrows in southeast portion of RCRA cap.

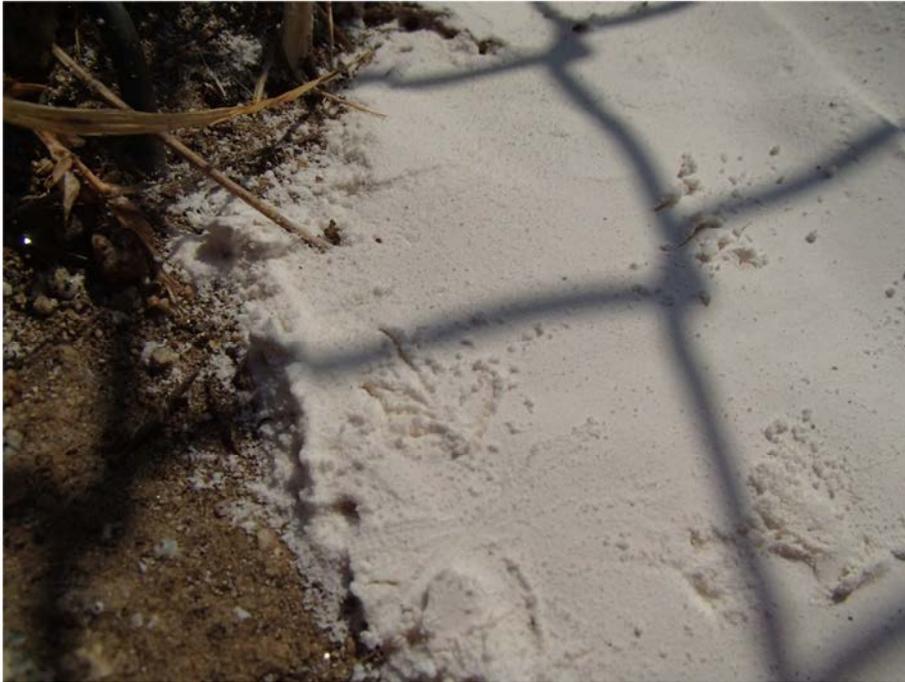
PHOTO: B&B-2014-60

DESCRIPTION:
 Side-blotched lizard prints and tail drag at burrow near 13-2.
