Remedial Action Report Mine Area Operable Unit (OU1)

**Lava Cap Mine Superfund Site
Nevada County, California**

November 2010

CH2MHILL
2485 Natomas Park Drive, Suite 600
Sacramento, CA 95833

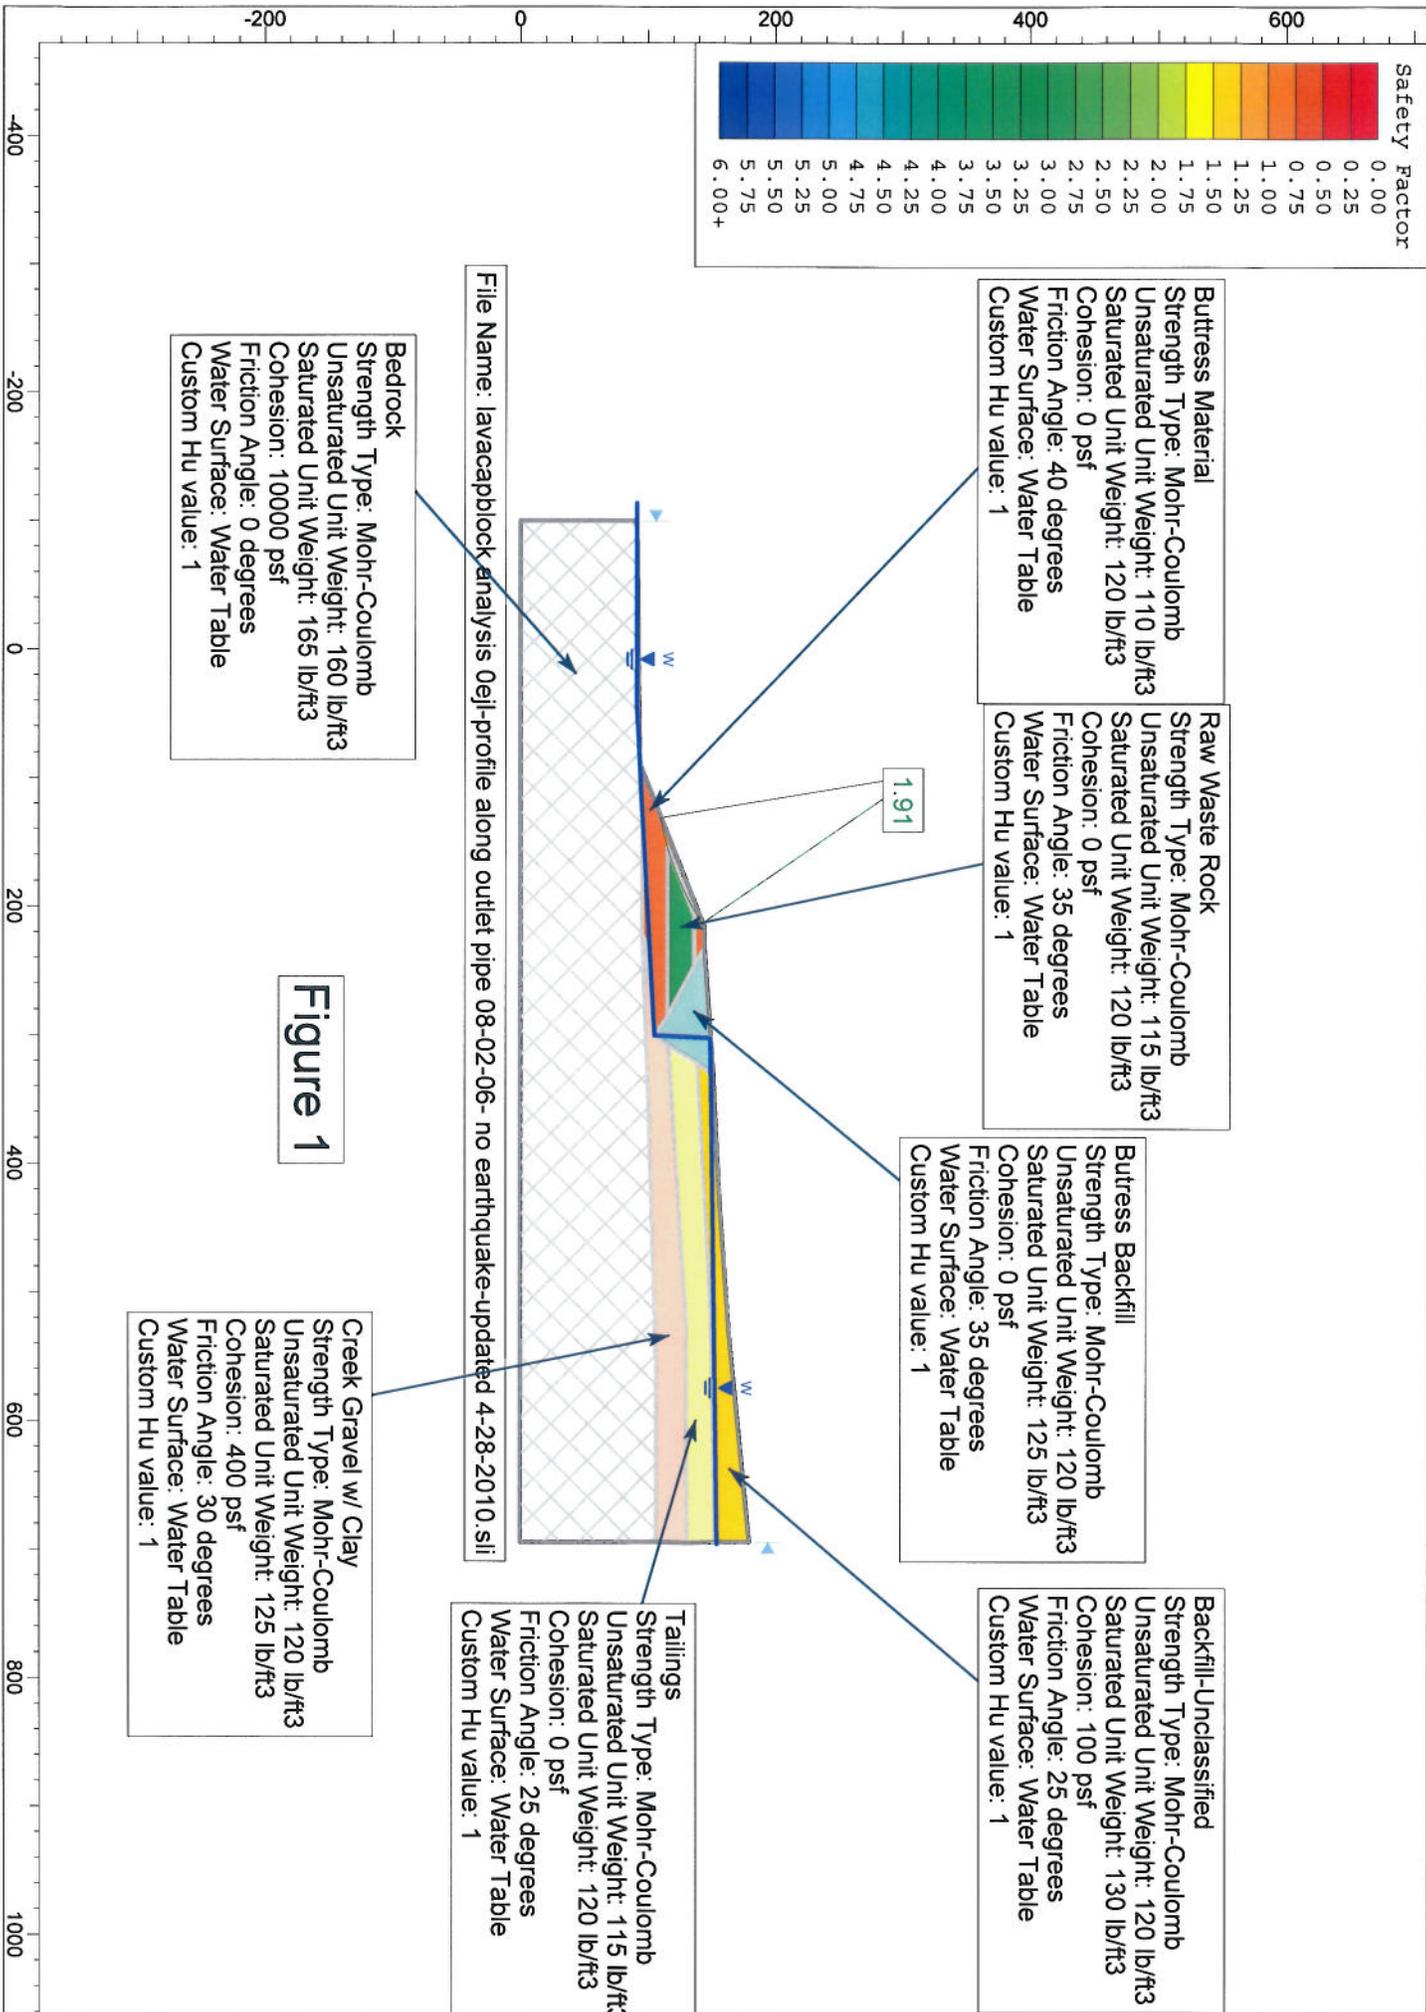
The results of the long term stability analyses are presented in Figure 1 along with the characteristics for each material included in the buttress and uphill of the buttress. The minimum calculated factor of safety was 1.91 which exceeds the normal required value of 1.5.

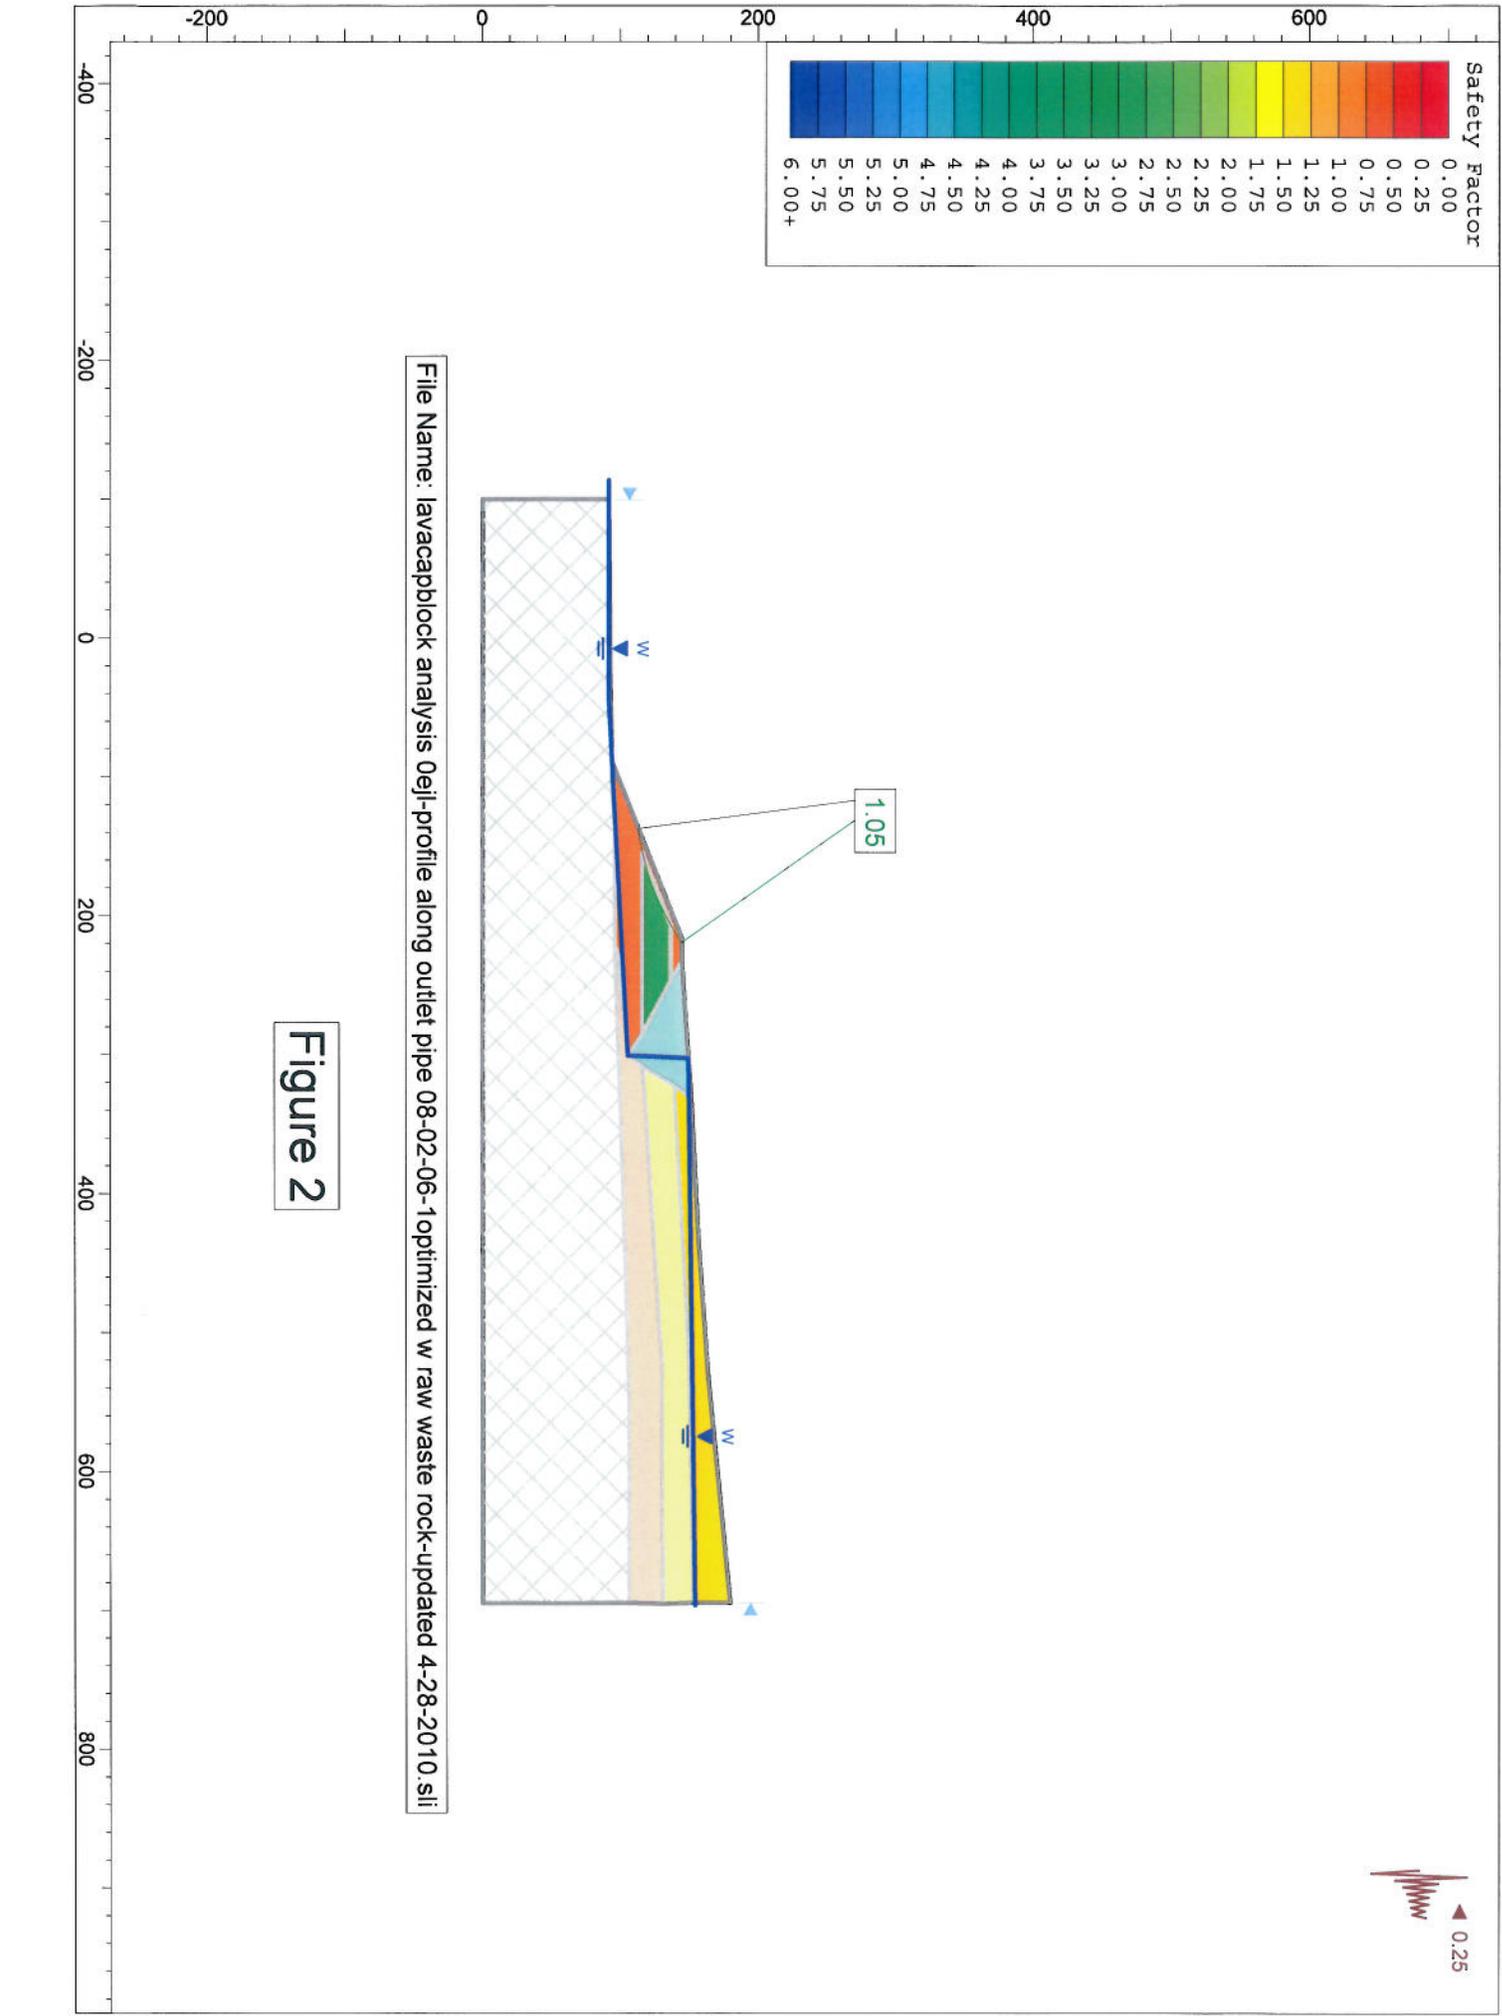
Stability results for the pseudo-static analysis are shown in Figure 2 with the minimum calculated factor of safety 1.05. This value can be rounded to 1.1 and is an acceptable result. The position of the lowest factor of safety is for a sliding surface against the raw waste rock with a 10-foot thick covering of the high quality buttress material on the downstream face. These types of shallow sliding surfaces are common in slope stability analysis and almost never cause major distress to the overall embankment. An inspection of the buttress would be warranted following a major earthquake.
