PHOTOGRAPHIC RECORD

OU2 Site Inspection

Site Name: Motorola 52 nd Street Superfund Site	EPA ID: AZD009004177
Review Report: 2011 Sitewide Five-Year Review	Review Period: August 2006 - October 2010
Treatment Facility Name: 20 th Street Treatment Plant	Operable Unit Region: 2

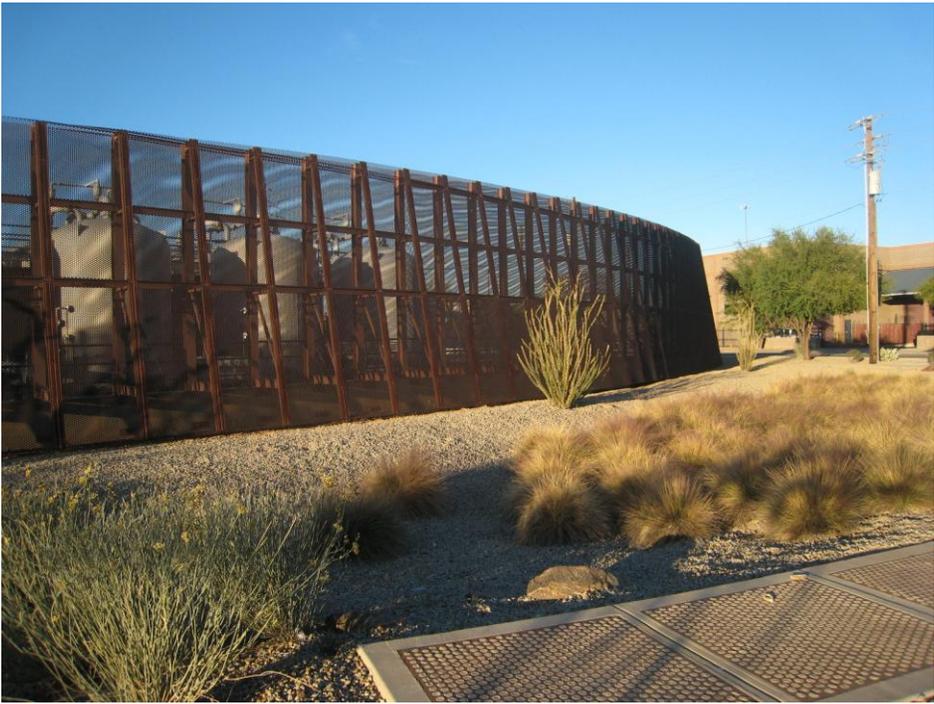
Photo No. 1

Description:
OU2 site security
fencing/screening. The
fencing is over 6 feet tall. The
property around the fenced
area is landscaped and well
maintained. No evidence of
vandalism or unauthorized
loitering around the perimeter
of the facility was observed.

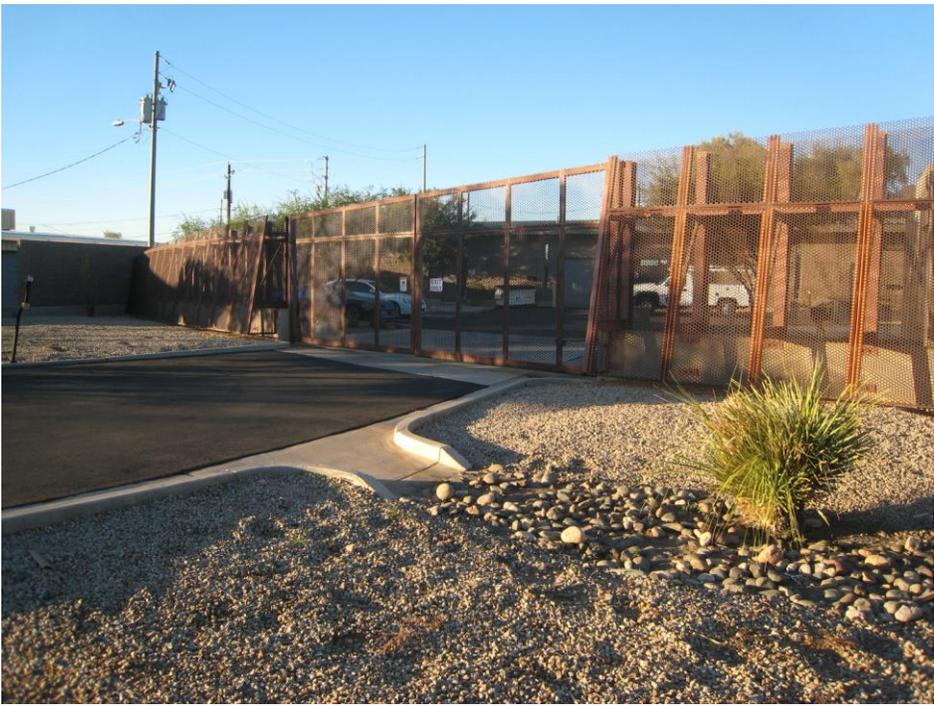
Photo No. 2

Description:
OU2 site security
fencing/screening showing
Washington Street access via
a retractable fence equipped
with an entry keypad (on the
far left of the photo). An
additional keypad controlling
fence operation is located on
the interior of the fenced area.

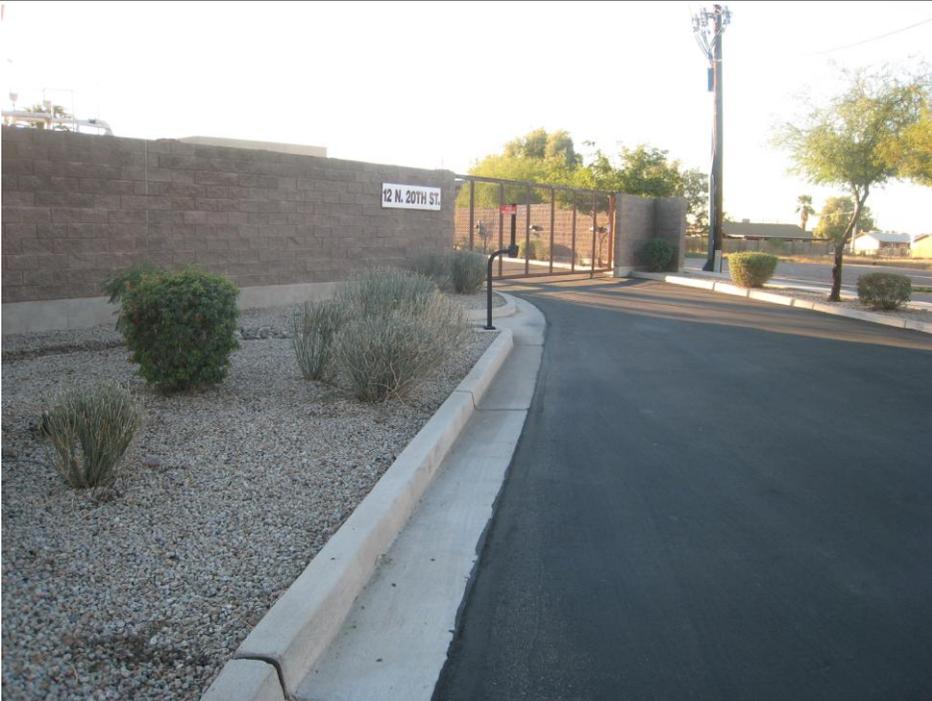
Photo No. 3

View Direction of Photo: Northeast from 20 th Street	
Date: 12/1/10	
Description: OU2 site security fencing showing 20 th Street access via a retractable fence with an entry keypad. This keypad is equipped with a mechanism for fire department access. Similar to the Washington Street access, an additional keypad controlling fence operation is located on the interior of the fenced area.

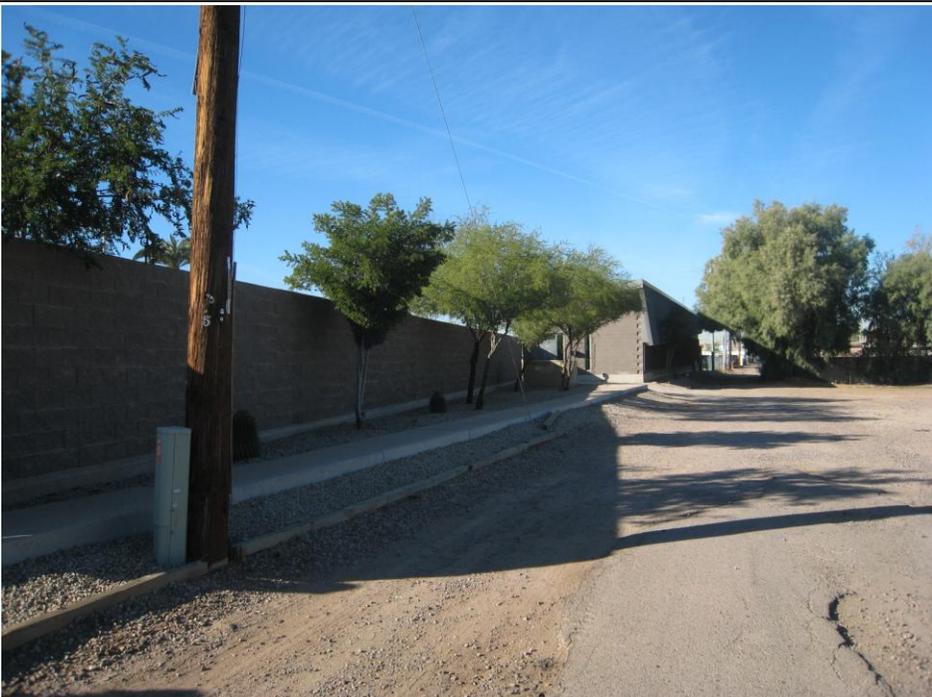
Photo No. 4

View Direction of Photo: West from 20 th Street	
Date: 12/1/10	
Description: OU2 site security fencing along the northern perimeter of the property. The building near the center of the photograph is the Treatment Building that forms part of the site enclosure. An office with access only to outside the compound (the entry is located in this alleyway) is used by the City of Phoenix Police Department as a field office.

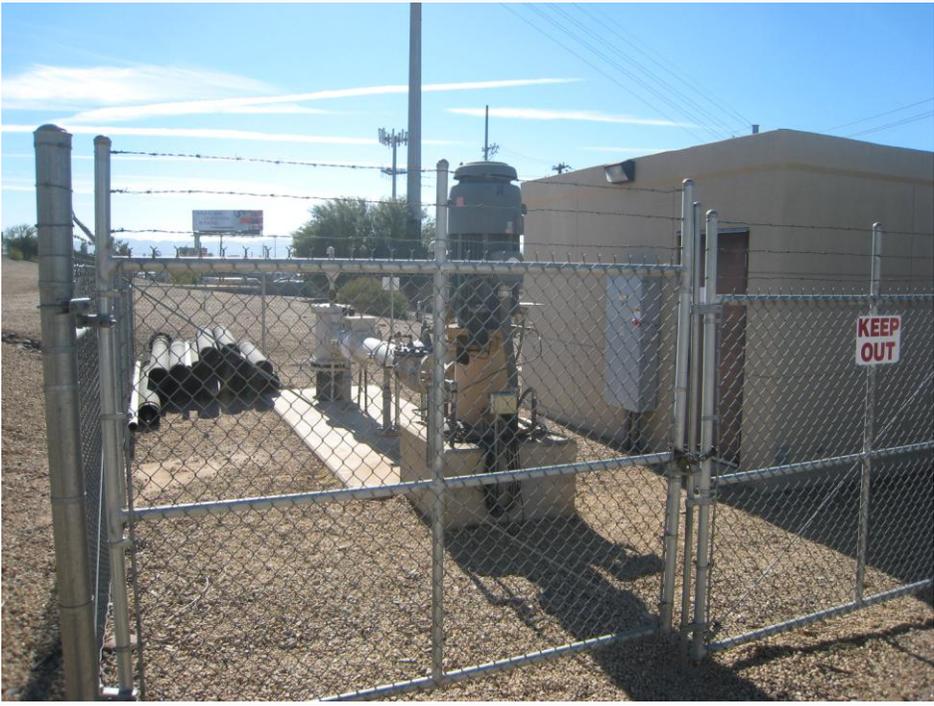
Photo No. 5

Description:
EW-N well site showing security fencing, signage and access secured by a chain and lock. Access to this well site is further secured by ADOT ROW security fencing.

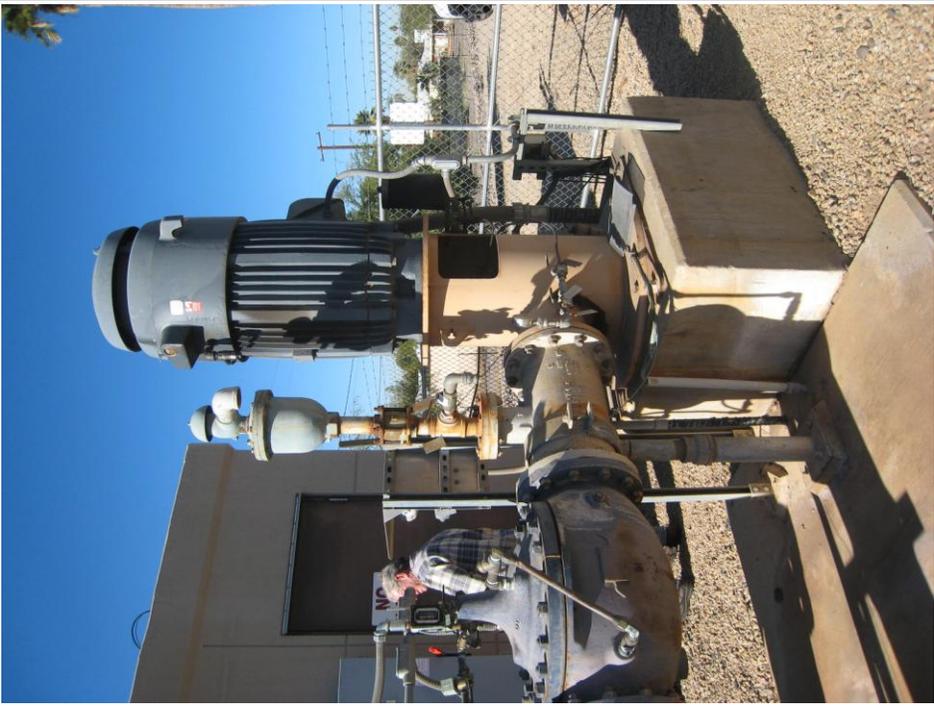
Photo No. 6

Description:
Lineshaft turbine pump installed in EW-N. Minor rust discoloration noted on exterior of piping – system appears intact and well maintained.

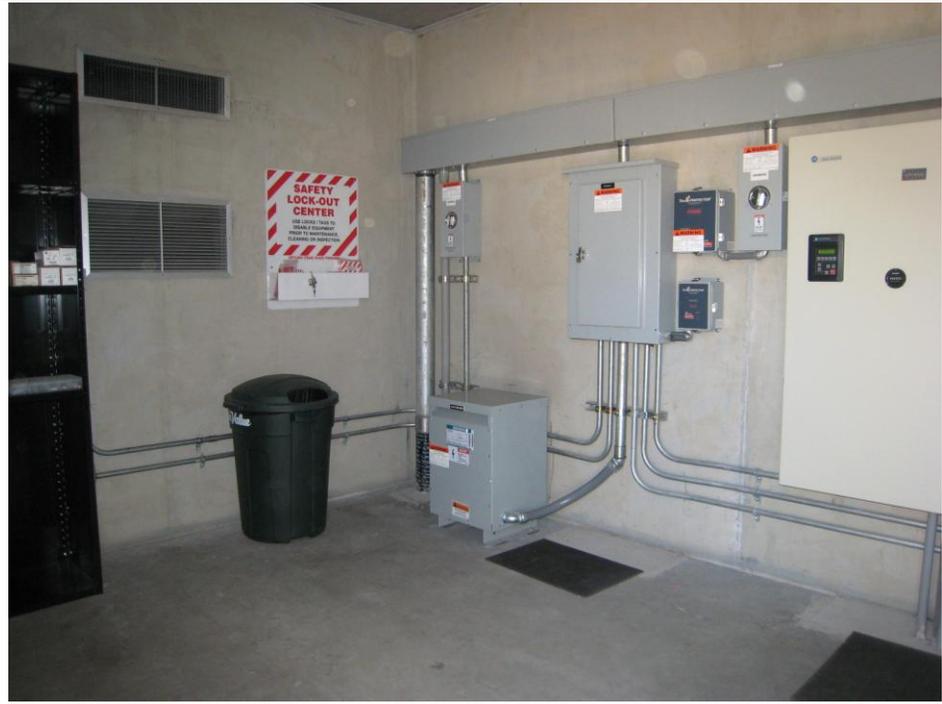
Photo No. 7

Description:
Representative photograph of all well site electrical/control buildings. These buildings are climate controlled and appear to be well kept. Direct reading instrument panels are located in these buildings.

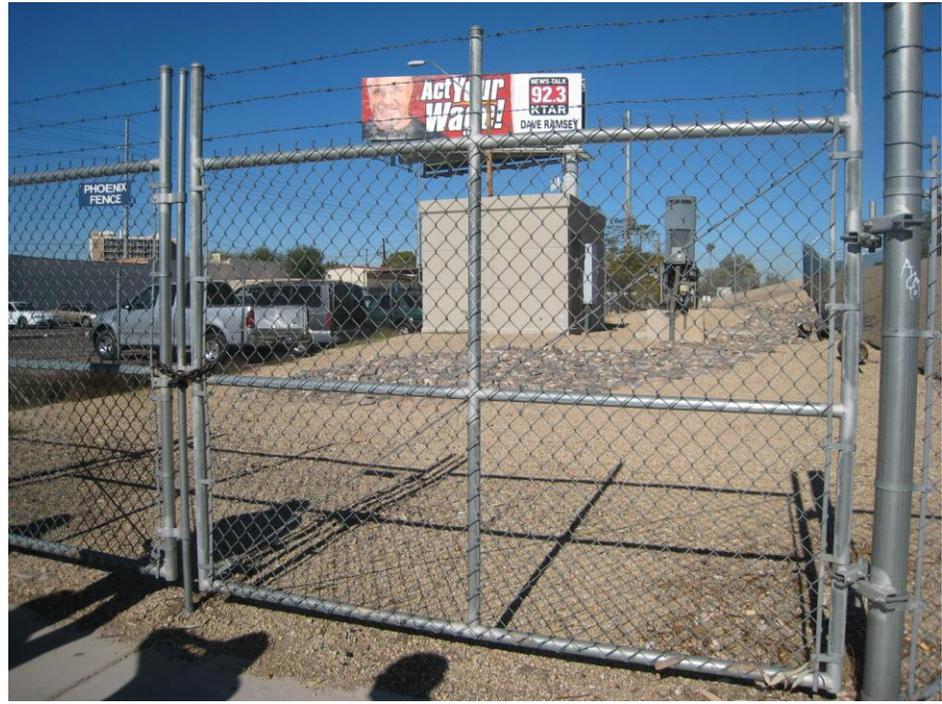
Photo No. 8

Description:
EW-M well site showing security fencing and access secured by a chain and lock. This well site is located on a relatively busy street in metropolitan Phoenix.

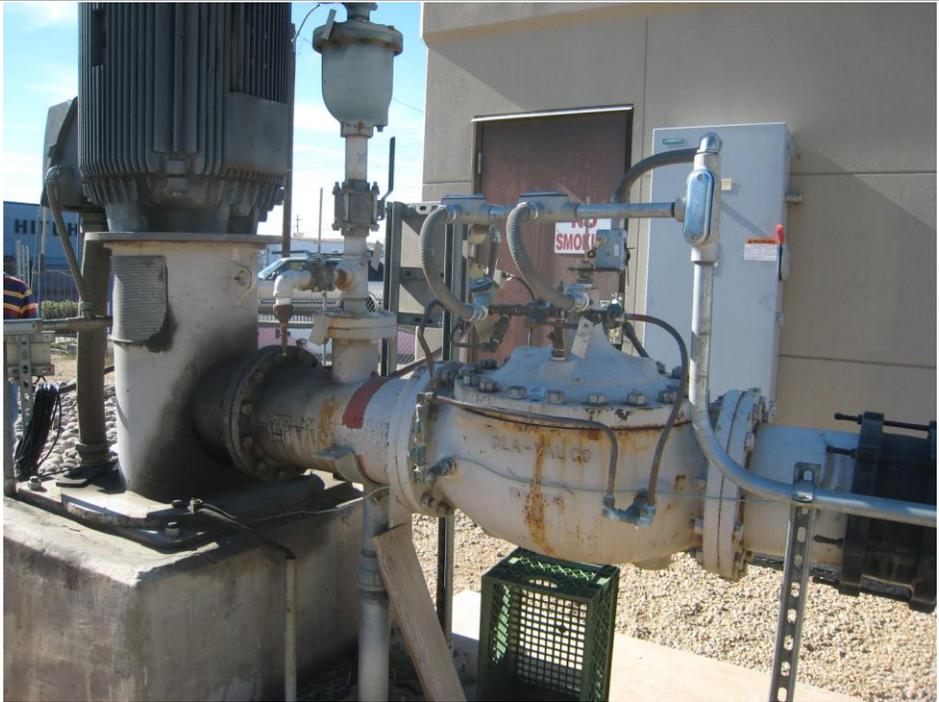
<p>Photo No. 9</p>

<p>View Direction of Photo: Southwest from inside the EW-M well site</p>	
<p>Date: 12/1/10</p>	
<p>Description: Lineshaft turbine pump installed in EW-M. Lubrication leak noted – per discussion with the treatment system operator, the leak has undergone troubleshooting and has been assessed as minor. No issue with pump operation noted. Some direct reading instrument panels on above ground piping were no longer locally readable and a pipe clamp was noted to be missing. Per the operator – the equipment is functioning properly and data are remotely accessible.</p>

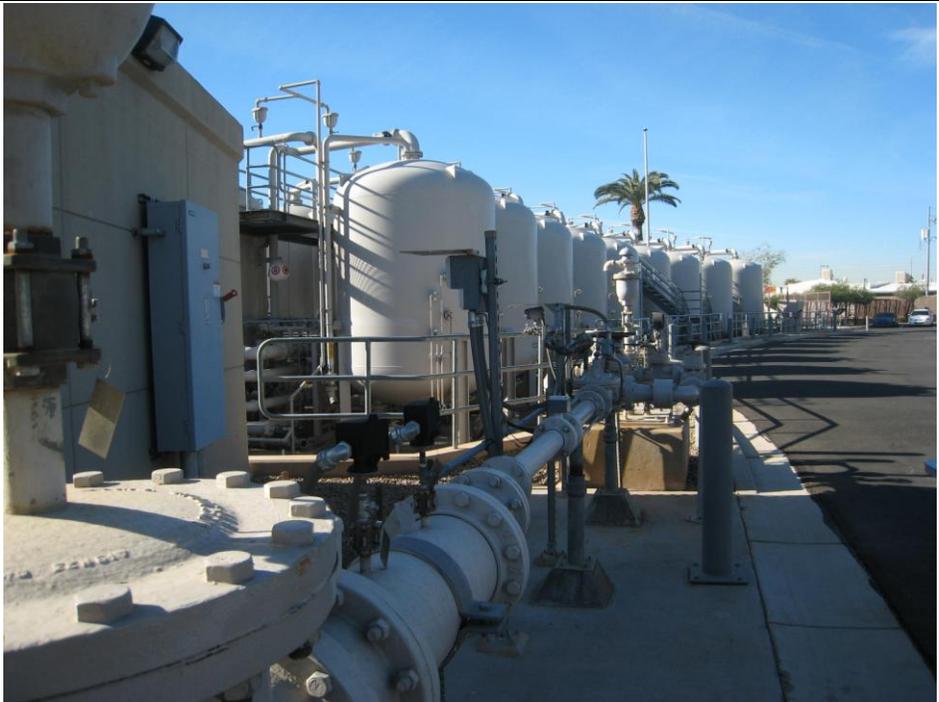
<p>Photo No. 10</p>

<p>View Direction of Photo: West from EW-S piping within Treatment Compound</p>	
<p>Date: 12/1/10</p>	
<p>Description: View of EW-S piping in the foreground (this well is equipped with a submersible pump), the EW-S electrical/control building to the left, the driveway to the right, and the 'A' carbon vessels in the background. Both the 'A' and 'B' vessels (not pictured) are located within a subgrade double containment structure (the 'A' and 'B' vessels operate together as a pair in series). The interior of the treatment compound is clean and well kept.</p>

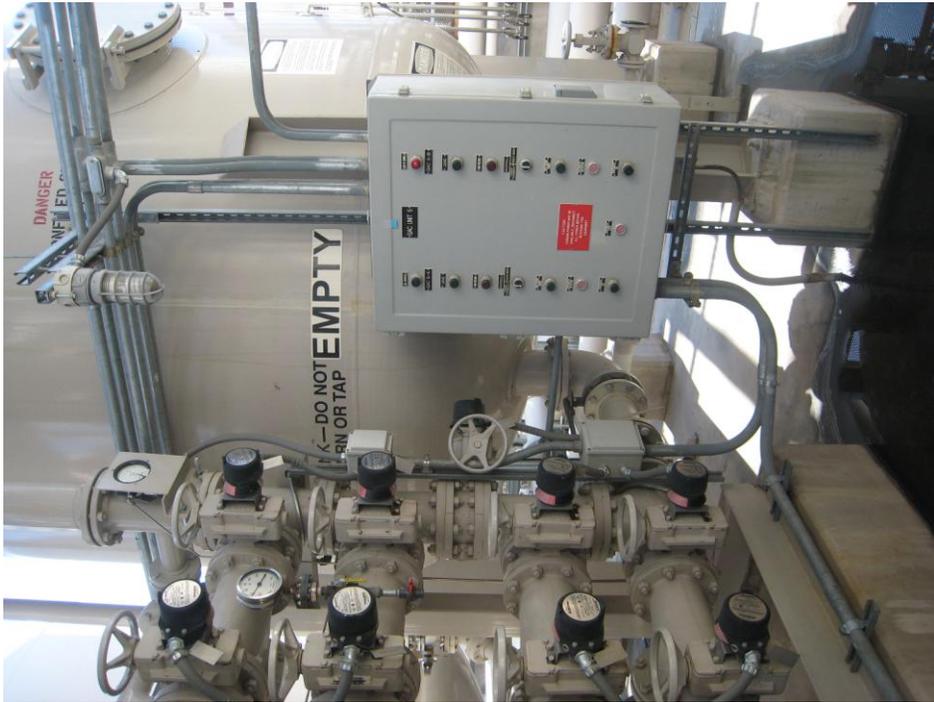
Photo No. 11

View of representative local control panel and carbon vessel valving (for the 5A and 5B vessel pair). The valves control process flow – directing which vessel is the lead and which is the lag vessel – and can be remotely actuated. The water puddle observed at the base of this photograph is from wash down of the area prior to the site inspection.

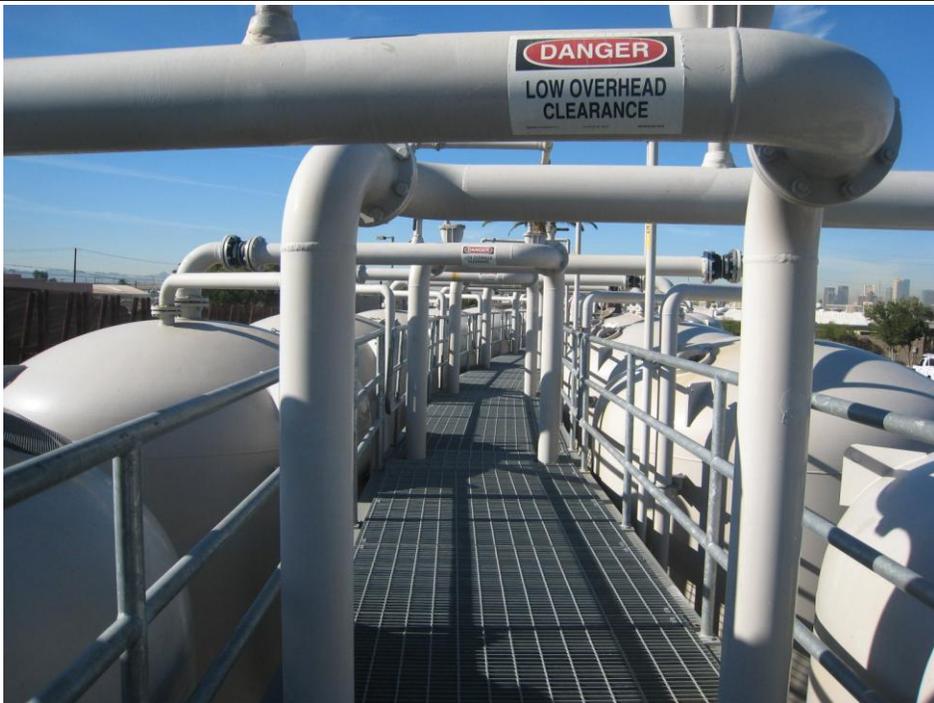
Photo No. 12

An overhead catwalk serves as access to carbon vessels and associated piping. Of the nine pairs of vessels installed at the facility, only five pairs with a ready spare pair were in operation at the time of the site inspection. The three remaining pairs were empty with open access hatches (bird wire covers the opening – see representative units in the right of the photograph). Minor rust discoloration and hard water deposits were noted on the exterior of some piping and vessels.

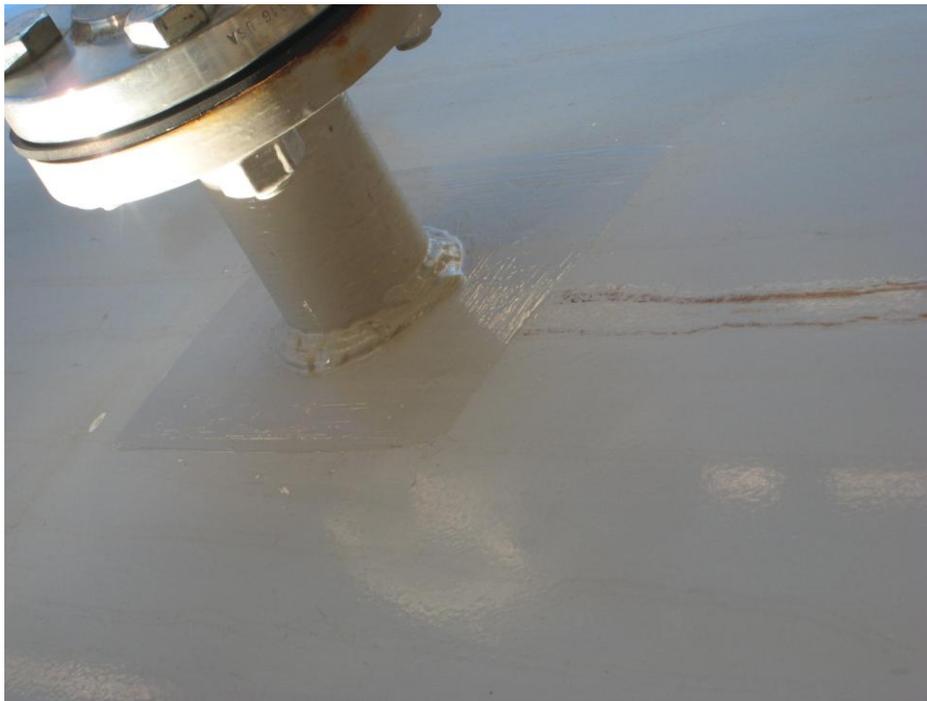
Photo No. 13

Description:
Repaired tank nozzle of Vessel 6A. The weld associated with this vent line (and the same line on Vessel 2B) had a minor noted leak and was repaired by a certified welder in 2008 at the time six pairs of vessels were relined.

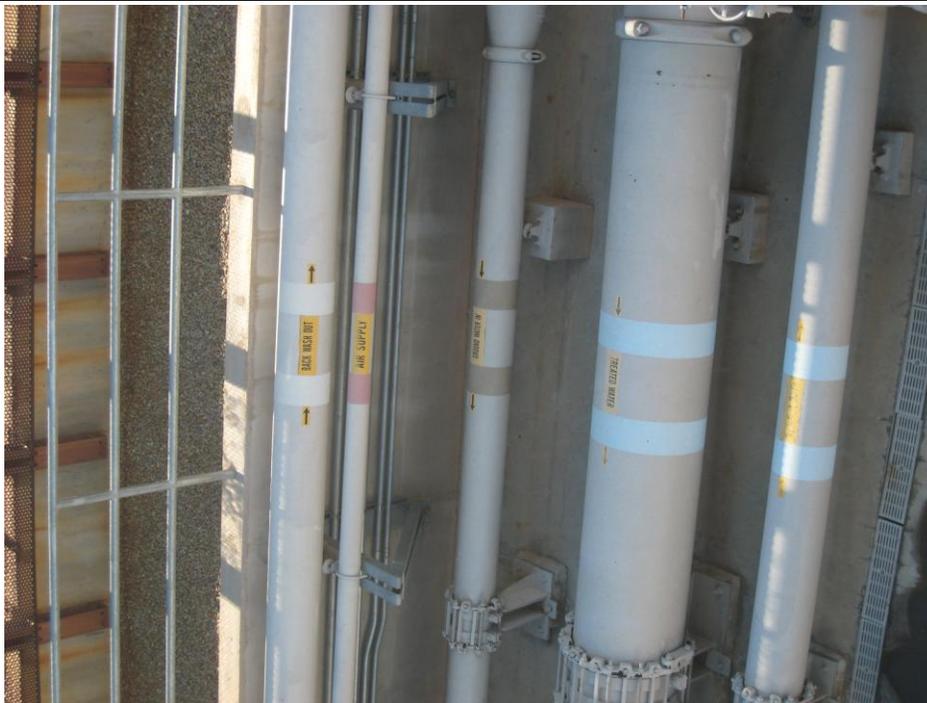
Photo No. 14

Description:
Pipes within the secondary containment area are labeled. In some instances the labels are beginning to become unreadable due to exposure to the elements.

Remarks: The site piping is in good repair and preventative maintenance activities include pipe replacement when necessary. Some sun bleaching of the site piping has worn the piping labels near the east of the compound.

Remarks: Equipment appears intact. However warning signs on the carbon adsorbers are sunbleached, unreadable, and should be replaced. Also the onsite wastewater sump is not currently labeled as a confined space. The sump should be labeled in accordance with OSHA requirements.

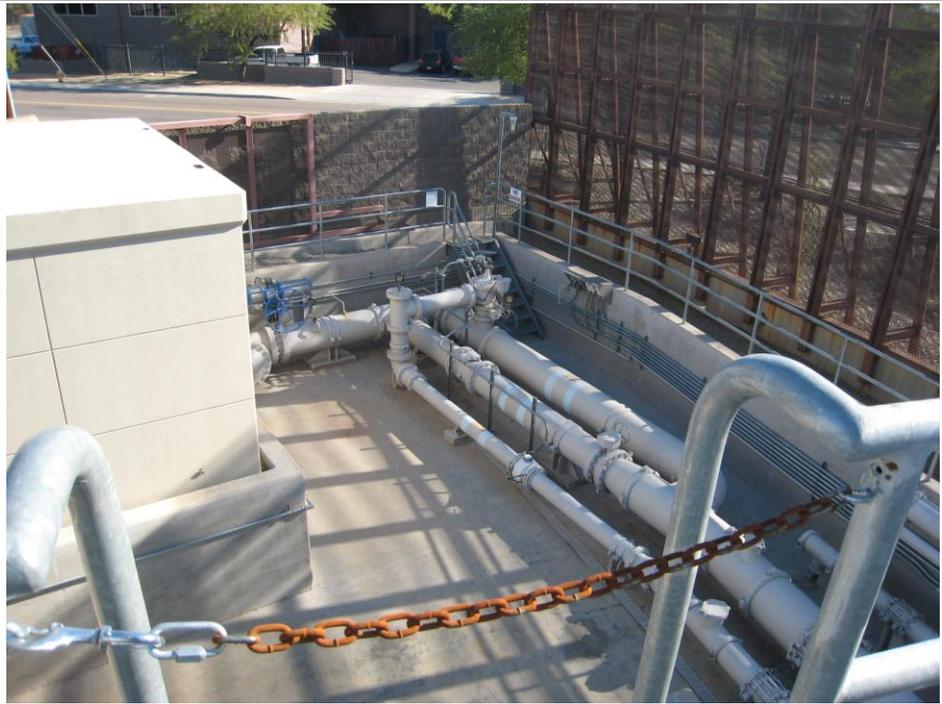
Photo No. 15

Description:
View of treated groundwater piping in the secondary containment structure. The blue hand wheel (in the center of the picture) is attached to process valving that can isolate flow from the treatment facility. Flow metering equipment is located on middle pipe shown in the right of this photograph (the other piping is used to direct treated water back to the carbon vessels for backwashing).

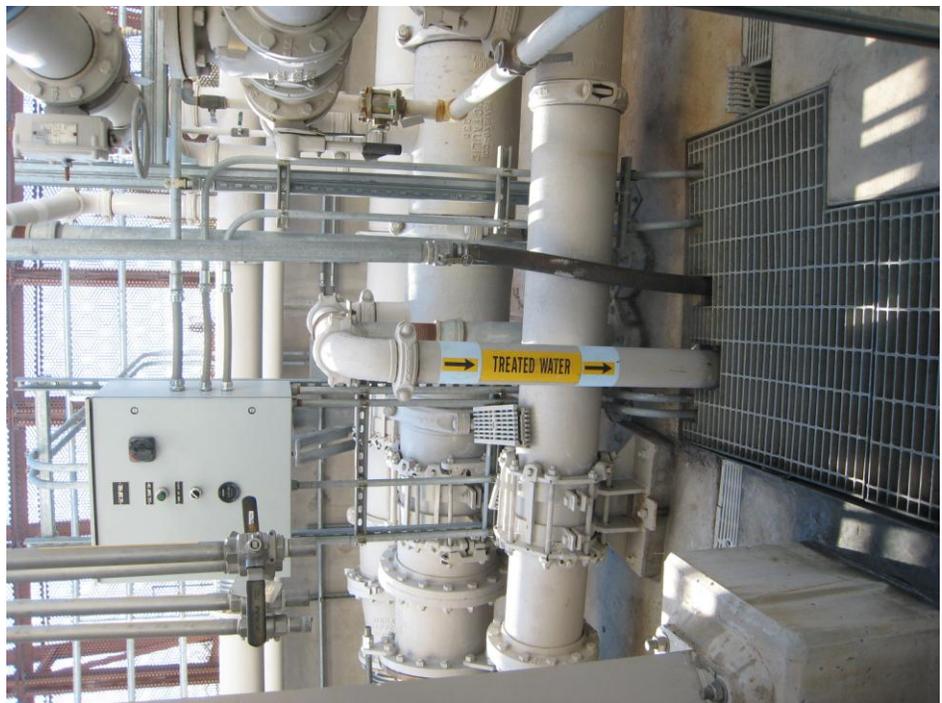
Photo No. 16

Description:
The grate in this photograph (which is turned sideways) covers a level-controlled sump equipped with a pump that all water collected in the secondary containment structure gravity feeds into. Multiple alarms within the sump and above the sump (activated by floats) are used to notify the operator and initiate various process responses (including on a high-high level, complete shut down of process flow).

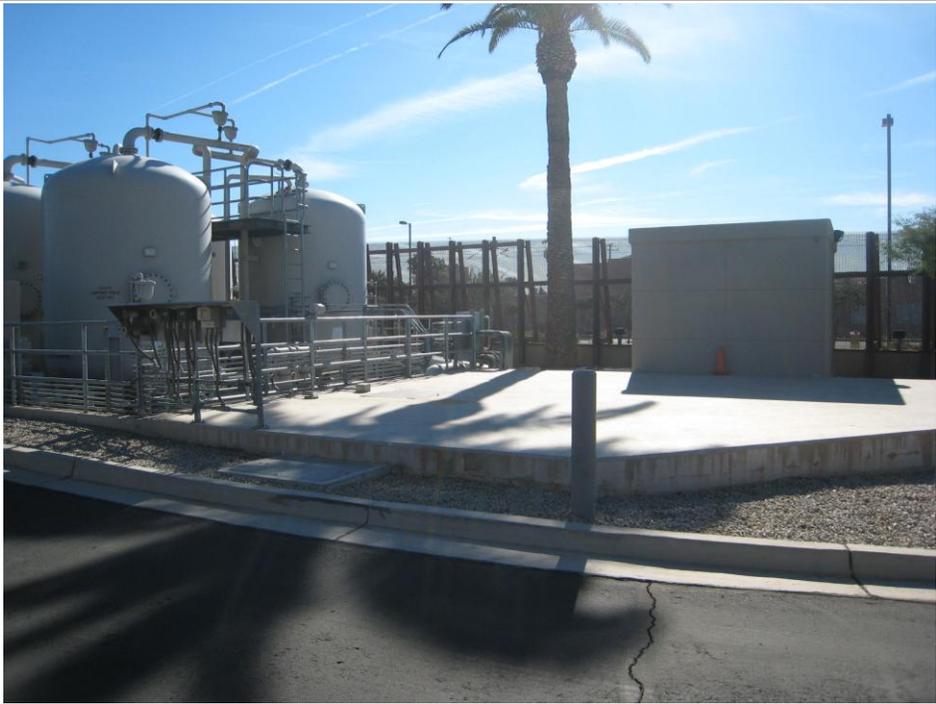
Photo No. 17

Description:
View of subgrade backwash wastewater tank (in the center of the photograph) and Carbon Vessels 1A and 1B (in the left of the photograph). Water from this tank is discharged (under permit) to the City of Phoenix sewer.

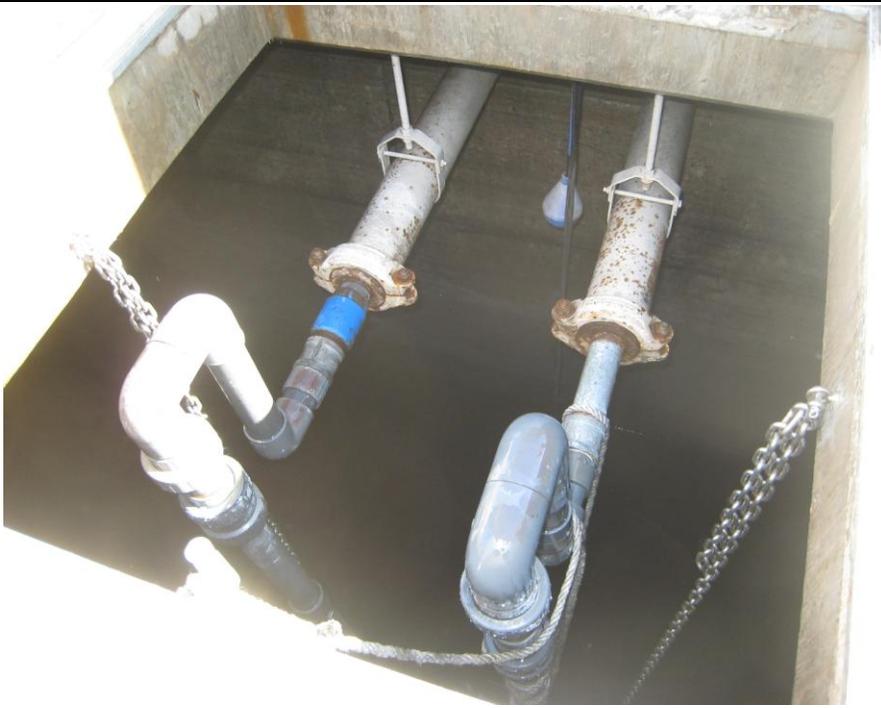
Photo No. 18

Description:
View of discharge piping and level control floats within the backwash wastewater tank. All floats are regularly tested to ensure proper function.

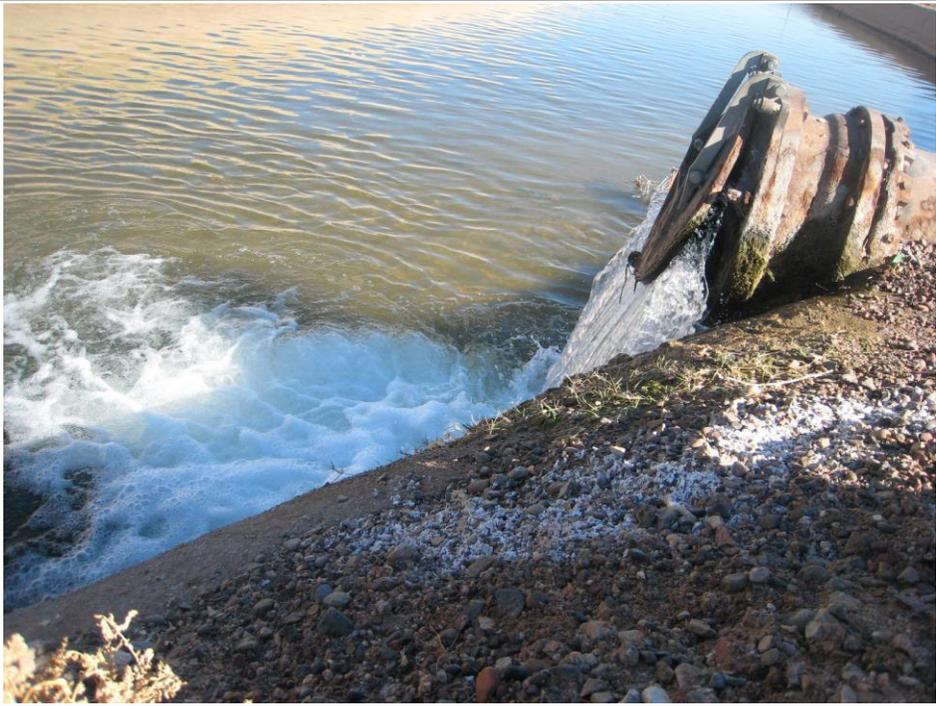
Photo No. 19

Description:
Discharge structure from treatment facility.

Remarks: See Photo 19 of the OU2 Inspection Photolog.

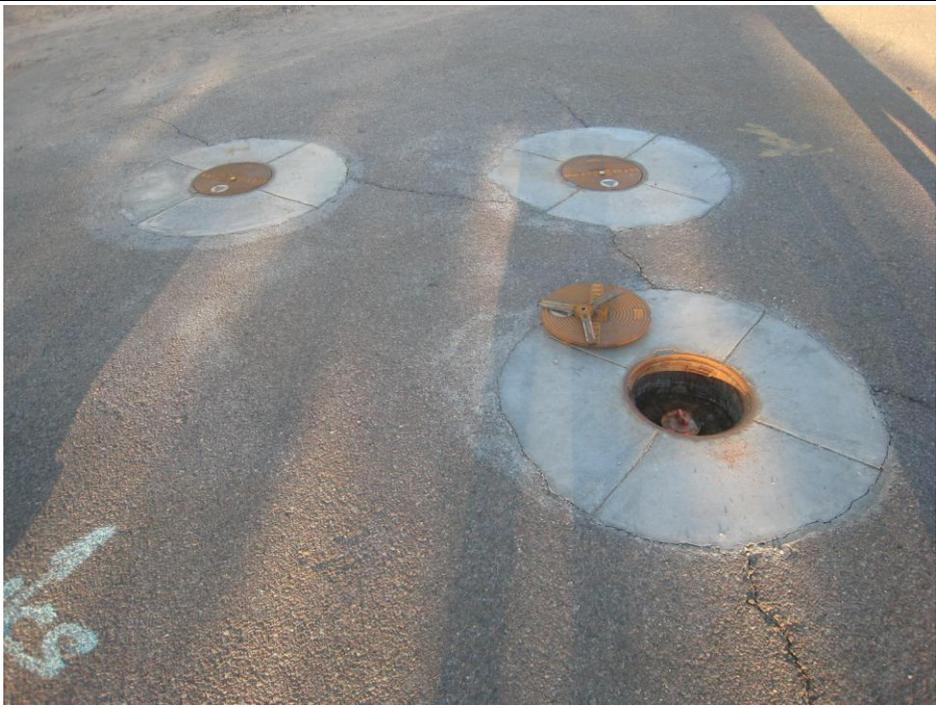
Photo No. 20

Description:
Representative OU2 clustered monitoring wells (NW08-S, M, and D).
