SUBJECT: Five-Year Review for the Selma Pressure Treating Superfund Site, Selma CA

Five-Year Review Report

Geomatrix Consultants, Inc (Geomatrix), on behalf of the United States Environmental Protection Agency (U S EPA), Region IX has conducted a five-year review of the remedial actions implemented to date at the Selma Pressure Treating Site in Selma, California Geomatrix was contracted by the U S Army Corps of Engineers (USACE) Omaha District, which was contracted by the EPA to conduct this work This review was conducted in October 2000 This report documents the results of the review and follows the recommended format of OSWER Directive 9355 7-03B-P, Comprehensive Five-Year Review Guidance ¹

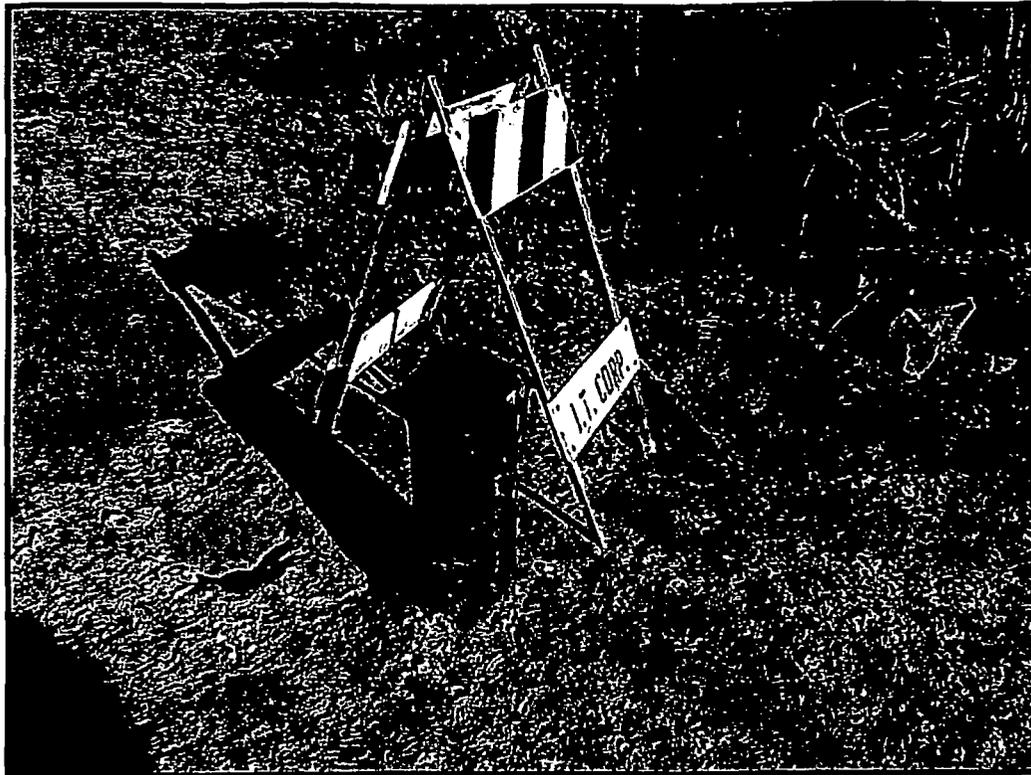
Monitoring well 114 missing locking lid

Many of the more minor issues can also be addressed immediately, as indicated on Table 5. Other issues, such as making repairs to the groundwater treatment system and installing lockable caps on the monitoring wells, should be addressed as soon as possible. We recommend that issues pertaining to the two stockpiles of soil and the soil impoundment be addressed in conjunction with the additional soil remediation efforts to be completed at the site in 2001. Recommendations that address cost effectiveness and operating efficiencies rather than deficiencies are considered to be less critical.

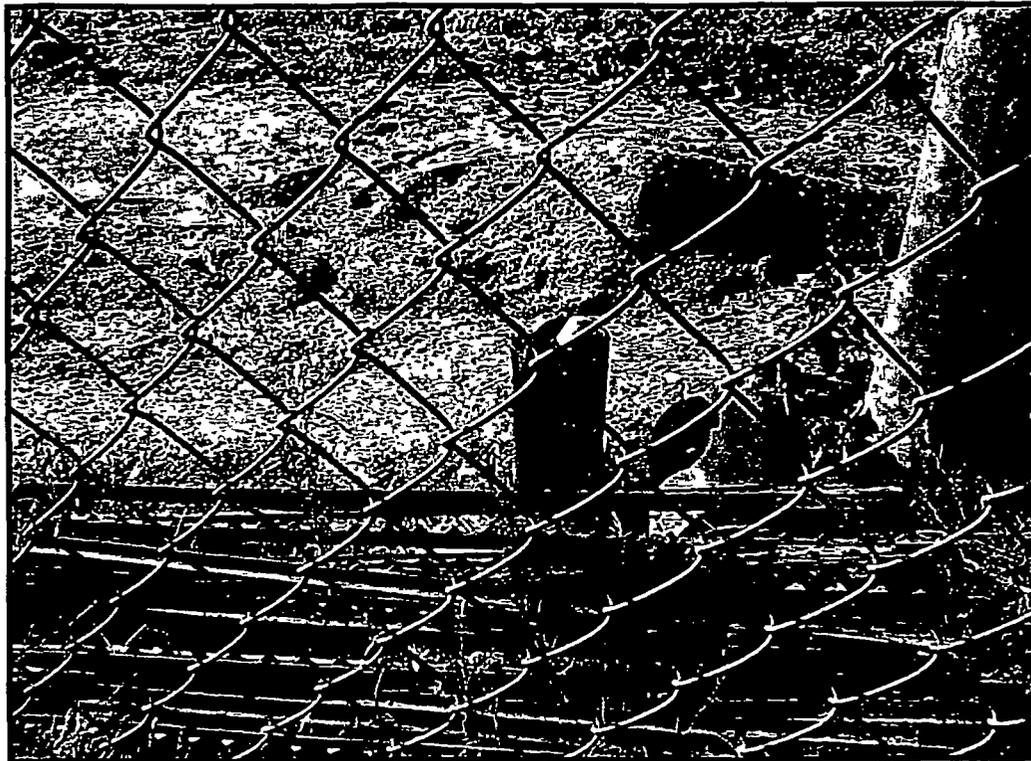
Monitoring well 115 with damaged casing and missing locking lid
