Annual Monitoring Checklist
IRP Site 5 (Landfill 7)
Andersen AFB, Guam
 N62742-09-D-1953 - Contract Task Order No. 009

**PHOTOGRAPHIC LOG – IRP SITE 5 (LANDFILL 7), ANDERSEN AFB, GUAM
N62742-09-D-1953 - CONTRACT TASK ORDER NO. 009 - JULY 8, 2011 INSPECTION**

3.0 Site 5 (Landfill 7) 2012 Annual LUC Monitoring Checklist

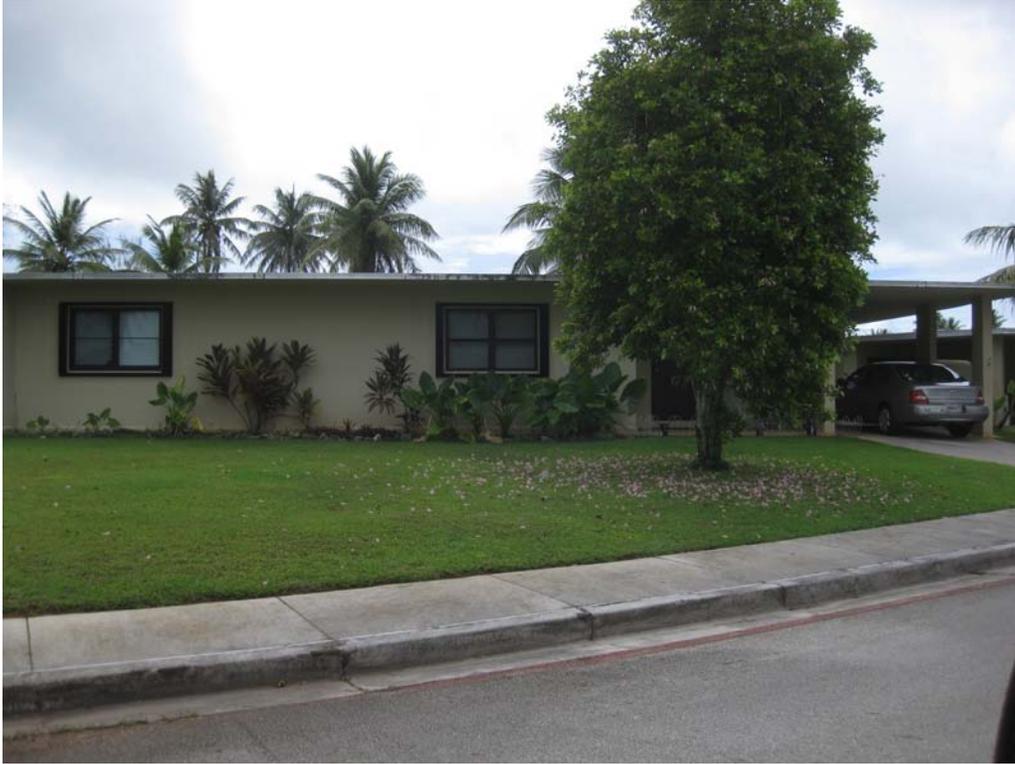
Photo 1 View looking east from Hibiscus Ave. within Land Use Control area within housing Area.

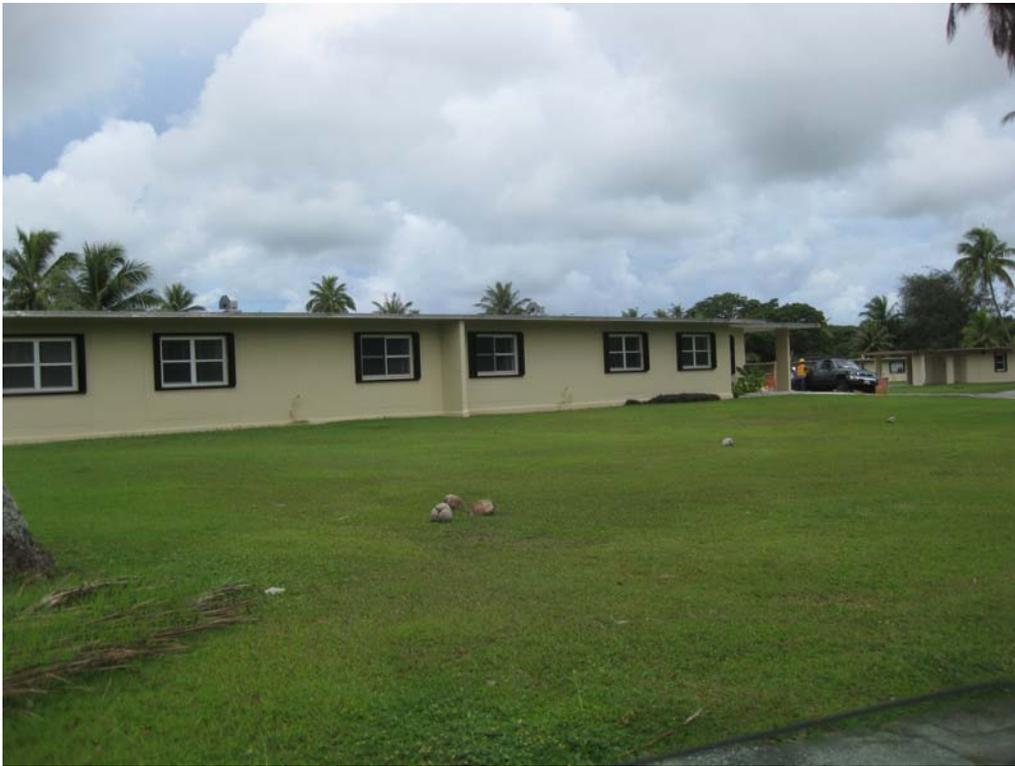
Photo 2 View looking west from Hibiscus Ave. within Land Use Control area within housing Area.

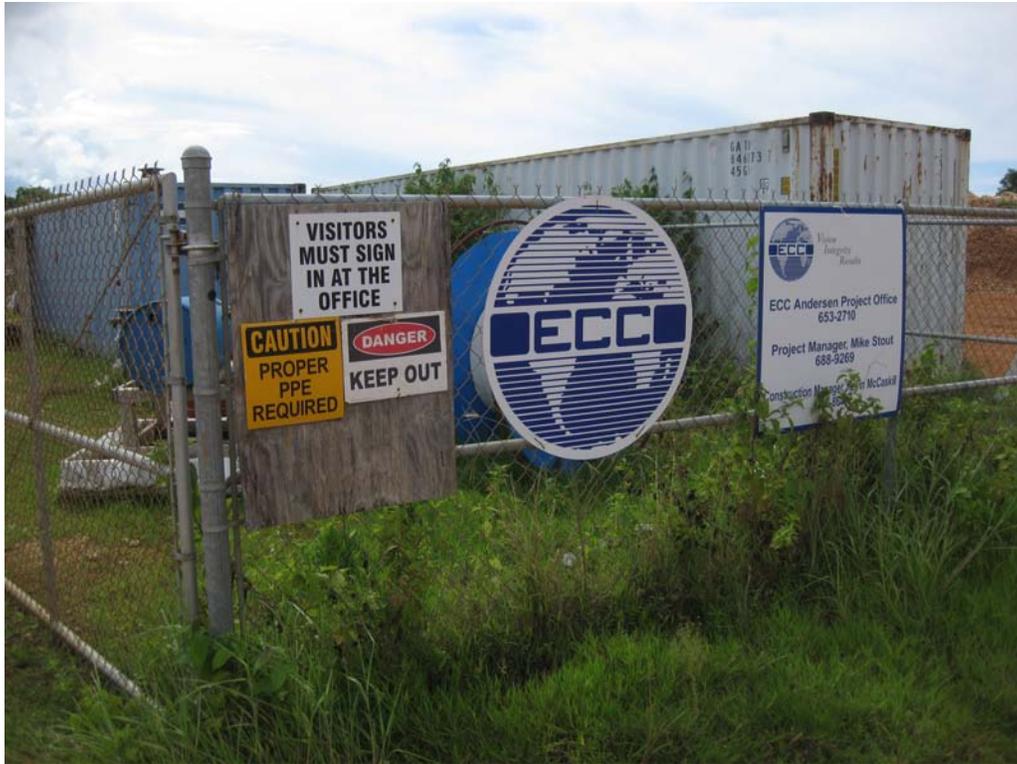
Photo 1 Entrance signs to ECC laydown/storage area constructed within Site 6.

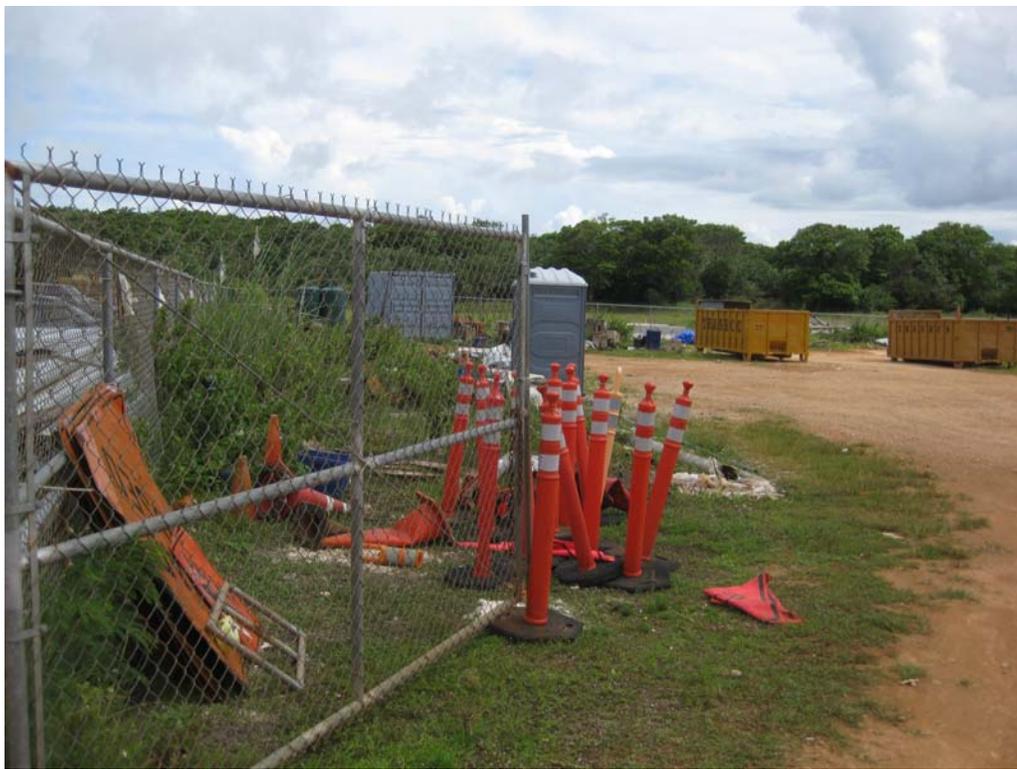
Photo 2 View looking south into ECC laydown/storage area.

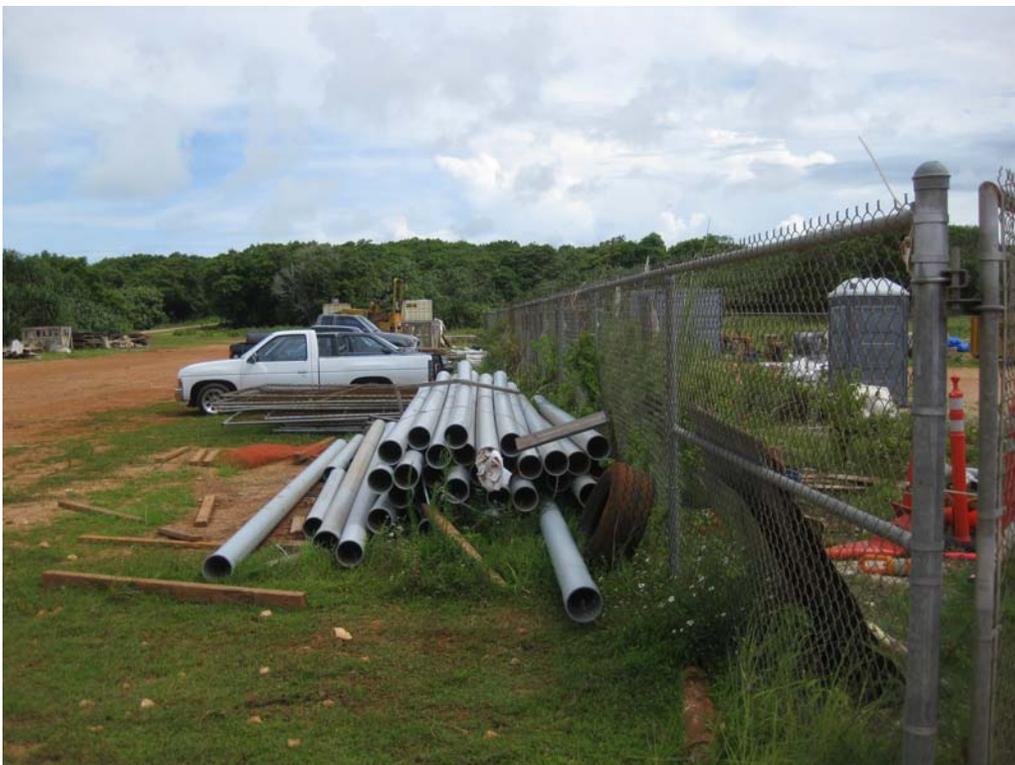
Photo 4 Material storage outside of ECC laydown/storage area
(east side looking south).

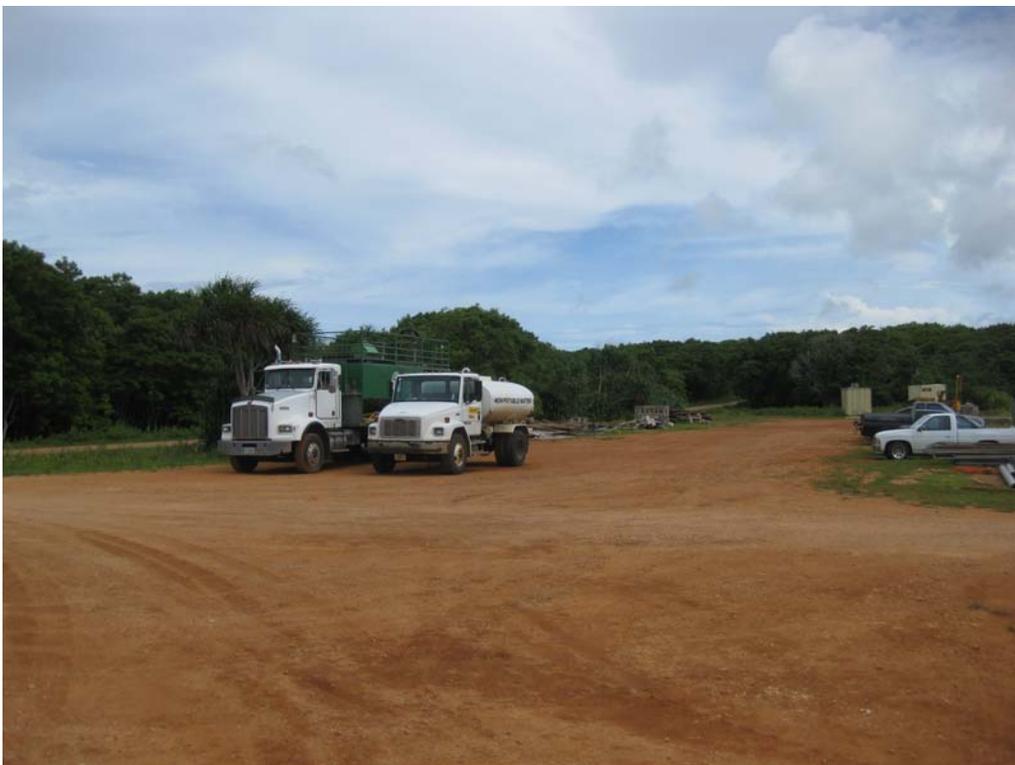
Photo 6 Vehicles parked outside of ECC laydown/storage area.

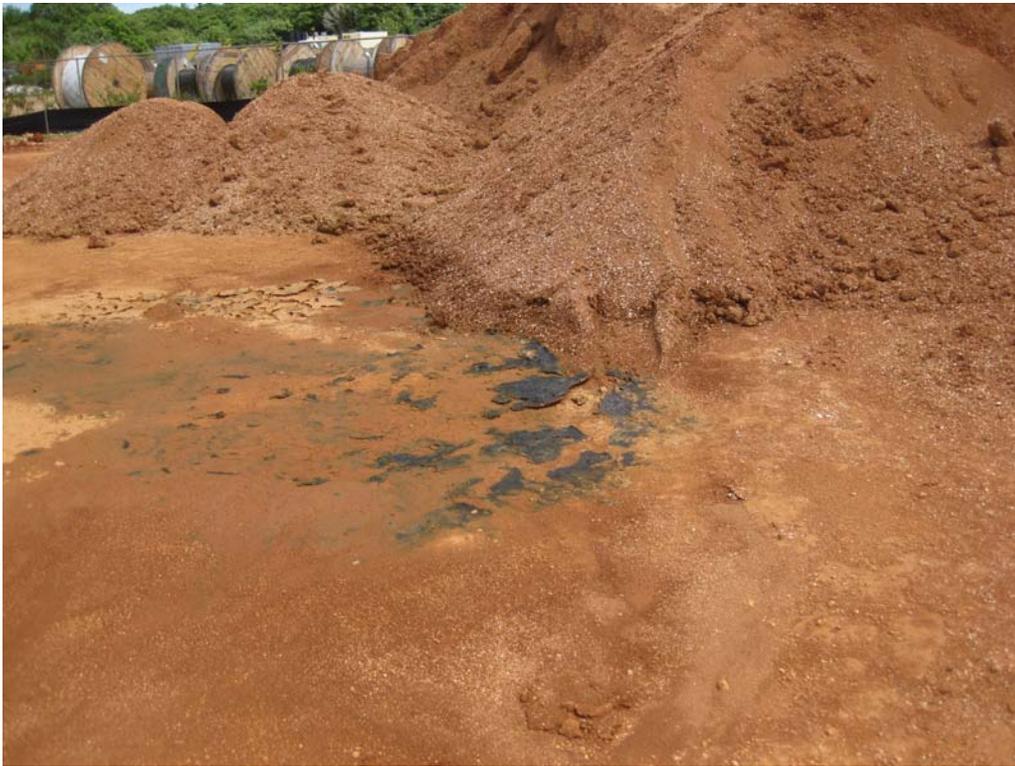
This site is currently being used as a laydown/storage yard by ECC Corporation. See Fig 1: Approximate Site Boundary, LUC Boundary, and ECC Laydown/Storage Fenced Area. Part of the ECC fenced area lies within the LUC boundary. Soil appears to have been moved between the LUC boundary area and other areas within the site.

Photo 10 Soil stockpiles northern part of Site 6.

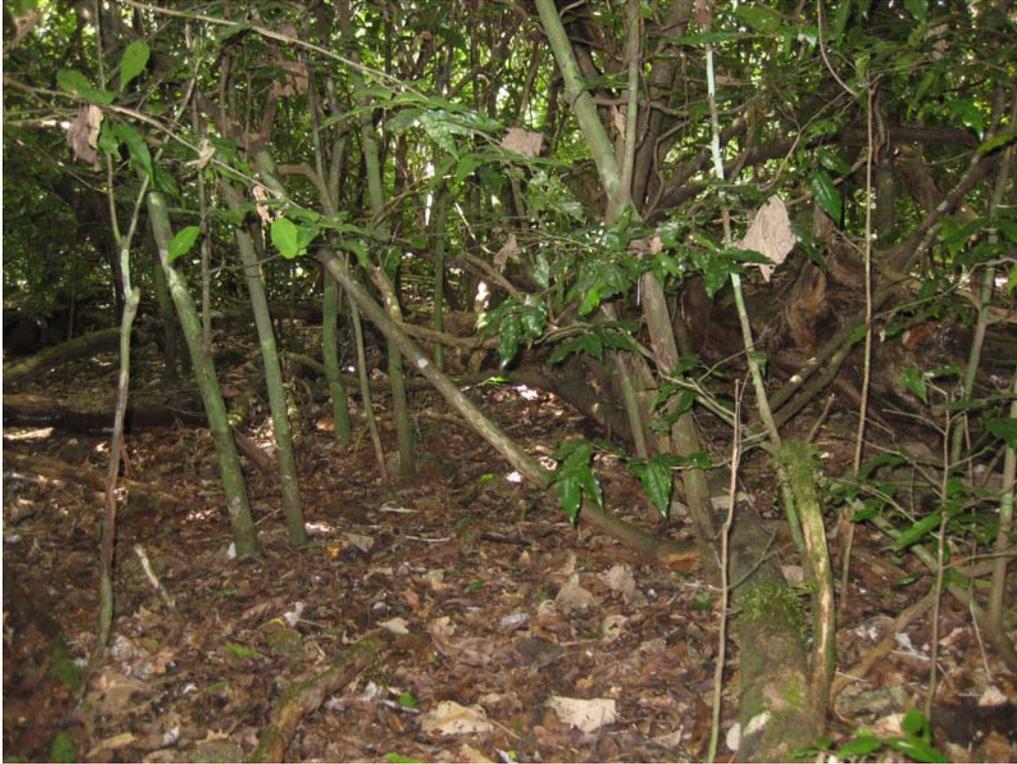
Photo 11 Southern region of Site 6.

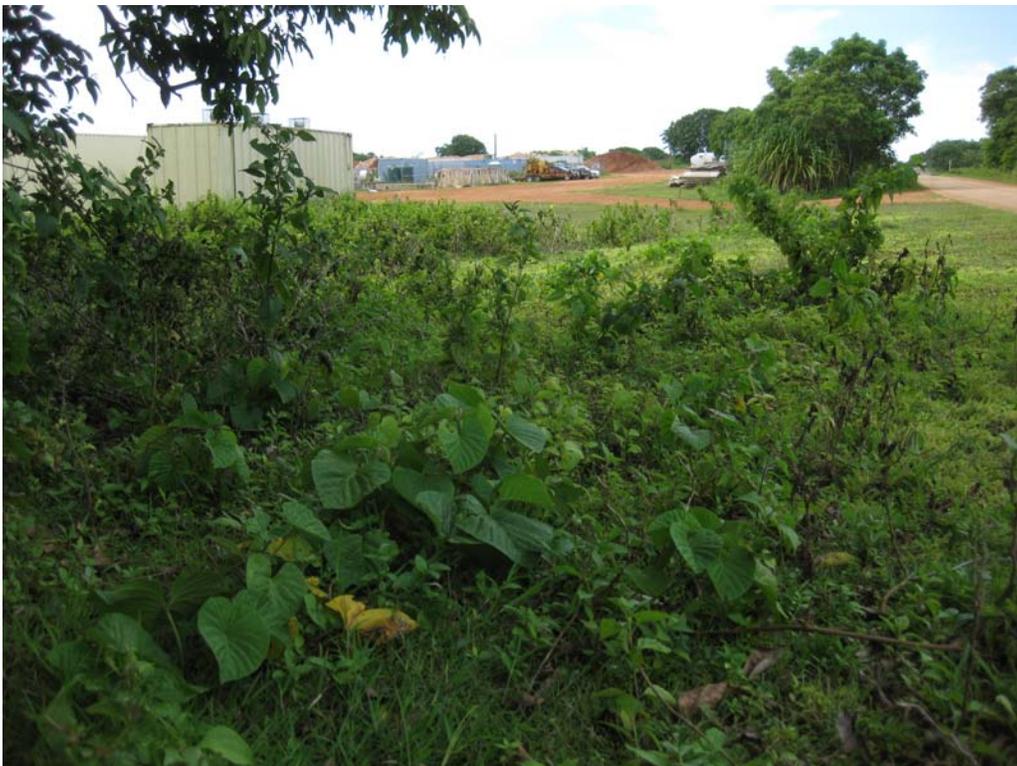
Photo 12 View from south eastern region of Site 6 looking north.

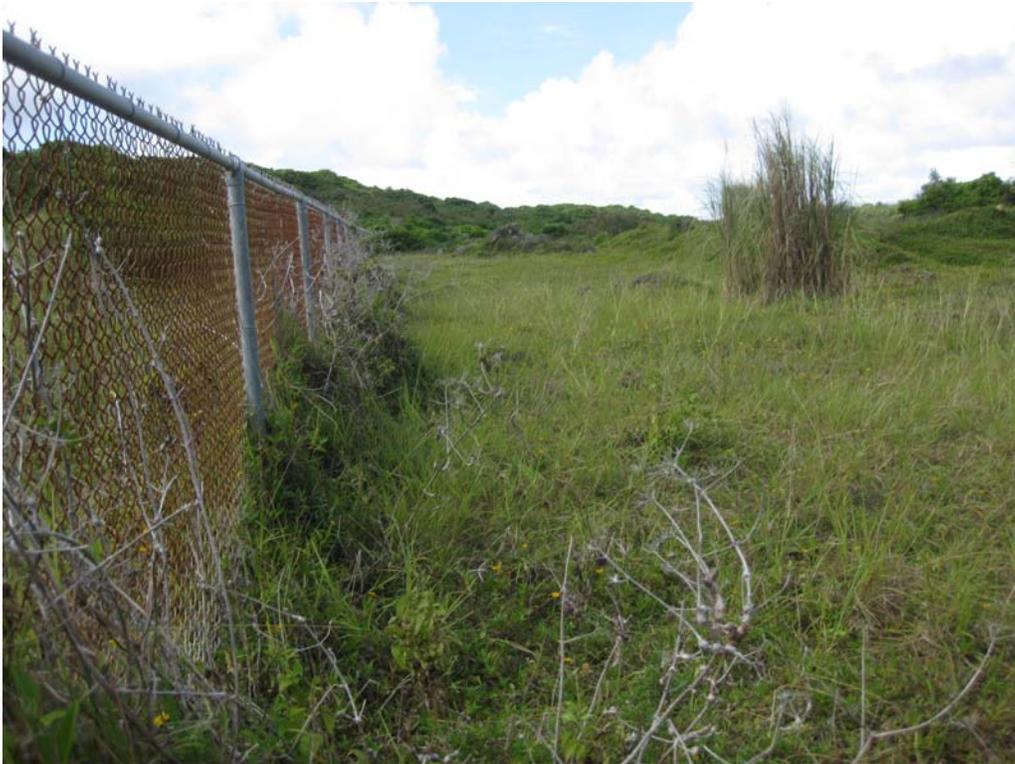
Photo 1 LUC Area 1 - View of site looking northeast along security fence.

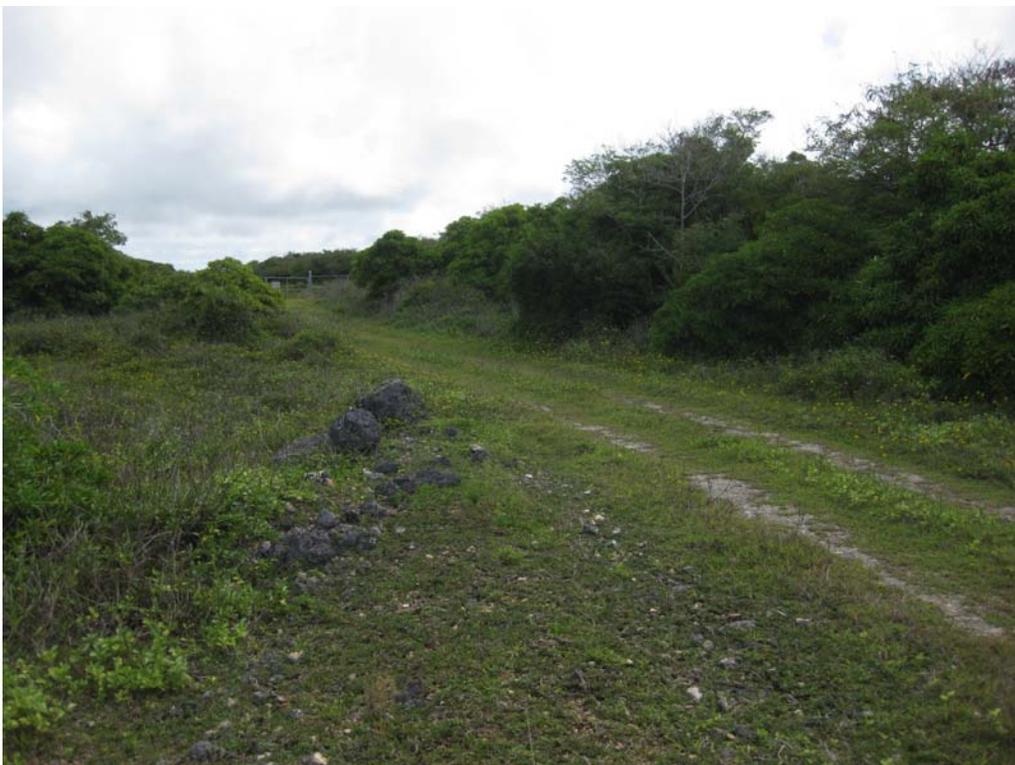
Photo 2 LUC Area 1 - View of site looking southwest along entrance road.

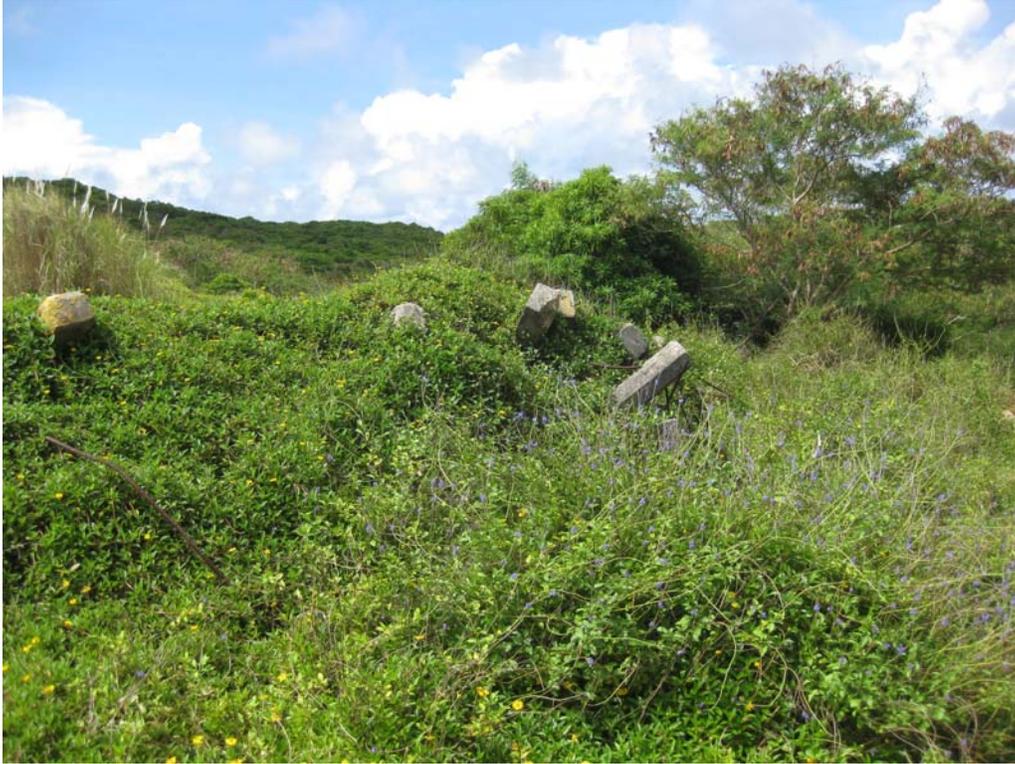
Photo 3 LUC Area 1 - Piles of concrete/rebar debris overgrown with vegetation.

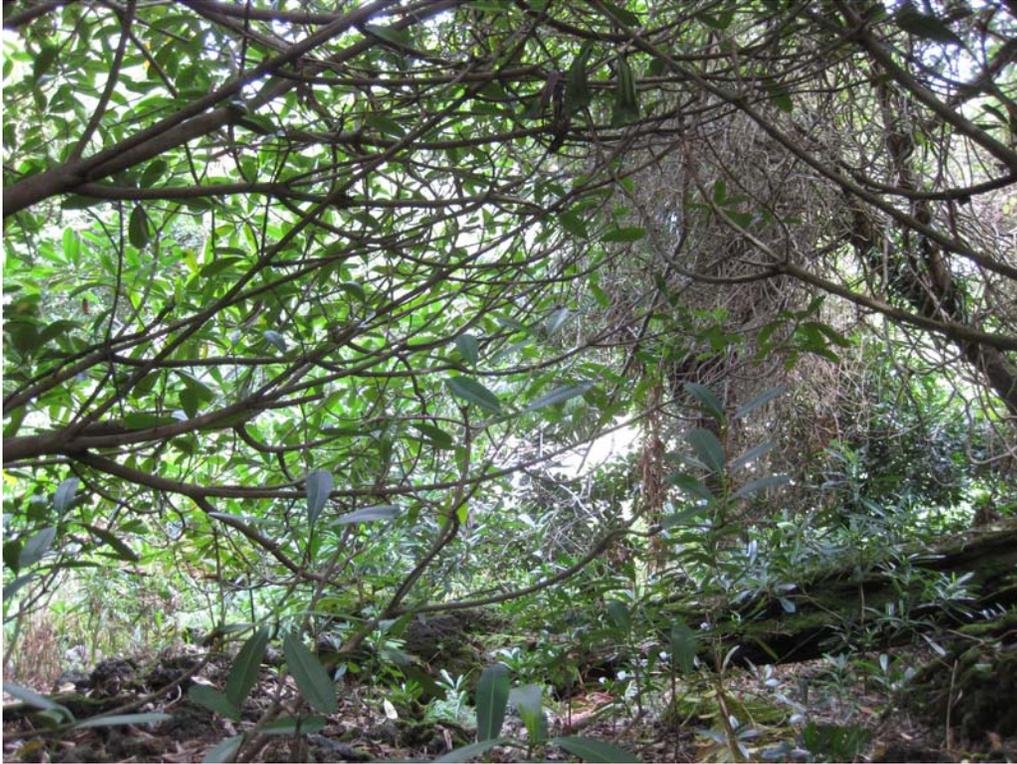
Photo 5 LUC Area 2 - View of site vegetation.

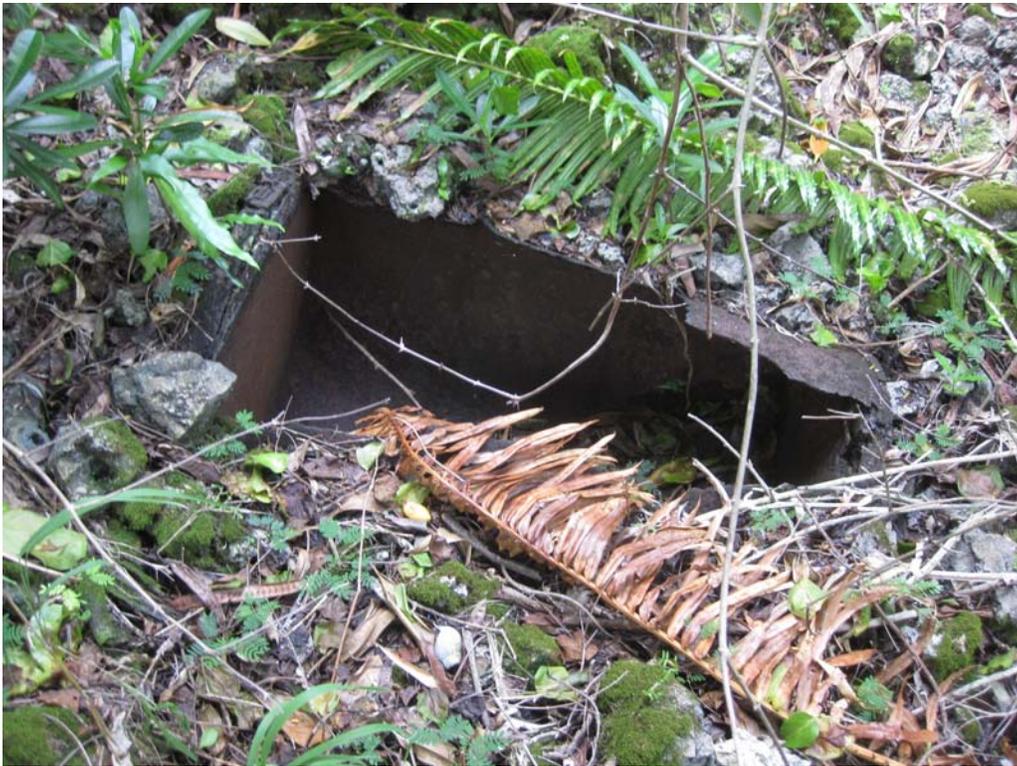
Photo 6 LUC Area 2 - Corroded, empty drum.

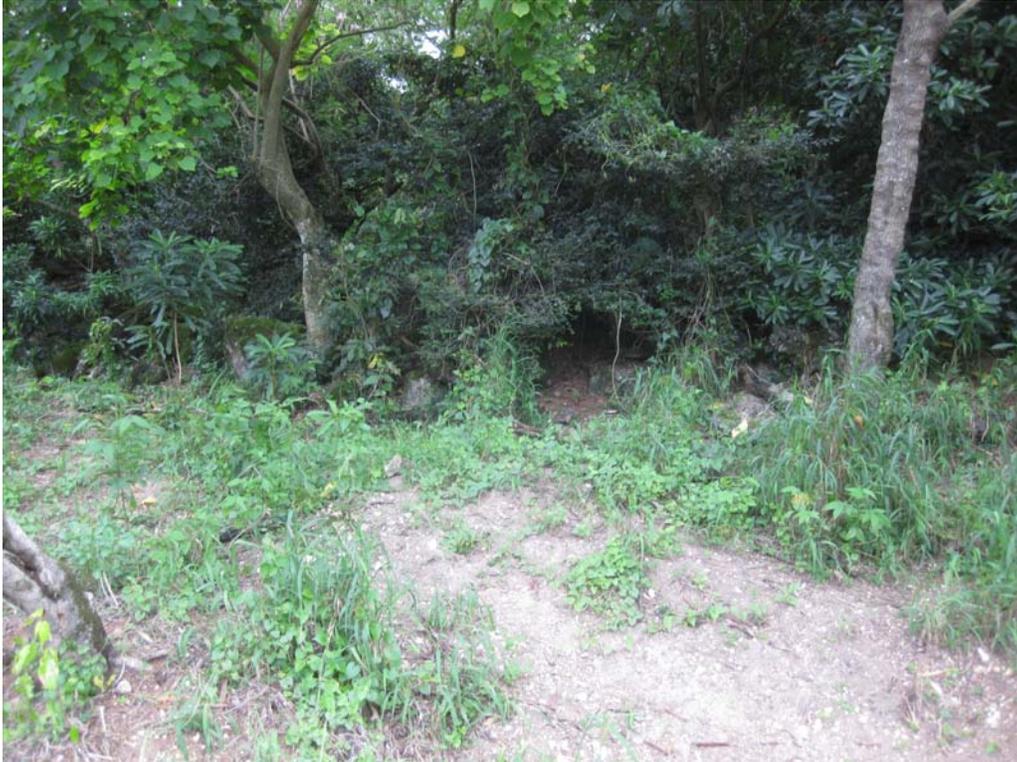
Photo 7 LUC Area 2 - View of site vegetation.

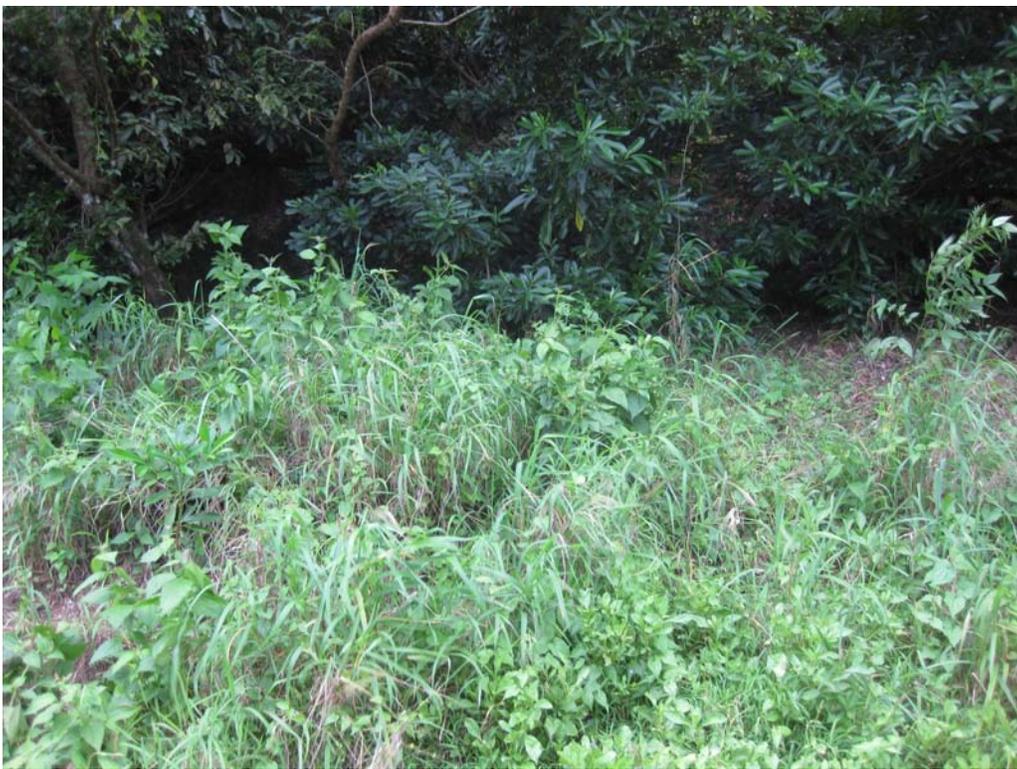
Photo 8 LUC Area 2 - View of site vegetation.

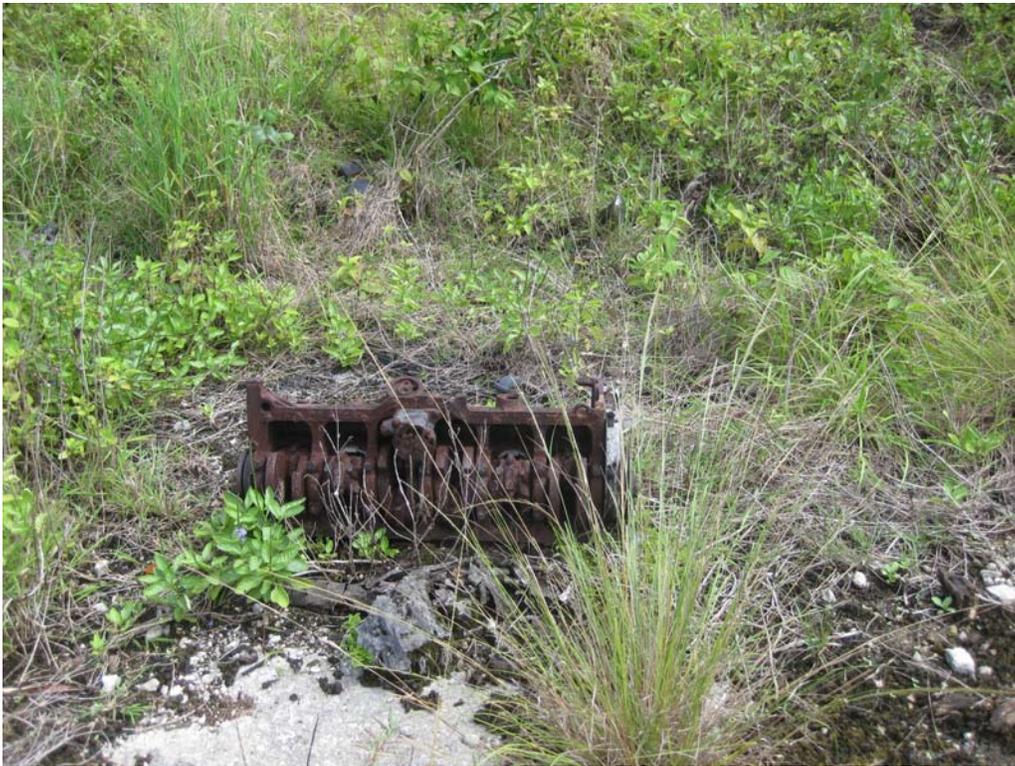
Photo 10 LUC Area 3 - Engine block corroding at site.

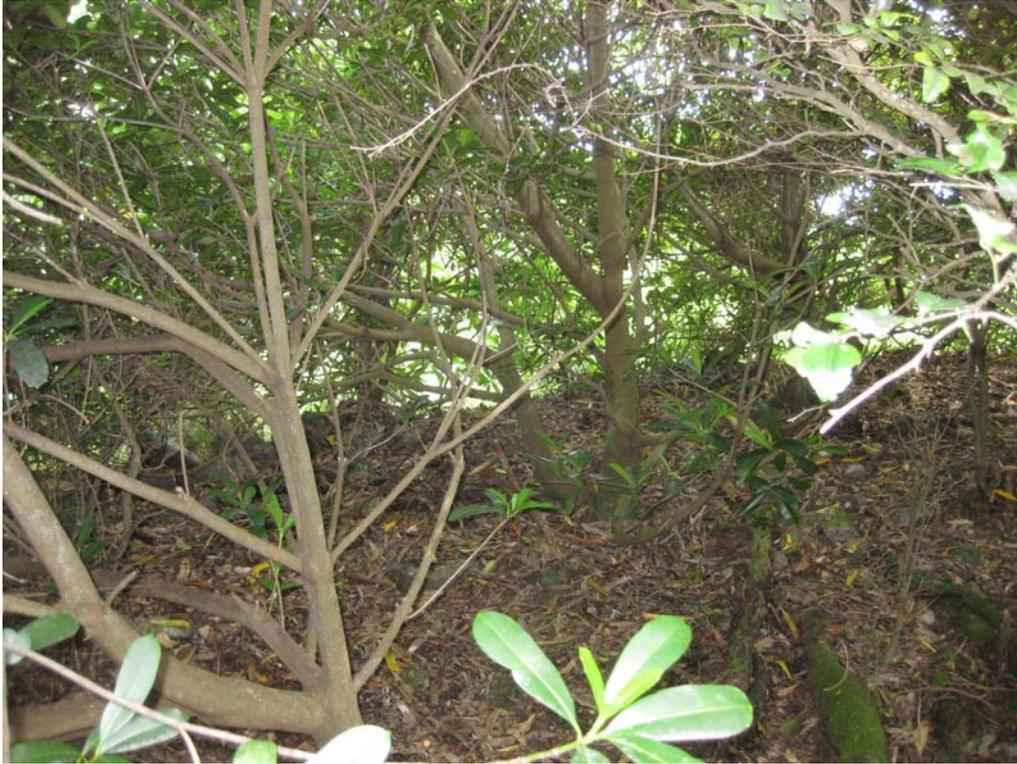
Photo 11 LUC Area 3 - View of site vegetation.

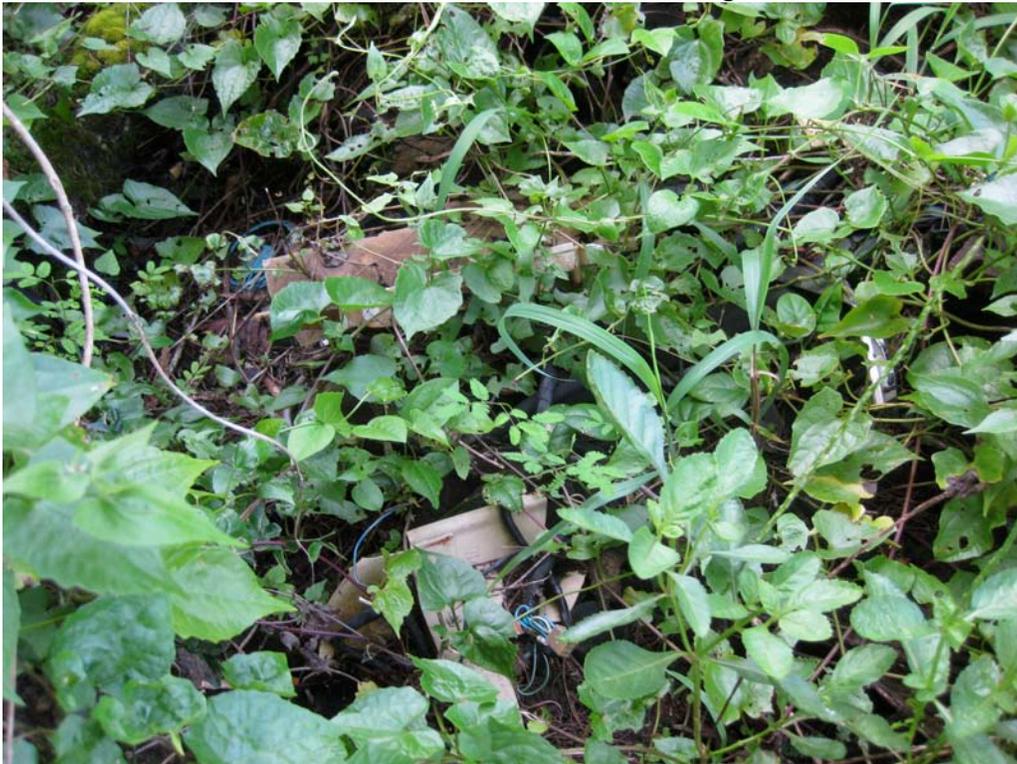
Photo 12 LUC Area 3 - Metal and plastic waste overgrown with vegetation.

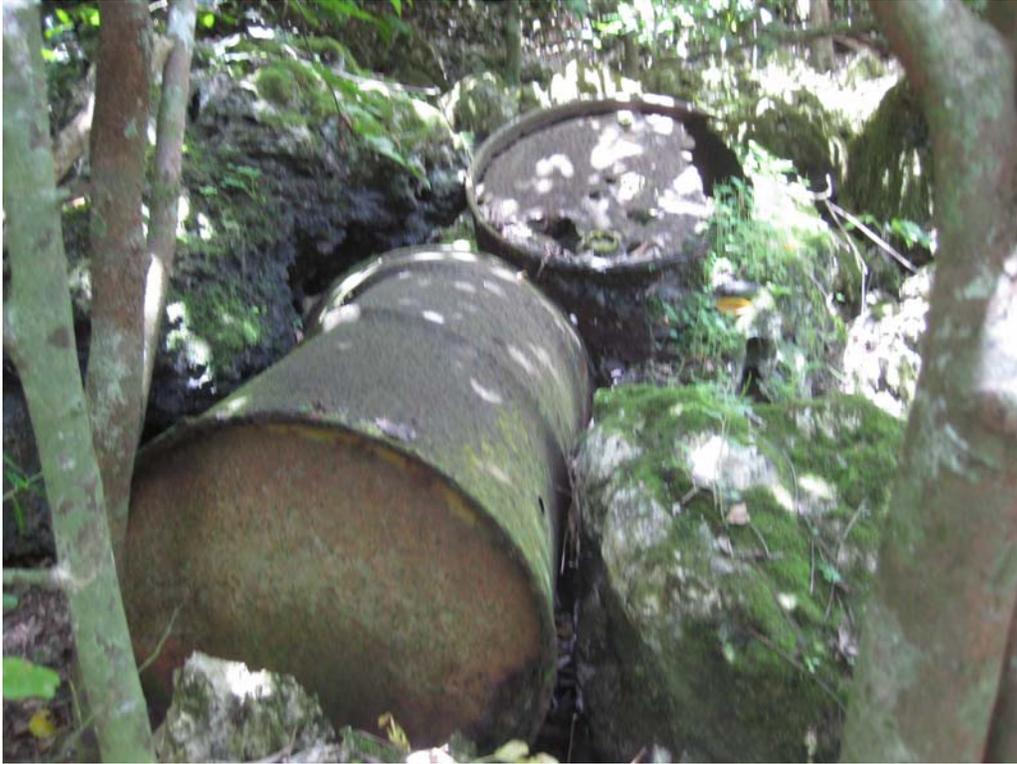
Photo 1 Area A: Corroded drums.

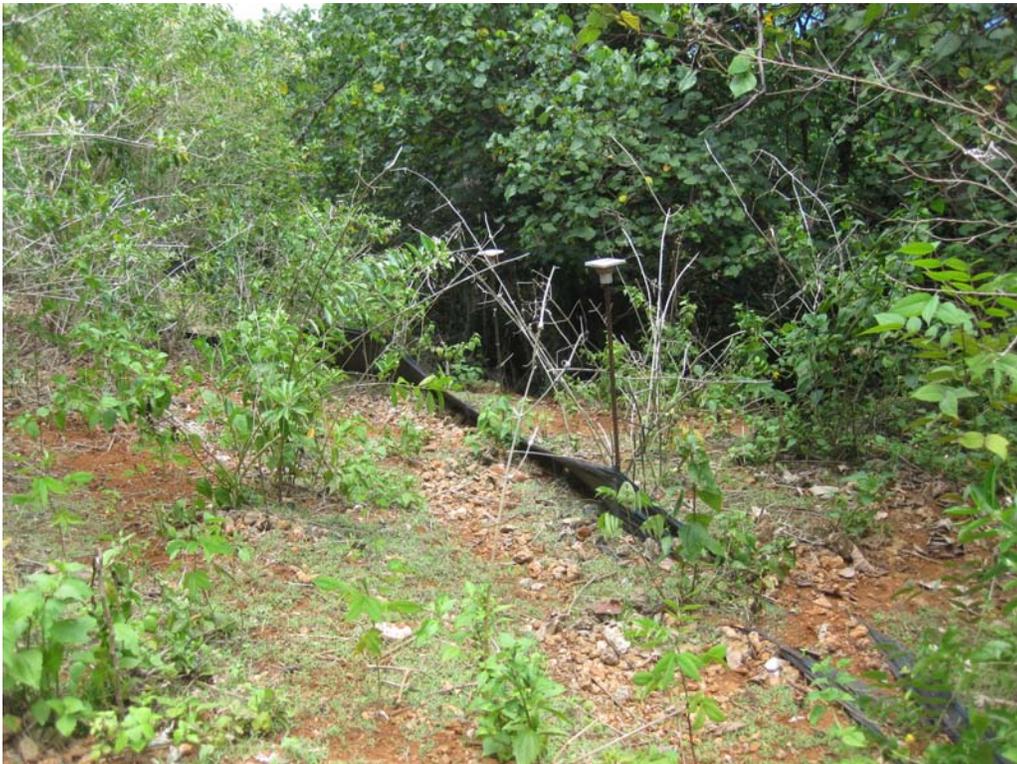
Photo 2 Area A: Silt screen and re-bar installation (not maintained).

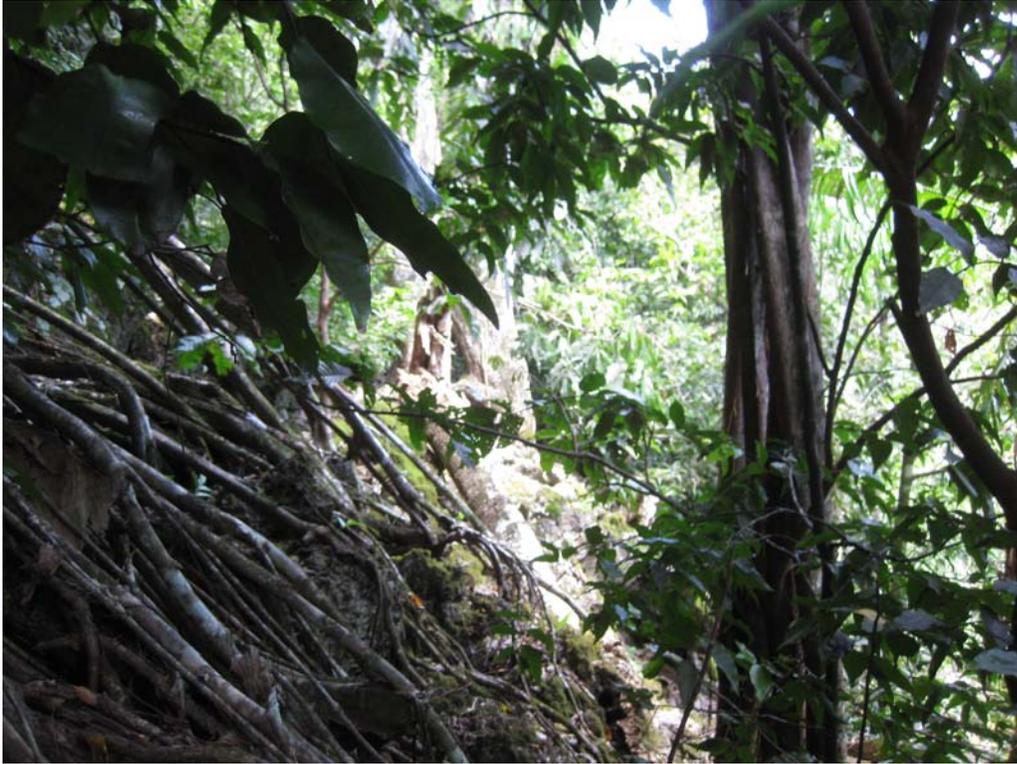
Photo 3 Area A: View looking west of vegetation on steep slope.

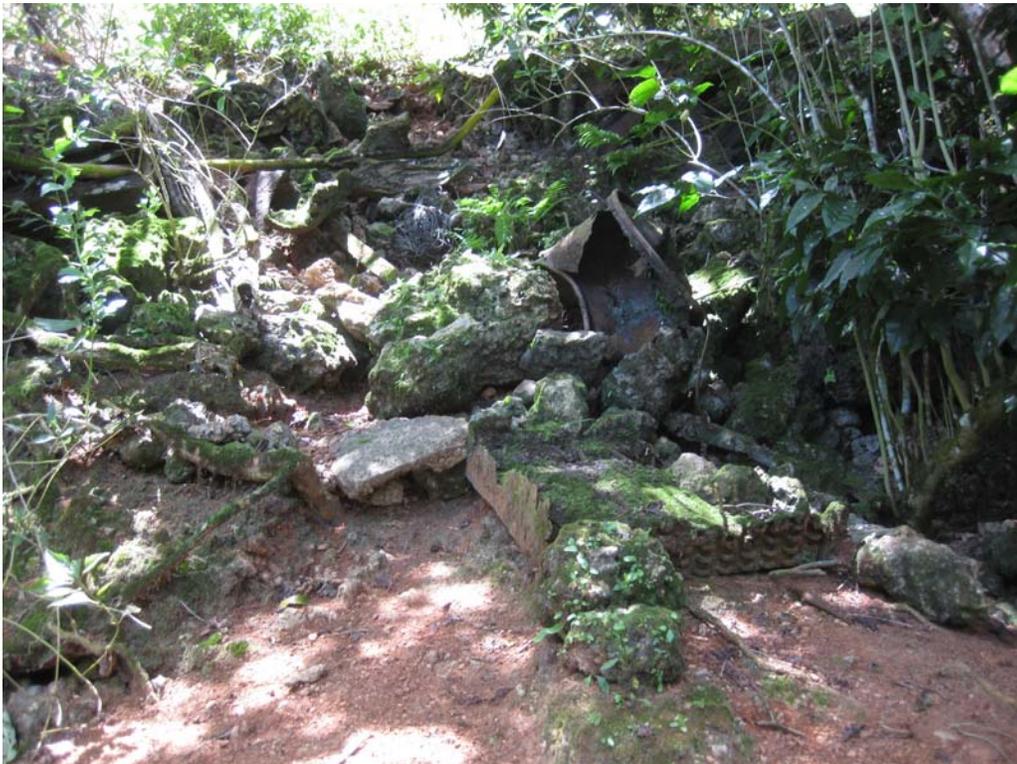
Photo 4 Area A: Various metal waste: wire, pipe, radiator, drum.

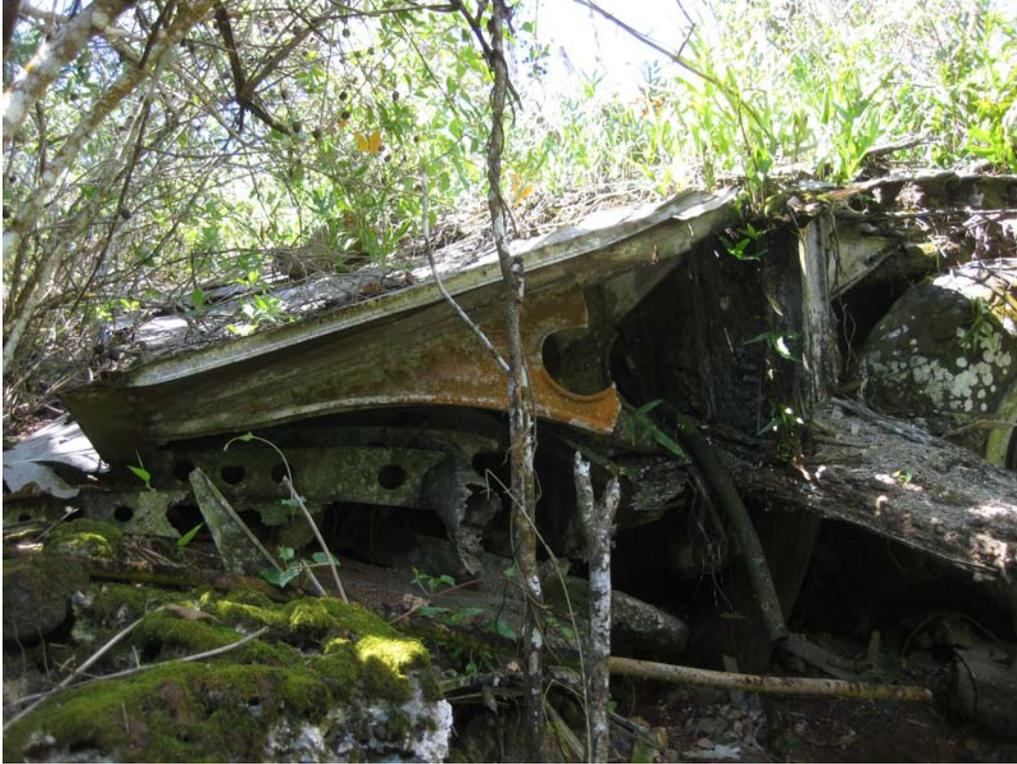
Photo 5 Area B: Aircraft wing on steep slope of site.

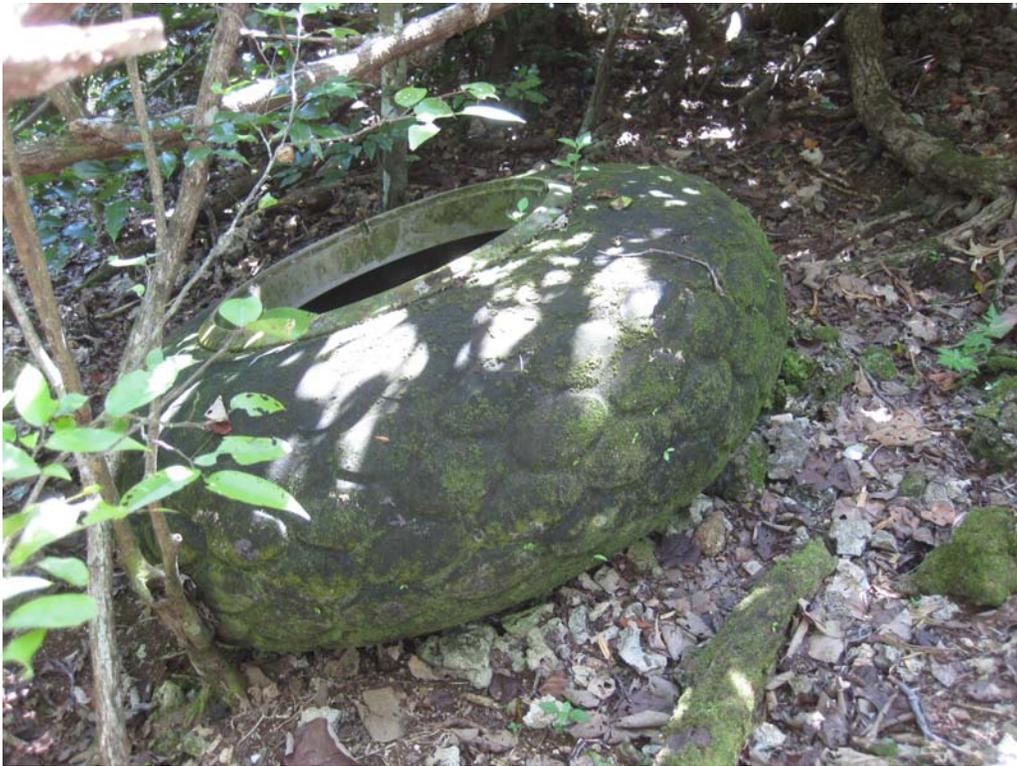
Photo 6 Area B: Aircraft tire.

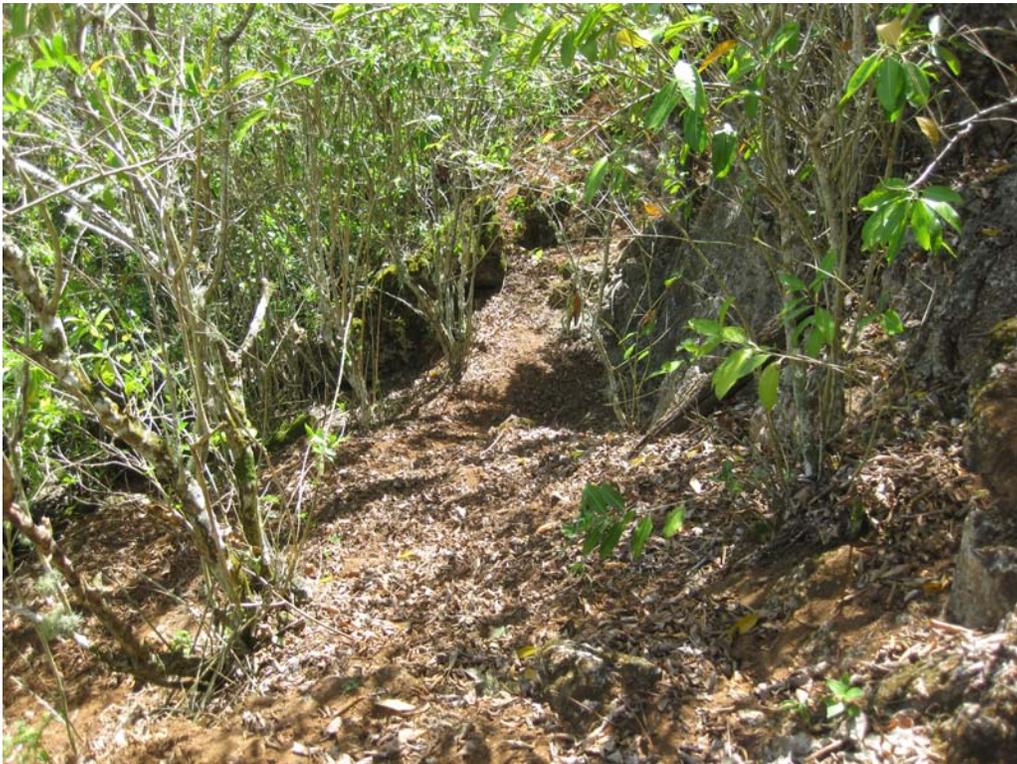
Photo 8 Area B: View of what appears to be an animal trail.

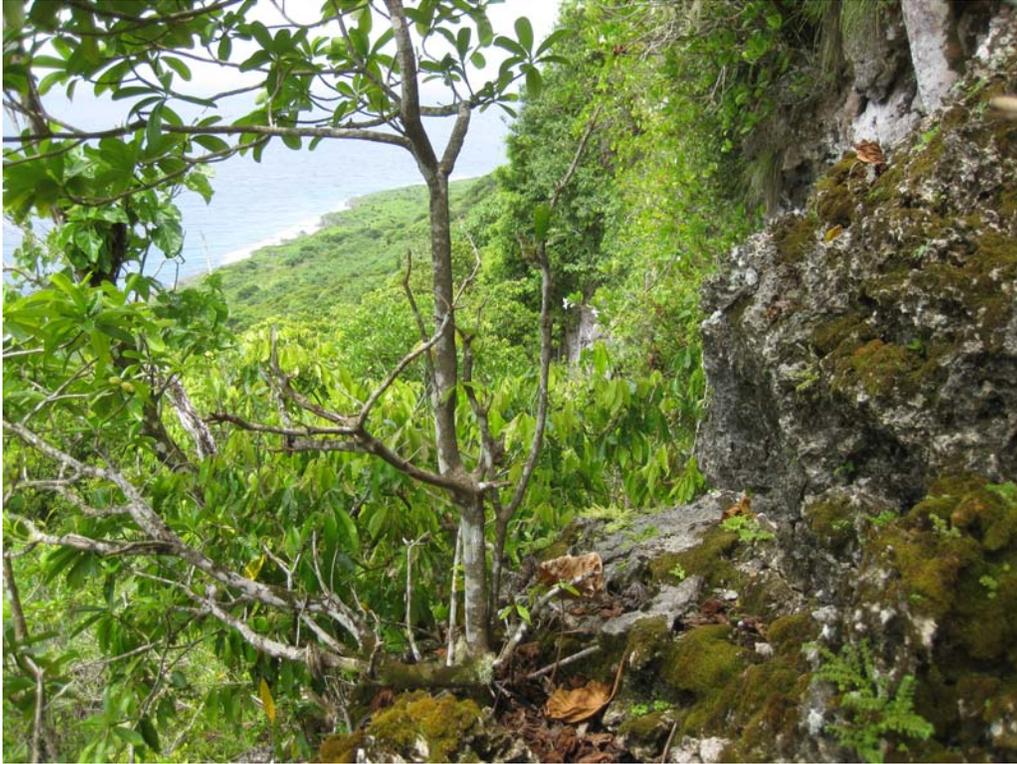
Photo 11 Area C: View of site at cliff line.

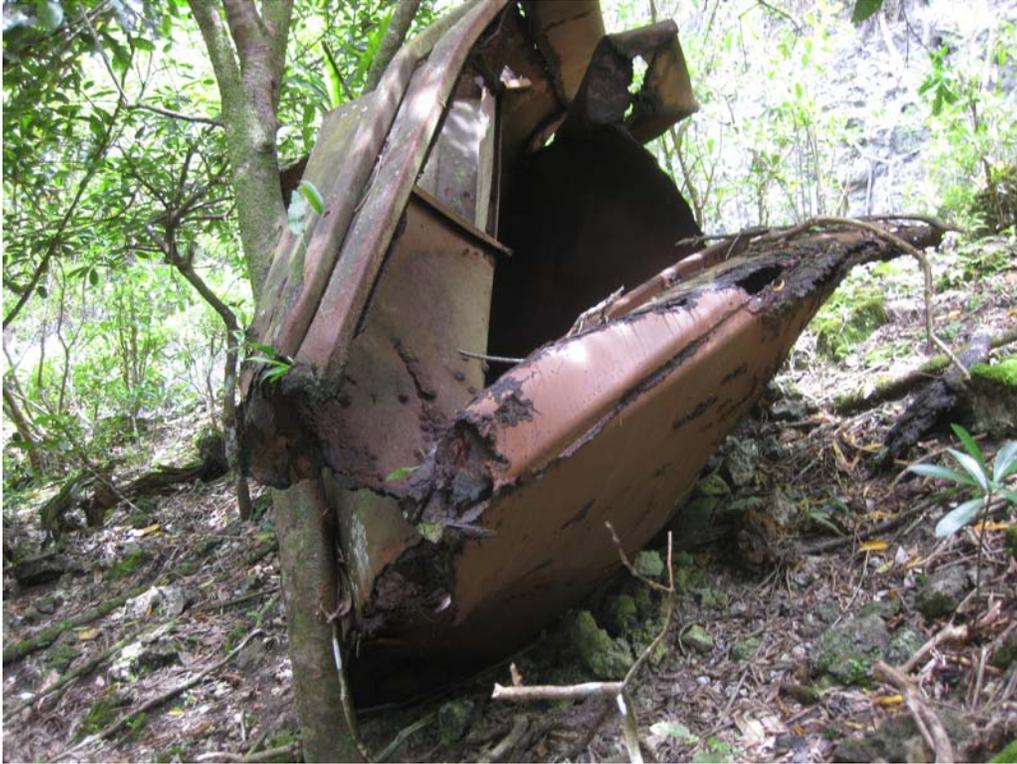
Photo 13 Area D: Metal solid waste container corroding at site.

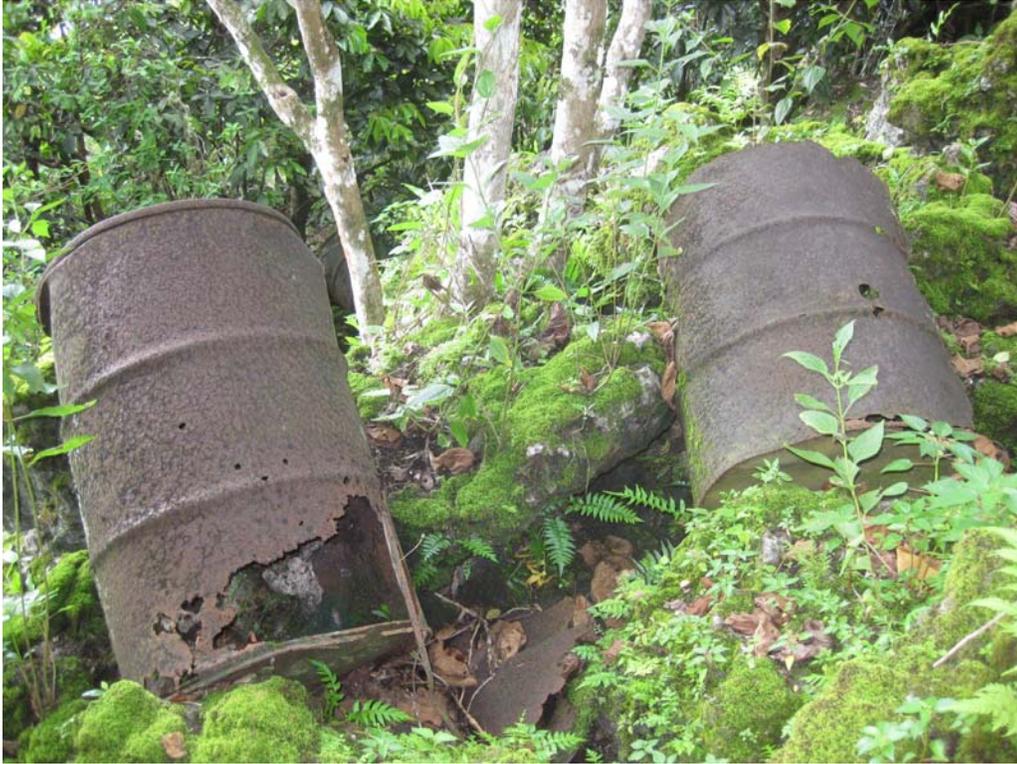
Photo 17 Area E: Corroding drums.
