Annual Monitoring Checklist
IRP Site 5 (Landfill 7)
Andersen AFB, Guam
 N62742-09-D-1953 - Contract Task Order No. 009

**PHOTOGRAPHIC LOG – IRP SITE 5 (LANDFILL 7), ANDERSEN AFB, GUAM
N62742-09-D-1953 - CONTRACT TASK ORDER NO. 009 - JULY 8, 2011 INSPECTION**

3.0 Site 5 (Landfill 7) 2012 Annual LUC Monitoring Checklist

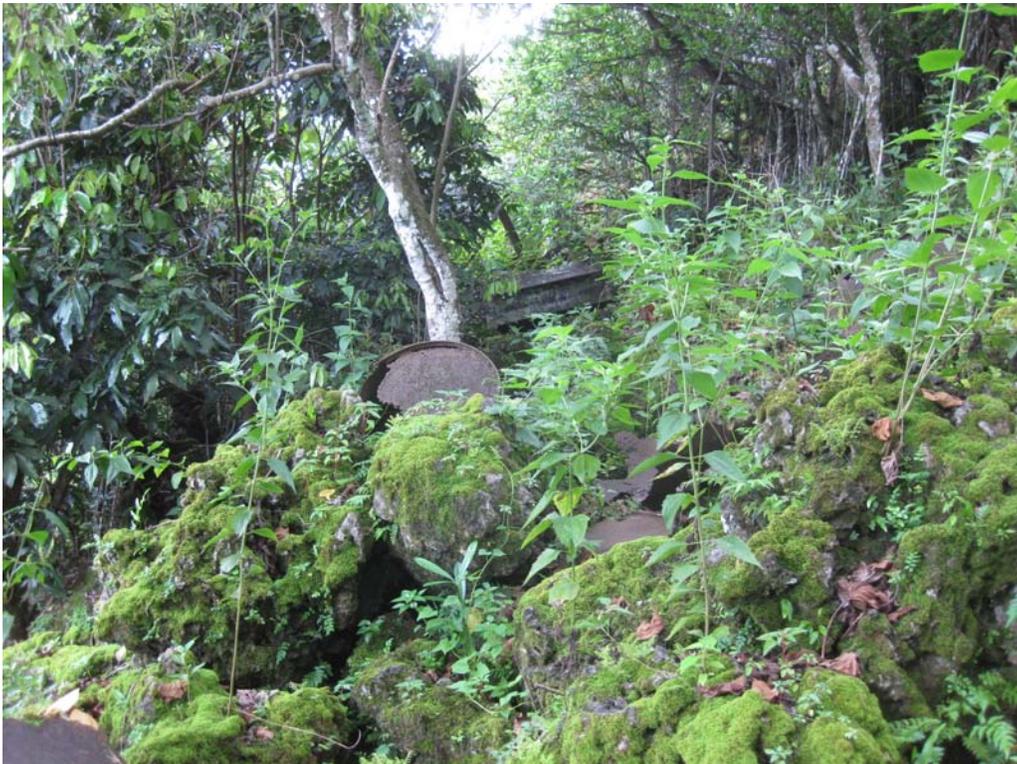
Photo 18 Area E: Corroding drums and other metal waste.

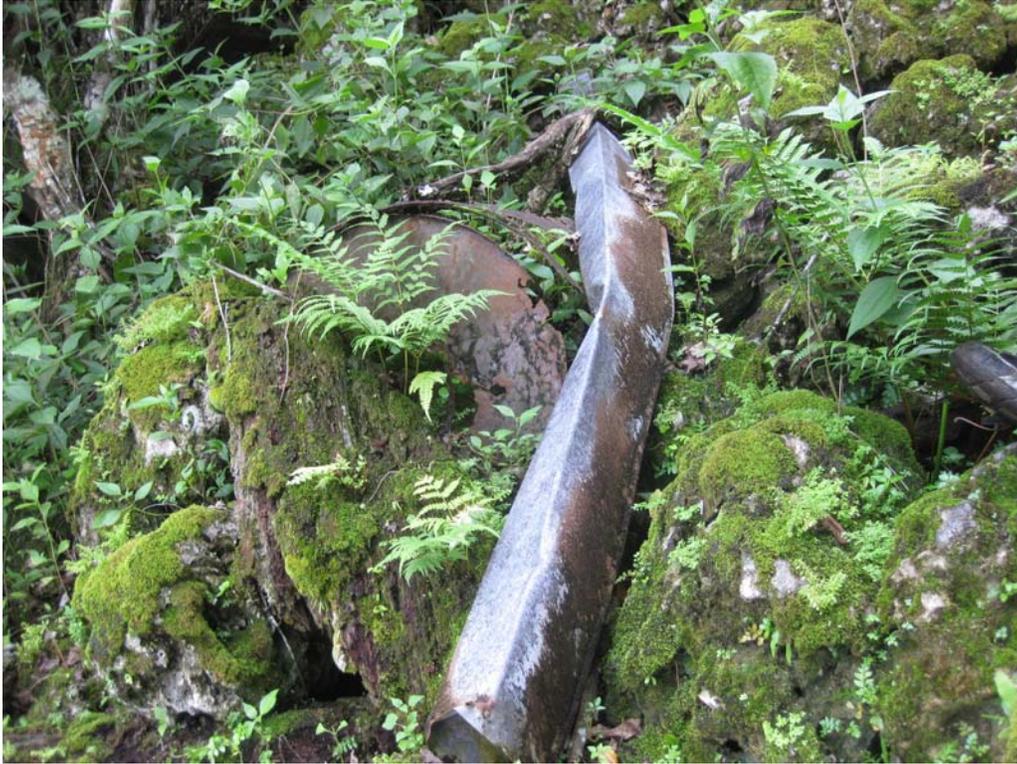
Photo 19 Area E: Corroding drums and other metal waste.

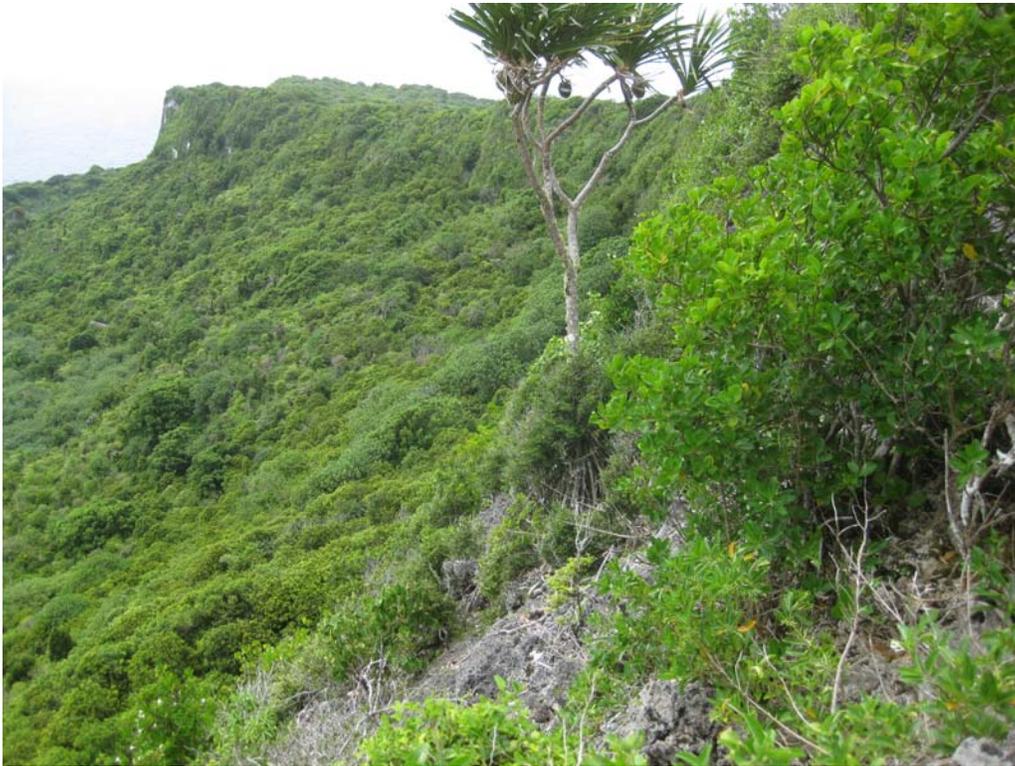
Photo 22 Area F: View of site along cliff line, looking east.
Site is in foreground.

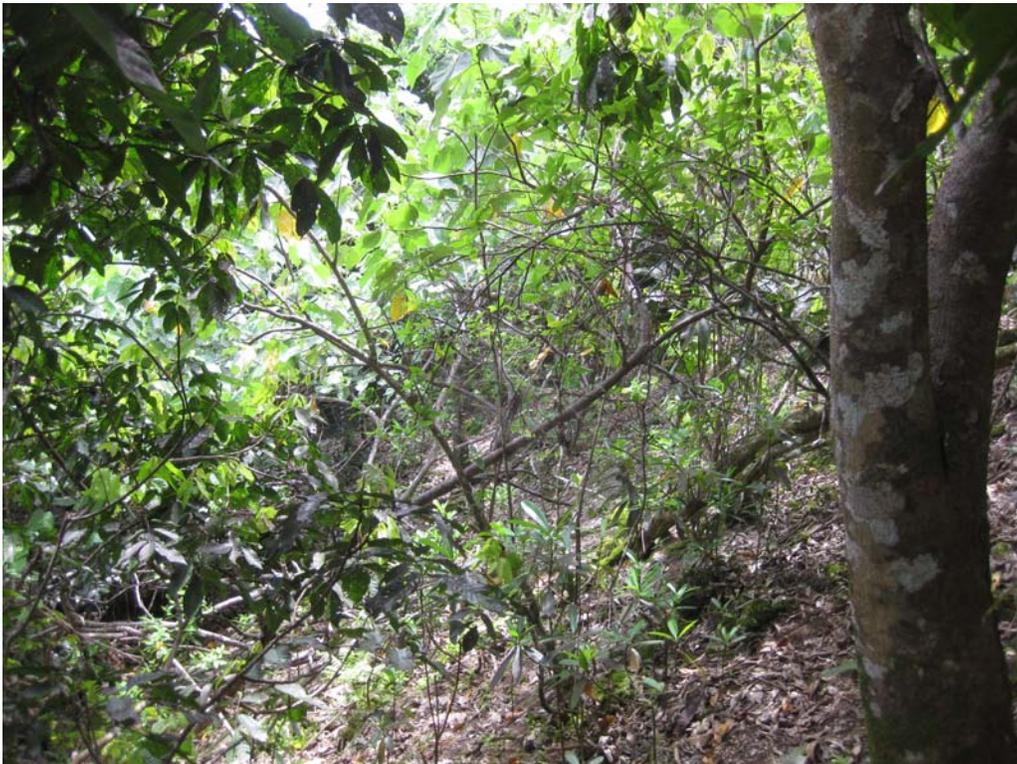
Photo 24 Area F: View of site vegetation on steep slope.

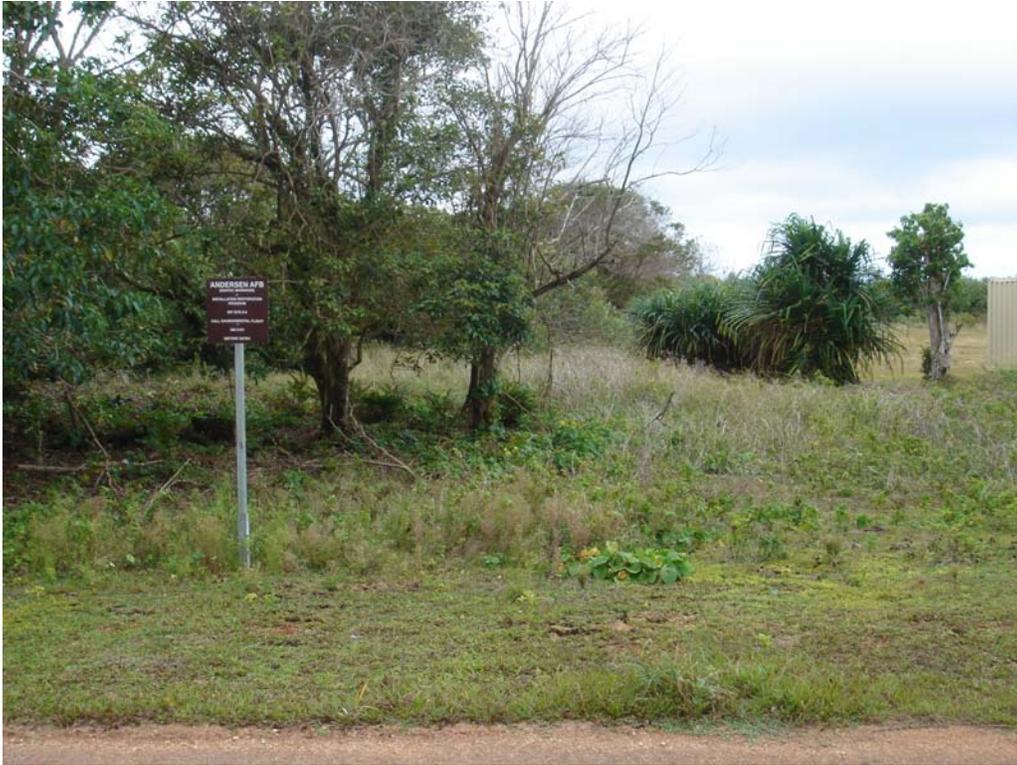
Photo 10 Site 6 (Landfill 8): LUC site signage

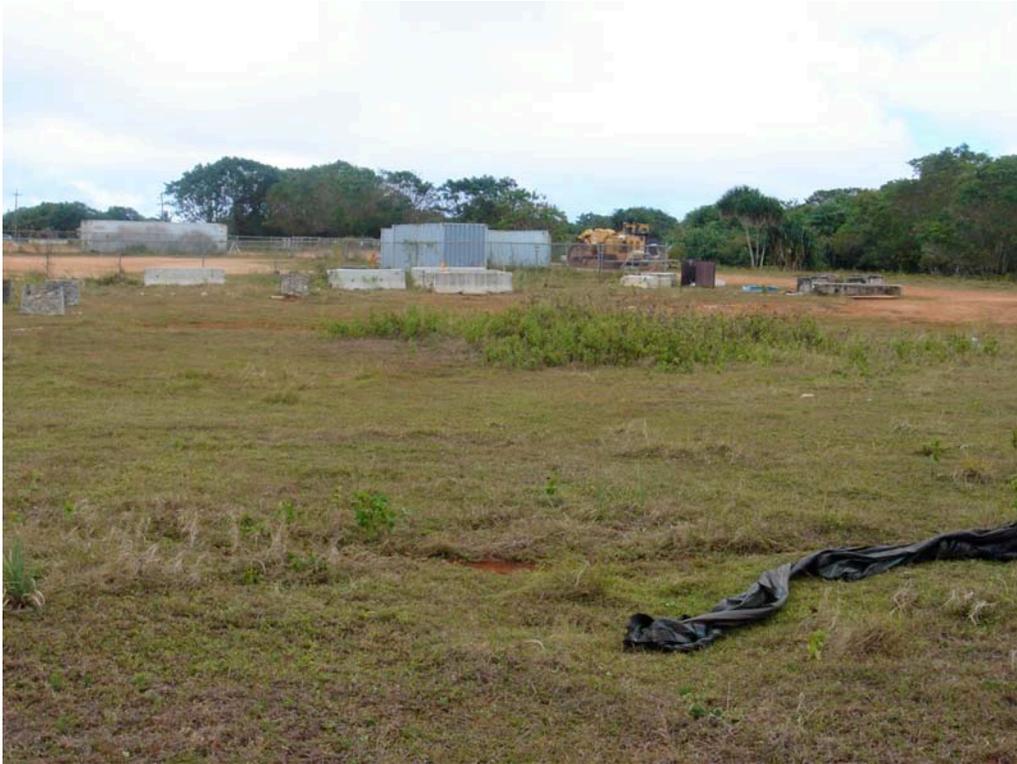
This site is currently being used as a laydown/storage yard by a contractor. Part of the fenced area constructed by the contractor lies within the LUC boundary. Soil appears to have been moved between the LUC boundary area and other areas within the site.

Photo 11 Site 6 (Landfill 8): View of site showing fenced laydown yard and staged heavy equipment in photo background.

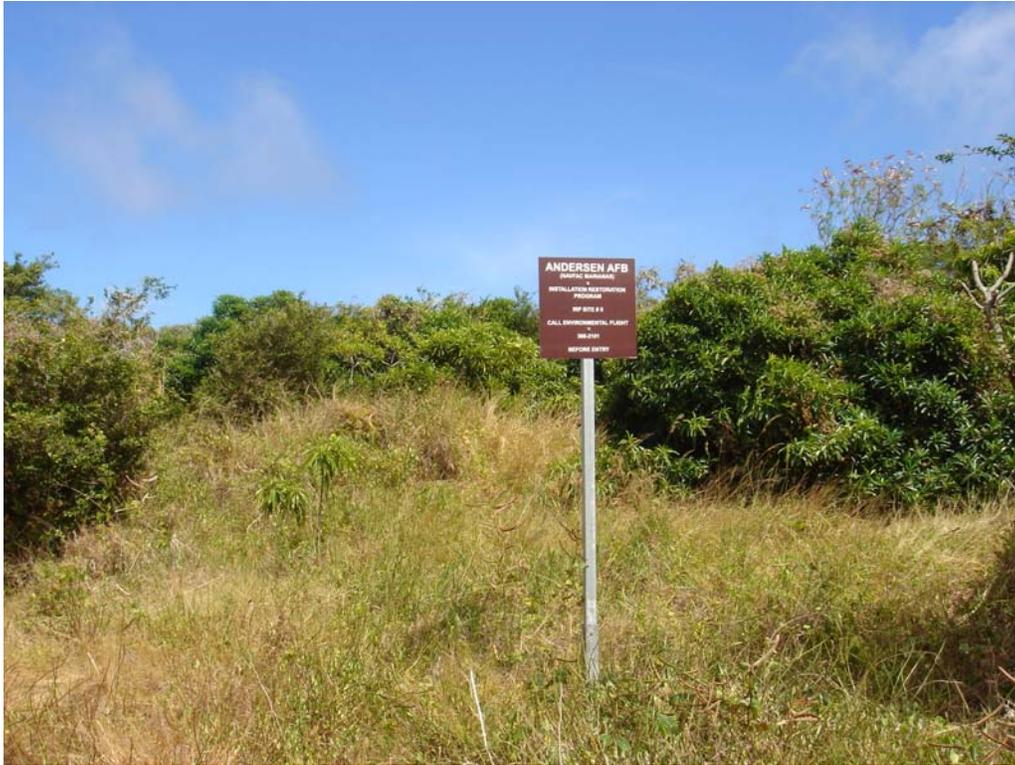
Photo 13 Site 8 (Landfill 10): LUC site signage

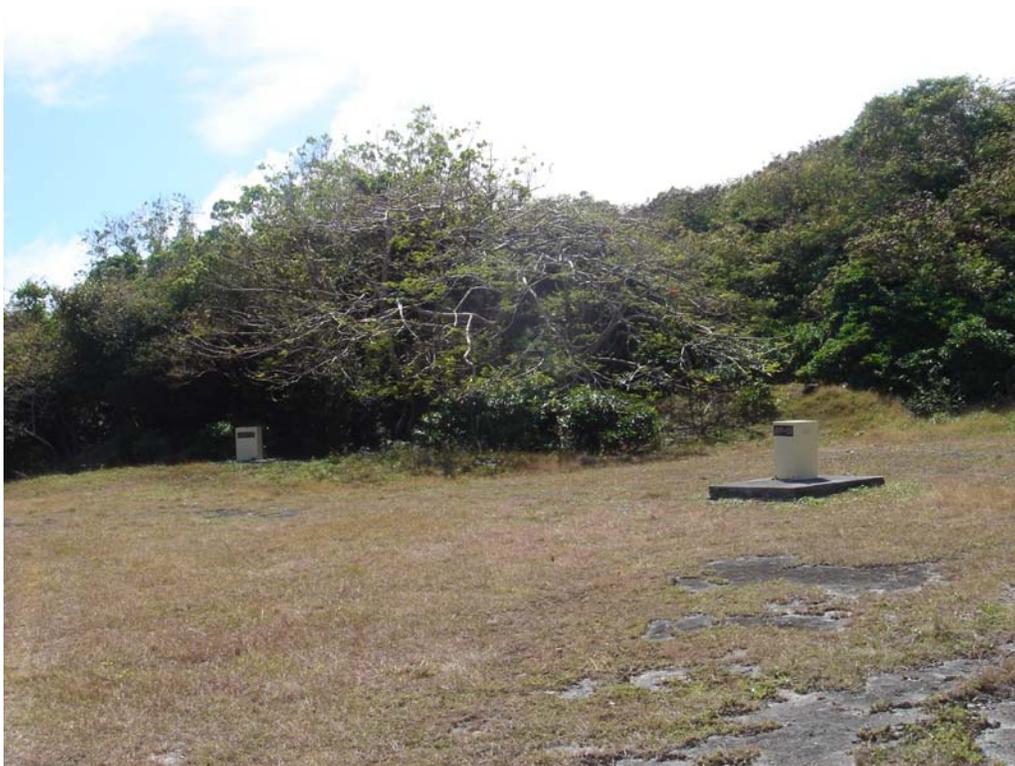
Photo 15 Site 8 (Landfill 10): IRP Wells located within site.

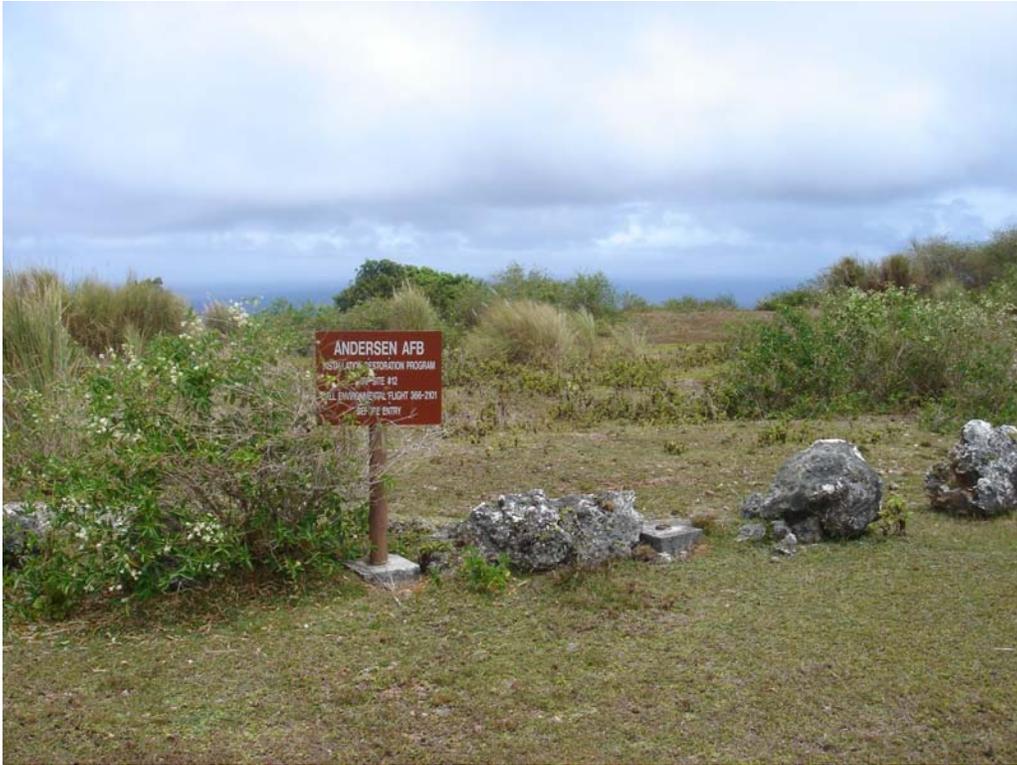
Photo 16 Site 12 (Landfill 17): LUC site signage

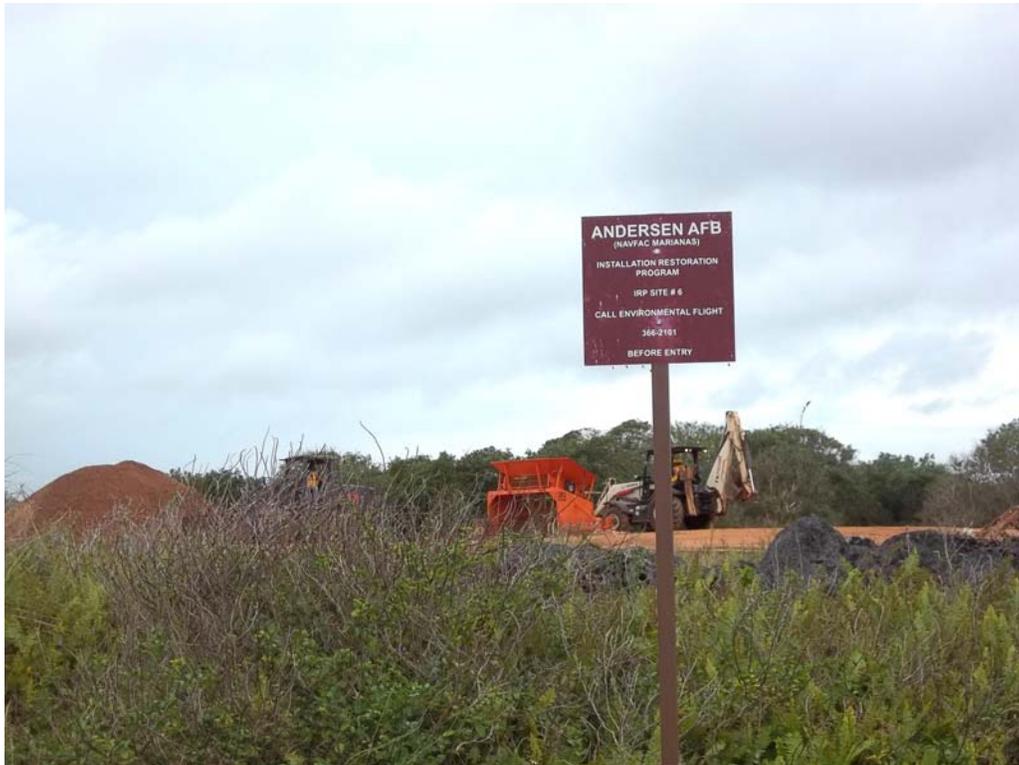
Photo 10 Site 6 (Landfill 8): LUC signage.

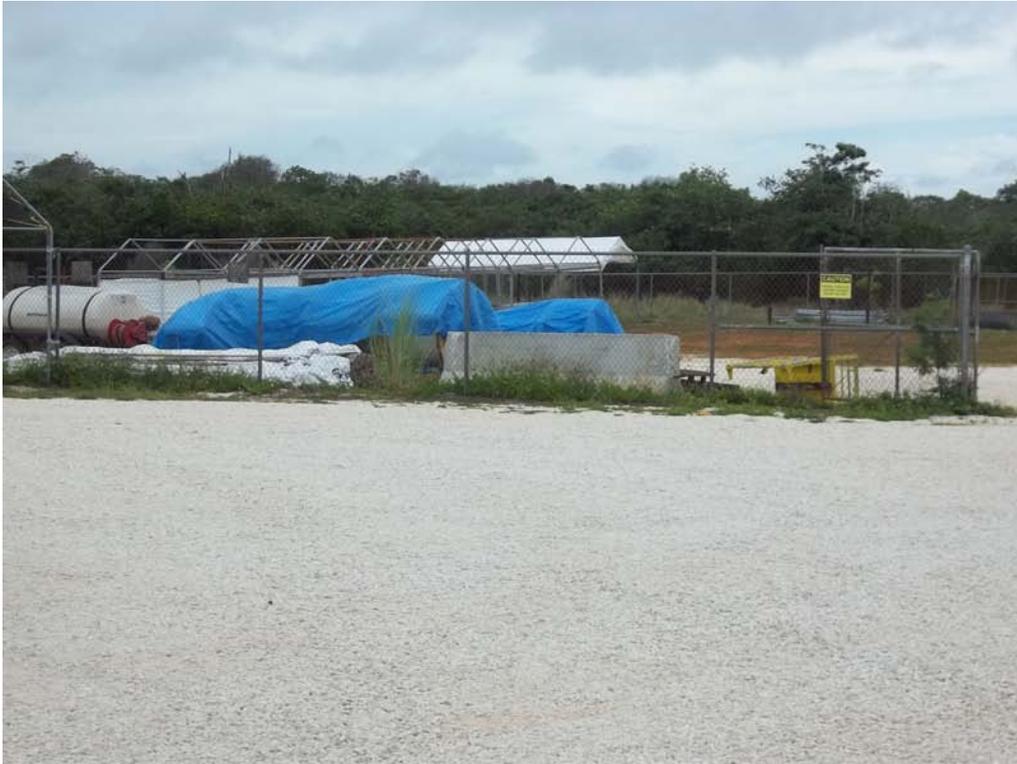
Photo 11 Site 6 (Landfill 8): View of site showing fenced laydown yard.

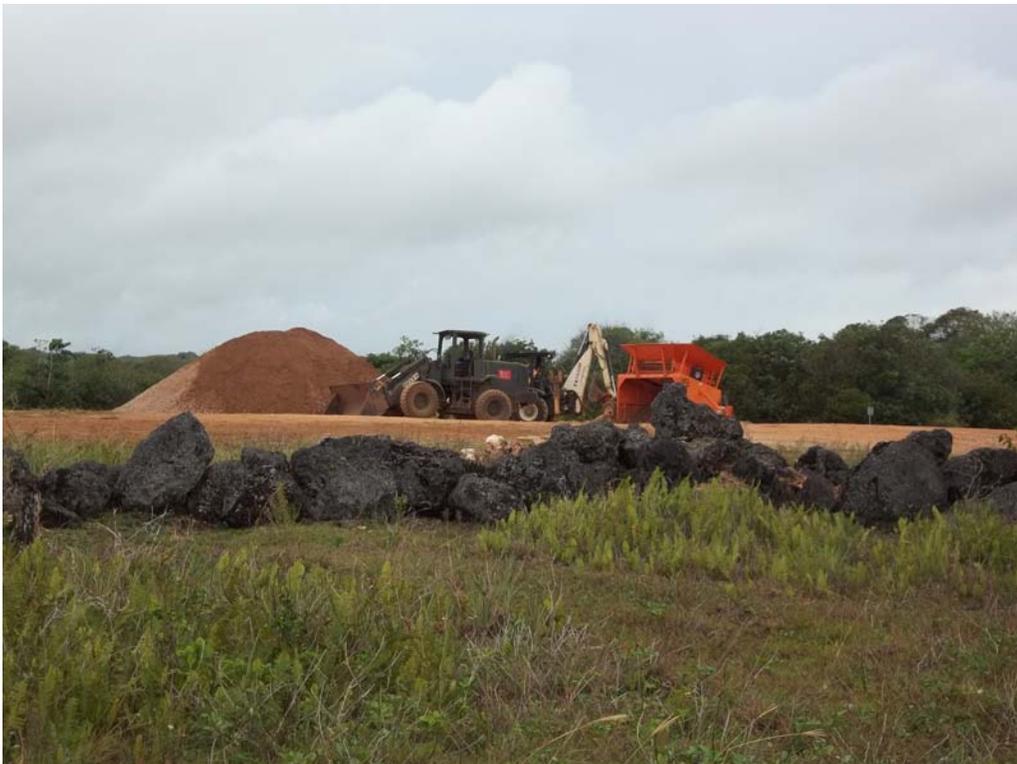
This site is currently being used as a laydown/storage yard by a contractor. Part of the fenced area constructed by a previous contractor lies within the LUC boundary. There is no fence surrounding the overall site. Signs are posted indicating that the site is restricted. Soil appears to have been moved between the LUC boundary area and other areas within the site. Soil is being stockpiled at the site, apparently moved in from outside of the site.

Photo 12 Site 6 (Landfill 8): View of northern section of site showing stockpiled soil and earthmoving equipment.

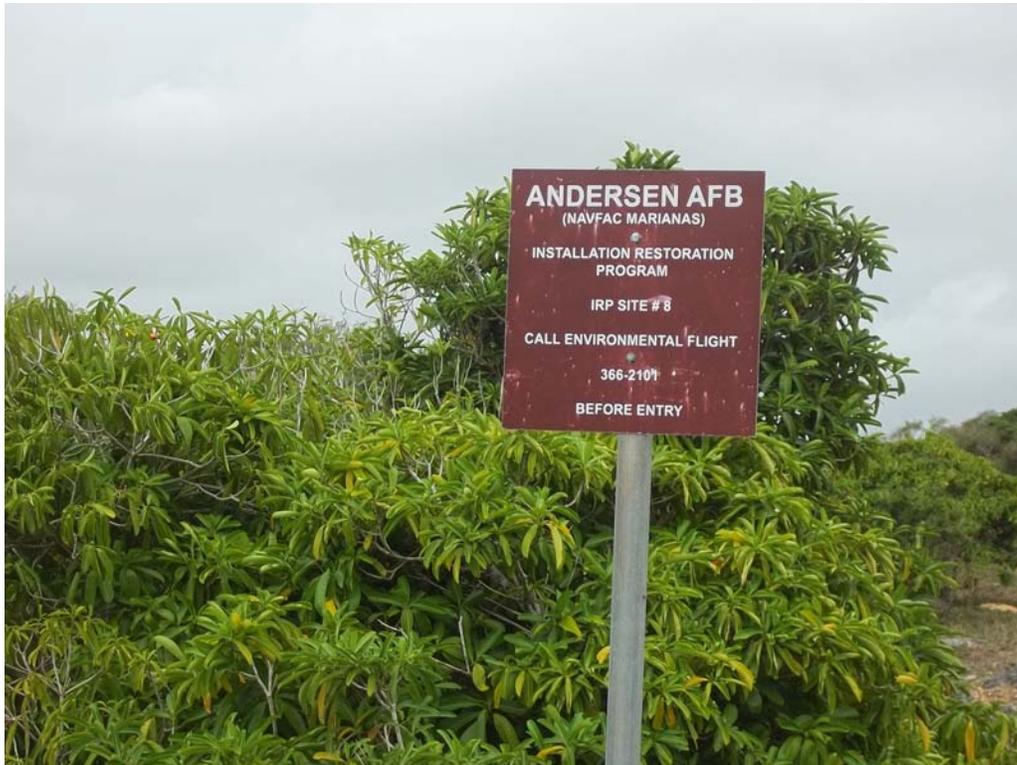
Photo 13 Site 8 (Landfill 10): LUC signage
