Customer:	[Enter Client Name]	Project Number:	100100.0101
Site Name:	[Enter Site Name]	Site Location:	[Enter Site Location]

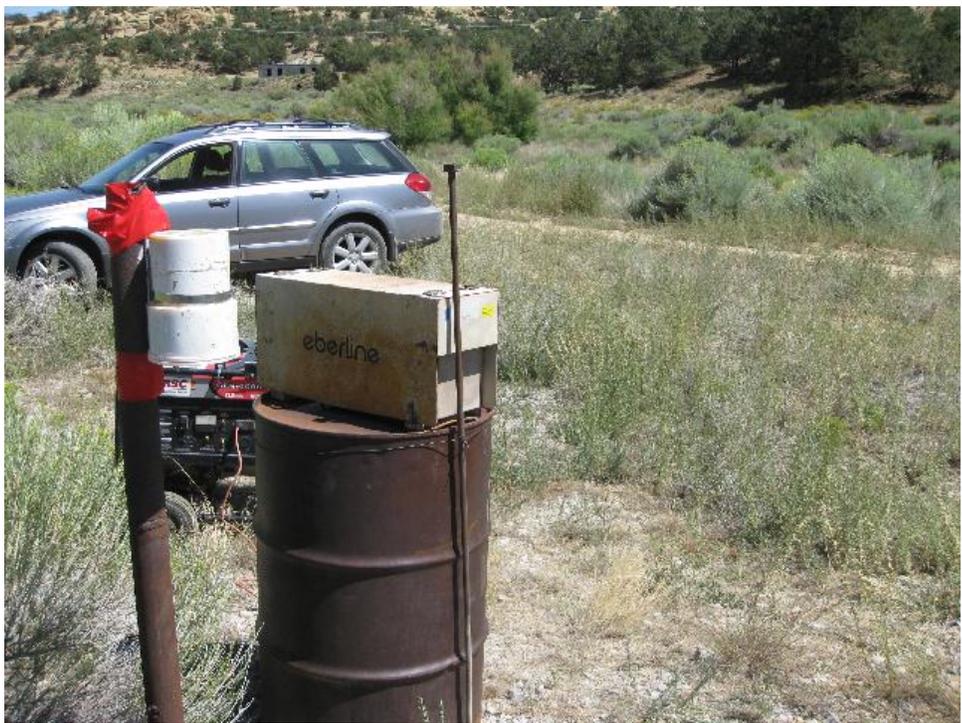
Photograph ID: 1

Date: Aug 18, 2009	
Location: NECR Mine	
Direction: Northwest	
Comments: Upwind air monitoring location

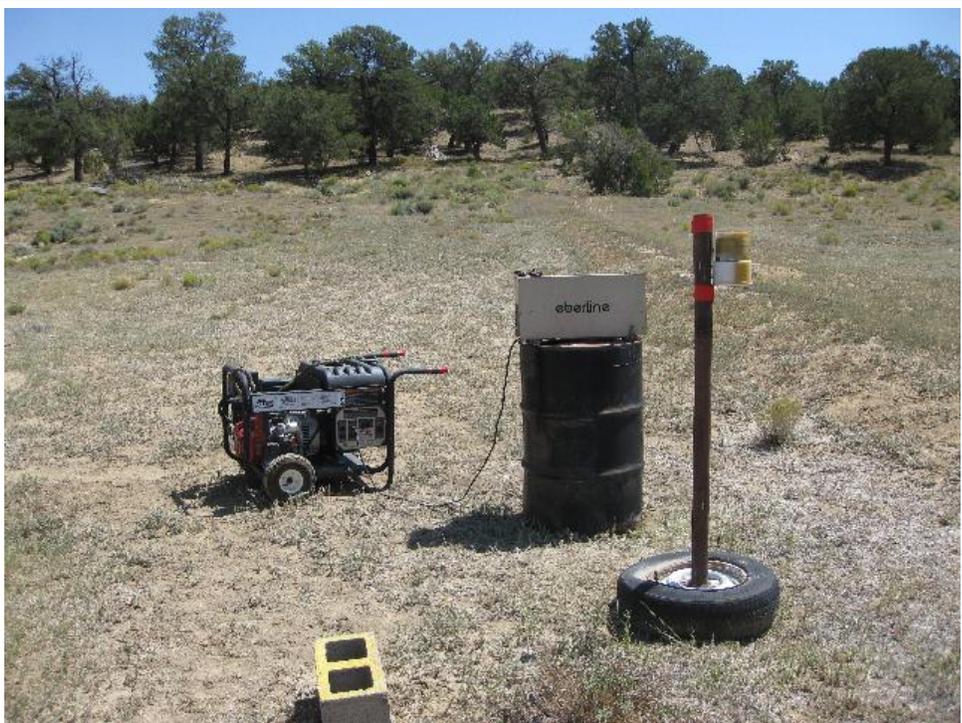
Photograph ID: 2

Date: Aug 18, 2009	
Location: NECR Mine	
Direction: North	
Comments: Downwind air monitoring location

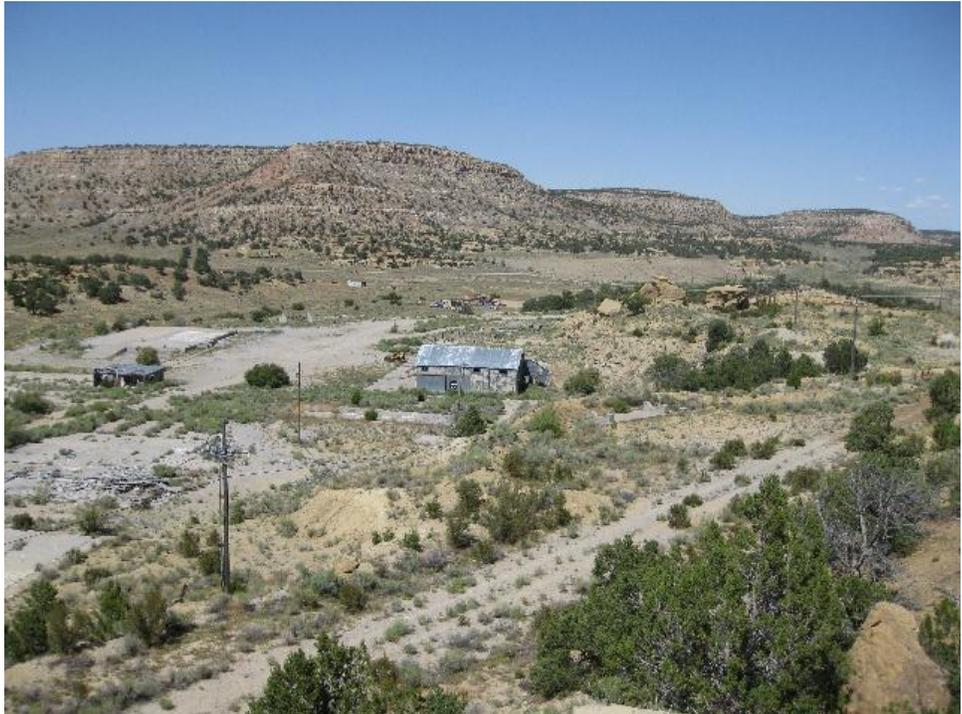
Photograph ID: 3

Date: Aug 18, 2009	
Location: NECR Mine	
Direction: North	
Comments: Overview of NECR-1 and Step-out area prior to construction

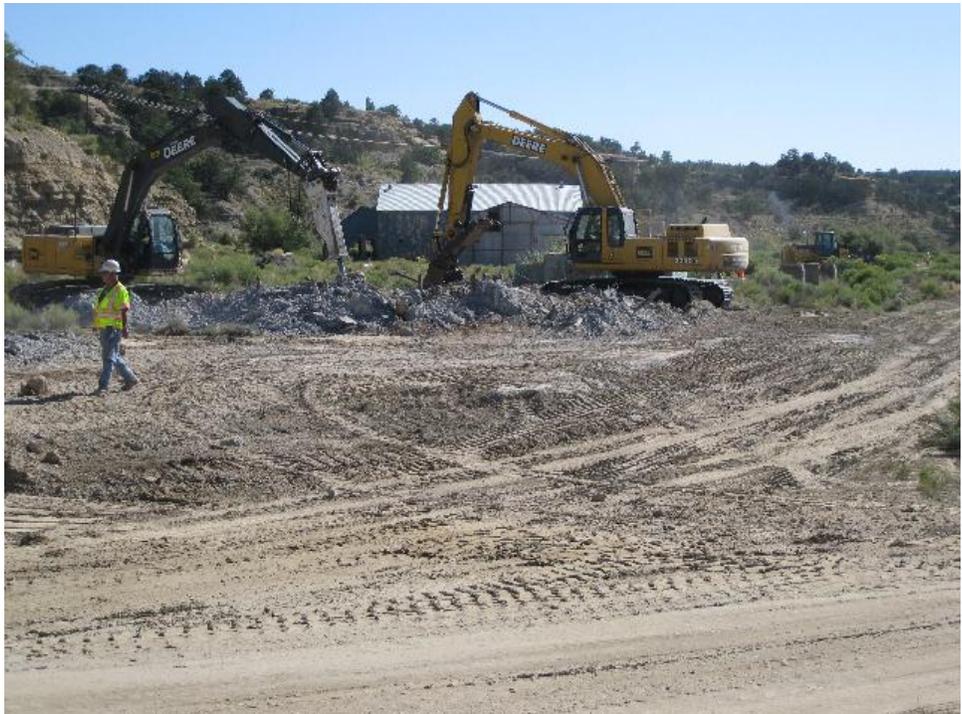
Photograph ID: 4

Date: Aug 19, 2009	
Location: NECR Mine	
Direction: Southwest	
Comments: Concrete demolition in progress

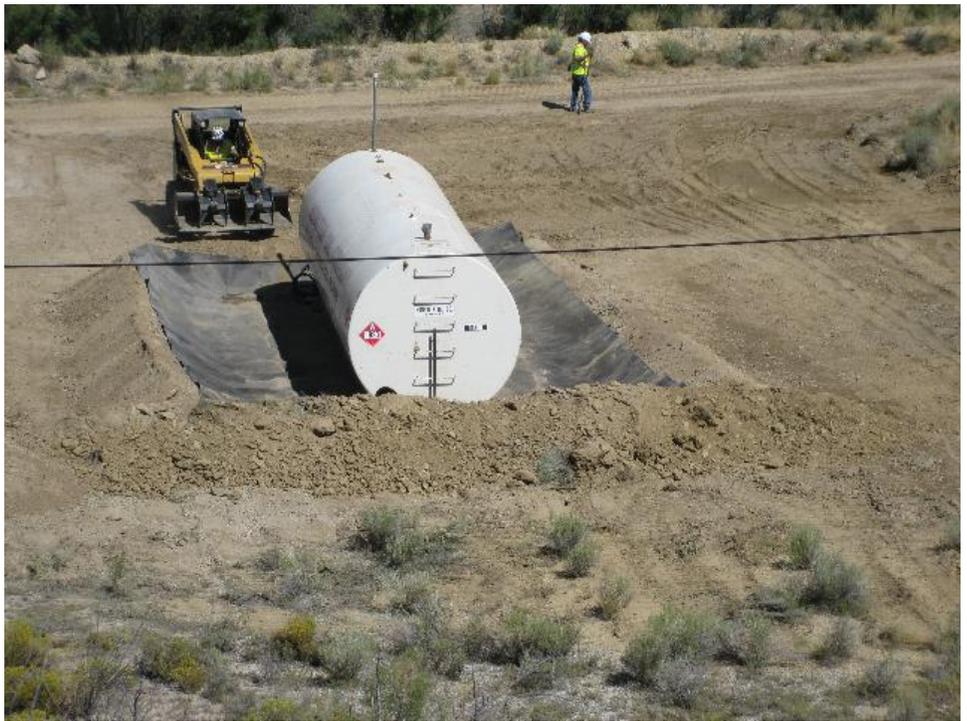
Photograph ID: 5

Comments:
Fuel tank in containment berm

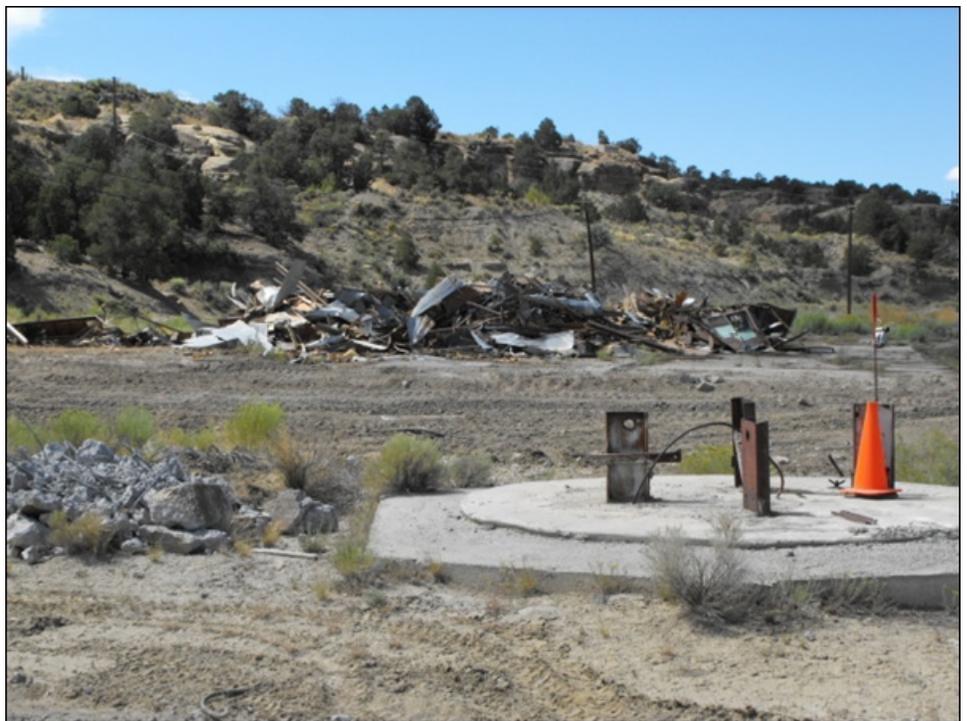
Photograph ID: 6

Comments:
Demolished remains of blue building. NECR-1 shaft with on-site dust monitor

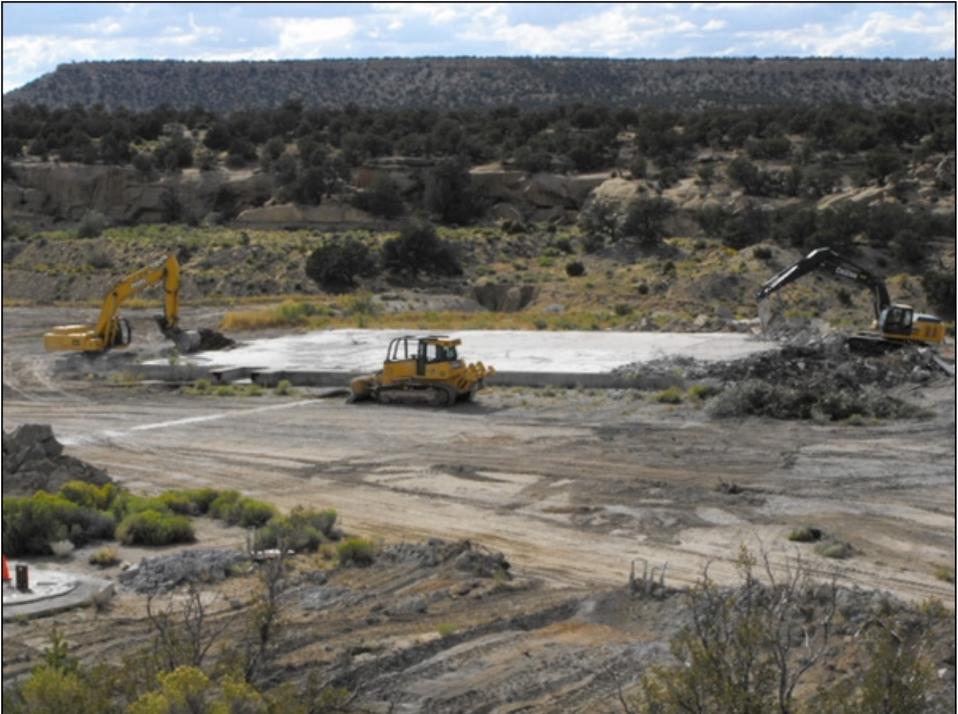
<p>Photograph ID: 7</p> <p>Date: Aug 25, 2009</p> <p>Location: NECR Mine</p> <p>Direction: West</p> <p>Comments: Demolition of warehouse concrete pad</p>

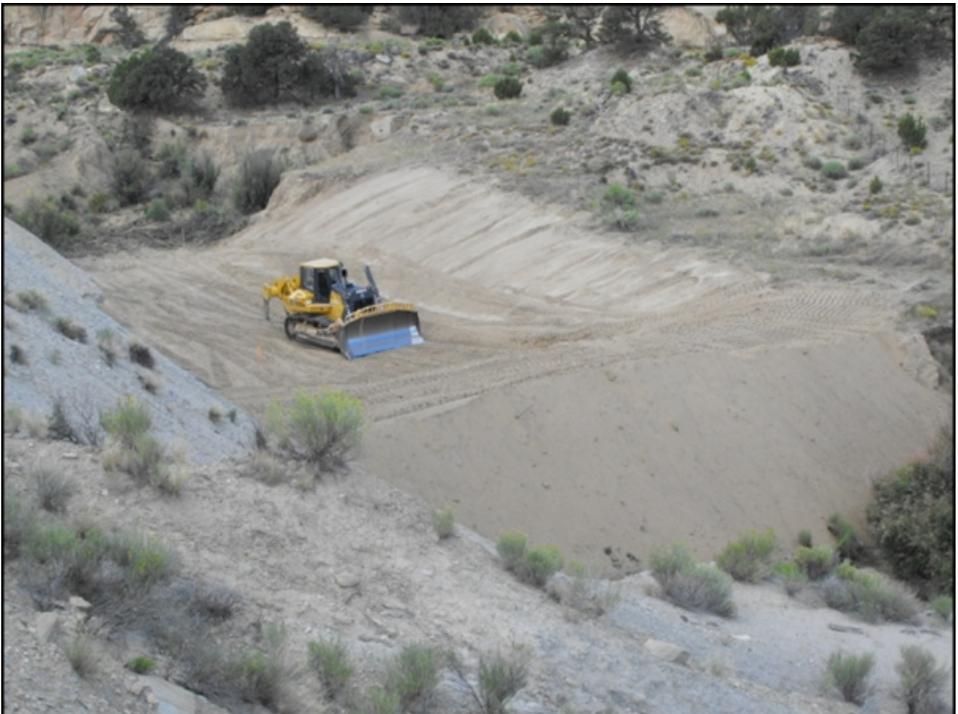
<p>Photograph ID: 8</p> <p>Date: Aug 25, 2009</p> <p>Location: NECR Mine</p> <p>Direction: Northwest</p> <p>Comments: Construction of sediment pond at west toe of NECR-1</p>

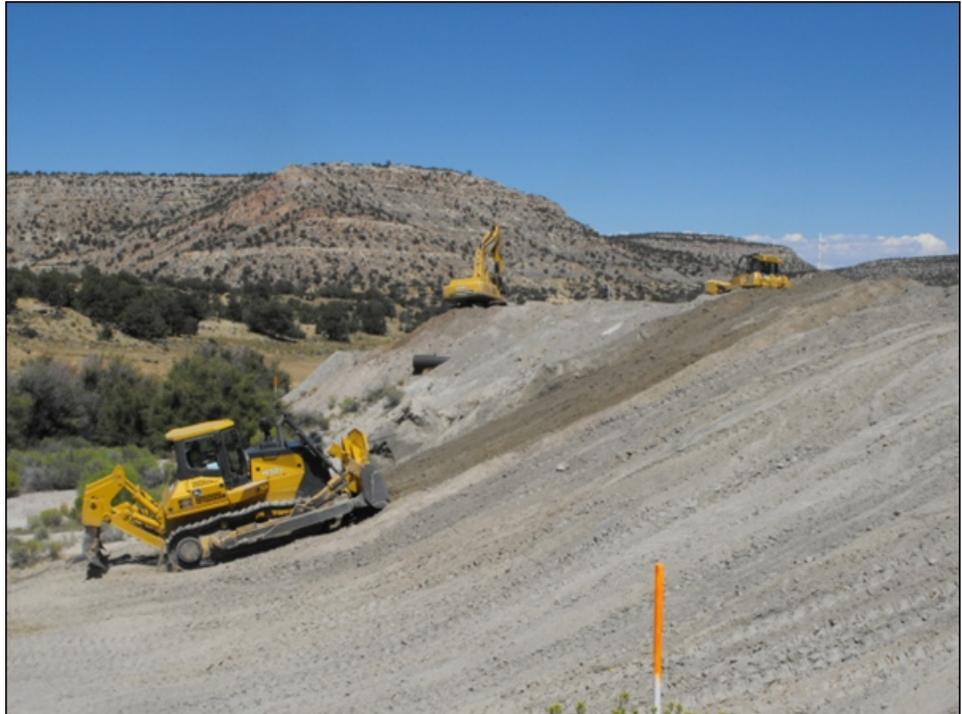
Photograph ID: 9

Date: Aug 27, 2009	
Location: NECR Mine	
Direction: Northwest	
Comments: Grading of West outslope of NECR-1

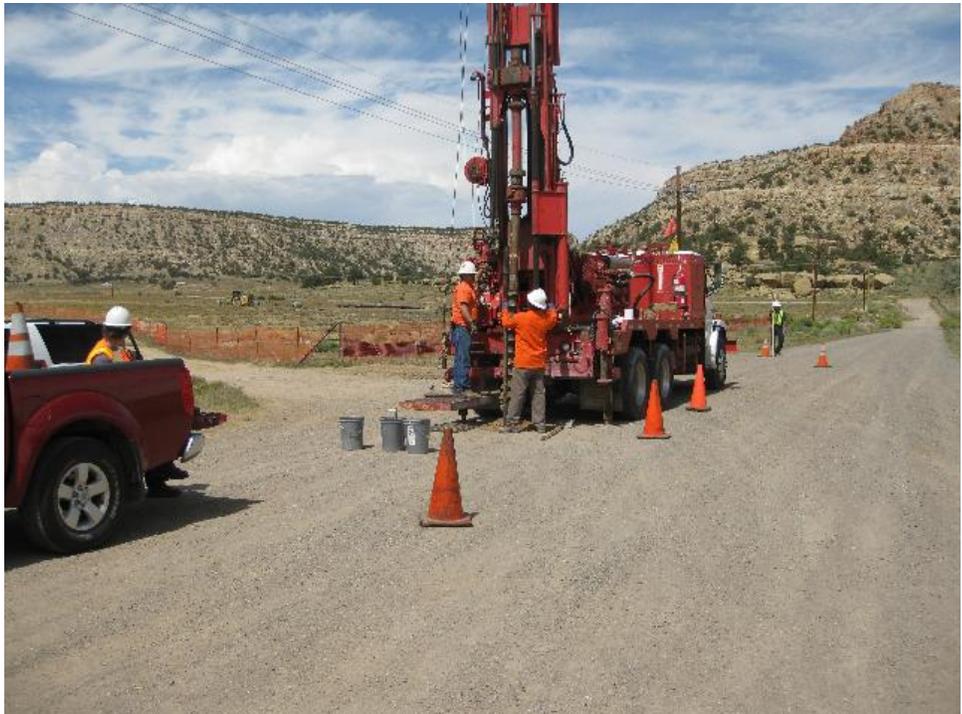
Photograph ID: 10

Date: Sep 9, 2009	
Location: Red water Pond Road	
Direction: Northwest	
Comments: Subsurface sampling on Red Water Pond Road

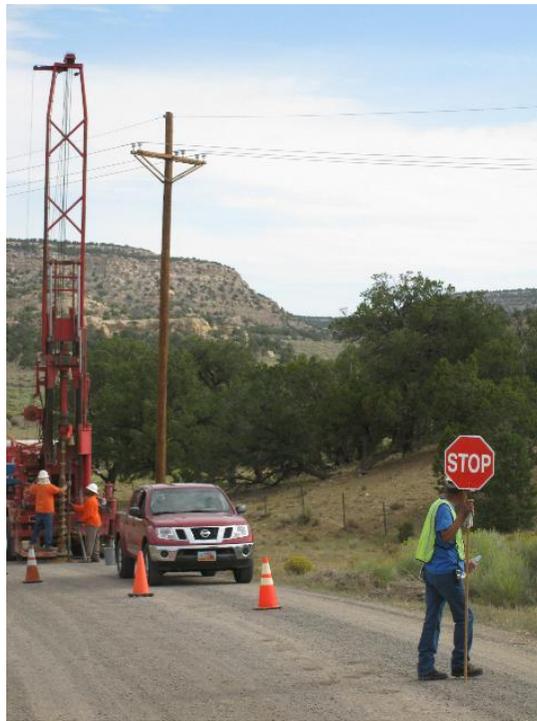
Photograph ID: 11
Date: Sep 9, 2009
Location: Red water Pond Road
Direction: Northeast
Comments: Subsurface sampling on Red Water Pond Road

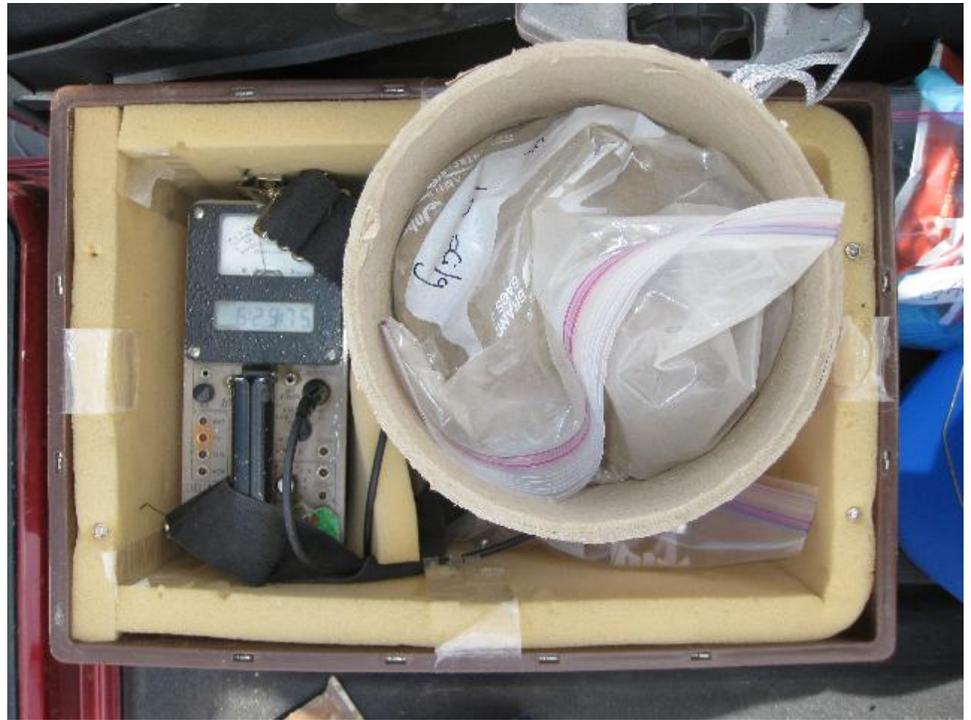
Photograph ID: 12
Date: Sep 9, 2009
Location: Red water Pond Road
Direction: N/A
Comments: Ludlum 2221 meter setup for comparison of Red Water Pond Road sample material against reference sample.

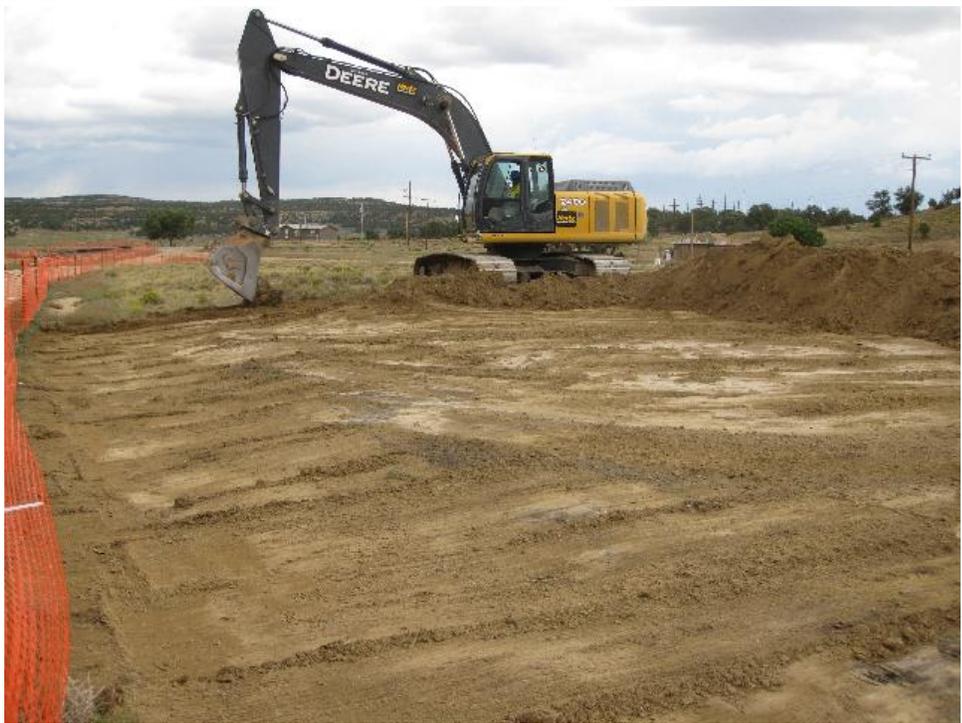
Photograph ID: 13

Date: Sep 12, 2009	
Location: Step-out Area	
Direction: Southeast	
Comments: Excavation of top 6 inches of material on south side of driveway in Zone 4. Orange snow fence on left side of photo is separating the driveway from the construction area.

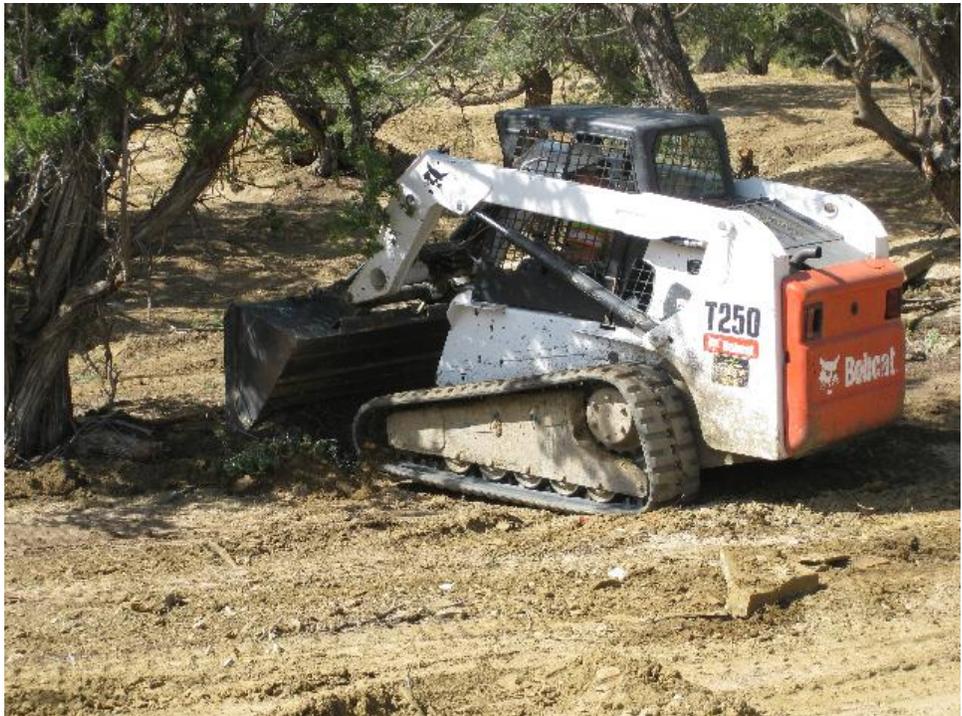
Photograph ID: 14

Date: Sep 12, 2009	
Location: Step-out Area	
Direction: Southwest	
Comments: Excavation under trees on hill side in Zone 2 using a skidsteer

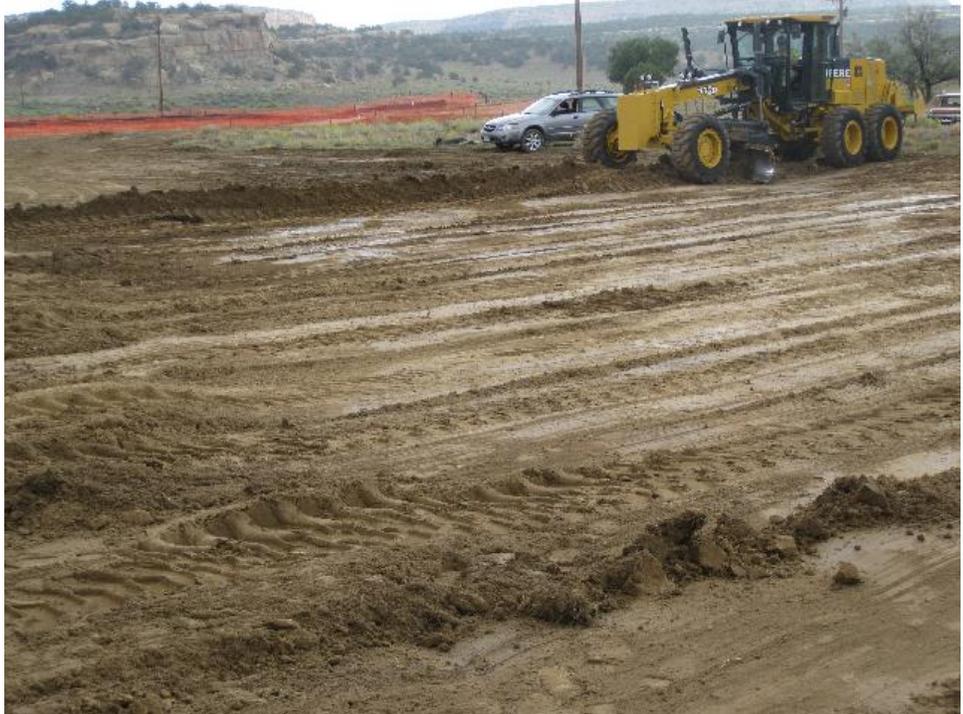
Photograph ID: 15

Date: Sep 15, 2009	
Location: Step-out Area	
Direction: East	
Comments: Excavation of Zone 4 using motor grader

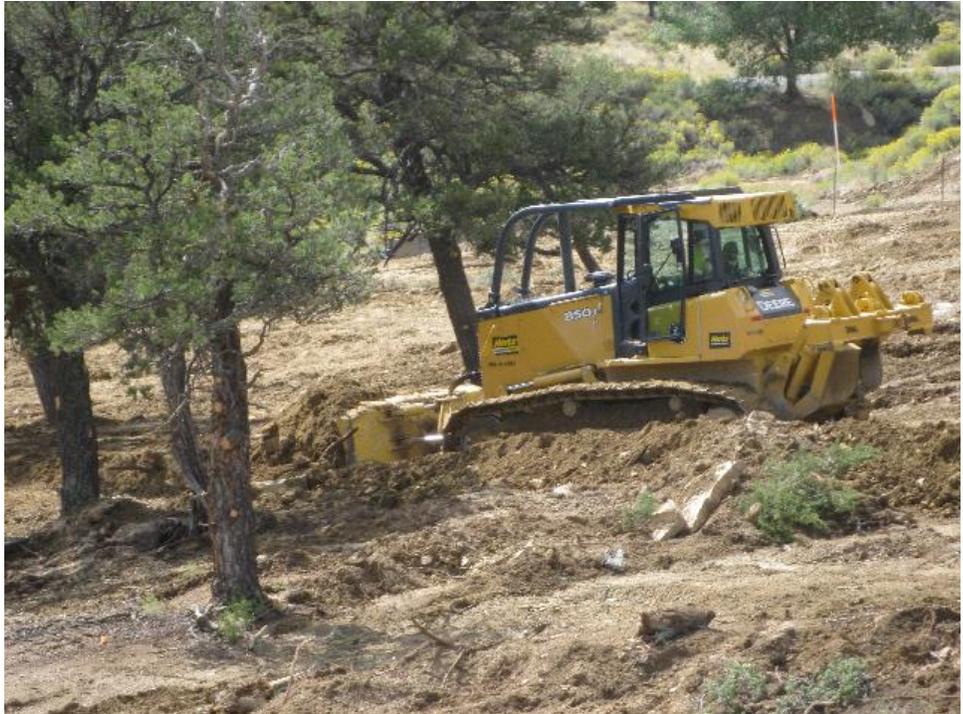
Photograph ID: 16

Date: Sep 17, 2009	
Location: Hill Side	
Direction: Southeast	
Comments: Removal of soil from hill side in Zone 2. Dozer is pushing material that was removed from underneath trees using skidsteer.

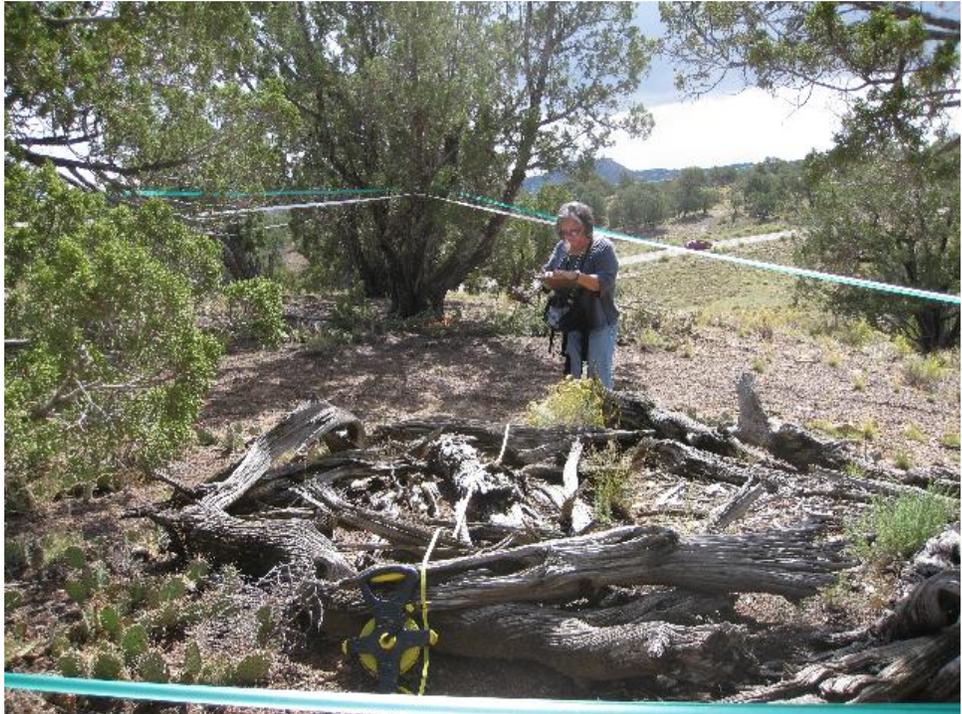
Photograph ID: 17

Date: Sep 17, 2009	
Location: Step-out Area	
Direction: East	
Comments: Rena Martin from Dinetahdoo Cultural Resource Management recording potential burial site on hill side in Step-out Area

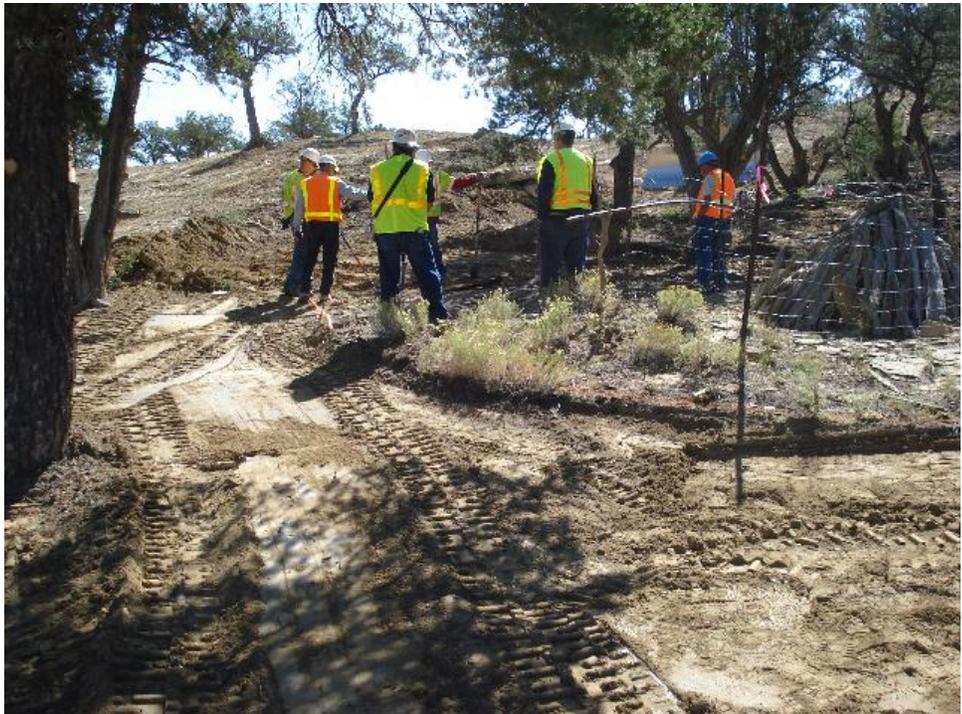
Photograph ID: 18

Date: Sep 23, 2009	
Location: Step-out Area	
Direction: Southeast	
Comments: Monitoring of removal of contaminated soils from around sweat lodge (TCP-1)

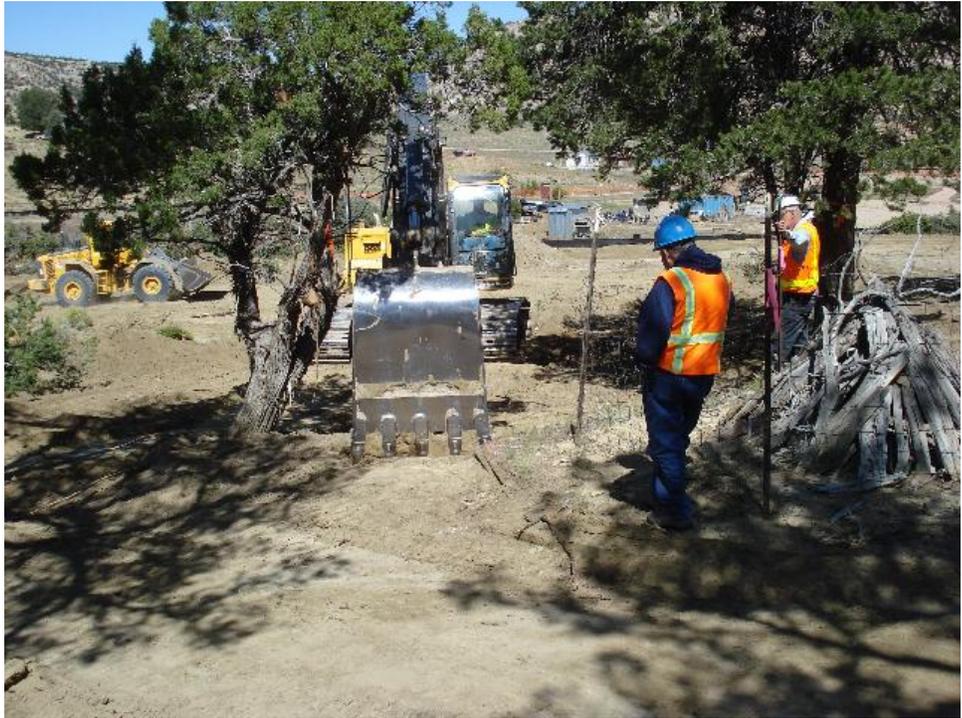
Date: Sep 23, 2009			
Location: Step-out Area			
Direction: Northeast			
Comments: Monitoring of removal of contaminated soils from around sweat lodge (TCP-1)			
Photograph ID: 20

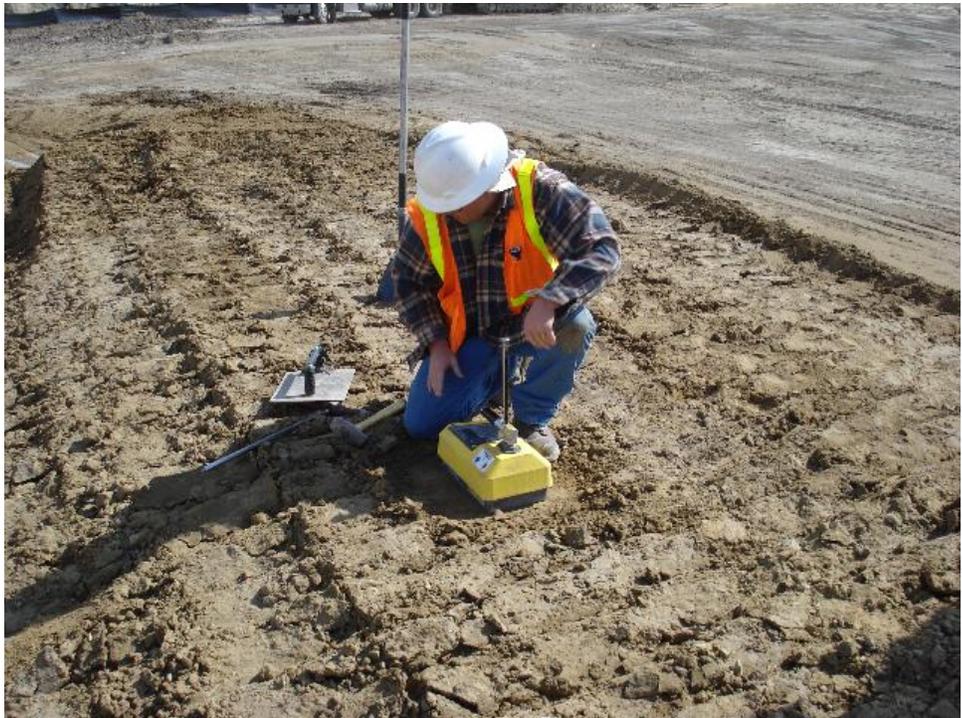
Date: Sep 30, 2009			
Location: Step-out Area			
Direction: North			
Comments: Nuclear density guage testing of compaction test pad

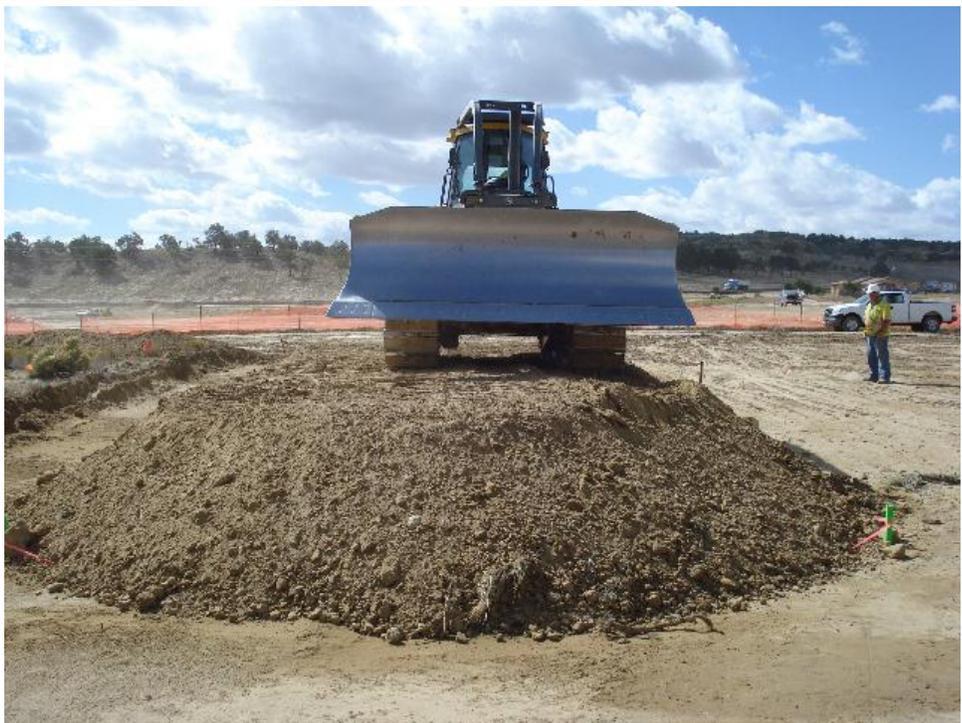
Date: Sep 30, 2009			
Location: Step-out Area			
Direction: South			
Comments: Construction of compaction test pad			
Photograph ID: 22

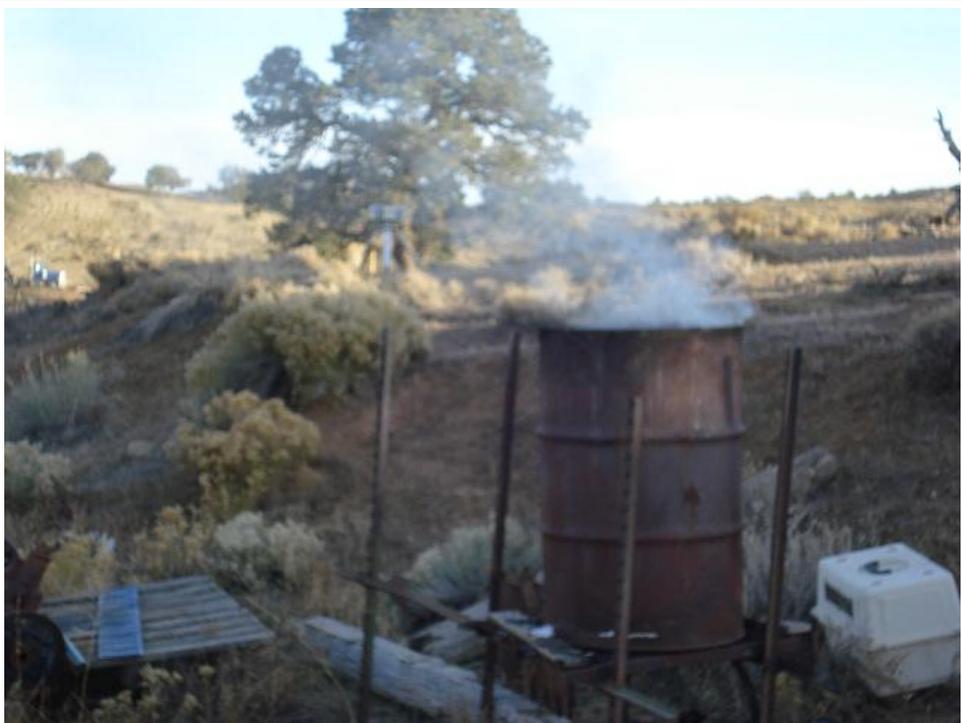
Date: Nov 10, 2009			
Location: West Dust Monitoring Station			
Direction: Southeast			
Comments: Barrel in foreground contains burning domestic garbage. West dust track monitor is visible down wind of burning garbage in background of photo

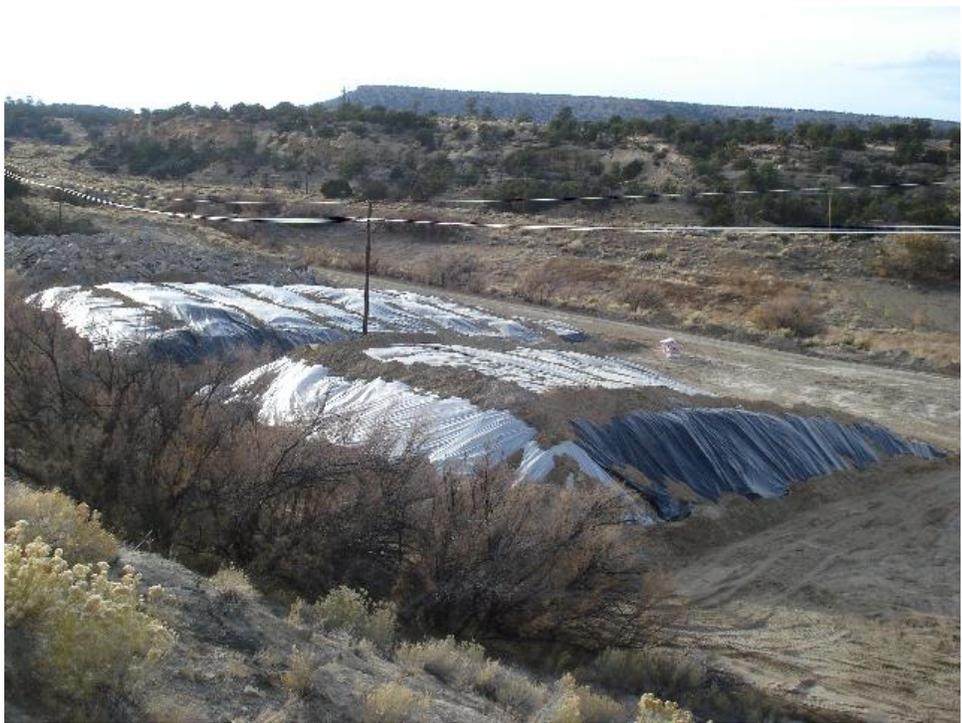
Date: Nov 12, 2009			
Location: Permit Area			
Direction: Southwest			
Comments: Plastic cover over petroleum contaminated soils			
Photograph ID: 24

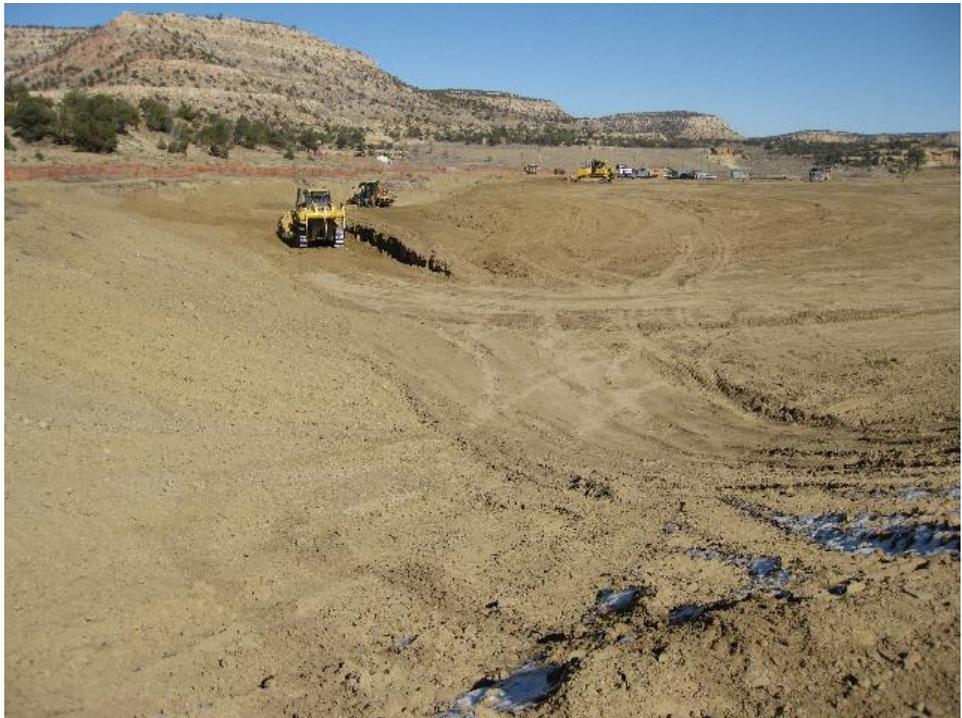
Date: Nov 18, 2009			
Location: Stepout Area			
Direction: North			
Comments: Backfill of unnamed arroyo

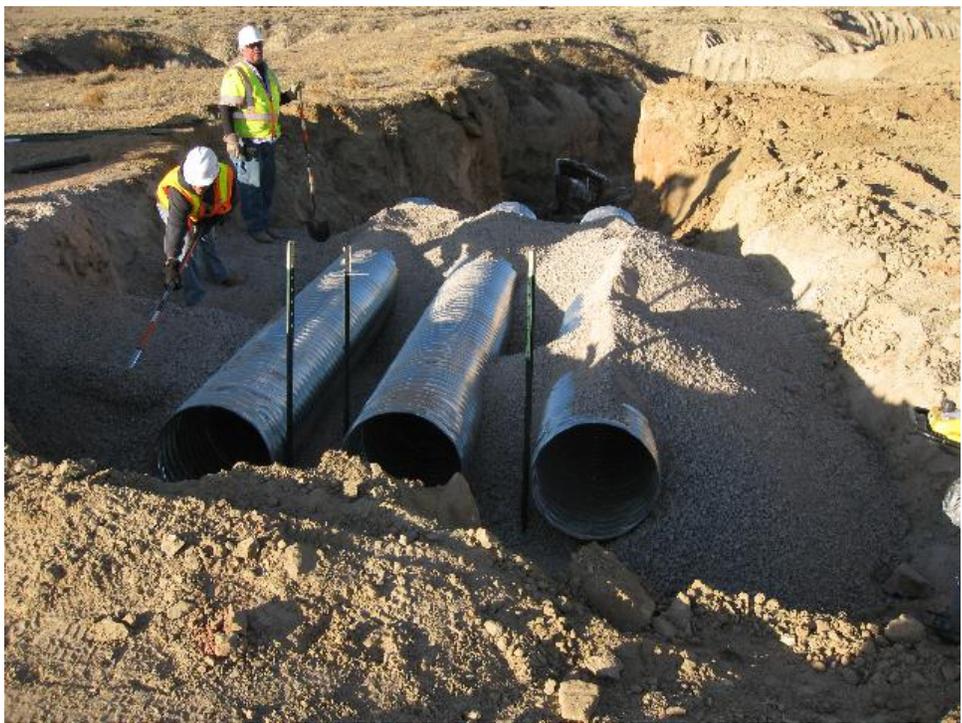
Date: Nov 19, 2009			
Location: Stepout Area			
Direction: South			
Comments: Installation of culverts where unnamed road crosses unnamed arroyo.			
Photograph ID: 26

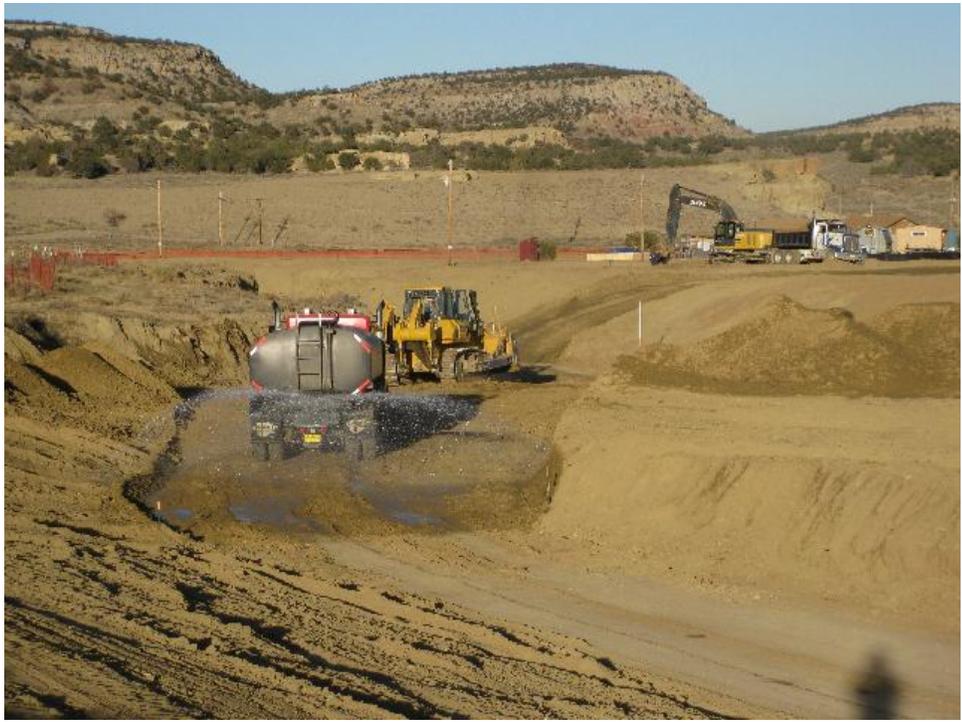
Date: Nov 20, 2009			
Location: Stepout Areas			
Direction: Northeast			
Comments: Water truck applying water to backfill in unnamed arroyo during compaction

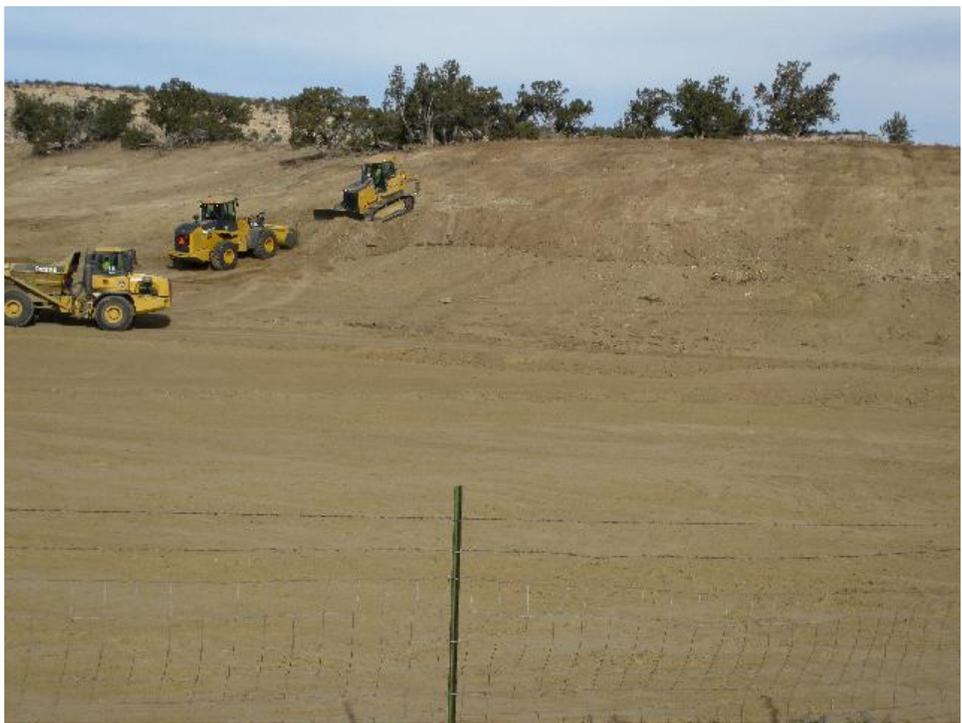
Date: Nov 21, 2009			
Location: Stepout Area			
Direction: East			
Comments: Stripping 1 foot of additional material from west side of hillside in stepout area			
Photograph ID: 28

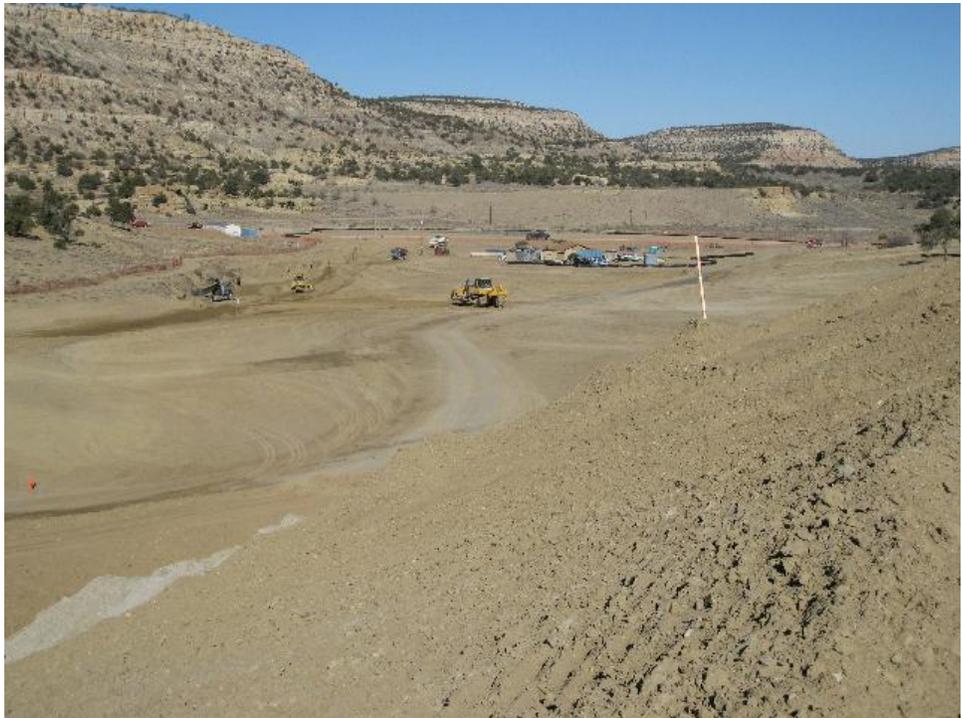
Date: Nov 22, 2009			
Location: Stepout Area			
Direction: Northwest			
Comments: Overview of stepout area and unnamed arroyo backfill progress

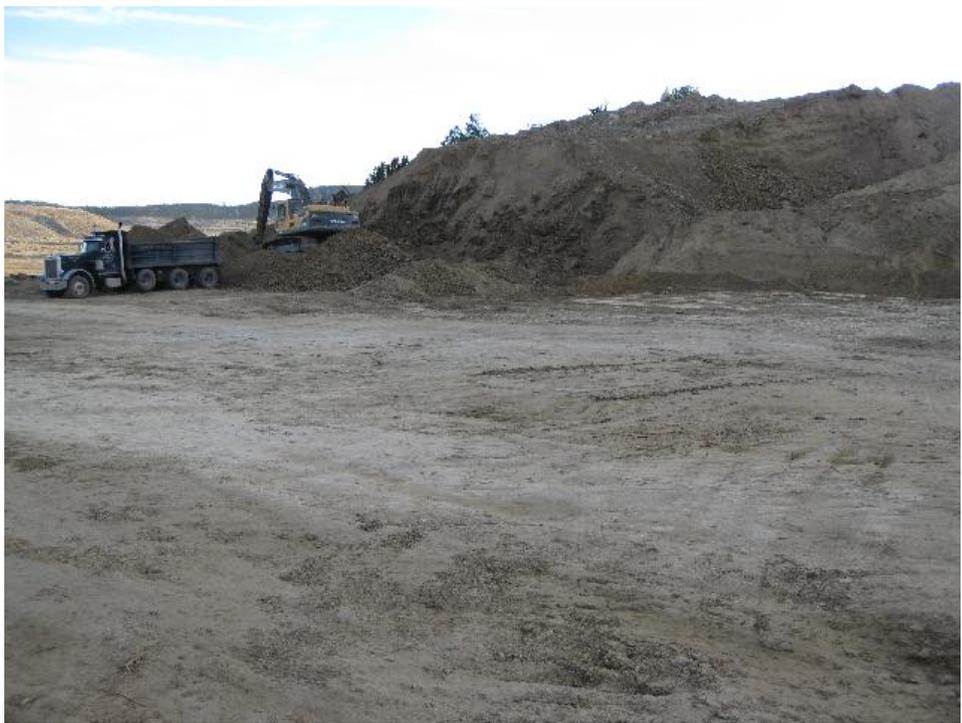
Date: Nov 22, 2009			
Location: Borrow			
Direction: Southeast			
Comments: Excavator loading tandem truck with clean material in borrow area			
Photograph ID: 30

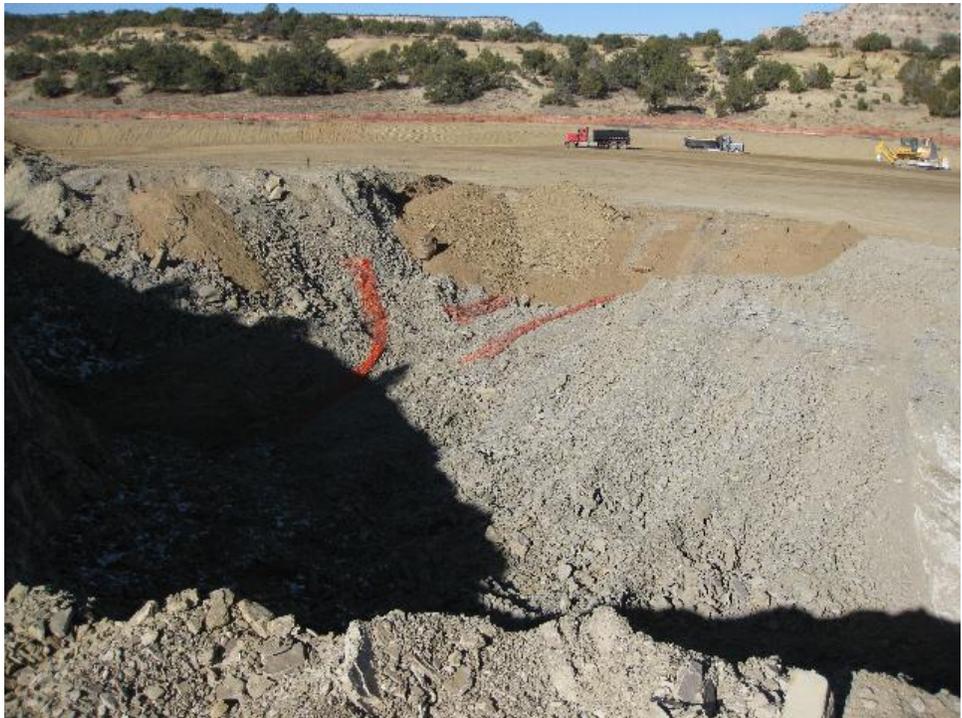
Date: Nov 22, 2009			
Location: Stepout Area			
Direction: West			
Comments: Used barricade fencing placed in the bottom of the petroleum contaminated soil excavation. Fencing is being used to demarcate limit of current excavation when excavation of soils continues.

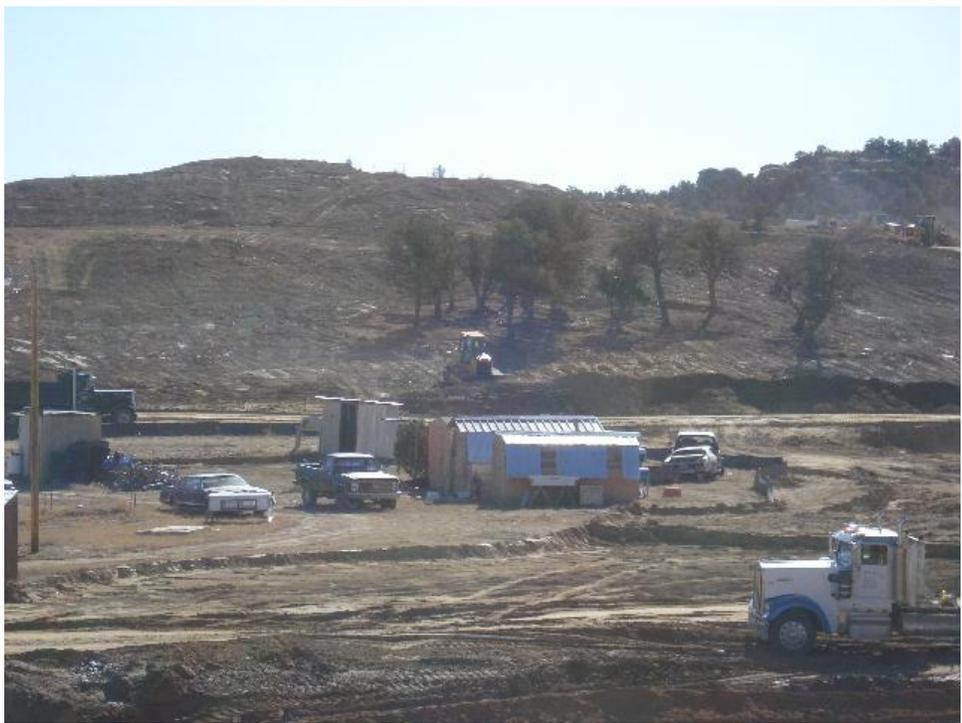
Date: Dec 2, 2009			
Location: Step-out Area			
Direction: East			
Comments: Hillside excavation using JD 850 bulldozer			
Photograph ID: 32

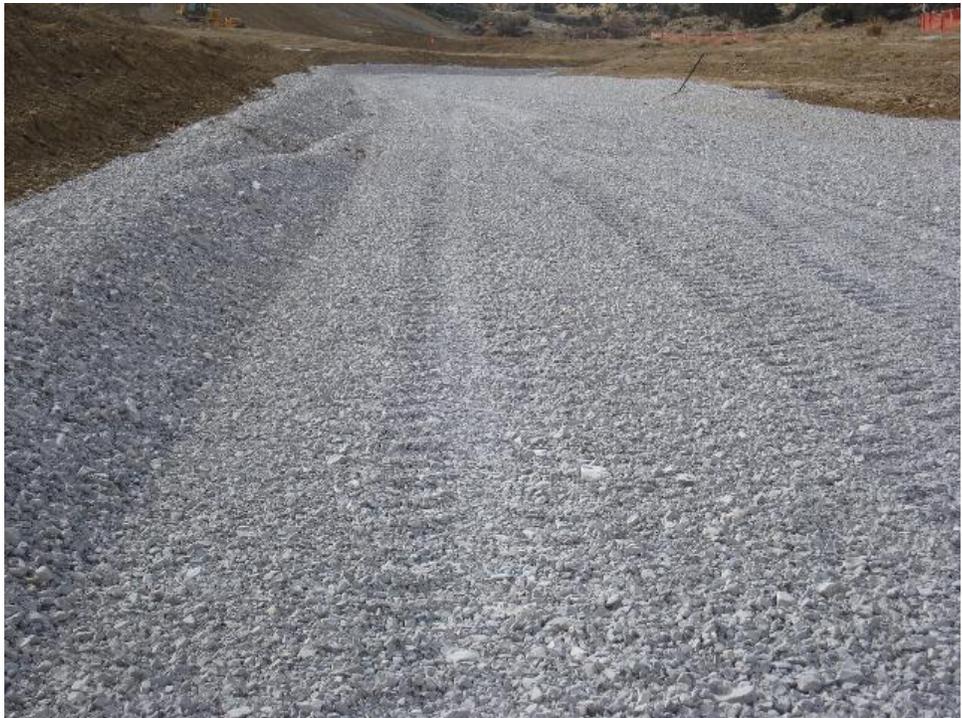
Date: Dec 5, 2009			
Location: Unnamed Arroyo			
Direction: South			
Comments: Placement of bedding material in the unnamed arroyo
