Customer:	[Enter Client Name]	Project Number:	100100.0101
Site Name:	[Enter Site Name]	Site Location:	[Enter Site Location]

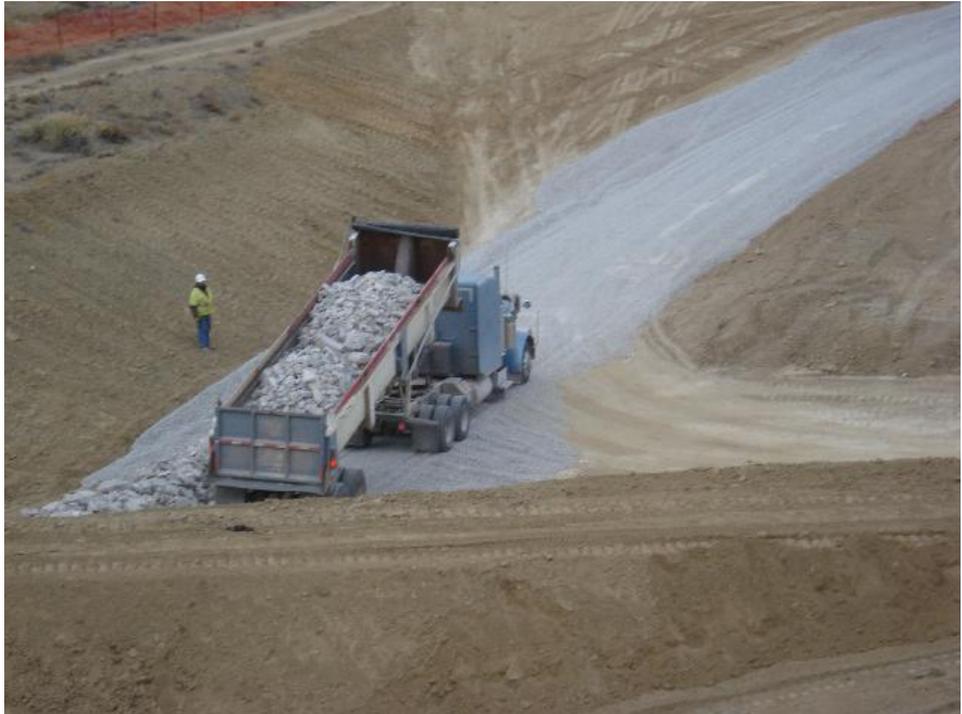
<p>Photograph ID: 33</p> <p>Date: Dec 5, 2009</p> <p>Location: Unnamed Arroyo</p> <p>Direction: North</p> <p>Comments: Placement of riprap in the south end of the unnamed arroyo. Photo taken from the crest of the NECR-1 pile.</p>

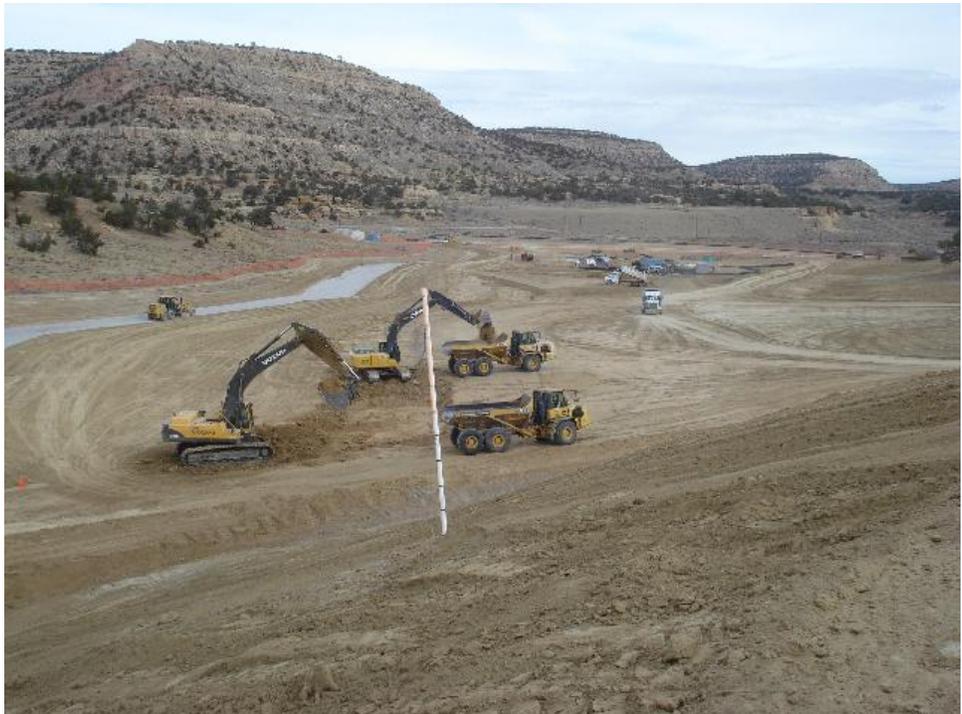
<p>Photograph ID: 34</p> <p>Date: Dec 5, 2009</p> <p>Location: Step-out Area</p> <p>Direction: North</p> <p>Comments: Excavation of areas above the correlated action level in Zone 1. Grading of bedding material in the unnamed arroyo is in the back left side of the photo.</p>

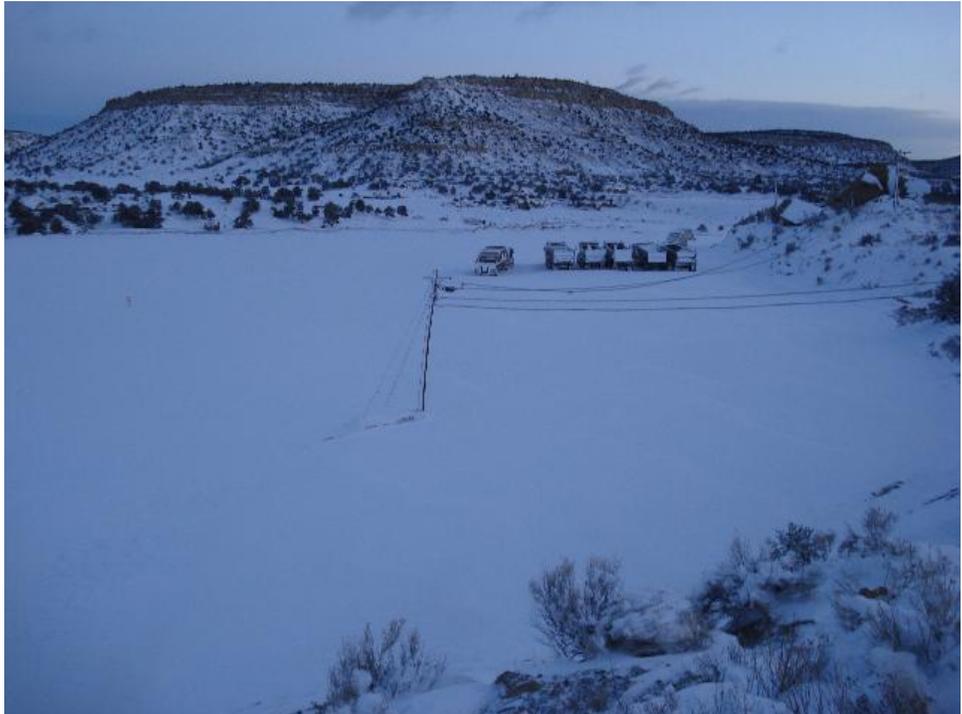
Photograph ID: 35

Date: Dec 8, 2009	
Location: NECR-1	
Direction: North	
Comments: Snow covering parked tandem trucks on the top surface of the NECR-1 pile. Construction activities suspended for the day due to unsafe conditions resulting from the snow fall.

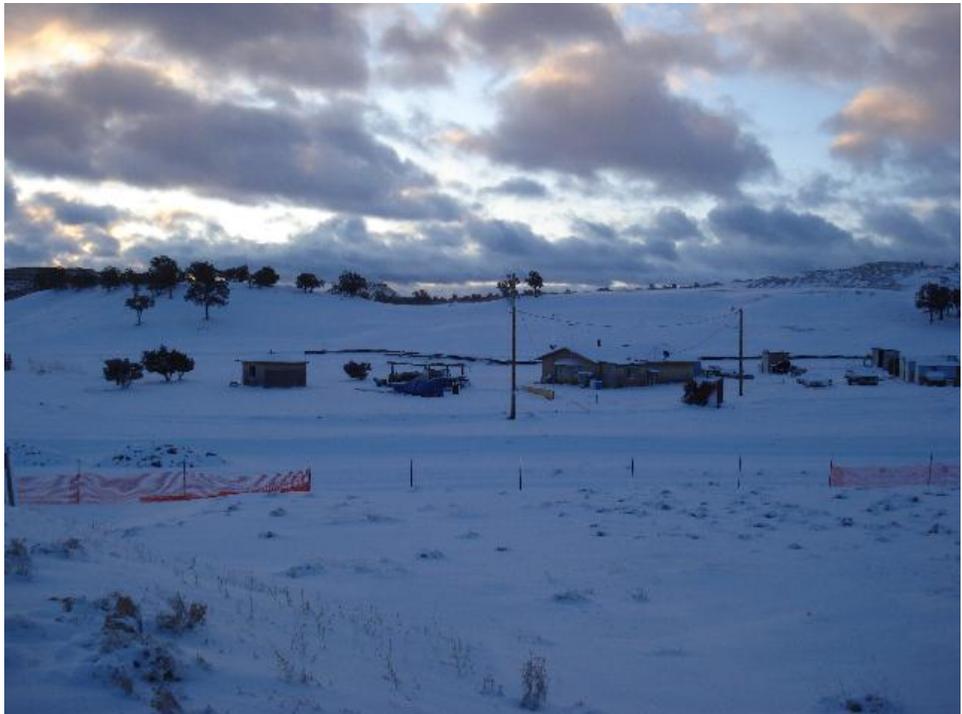
Photograph ID: 36

Date: Dec 8, 2009	
Location: Step-out Area	
Direction: East	
Comments: Snow accumulation in the step-out area near the T. Nez residence.

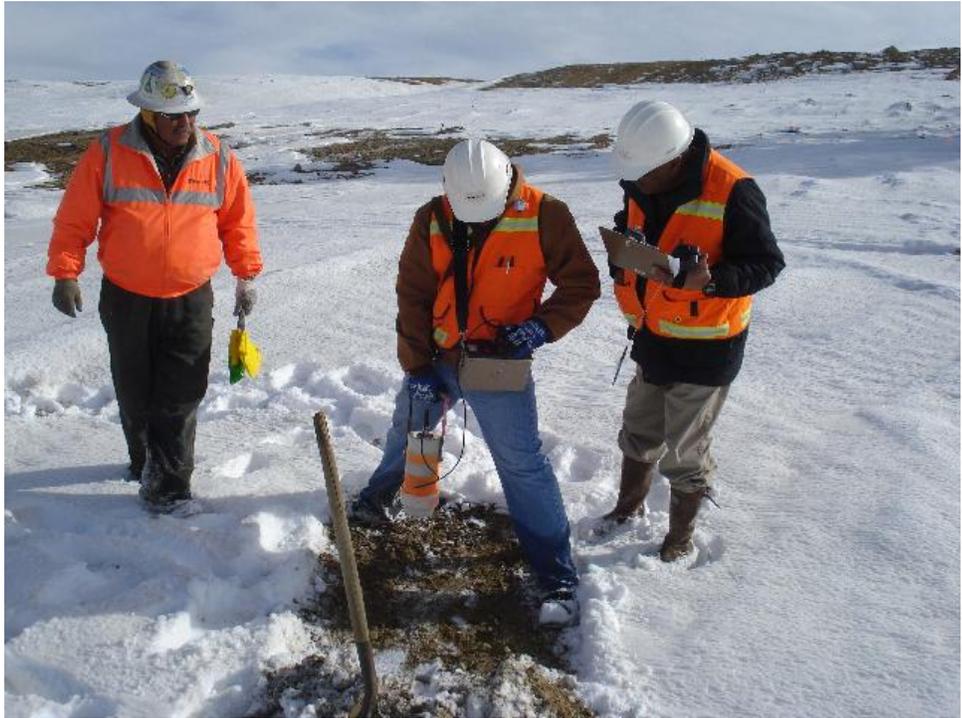
Date: Dec 13, 2009			
Location: Step-out Area			
Direction:			
Comments: IRA status survey 80 ft grid location being tested by AVM. Snow was cleared at each testing location prior to gamma count.			
Photograph ID: 38

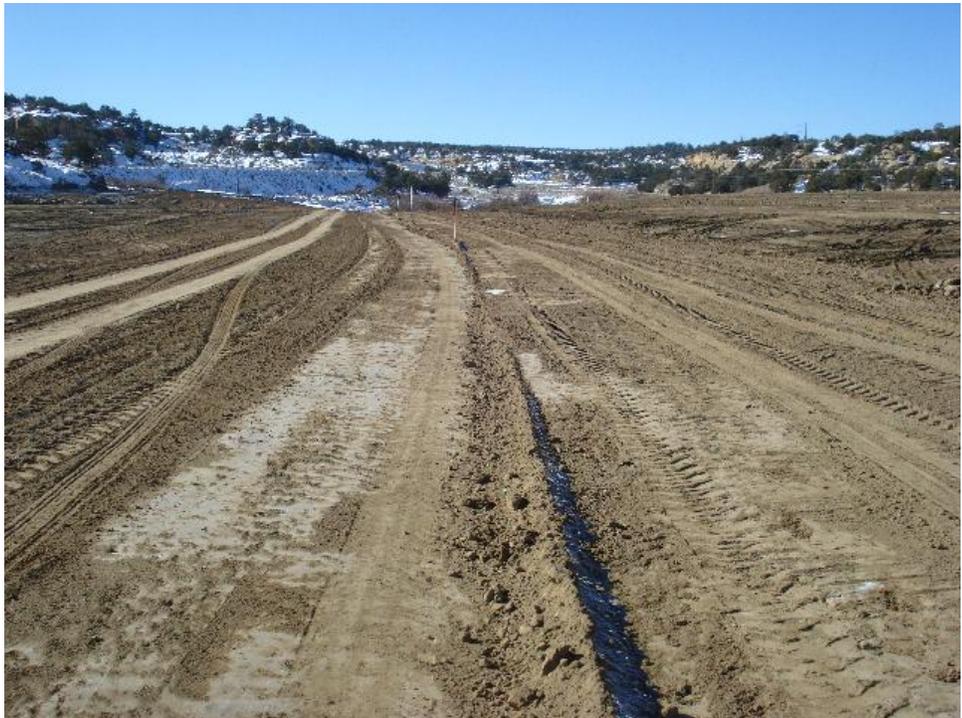
Date: Dec 17, 2009			
Location: NECR-1			
Direction: Southwest			
Comments: Grading of NECR-1 top surface.

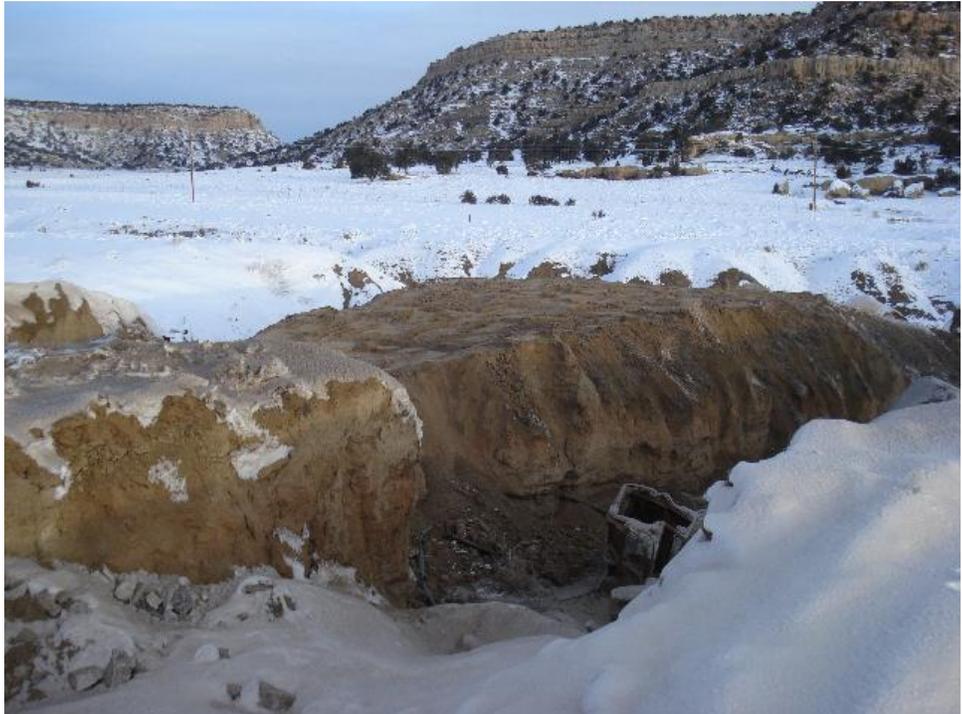
Photograph ID: 39

Date: Dec 13, 2009	
Location: Step-out Area	
Direction: Northwest	
Comments: Post removal view of small area in Zone 4 west of the unnamed arroyo north of the culvert crossing.

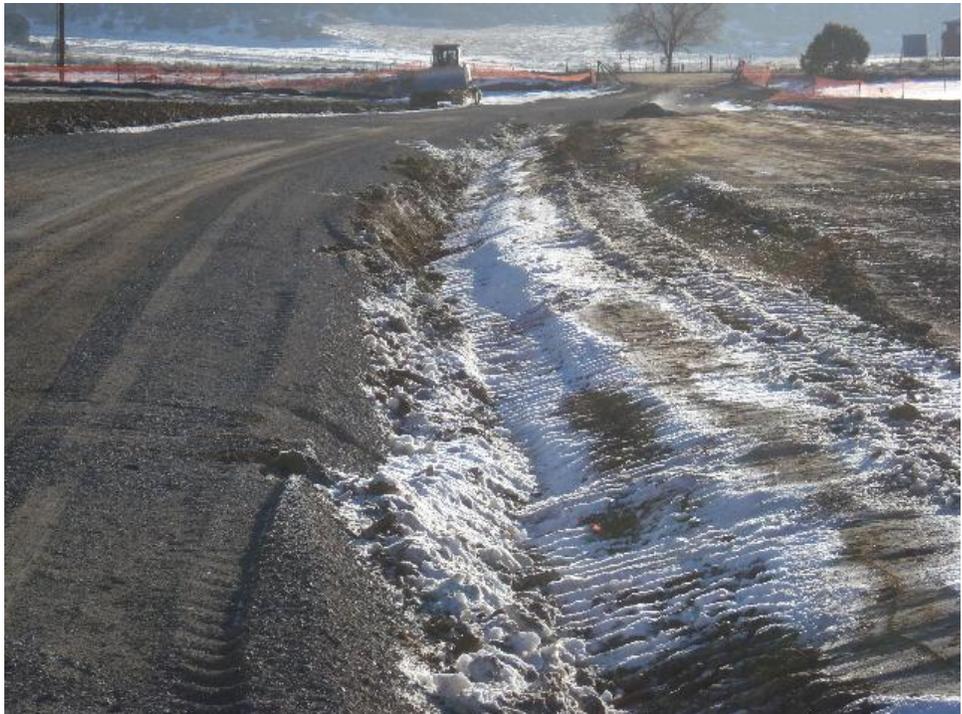
Photograph ID: 40

Date: Dec 17, 2009	
Location: Step-out Area	
Direction: East	
Comments: Unnamed road through Zone 4 before regrading of the roadway drainage swale

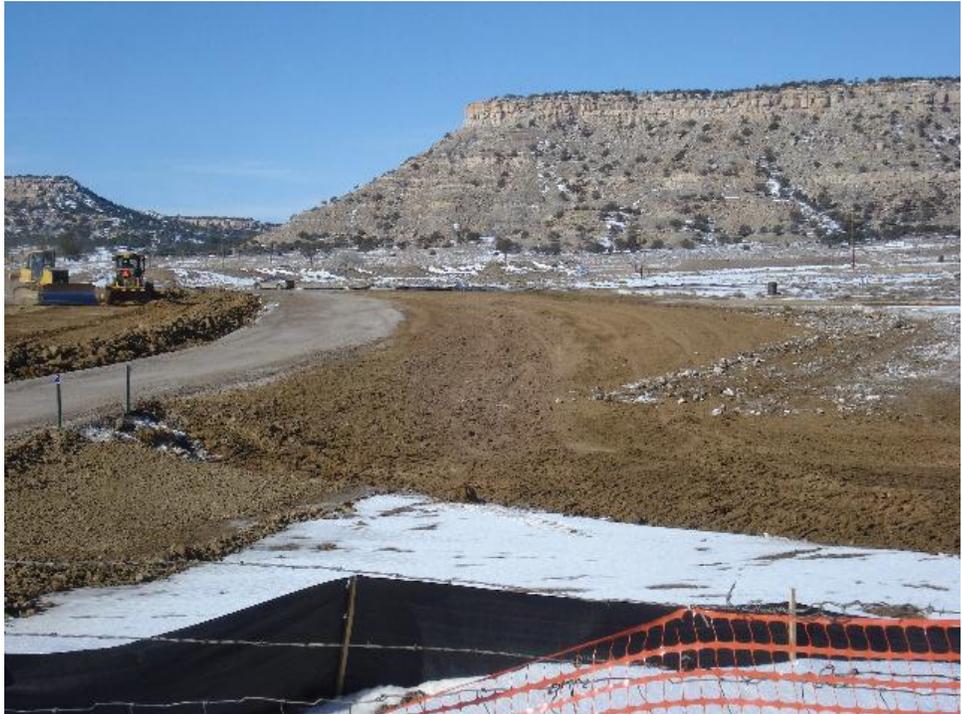
Photograph ID: 41

Date: Dec 17, 2009	
Location: Step-out Area	
Direction: East	
Comments: Unnamed road through Zone 4 after regrading of the roadway drainage swale

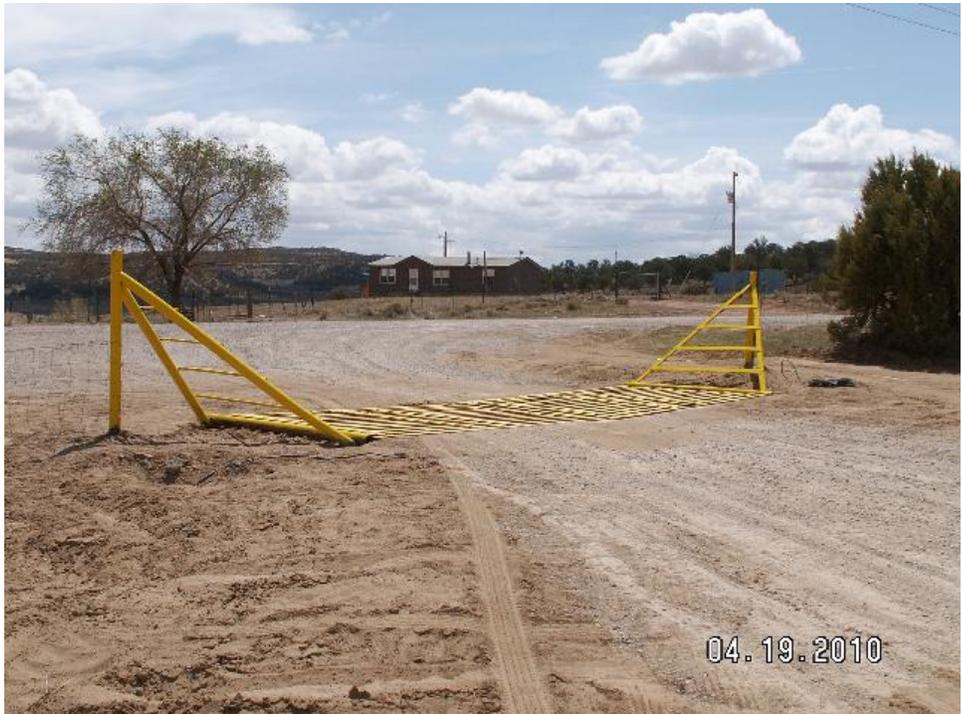
Photograph ID: 42

Date: May 3, 2010	
Location: Step-out Area	
Direction: Southeast	
Comments: Cleaned cattleguard at Red Water Pond Road

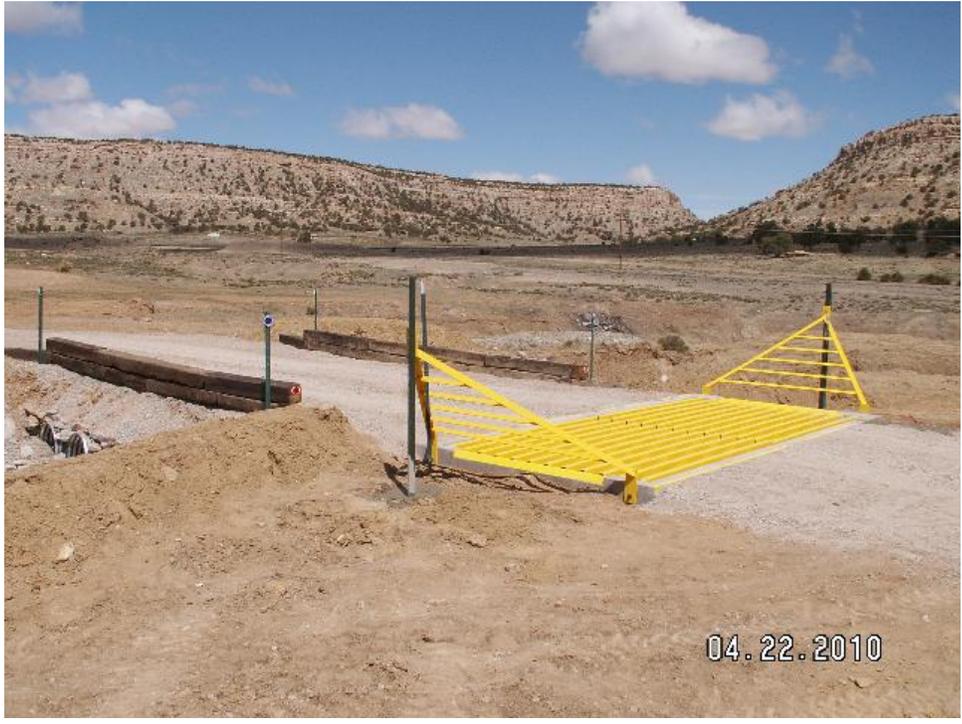
Date:	May 3, 2010		
Location:	Step-out Area		
Direction:	Northwest		
Comments:	New Cattleguard at unnamed arroyo
