Appendix G
Site Inspection Photos

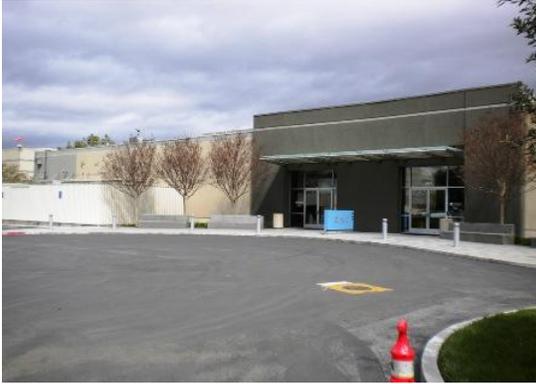
Figure 1: Applied Materials Building 1
Facing Northeast

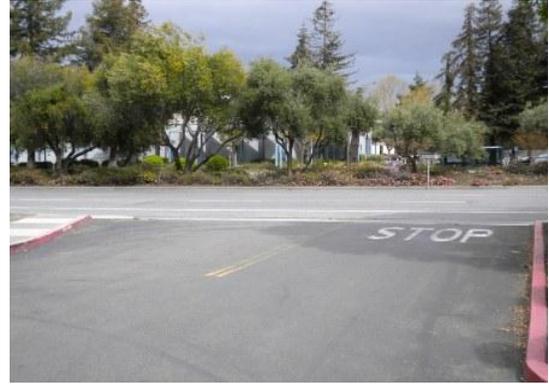
Figure 2: Adjacent Church Property
Facing East

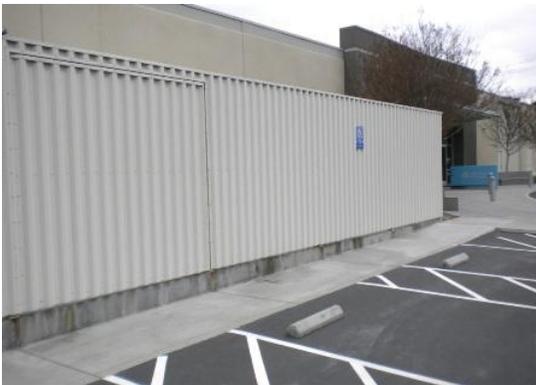
Figure 3: Former Groundwater Extraction System
Facing Southeast

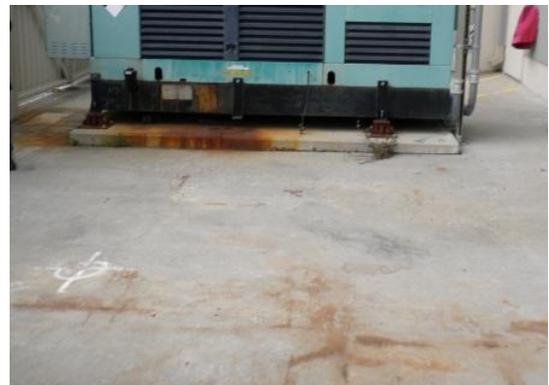
Figure 4: Former Location of Extraction System
Facing North

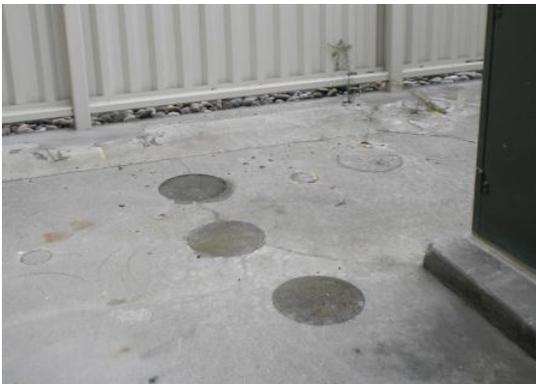
Figure 5: Former Extraction Trench
Facing South

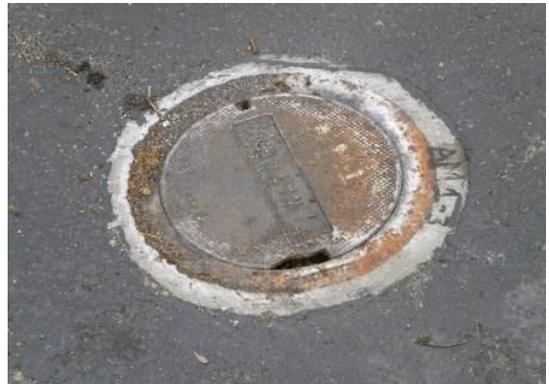
Figure 6: Monitoring Well AM1-3 w/ Damaged
Lid

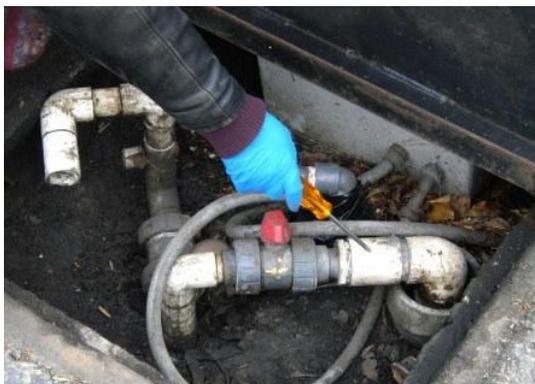
Figure 11: Former Extraction Well and Current
Monitoring Well AM1-5E
