Five-Year Review Report

Third Five-Year Review

Liquid Gold Oil Corporation Site

Richmond, California

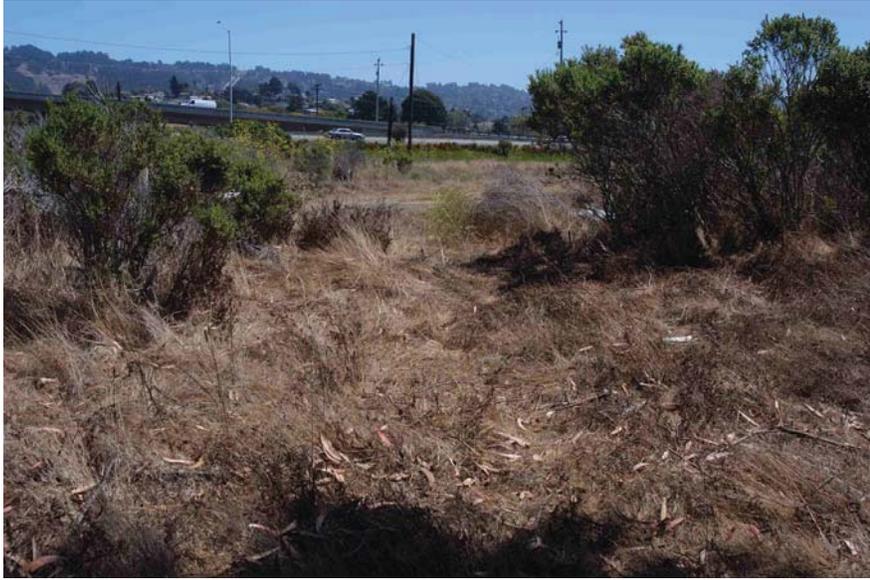
Photo 1: Tire tracks north of landfill cap

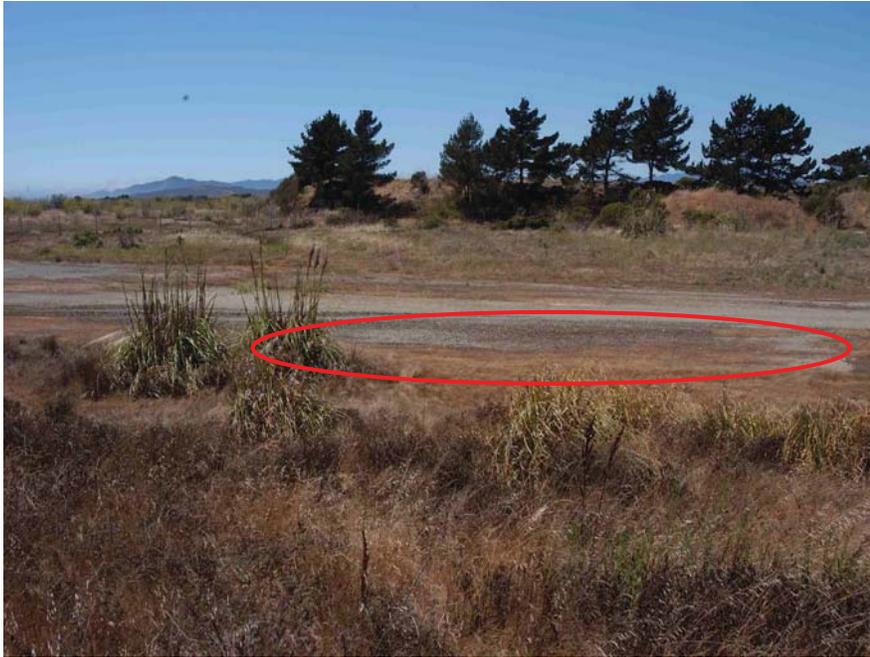
Photo 2: Low spot area west of landfill cap

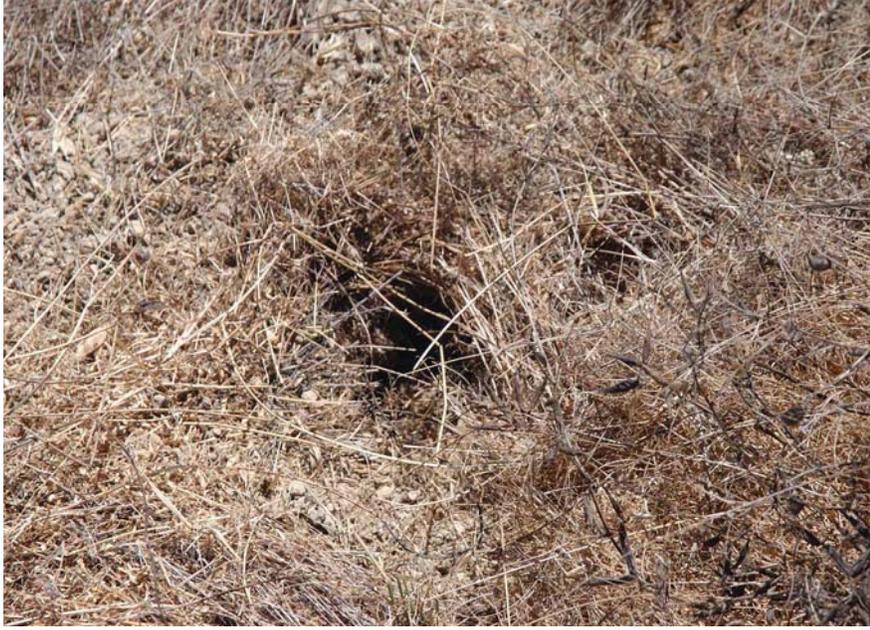
Potential rodent holes (Photo 3) were observed in areas along the east perimeter of the landfill cap boundary area.

Photo 3: Potential rodent hole along perimeter fence.

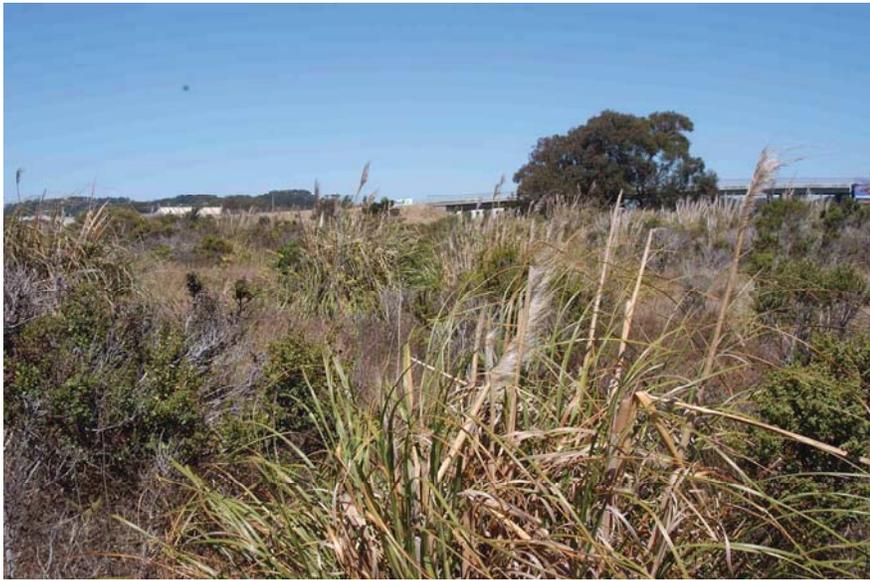
Well established vegetation (Photo 4), including tall bushes and pompous grass was observed on and around the landfill cap during the site inspection. The vegetation does not show visual indications of plant deterioration (wilted or change in color).

Photo 4: Typical Vegetation

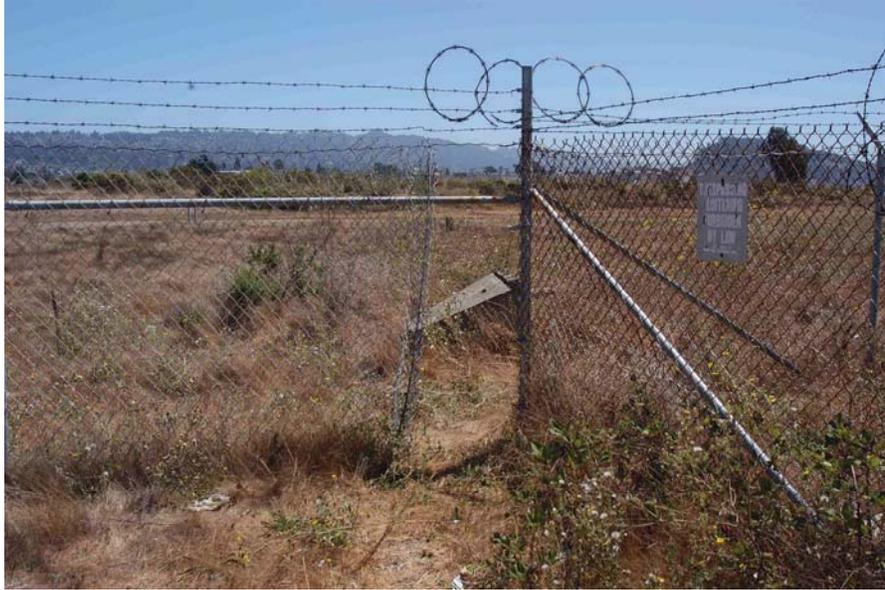
Several broken sections of the Site fence, which encircles the landfill cap boundary and surrounding area, were observed during the site inspection. Approximately 2-3 linear feet of the fence facing the access road which leads to the Site from S 51st street is broken (Photo 5). Approximately 5 to 6 linear feet of the fence on the east side of the property adjacent to Interstate 580 are also damaged (Photo 6). New fencing installed in 2007 along the southeast side of the Site is 6 to 12 inches higher than ground level (Photo 7).

Photo 5: Broken fence facing access road on west side of the site

CH2M HILL recommends that the openings in the fence be repaired. The repairs will be completed in 2008.

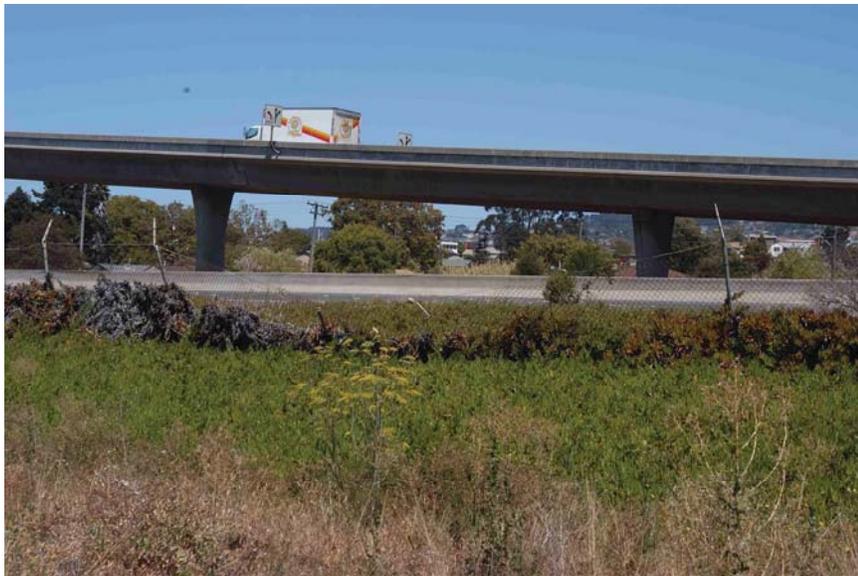
Photo 6: Broken fence on north east side of the property facing Highway 580

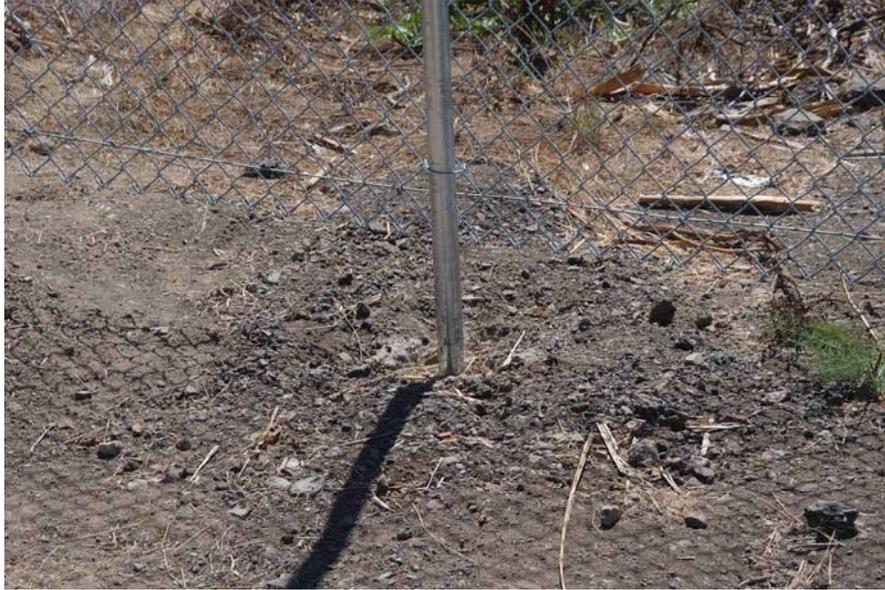
Photo 7: Opening on bottom of new fence

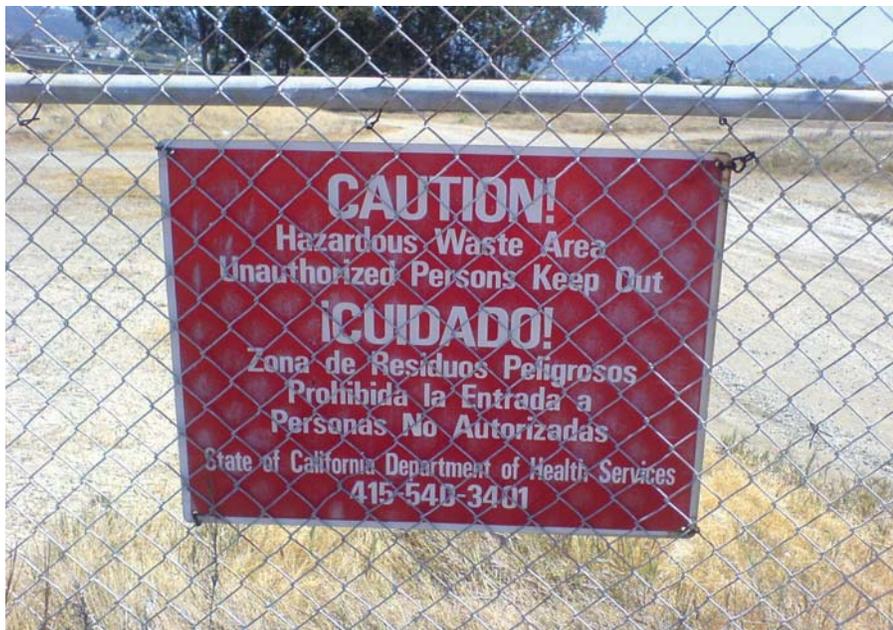
The fence gates are locked and the chains and locks are in good condition. The fence posts are also in good condition. Perimeter signs (Photo 8) were observed on the fence around the Site except for the northeast side of the Site adjacent to Highway 580.

Photo 8: Sign on Fence

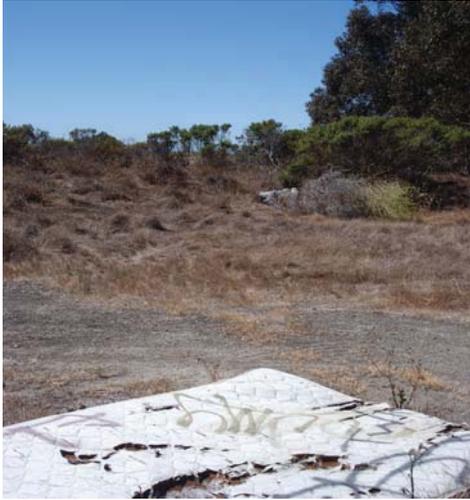
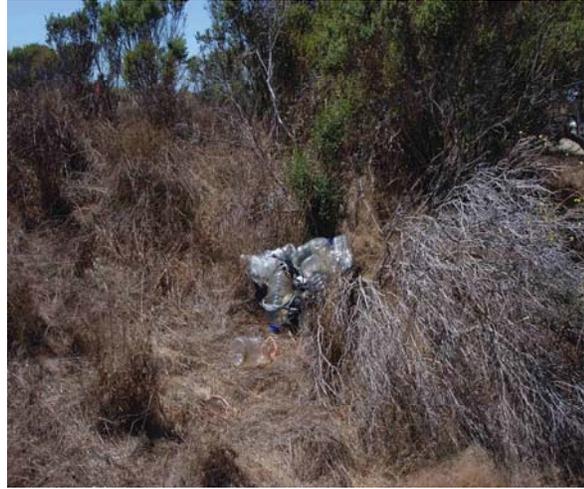
Trash (Photo 9 and 10) was observed on the north side of the landfill cap boundary area.

Photos 9 and 10 (left to right): Trash located near north side of Landfill Cap boundary

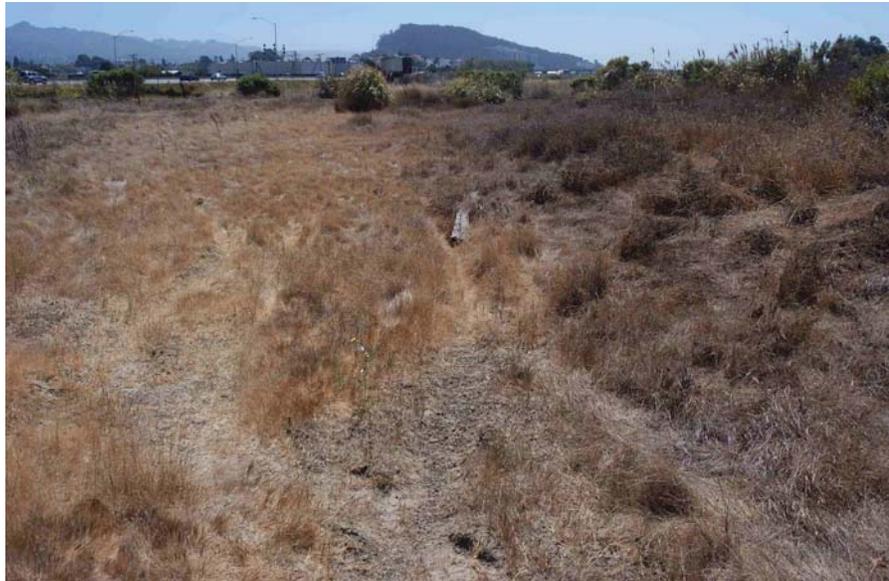
Photo 11: Tire tracks northeast of the landfill cap

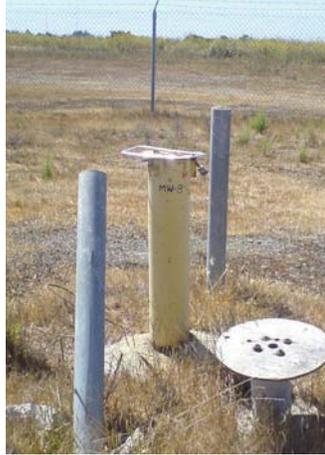
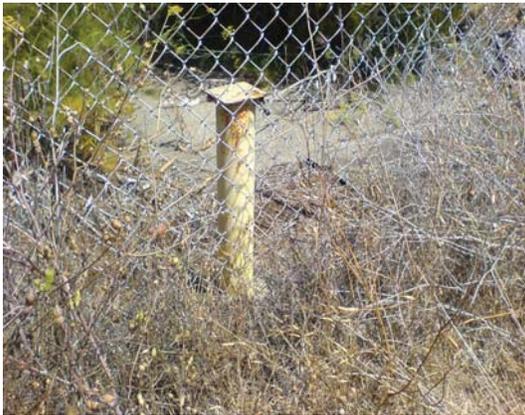
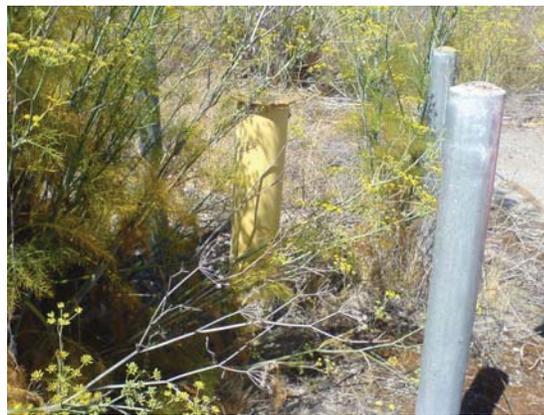
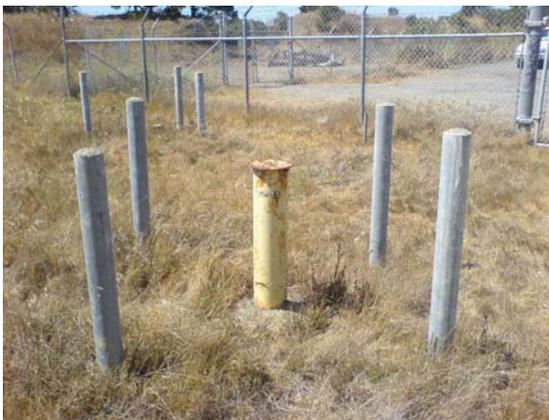
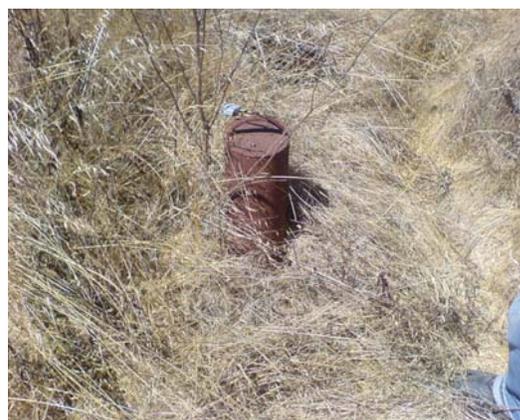
Site monitoring wells (Photos 12-16) were also visually inspected for damage during this site inspection. The locations of the monitoring wells are shown on Figure 2 of main text. No damage was noted and all wells were secured with locks. Three monitoring wells (MW-8, MW-12R, and MW-13) have identification marks. The other wells were located with well

Photo 13, 14, 15, and 16 (clockwise): Monitoring Wells (Not photograph of Monitoring Well - 7)

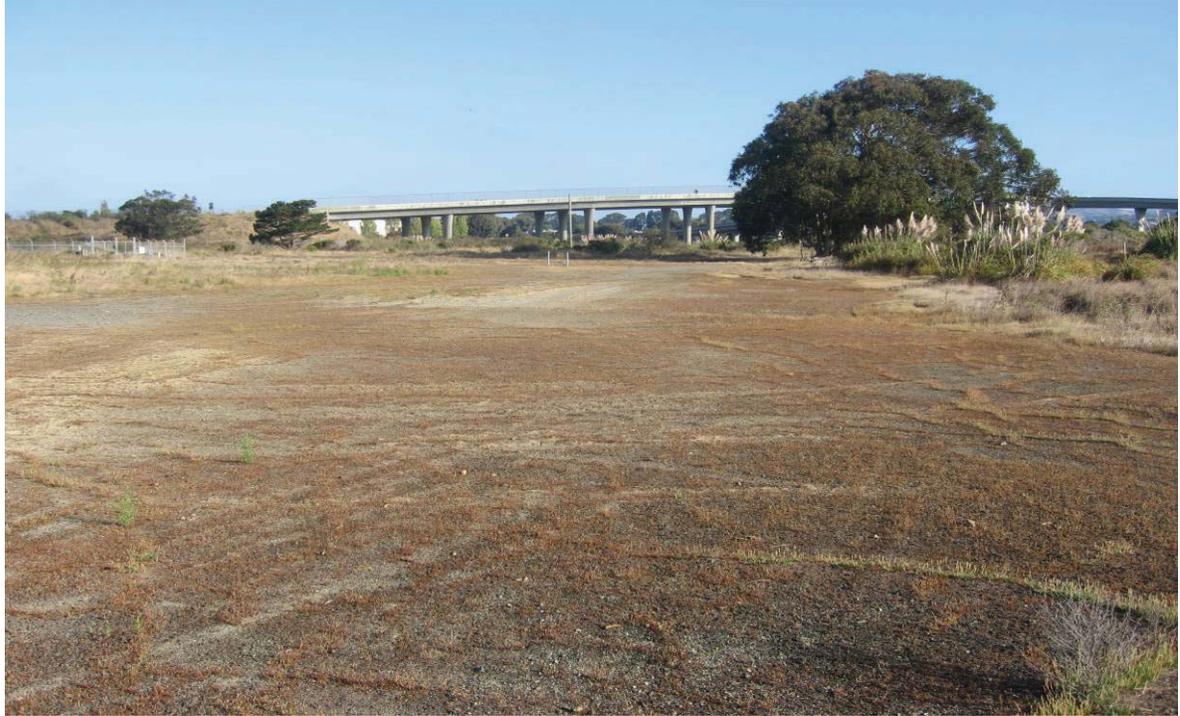
No indication of erosion of the landfill cap was observed. A low spot (Photo 1) was observed on the west side of the landfill cap.

Photo 1: Low spot area west of landfill cap (looking north)

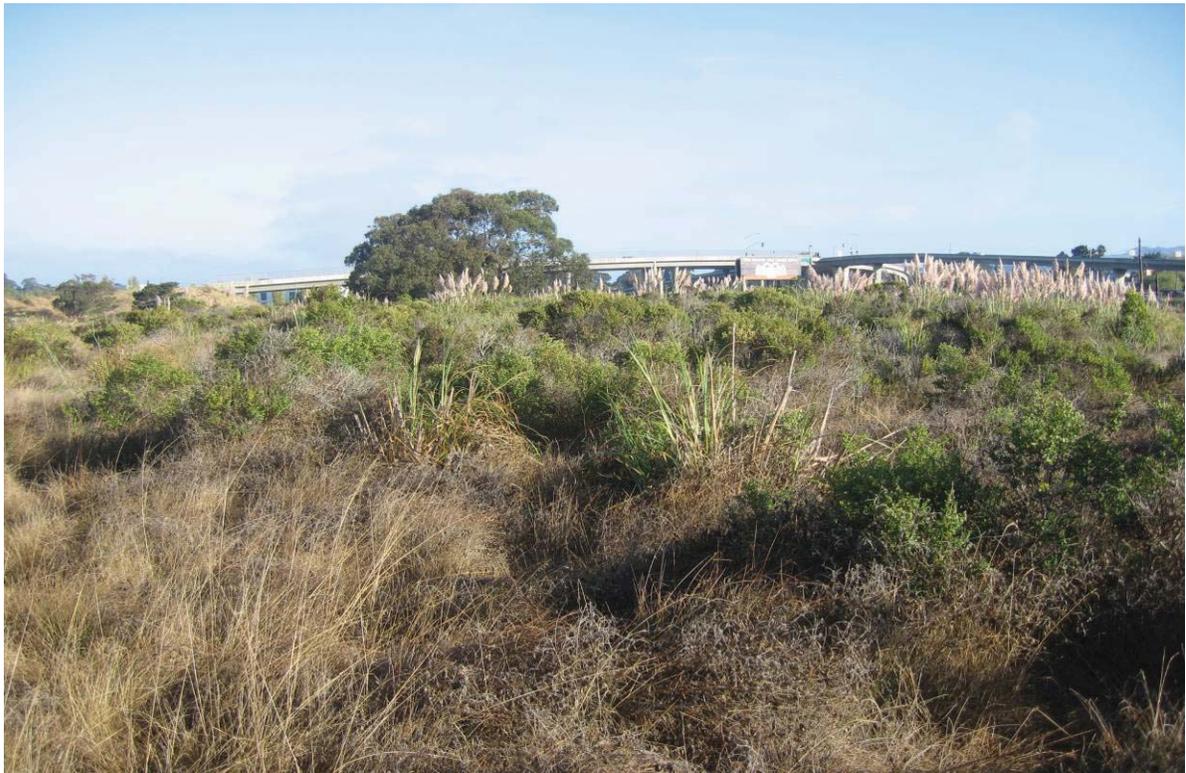
Well-established vegetation (Photo 2), including tall bushes and pampas grass, was observed on and around the landfill cap during the site inspection. The vegetation does not show visual indications of plant deterioration (no observed wilting or changes in color).

Photo 2: Typical Vegetation (looking north)

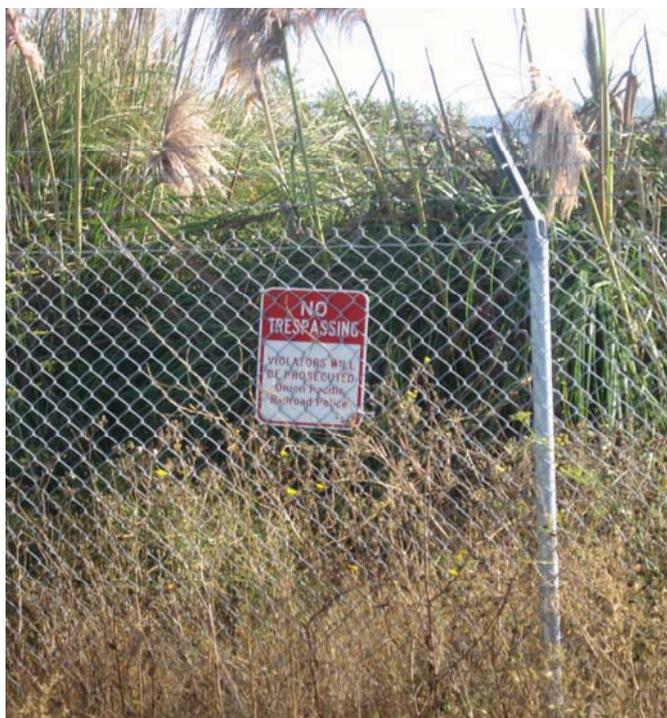
The fence gates are locked and the chains and locks are in good condition. The fence posts are also in good condition. Perimeter signs (Photo 3) were observed on the fence around the site.

Photo 3: Sign on perimeter fence

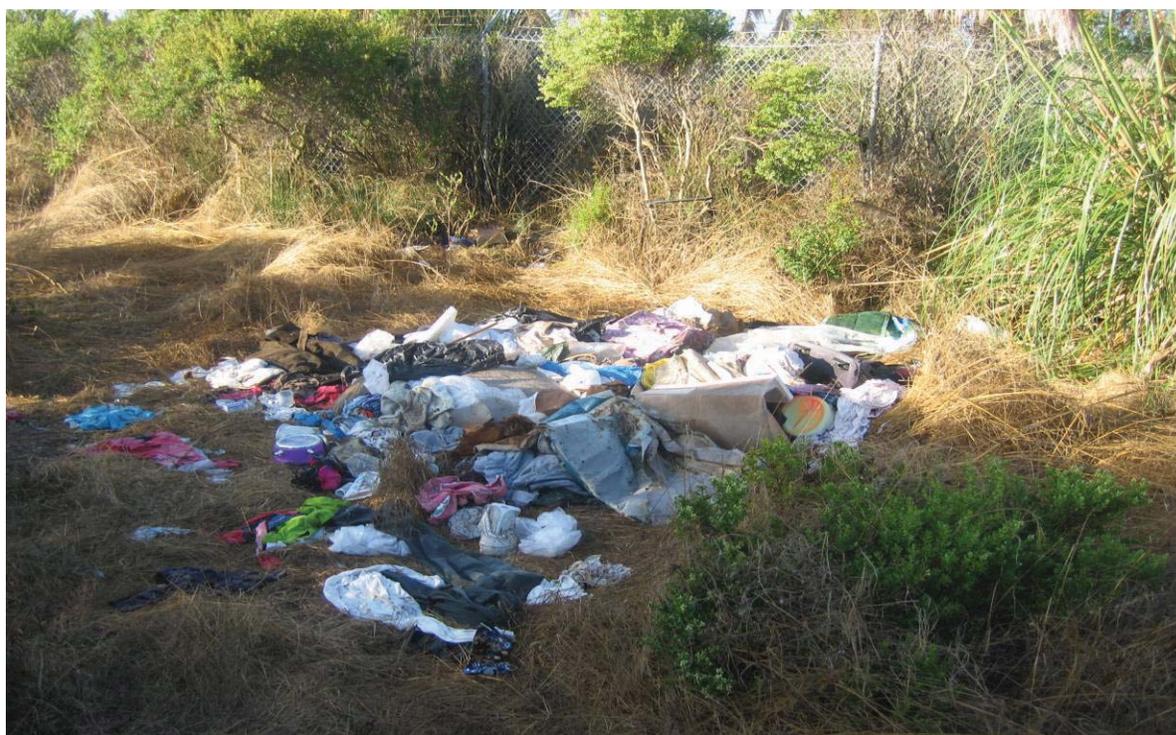
Trash (Photo 4) was observed near the east side of the landfill cap boundary area.

Photo 4: Trash located within east side of Landfill Cap boundary

CH2M HILL recommends removing the trash from the surface of the landfill cap and repairing the broken bollard at monitoring well MW-8. Although the site is secured with a permanent fenced that remains locked, CH2M HILL recommends that locks be placed on the four monitoring wells that currently are not secured with locks.
