Attachment E

Site Photographs

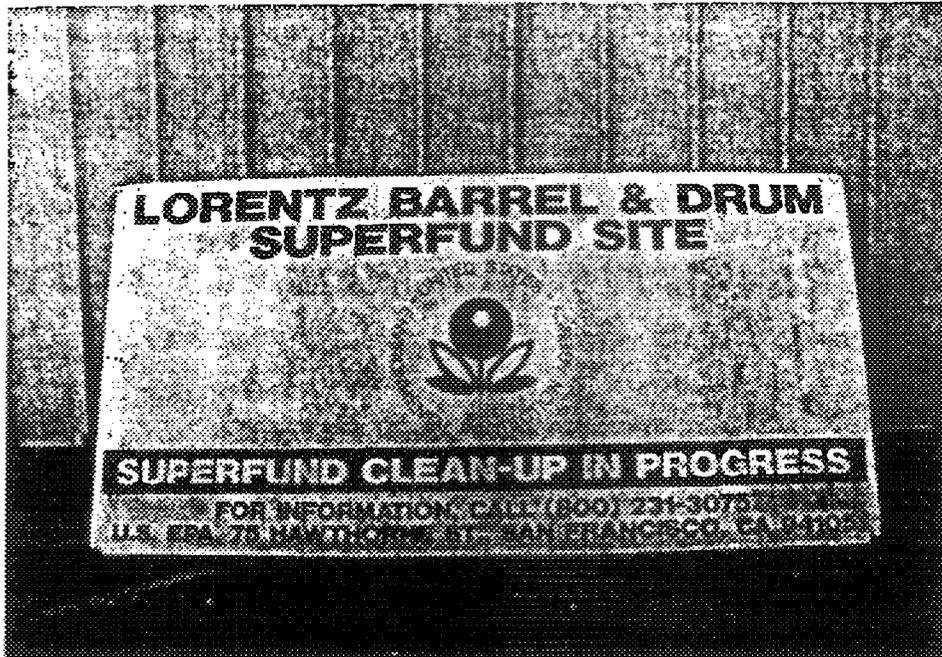
1. Project Sign leaning Against Northwest Side of Building

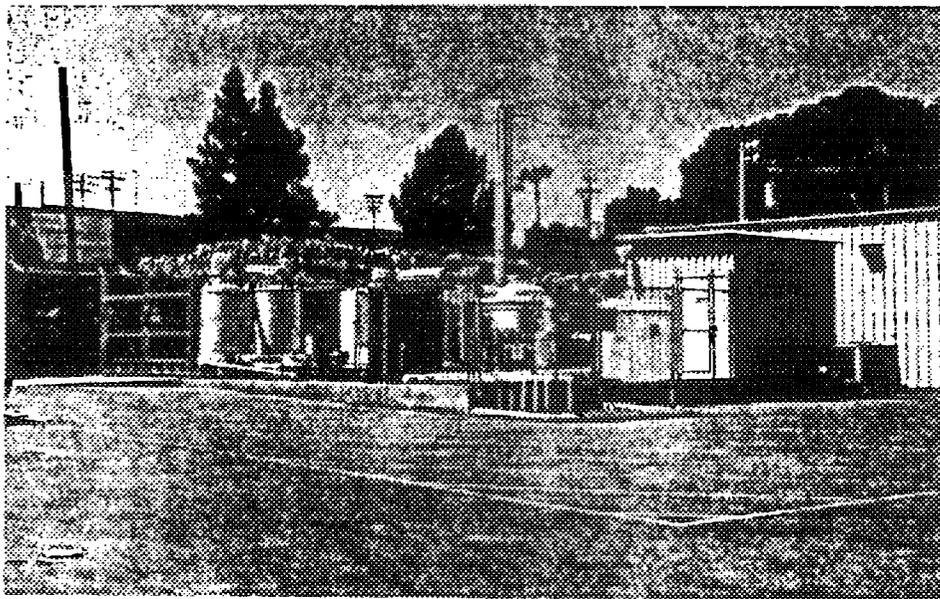
2. View of OU2 Treatment Facility in Foreground with the South Wall of the OU2 Treatment Facility in the Background. Also in Background is the RFI Facility

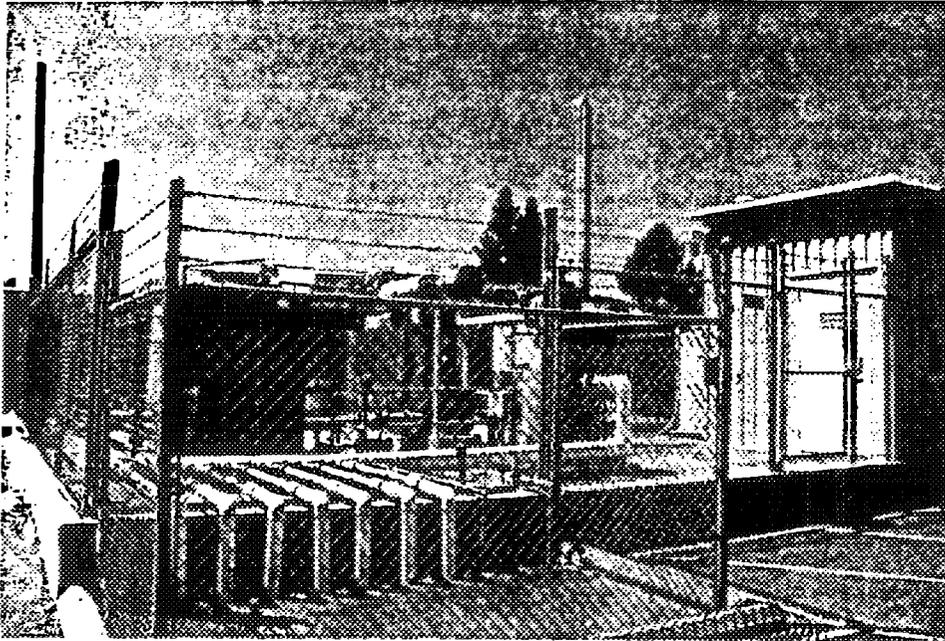
3. View of Individual Pipelines from the OUI SVE Wells

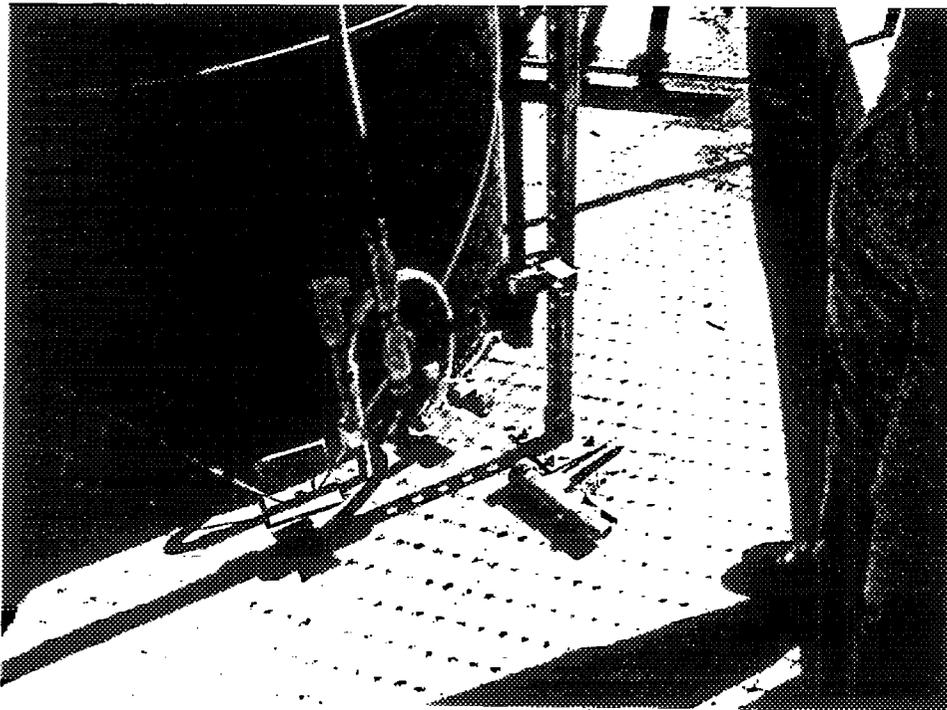
4. Damaged Piping at OUI Condensate Holding Tank

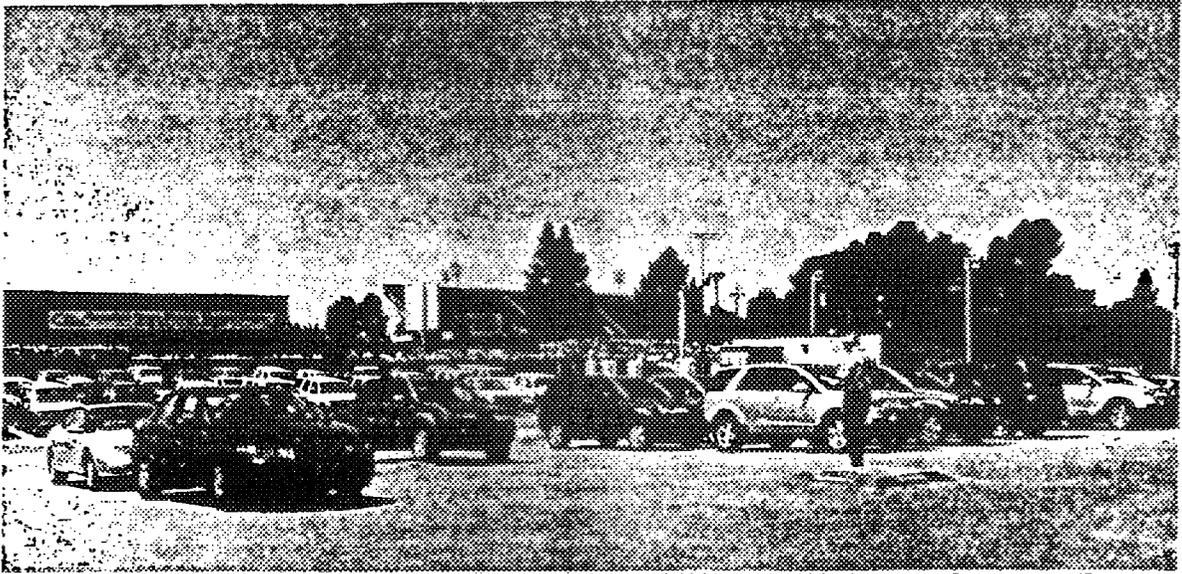
5. Treatment Facilities as well as Recycled Fibers Inc, in Background

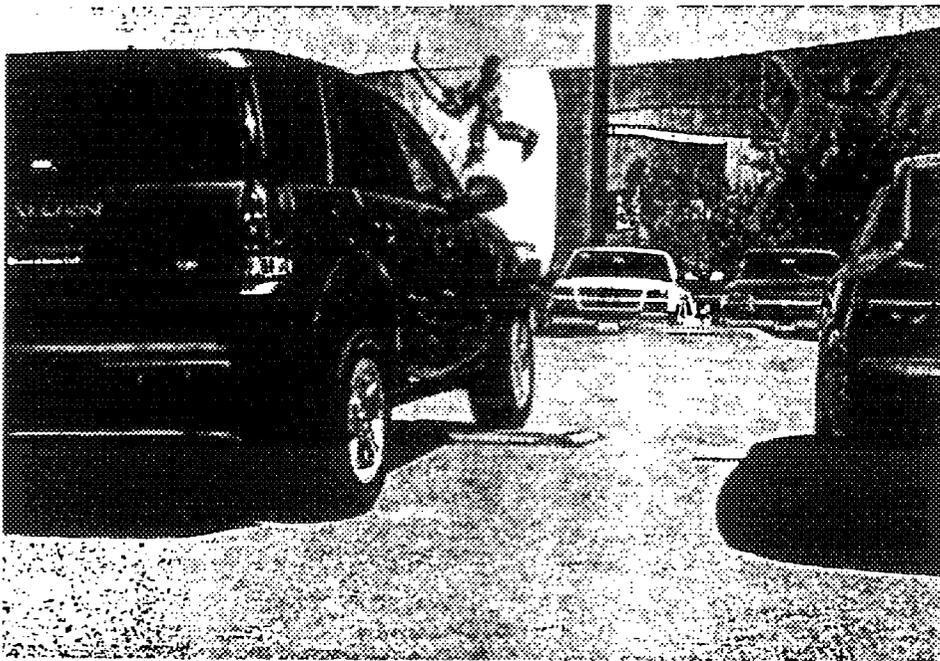
6. Cars Parking on Vault Covers
Crown on Landfill Evident, Ice Rink in Background

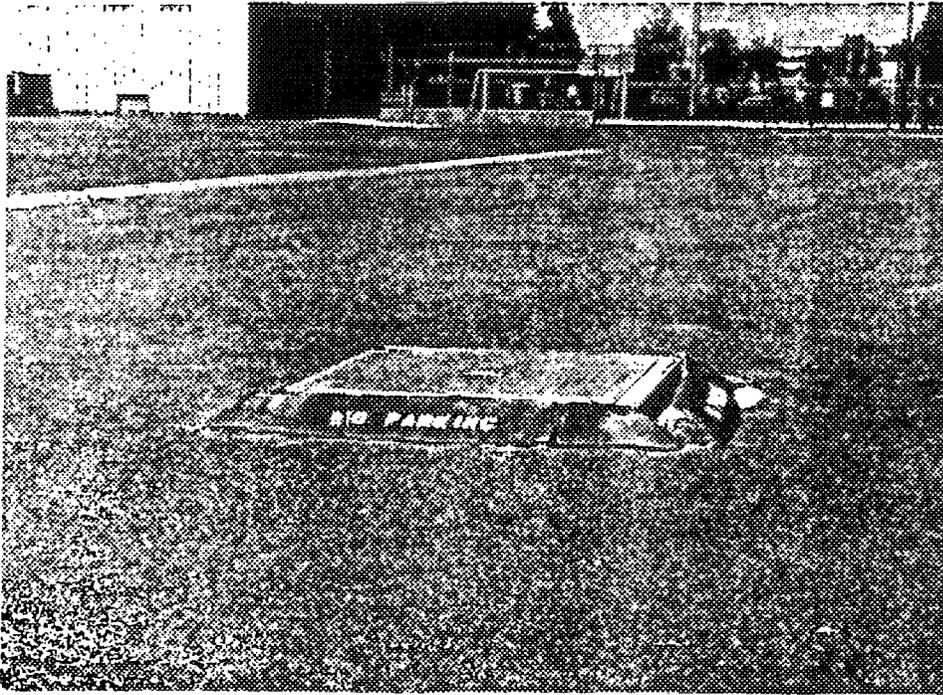
7. Damaged Curbing Surrounding SVE Vault Well No. 4
OU2 Treatment Building and Site Fencing in Background

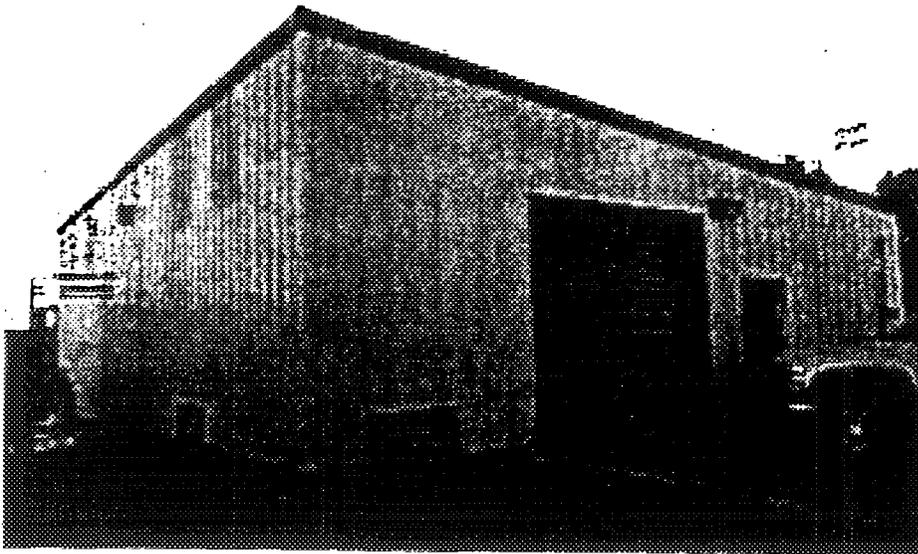
8. OU2 Treatment Building

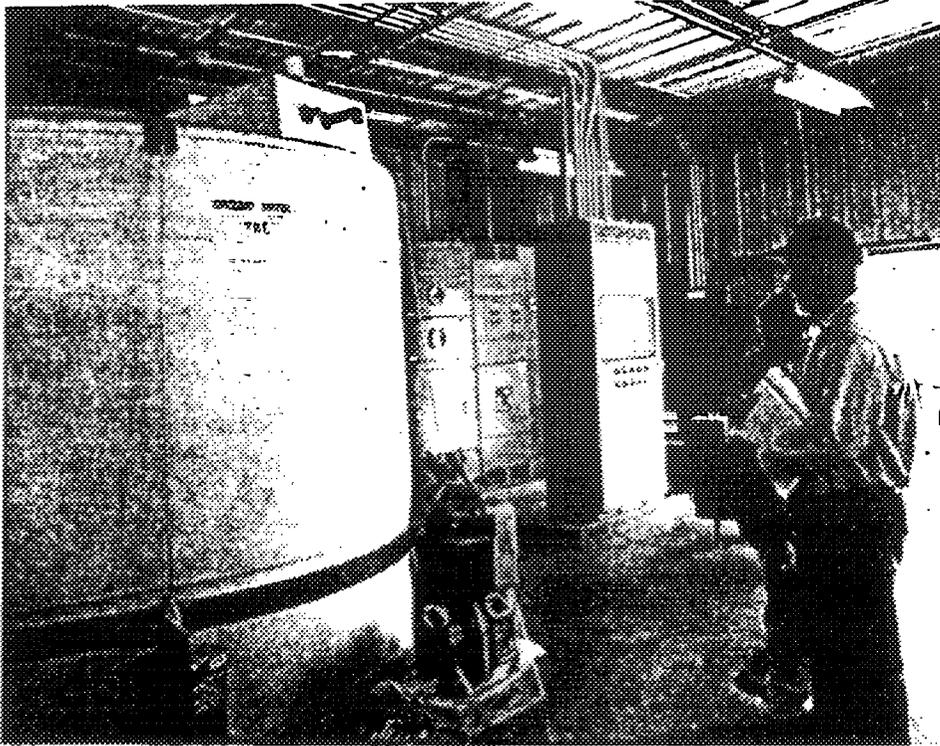
9. Influent Equalization Tank, Motor Control Center in Background along with UV/OX Control Panel (PeroPure)

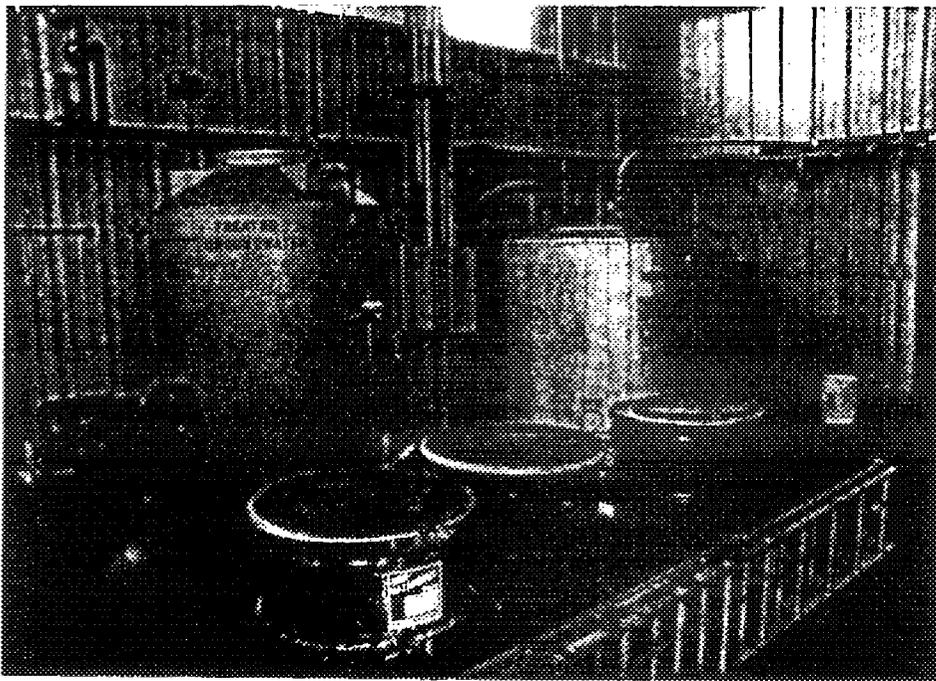
10. GAC Units in the OU2 Groundwater Treatment Plant

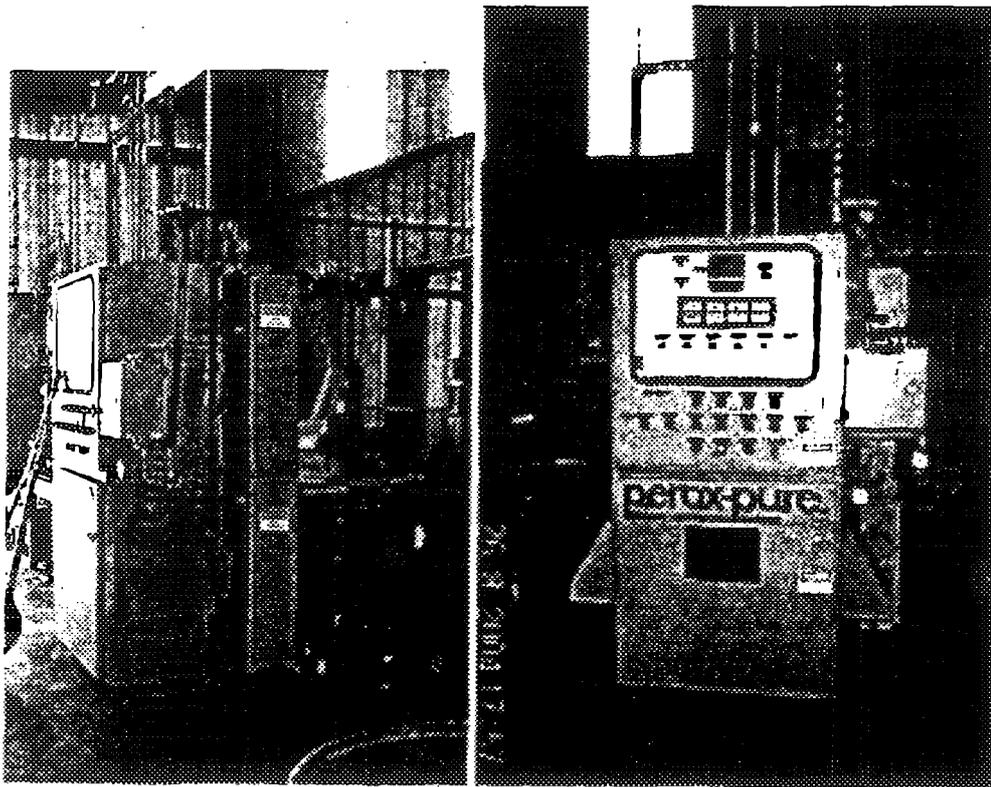
11. UV/Oxidation System (no Longer use in the OU2 Treatment Train)

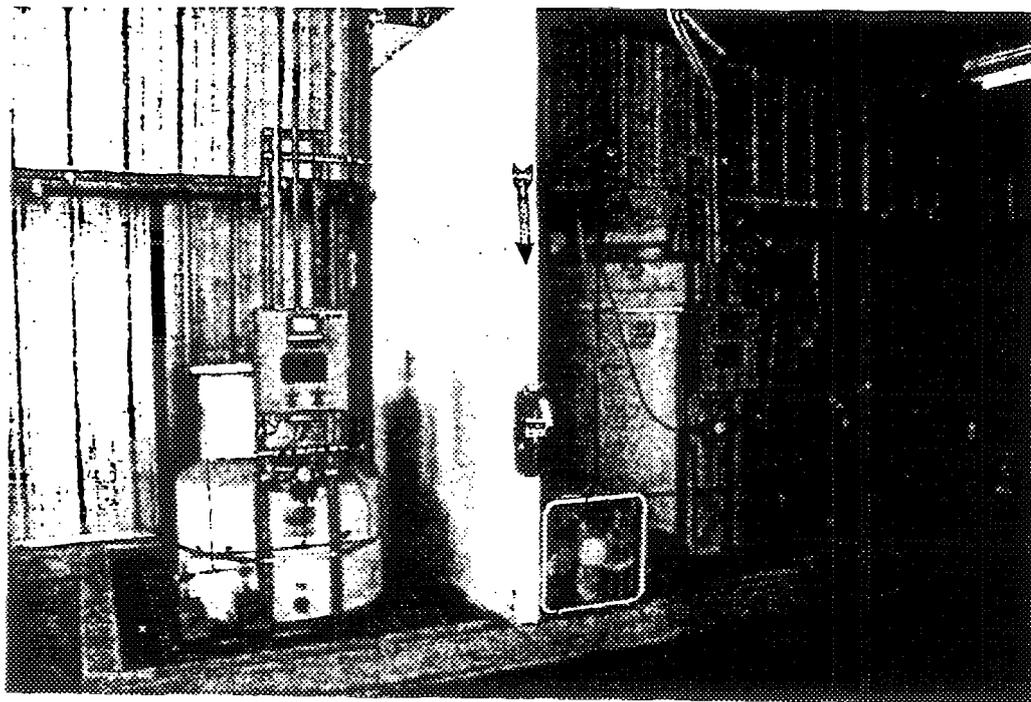
12. Caustic and Acid Storage for UV/Oxidation System
