Final
Five-Year Review Report
for
Phoenix-Goodyear Airport (North and South Areas)
Superfund Site
Goodyear, Arizona

September 2010

Prepared By:
U.S. Environmental Protection Agency
Region IX
75 Hawthorne Street
San Francisco, California 94105

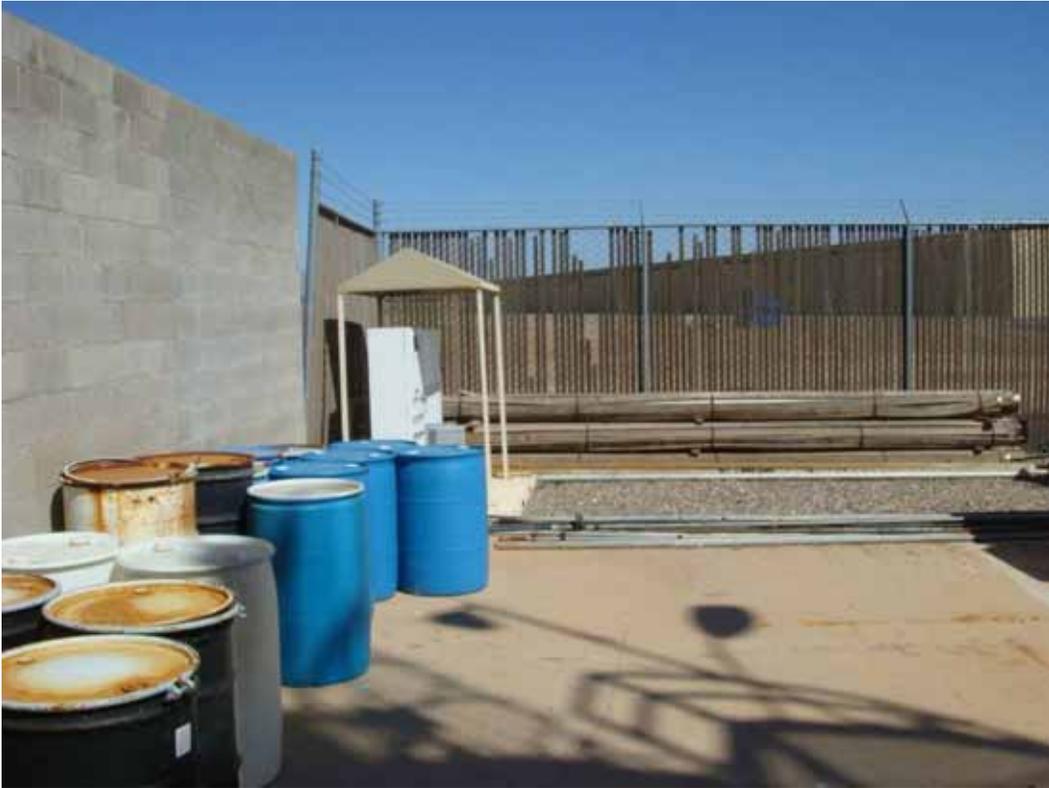
Photo 10. PGAS Site Visit. Subunit A treatment compound showing unmarked drums, some of which contain material.

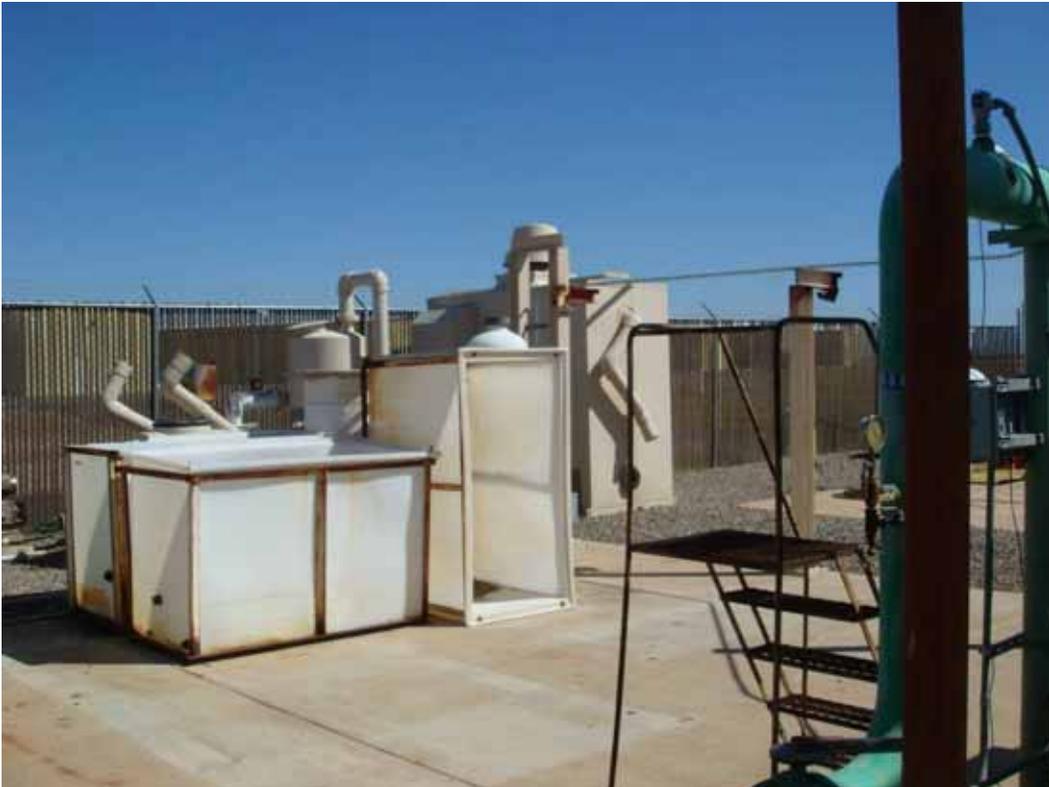
Photo 11. PGAS Site Visit. Subunit A treatment compound showing decommissioned equipment.

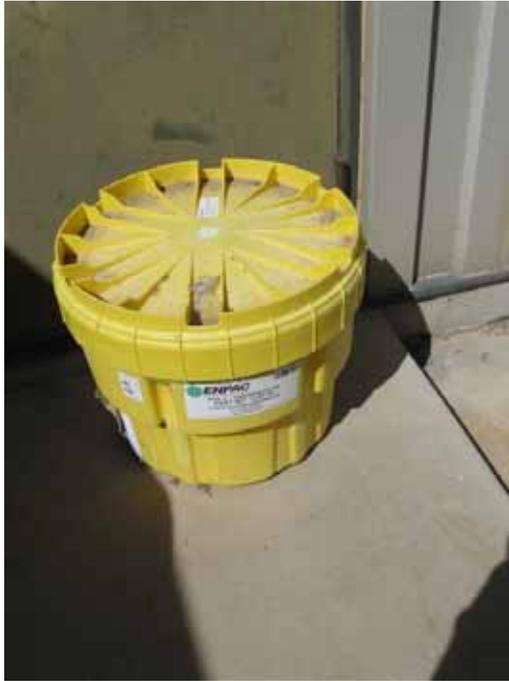
Photo 24. PGAS Site Visit. Unlabelled container.

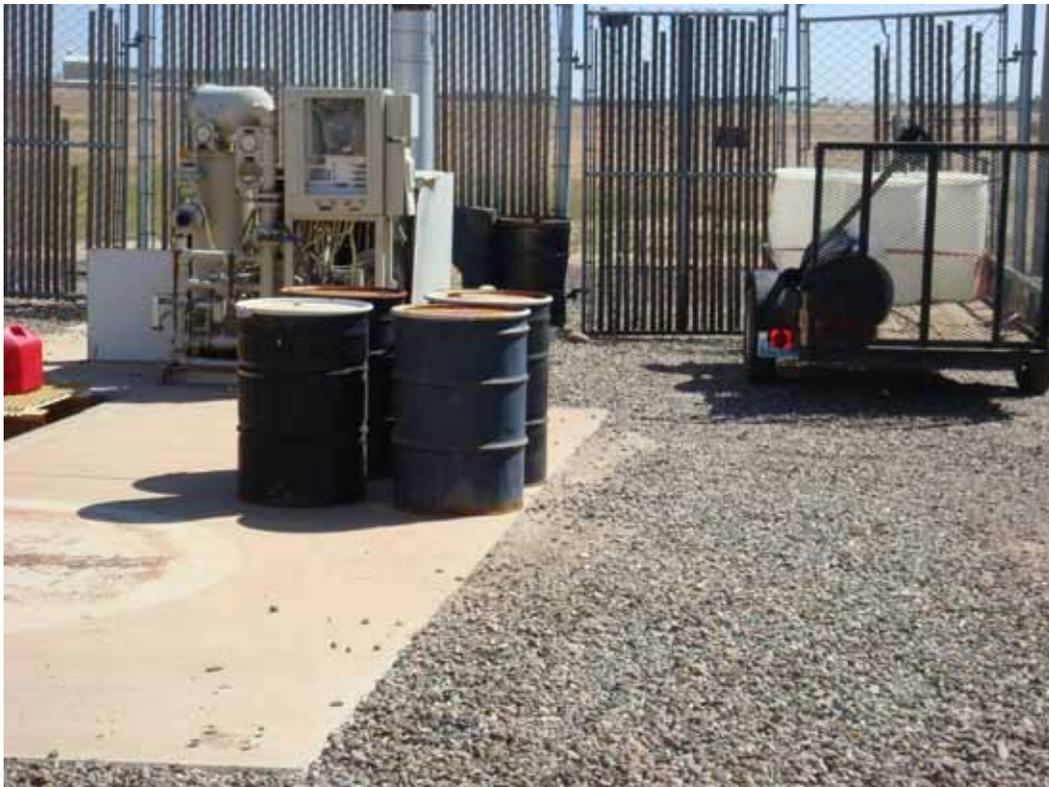
Photo 27. PGAS Site Visit. Subunit A treatment compound showing unmarked drums and decommissioned SVE system.
