**FOURTH FIVE-YEAR REVIEW REPORT FOR
HEWLETT-PACKARD (620-640 PAGE MILL ROAD) SUPERFUND SITE
PALO ALTO, SANTA CLARA COUNTY, CALIFORNIA**

U.S. Army Corps of Engineers, Seattle District

Executive Summary

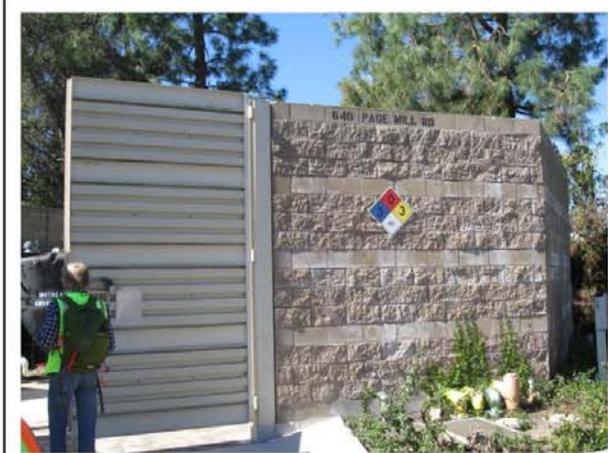
Groundwater Treatment Plant Facility (GWTP)

The updated groundwater treatment system at the Site that came online in January 2014 was in good condition. The site visit team observed the holding tank for untreated groundwater, the hydrogen peroxide and ozone treatment, and the GAC polishing. The site visit team also observed the extraction wells TW-1 and TW-2 as well as monitoring wells P1-A1 and P1-A2. All wells were in good working order with proper caps and locks in place.

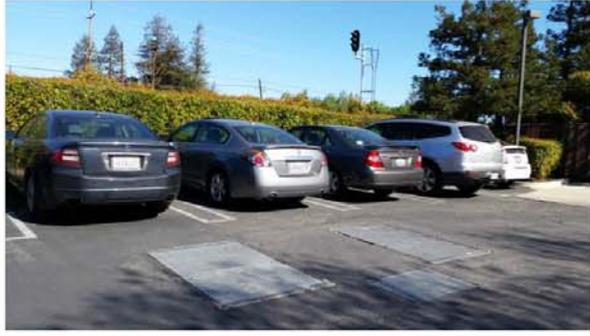
HP and Varian conducted a trial shutdown of wells EW-15 and EW-16, the purpose of which was to determine if groundwater in this area would be captured by the OEU dewatering system (Stantec, 2014c). The results indicate that the OEU dewatering system will capture the groundwater in the area and it was, therefore, recommended that EW-15 and EW-16 remain shut down.

Out-of-service extraction wells EW15 and EW 16 near 395 PMR

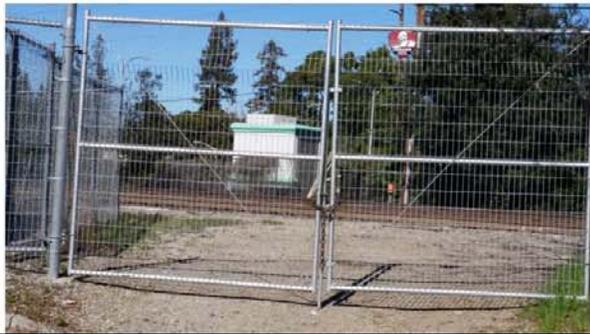
O.E.U. Pump House (air stripper not visible)
