**FIVE-YEAR REVIEW REPORT FOR  
MOUNTAIN VIEW MOBILE HOME ESTATES  
SUPERFUND SITE  
GILA COUNTY, ARIZONA**

Prepared by

United States Corps of Engineers, Seattle District

U.S. Environmental Protection Agency

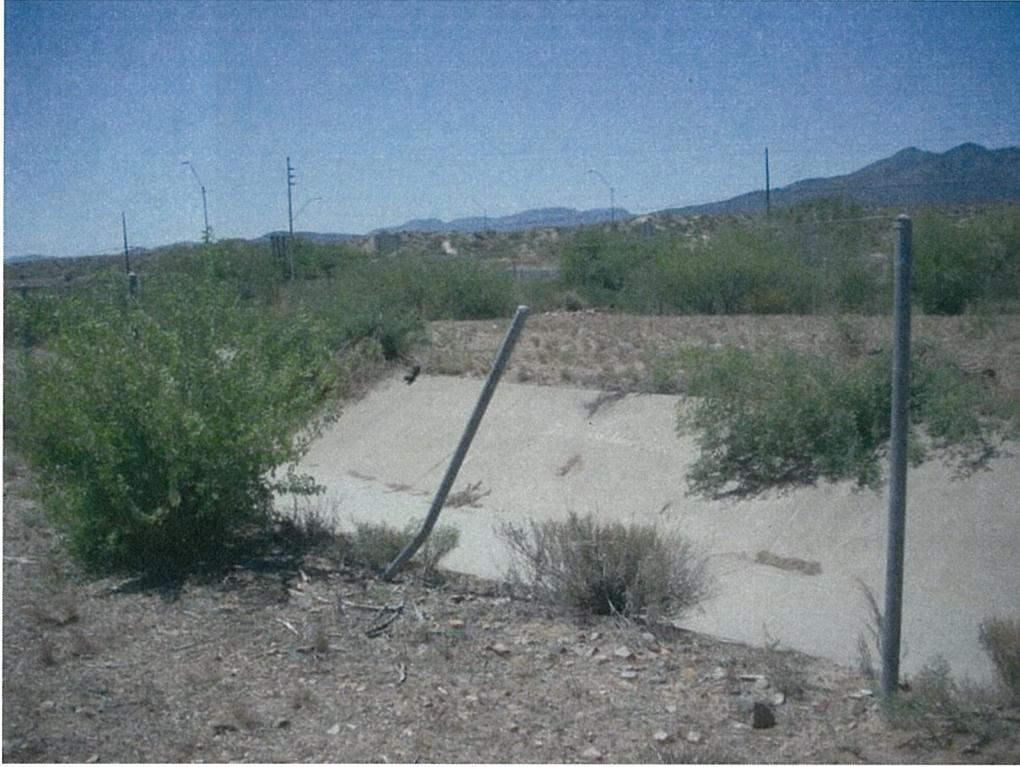
Figure A-1 - Fencing that was missing on site

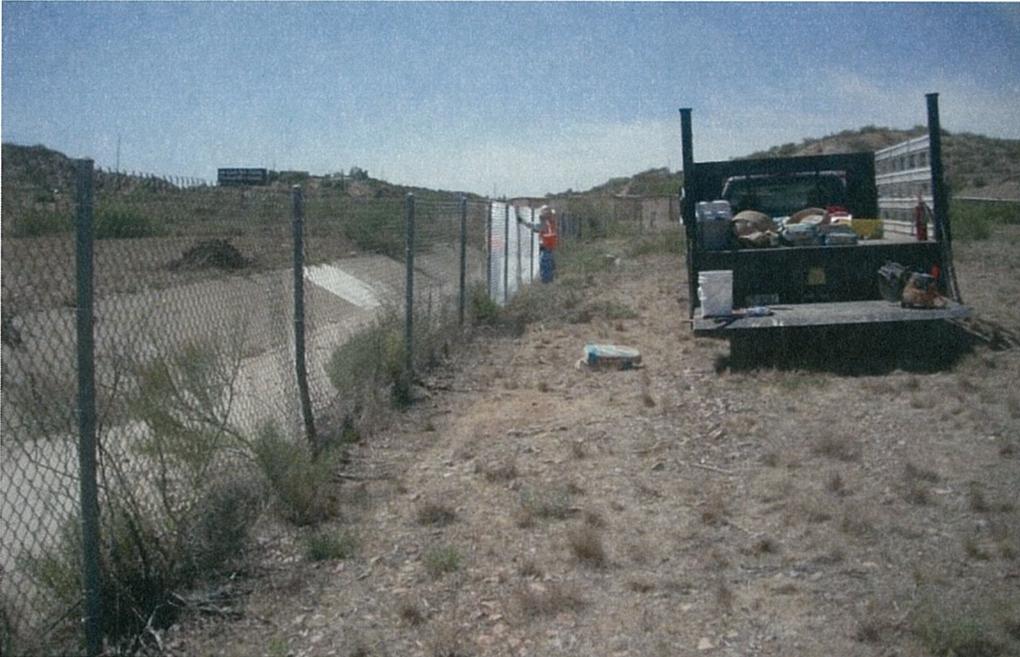
Figure A-2 - Fencing added where damaged or removed

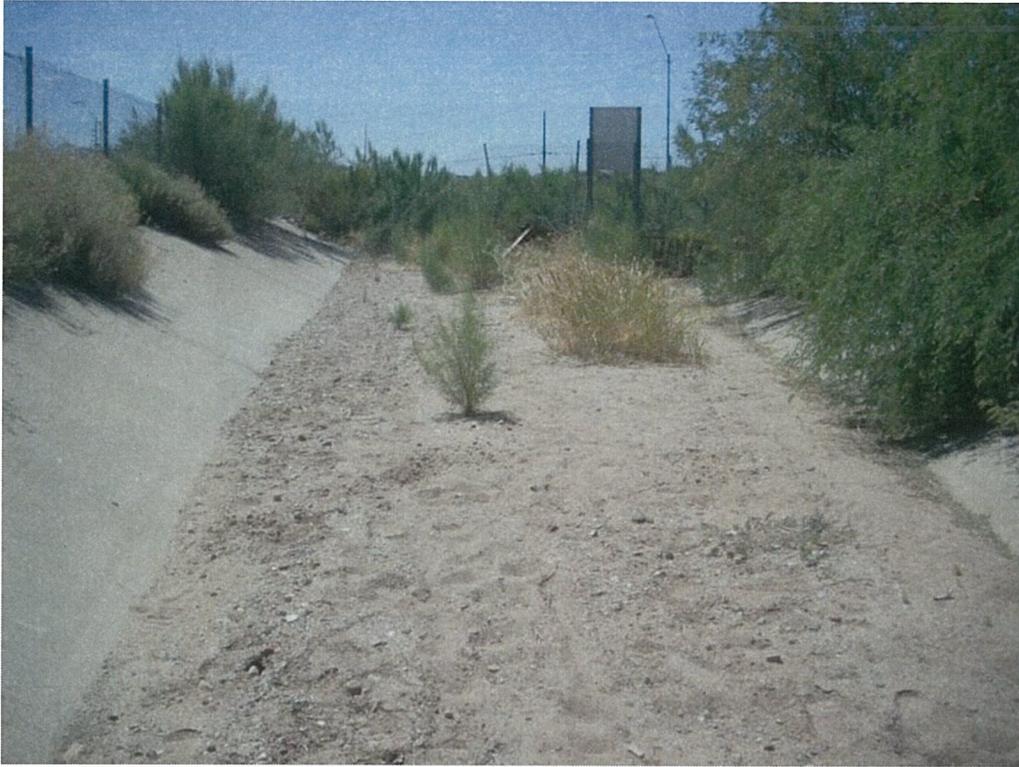
Figure A-3 - Sediment located within drainage channel on site

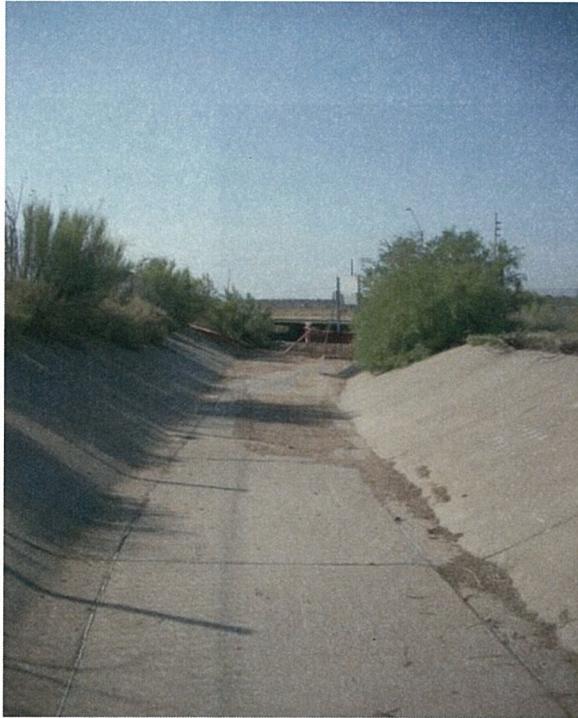
Figure A-4 - Channel conditions after sediment was removed from drainage channels

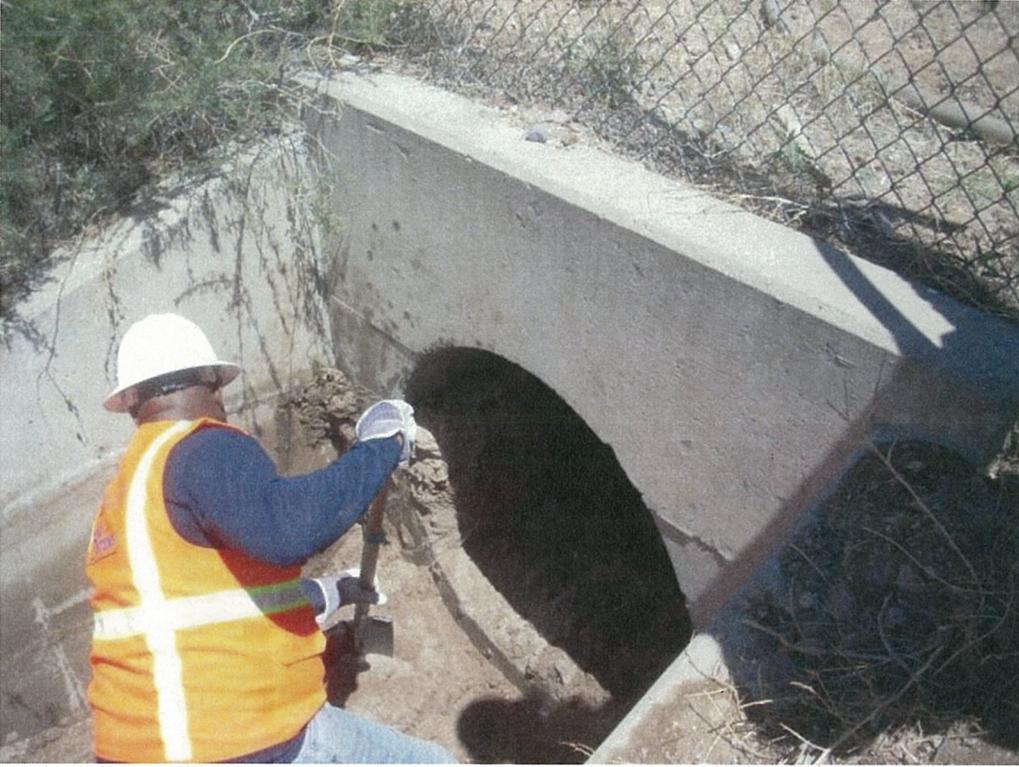
Figure A-5 - Dirt being removed from outfall culvert on site

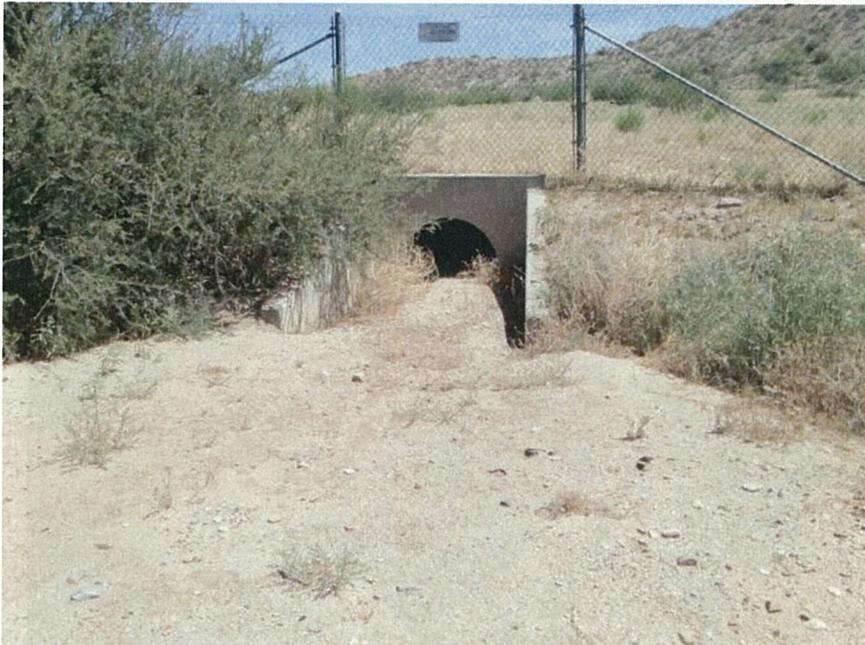
Figure A-6 - Pipe #1 outfall. Approximately one-third blocked with accumulated sediment

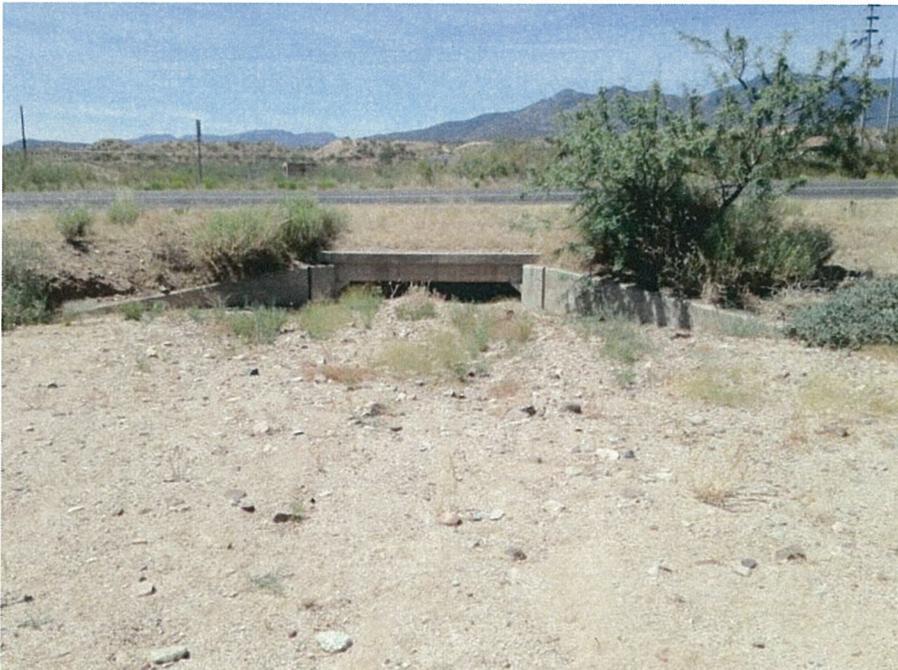
Figure A-7 - Sediment deposited by Pipe #1 outfall and blocked box culvert

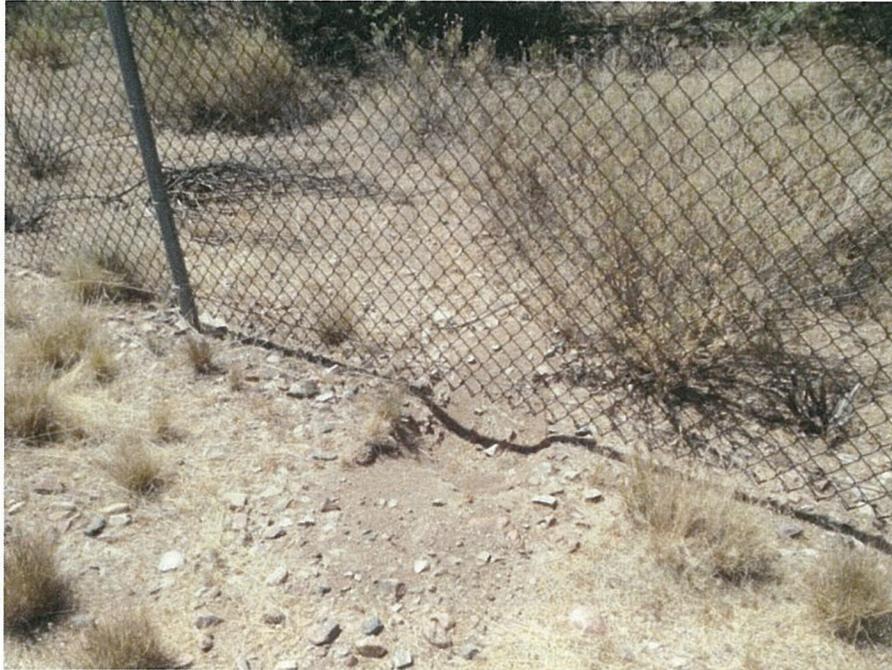
Figure A-8 - Burrow underneath perimeter fence

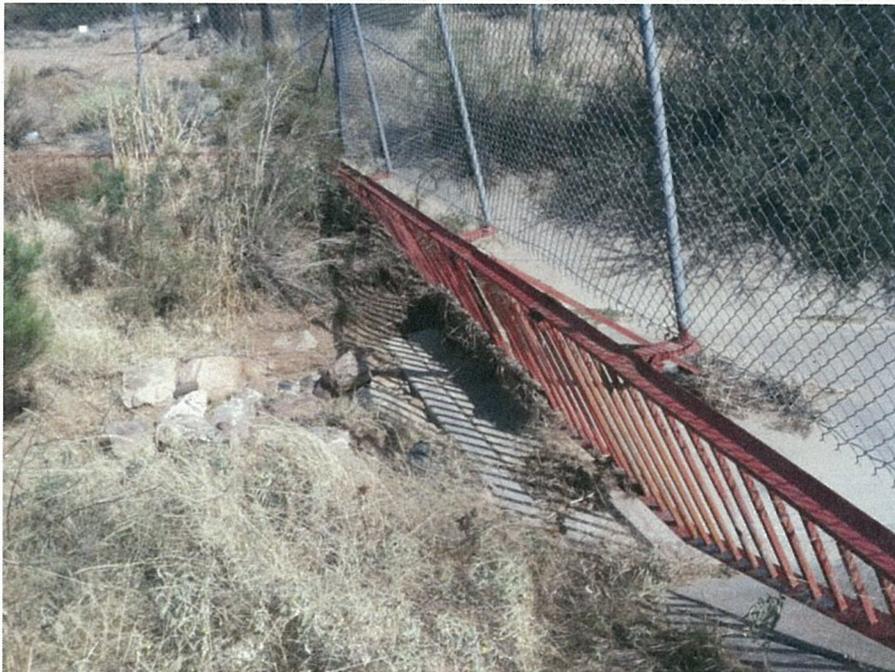
Figure A-9 - Minor damage and debris accumulation on channel inlet grate

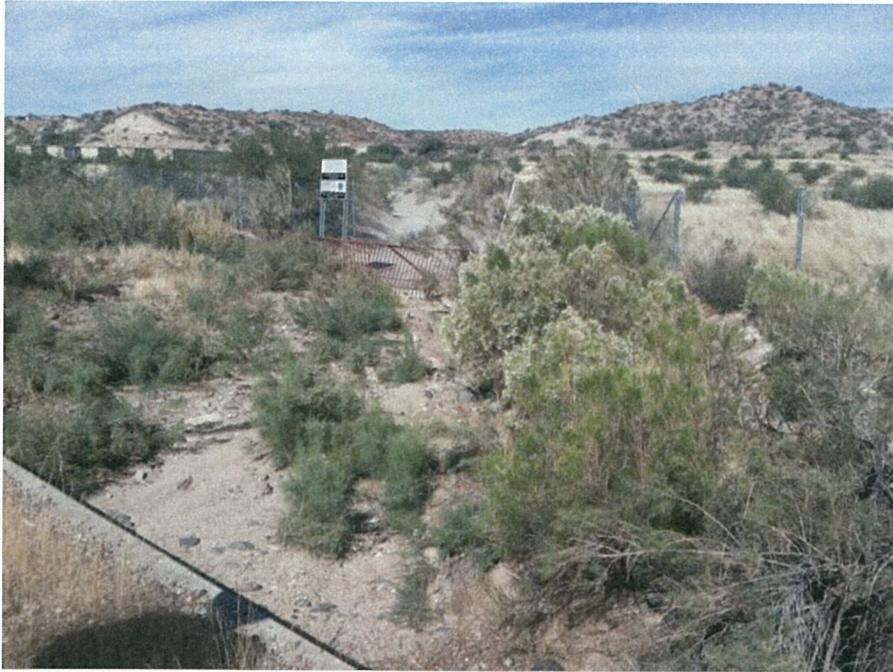
Figure A-10 - Channel outlet and vegetation accumulation

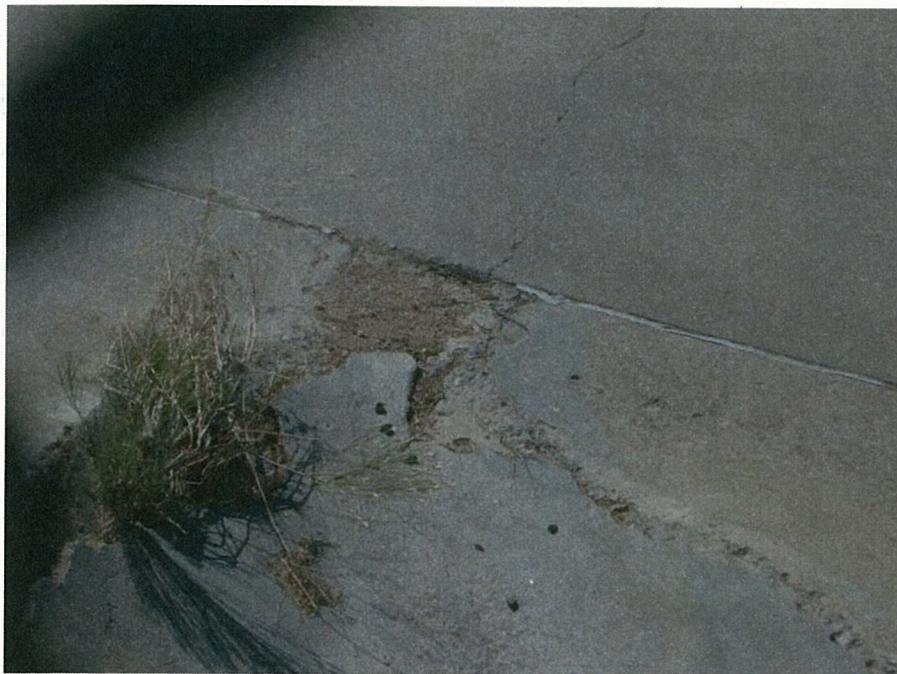
Figure A-11 - Cracks and degradation of concrete near pipe #2 outlet

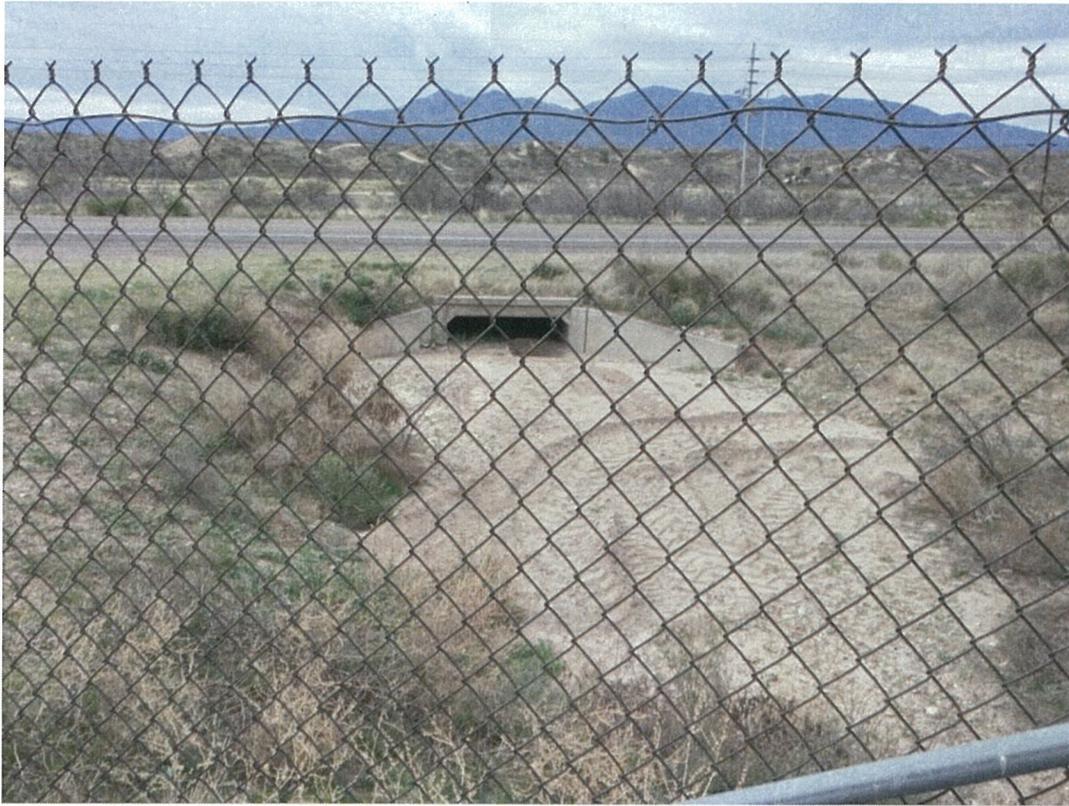
The culvert under U.S. Highway 70, which transports drainage from the Site, contained approximately two feet of sand and sediment. Removal of this was noted to be the responsibility of the Arizona highway department. The increased sediment in this drainage channel, which cuts across the Site, may have been a result from a December 2014 storm. The grate appeared to be functional and in good condition.

Figure D-3 – State of Arizona Highway Department culvert under Hwy 70

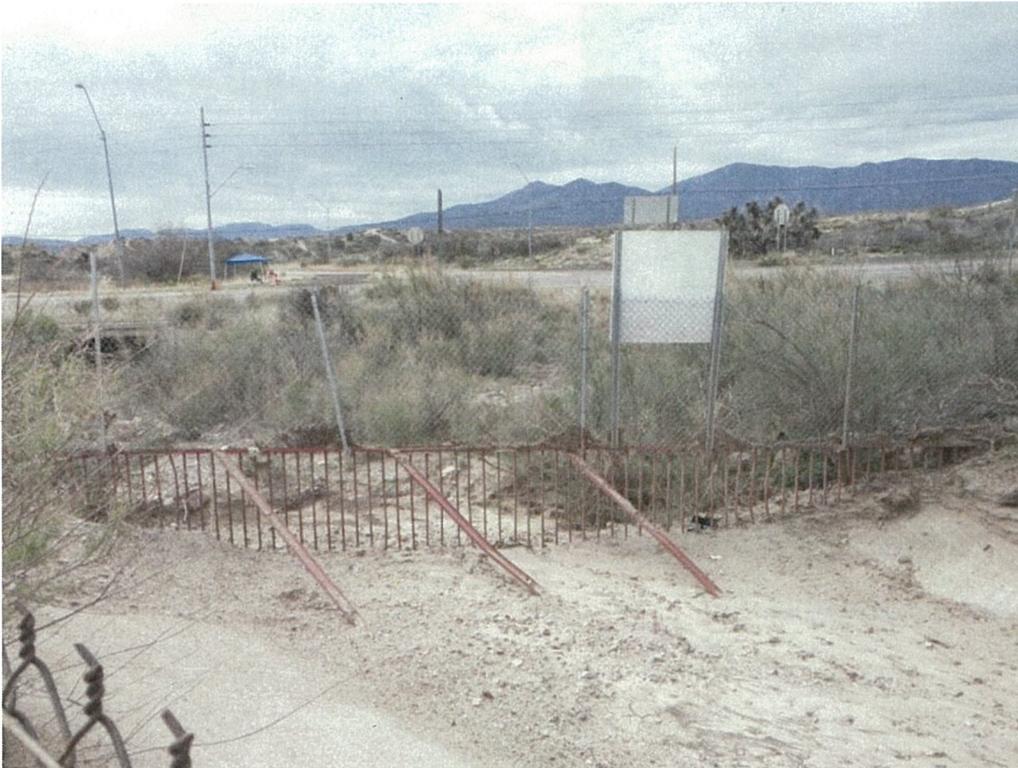
Figure D-5 - Grate at south end of drainage channel

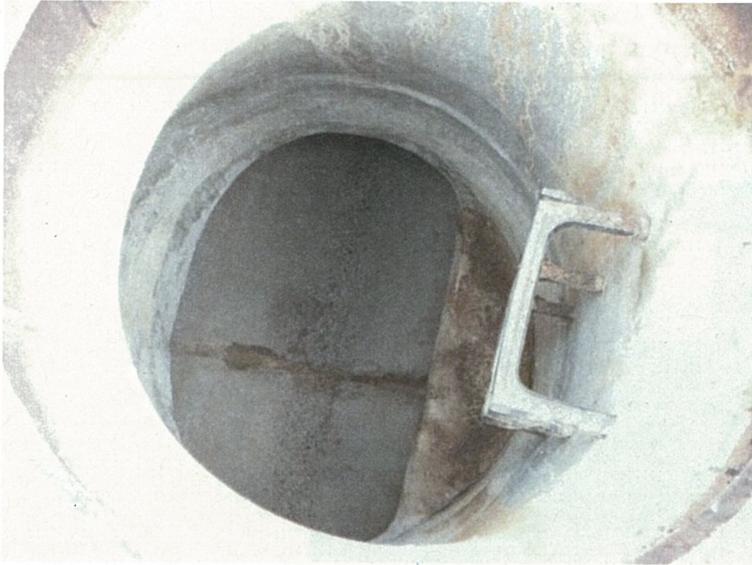
Minor erosion under the fence line was observed on the west side of the Site, near the storage units. This was not affecting the protectiveness of the fencing. A man-hole for the storm drain sewer line under the Site was opened. The drain was clear; Mr. Atkinson stated that the storm drain had been "jetted out" in the past two years.

Figure D-7 - Interior of manhole, showing clean sewer line

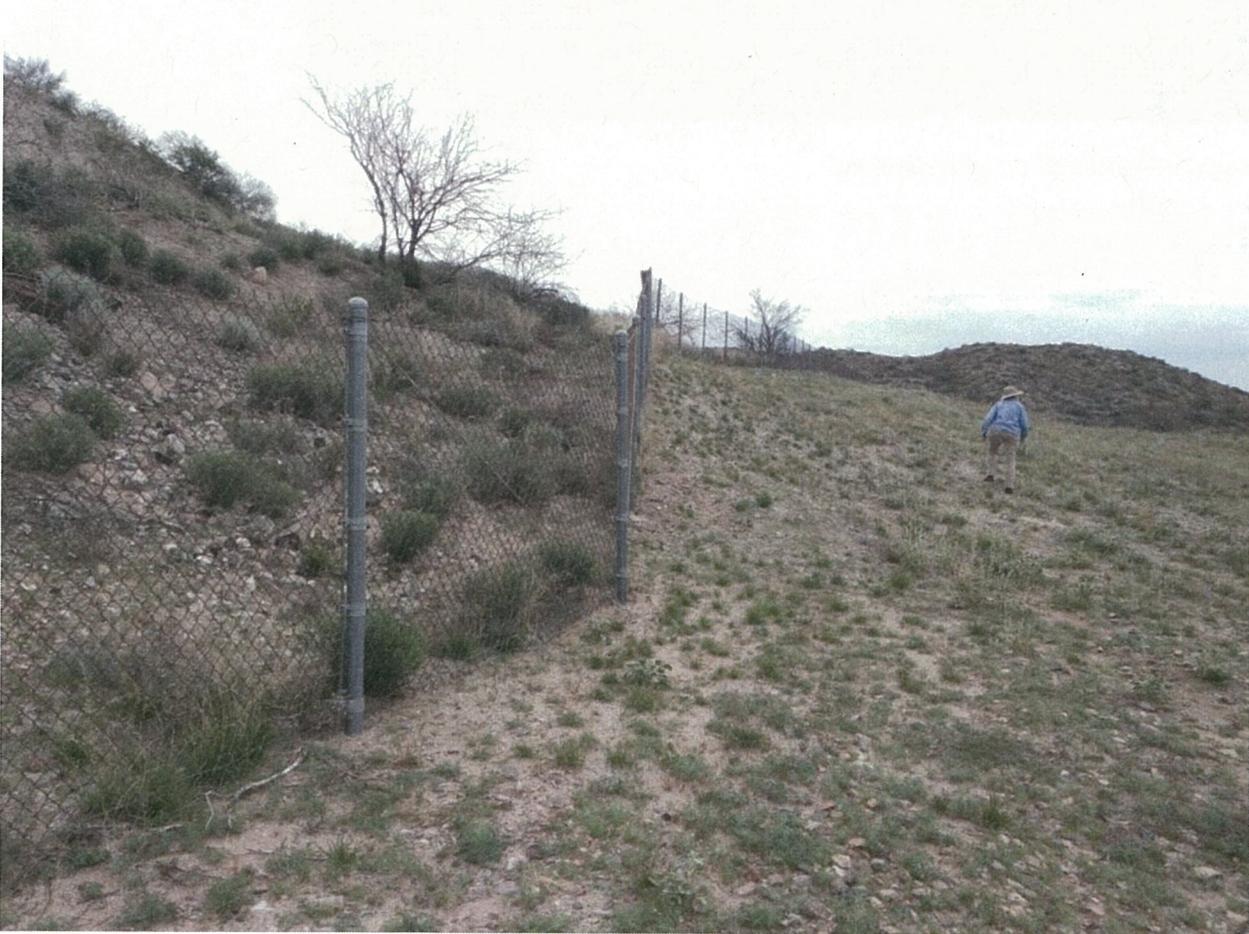
The north boundary of the Site was observed, the fence line here runs parallel to the railroad tracks. Numerous railroad ties have been replaced by the railroad company here in the past few years. Many waste ties were disposed of, on railroad property, between the rail line and the fence line. A number are on the slope just outside the north fence.

Figure D-8 - North fence line, facing east

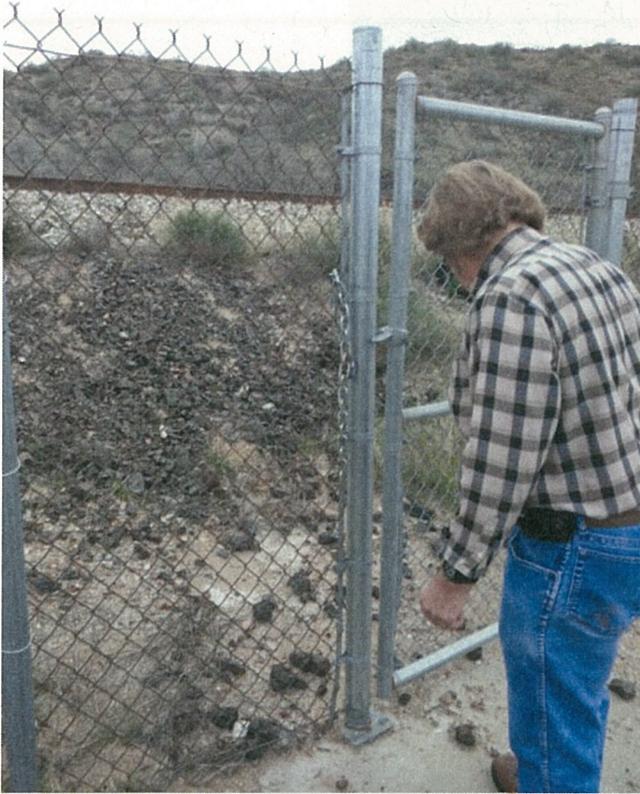
It was discovered that the gate on the north side of the Site had its chain cut, this occurred sometime within the last month according to Mr. Atkinson. The gate was closed, but unsecured. Mr. Atkinson obtained a replacement lock during the Site visit to adequately secure the Site.

Figure D-9 - Unsecured north gate, cut chain

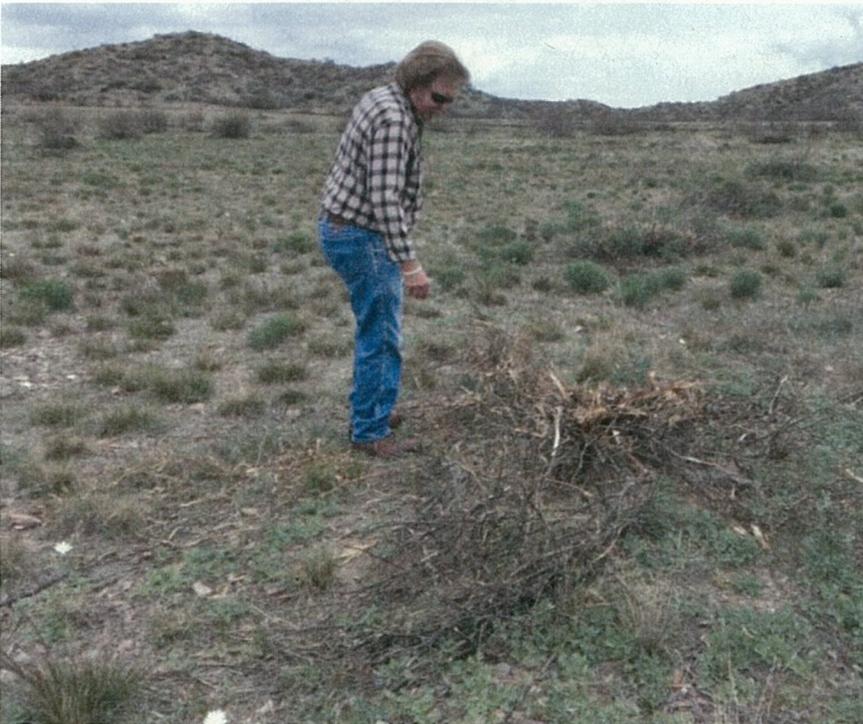
Figure D-10 - Example of mowed down mesquite bush

The site is being maintained, O&M is adequate. The growth of bushes across the site should be considered in any update to the O&M procedures. It was reported by ADEQ that cutting back the bushes may promote increased re-growth. Removing the bushes may damage the cap, while letting them grow may also damage the geotextile layer. ADEQ also explained that the roots of the mature shrubs/trees had already penetrated the geo-textile layer of the cap.

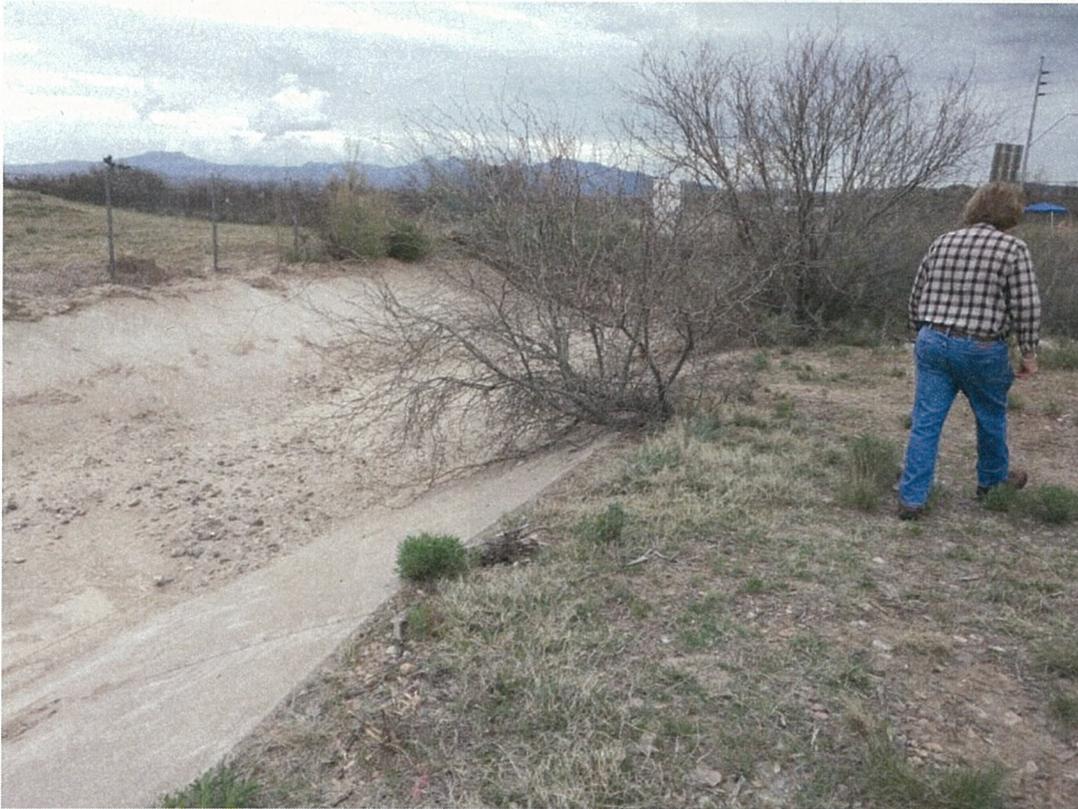
The cap covering the entire Site did not appear to be damaged or show signs of erosion. It appears to be adequately protecting the Site. On the small parcel across the concrete channel large mesquite bushes were seen growing behind the channel wall on Site, but as the Site inspection indicated no damage has occurred from the bushes. The cap covering the small parcel had no damage and showed no signs of erosion during the Site inspection for this FYR.

Figure D-12 - Mesquite bushes growing behind channel wall

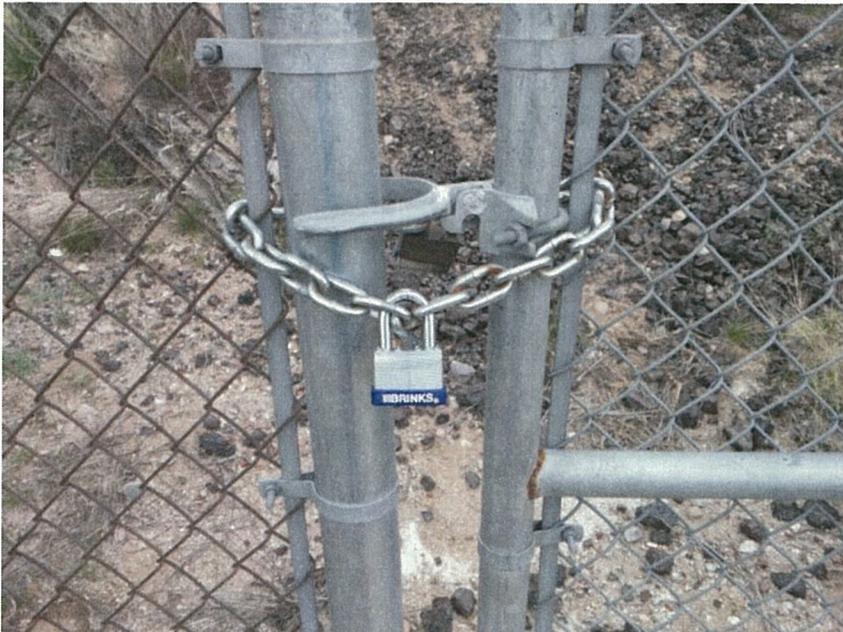
Figure D-14 - North gate secured with new lock
