Appendix G
Geotechnical Evaluation Technical Memorandum

Limited Geotechnical Evaluation of Tailings Impoundments AB/BC, and D, ASARCO LLC Hayden Plant Site, Hayden, Arizona

PREPARED FOR: U.S. Environmental Protection Agency

ISSUE DATE: June 19, 2007

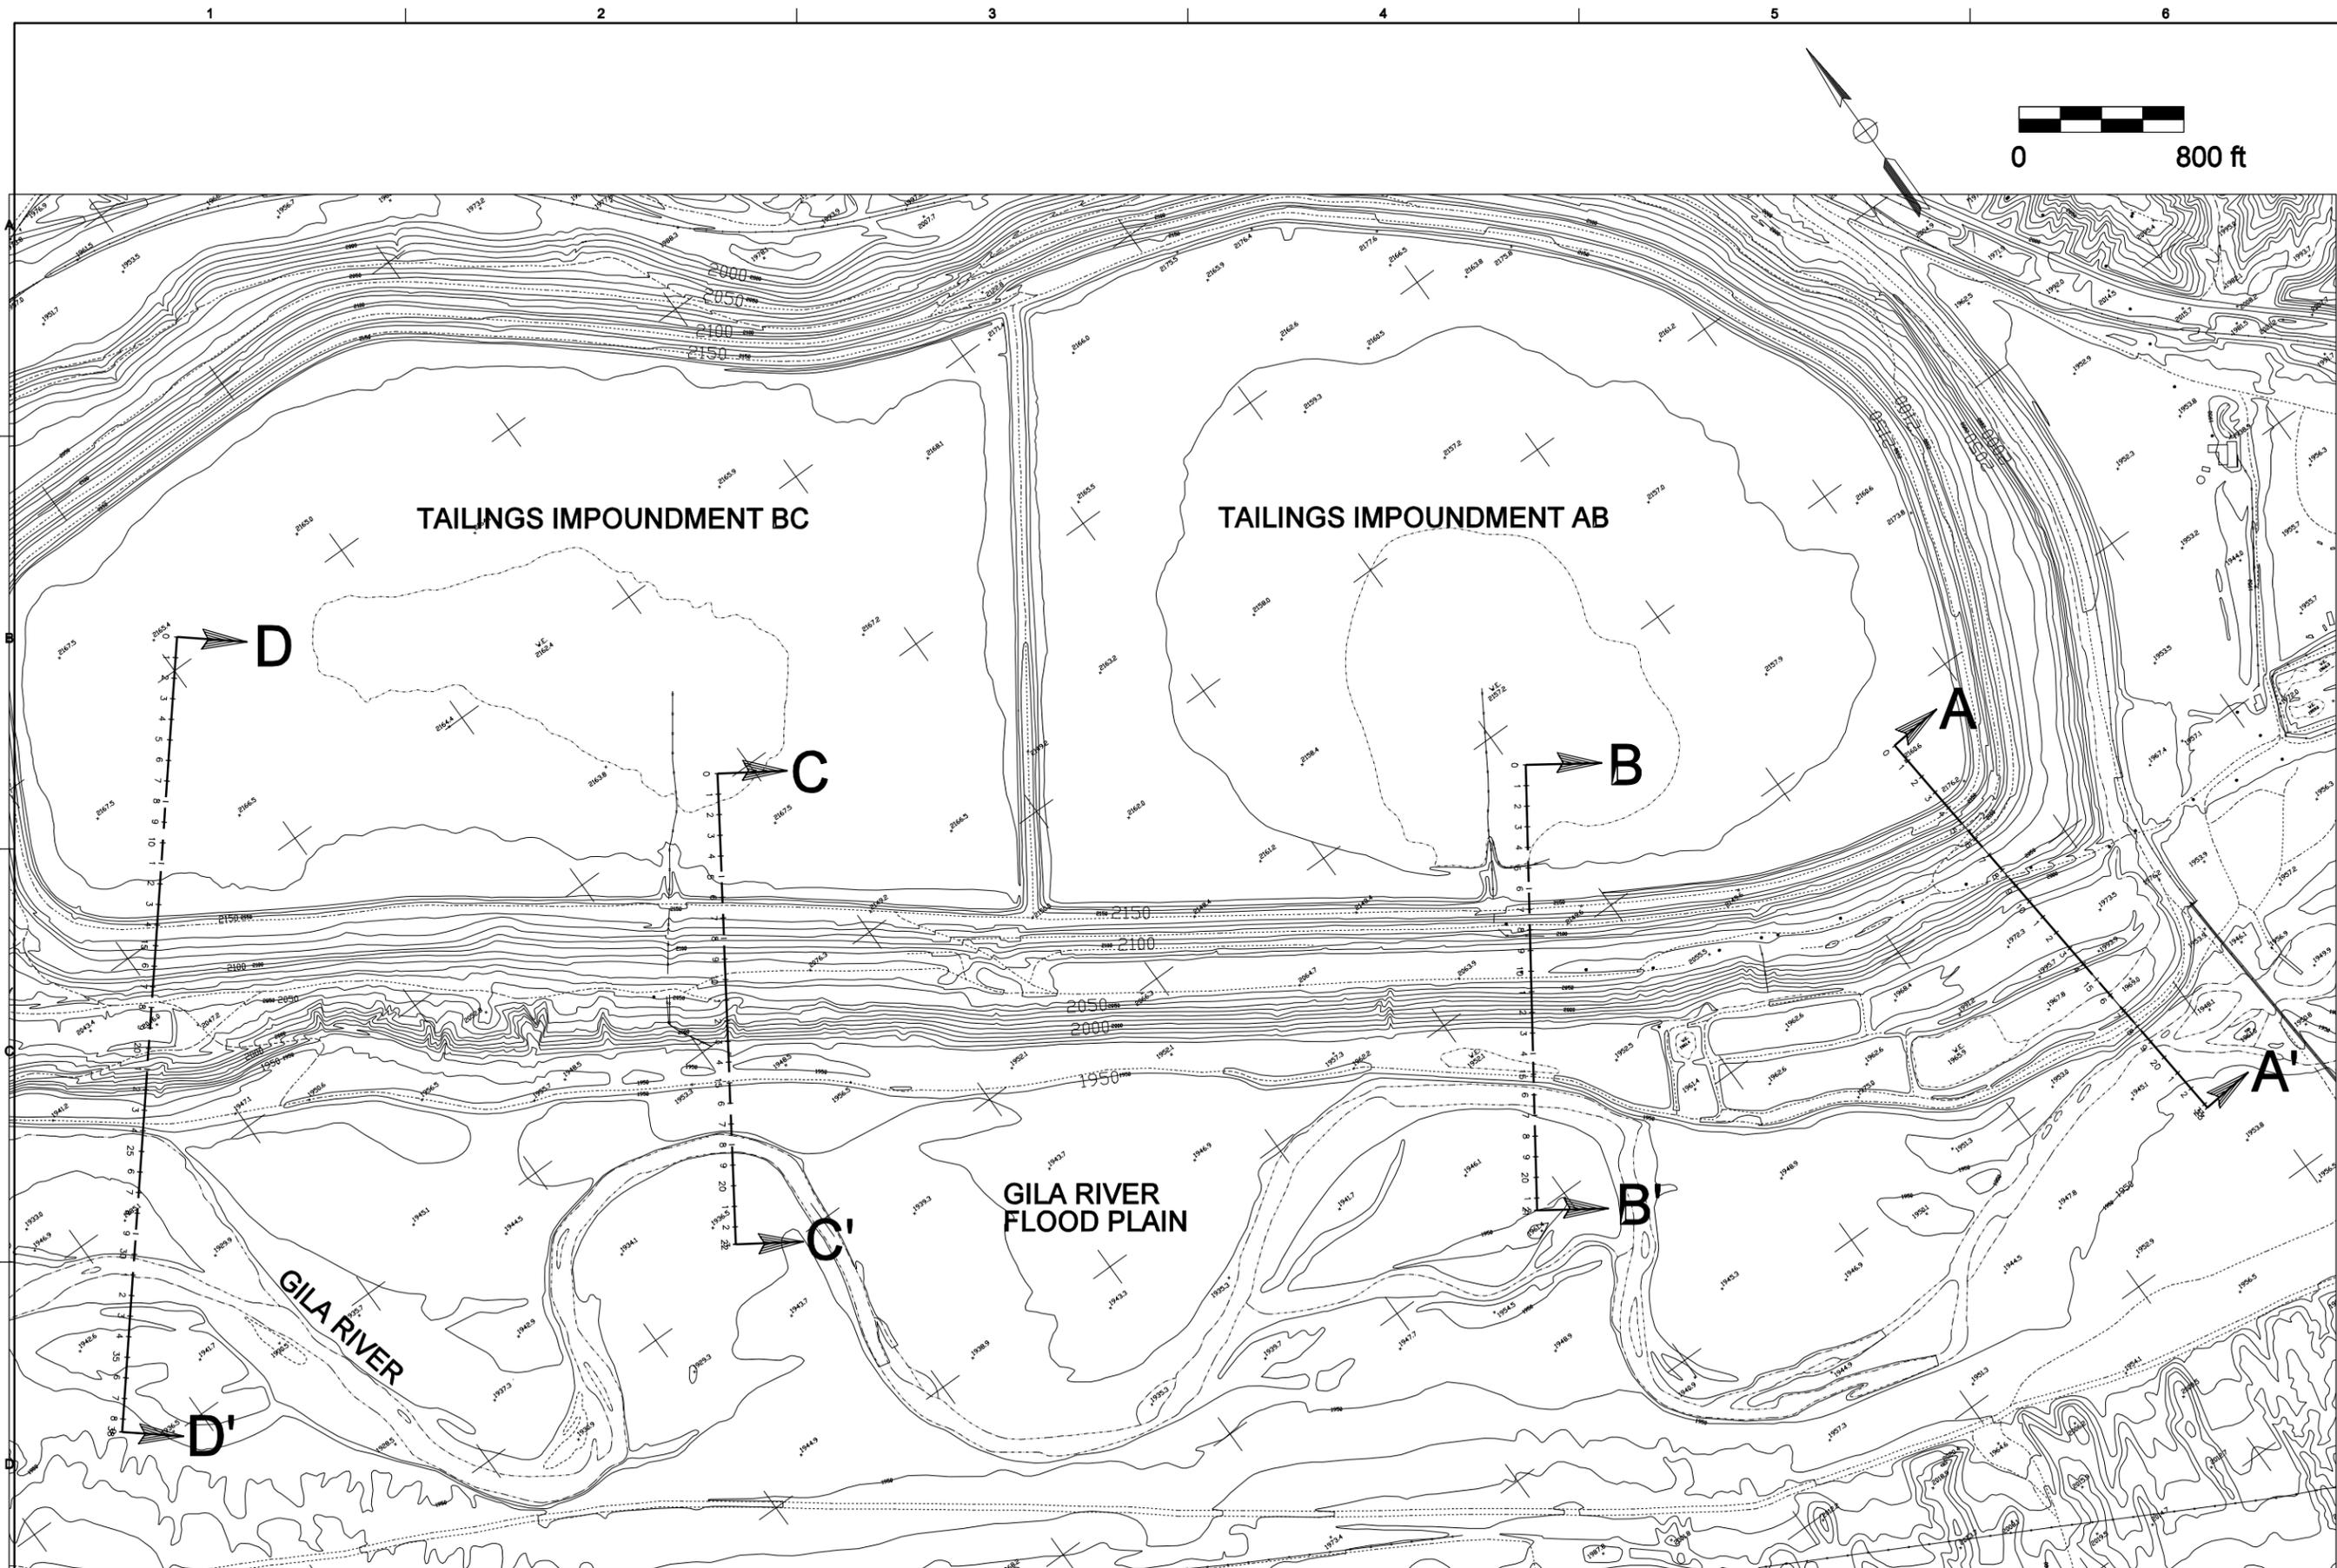
FIGURE 2A
CROSS-SECTION LOCATIONS
TAILINGS IMPOUNDMENT AB/BC

In accordance with Task 3g from the Workplan, eight cross-section-locations were selected to develop profiles for stability analyses; four at Tailings Impoundment AB/BC and four at Tailings Impoundment D. The section locations are designated A-A' through H-H'. CH2M HILL located the sections with respect to conclusions from the site reconnaissance, information from previous studies, and the potential for overall impacts to the Gila River floodplain associated with potential slope failure. As such, the sections are located on the sides of the impoundments that are adjacent and parallel to the Gila River floodplain, as shown in Figure 2.
