**DRAFT FINAL**  
**Third Five-Year Review Report**  
**for**  
**Sacramento Army Depot**  
**Sacramento**  
**Sacramento County, California**

**August 2007**

**THE DEPARTMENT OF THE ARMY**  
**ASSISTANT CHIEF OF STAFF FOR INSTALLATION MANAGEMENT**  
**BASE REALIGNMENT AND CLOSURE DIVISION**  
**600 ARMY PENTAGON**  
**WASHINGTON DC 20310-0600**

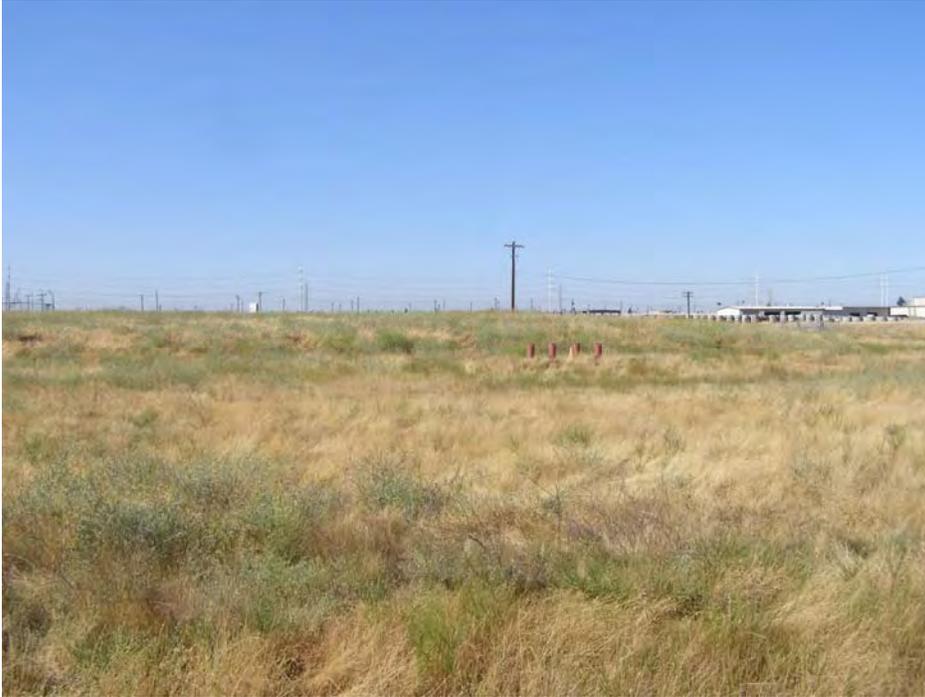
Photograph 3. Stabilized Soils CAMU and lysimeters

The institutional controls, identified in Section 3.2, are being enforced. No significant operations and maintenance issues were identified during the site inspection, i.e., there was nothing constructed on the sites, the soil cover was not damaged, and the vegetation was appropriate.

The primary remedial focus of the remedies was to consolidate and treat the soil with the highest metal concentrations to both reduce the potential for exposure and impacts to groundwater. The existing CAMU is functioning as designed. Lysimeter monitoring has not indicated any migration of metal contamination from the stabilized soils. The soil cover is in good condition. Containment of the stabilized soil under the soil cover is effective. No issues have been identified in the CAMU at the South Post Burn Pits
