THIRD FIVE-YEAR REVIEW REPORT

**FOR
KOPPERS COMPANY, INC.
SUPERFUND SITE
OROVILLE, CALIFORNIA**

July 2008

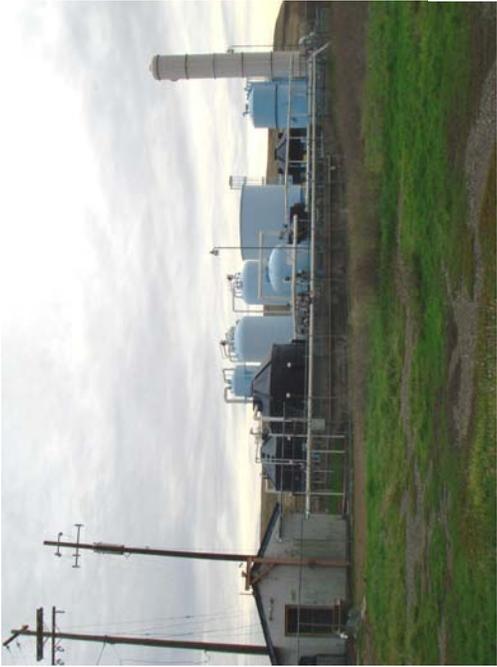
The fence gate to the pump station was locked at the time of the inspection. An alarm system is maintained in the pump station to prevent unauthorized entry to the station. The onsite treatment plant, including air strippers, filters, carbon absorption units, surge tanks and effluent and influent holding tanks, appeared to be well maintained and in good condition.

Photo 1: Onsite water treatment plant

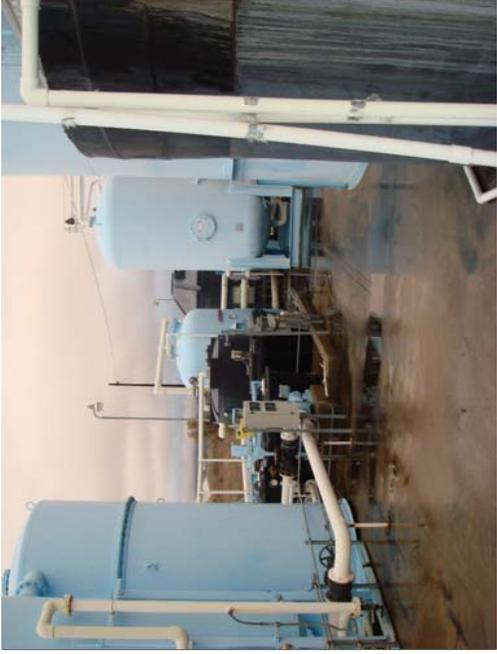
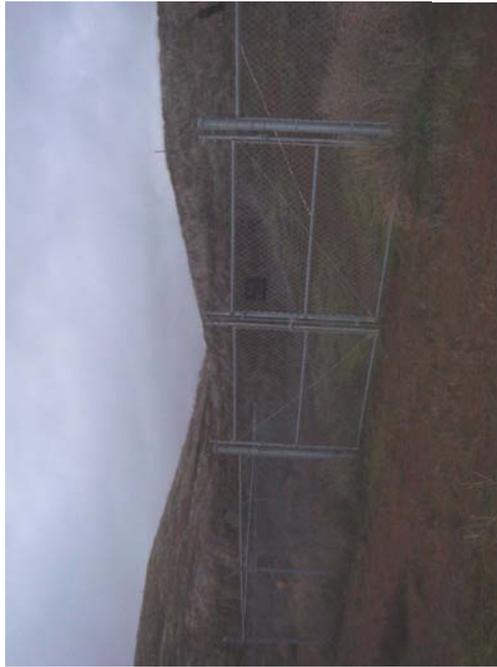
Photo 2: Onsite Soil Disposal Cells

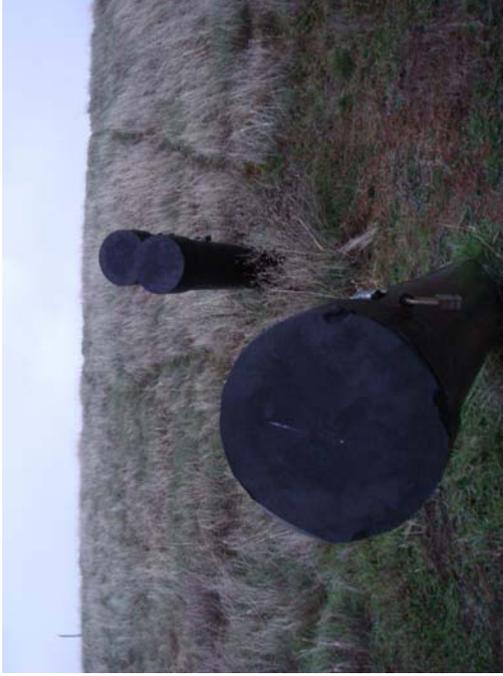
Photo 3: Leachate sumps on Landfill

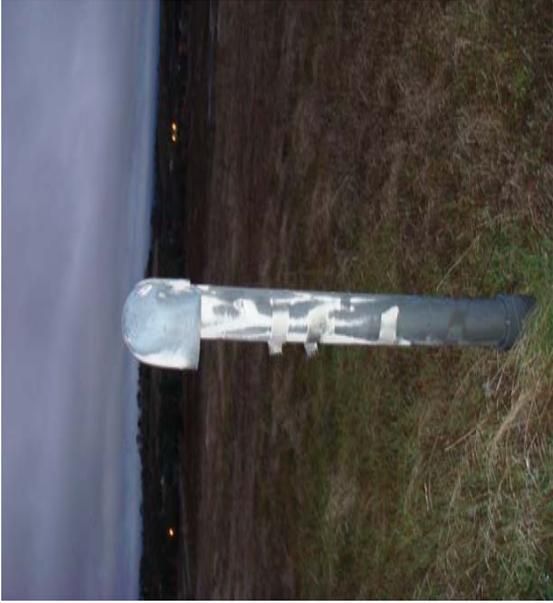
Photo 4: Landfill gas vents

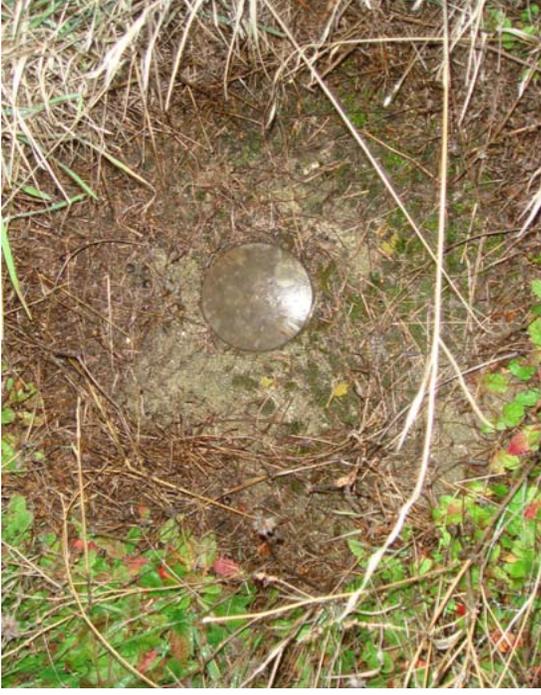
Photo 5: Landfill settlement monument

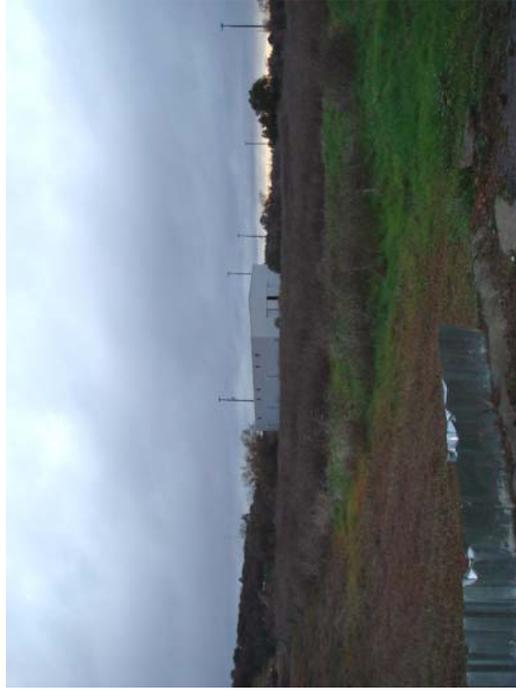
As a part of the onsite inspection, the location of the storage building, which was formerly used to store contaminated soil, was noted. Presently the building is not in use and has been decontaminated and pressure washed. Injection well 3 and the product recovery well appear to be in good condition, and there are no indications of damage.

Photo 6: Location of former soil storage building

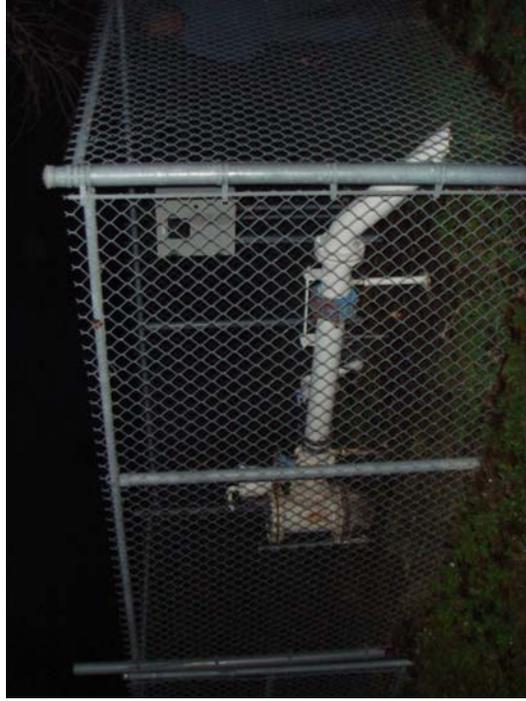
Photo 7: Injection well-3

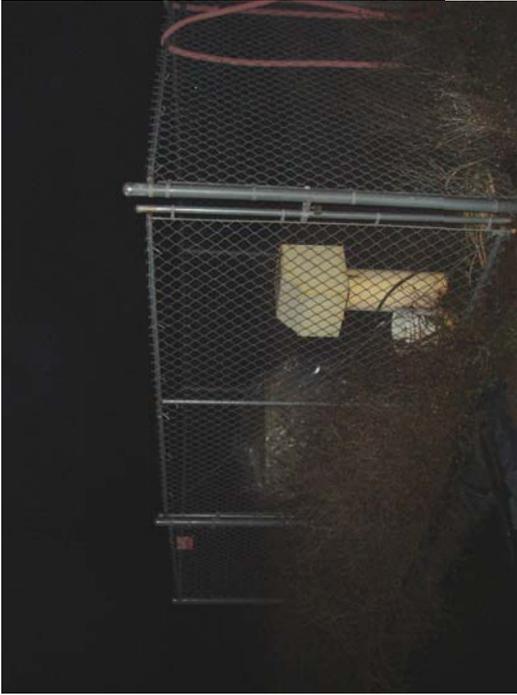
Photo 8: Product Recovery Well

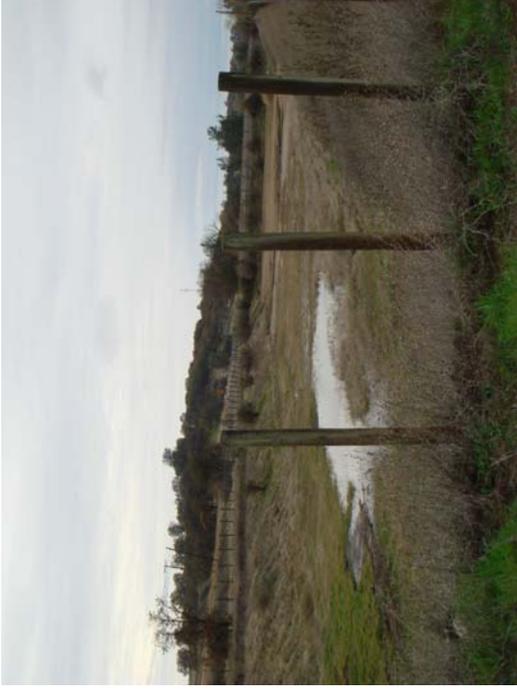
The biological treatment bed near EW-1 was inspected on December 19, 2007. Standing water was observed in the bed, which can be attributed to the heavy rainfall on December 18, 2007. Wells EW-1 and EW-2 were both leaking at the time of inspection. Leaking well EW-2 can be of potential concern because pentachlorophenol has been detected at concentrations above the ROD cleanup level (1 ppb) in EW-2 with values ranging from 12 ppb in 2003 to 2.9 in 2007.

Photo 9: Biological treatment bed

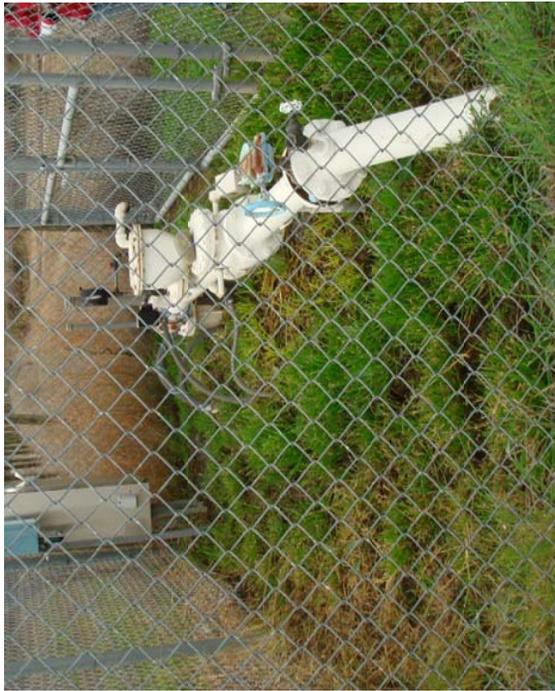
Photo 10: EW-1

The onsite groundwater P&T remediation system continues to treat groundwater extracted from EW-1 and EW-2. The system is pumping at optimum rates with minimal shutdown time due to maintenance. Influent PCP concentrations have decreased over time. Injection wells IW-3 and IW-4 are functioning optimally. It was observed during the December 2007 Site inspection that both extraction wells EW-1 and EW-2 had minor leaks that were described by the O&M manager as an on-going problem. The area around the wells is fenced and the O&M manager tries to control the leaks on a regular basis. The potential for exposure is minimized; however, because it is an on-going problem, it should be more optimally addressed. Photos 10 and 11 found in

H show that there is no secondary containment for either of the extraction wells; therefore any leaks go directly onto the ground. Monitoring data do, however, indicate that they are adequately capturing the plume in Sub-unit A. Extraction of MW-8 water and diluting it with the influent water from EW-1 and EW-2 continues to mitigate the high boron

At the time of the December 2007 Site inspection, both extraction wells EW-1 and EW-2 were observed to be leaking. According to the O&M manager, these leaks are a regular occurrence. The water from the leaks falls directly onto the grass covered ground and soaks back into the soil (pictures of the extraction wells are included in Appendix H). However,

the leaks appeared to be minor at the time of the site inspection, and the area around the wells is fenced to minimize potential exposure. With the fence preventing exposure to contaminated water, at the current time these leaks are considered to be O&M issues that need to be addressed, but they do not affect the protectiveness of the remedy.

Leaking extraction wells	While the areas are fenced, and there is no potential exposure, Beazer should find a more permanent solution to eliminate the leaks, either by replacing parts and/or providing secondary containment so as not to allow for contaminated groundwater to contact the ground surface.

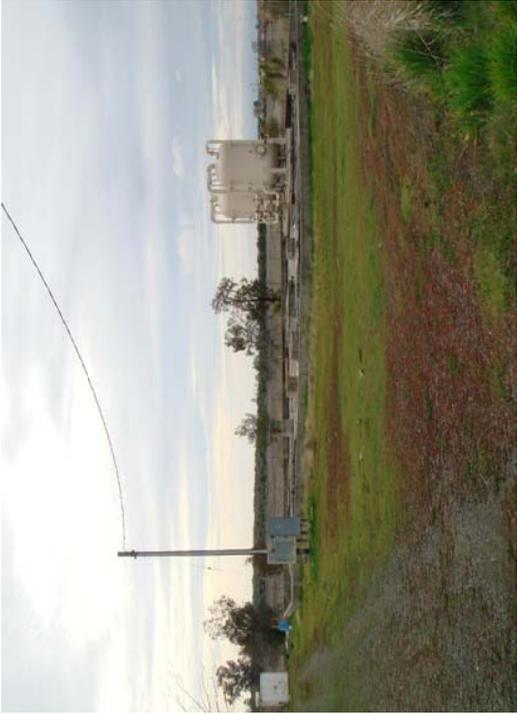
Inspection of the offsite treatment plant and adjoining areas were conducted by driving through the area and stopping occasionally for documentation and photographs. The inactive offsite treatment plant was not accessible due to locked gate and fence. The offsite treatment plant has been abandoned, and all treatment units except for the carbon absorption units have been removed. Wells RI-11 and RI-12 were observed for signs of damage, and the general direction of the offsite pentachlorophenol plume was noted. The locations of four unknown wells that could not be located on the map were noted south of Prince Road. These appeared to be old or abandoned wells. Location of extraction wells EW-3 and EW-4 could not be found during the inspection.

Photo 12: Former off-site water treatment plant

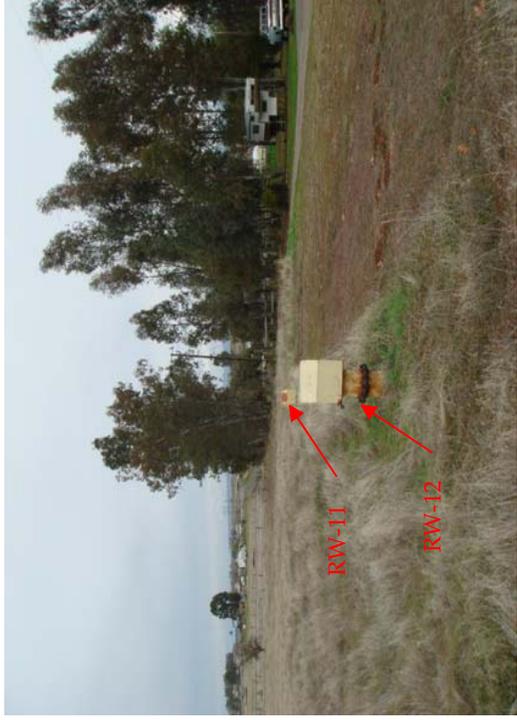
Photo 13: Wells RW-11 and RW-12
