# Mountain View Mobile Estates

## Five-Year Review Report Summary

MEMORANDUM

**SUBJECT:** Five-Year review for the Mountain View Mobile Home Estates Superfund Site, Globe, AZ

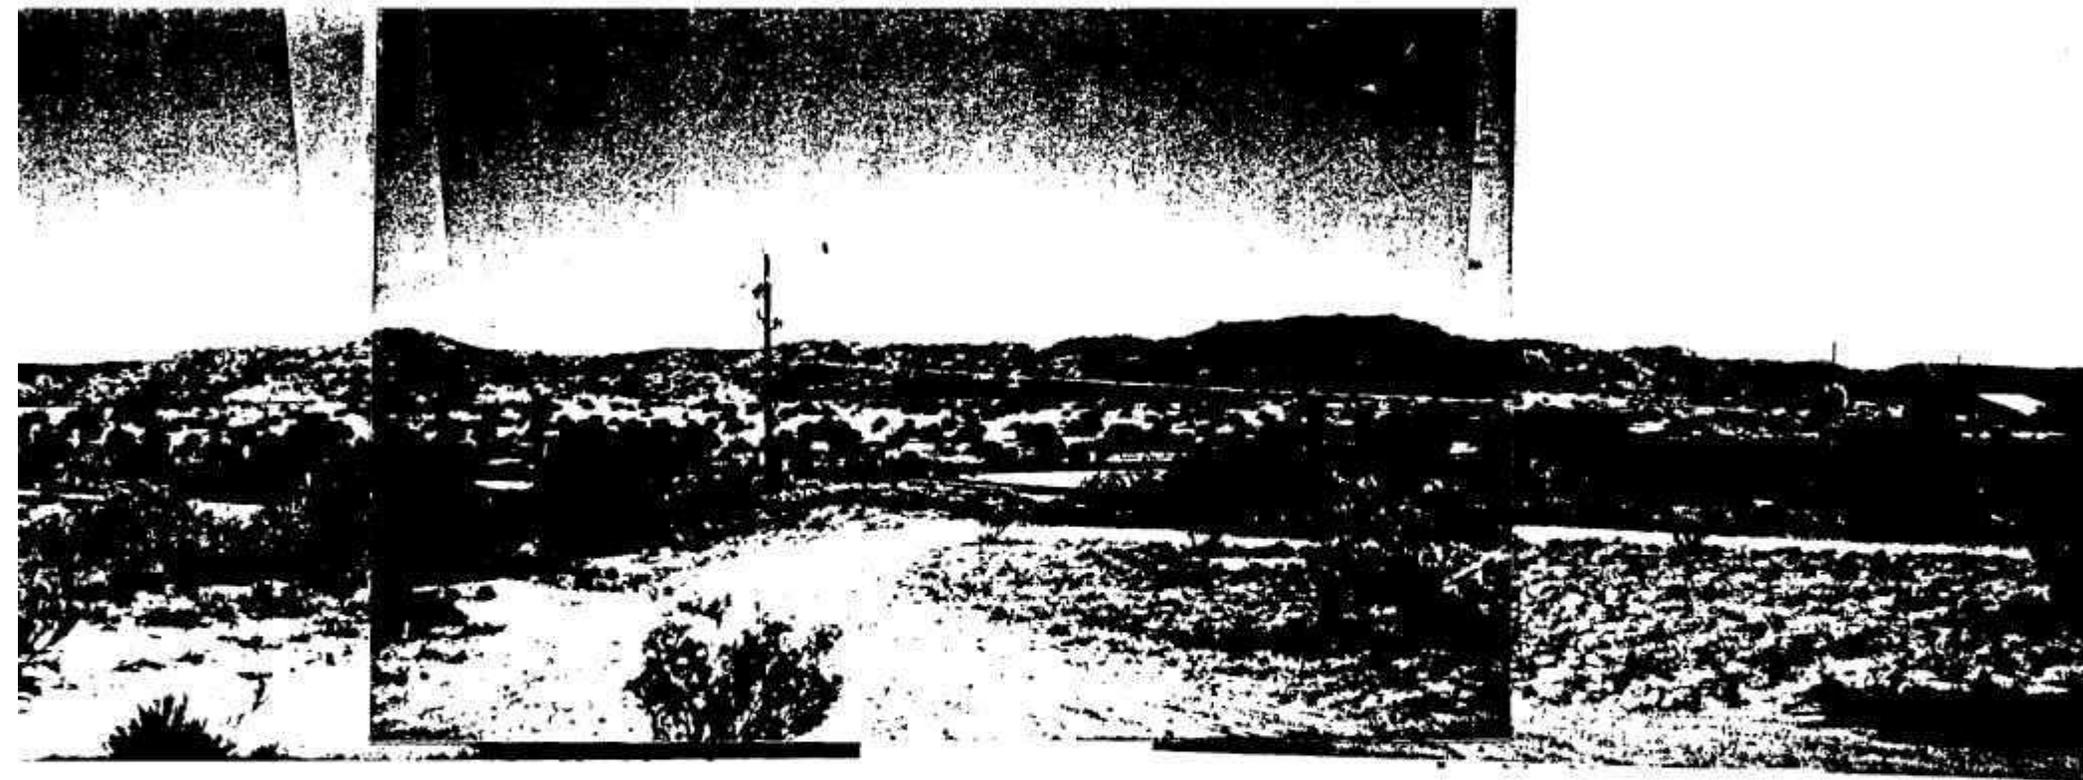
View of site from across hwy

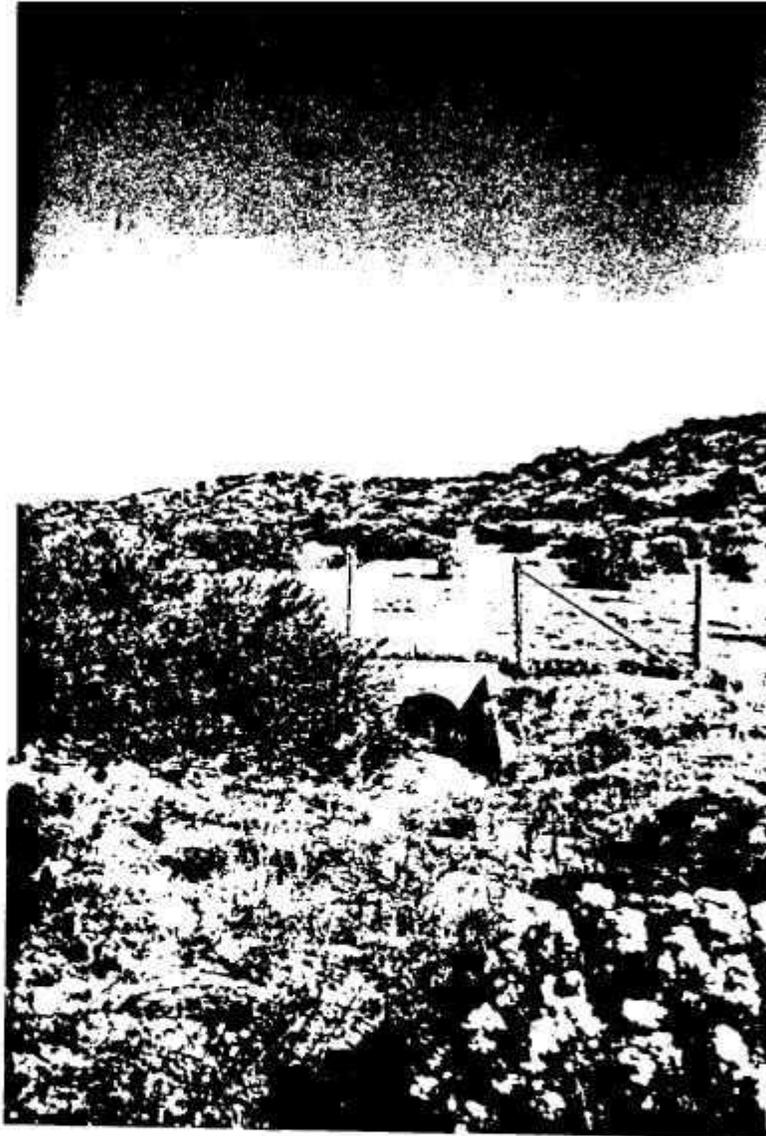
Central culvert - view north

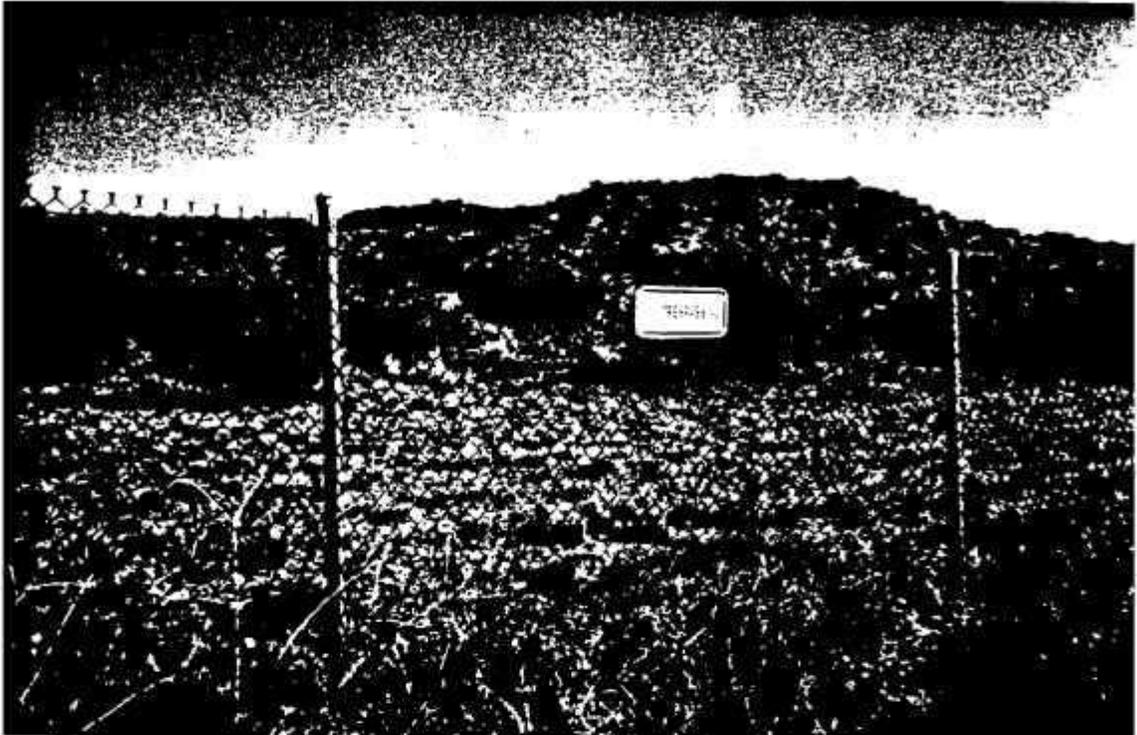
Signage adjacent to hwy

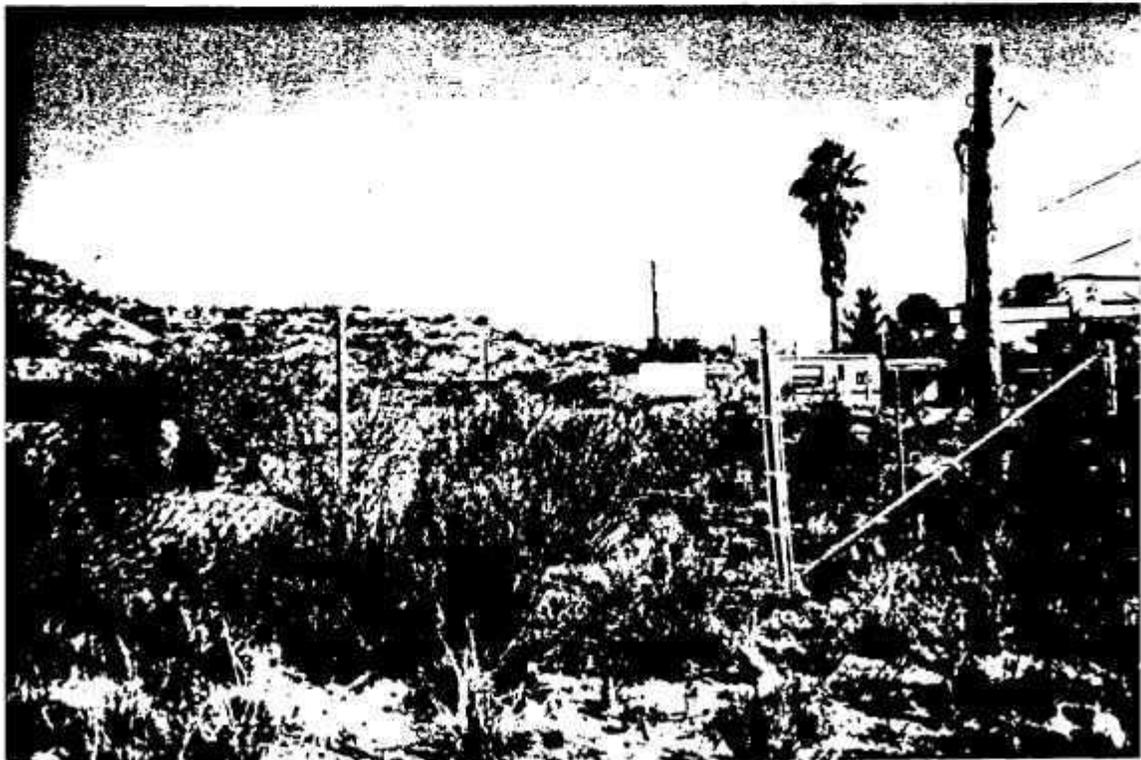
Eastern edge of site facing north

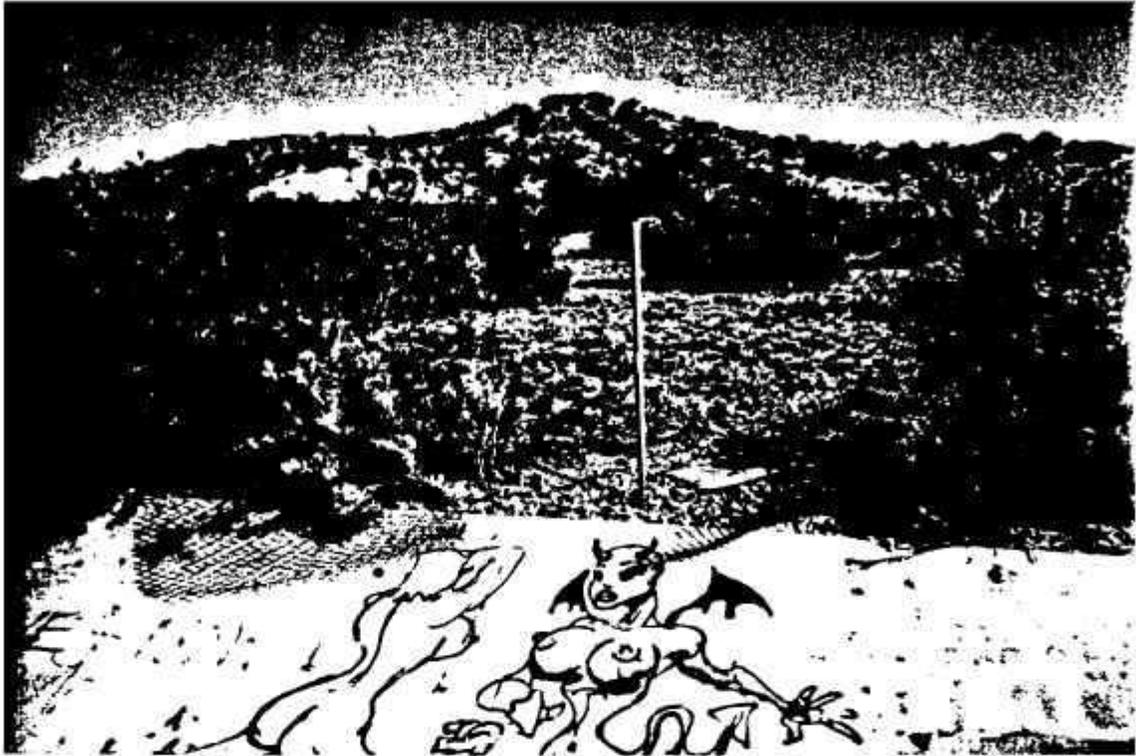
The site was found to be in excellent condition. The fence was in good condition with the exception of a breach adjacent to the open drainage channel. Some weed growth and accumulation along the fence might present a fire hazard to nearby residents but this is regularly addressed by the state's O&M procedures. The site was generally free of collected debris.

vandalism of fence/graffiti  
facing north east

There were no areas or conditions of noncompliance with the goals of the remedial action at the site. While recent acts of vandalism have temporarily disturbed site fencing, the state's reconfiguration of drainage and site fencing should reduce future disruption.

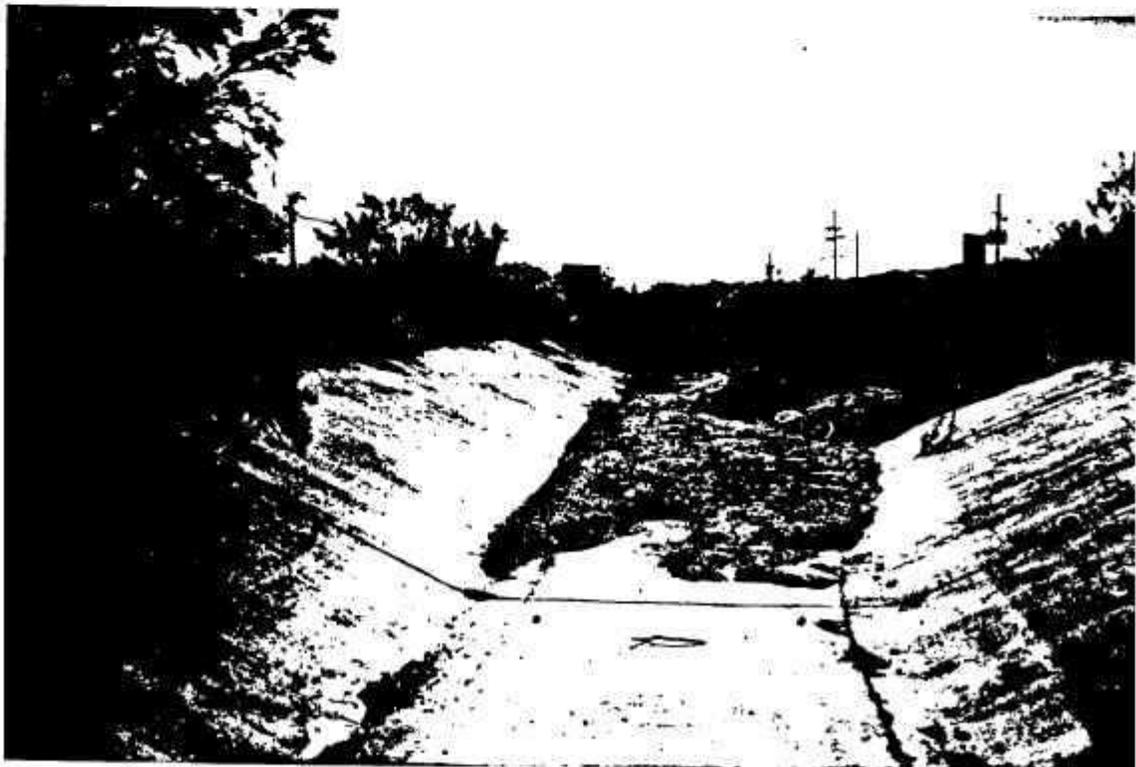
base of culvert - west end of site facing south

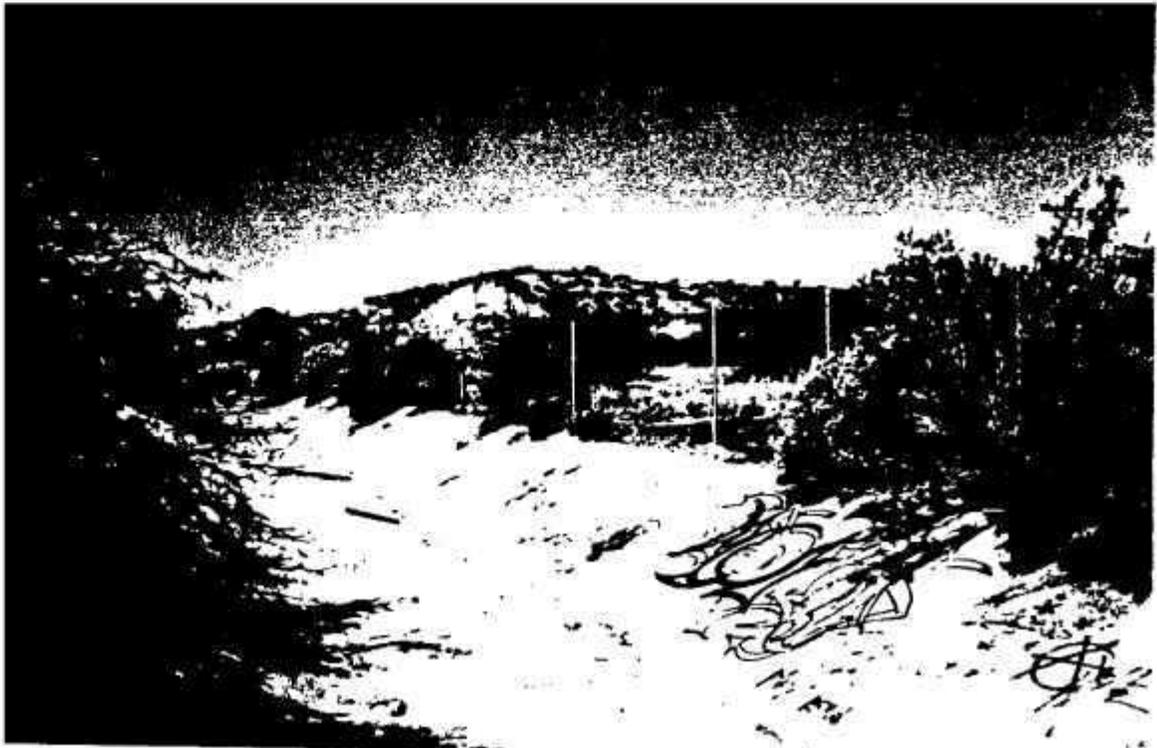
vandalism to fence view north west

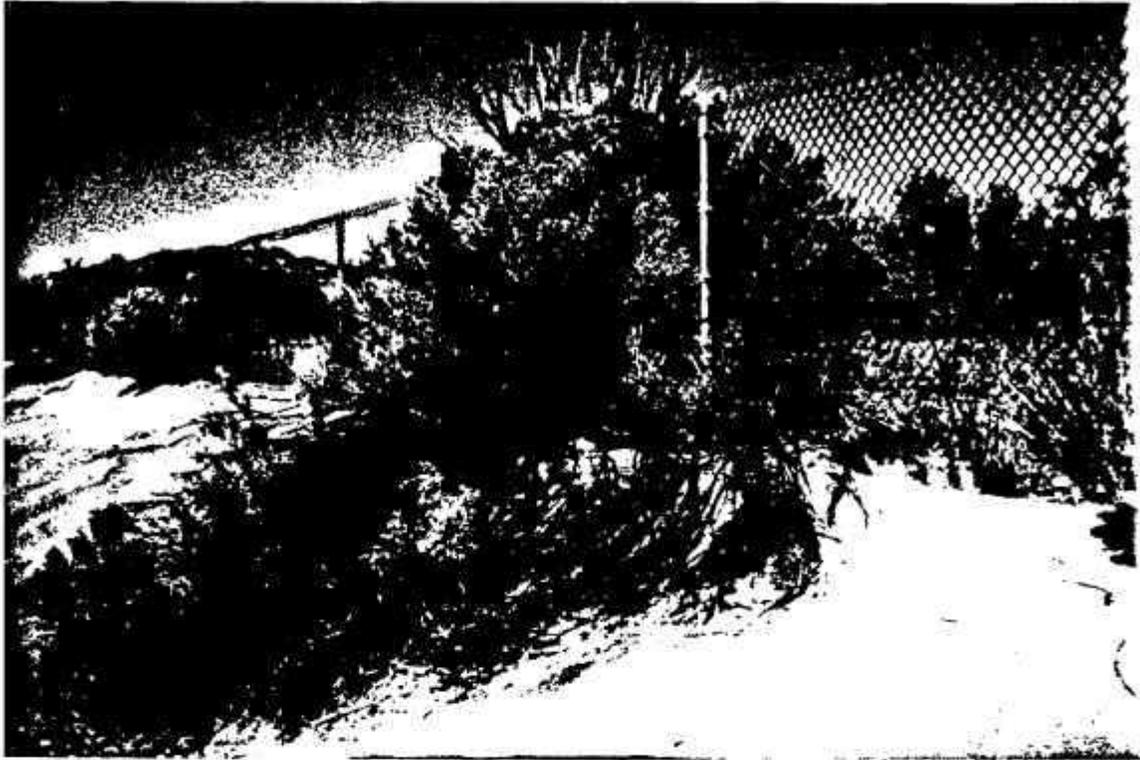
vegetation / fencing view north
