Five-Year Review Report
Second Five-Year Review Report
Selma Pressure Treating Superfund Site
Selma, California
September, 2006

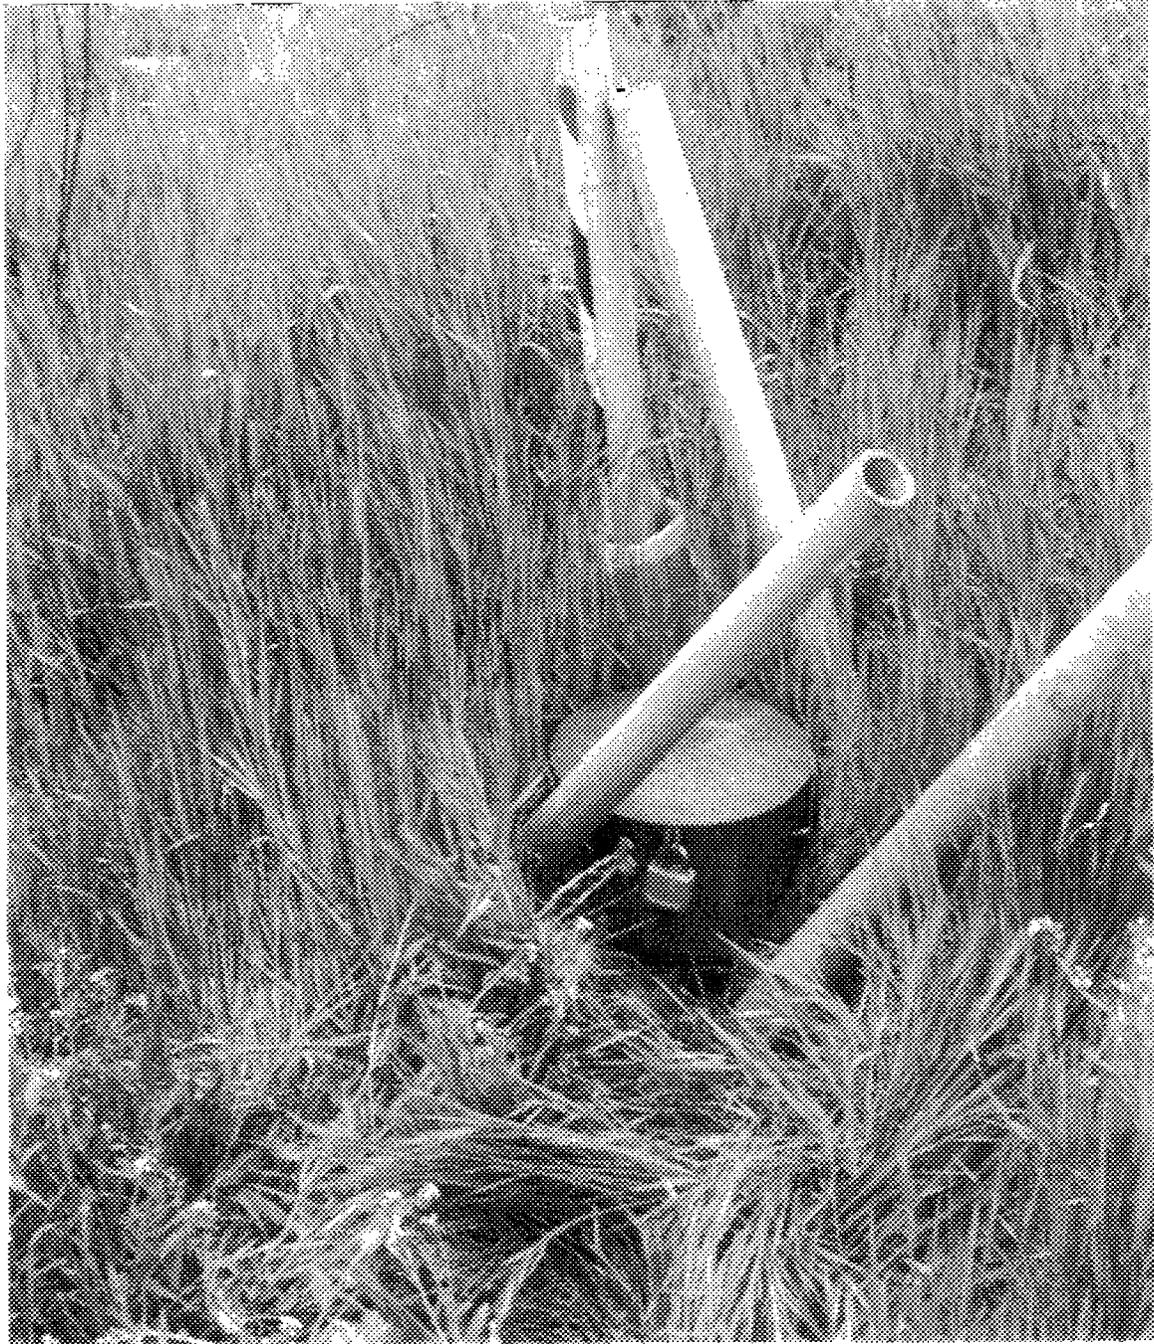
Photo 1 – Monitoring well P4S, improvement of well protection recommended.

2. Establish routine procedures to make replacement locks for the wells readily available to the field crews. Repair bollards (protective outer poles for wells).

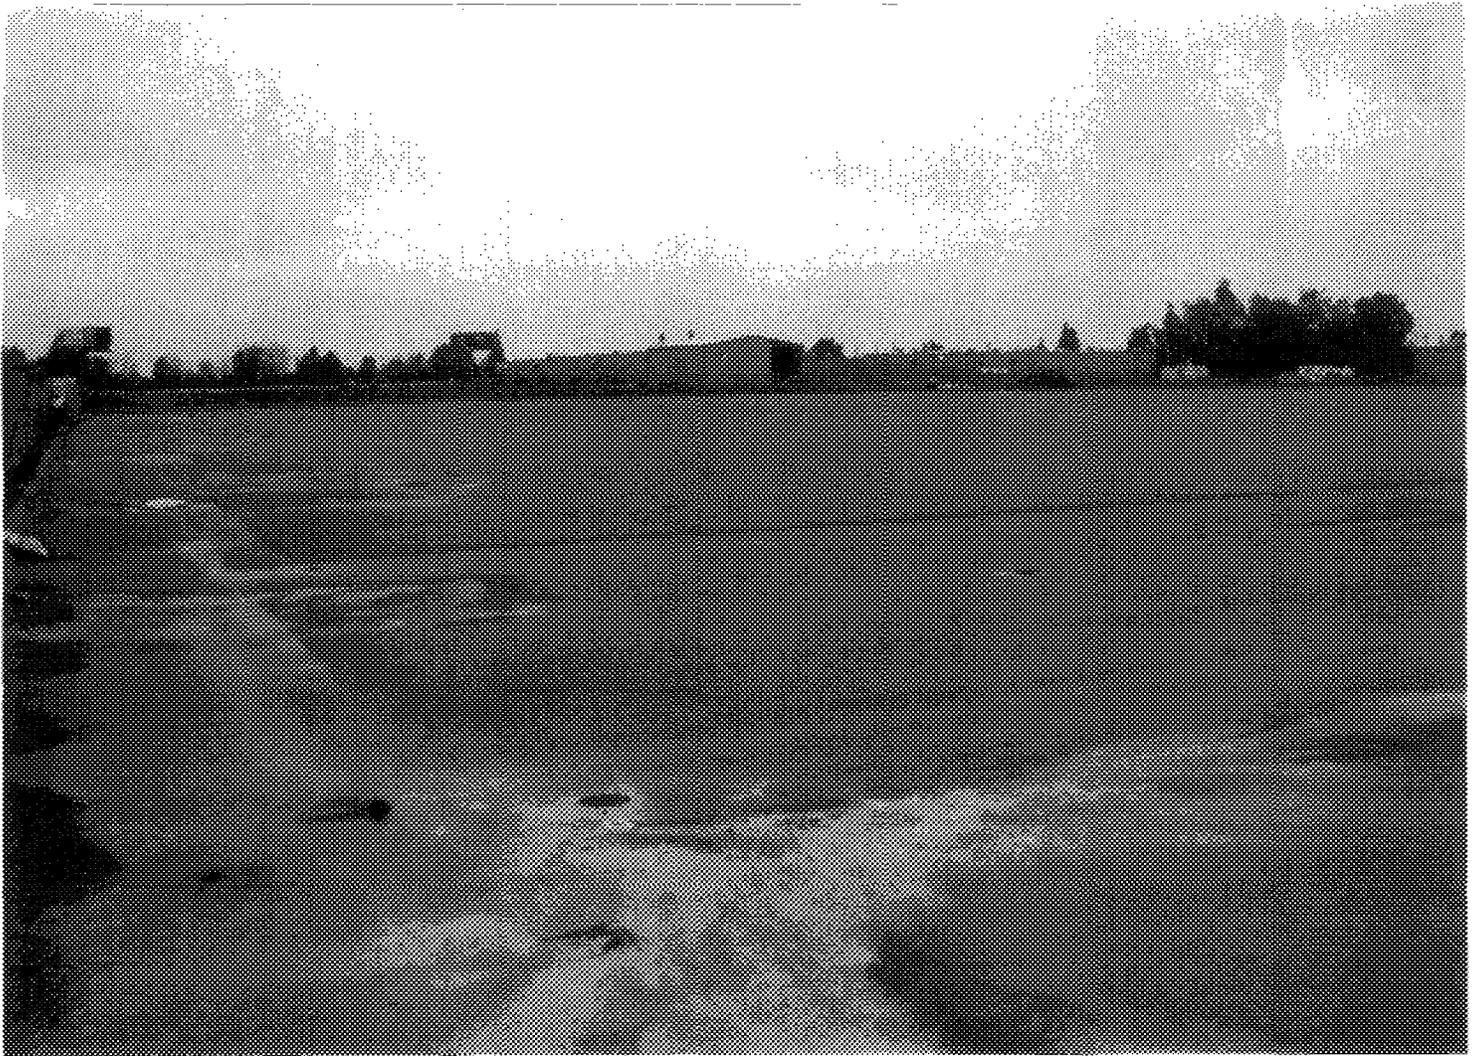
Photo 2 – Site view from EW1 looking west-northwest. Note evidence of Phase 1A in-situ bioremediation boring in foreground

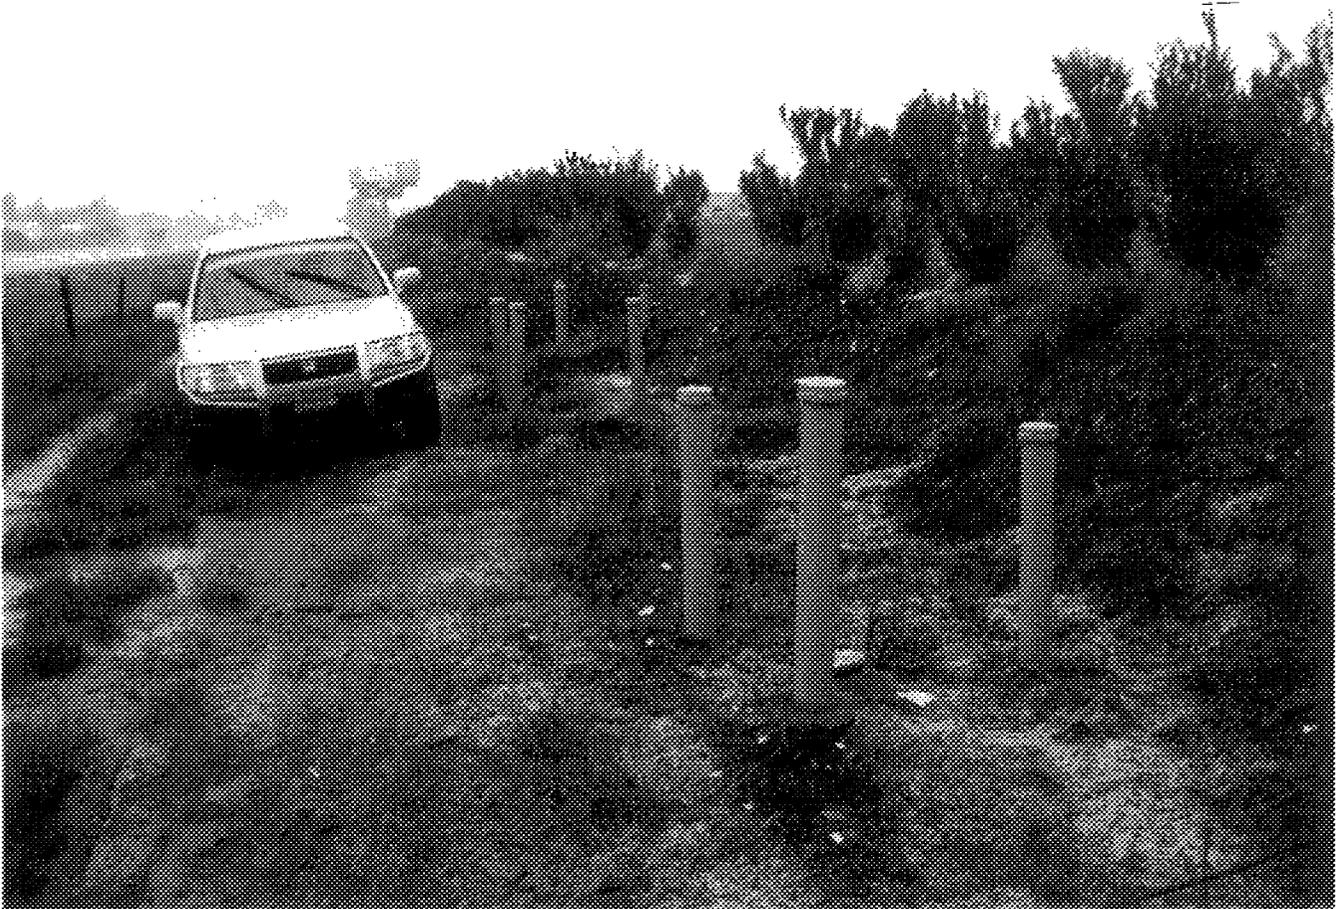
Photo 3 – Wells P2I, P2D, R25, better protection

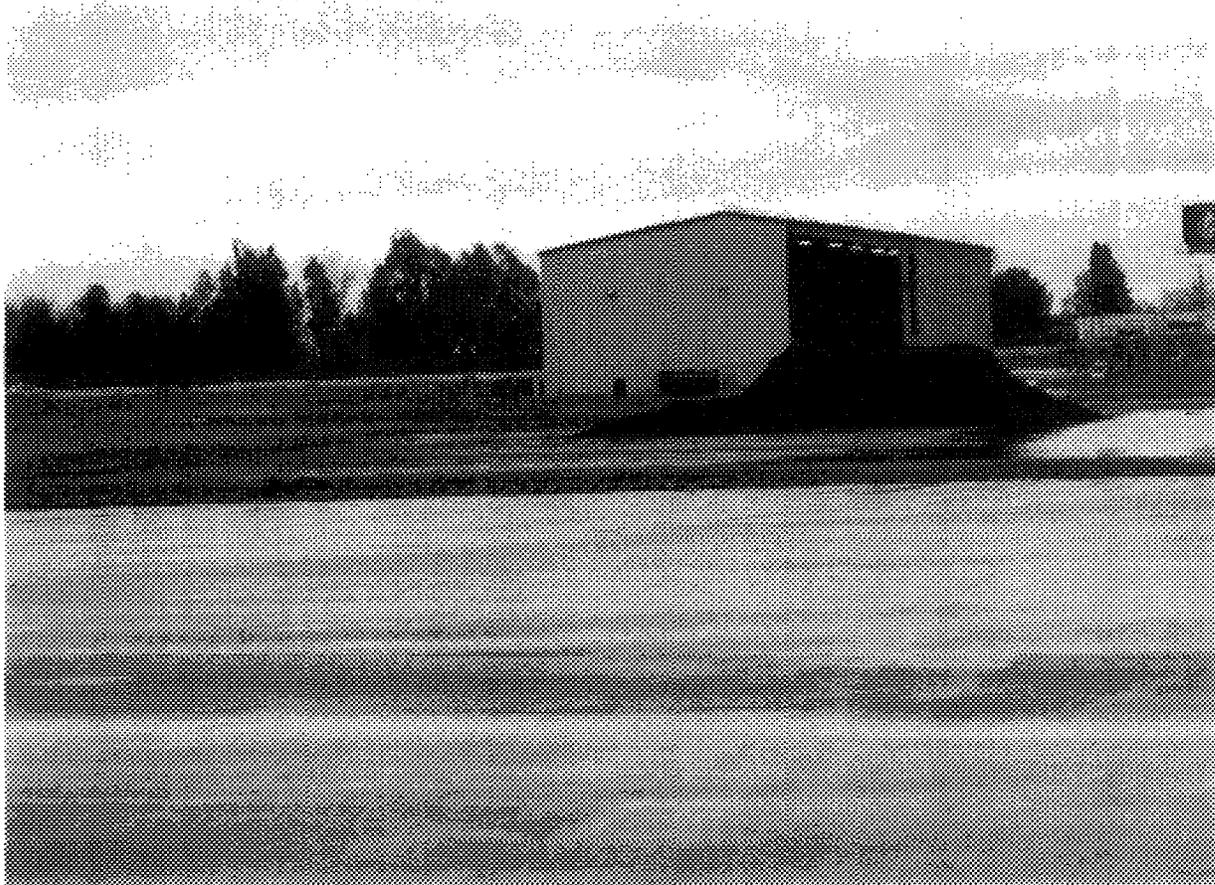
Photo 4 – Looking at east wall of treatment building. Asphalt rubble pile and drainage swale in foreground

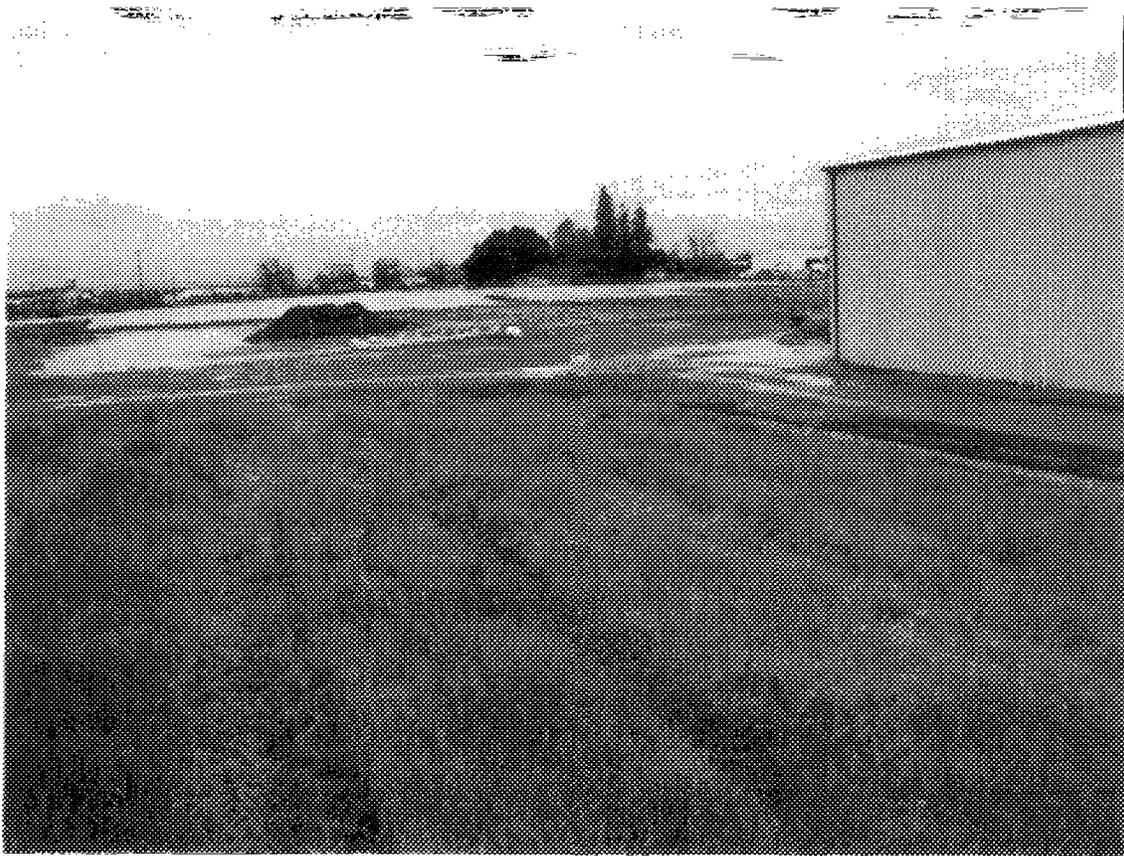
Photo 5 – Top of soil impoundment looking east toward asphalt paved soil remediation area

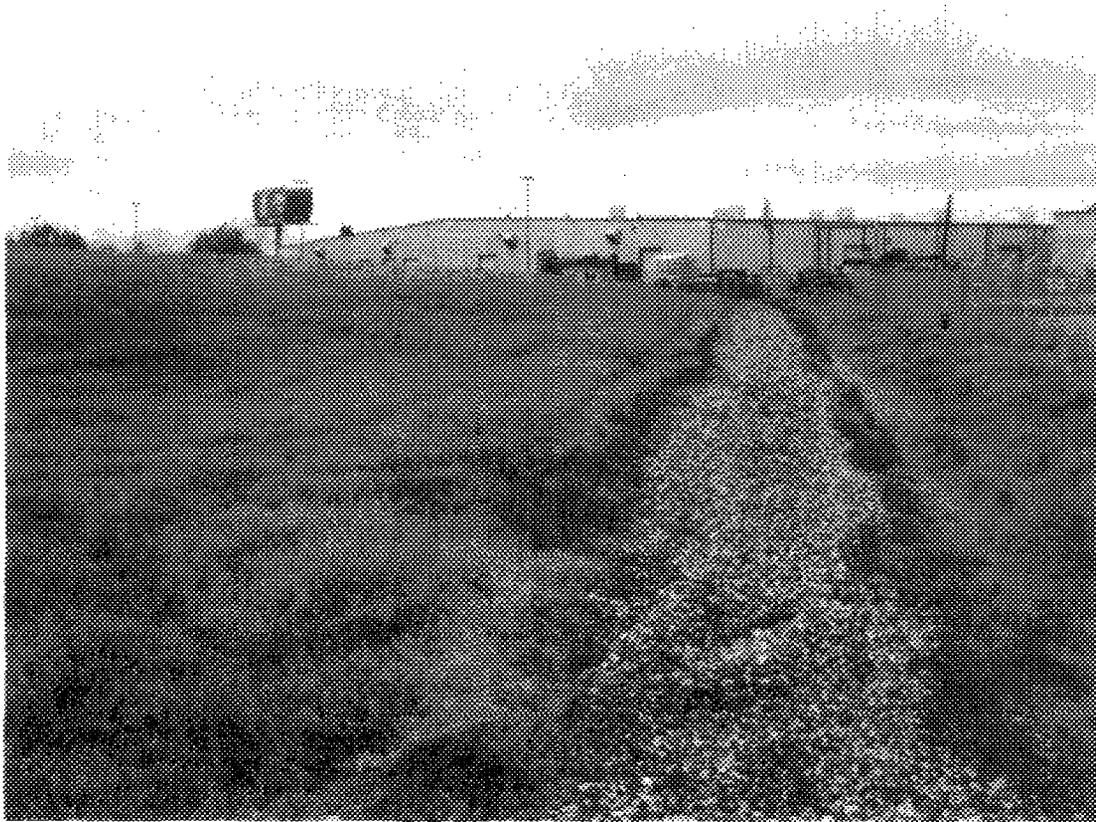
Photo 6 – North edge of soil impoundment looking west

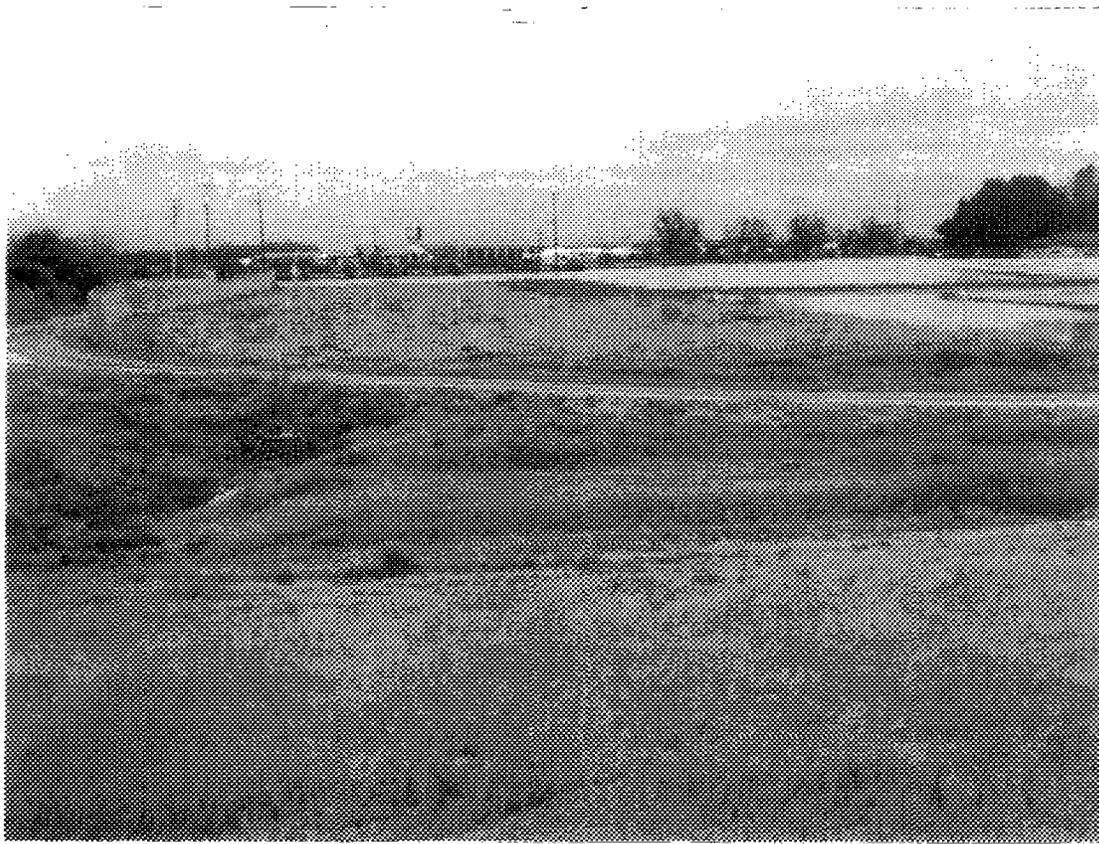
Photo 7 – Top of soil impoundment looking east toward access road and impoundment drainage culvert

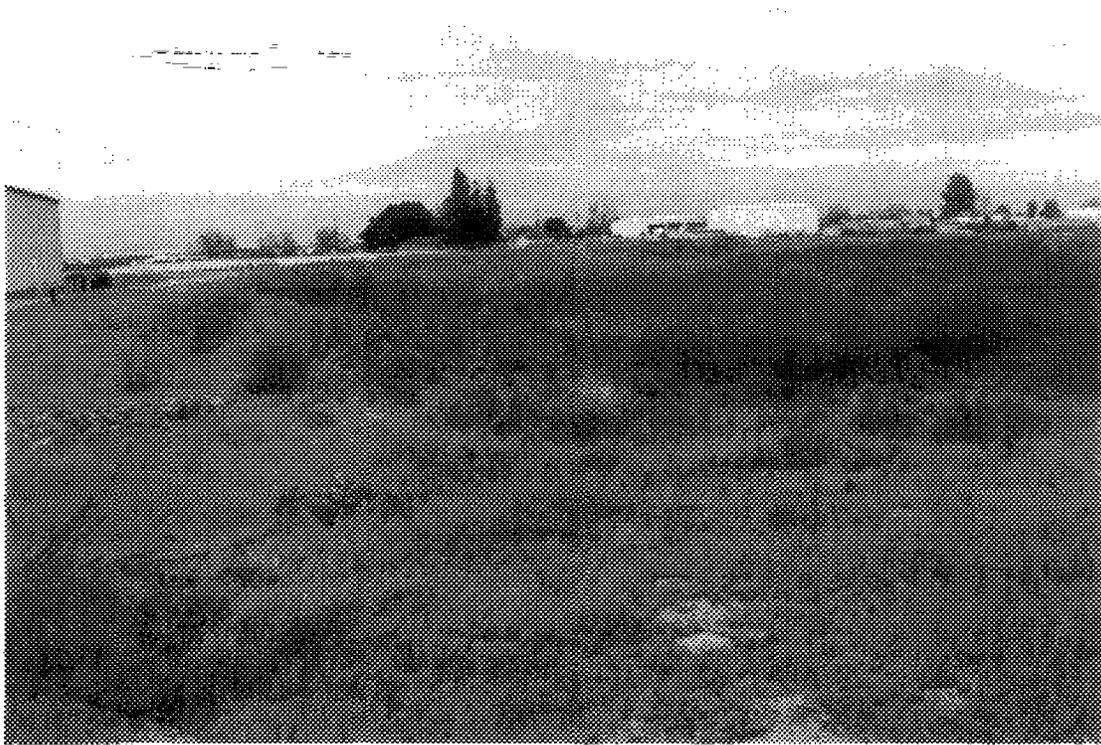
Photo 8 – Percolation ponds from west end looking east

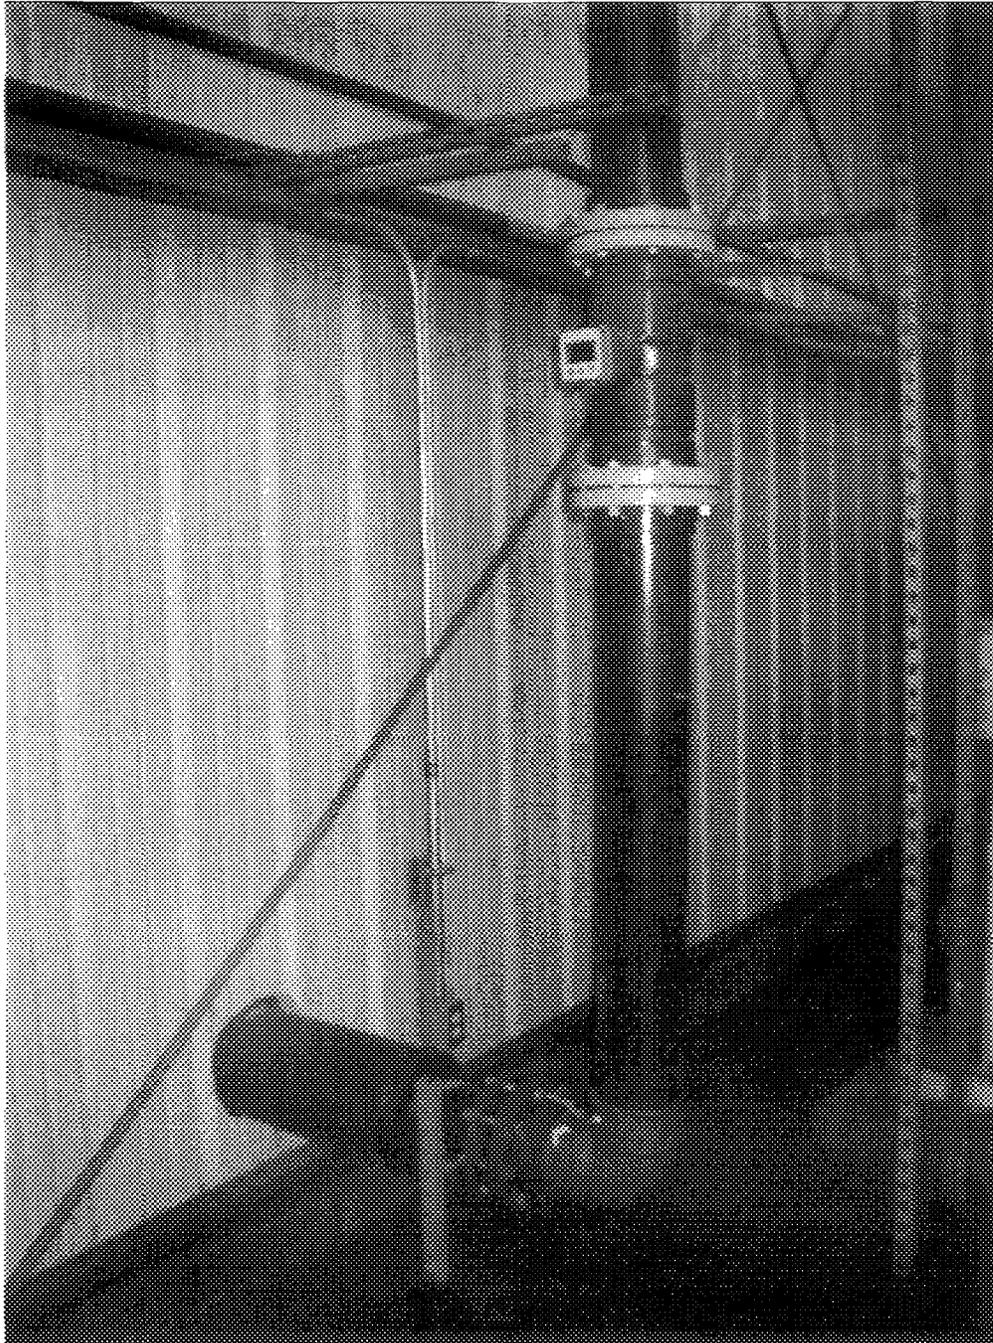
Photo 9 – Treatment plant influent line, flow indicator and sample tap

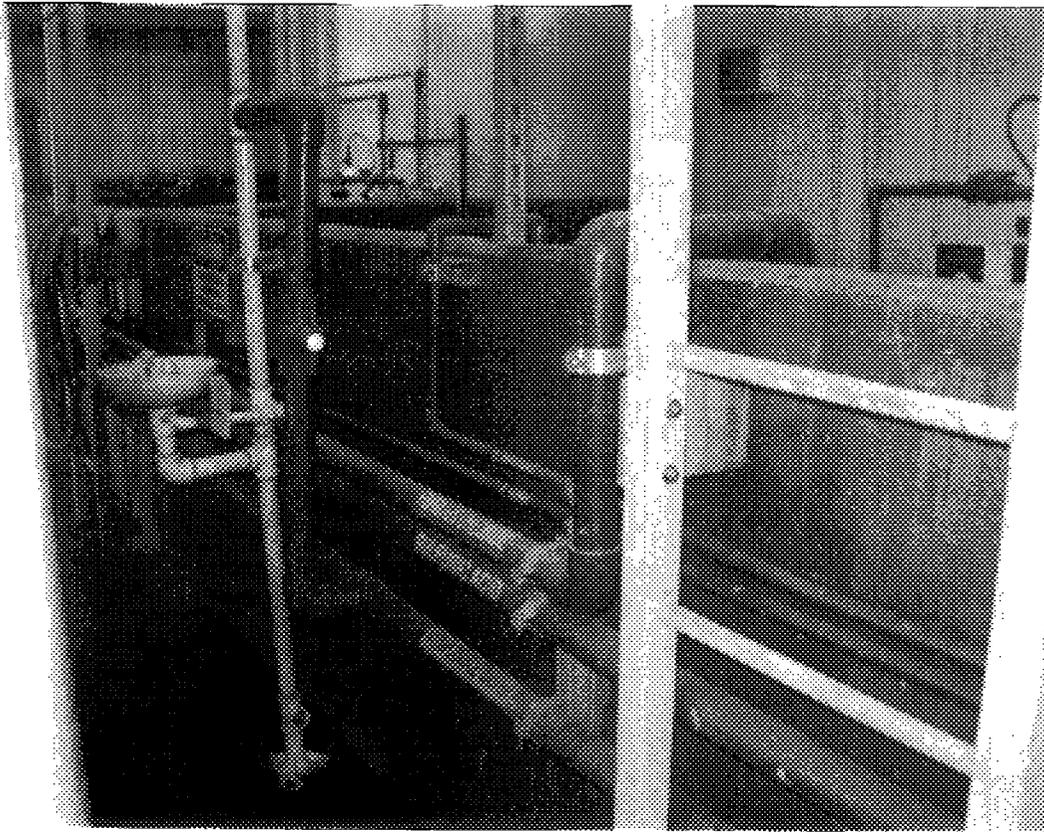
Photo 10 – Chemical tank containment area wall. Pipes labeled, eye wash present.

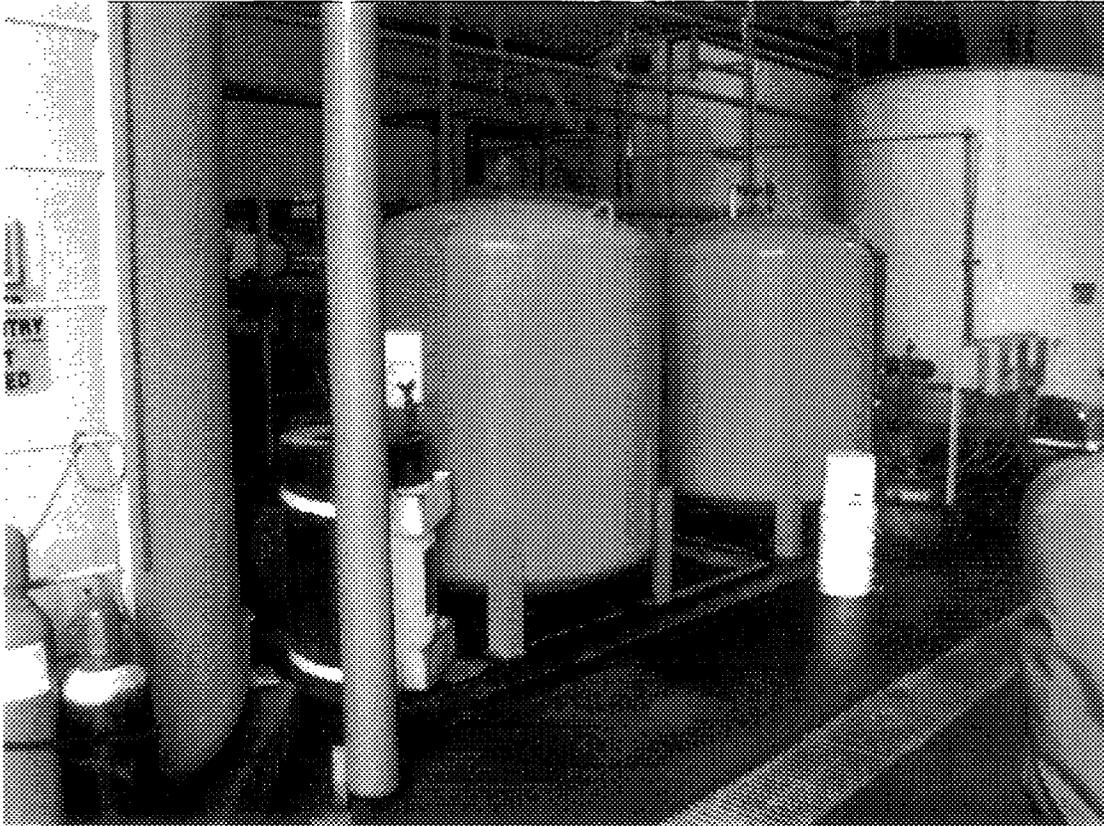
Photo 16 – Sand filters, remove last suspended solids before discharge

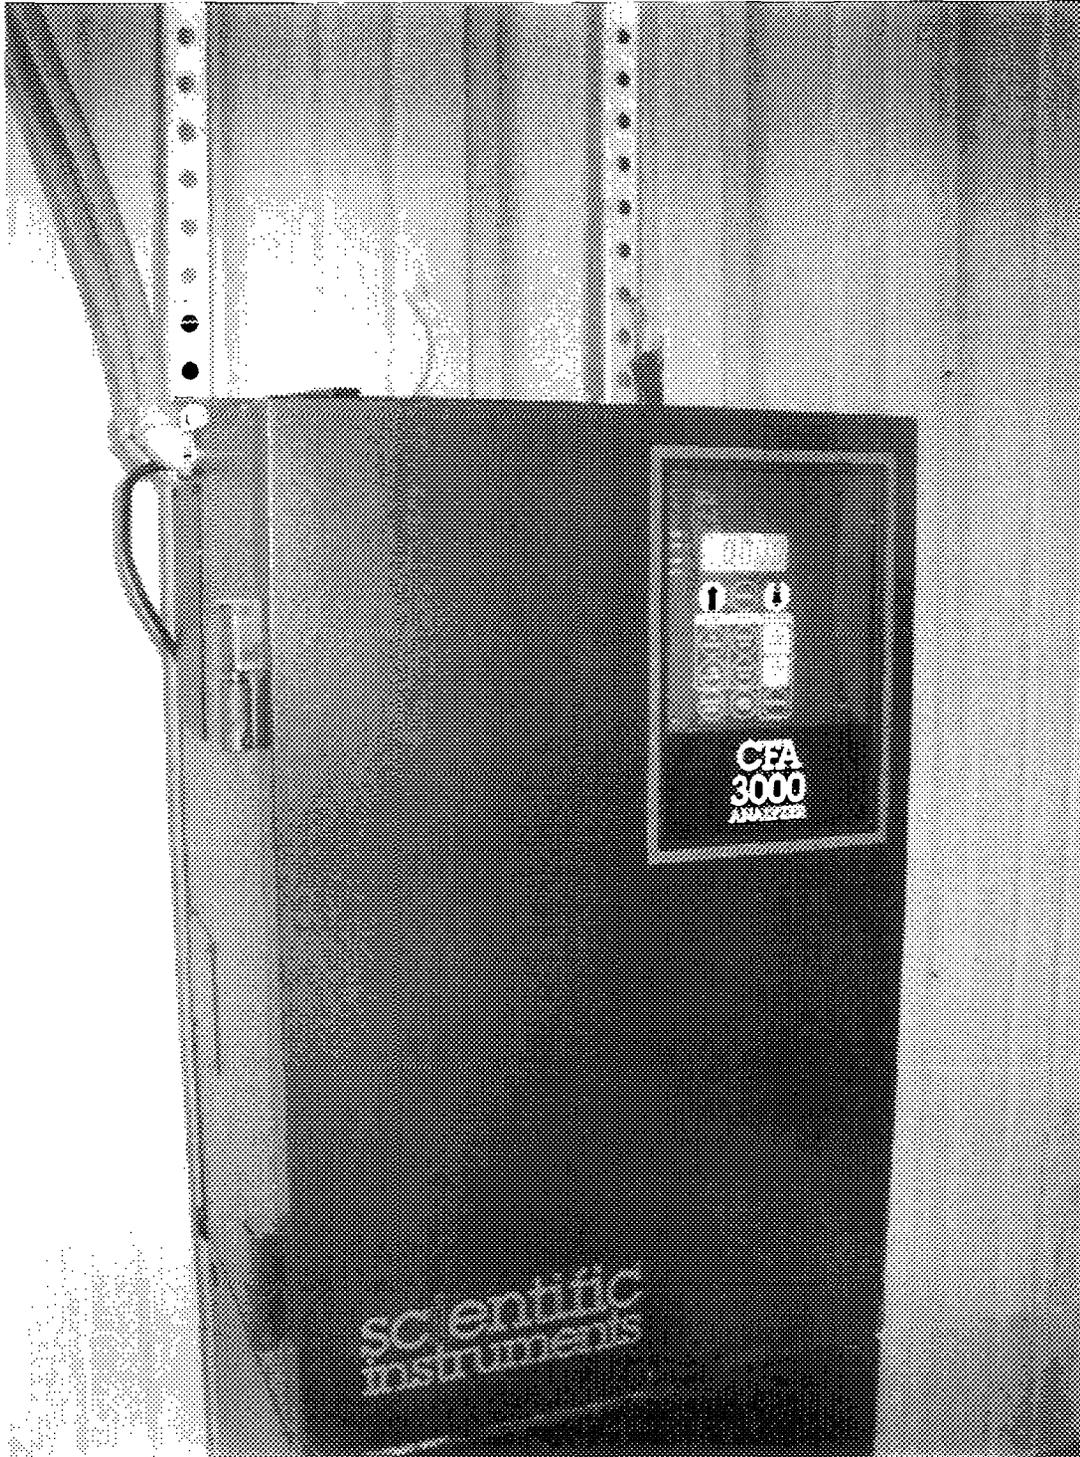
Photo 17 – Chrome analyzer on discharge line
