Mountain View Mobile Home Estates 2010 Five Year Review

Appendix H USACE Site Inspection Checklist

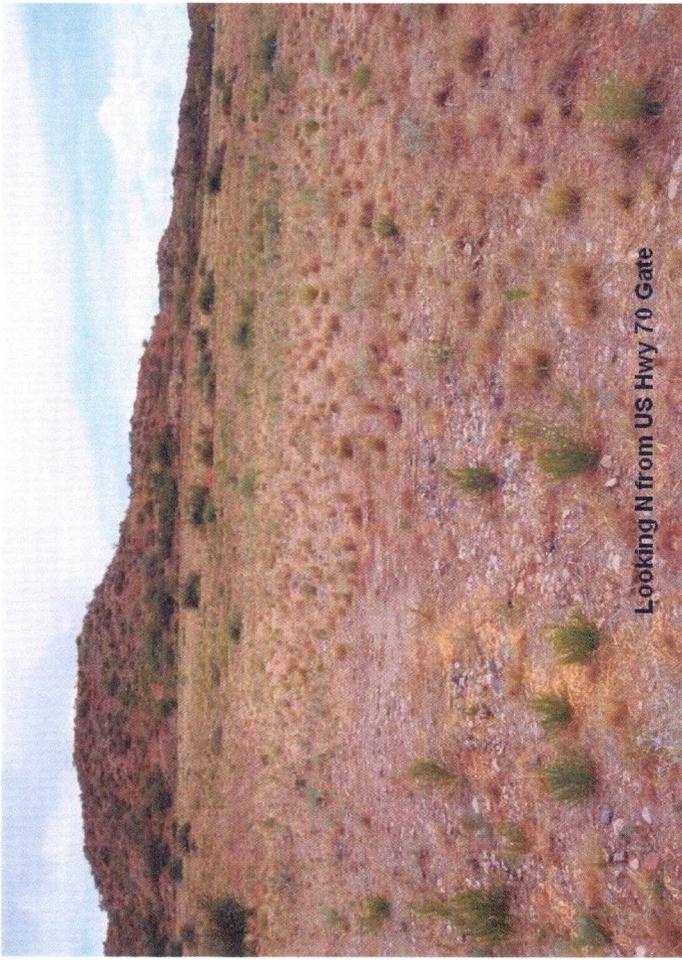
Looking N from US Hwy 70 Gate

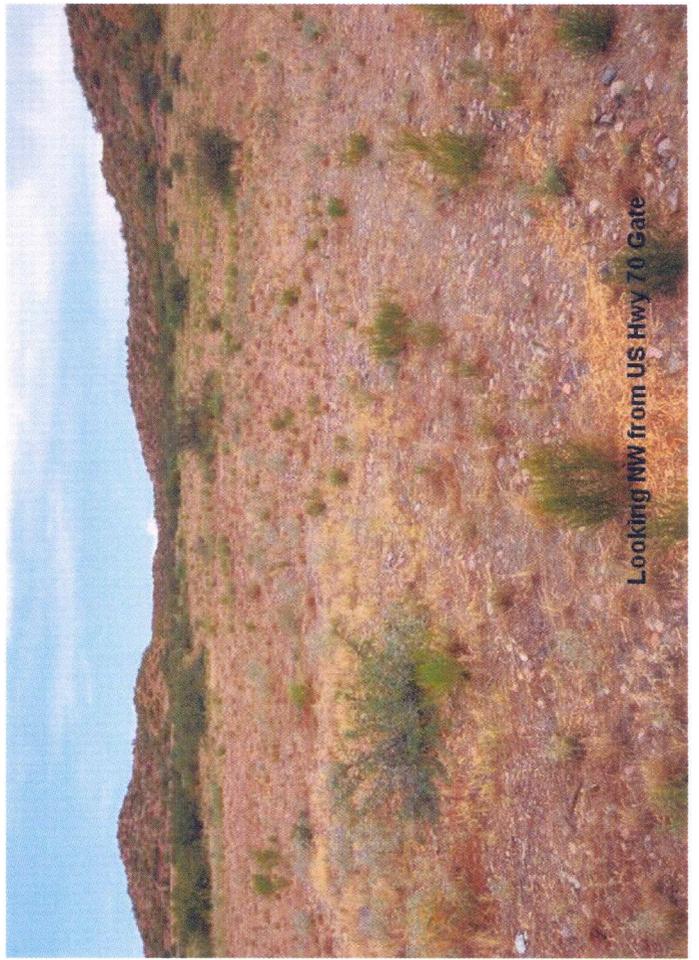
Looking NW from US Hwy 70 Gate

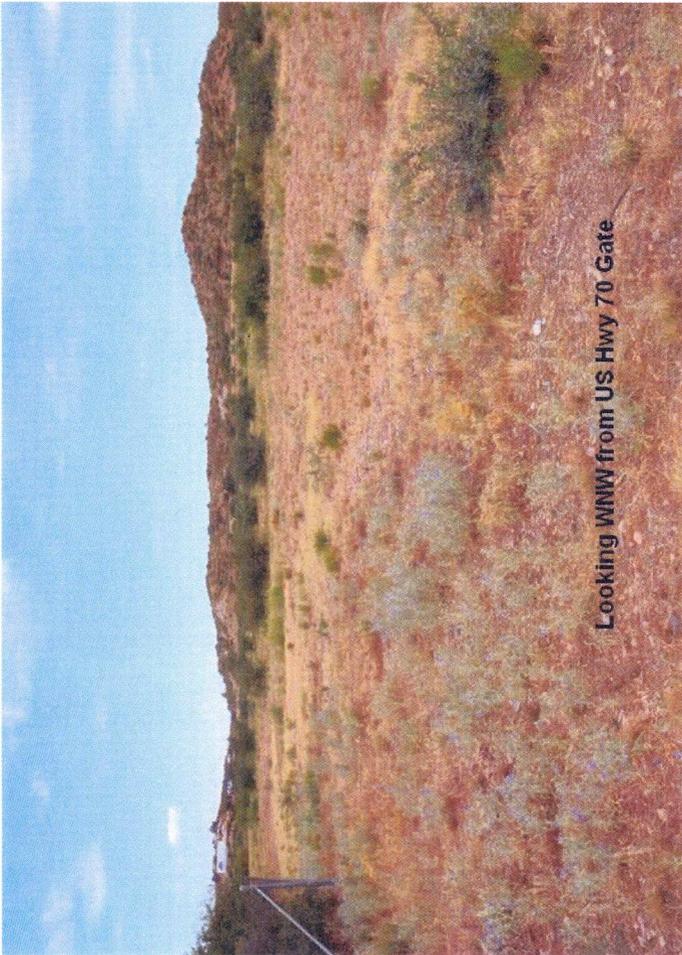
Looking WNW from US Hwy 70 Gate

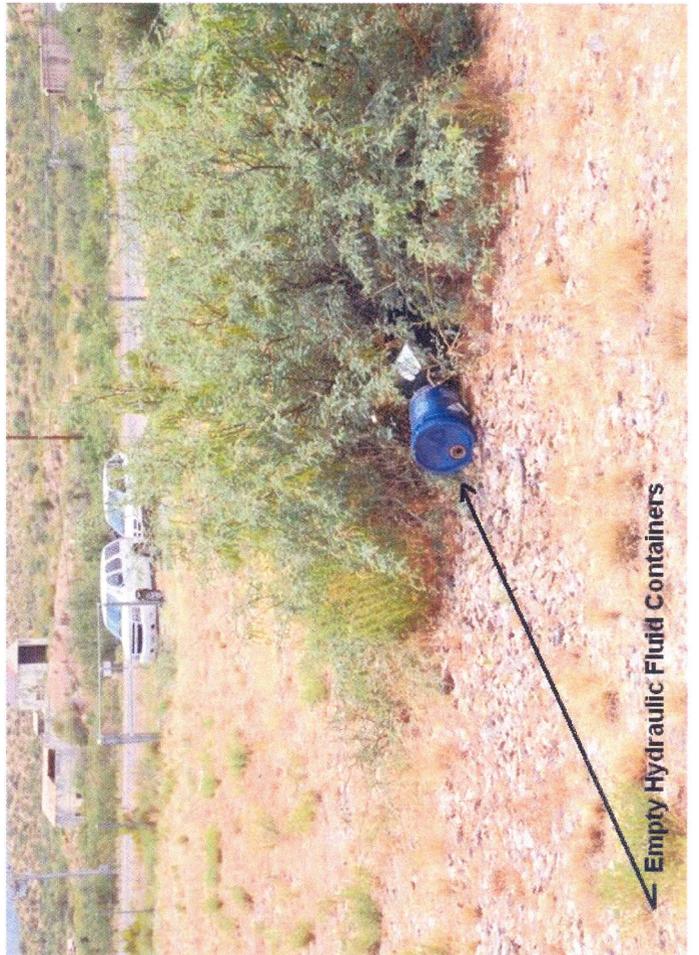
B. Adequacy of O&M				
Describe issues and observations related to the implementation and scope of O&M procedures. In particular, discuss their relationship to the current and long-term protectiveness of the remedy.				
<p><i>The current O&M is performed by ADEC contractors. O&M is adequate, however several issues were observed which require attention. This includes repair of fences damaged by mowers, storm events, and vandals. Also diversion channels and storm drains require the removal of silt & debris. Regular mowing is performed to minimize growth of large plants. State maintenance contractor appears to be using the site for improper storage/disposal of used hydraulic fluid containers. Fence and drainage grates need repair to maintain site access control. (See Photos).</i></p>

← Empty Hydraulic Fluid Containers

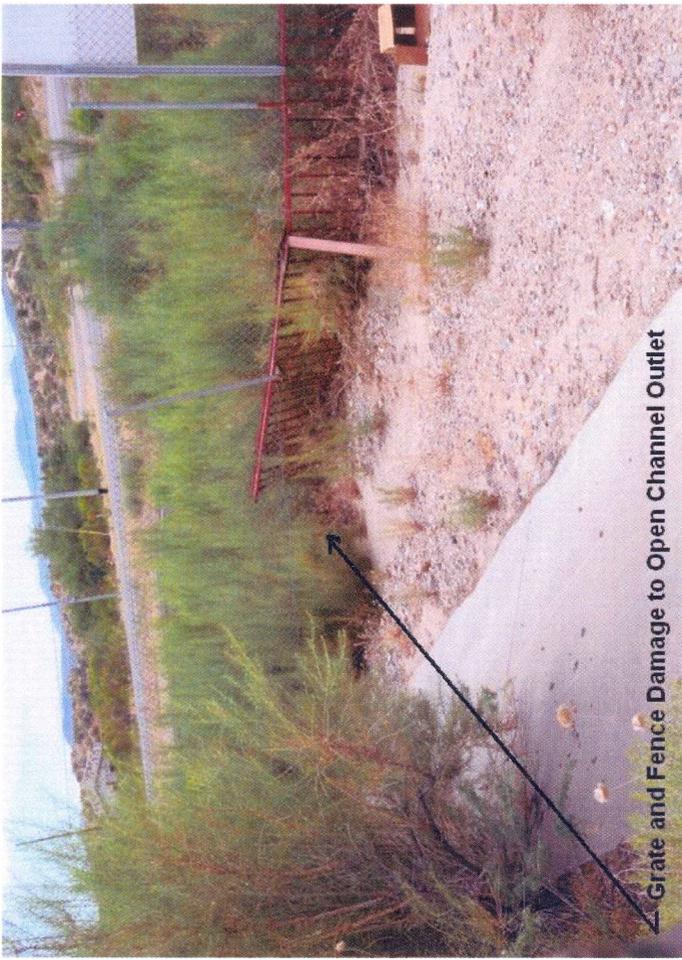
← Grate and Fence Damage to Open Channel Outlet

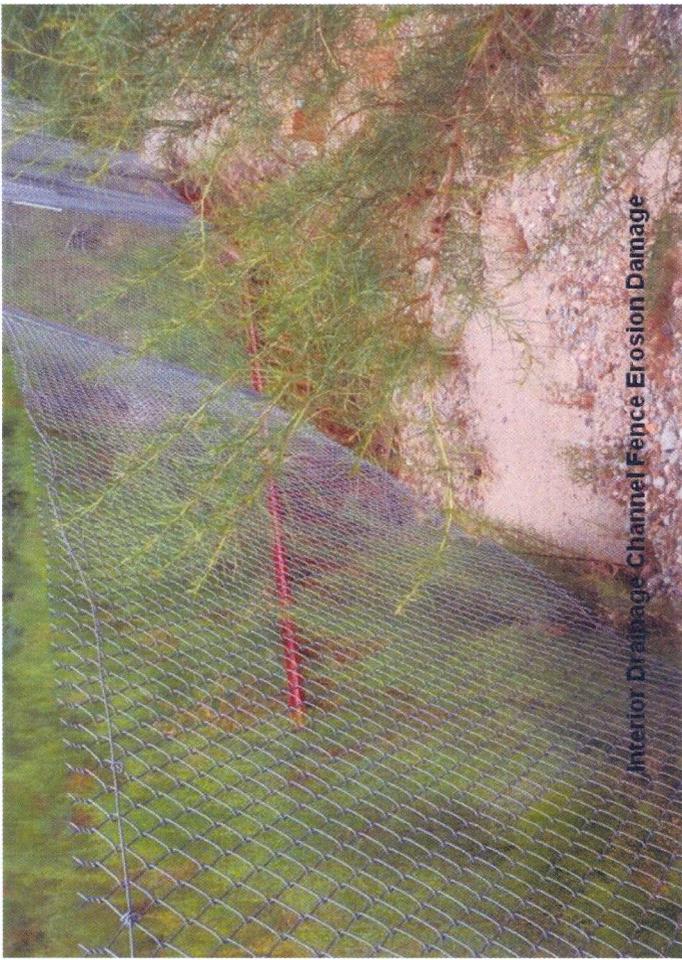
Interior Drainage Channel Fence Erosion Damage

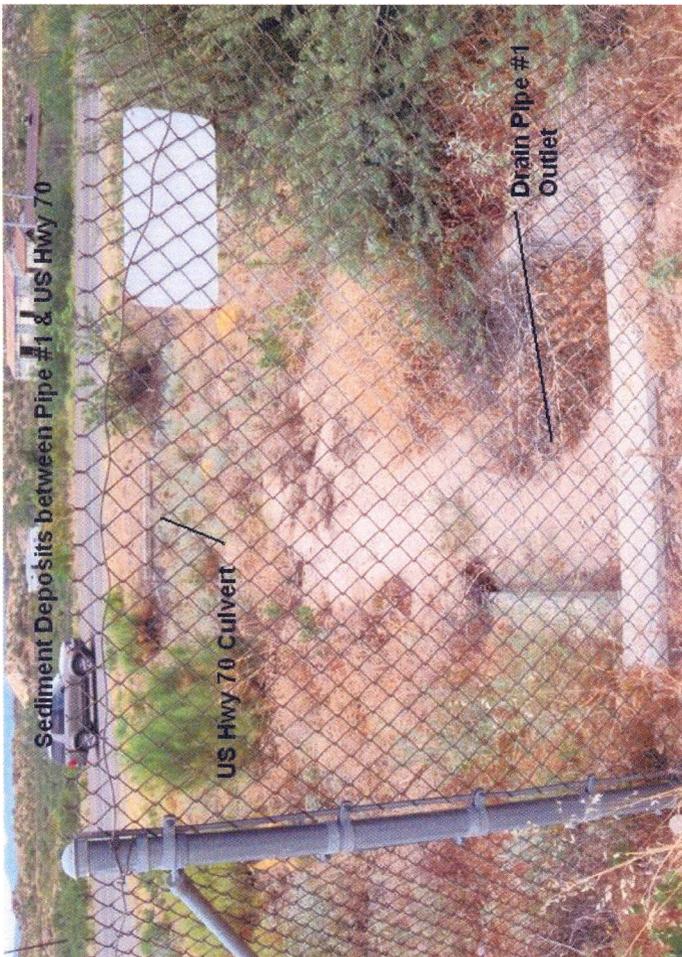
2.	Surface Water Collection System Pipelines, Valves, Valve Boxes, and Other Appurtenances Good condition <u>Needs Maintenance</u>		
Remarks <u>Periodic sediment & debris</u> _____

Sediment Deposits between Pipe #1 & US Hwy 70

US Hwy 70 Culvert

Drain Pipe #1 Outlet

*Storm drainage pipe should be checked for possible
plugs up gradient of the RR tracks (pipeline #1)*

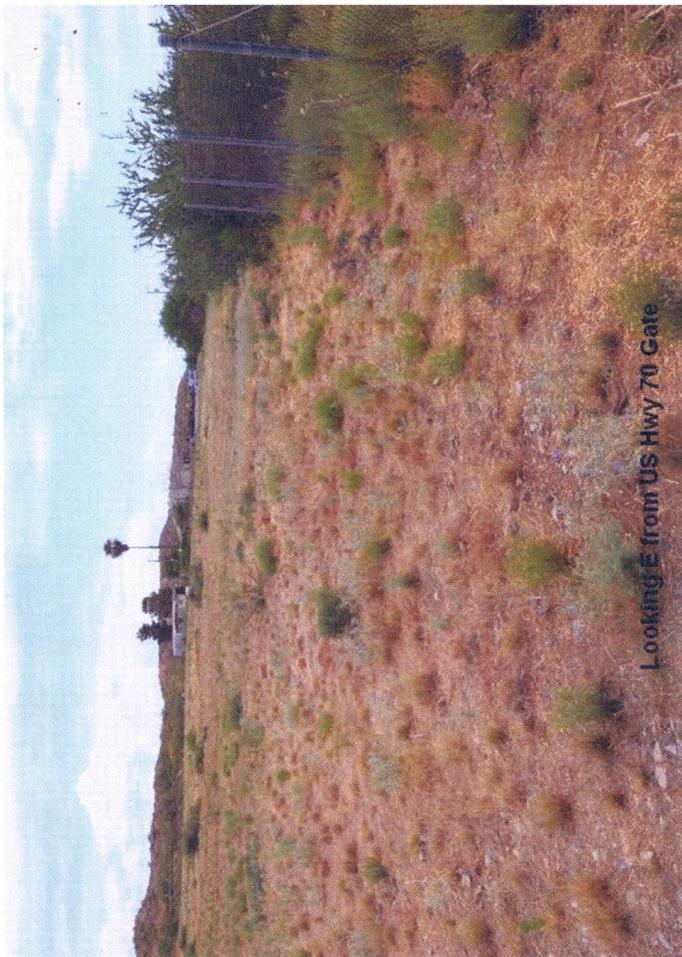
Looking E from US Hwy 70 Gate

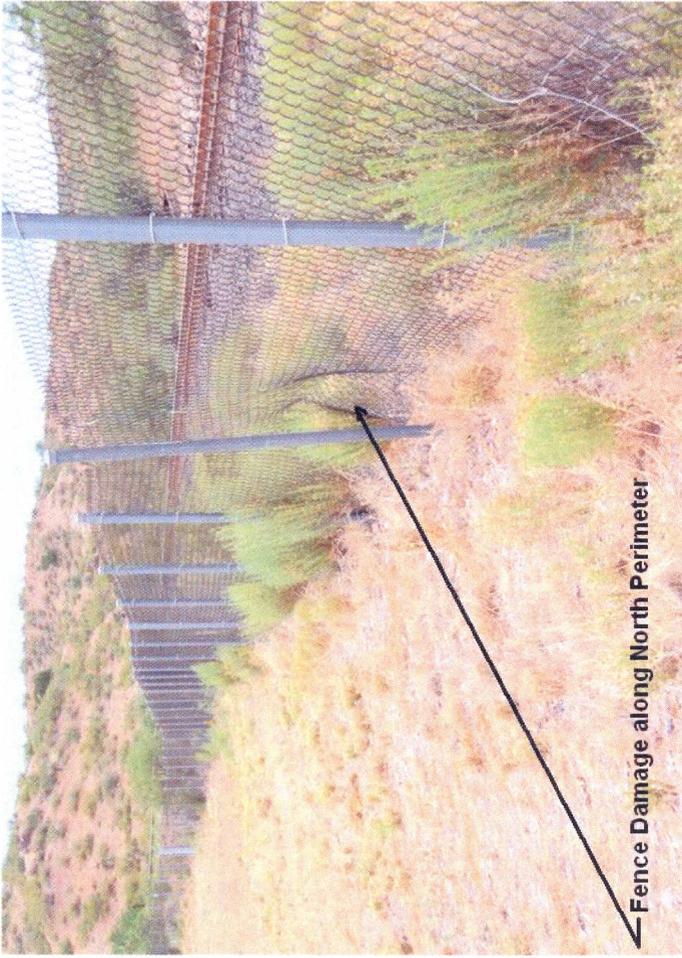
Fence Damage along North Perimeter

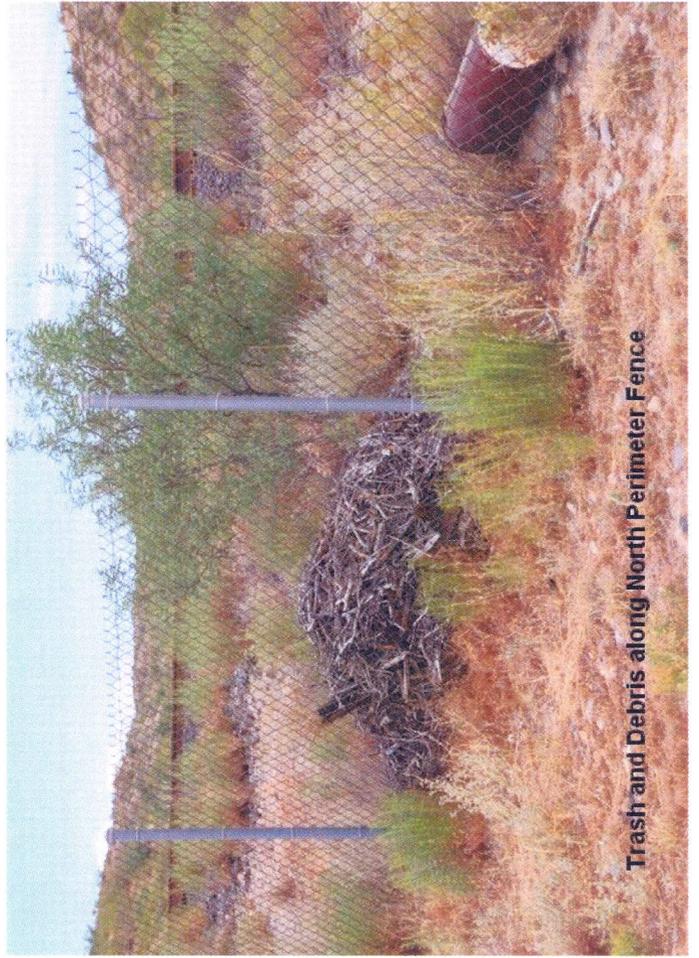
Trash and Debris along North Perimeter Fence

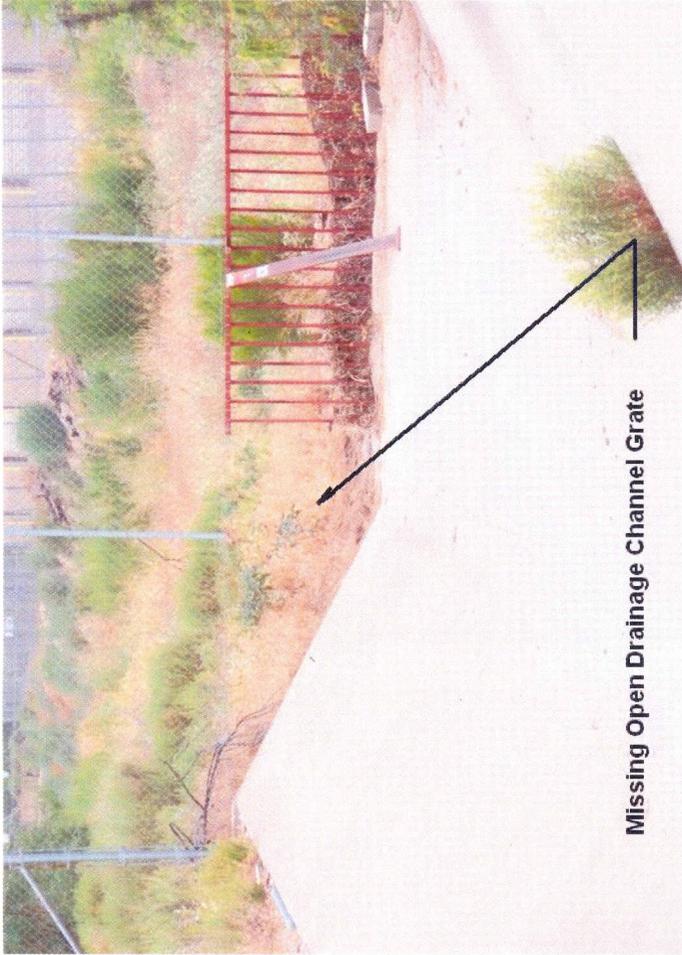
Missing Open Drainage Channel Grate

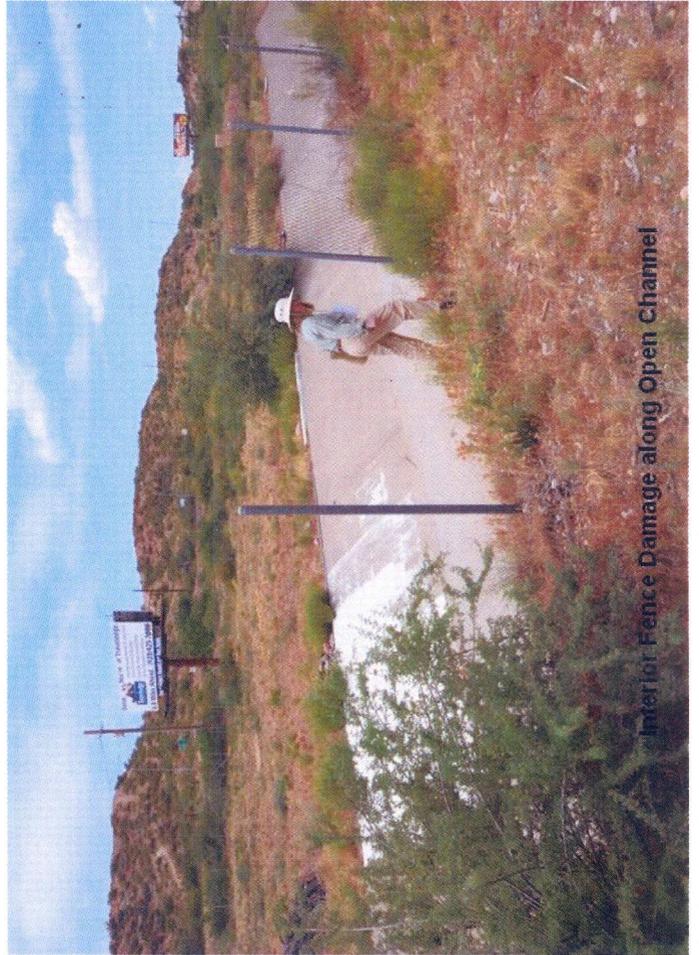
Interior Fence Damage along Open Channel
