Appendix G
Site Inspection Technical Memorandum,
Checklists, and Photographs

Site Inspection Checklists for the 5-year Reviews of the Atlas Asbestos Mine and Coalinga Asbestos Mine Superfund Sites

PREPARED FOR: United States Environmental Protection Agency
 PREPARED BY: Alexa Stamets/CH2M HILL
 DATE: May 18, 2006

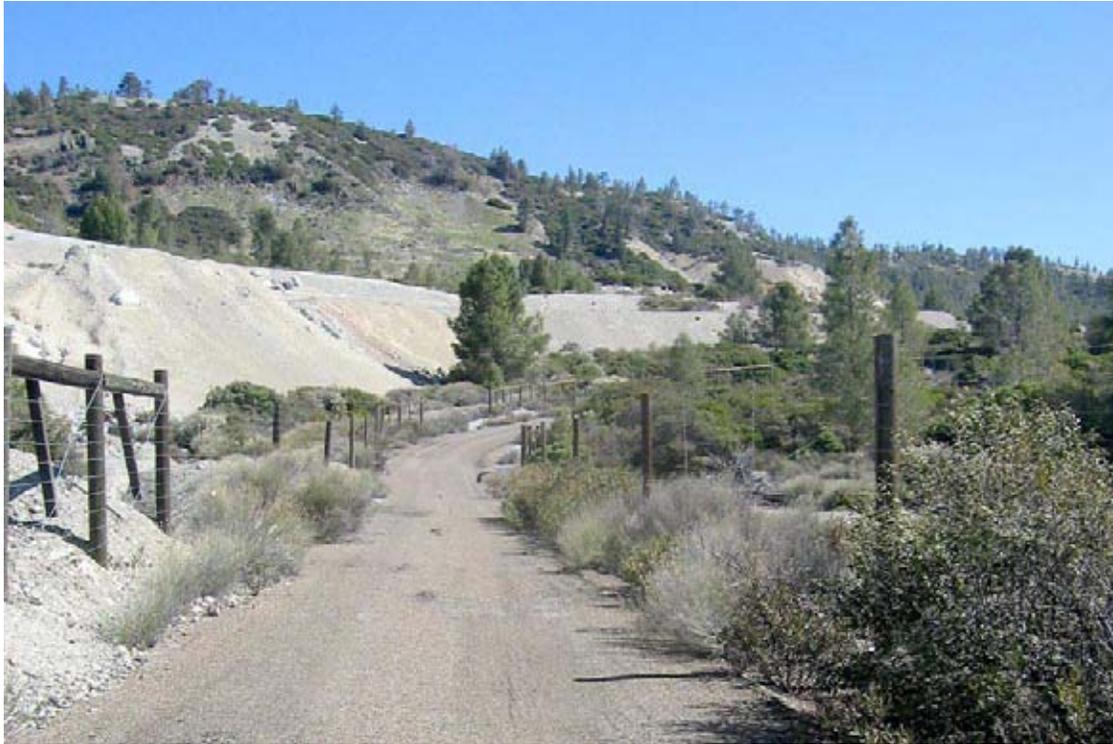
Access road from the south of the site, extending along Pond C.

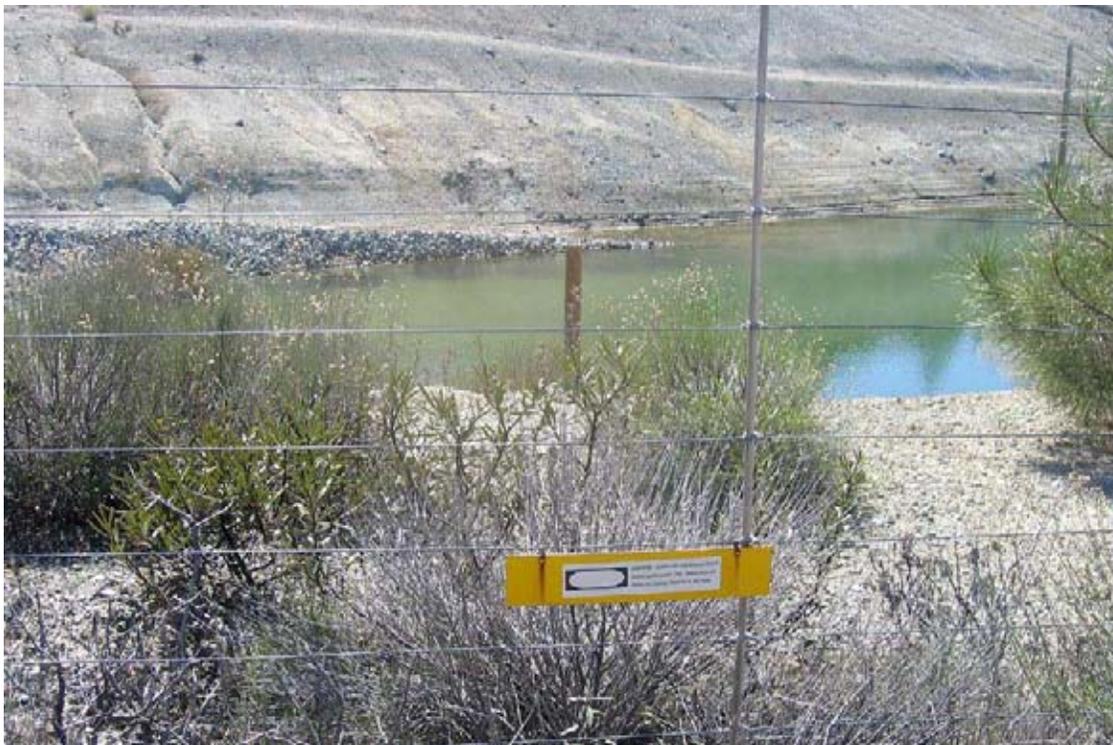
Fencing outside Pond C. Sign reads "ASBESTOS - Cancer and Lung Disease Hazard, Authorized Personnel Only, Respirators and Protective Clothing Required in this Area."

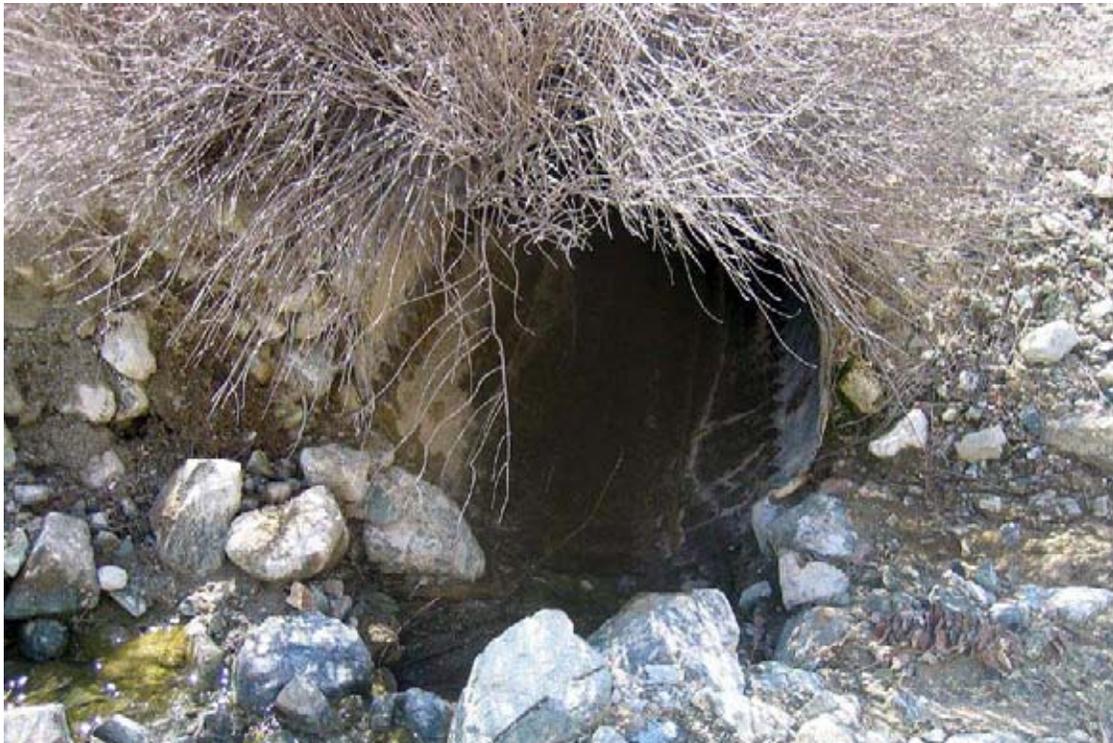
Culvert extending beneath the access road to Pond C. No significant sediment or vegetation was observed at the inlet to the culvert during the site inspection.

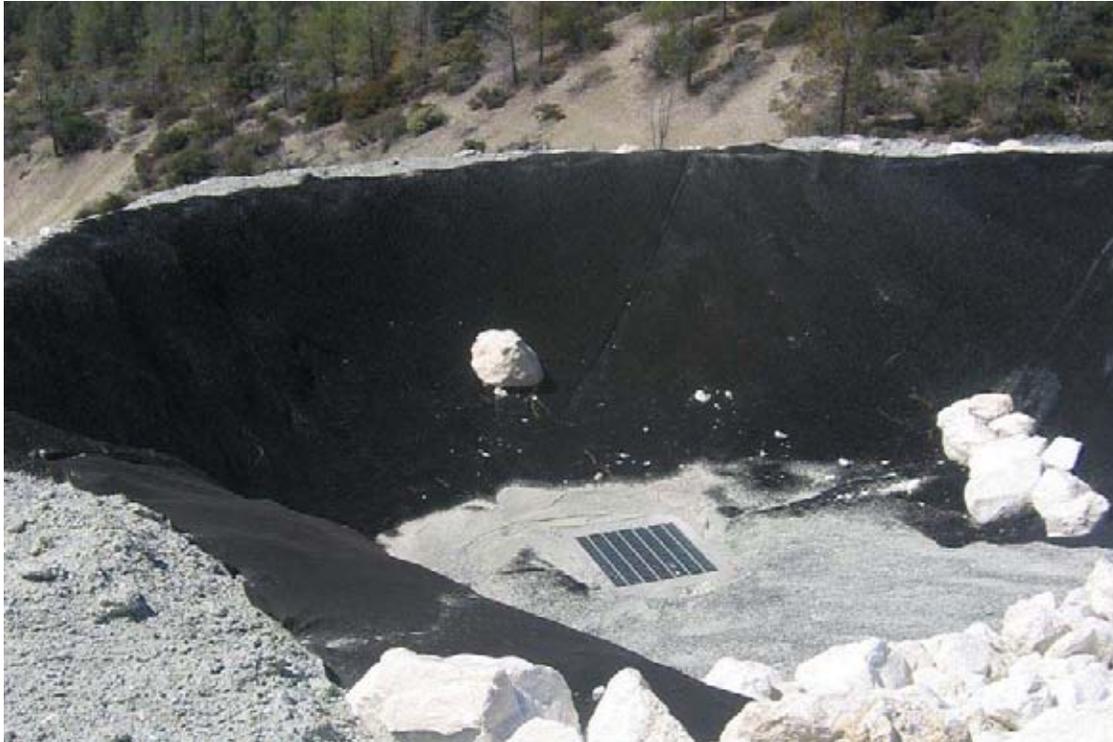
Gully on the southern face of the tailings pile, repaired during 2005 maintenance activities. Surface water is conveyed down the tailings pile through subsurface piping via the surface water catchment shown in the photograph. Drain rock and berms prevent erosion from occurring in this area.

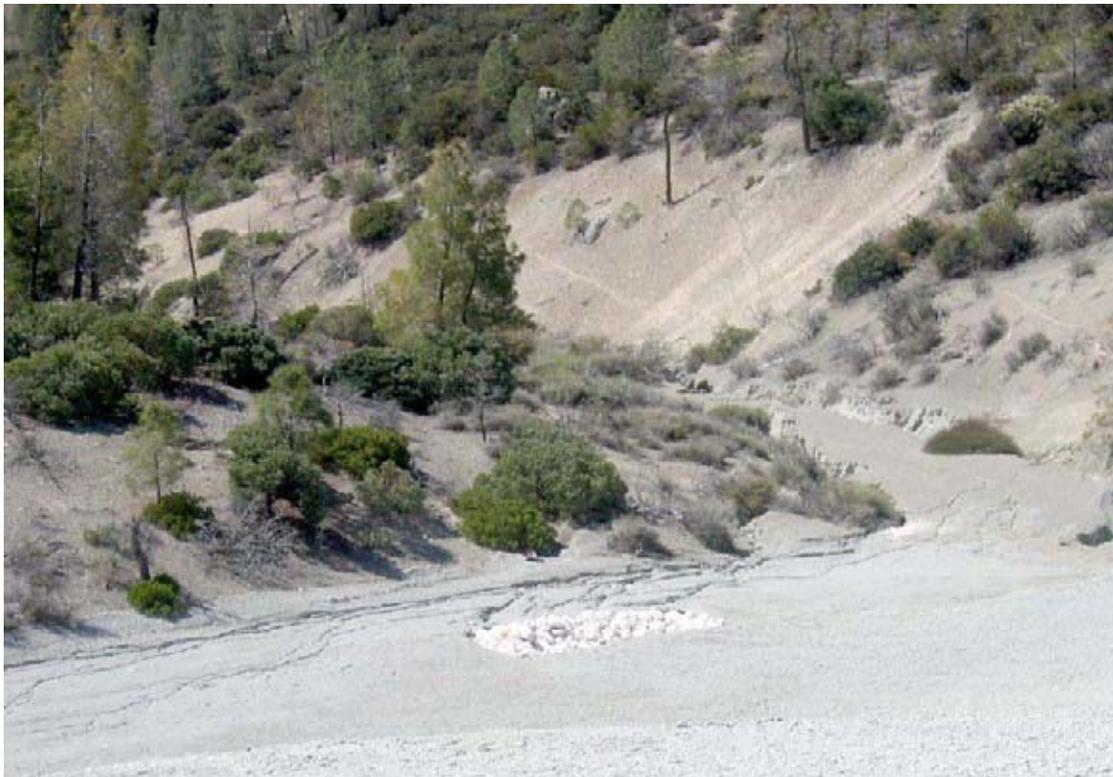
Rills extend downstream from the outlet of the subsurface piping at the bottom of the tailings pile.

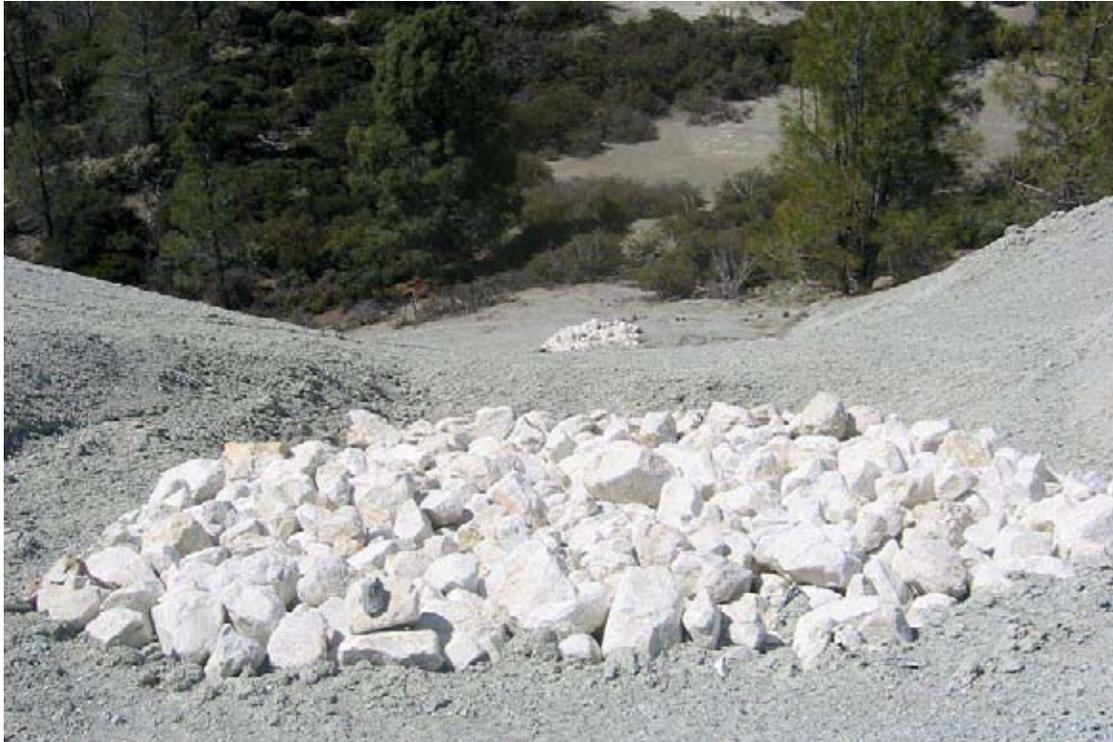
Drain rock installed during 2005 maintenance activities to prevent erosion from occurring on the southern face of the tailings pile.

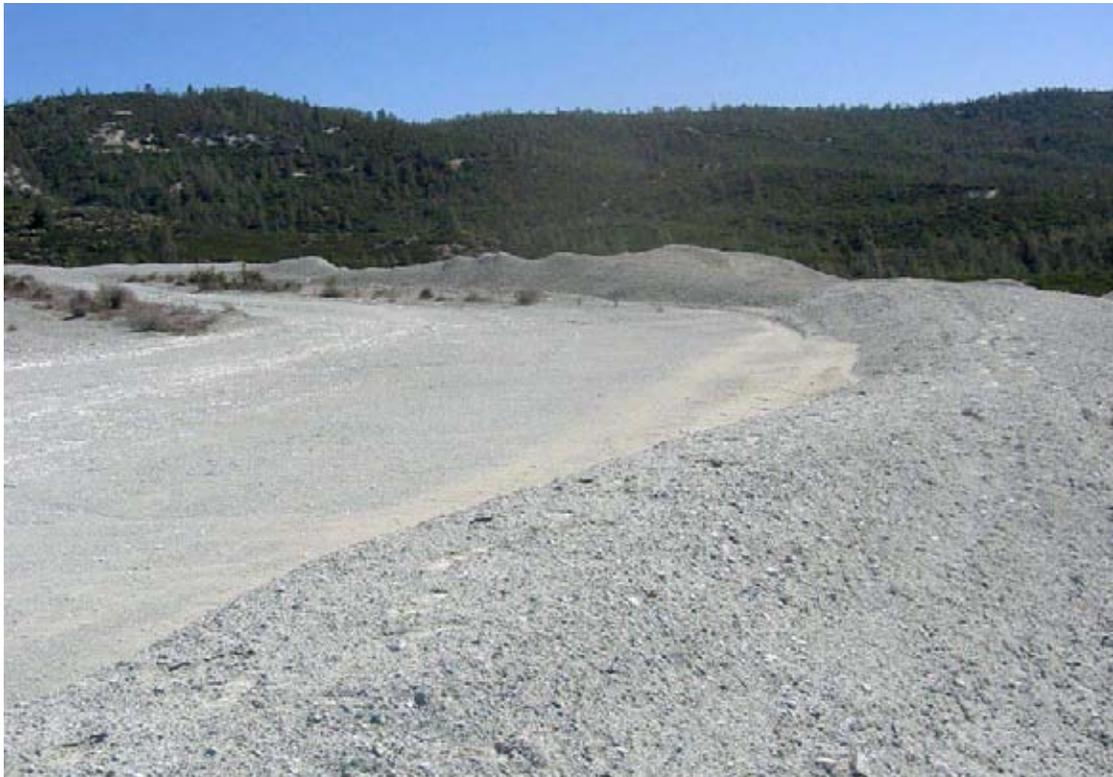
Berm installed south of the Regional Sediment Storage Area to prevent erosion from occurring.

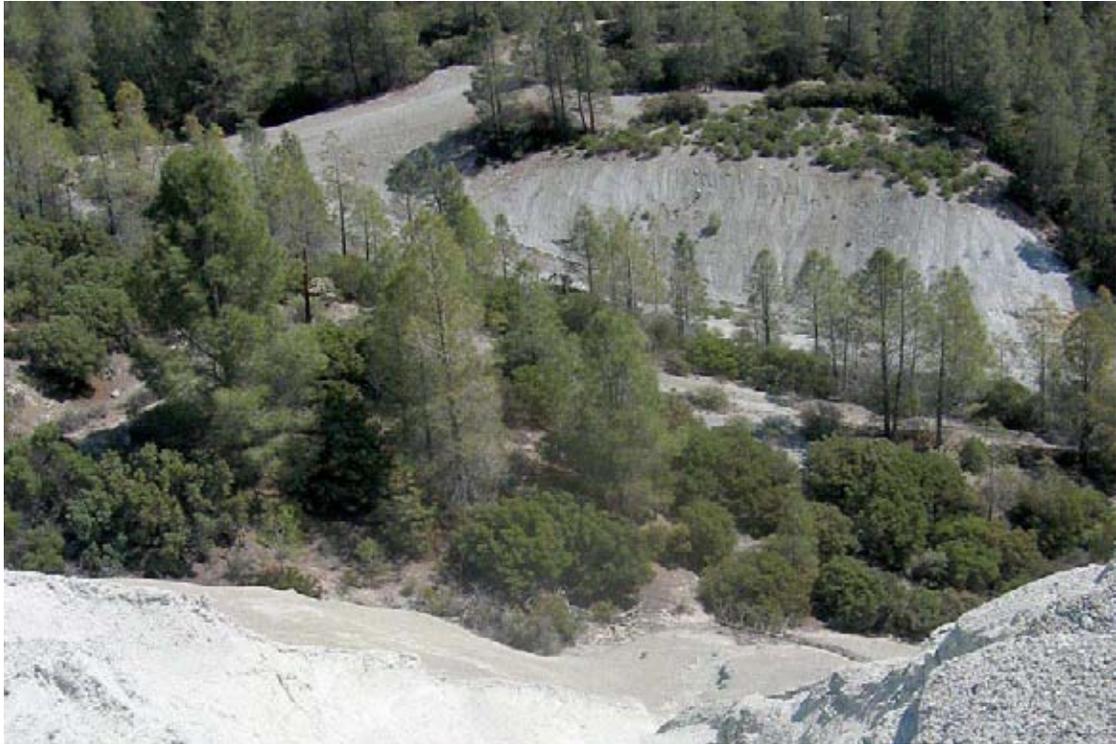
Gully on eastern slope of tailings pile (Channel B in the background).

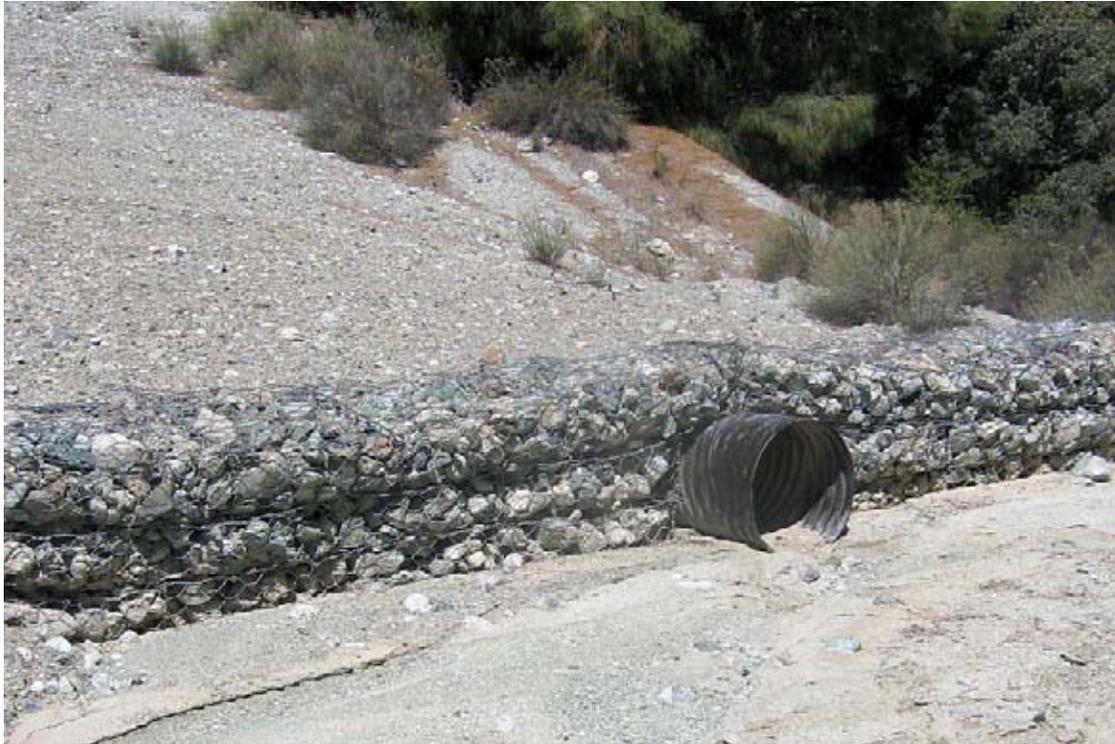
Sediment trap area at the discharge outlet of Pond G, upstream of Channel B. No sediment buildup was observed in the outlet.

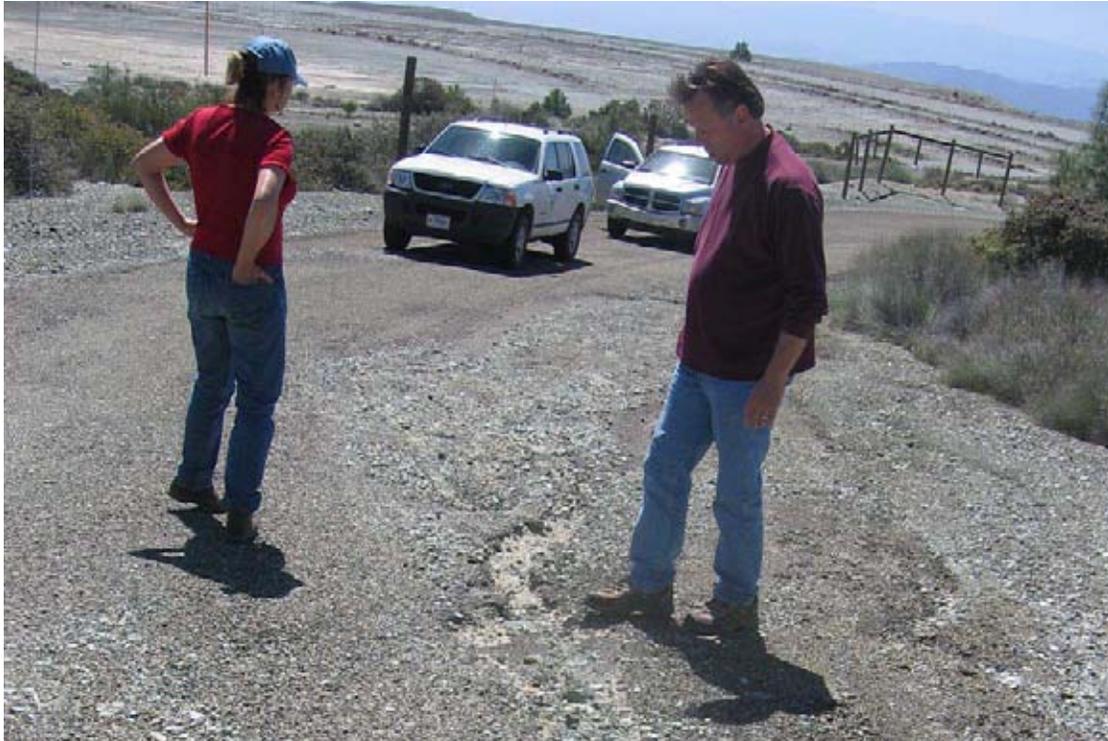
2.	Cracks	Location shown on site map	Cracking not evident <input checked="" type="checkbox"/> N/A
	Remarks:		
3.	<input checked="" type="checkbox"/> Erosion	Location shown on site map	Erosion not evident
	Remarks: Much of the erosion across the site has been mitigated by installation of drain rock, berms, subsurface piping for conveying surface water, surface water diversion structures, and vegetation. Erosion continues to occur on the roads to Pond A (at the highwall slope of Pond B) and Rover Pit/Channel A.

Erosion along southern side of road extending to Pond A.

Alternative routes to Pond A and Rover Pit/Channel A should be identified in the event that erosion/sliding continue to occur along the existing roads to Pond A and Rover Pit/Channel A.

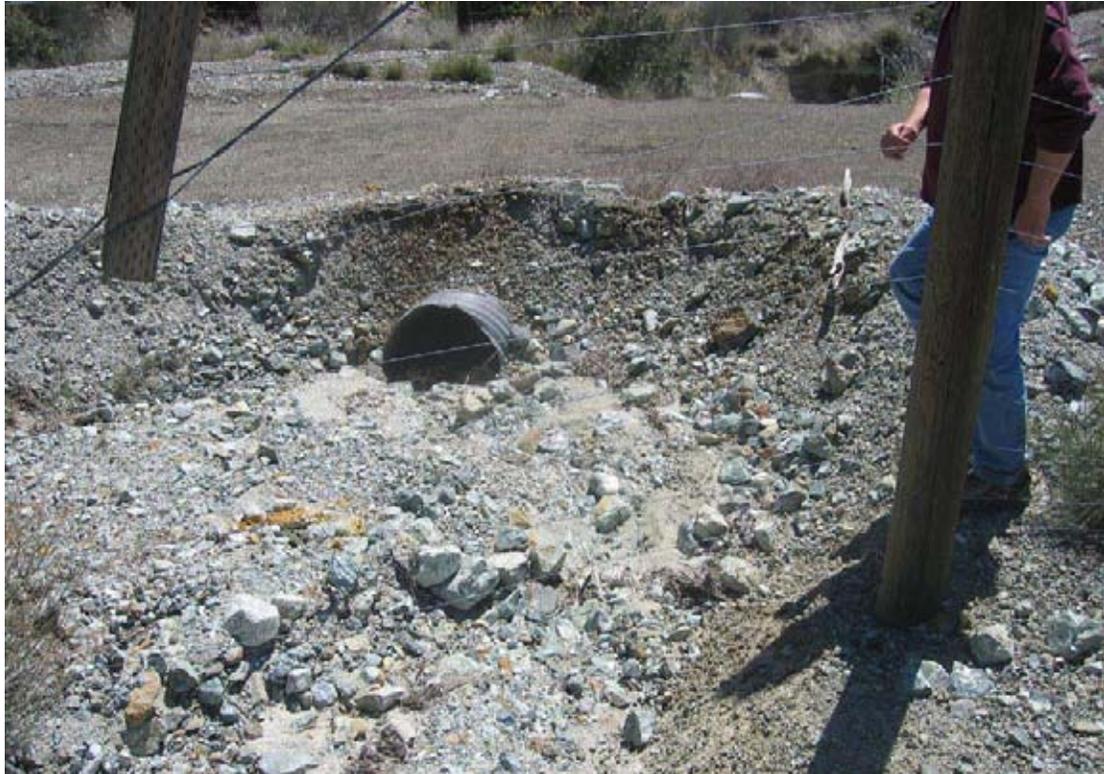
Culvert at the end of the drainage channel along the road to Pond A. The culvert inlet is approximately 50% blocked by sediment and vegetation.

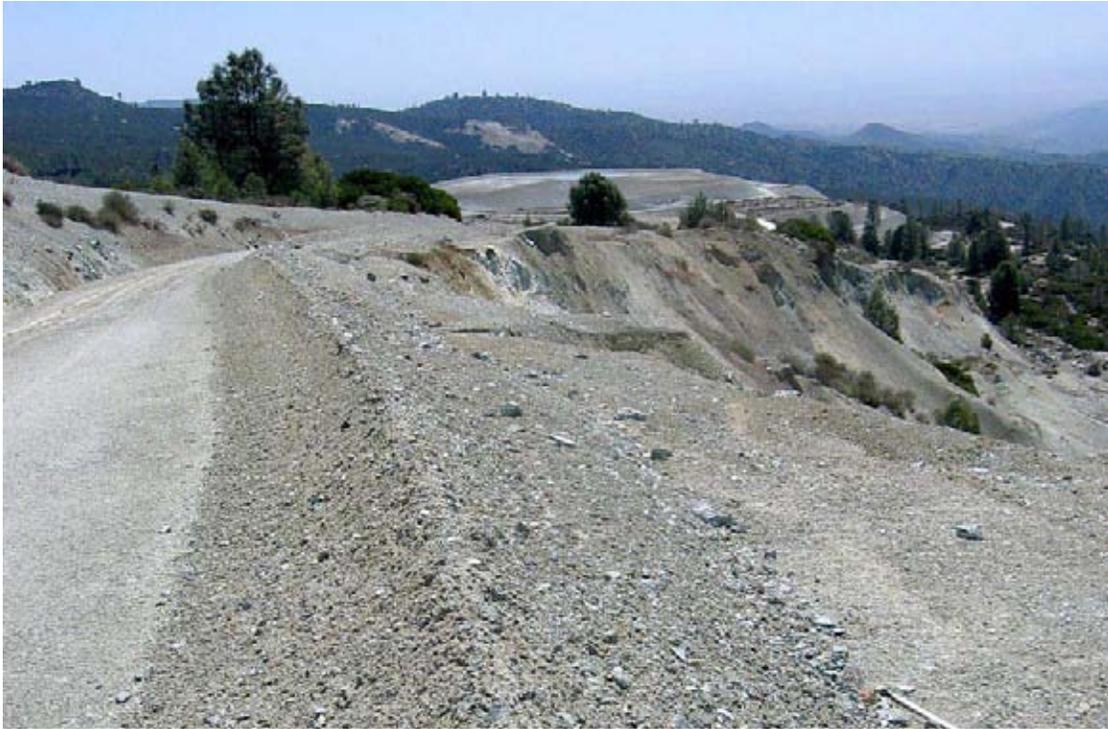
Berm installed along the access road to Pond A to prevent erosion on the highwall slope above Pond B.

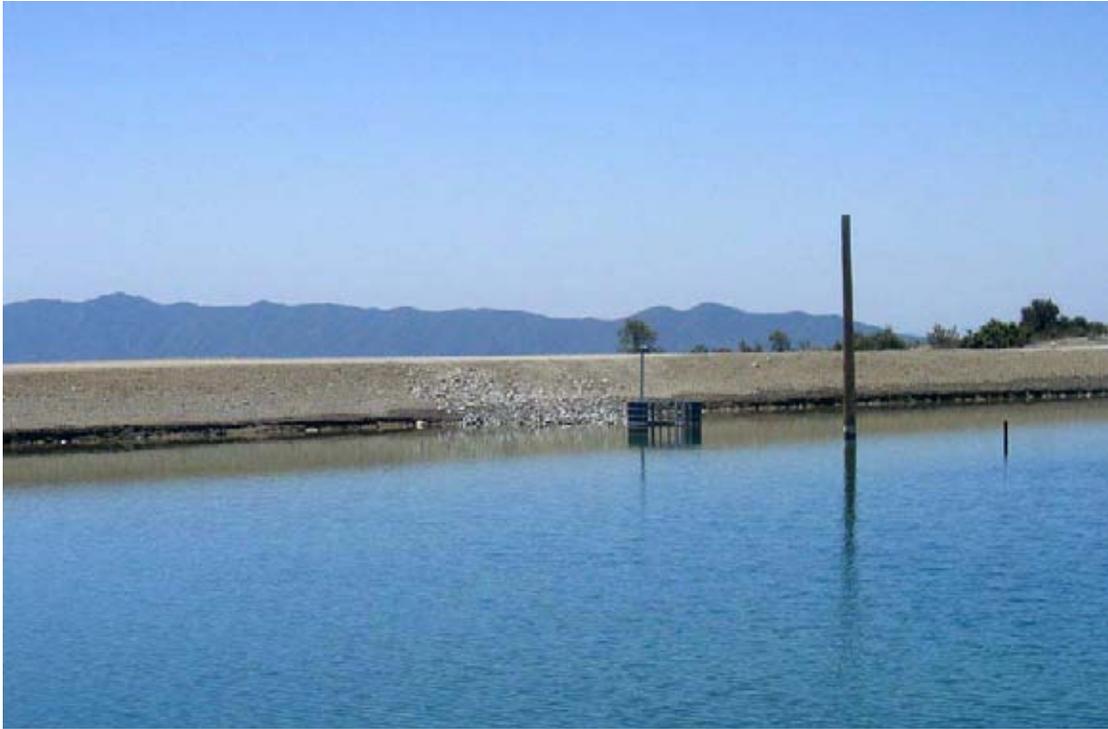
Pond B. Volume of sediment within the pond is uncertain because sediment markers are submerged. Sediment was last removed from Pond B in 1998.

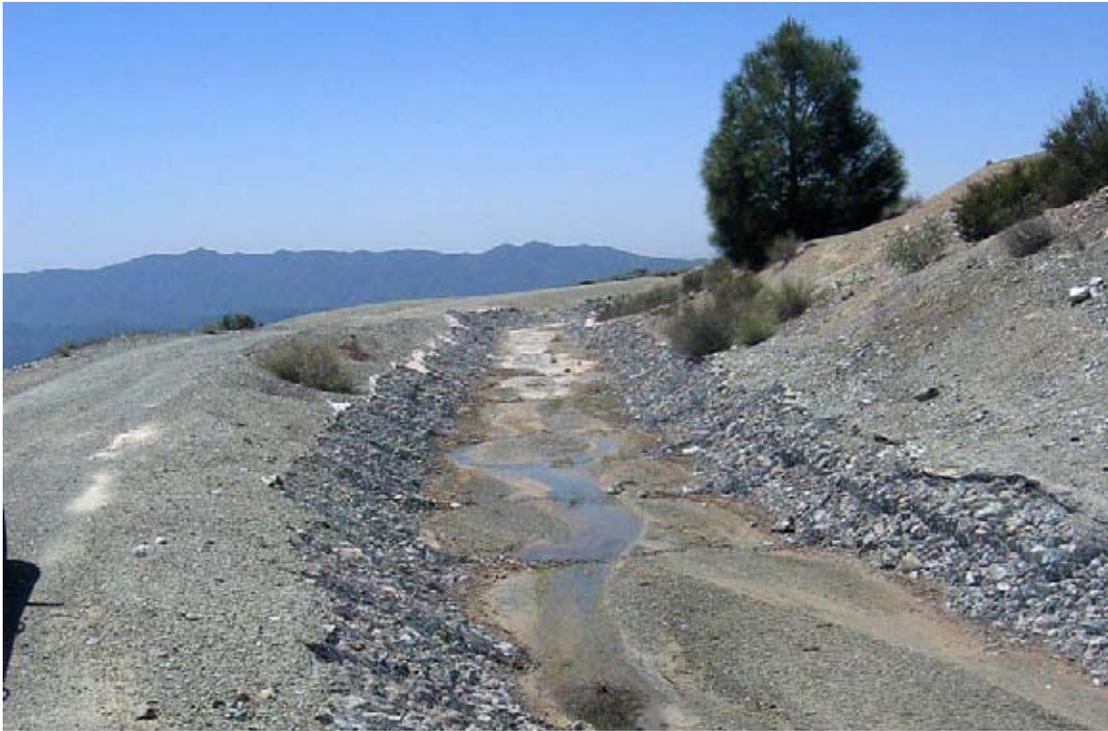
Channel A. No indications of significant erosion or sedimentation were observed.

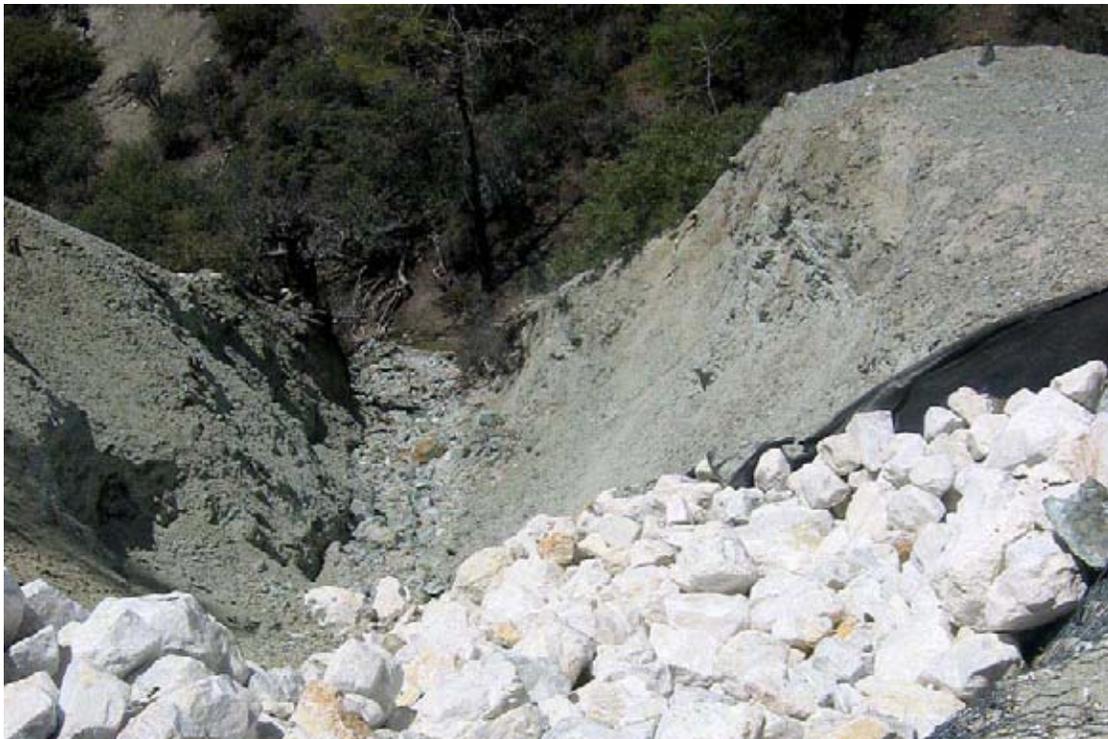
3.	Erosion Areal extent _____ Depth _____ Remarks:	Location shown on site map	<input checked="" type="checkbox"/> No evidence of erosion
4.	Undercutting Areal extent _____ Depth _____ Remarks: The undercutting at the end of Channel A was repaired in 2005.	Location shown on site map	<input checked="" type="checkbox"/> No evidence of undercutting

Channel A terminus. Drain rock installed during 2005 maintenance activities.

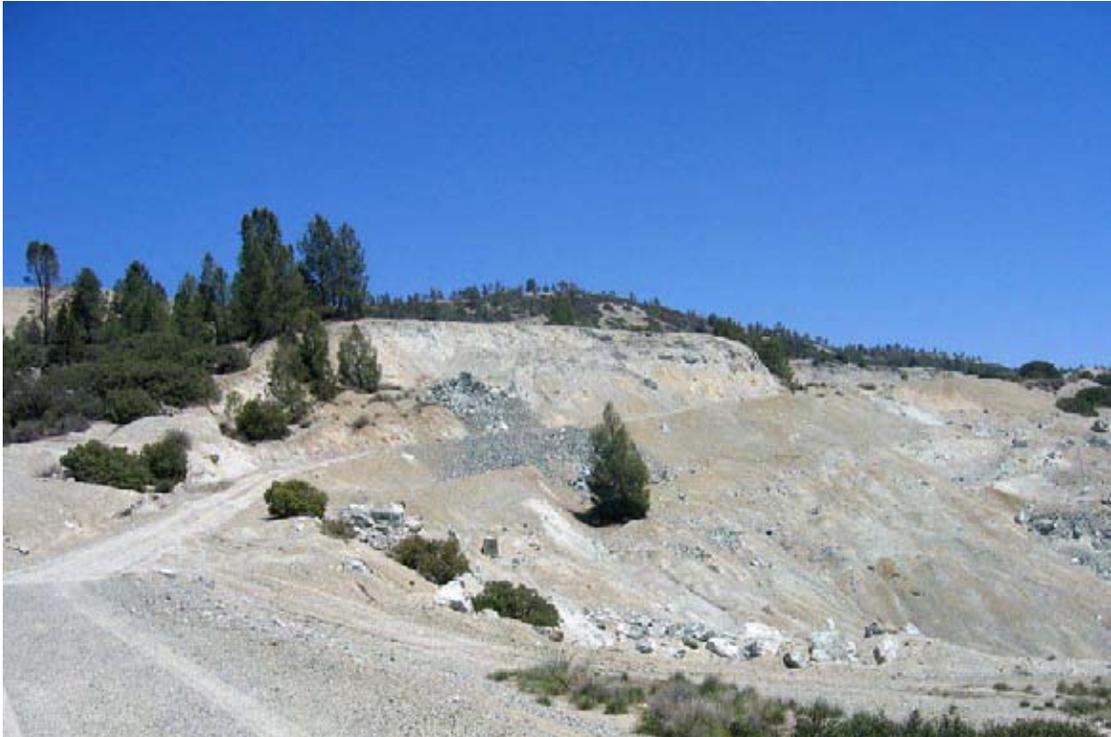
Active landslide on the road to Rover Pit.

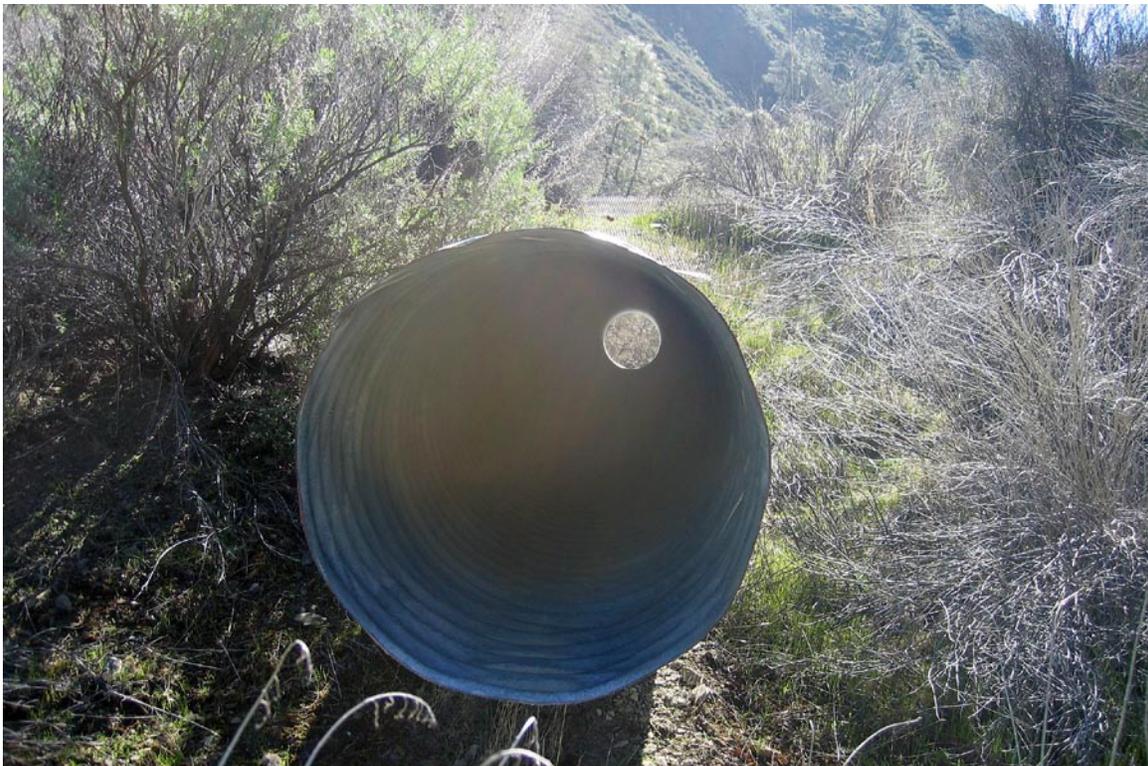
The outlet pipe is free of debris and sediment.

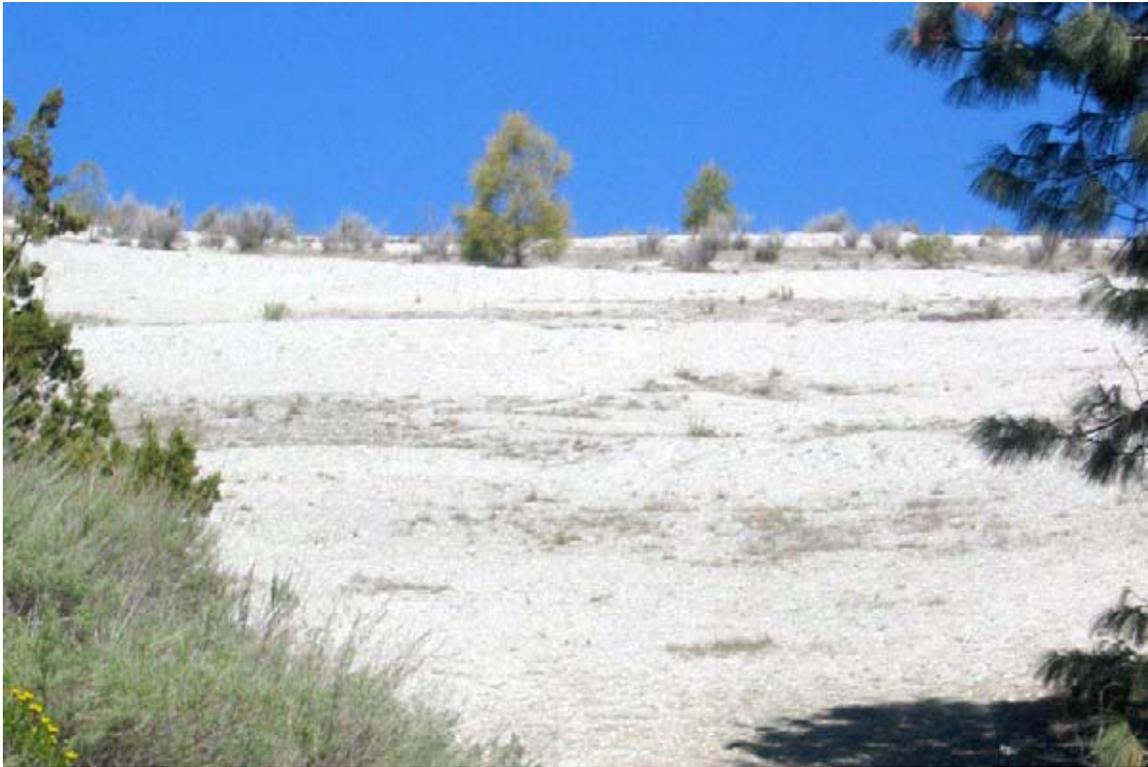
Photo looking northwest up the slope of the tailings pile. Vegetation continues to grow on top of the tailings pile.

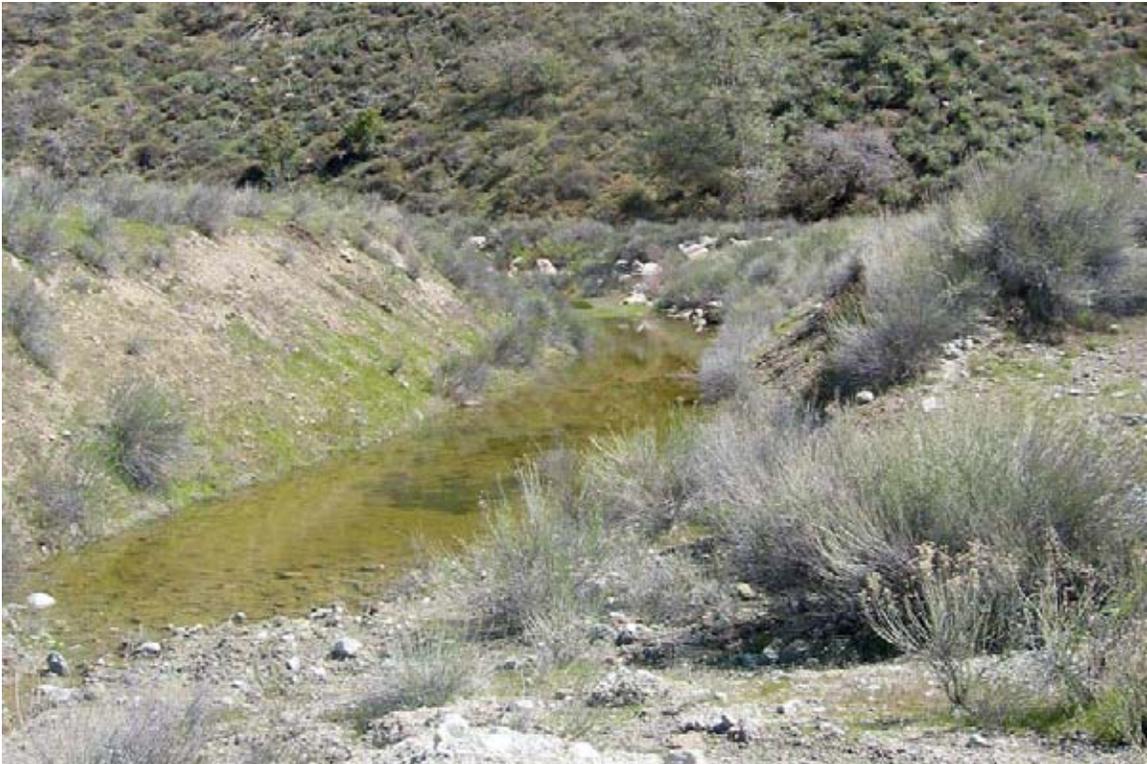
Surface water near the bend in the Cross-Canyon Stream Diversion channel. Surface water has collected near this area of the channel due to minor erosion caused by tractor tires.

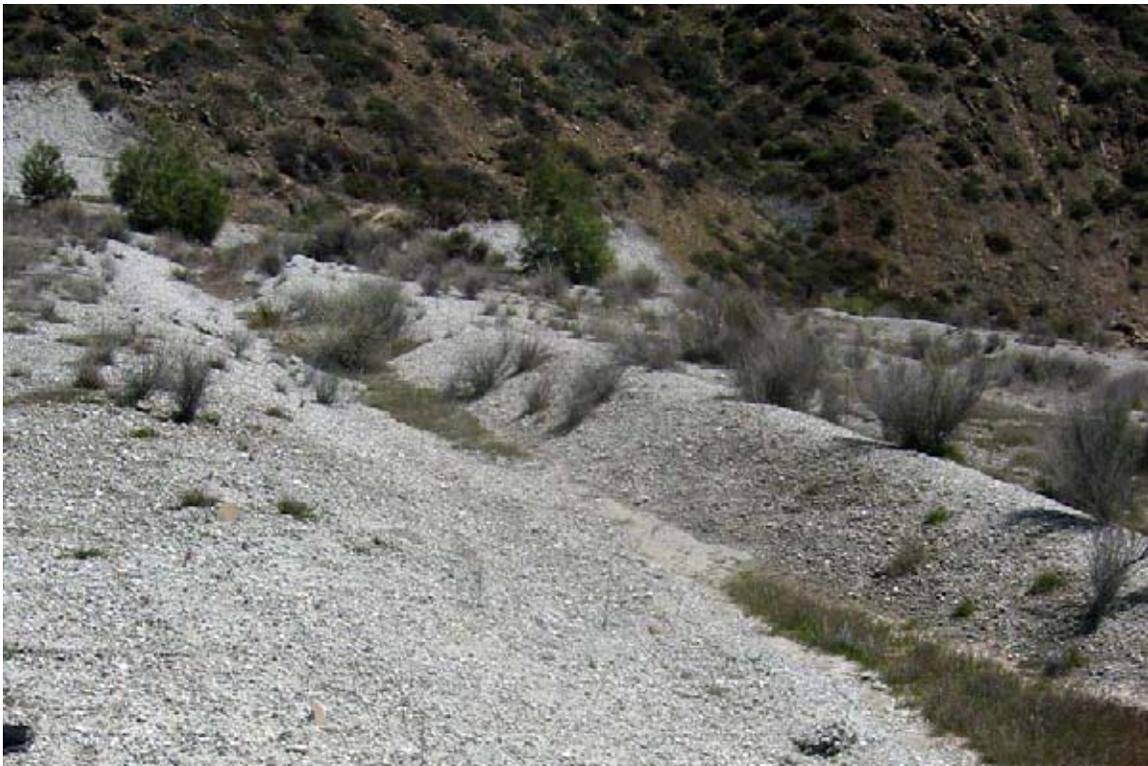
V-ditches on tailings pile for collecting surface water fun-off. Runoff drains through subsurface piping to the Energy Dissipation Pond via drainage inlets.

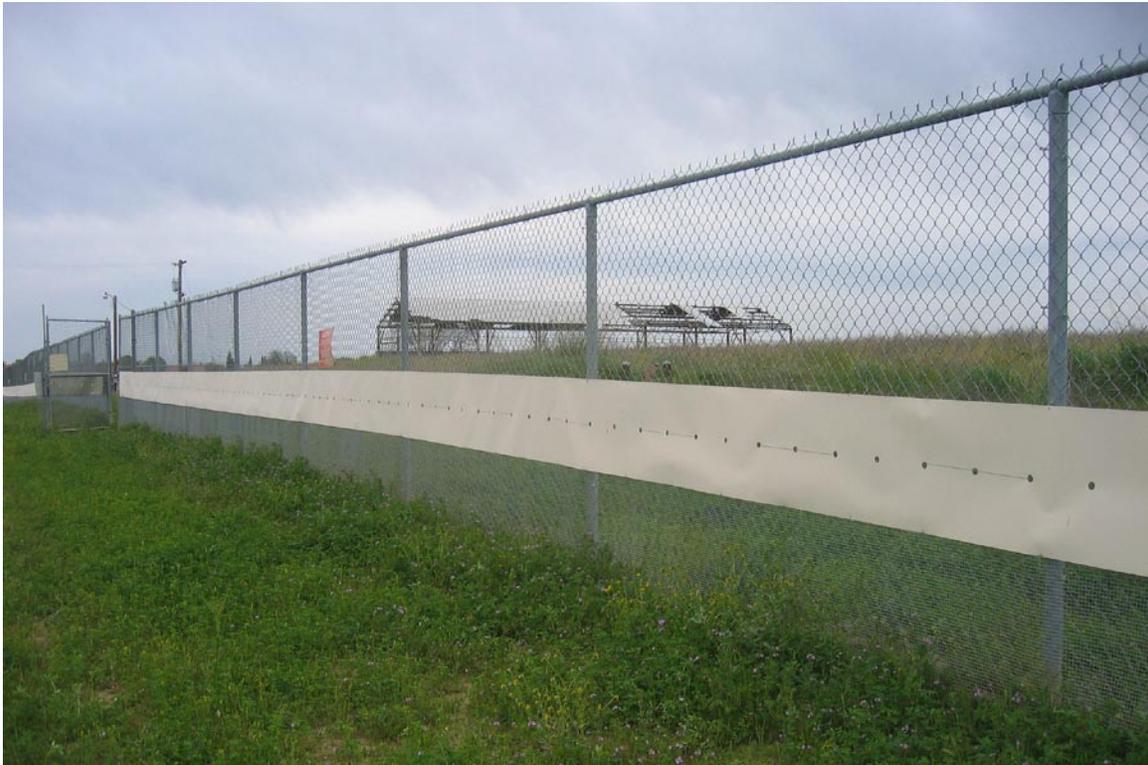
Fencing surrounding the Waste Management Unit. Fence material with a smaller screen size was installed across the base of the fence to prevent burrowing animals from entering the site.

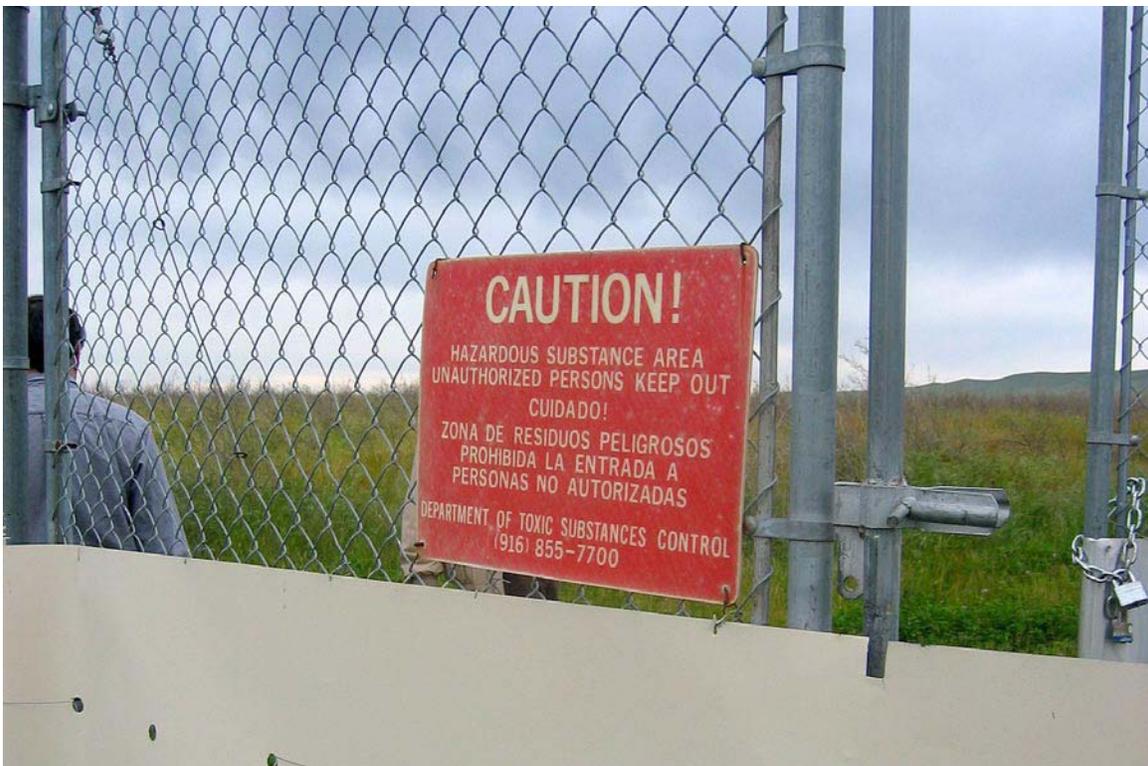
Warning sign posted on fence surrounding the site. The DTSC contact phone number presented on this sign is no longer valid.

D.	Opportunities for Optimization
	<p>Describe possible opportunities for optimization in monitoring tasks or the operation of the remedy.</p> <p>The signs on the perimeter fence should be updated with a current phone number for DTSC.</p>

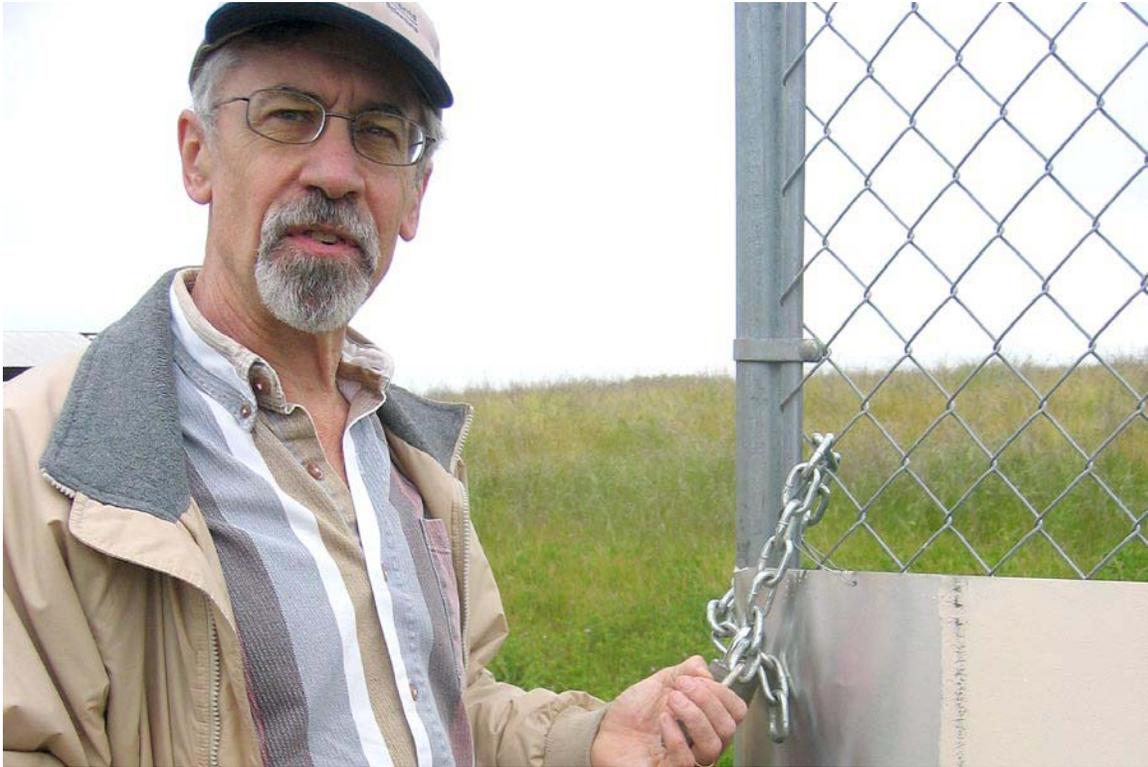
Access to the Waste Management Unit is restricted by a locked gate.

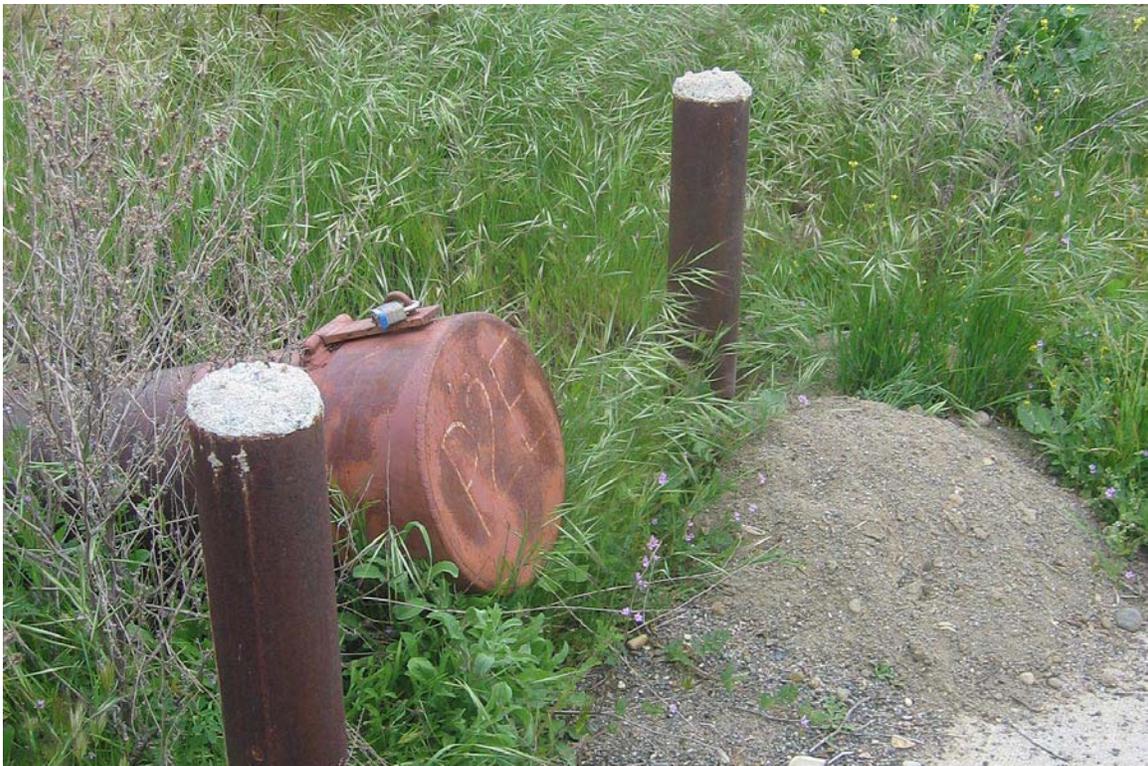
Neutron probe access tube previously monitored to assess moisture content in soil vapor beneath the cap.

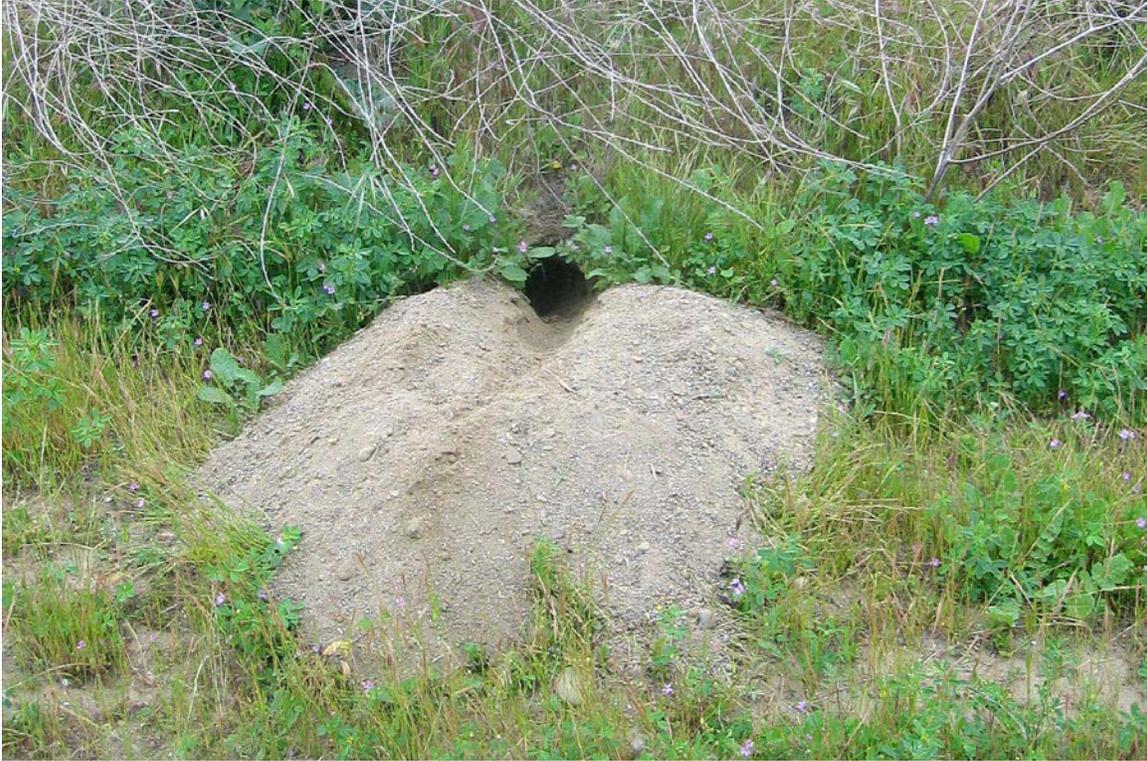
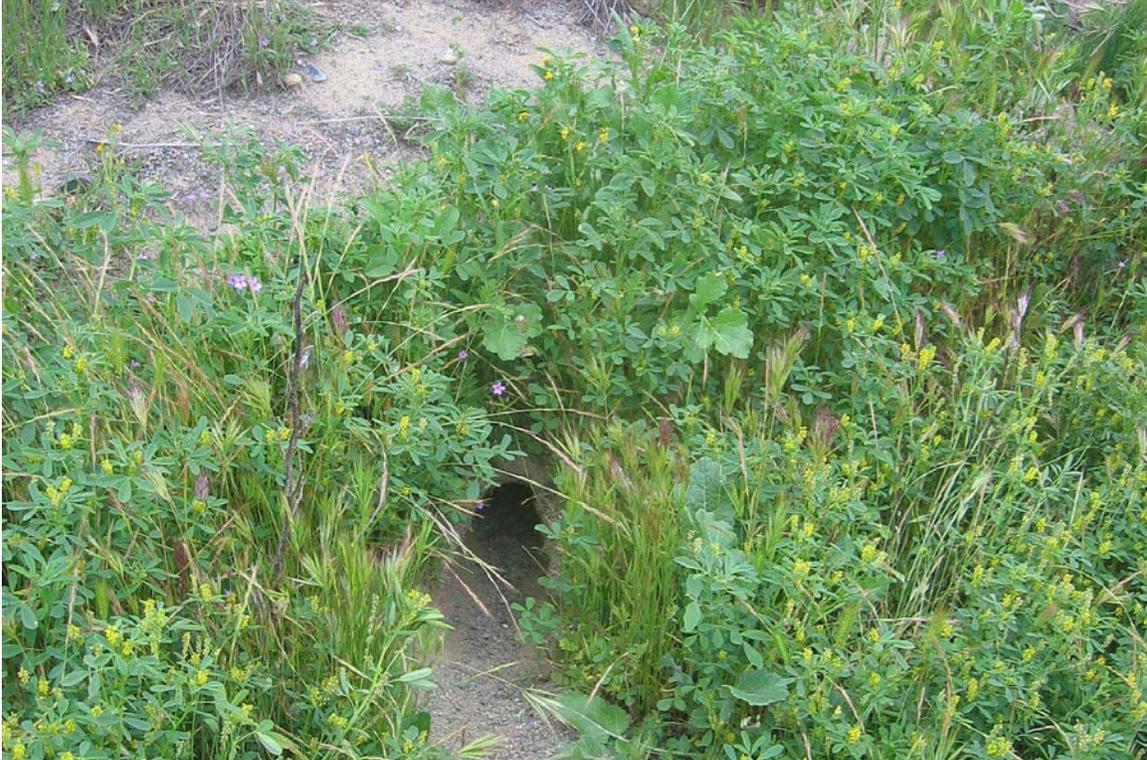
Hole in cap created by burrowing animals.
