**American Petroleum Institute's Review of EPA's Pavilion
December 8, 2011 Draft Report With Focus On Monitoring Well
Drilling, Completion, Development, And Sampling Activities
Related To Deep Monitoring Wells MW-01 And MW-02**

JUNE 25, 2013

Prepared by: The American Petroleum Institute | 1220 L Street, NW | Washington, DC 20005-4070 | www.api.org

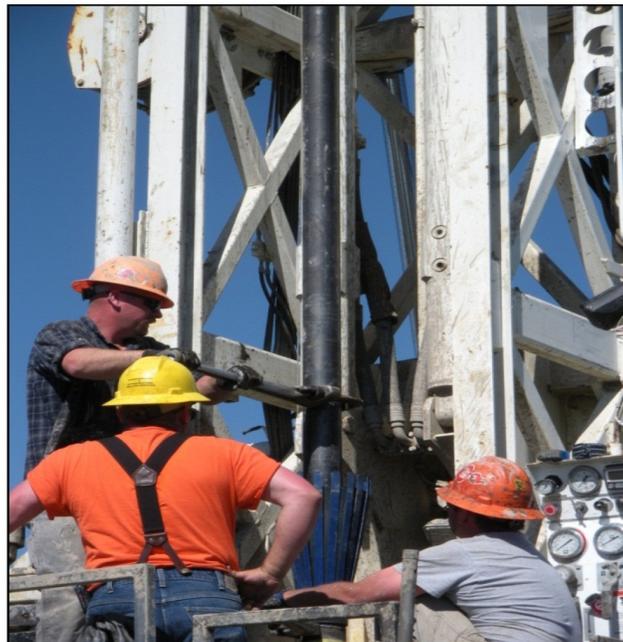
Figure C21. Photograph of securing sand basket and casing above screen.

The painted sand basket was welded to the top of the screen in both wells. Welding flux and associated materials can contain metals and organics. There are no records to indicate that once the welding was completed, that the welded portions of the screen and sand catcher were ever decontaminated. If they were not decontaminated, chemicals associated with welding could impact groundwater. The picture (**Figure 1**) provided below (taken from the Draft Report¹) below shows the blue-painted sand basket and black painted/coated carbon steel casing used by EPA at Pavillion.

Figure 1. Photograph¹ of carbon steel casing and sand basket used in the construction of EPA’s Pavillion monitoring wells.

The type of paint/coating used on this riser pipe and sand basket might be an epoxy, paint, varnish, primer, bituminous, coal tar, oiled/painted, zinc, or other types of paint/coating. Further, it should be determined if this riser pipe was also coated on the inside, as this particular pipe manufacturer appears to supply pipe of this type with interior coatings. This type of riser pipe may also have had rust inhibitors applied to the threads, and may have milling oils present, which needed to be removed through decontamination procedures.

Examination of the photographs provided in EPA's December 2011 Draft Pavillion Report¹ and **Figure 1** show the sand basket painted blue, approximately 1.8 feet long, possibly rubber/plastic lined, and welded to the top of the stainless steel well screen. A painted sand basket is not shown on figure 6a of EPA's Draft Report¹.

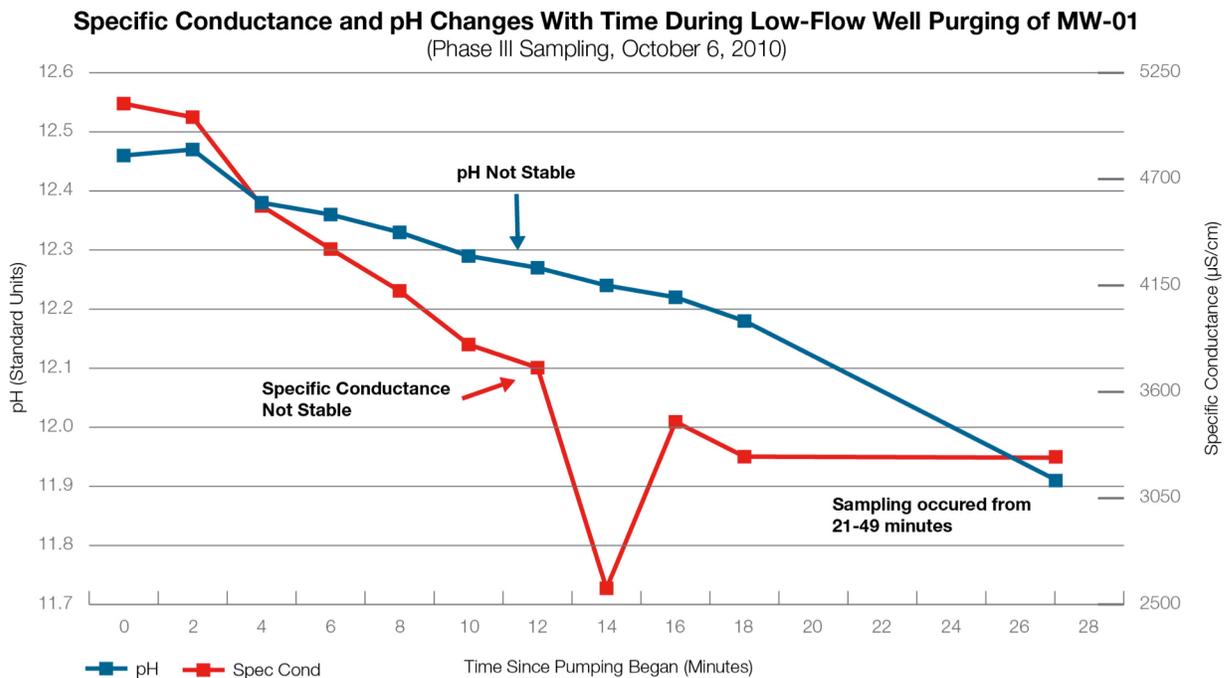
Figure 2. Graph of pH and specific conductance readings taken during low-flow sampling of MW-01 by EPA during Phase III (October 6, 2010).

Data provided in **Tables 2 and 3** clearly and concisely show that the pH, oxidation-reduction potential, and specific conductance were not stable in well MW-01 during either of the Phase III or Phase IV sampling events, contrary to EPA’s statement noted earlier on page 20 of their Draft Report¹. **Figures 2 and 3** are plots of the pH and the specific conductance data from MW-01 during these Phase III and IV sampling events, respectively, and show the pH and specific conductance instability.

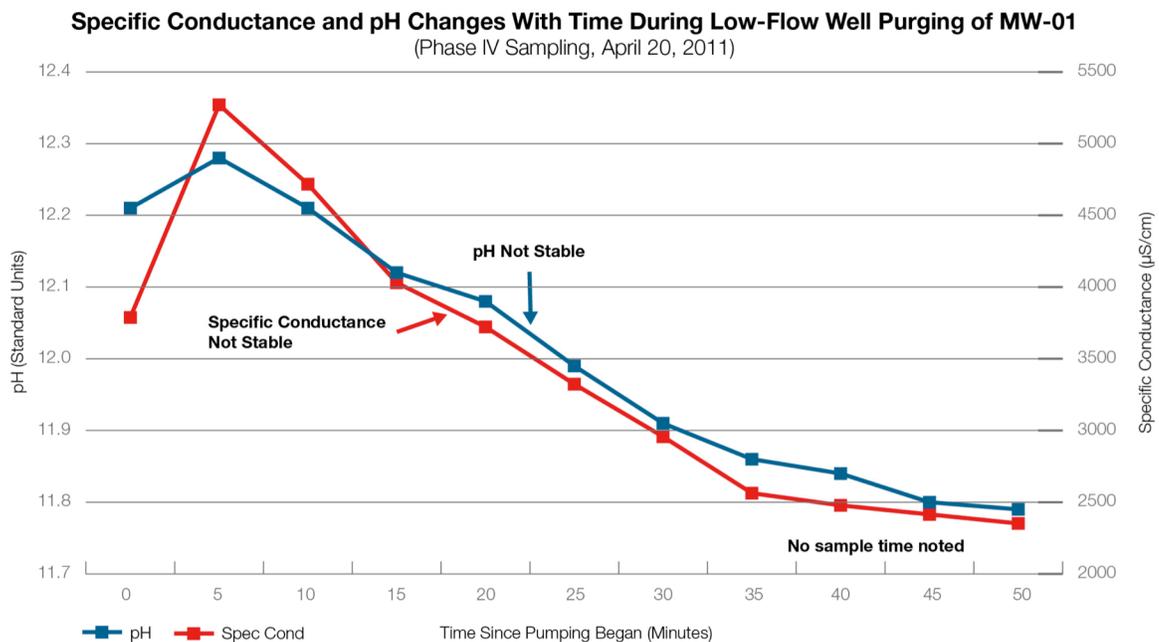
Figure 3. Graph of pH and specific conductance readings taken during low-flow sampling of MW-01 by EPA during Phase IV (April 20, 2011).

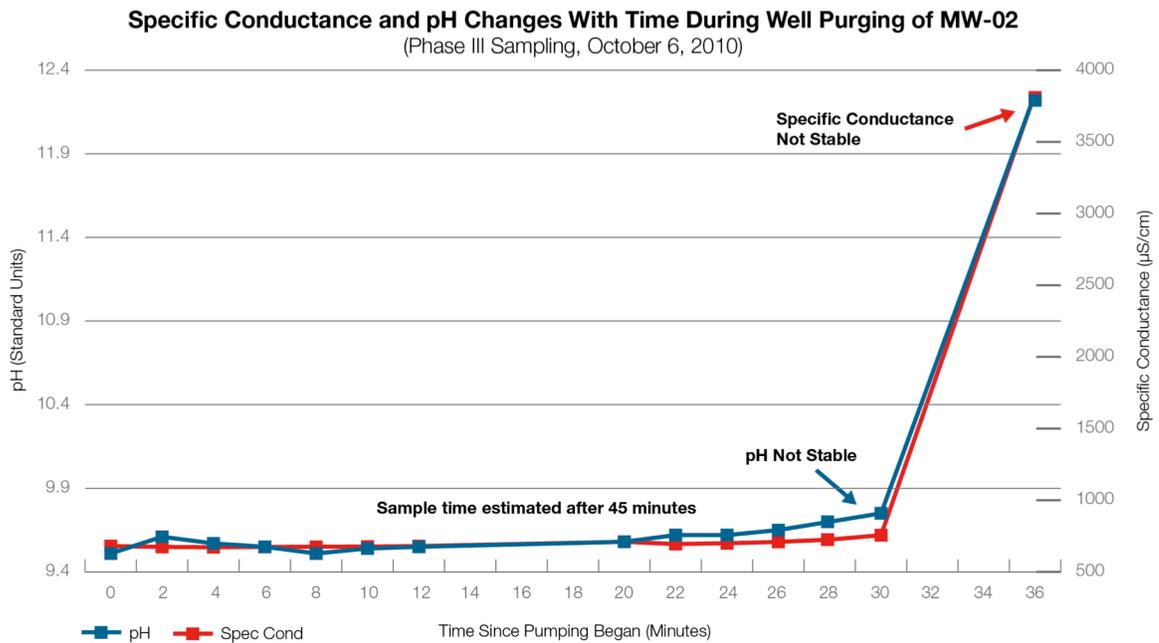
The instability in pH shown in data from **Tables 2, 3, and 4** likely relates to cement contamination of groundwater in monitoring wells MW-01 and MW-02. Any and all groundwater quality data from wells MW-01 and MW-02 should be disregarded as inaccurate and invalid because pH is considered a key geochemical variable and highly controls many geochemical reactions involving both inorganic and organic dissolved solids.

Figure 4. Graph of pH and specific conductance readings taken during low-flow sampling of MW-02 by EPA during Phase III (October 6, 2010).

During Phase III sampling of well MW-02, a major change in pH, oxidation-reduction potential, and specific conductance occurred between 30 to 36 minutes into the low-flow pumping period. EPA does not point out this change or discuss possible reasons for the dramatic increase in pH and specific conductance (decrease in oxidation-reduction potential) in MW-02, consistent with cement contamination. Likewise, EPA fails to discuss or point out the lack of stability in the pH, oxidation-reduction potential, and specific conductance during sampling of MW-01 during both Phase III and Phase IV sampling events. The low pH between 9.3 to 9.8 and low specific conductance in monitoring well MW-02 may be due to imported water added and left in the monitoring well during development on September 11, 2010.

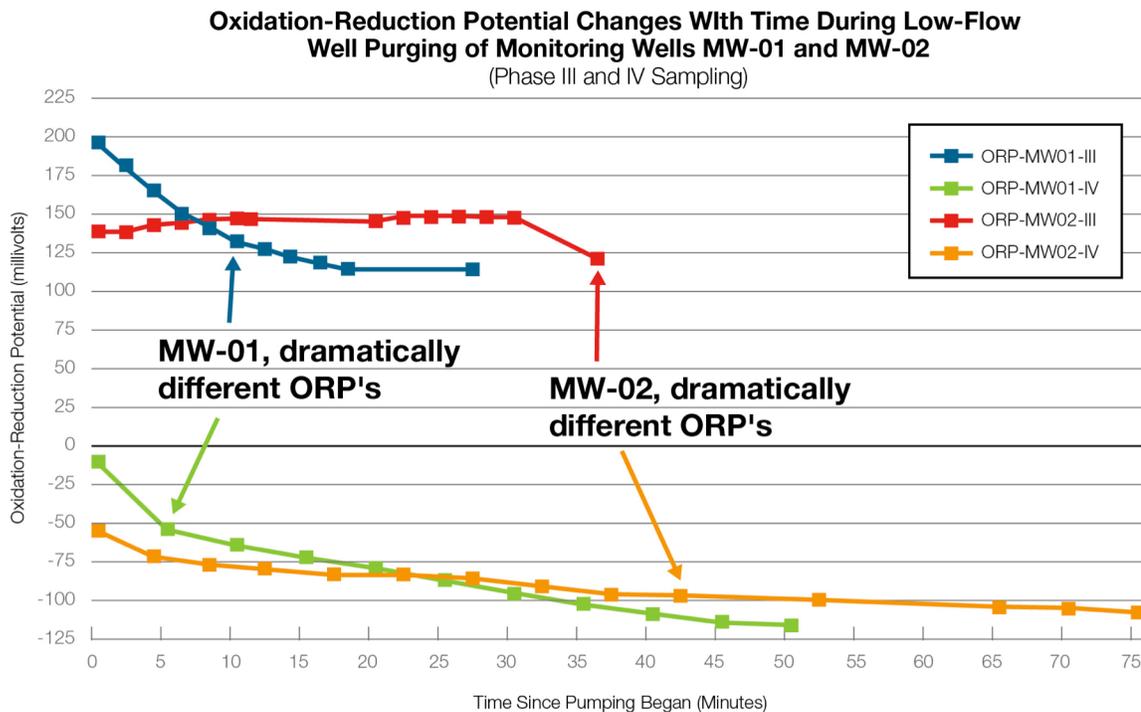
Figure 5 is a graph of the oxidation-reduction potential (ORP) measured in groundwater from monitoring wells MW-01 and MW-02 during the Phase III and IV sampling events. These graphs also show that the ORP was unstable during the low-flow sampling events. **Figure 5** also shows that there is a large discrepancy between the ORP measured in each well between the Phase III and Phase IV sampling events. For example, the ORP measured in monitoring well MW-01 during the Phase III sampling event on October 6, 2010 ranged from 114.3 millivolts (mV) to 196.4 mV. During the Phase IV (April 20, 2011) sampling event, the ORP in this same monitoring well ranged from -10.2 mV to -116.2 mV. A similar discrepancy occurs in the ORP reading from monitoring well MW-02. EPA fails to discuss how such a large difference in ORP readings can occur in groundwater from the same well.

Figure 5. Graphs of oxidation-reduction potential from low-flow sampling data from monitoring wells MW-01 and MW-02 during the Phase III and IV sampling events.

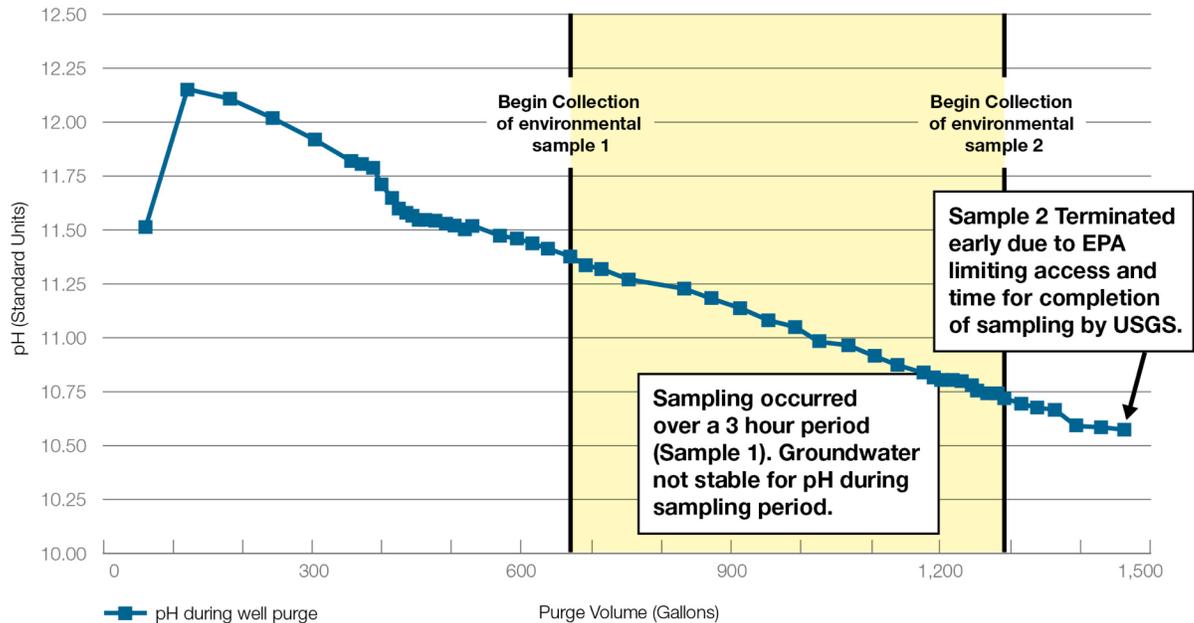
Although EPA maintains the groundwater was stable (contrary to their own data) during their short-term sampling events on October 6, 2010 and April 20, 2011 from monitoring well MW-01, data from USGS's 2012 report³ (Figure 6) shows that the pH could not have been stable in monitoring well MW-01 (sampled by USGS on April 24, 2012), especially since groundwater from this well was not yet stable even after removing approximately five times the volume as removed by EPA on April 20, 2011 and over 12 times the volume removed by EPA on October 6, 2010. The occurrence of cement contamination in the monitoring well water is not unexpected given that the well screens are in contact or near contact with cement. In MW-01, cement is located immediately above and below the screen interval. In MW-02 cement is located immediately above the well screen and drilling mud and cuttings are located immediately below the well screen. Cement also likely invaded the screen interval in both monitoring wells.

Figure 6. Modified after USGS Figure 2, Data Series Report 718 (samples collected by USGS on April 24, 2012)

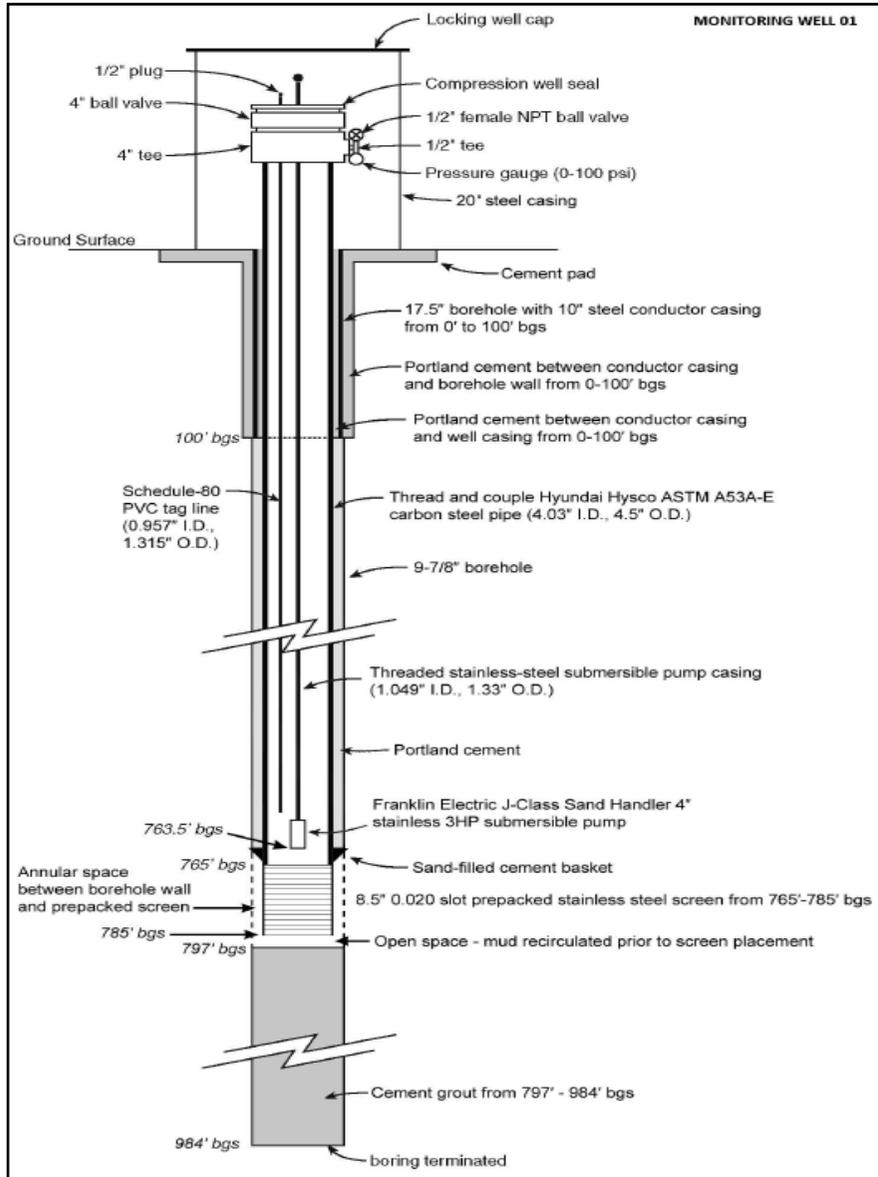
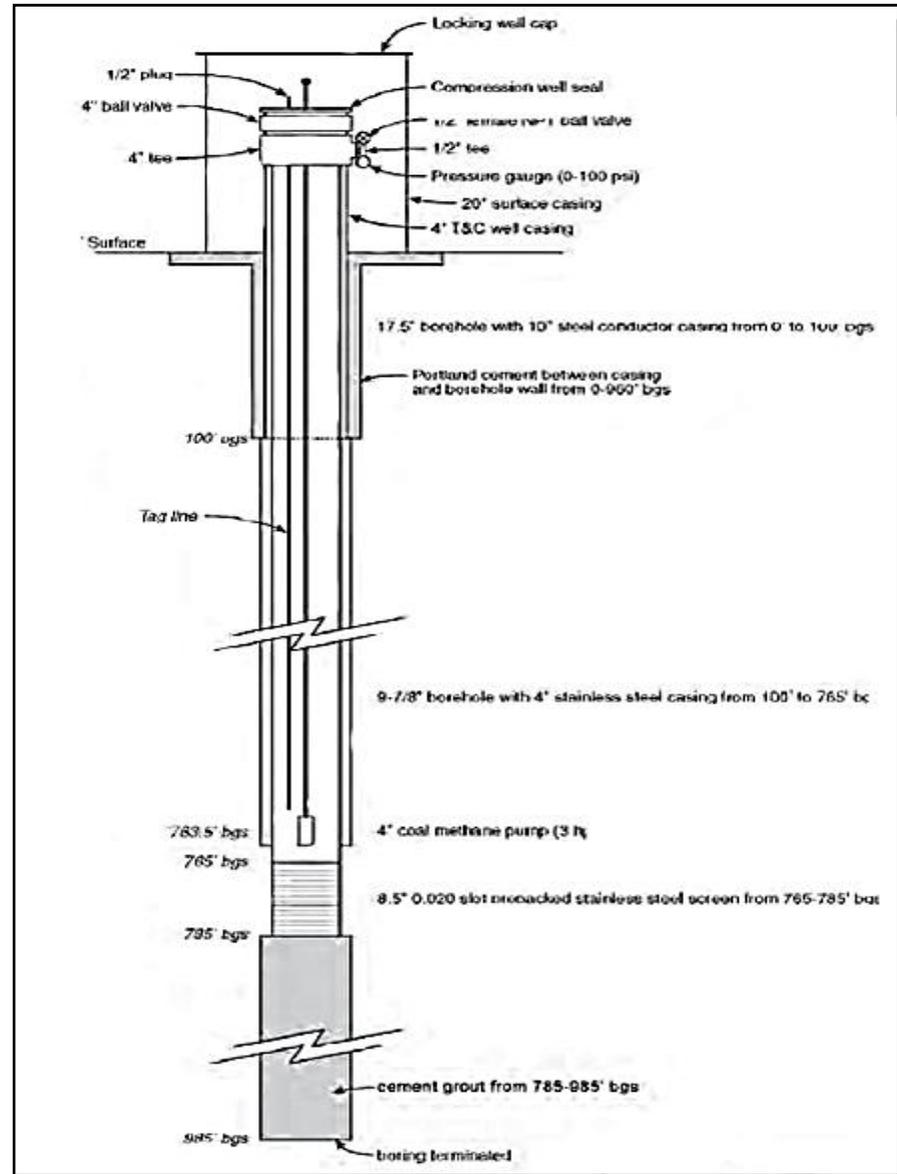
Corrected Well Construction Diagram Posted
On EPA's Pavillion Website: 11/8/12

- Construction diagrams for these monitoring wells in the Draft Report¹ contained numerous and significant errors, such as representing the hundreds of feet of the 4-inch riser casing as stainless steel, when in fact it was black painted/coated carbon steel casing. While some of this information has now been corrected, most peer reviewers are likely unaware of these corrections;

constructed. Both of these monitoring well construction diagrams (and associated discussion within the text of that Draft Report¹) have approximately 10 errors or inaccurate representations and/or missing details on how these monitoring wells were constructed. Most importantly: 1) EPA used carbon steel casing riser pipe, approximately 765 feet in MW-01 and approximately 969.5 feet in MW-02, which USGS reported⁴ (page 2) as: “...**4-in. inside diameter, threaded and coupled, black painted/coated carbon steel casing...**”; and 2) EPA used a blue-painted, 1.8 foot long lined sand basket in lieu of a bentonite grout seal above the well screen. The painted sand basket was welded to the top of screen in both wells.

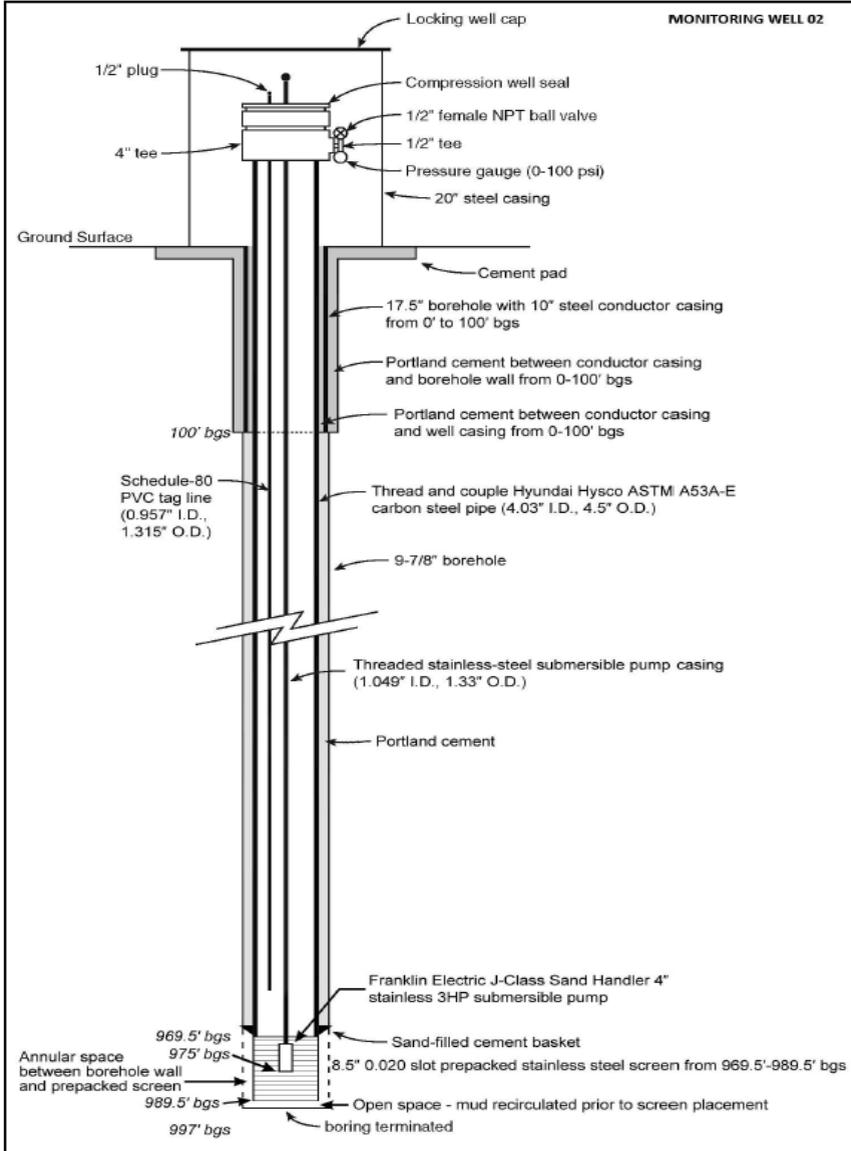
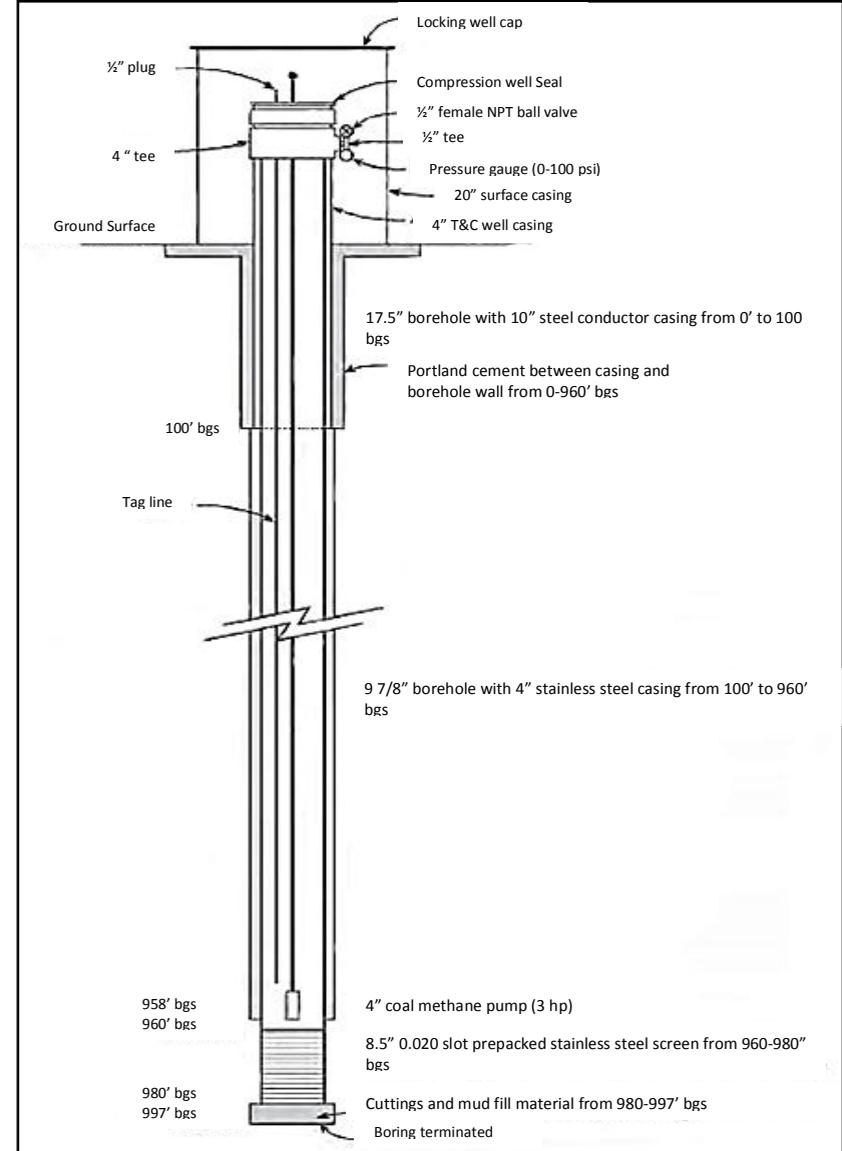
Monitoring well MW-02 construction diagram provided in the Draft Report¹ (besides EPA’s similar incorrect statements regarding use of the stainless-steel riser pipe versus what was actually used black painted/coated carbon steel), does not show the 1.8 foot long blue-painted (possibly black rubber or plastic lined) sand basket welded to the top of the well screen. No centralizers are shown on the on-site geologist field construction diagram¹⁹ on figure 6b, or on the newly-revised (November 6, 2012) well construction diagram¹⁴. The well construction drawing (figure 6b) for MW-02 in the December 2011 Draft Pavillion Report¹ incorrectly indicates nothing but open space in the annular space between the 10-inch steel conductor surface casing set to 100 feet bgl and the 4-inch carbon steel casing. However, on the November 6, 2012 revised well construction diagram¹⁴, this annular interval is shown filled with Portland cement. None of the well construction diagrams for MW-02 indicate that powdered bentonite was added to the cement as required by the Work Plan⁵, but rather, all construction diagrams for MW-02 indicate only **“Portland cement”** was used.
