NPDES General Permit for Storm Water Discharges From Construction Activities

Summary of Findings and Corrective Actions

AFA Privatize Housing

5/5/08

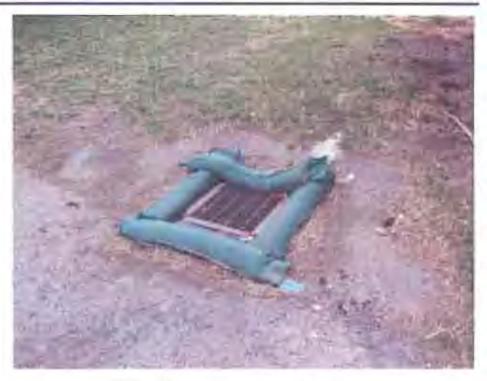
Example of BMP of stormdrain in Douglass Valley. Closeup of photo 4 looking east.

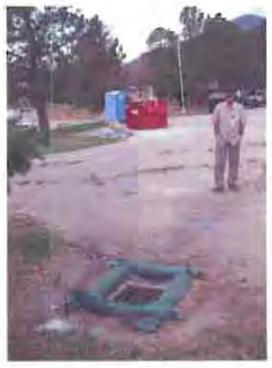
The SWPPP called for sediment logs to be placed across open drainage ditches or around drain inlets. The inspectors observed the straw waddle on curbs where construction or renovation activities were occurring, and around sand piles. However, the sediment logs were not trenched in to prevent sediment from going beneath the logs. The straw waddles may not have been the appropriate BMP around sand piles deposited on the street (see photo 9) and where sand was observed beneath and outside the straw waddles. There was no BMPs around another sand pile that was upstream from a storm drain (see photos 4 and 5).

Stormdrain and sand pile (upstream from storm drain) at the cul-de-sac east of 4202E W. Muledeer East, Lower Douglass Valley, looking west.

Hunt is requested to review all BMPs on site and correct any deficient BMPs. Documentation, including photos on when and how the BMPs were corrected must be provided in Hunt's response to the inspection report and this Summary of Findings.

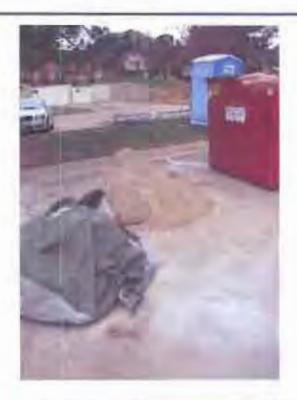
Close up of sand pile in photo 4 and staging area, not described in SWPPP, at the culde-sac at 4202G W. Muledeer East, Lower Douglass Valley, looking southwest.

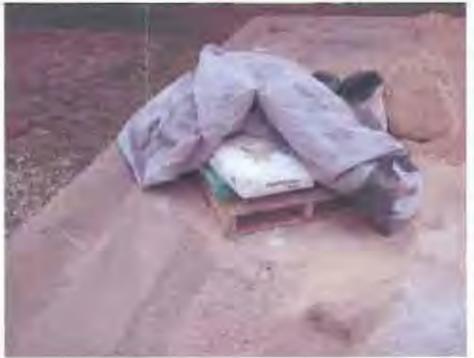
6

Close up of supplies (cement-lime) under tarp in photo 4.

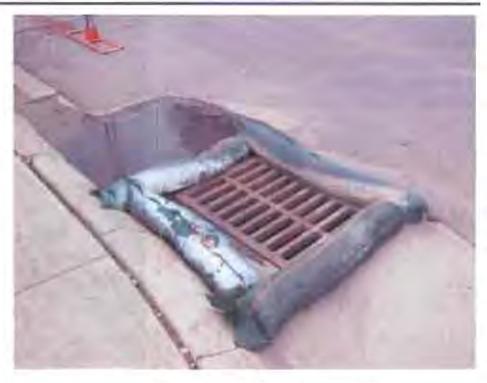
Another example of storm drain inlet in Douglass Valley; located at southeast corner of W. Douglass Dr. and W

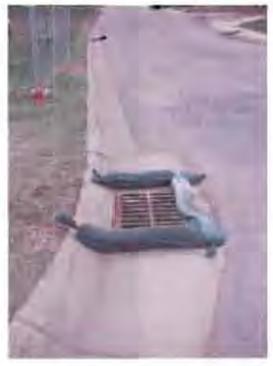
Description Storm drain inlet at southwest corner of W. Douglass Dr. and W. Muledeer East. Downstream of sediment in road in

photo 12.

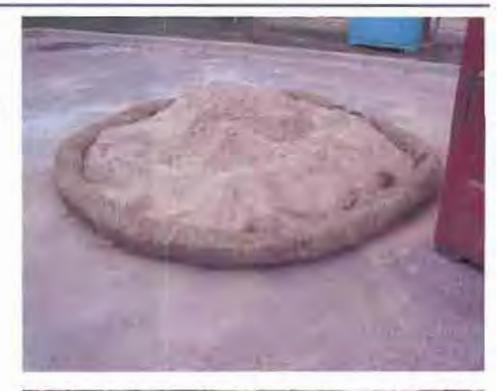
Sand pile with straw rolls west of 4201A W. Muledeer East.

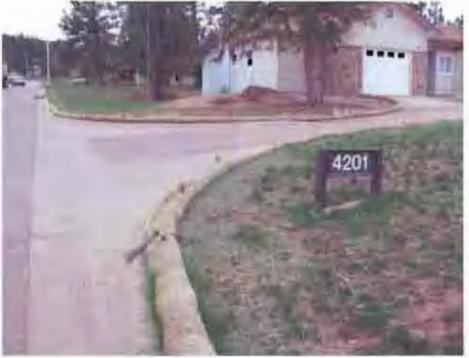
12

- 9. The following BMP deficiencies were observed:
- The sediment logs were not trenched in to prevent sediment from going beneath the logs,
- The sediment logs may not have been the appropriate BMP in the staging area where sand was observed beneath and outside the sediment logs. There was no BMP around another sand pile that was upstream from a storm drain,
- Rock socks casings were torn/damaged,
- storm drains in the swales at Pine Valley were not protected from the construction debris, especially from the asbestos contamination due to the demolition activities, and
- Sediment loading onto the streets in Douglass Valley and Pine Valley.

Waddles at 4201A W. Muledeer East:

not trenched in.

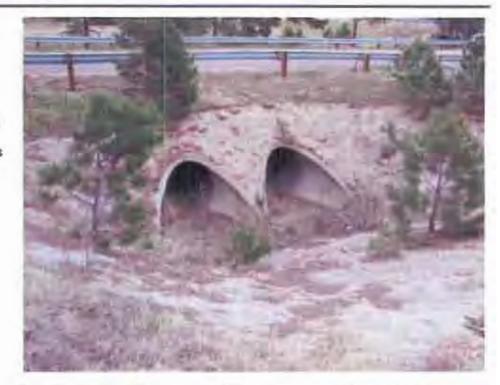
Close up view of photos 13 and 14 of stormwater culvert.

looking west towards Douglass Loop

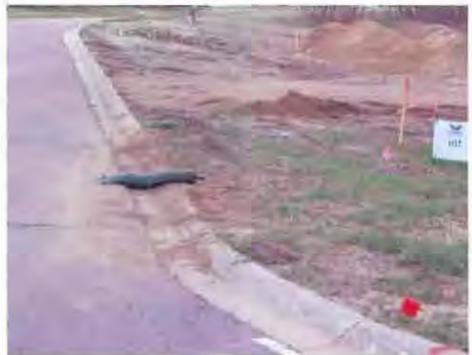
16

Rock sock with dirt on road at 4112 Dauglass Loop.

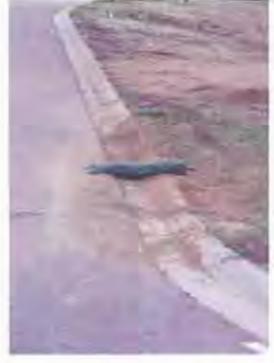
Rock sock with dirt on road at 4112

Douglass Loop.

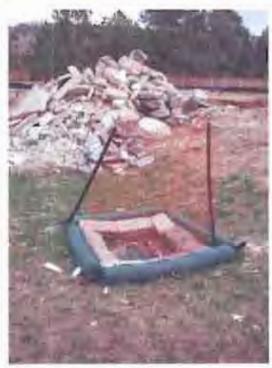
At Pine Valley, demolition had coased since Feb 26, 2008 due to asbestos abatement issues. The storm drains in the swales were not protected from the construction debris including asbestos contamination since the demolition started in fate January 2008 or since work coased in late Feb. This swale drains directly into the West Monument Creek drainage (see photos 18, 19, 20, 21, and 22). Note the construction debris and the ground disturbance uphill and adjacent to the storm drain in photo 18.

Pine Valley: Storm drain inlets in swale between houses southeast of Bluebelle Dr. and Pine Loop looking north; housing demolition debris pile

in background

Hunt must include a review of any discharge of asbestos material to the drainage to West Monument Crcek. Documentation of this review must be provided in the response to this report. If a cleanup is necessary, the schedule for the cleanup must also be provided.

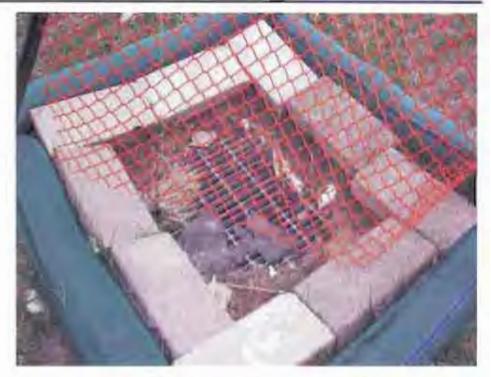
Close up of photo 18; debris on inlet grate. No BMP above or below

storm drain grate.

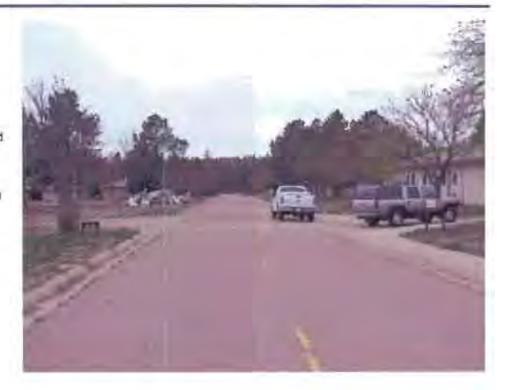
The SWPPP states that "if dirt or soil accumulates in local streets due to this project, the operator shall clean those areas by the end of the workday". Sediment loading on streets in Douglass Valley and on Bluebelle Dr./Dogwood Dr. and Pine Loop in Pine Valley were observed (see photos 12, 16, 17, and 29). The facility representative stated that sediment loading in Pine Valley occurred the previous day (although no work has occurred at this site since the project was "shut down" since 2/26/08 due to the asbestos issues). The sediment loading in Douglass Valley occurred the previous day (or days) based on the comments from the site representatives.

Intersection of Bluebelle

Dr./Dogwood Dr. and Pine Loop looking south. Sediment loading in this area flow to storm drain in photo 37 and to West Monument Creek drainage. photo 39.

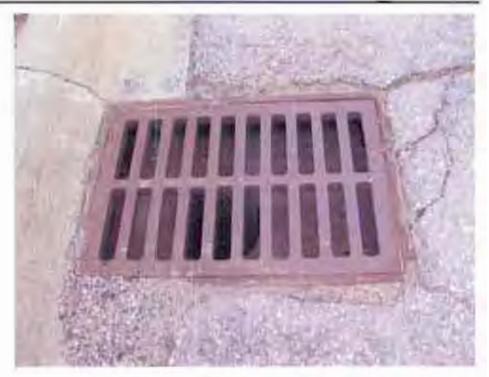
Close up of photo 30; dirt inside inlet

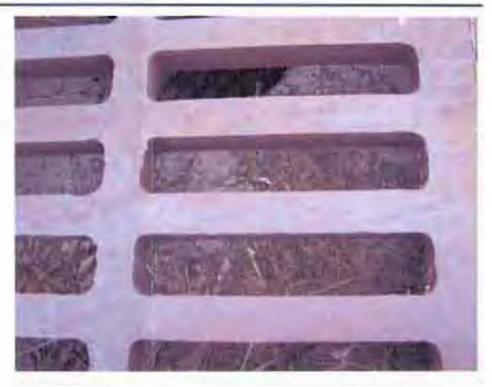
Close up of photo 32: dirt and straw

inside inlet.

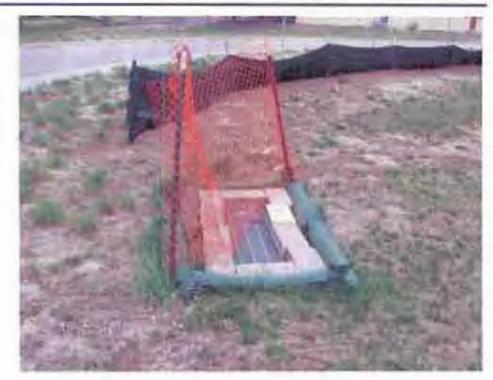
Drain and silt fence west of the drain in photo 35, west of the sidewalk along Dogwood Dr.
