Photo Log of the Lower Boise River
Ada and Canyon Counties, Idaho
July 9, 2008

This photo log will document the appearance of the Lower Boise River on the date of July 9, 2008. This log begins at Lucky Peak Reservoir and the photos will run downstream to the mouth of the River where the Lower Boise enters the Snake River. Each photo site will give a latitude and longitude position where the photos were taken. The latitude and longitude was obtained through the use of a Garmin hand-held GPS unit at the time the photos were taken.

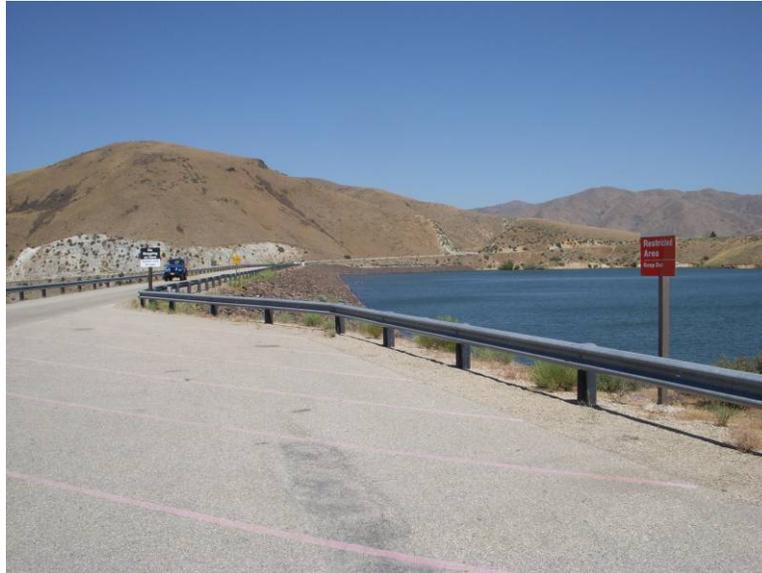
1. This photo was taken on the dam of the Lucky Peak Reservoir. No GPS coordinates were collected at this location. All other locations have GPS coordinates. The weather was clear and hot. The water appeared to be very clear in the reservoir.

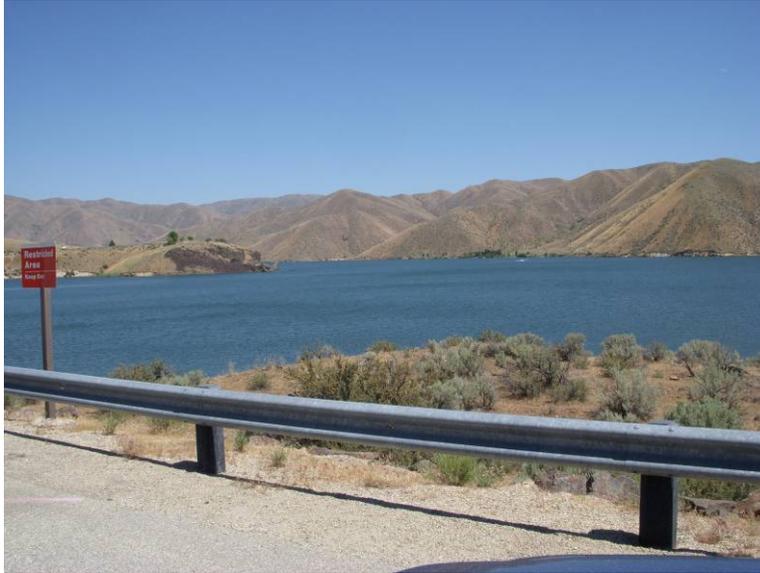
2. This is another view of the reservoir from the same location as photo 1. Lucky Peak is the source of water in the Lower Boise River.

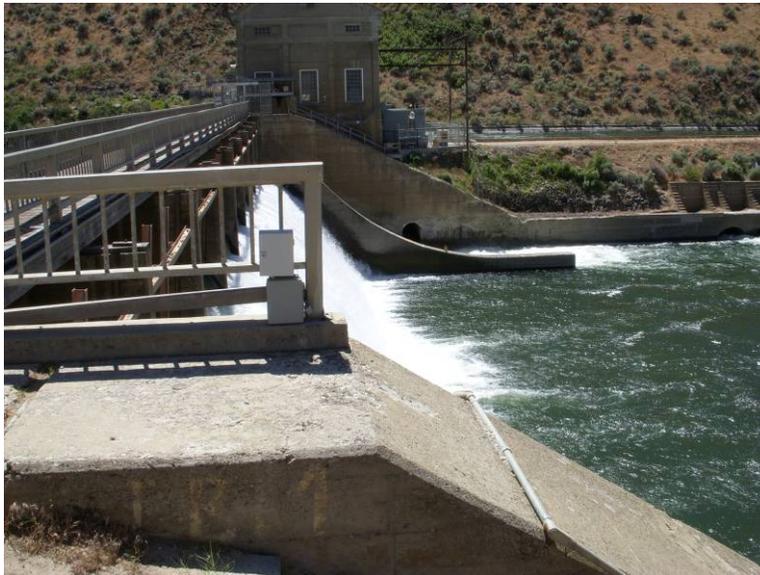
3. The Lower Boise River Diversion Dam. $N 43^{\circ} 32.304'$ $W 116^{\circ} 05.562'$
This structure on the Lower Boise River separates the flow into the New York Canal and down the main river channel. The water at this location was clear and appeared to be in good shape.

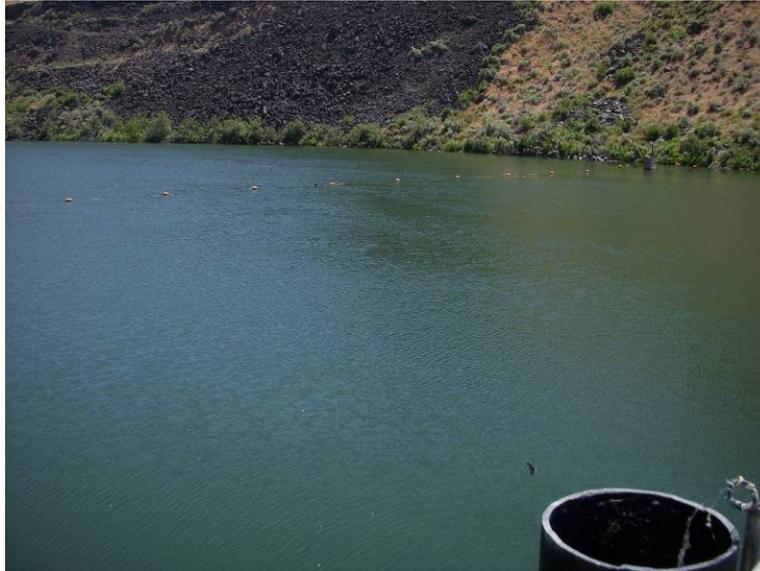
4. The Lower Boise River Diversion Dam. N 43⁰ 32.304' W 116⁰ 05.562'
This photo shows the water upstream of the diversion dam. As stated earlier, the water appeared to be in good condition.

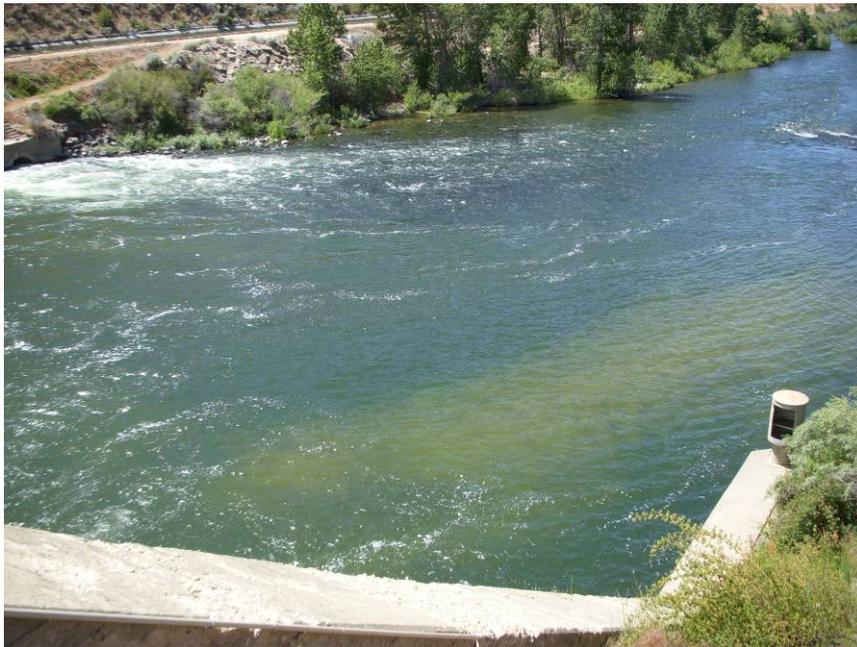
5. The Lower Boise River Diversion Dam. N 43⁰ 32.304' W 116⁰ 05.562'
This photo shows the flow in the Lower Boise River channel below the diversion dam after water is diverted to the New York Canal, upstream from the City of Boise.

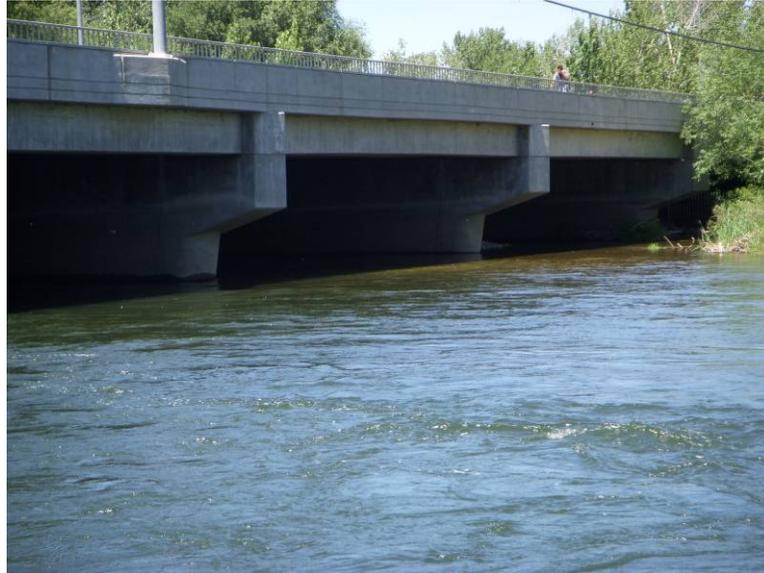
6. City of Boise, Glenwood Bridge N 43° 39.643' W 116° 16.764'
This photo was taken just upstream of the Glenwood Bridge in the City of Boise. The river was running with a good flow and the water appeared clear.

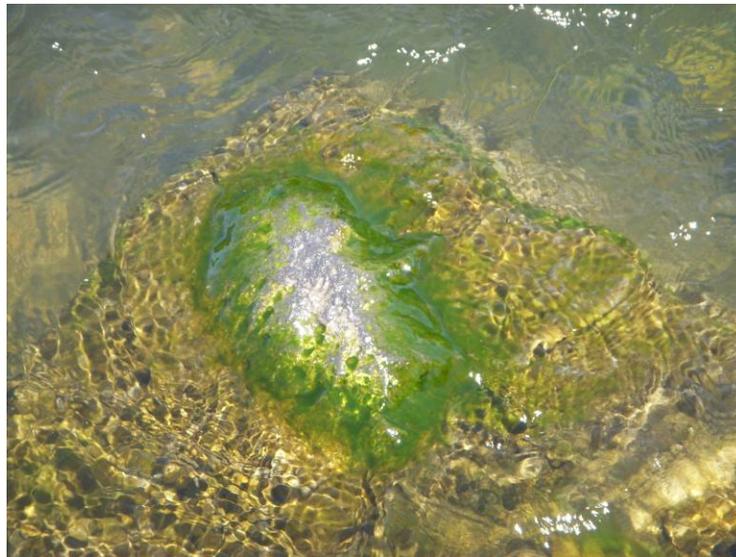
7. City of Boise, Glenwood Bridge N 43° 39.643' W 116° 16.764'
There was some vegetation noticeable on the rocks at this location. Not immediately noticeable nuisance levels at this location.

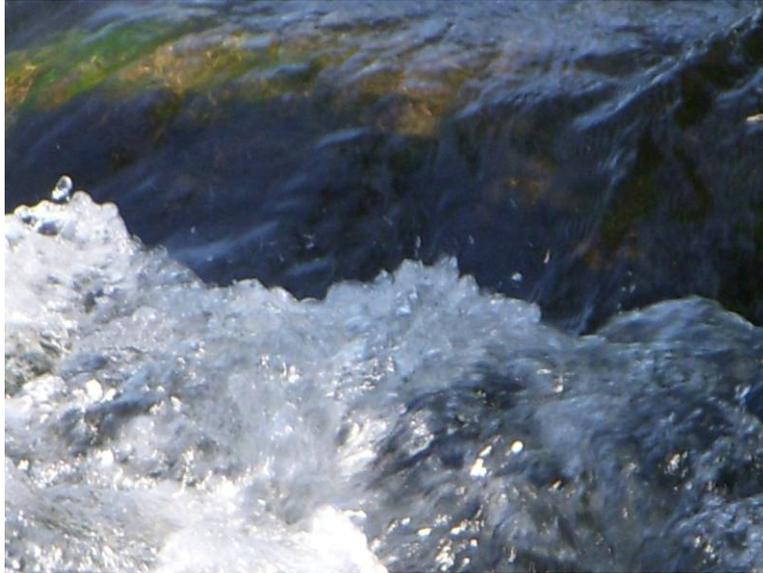
8. City of Boise, Glenwood Bridge N 43⁰ 39.643' W 116⁰ 16.764'
For some reason, the vegetation at this location was visible on the rocks in riffle areas of the river.

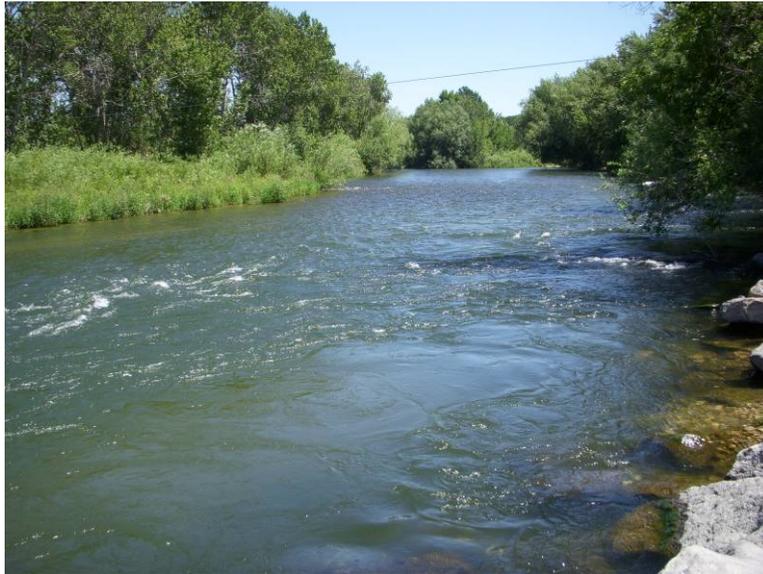
9. City of Boise, Glenwood Bridge N 43⁰ 39.643' W 116⁰ 16.764'
This is a view of the river looking upstream from the Glenwood Bridge.

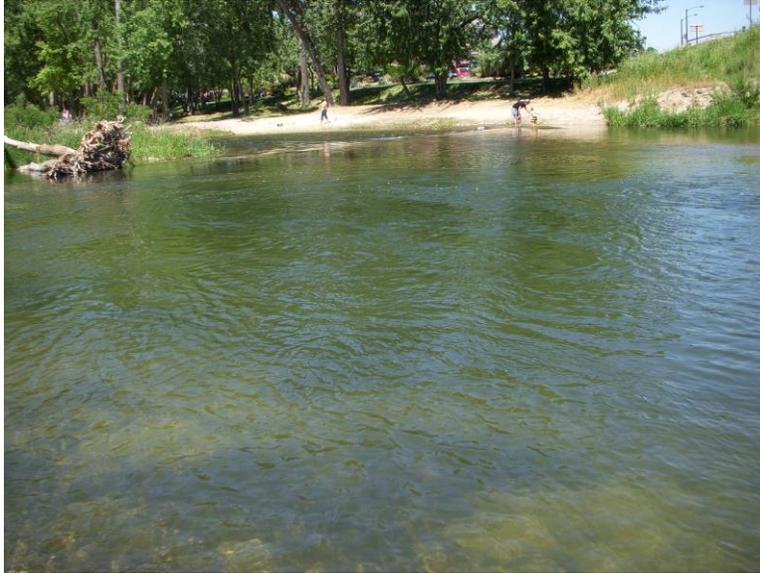
10. North Channel of the Lower Boise River on Eagle Road.
N 43⁰ 39.643' W 116⁰ 16.764'

The river in this location was slightly turbid but still fairly clear. There was a little more periphyton visible on the rocks.

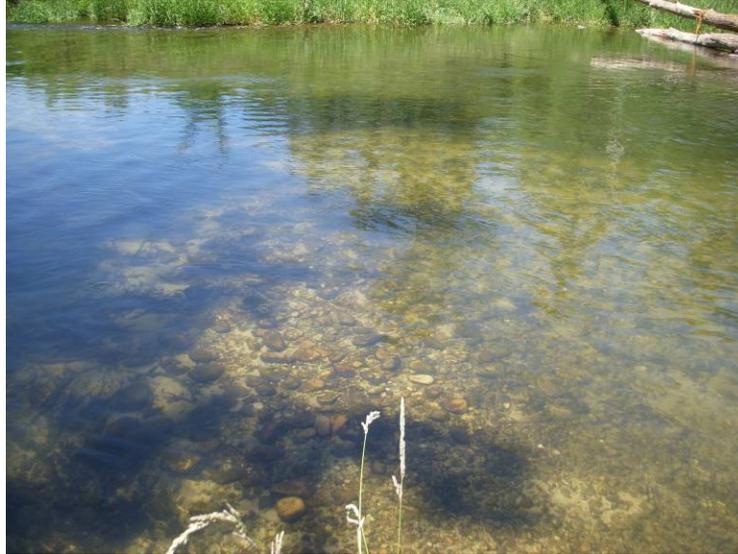
12. North Channel of the Lower Boise River on Eagle Road.
N 43⁰ 39.643' W 116⁰ 16.764'

There was some periphyton visible in the photo but the water was very clear.

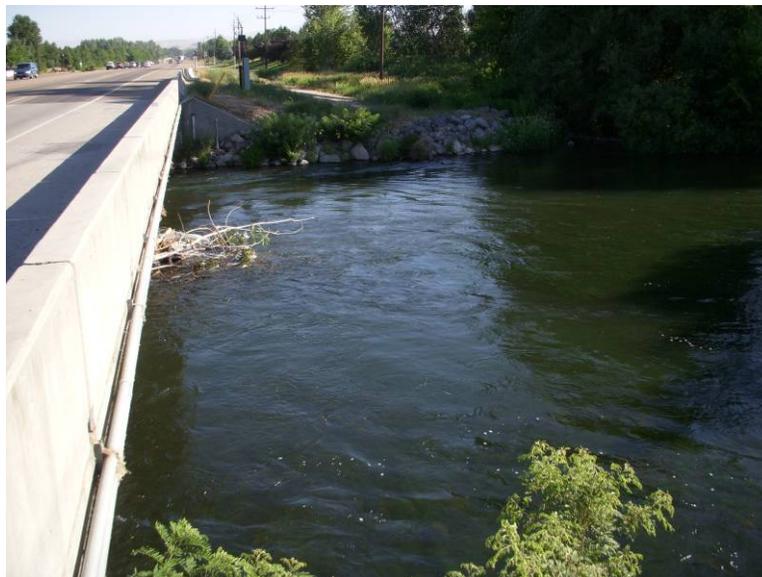
13. South Channel of the Lower Boise River on Eagle Road.
N 43⁰ 40.517' W 116⁰ 21.217'

The Lower Boise River splits into a north channel and a south channel at eagle. The West Boise Wastewater Treatment Plant discharges just upstream of this crossing on Eagle Road.

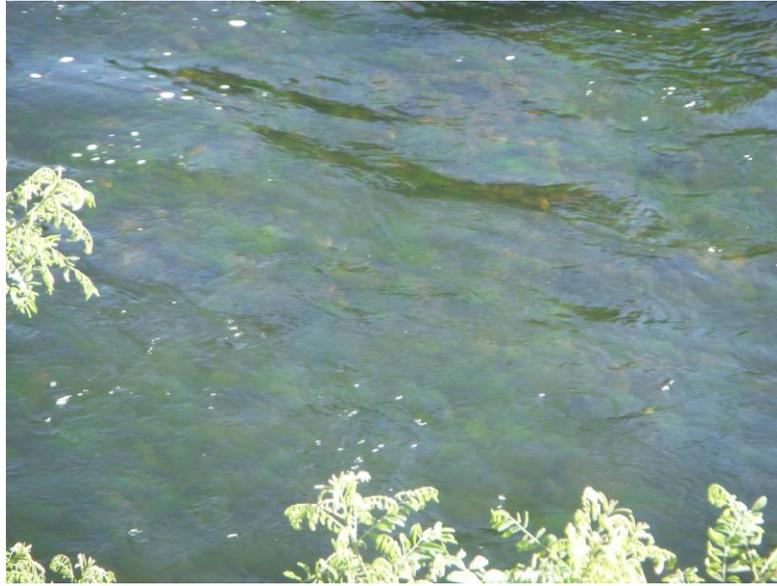
14. South Channel of the Lower Boise River on Eagle Road.
N 43⁰ 40.517' W 116⁰ 21.217'

The rocks on the bottom of the stream clearly show what appears to be heavy periphyton growth.

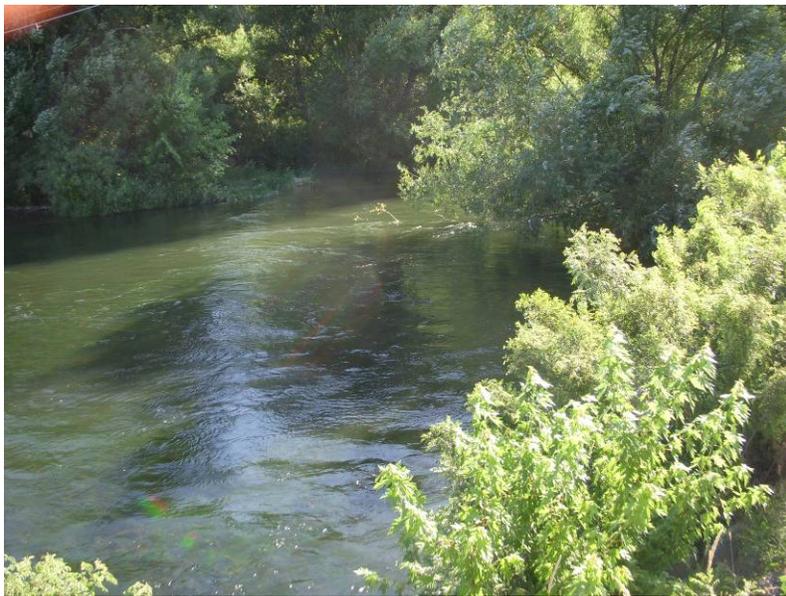
15. South Channel of the Lower Boise River on Eagle Road.
N 43⁰ 40.517' W 116⁰ 21.217'

This view of the river is looking upstream from the bridge on Eagle Road.

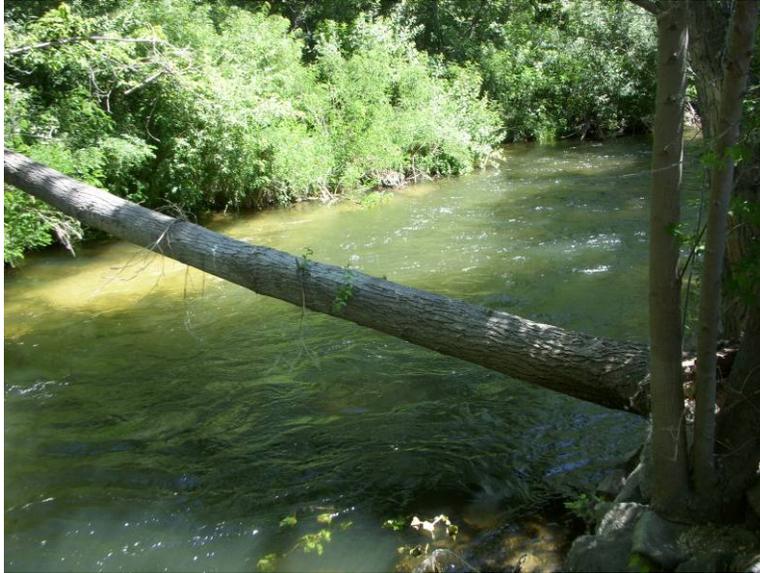
16. Lower Boise River at Eagle Island State Park.
N 43⁰ 41.356' W 116⁰ 23.135'

This photo shows a view of the Lower Boise River at Eagle Island State Park. It was difficult to get to the river due to construction of a new bridge in the park. Special permission was required to get to this part of the park.

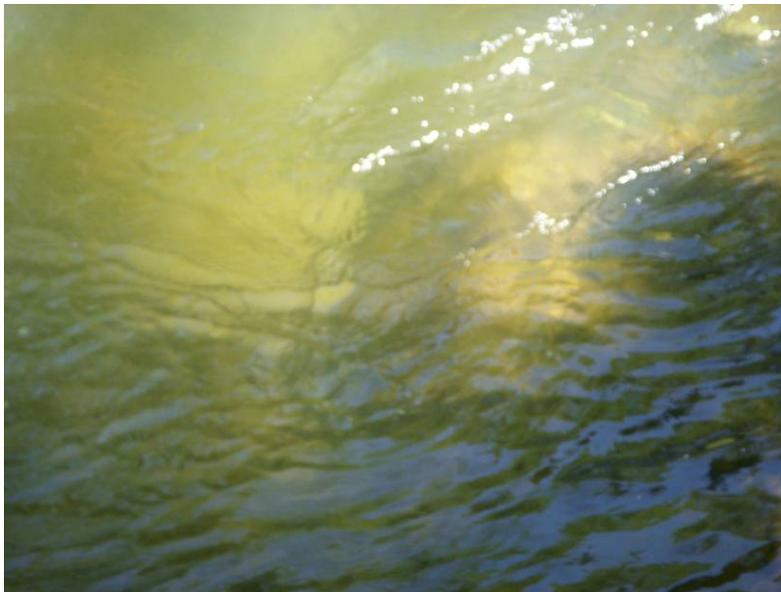
17. Lower Boise River at Eagle Island State Park.
N 43⁰ 41.356' W 116⁰ 23.135'

This is a photo of the water and a rock at the state park.

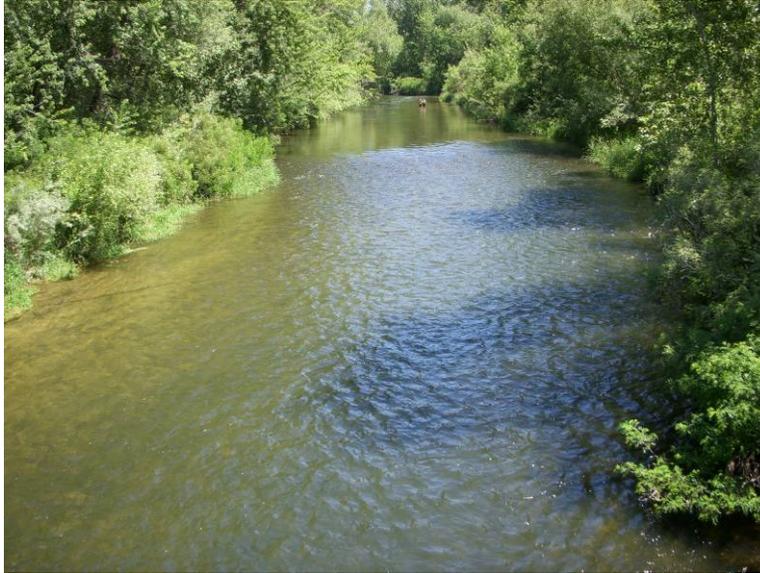
18. Lower Boise River from Linder Bridge
N 43⁰ 41.240' W 116⁰ 24.825'

This is a view of the river, looking upstream of the Linder Bridge. Turbidity appears to have increased slightly.

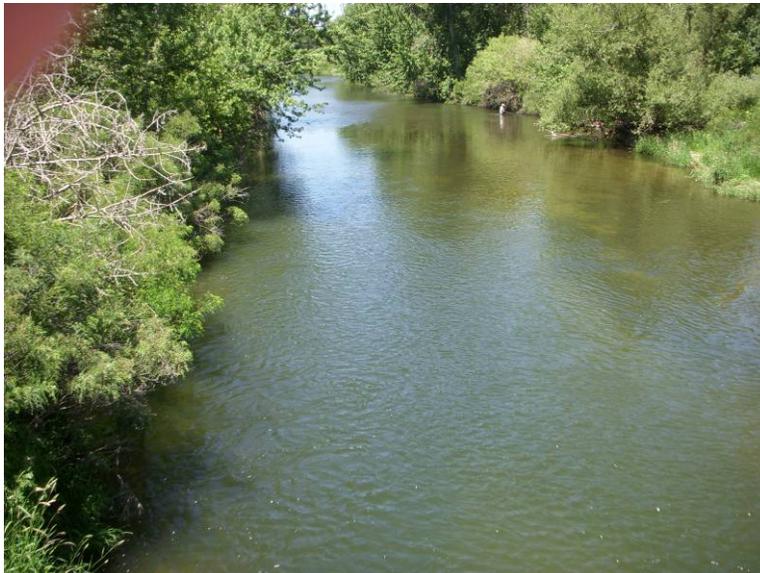
19. Lower Boise River from Linder Bridge
N 43⁰ 41.240' W 116⁰ 24.825'

This is a view of the river, looking downstream of the Linder Bridge.

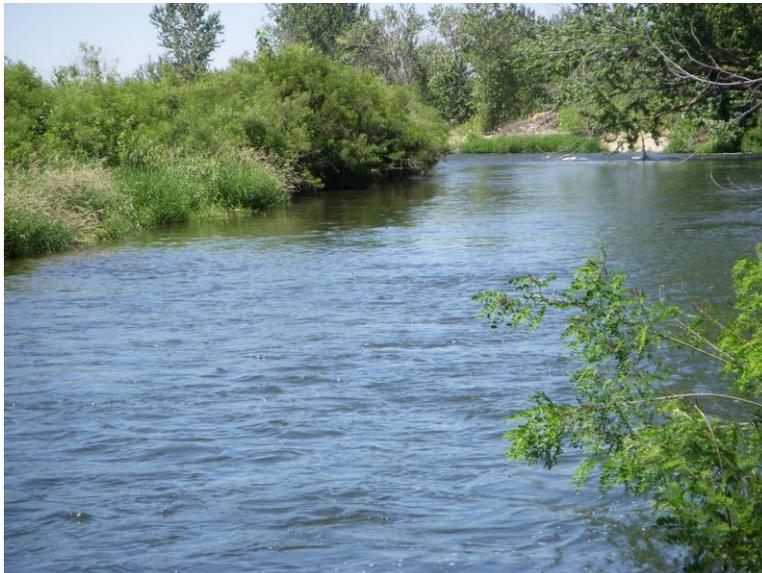
21. Lower Boise River from Sportsman Access near Middleton, ID.
N 43⁰ 41.095' W 116⁰ 34.400'

This is a view of the river, looking downstream of the Sportsman Access.

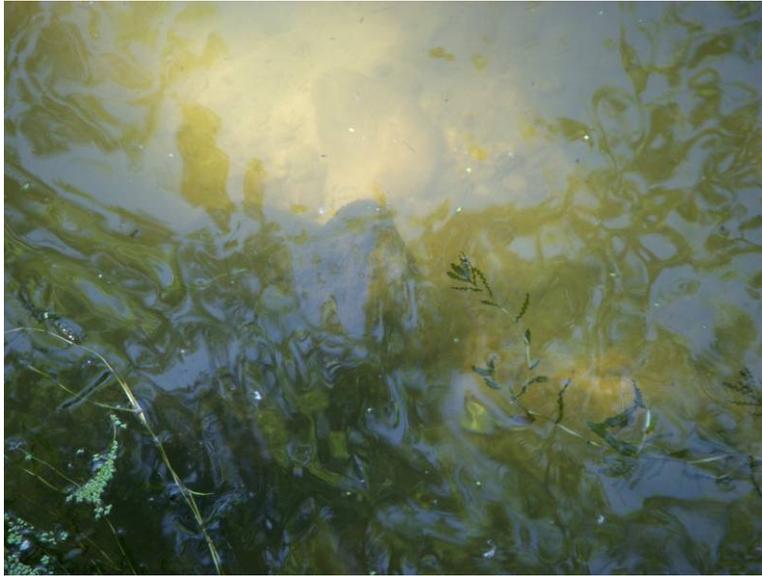
22. Lower Boise River from Sportsman Access near Middleton, ID.
N 43⁰ 41.095' W 116⁰ 34.400'

This is a view of the water with periphyton and macrophytes visible in the river.

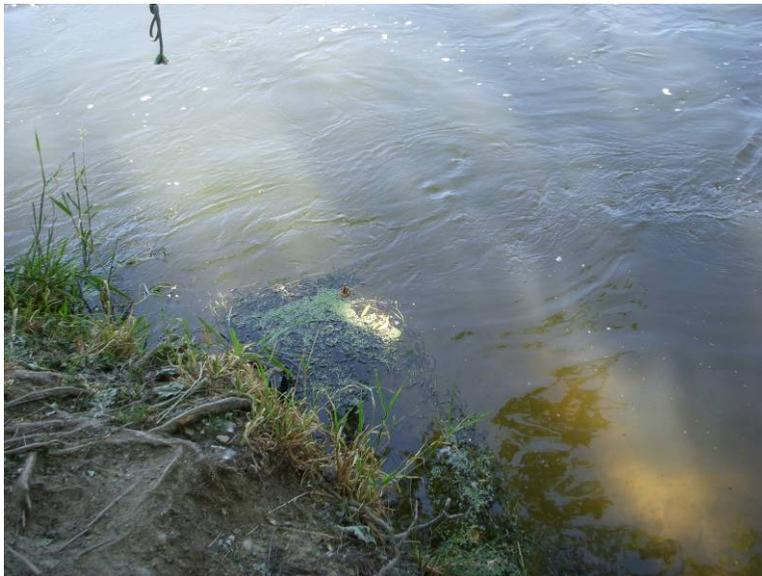
23. Lower Boise River from Sportsman Access near Middleton, ID.
N 43⁰ 41.095' W 116⁰ 34.400'

Turbidity increasing in the water when compared to earlier pictures, and some aquatic macrophytes visible in the photo.

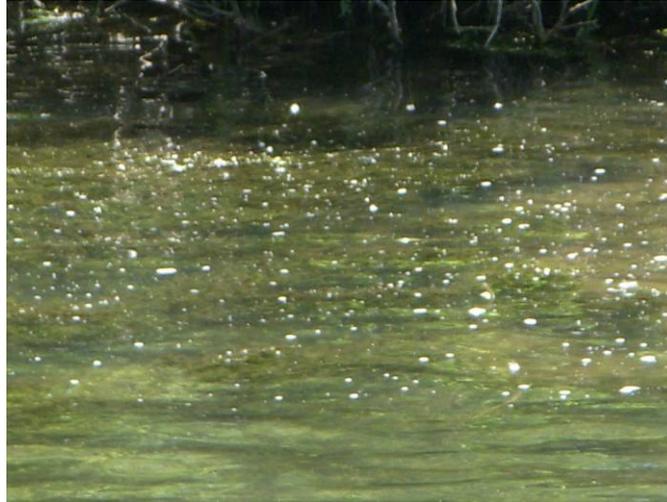
24. Lower Boise River from Sportsman Access near Middleton, ID.

This slack water area near a bend in the river had beds of submerged macrophytes.

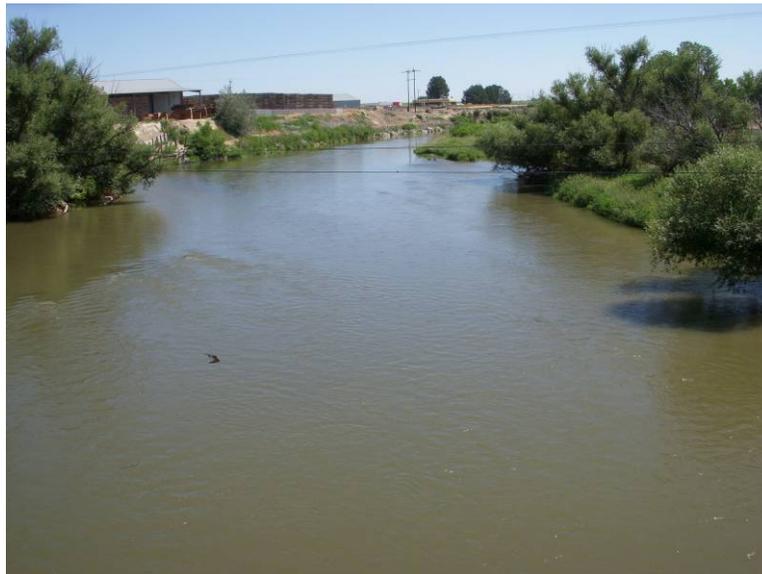
25. Lower Boise River near Notus, Idaho.

This is the view of the Lower Boise River facing upstream on the bridge at Notus. There was a cattle feeding operation immediately to the right of the photo.

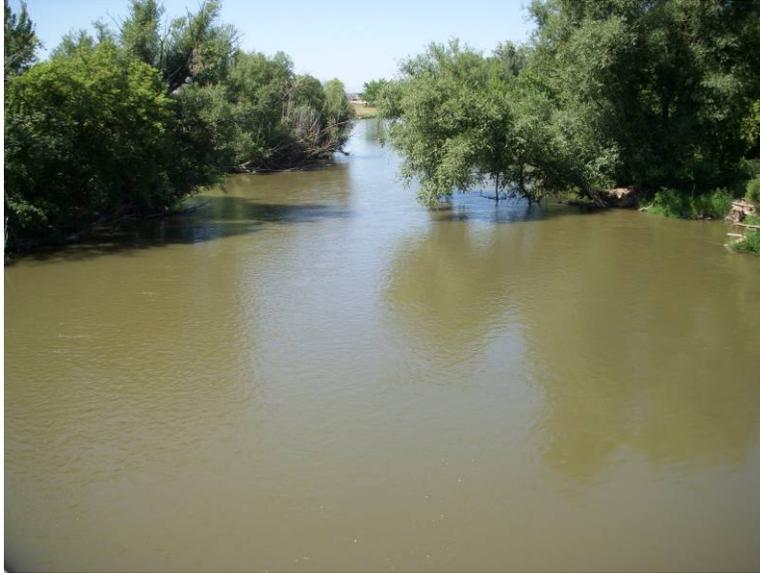
26. Lower Boise River near Notus, Idaho.
N 43⁰ 43.228' W 116⁰ 47.872'

This is the view of the Lower Boise River facing downstream on the bridge at Notus.

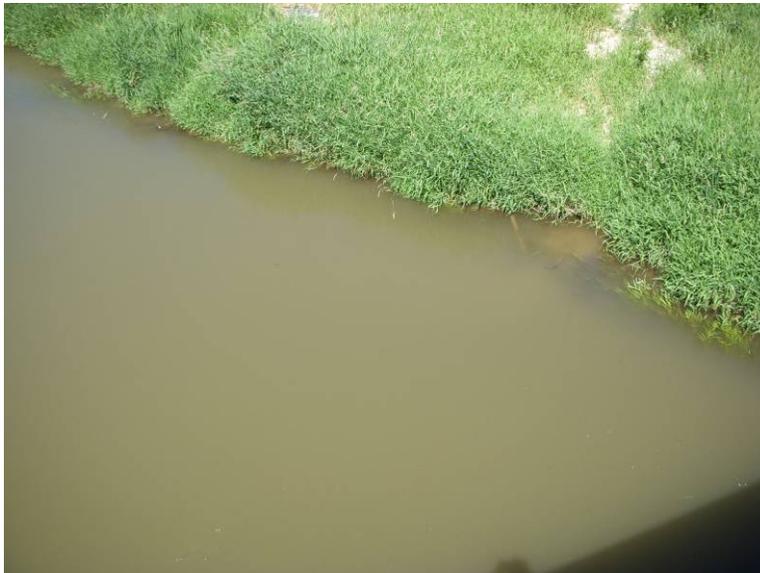
27. Lower Boise River near Notus, Idaho.
N 43⁰ 43.228' W 116⁰ 47.872'

This photo was taken looking down from the bridge at Notus. Note the increase in turbidity of the water from the previous photos.

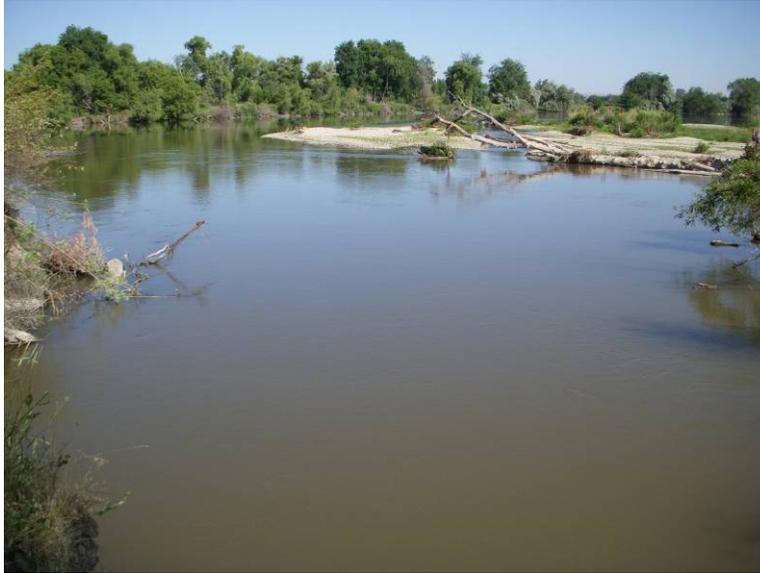
28. Lower Boise River near the mouth near Parma Idaho.
N 43⁰ 48.853' W 117⁰ 01.296'

This is a photo of the last access to the Lower Boise River before it enters the Snake River.

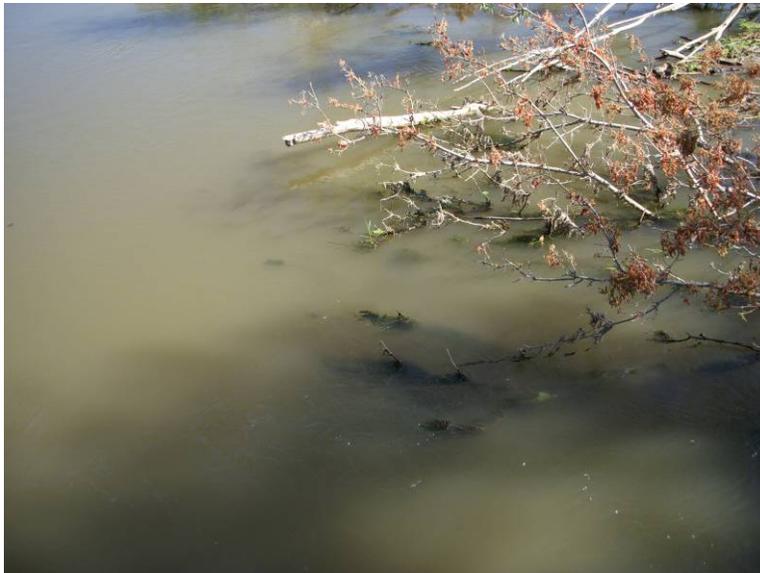
29. Lower Boise River near the mouth near Parma Idaho.
N 43⁰ 48.853' W 117⁰ 01.296'

This is a photo shows macrophytes and general water color in this location.

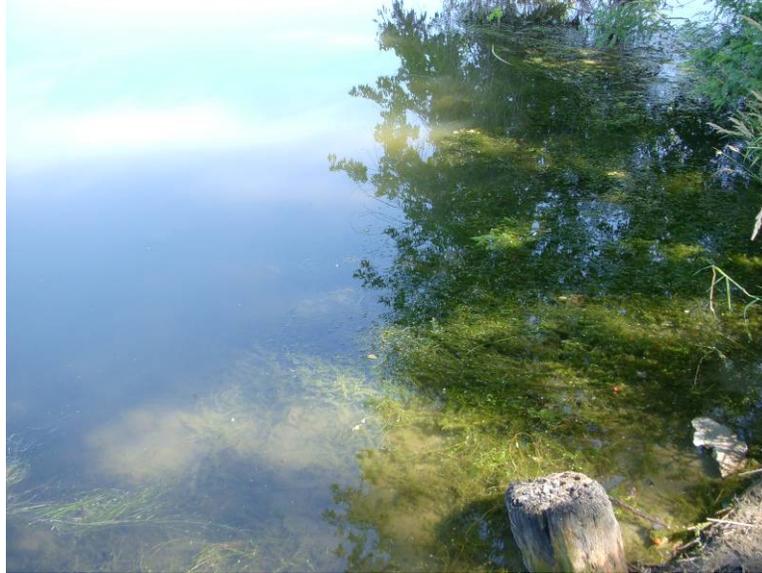
30. Lower Boise River near the mouth near Parma Idaho.
N 43⁰ 48.853' W 117⁰ 01.296'

This is a photo of submergent macrophytes in the Lower Boise River which were growing along the river bank.

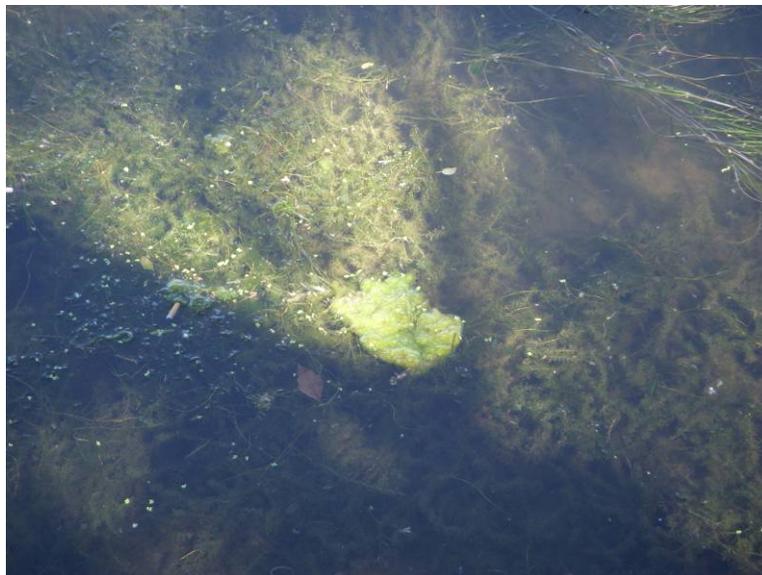
31. Lower Boise River near the mouth near Parma Idaho.
N 43⁰ 48.853' W 117⁰ 01.296'

This is a photo of some submergent vegetation and filamentous algae growing on the rocks along the river bank.

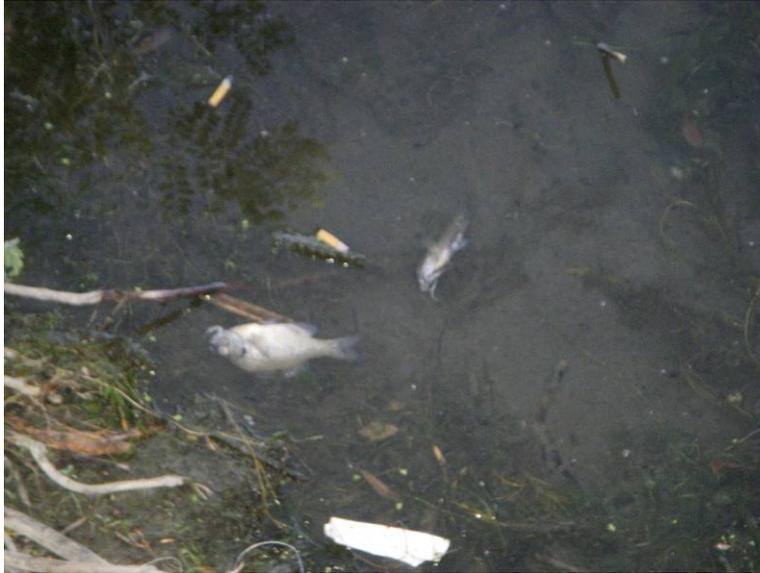
32. Lower Boise River near the mouth near Parma Idaho.
N 43⁰ 48.853' W 117⁰ 01.296'

This is a photo of two dead bluegills and trash, vegetation, etc along the river. The cause of the fish mortality is unknown and these were the only dead fish seen.

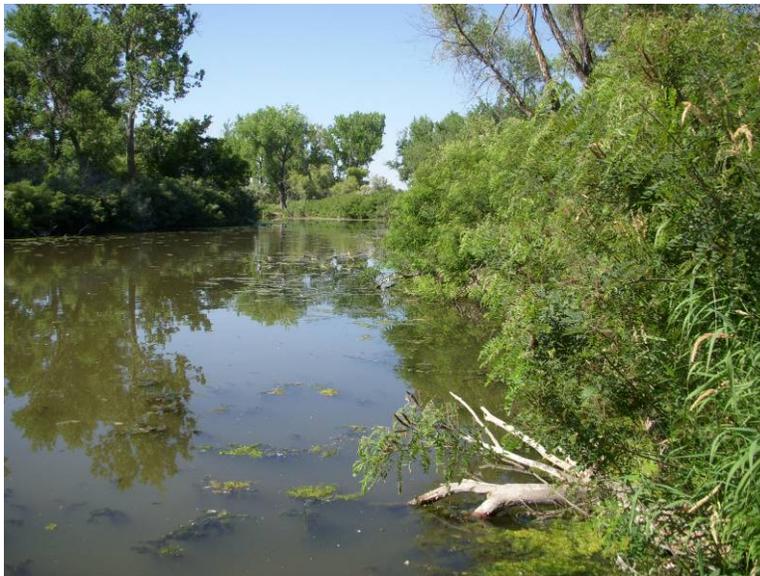
33. Lower Boise River side channel approximately 50 feet from the mouth on the Main Lower Boise River. N 43⁰ 48.813' W 117⁰ 01.297

Note the emergent vegetation, submergent vegetation and filamentous algae in the water.

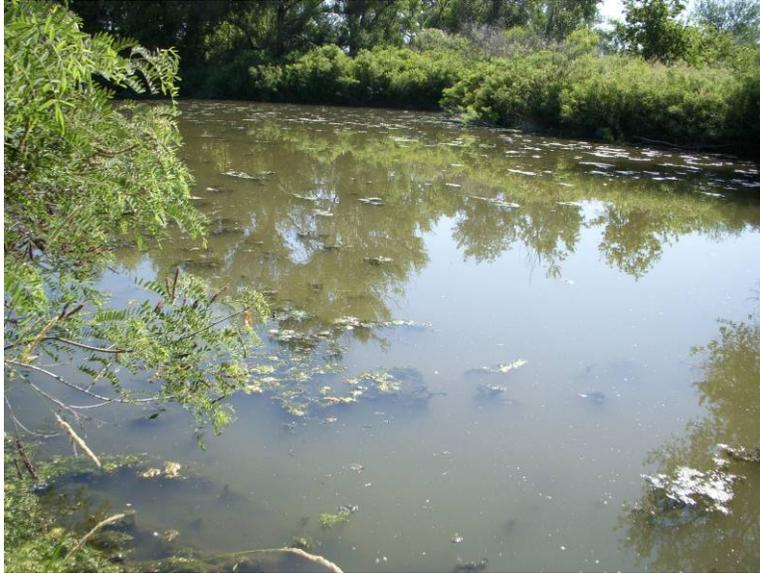
34. Lower Boise River side channel approximately 50 feet from the mouth on the Main Lower Boise River. N 43⁰ 48.813' N 43⁰ 48.813' W 117⁰ 01.297

Note the emergent vegetation, submergent vegetation and filamentous algae in the water.

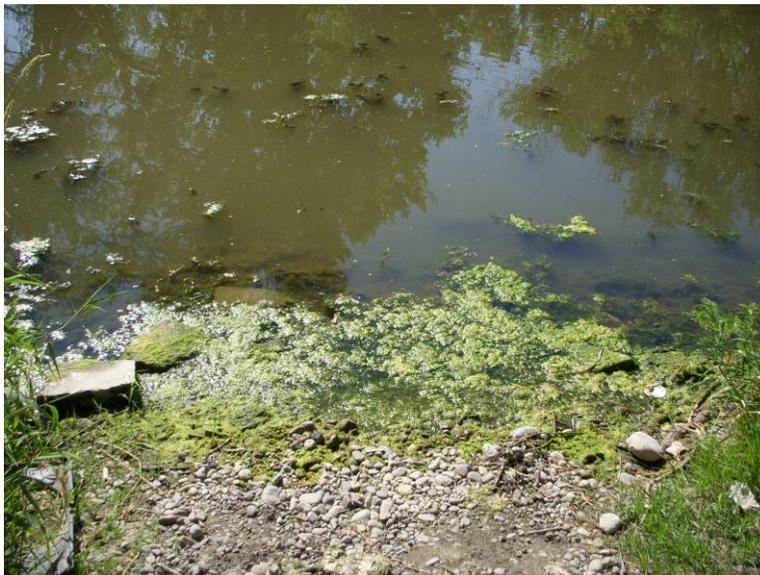
35. Lower Boise River side channel approximately 50 feet from the mouth on the Main Lower Boise River. N 43⁰ 48.813' W 117⁰ 01.297

Note the emergent vegetation, submergent vegetation and filamentous algae in the water.

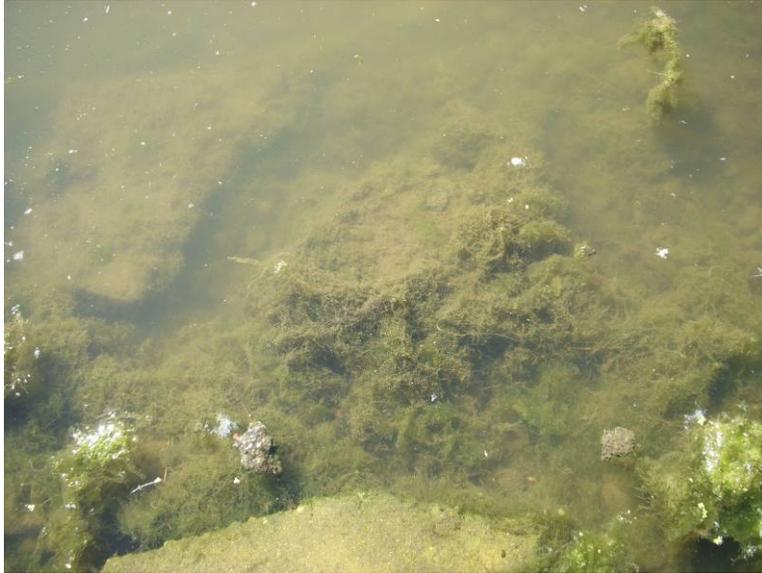
36. Lower Boise River side channel approximately 50 feet from the mouth on the Main Lower Boise River. N 43⁰ 48.813' W 117⁰ 01.297'

Note the heavy growth of Periphyton on the rocks in the water.

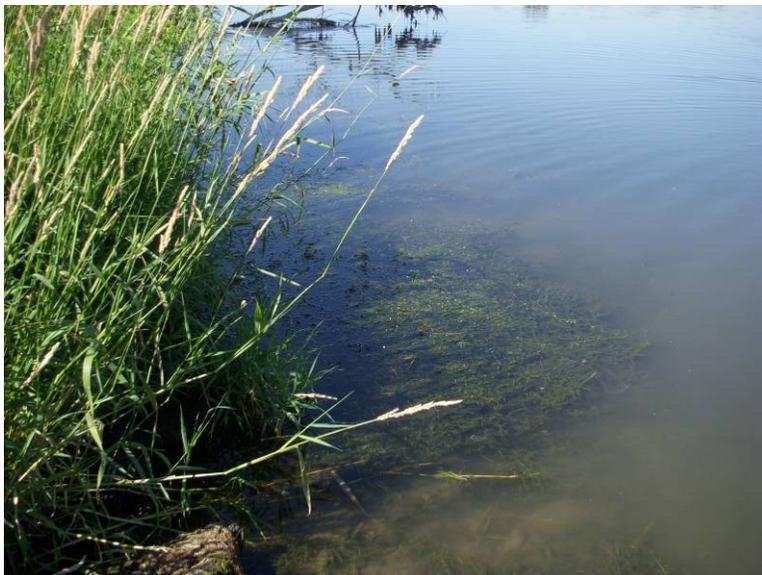
37. Main Lower Boise River near Parma. N 43⁰ 48.812' W 117⁰ 01.347'

This photo shows macrophytes growing near shore.

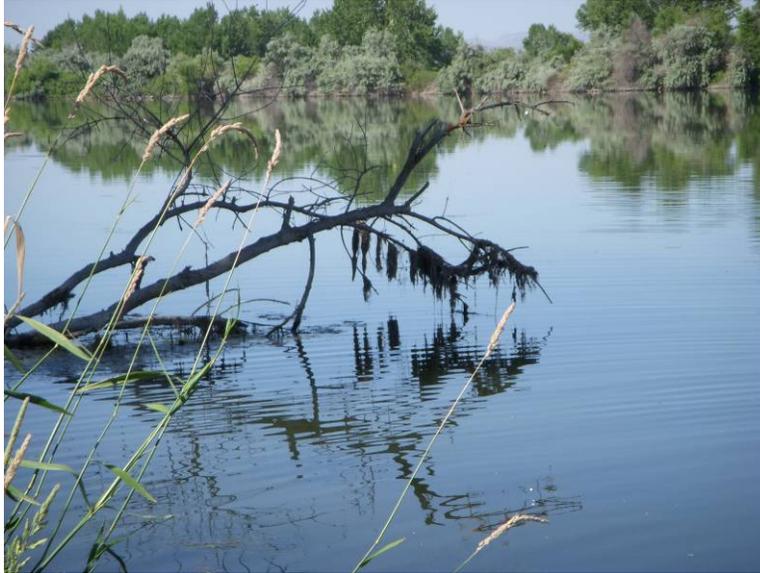
38. Main Lower Boise River near Parma. N 43⁰ 48.812' W 117⁰ 01.347'

This photo shows macrophytes hanging on a dead snag from earlier high water period.

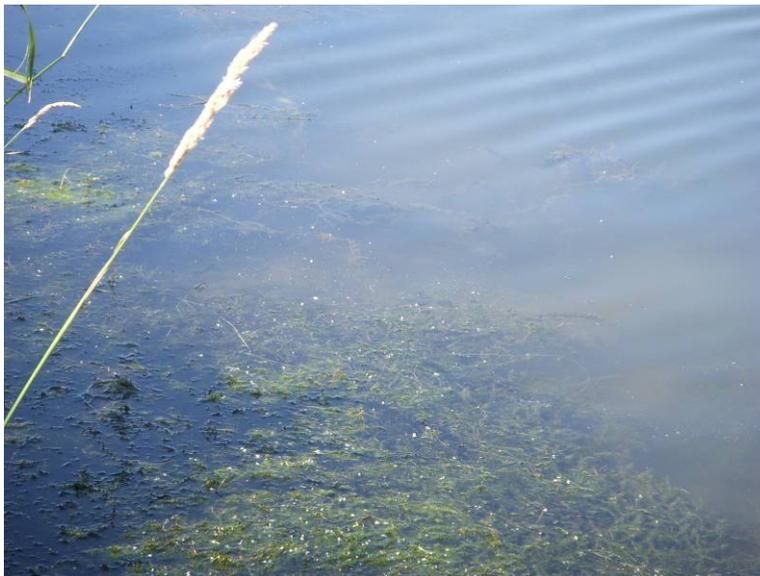
39. Main Lower Boise River near Parma. N 43⁰ 48.812' W 117⁰ 01.347'

This photo shows a closer view of the macrophytes growing near shore. The water in this area was very turbid.

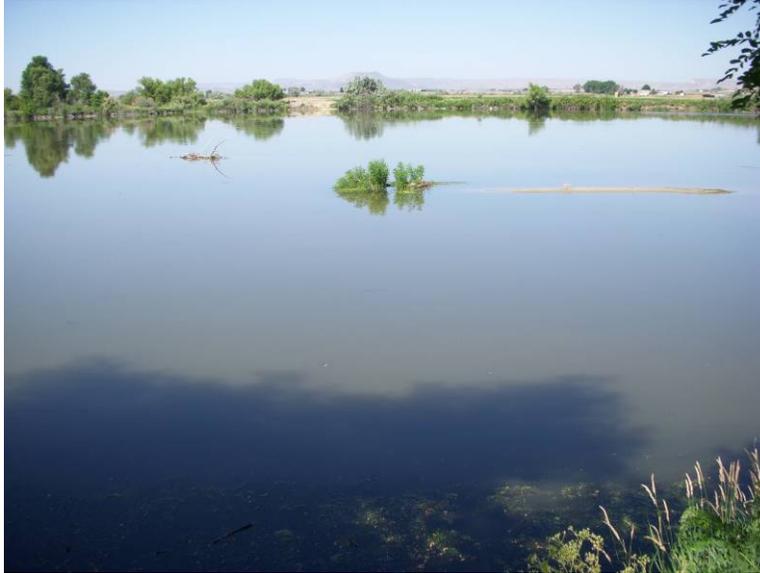
40. Snake River at Ft. Boise Wildlife Management Area, downstream of the mouth of the Lower Boise River. N 43⁰ 49.297' W 117⁰ 01.174'
This view is the Snake River approximately .5 – 1 mile downstream of the mouth of the Lower Boise River. The water was very turbid and a sandbar is visible in the upper right of the photo.

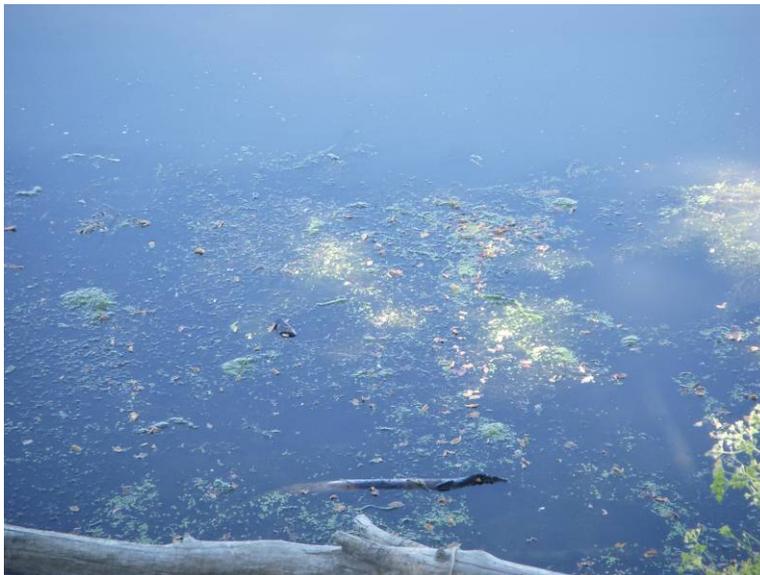
41. Snake River at Ft. Boise Wildlife Management Area, downstream of the mouth of the Lower Boise River. N 43⁰ 49.297' W 117⁰ 01.174'

This vegetation was growing along the bank of the Snake River in this location.

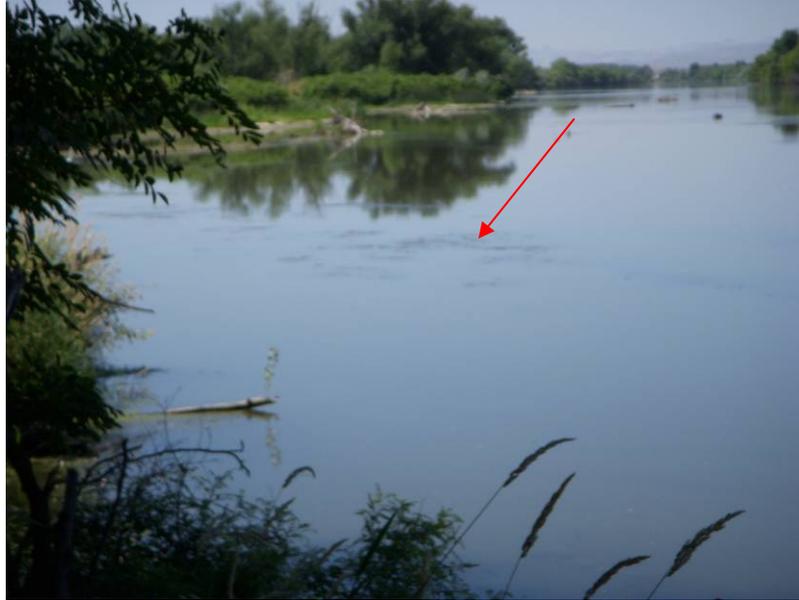
42. Snake River at Ft. Boise Wildlife Management Area, downstream of the mouth of the Lower Boise River. N 43⁰ 49.297' W 117⁰ 01.174'

The red arrow in this photo is marking the floating vegetation on the Snake River in this location.
