# DAMAGE TO THE HISTORIC TOWN OF STAUFEN (GERMANY) CAUSED BY GEOTHERMAL DRILLINGS THROUGH ANHYDRITE-BEARING FORMATIONS

## Ingo SASS<sup>1</sup> & Ulrich BURBAUM<sup>2</sup>

ACTA CARSOLOGICA 39/2, 233-245, POSTOJNA 2010

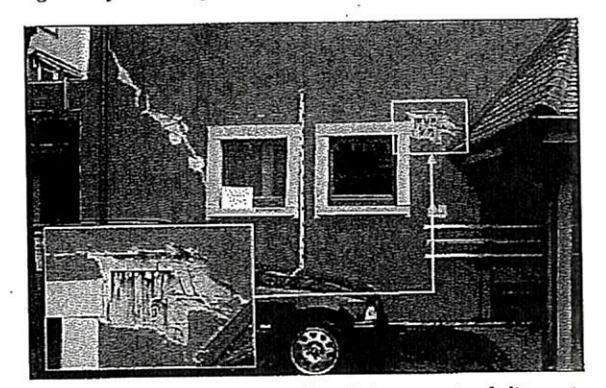
Fig. 2: Uplift cracks in building Kirchstraße, inner courtyard, distance to the well field approx. 20 m to the east. Destruction of the supporting masonry, March 2009 (Photo: U. Burbaum).

The differential uplift affects buildings as well as infrastructure by inducing stresses which exceed the tension and shear strengths of the structural components, producing tension and shear cracks (Figs. 2 and 3). In addition, the deformations also cause tilting, which in turn puts compressive stress on bearing elements. The uniaxial compressive strength of construction components is locally exceeded, and they fail. Damages to the local infrastructure (Fig. 4) are severe. For example, gas and water utilities require expansion bends (Fig. 5) to prevent future desasters. The damage patterns are dependent upon the tectonic setting, the lithologic conditions, hydrogeological heterogeneity, and the BHE drilling geometry as well as varying BHE construction quality.

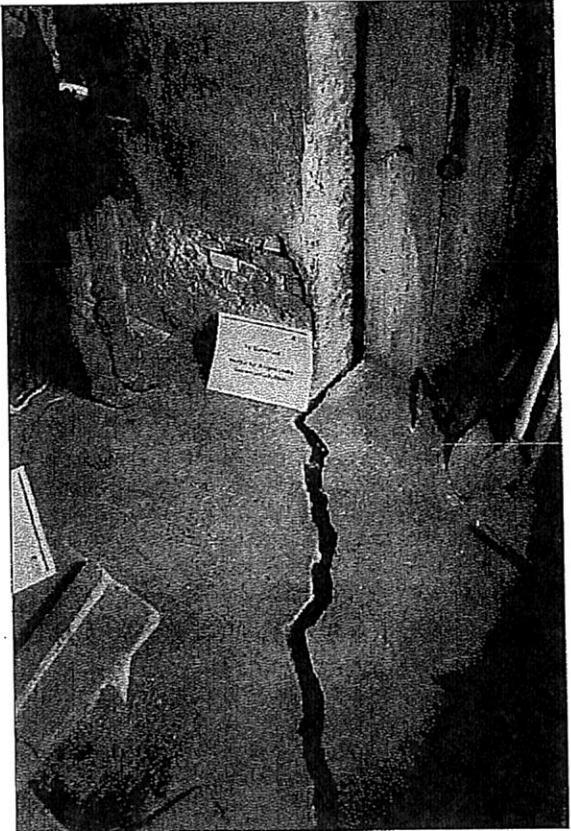
Fig. 3: Tension crack in a baseplate, building Jägergasse, distance to the well field approx, 70 m to the northeast, March 2009 (Photo: U. Burbaum).

Apertures of cracks typically range up to some centimeters, with some more than 10 cm. To date (March 2010) approximately 250 houses are seriously affected, and the number is still increasing (although this num-

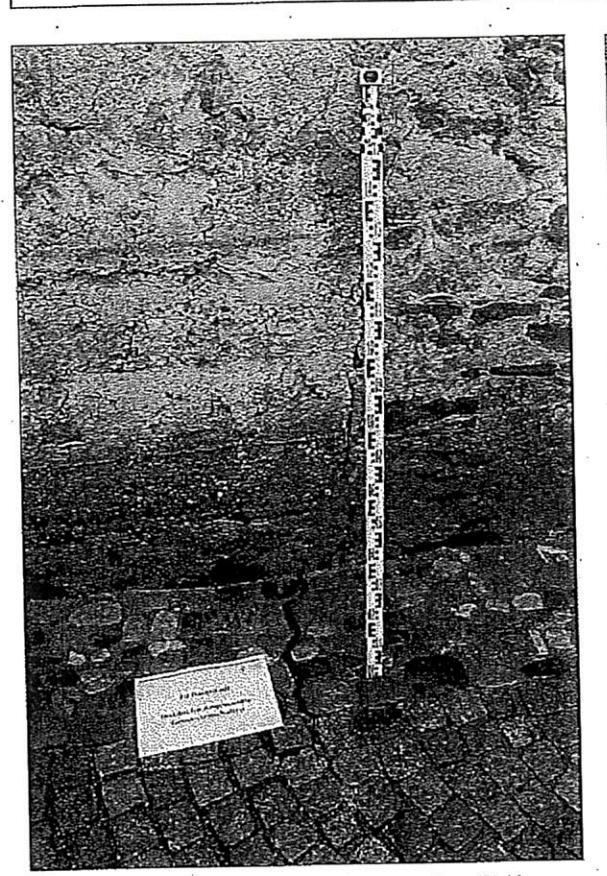
Fig. 4: Crack in the street "Jāgergasse", distance to the wellfield approx. 80 m to the NE, March 2009 (Photo: U. Burbaum).

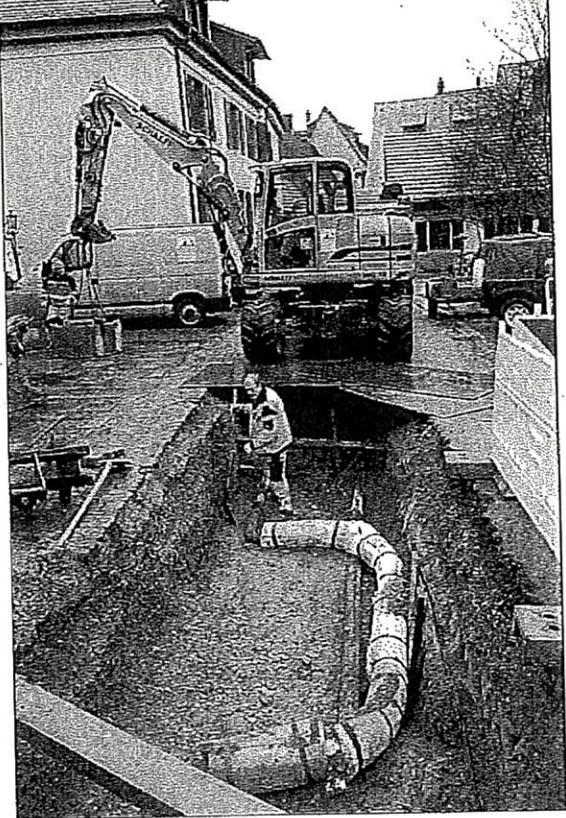
Fig. 5: Installation of an expansion bend in a PE-HD gas pipe, Meiergasse, distance to the well field approx. 80 m in northnortheast direction, March 2009 (Photo: U. Burbaum).

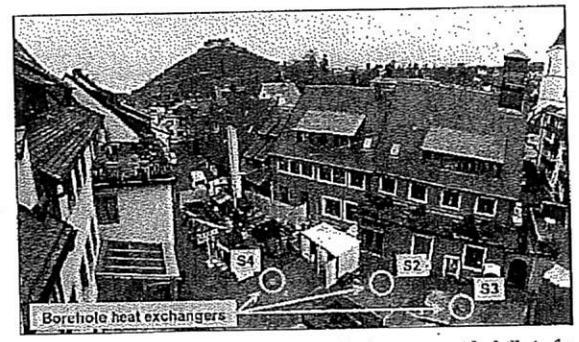
Fig. 12: Borehole heat exchanger field at Rathausgasse with drill rig for the first exploration boring for determining the cause of damage (March 2009). Photo taken from the tower of the town hall by U. Burbaum.

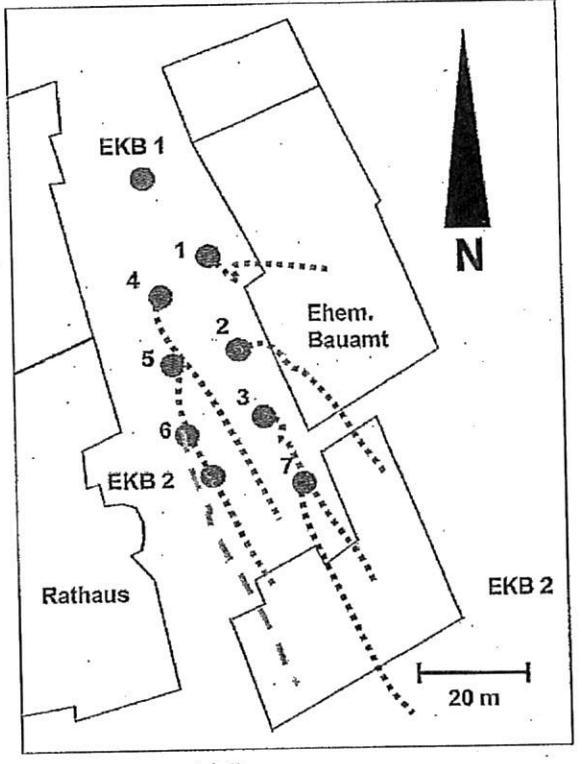
Fig. 13: Deviation of drillings.

An investigation of the inclination of the drillings shows a great horizontal deviation of all drillings up to some 20 m (LGRB 2010). This is shown in Fig. 13. The main deviation occurs in a depth of approx. 60 to 70 m. The depth correlates with the lower end of the temporary drilling casings.

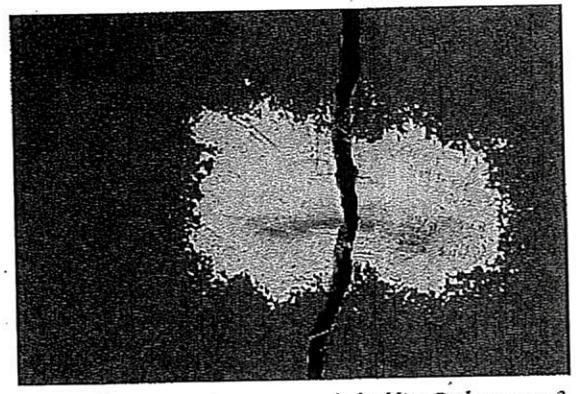
In November 2007, only 6 to 8 weeks after finishing the installation of the BHE, the first cracks were noticed in buildings. Cracks were quite small at first, and were

not linked to the drilling operations. From 12/2007 to 01/2008 cracks were marked with gypsum markers (Fig. 14).

Fig. 14: Gypsum markers on a crack, building Rathausgasse 3, with logs of the fracture spacing since December 2007 (Photo from March 2009 by I. Sass & U. Burbaum).

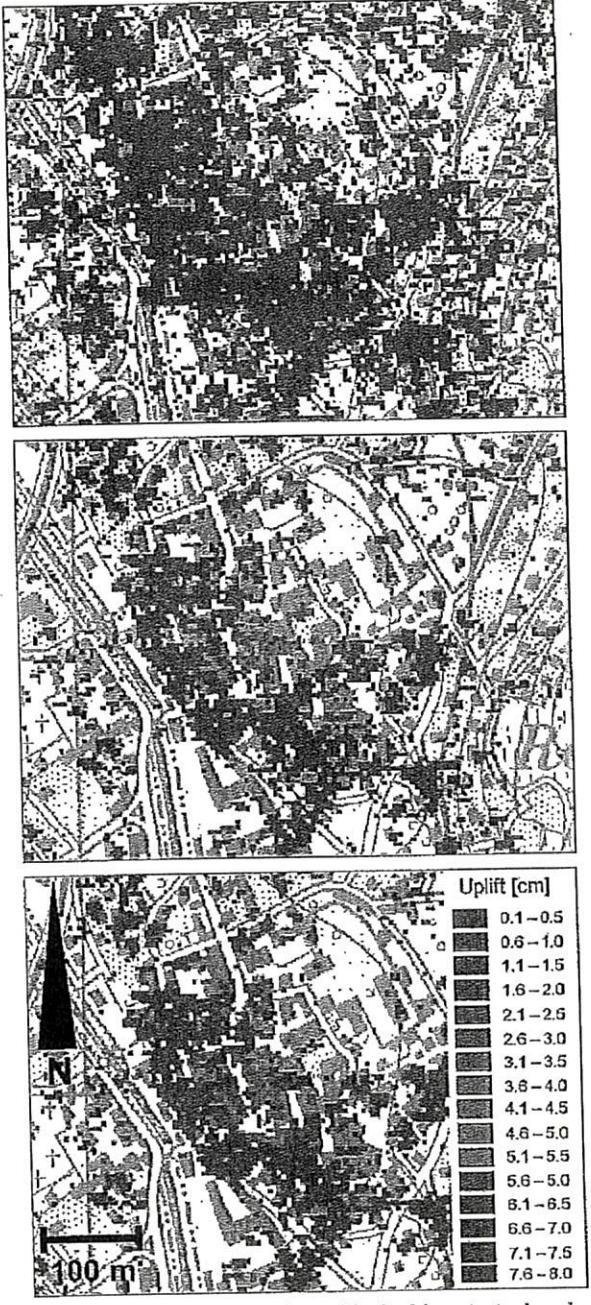
Fig. 15: Analysis of satellite-based ground level uplift monitoring by radar interferometry, a) July 2008 to 29. October 2008, b) July 2008 to 3. January 2009, c) July 2008 to 25. January 2009.

In general, results of the geodetic surveillance and satellite-based radar images (Fig. 15a-c) of the uplifted zone show an elliptical dome with a NNE-SSW axis (Fig. 16). This position coincides well with the bedding of the Jurassic, Keuper and Muschelkalk series.

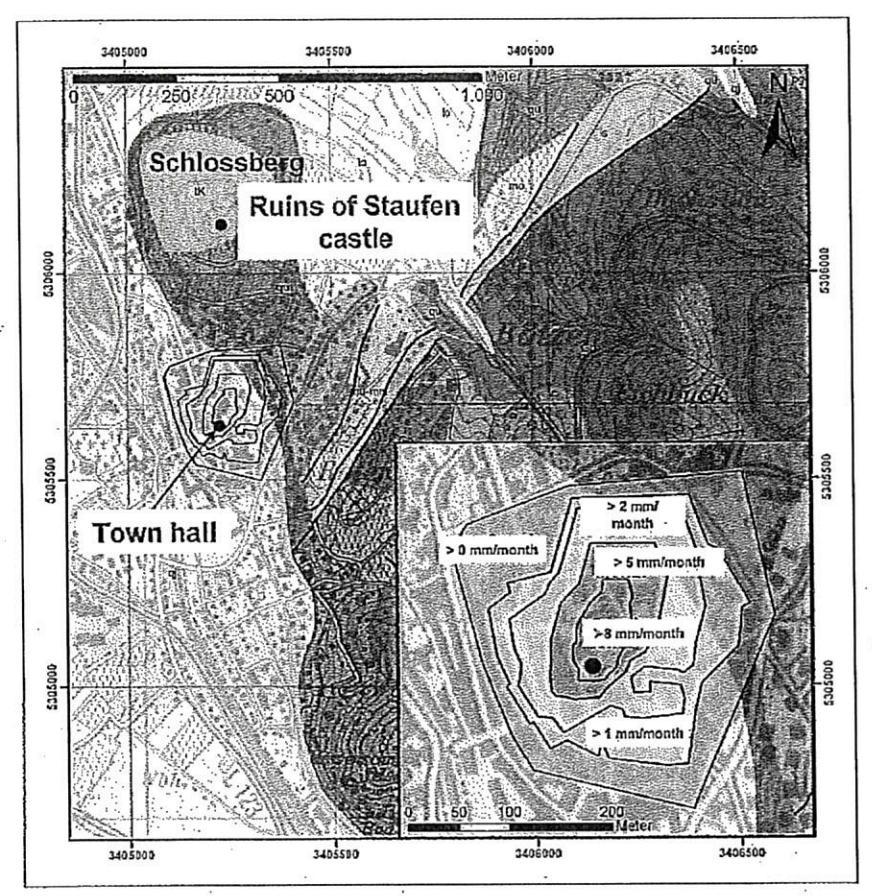
Fig. 16: Uplift rates in the city centre (LGRB 2009) plotted over the geological map Blatt 8112, Staufen im Breisgau, M 1:25.000.

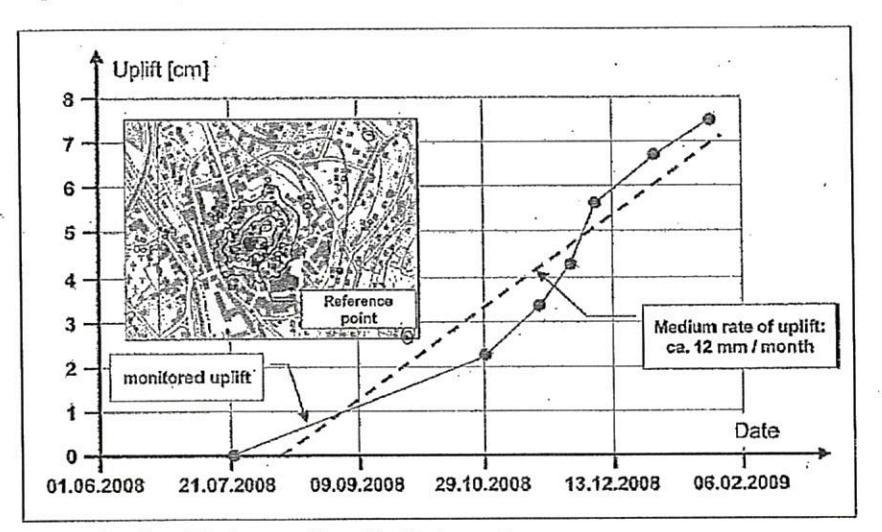
Fig. 17: Chronological development of the uplift of the town centre.

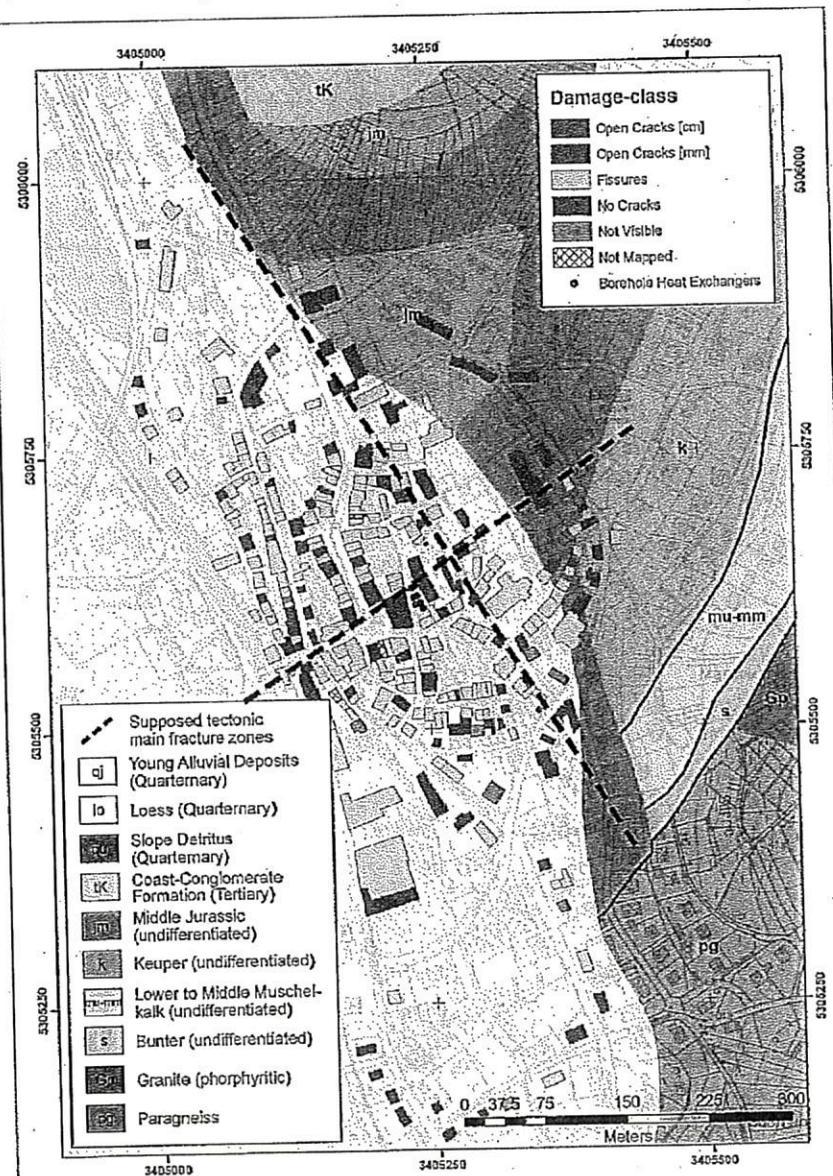
Some buildings or parts of the buildings could not be evaluated. Most of the fissures were smaller than one millimeter. Some buildings have fissures of some millimeters width. More than four buildings have fissures of some centimeters width.

The zone of the most damaged buildings is consistent with the main orientation of geological fault structures, which is NNW-SSE and WSW-ENE (Fig. 18).

The orientation of building damages corresponds to the orientation of the discontinuities (Figs. 18 and 19) that were obtained by a field study in October 2009. It can be concluded that groundwater not only flows through drillings but now through discontinuities, too. The swelling process therefore cannot be stopped by sealing the BHE-Drillings. A larger area remediation approach must be found.

Fig. 18: Mapping of damages and geology.
