United States Environmental Protection Agency Washington, D.C. 20460								
Water Compliance Inspection Report								
Section A: National Data System Coding (i.e., PCS)								
Transaction Code NPDES	S yr/mo. Alalalalii i2lalala	/day in	spection Type	Inspector Fac Type				
	Ren	narks						
21 21 66 Inspection Work Days Facility Self-Monitoring Evaluation Rating BI QA Reserved-								
67 69 70 71 72 73 74 75 80								
Section B: Facility Data								
Name and Location of Facility Inspected (For industrial users discharging to POTW, also include POTW name and NPDES permit number)			Entry Time/Date	Permit Effective Date				
Tuleview Holsteins, LC			8.20am 4/7/09	9/17/2001				
3021N 2800W Brigham City, UT 84302			Exit Time/Date	Permit Expiration Date

# Tuleview Holstein Dairy 4/7/09 Inspection Photo Log

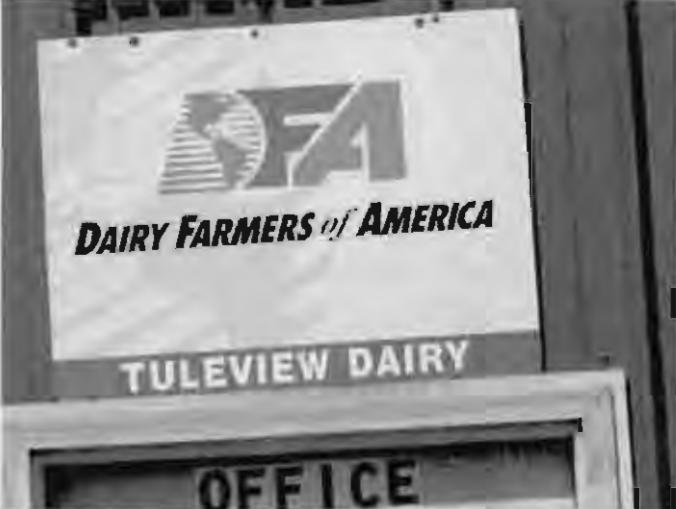
Facility sign

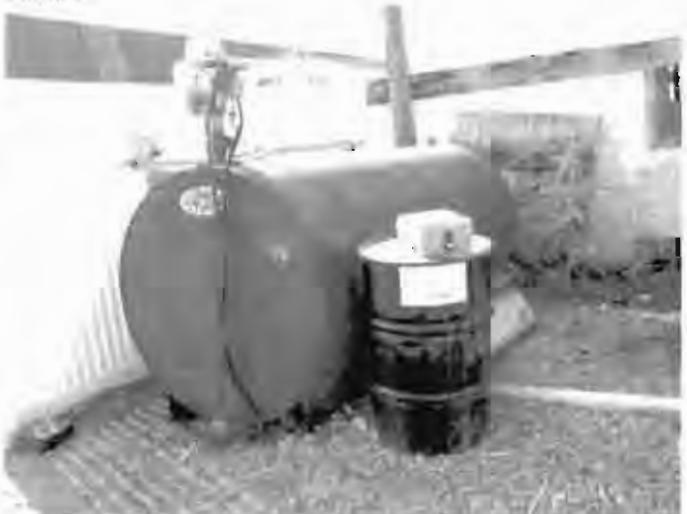
Photo 2:

2000 gallon gasoline tank that is no longer in use.

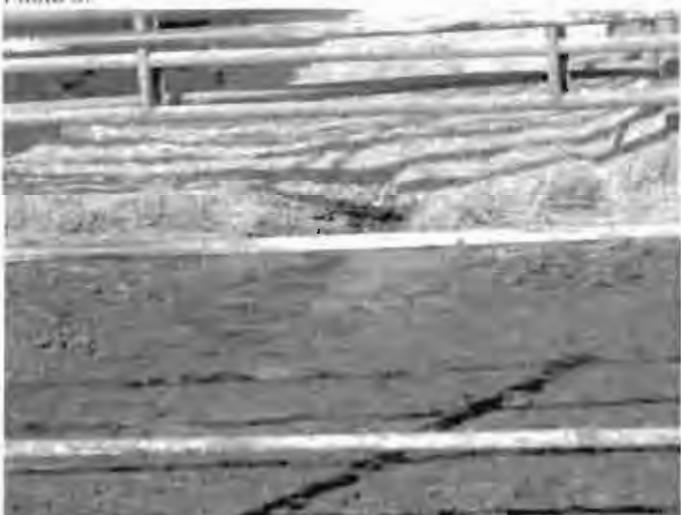
Photo 3:

Drain located south of the calving area. Wastewater from the milk barn is connected to this drain.

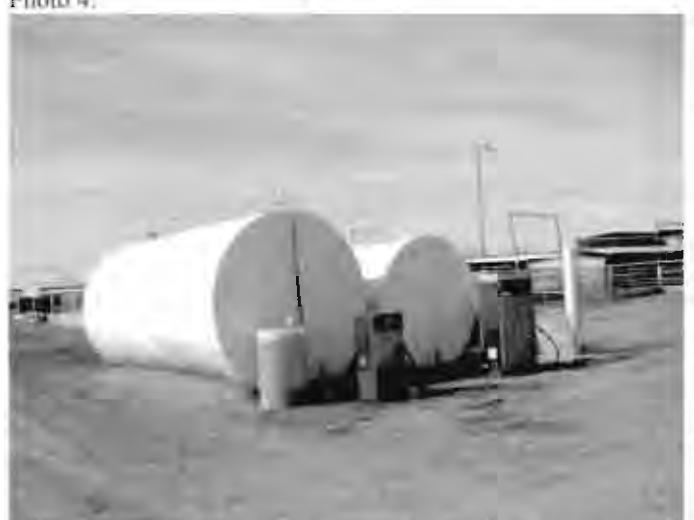
Diesel tanks: 6000 gallons is in use; 2000 gallon has rust and not in use.

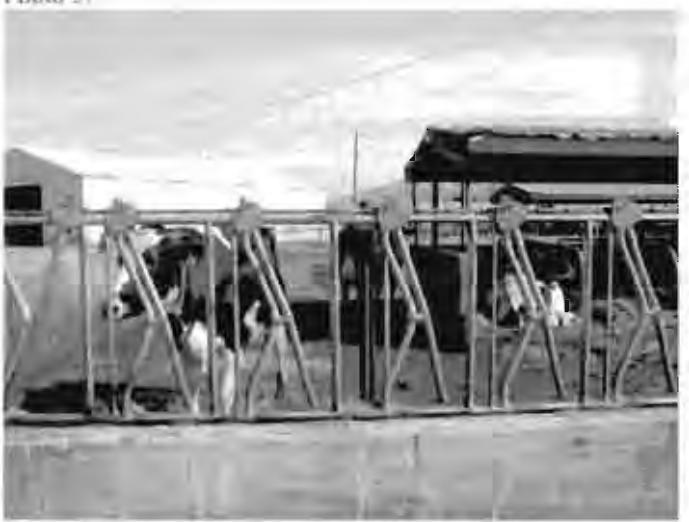
Example of cow alley. Looking north to bunker.

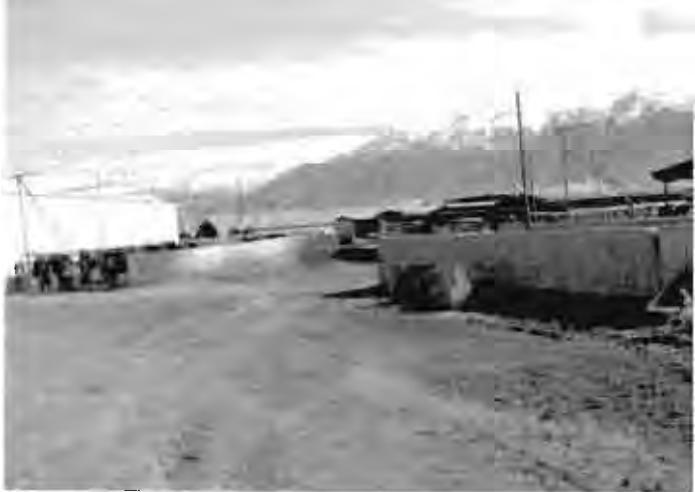
#### Photo 6:

Overview of the bunker.

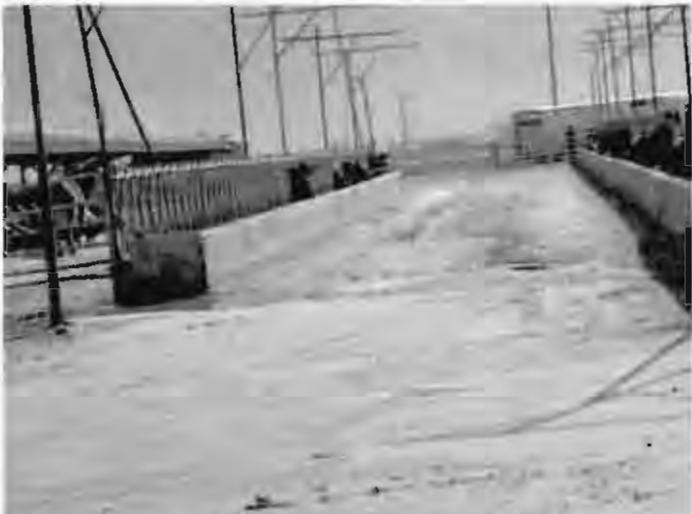
Example of feed alley. The drain is beneath the puddle.

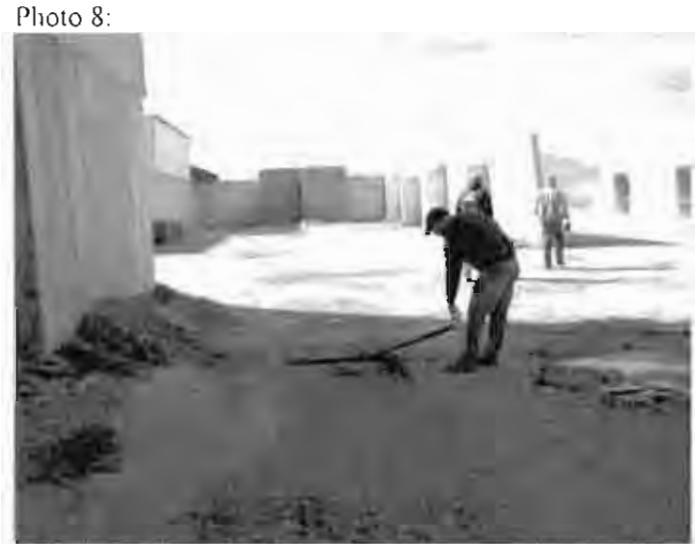
Drain behind hay shed. When there is heavy precipitation, the cover is lifted to allow the area to drain. This is a heavily tracked area. Cover is used to minimize the debris that may enter the drain.

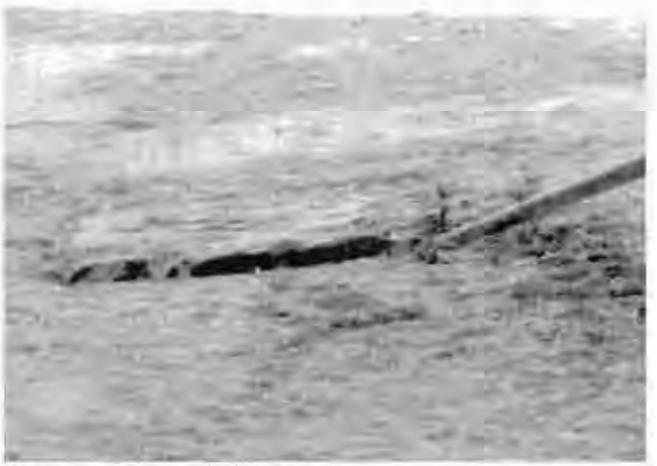
Photo 9:

Close up of the drain in photo 8.

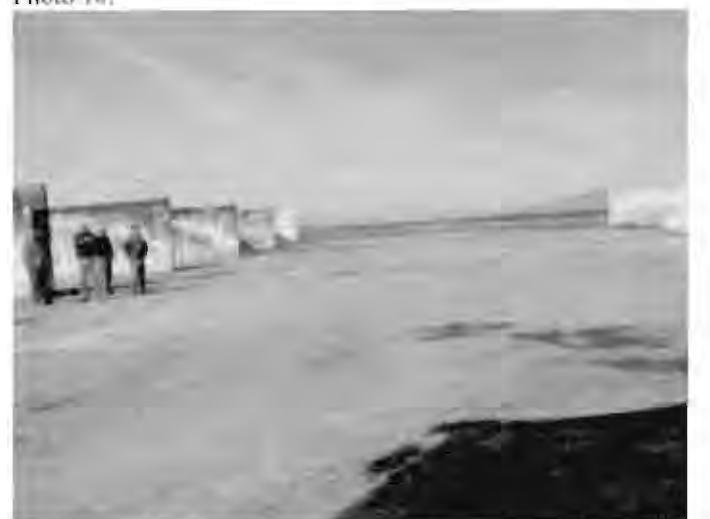
Looking north. This is the feed storage area. Area drains to the drain in photo 8 ( tanding on the drain to take this photo).

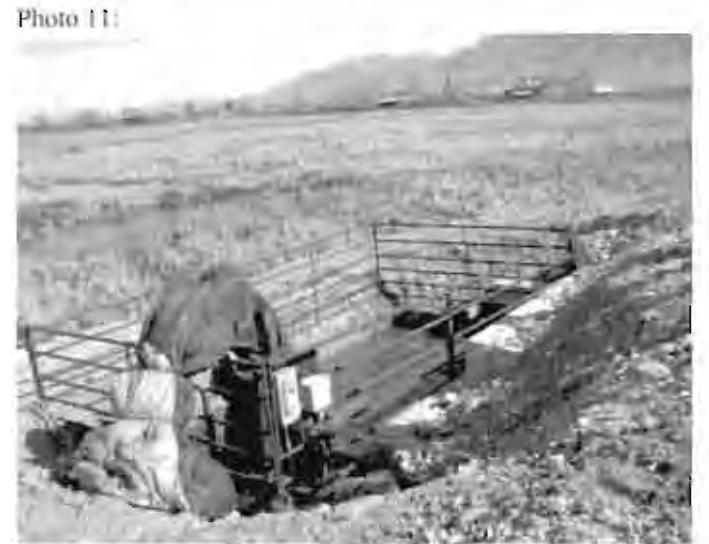
Pump area. Drains flow to this site. Wastewater is pumped to evaporation pond.

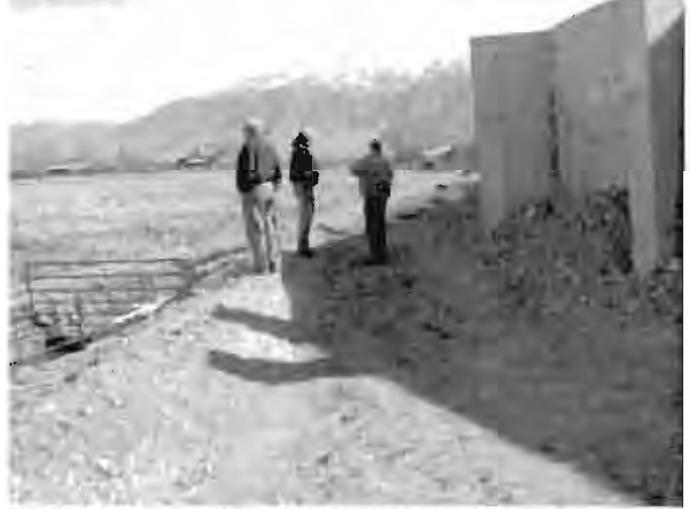
Photo 12:

Looking northeast along the edge of the facility boundary.

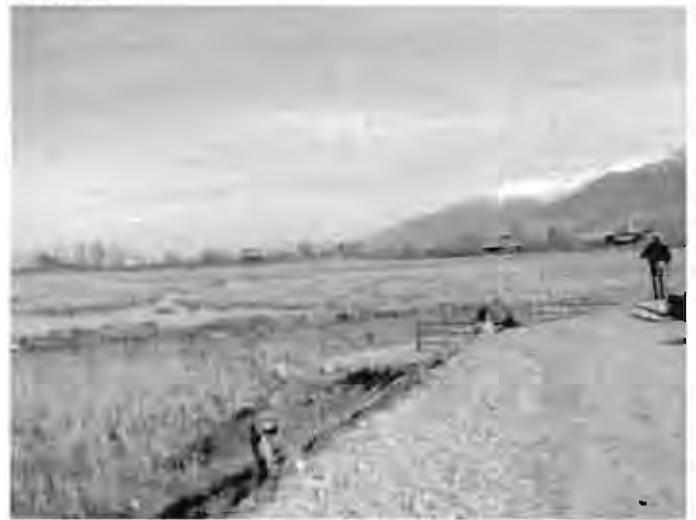
Looking northeast over the slough

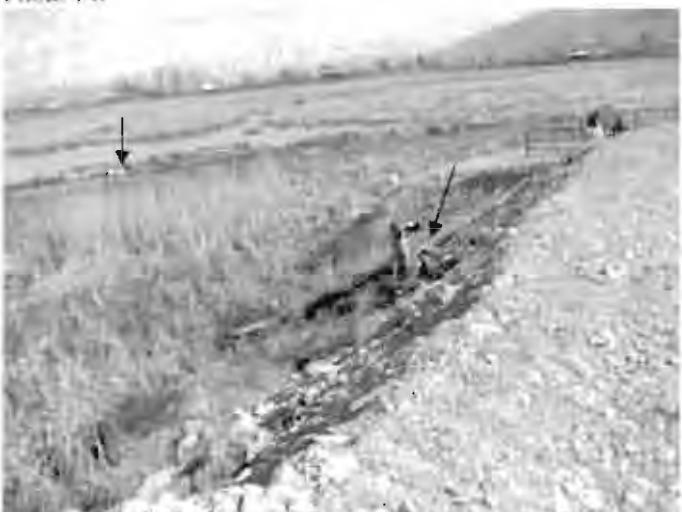
Photo 14:

Overview of photo 13. Note examples of debris in the slough (arrows).

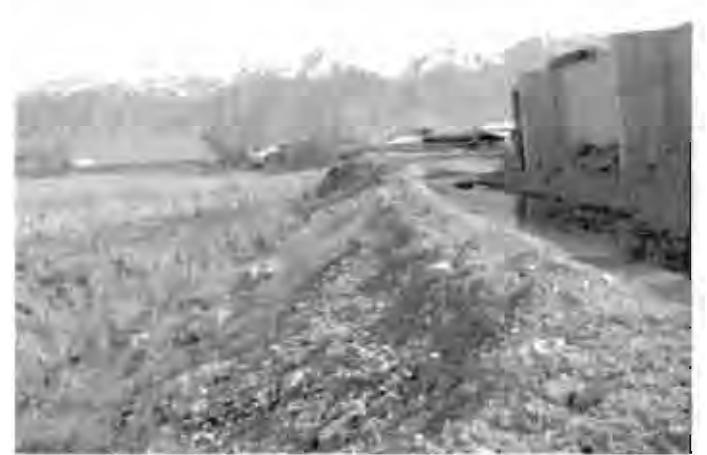
Photo 15:

Surface drainage going to pump area. Water is from broken water line that is under repair. Photo shows water flow pattern.

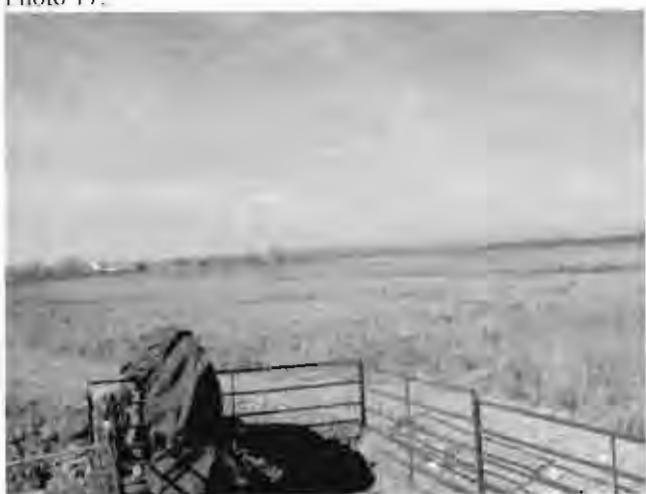
Looking southwest from the pump area.

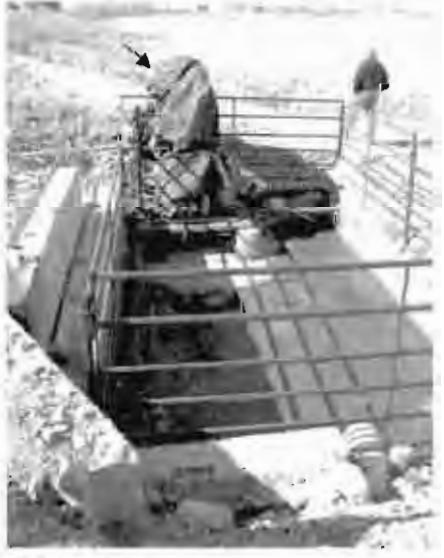
Photo 18:

arrow points to pump.

Red arrow is drain from feed area. Orange arrow is drain from milk barn. Black

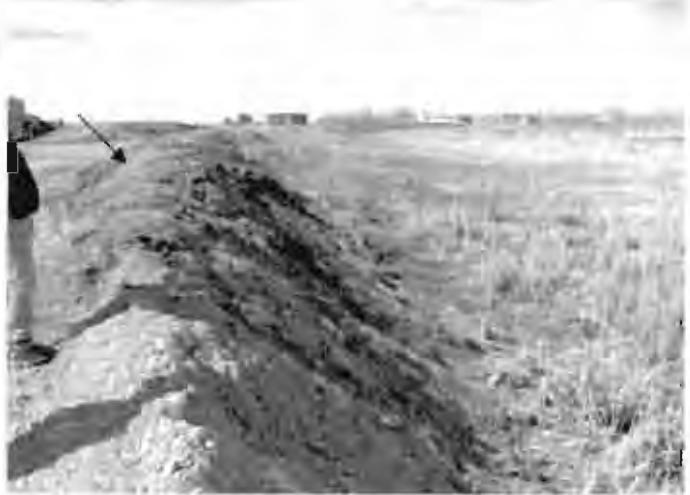
Looking southwest along edge of facility and slough. Facility would push snow (and feed) (black arrow) to edge of slough to drain feed storage area. Note that material goes into the slough (red arrow).

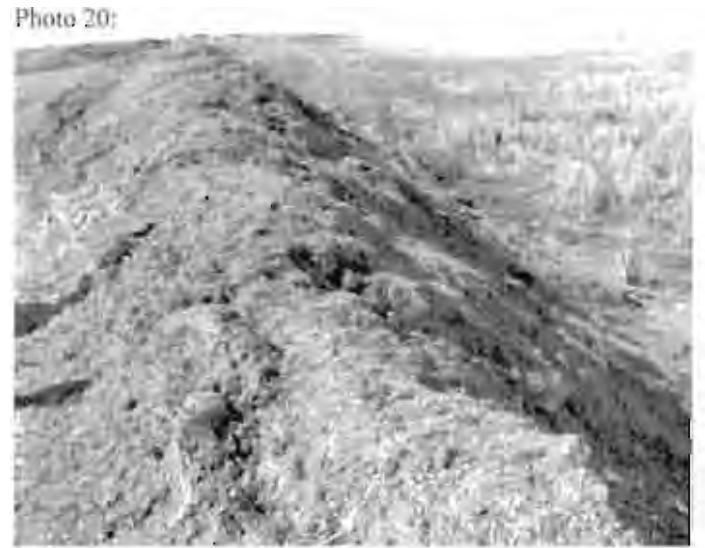
Close-up of snow and feed from feed storage area.

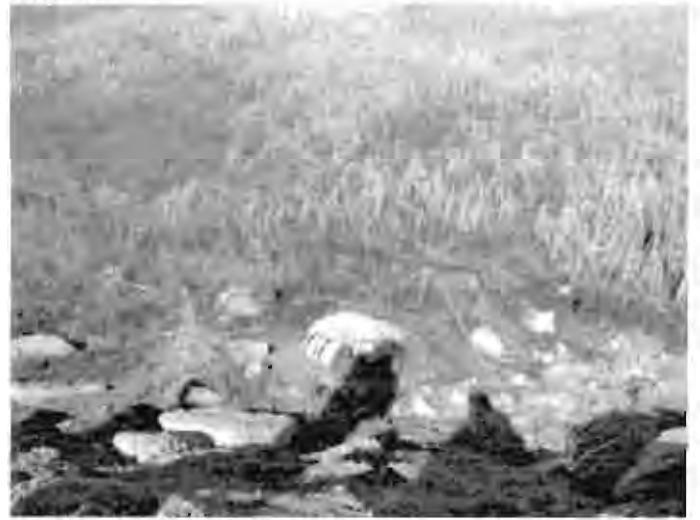
Photo 21:

Trash in slough; bucket was empty.

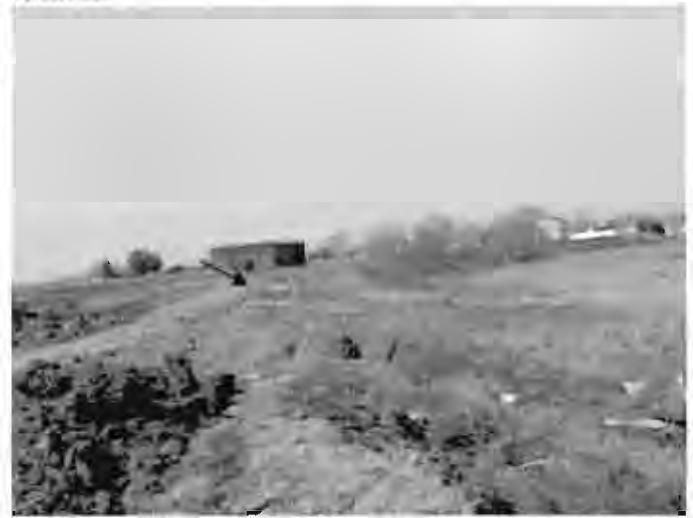
Looking southwest along facility's west boundary and slough. Evaporation pond is to the left of the access multi-Arrow point to the berm breach (see Photo 23).

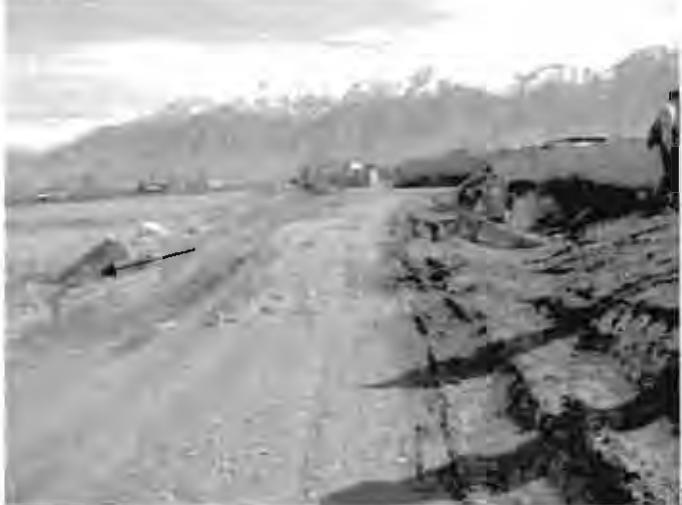
Photo 23:

boking northeast from the same location as Photo 22.

Note the breach in the facility berm (arrow). The facility believes that storm water from the access road (seen in Photo 22) has not be contaminated with process water and could therefore drain into the slough.

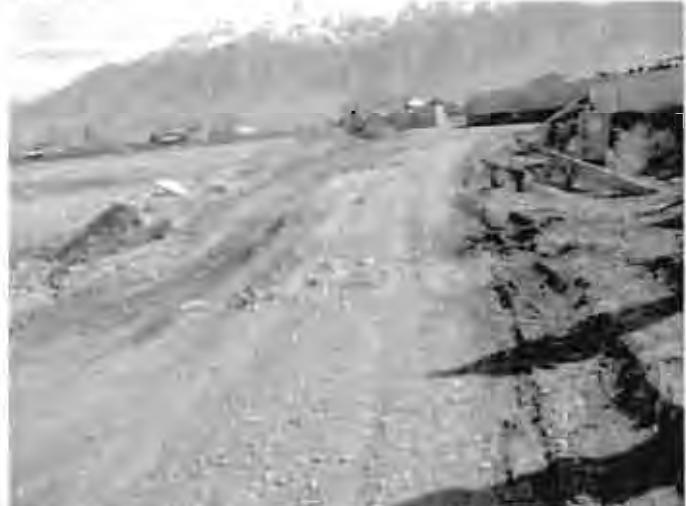
Photo 24:

Close up of breach area seen in Photo 23.

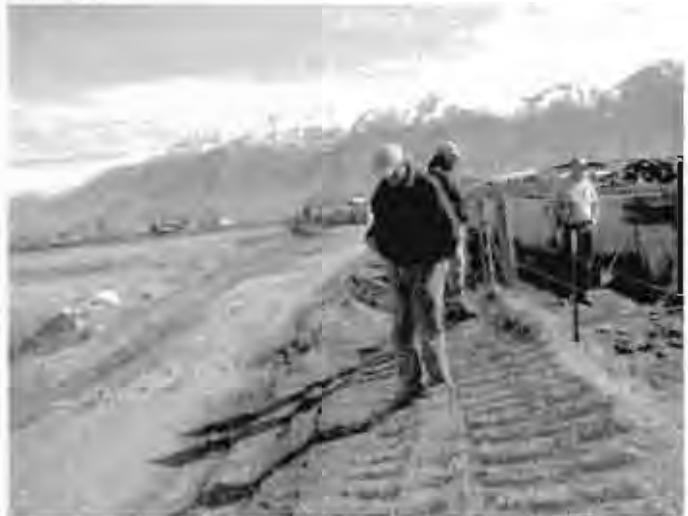
Overview of area between evaporation pond (to the right of photo) and the breached berm (in photos 23 and 24). Red arrow points to top edge of pond.

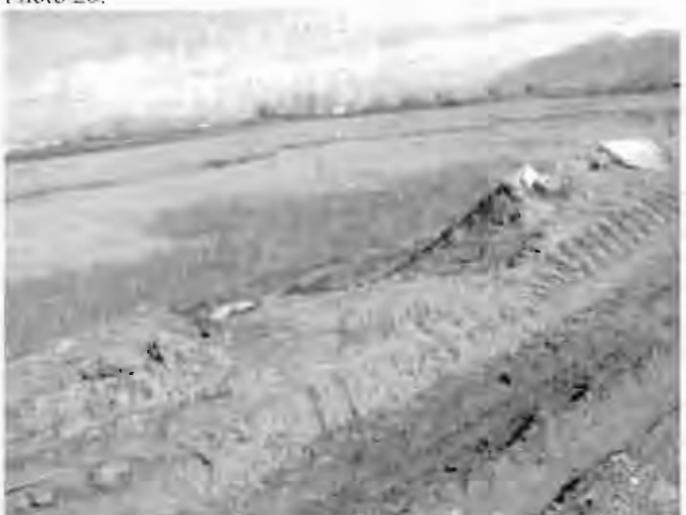
Photo 26:

Close-up of breached berm.

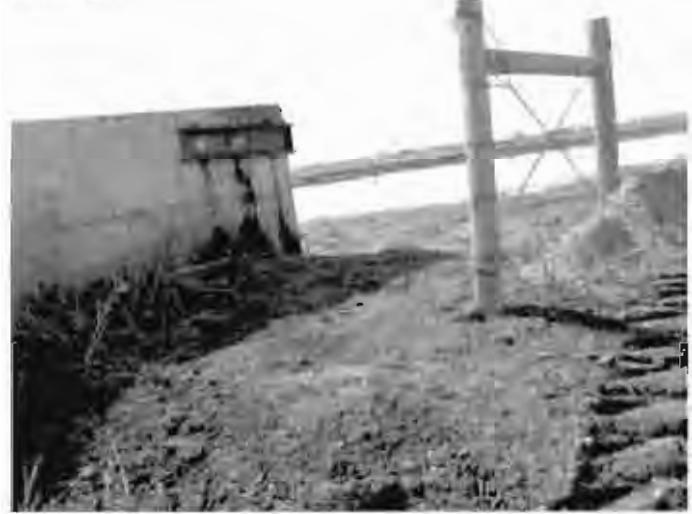
Photo 27:

Close-up of the northwest corner of the evaporation pond. Red arrow points to same location as red arrow in Photo 25.

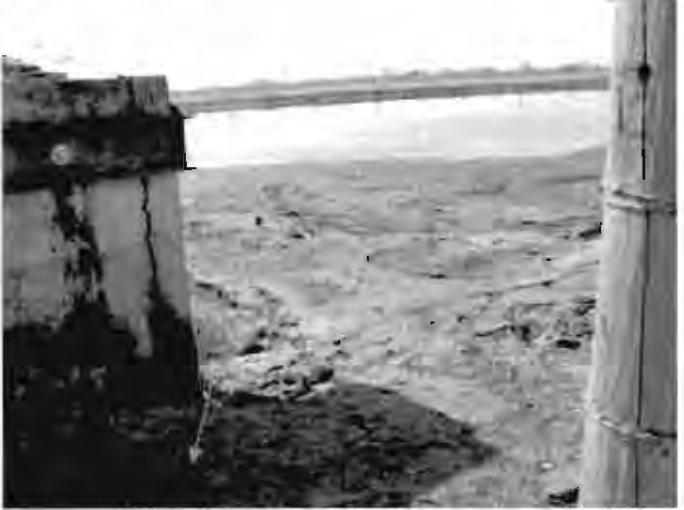
Photo 28:

Close-up of Photo 27 and the edge of evaporation pond. Note the dried pond residue. Ked arrow points to same area in photos 25 and 27.

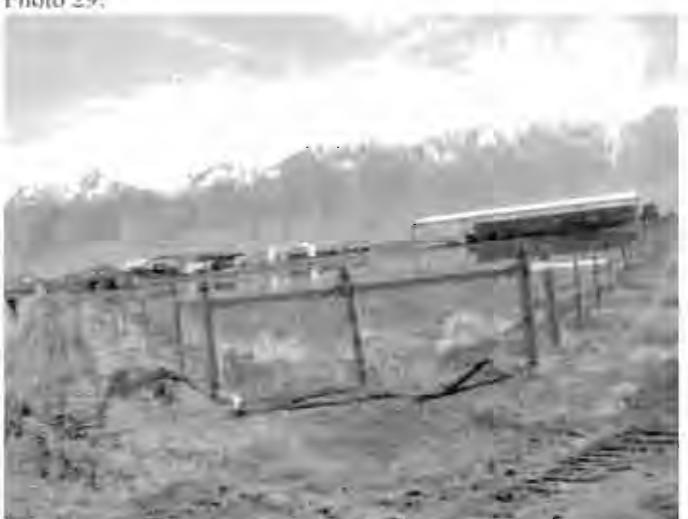
Photo 29:

Southwest corner of evaporation pond.

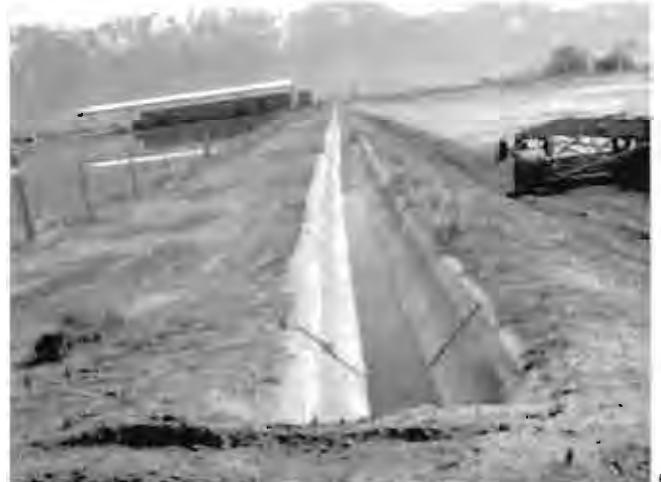
Photo 30:

Concrete channel along the south side of the evaporation pond used to drain and divert pond water to fields owned by facility owners. Pond water not analyzed for nutrient content.

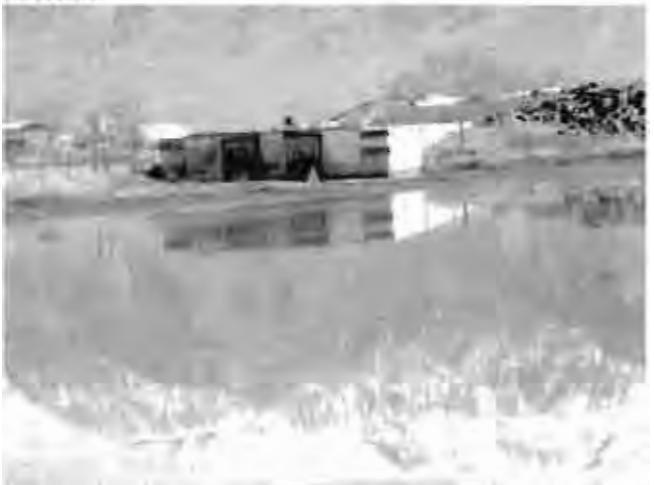
Looking north across evaporation pond at the separation cell. Process water from pump in Photo 18 goes to these cells. Facility indicated it used the water mark (purple arrow) on the right cell wall. If pond water is above this water mark, there is 6" of freeboard. If pond water is right below the weeping walls (red arrow) there is no freeboard in the pond.

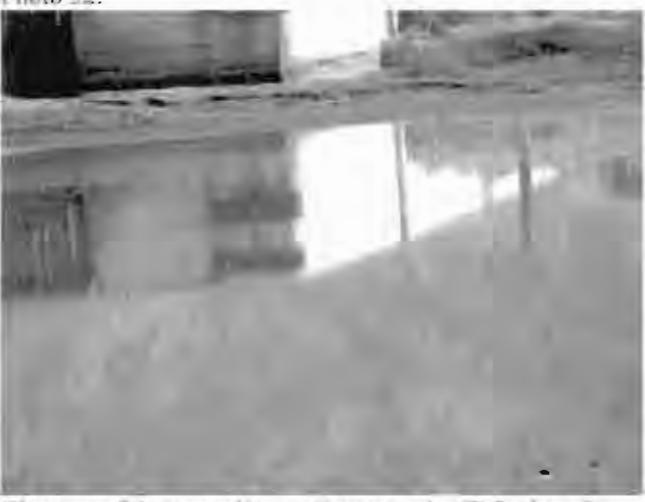
Close-up of the water line used to gage the 6" freeboard.

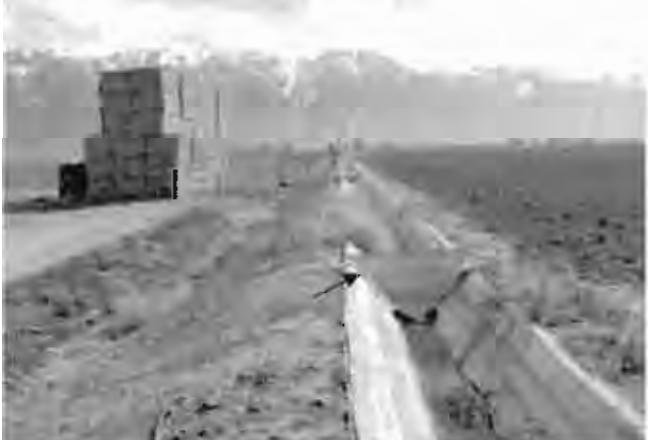
Photo 33:

Looking east, this concrete channel connects to the channel in Photo 30. From this channel water is distributed to the facility owners' fields. The facility representative indicated the metal baffle (arrow) was installed to stop water from continuing east. Water was observed beyond the metal baffle.

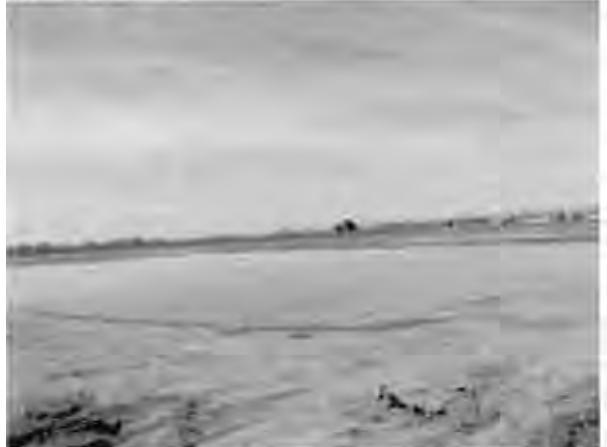
Photo 34:

Looking southeast at new evaporation pond.

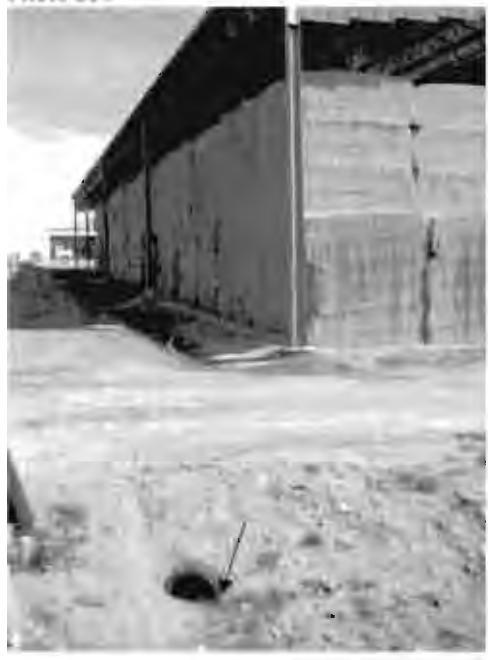
Photo 35:

Roof drain over hay bails that goes to the slough.

Roof drain (black arrow) and drain to slough (red arrow).

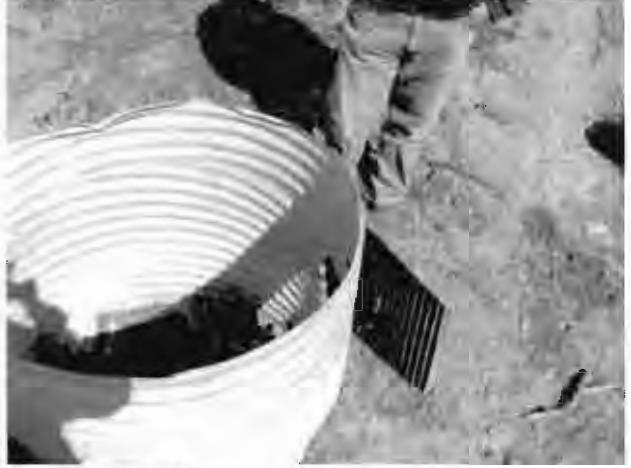
Same as Photo 36.

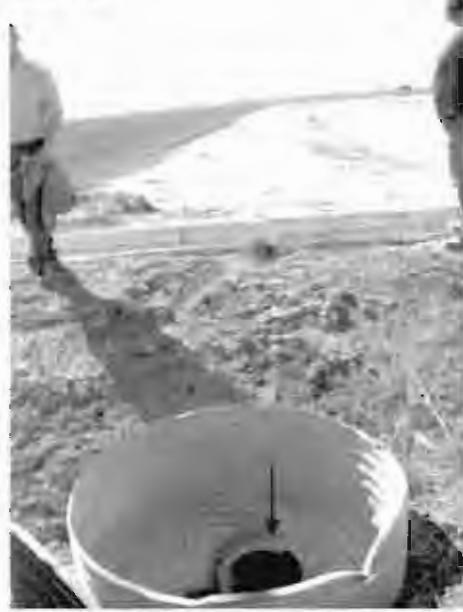
There are drain pipes in the fields (top of photo) that capture excess water to this outfall (arrow) (in same metal ring in Photos 36 and 37) that contains the drain to the slough.

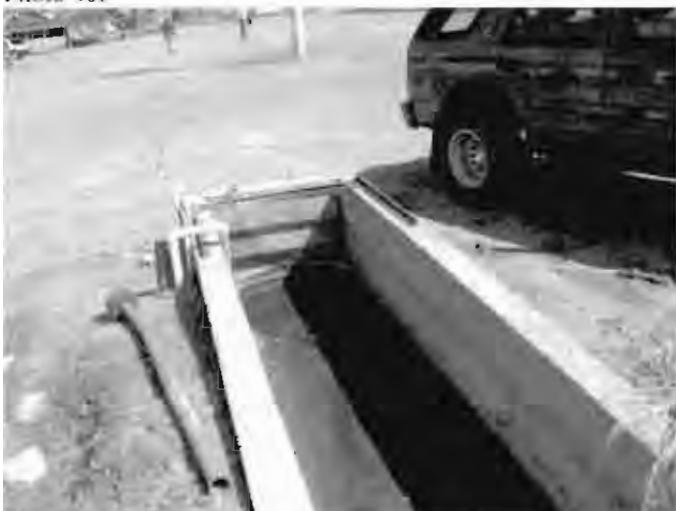
Close-up of end of concrete channel. Water flows in an underground pipe to a pump station approximately 150 feet to the north. Photos of the pump are in Photos 43 and 44

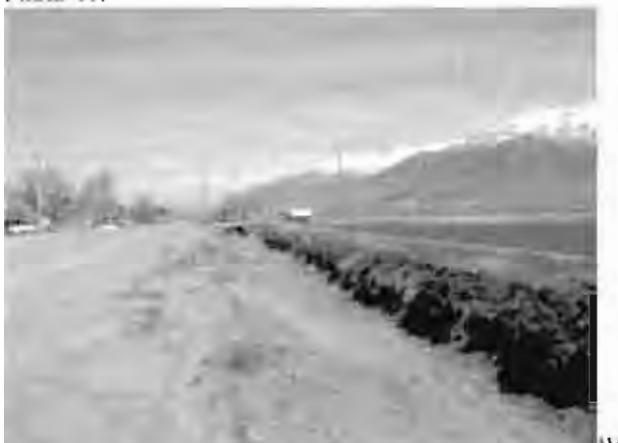
Photo 41:

When water is released from the concrete channel it will go to this canal (Hammond West Branch Canal) which is across the street from the facility.

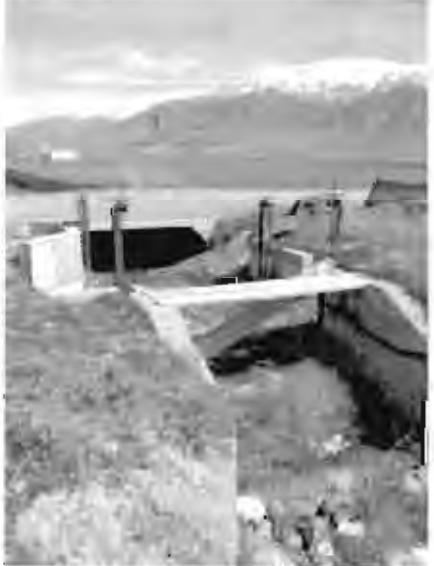
Photo 42:

Close-up of the canal valve.

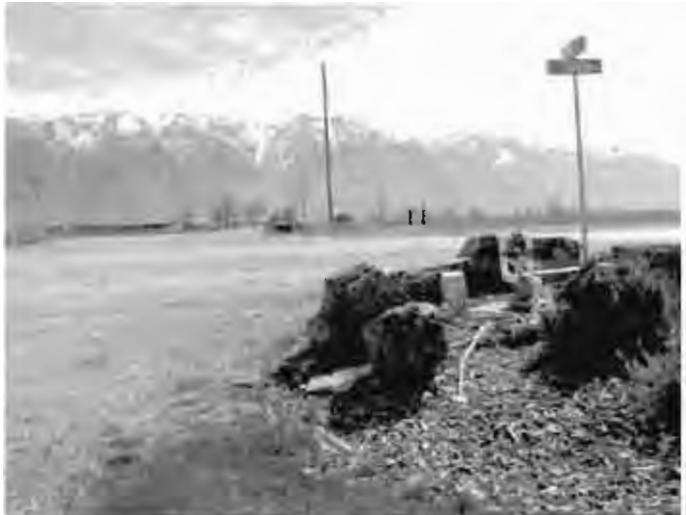
Close-up of the pump station to pump water from the

underground pipe to the Canal.

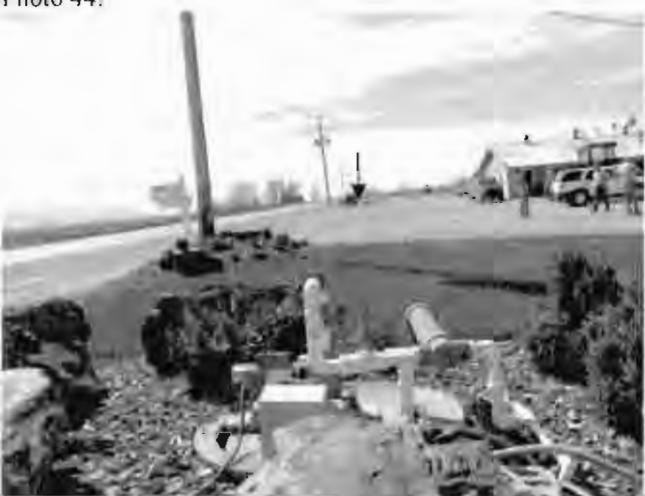
Photo 44:

concrete channel (arrow).

Looking south from the pump station to the end of the
