PHOTOGRAPHIC RECORD – GEOMORPHOLOGICAL EVALUATION

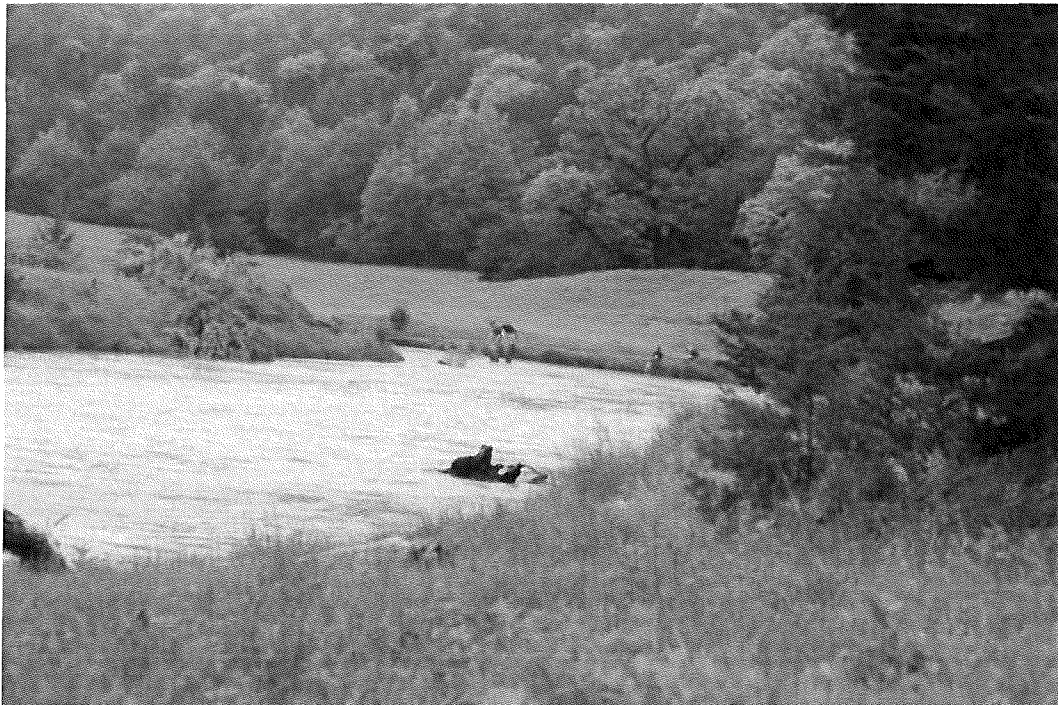
Photo 15 - Measuring habitat and conducting flow measurements near the top of site PC3.

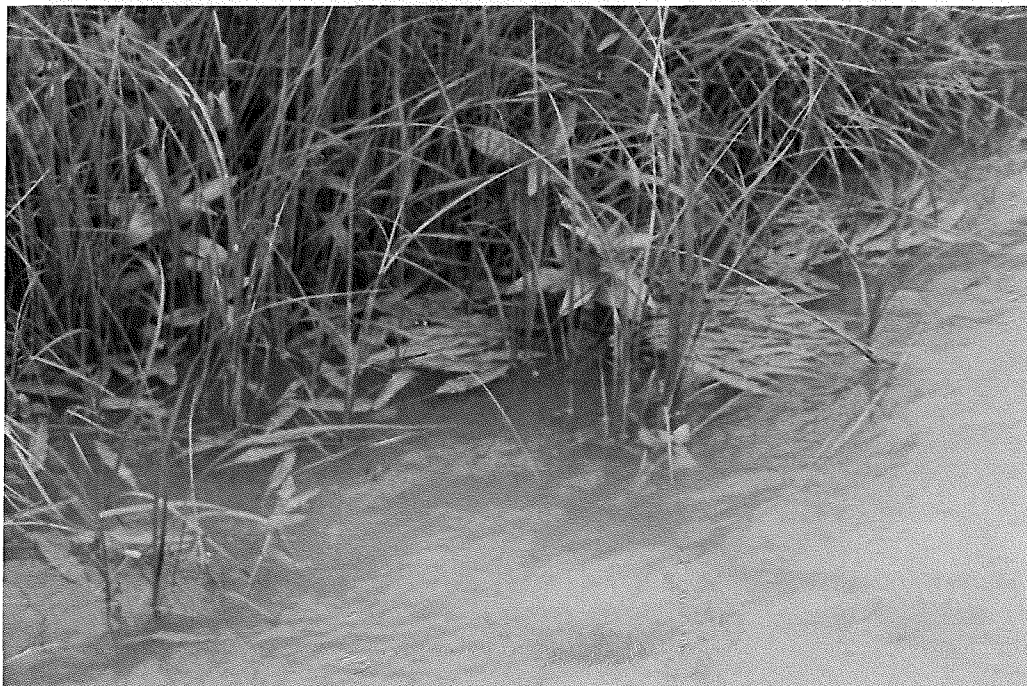
Photo 16 - Significant observation of *Potamogeton nodosus* growing at site PC3. Strong indicator of sediment stability.
