UNION CARBIDE CORPORATION 39 OLD RIDGEBURY ROAD, DANBURY, CT 06817-0001

8EHQ-92-12248

Re: CAP Agreement Identification No. 8ECAP-0110

TOXICITY TO TOLYLENE DIISOCYANATE

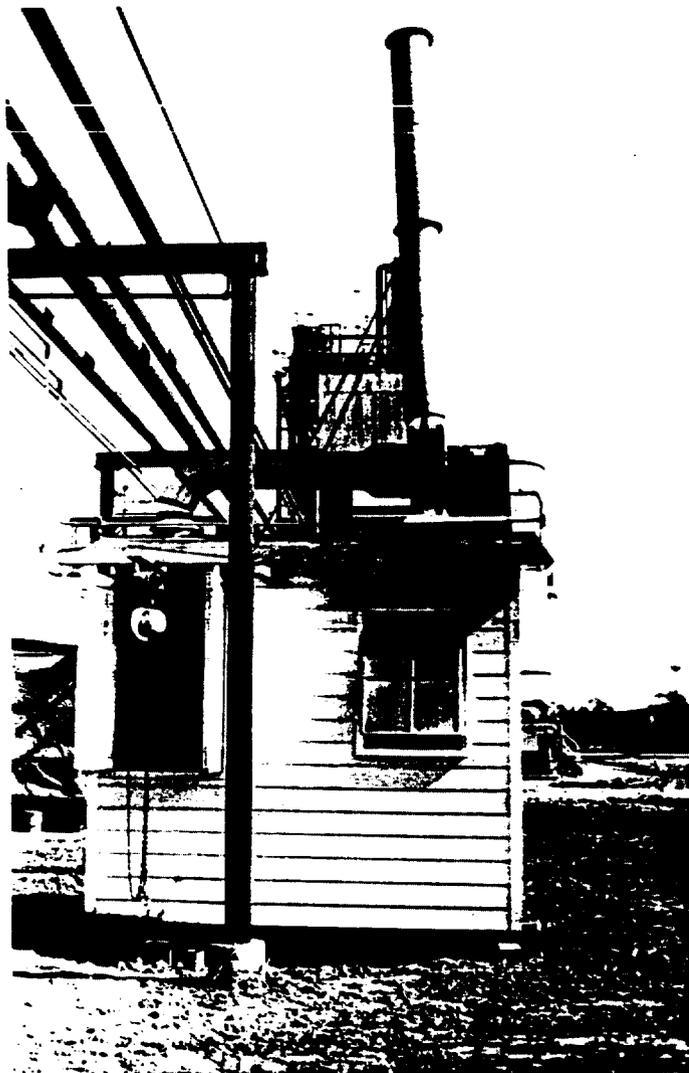
Figure 3

The decontamination station, built on skids, is shown located in the TDI unit area. This view shows the open entranceway into the laboratory hood with the chain hoist attached to the monorail. The window on the right is open for ventilation so that when the doors of the building are shut, makeup air can enter the decontamination station to feed the ventilating fan of the hood. The contaminated air is blown out the top of the 15 foot high stack, roughly 26 feet above ground level.

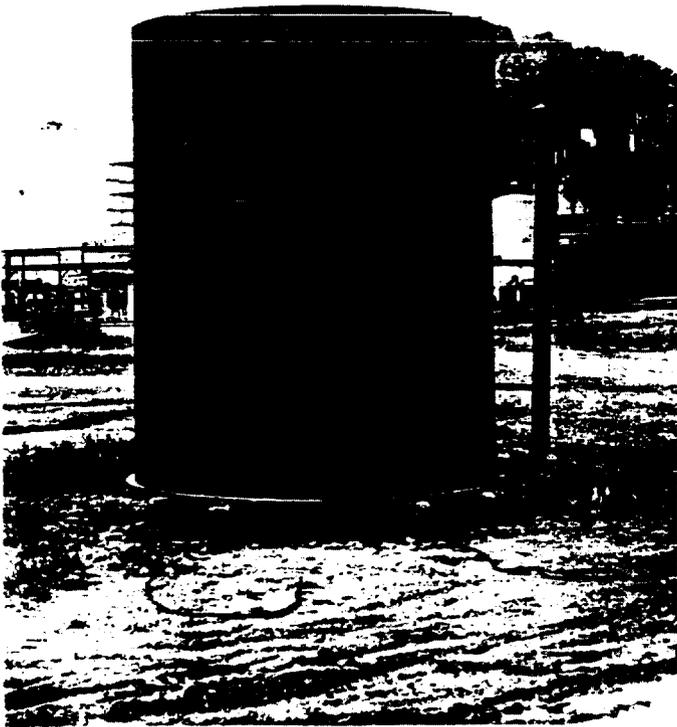
Figure 10

Shows the decontamination vat, measuring ten feet in diameter and ten feet in height. This vat will be partially buried in the ground (shown on Figure 11).

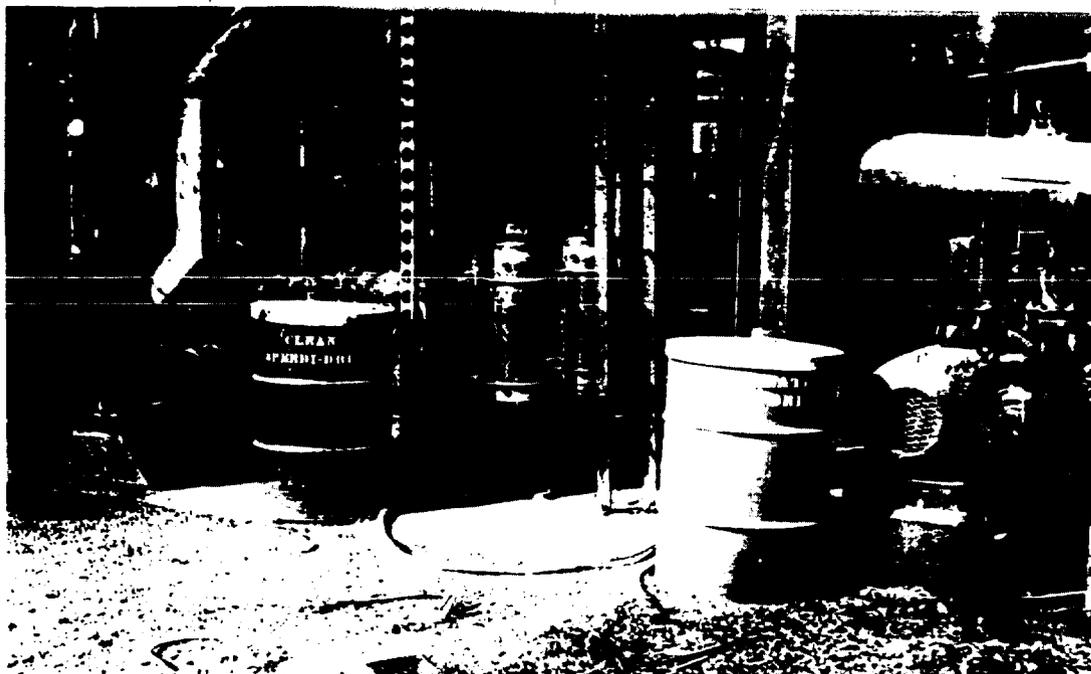
Figure 12

Shown on the left is the green drum containing clean Speedi-dri® and on the right the red drum where the contaminated Speedi-dri® is placed. If liquid TDI is spilled on the ground or tank pad, clean Speedi-dri® is immediately thrown on the spill. Neutralizing solution (shown in Figure 13) is then sprinkled on the Speedi-dri®. The neutralized TDI-Speedi-dri® mixture is swept together and shoveled into the red drum.

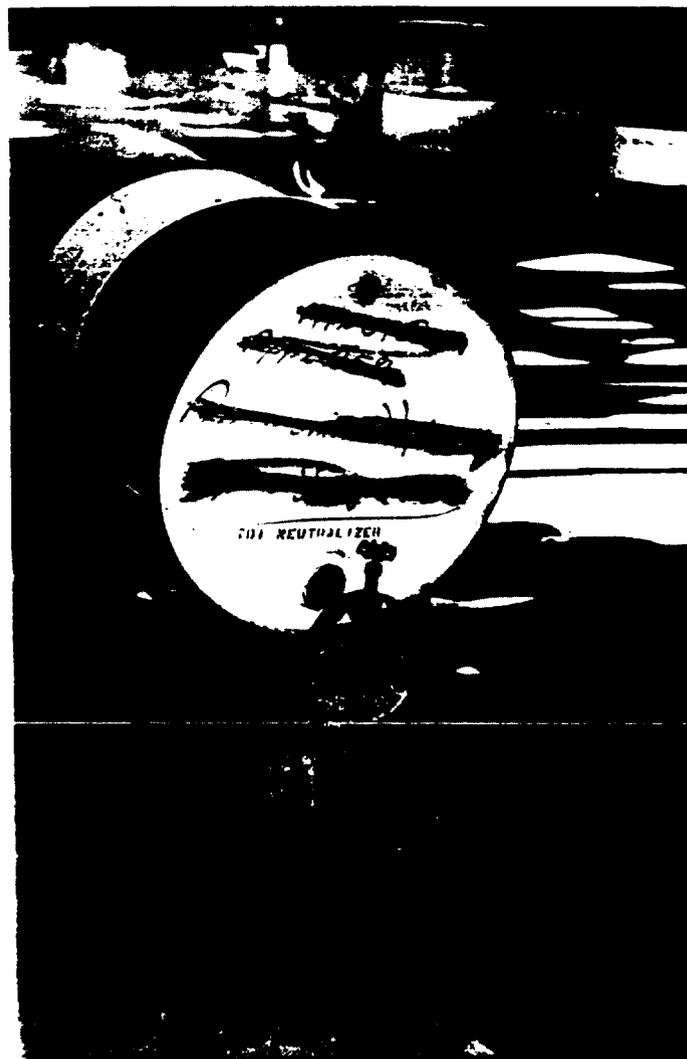
Figure 13

Shows one of the drums located in the TDI unit containing TDI neutralizing solution and shown also is an ordinary sprinkling can used to disperse the neutralizing solution on the Speedi-dri® covering a spill.
