**Re:** Addendum to Work Plan for Off-Property Vapor Intrusion Assessment  
Building SU3-8  
Sunnyvale, California  
Langan Project No.: 750620724

**ATTACHMENT A  
PHOTOGRAPHIC LOG**

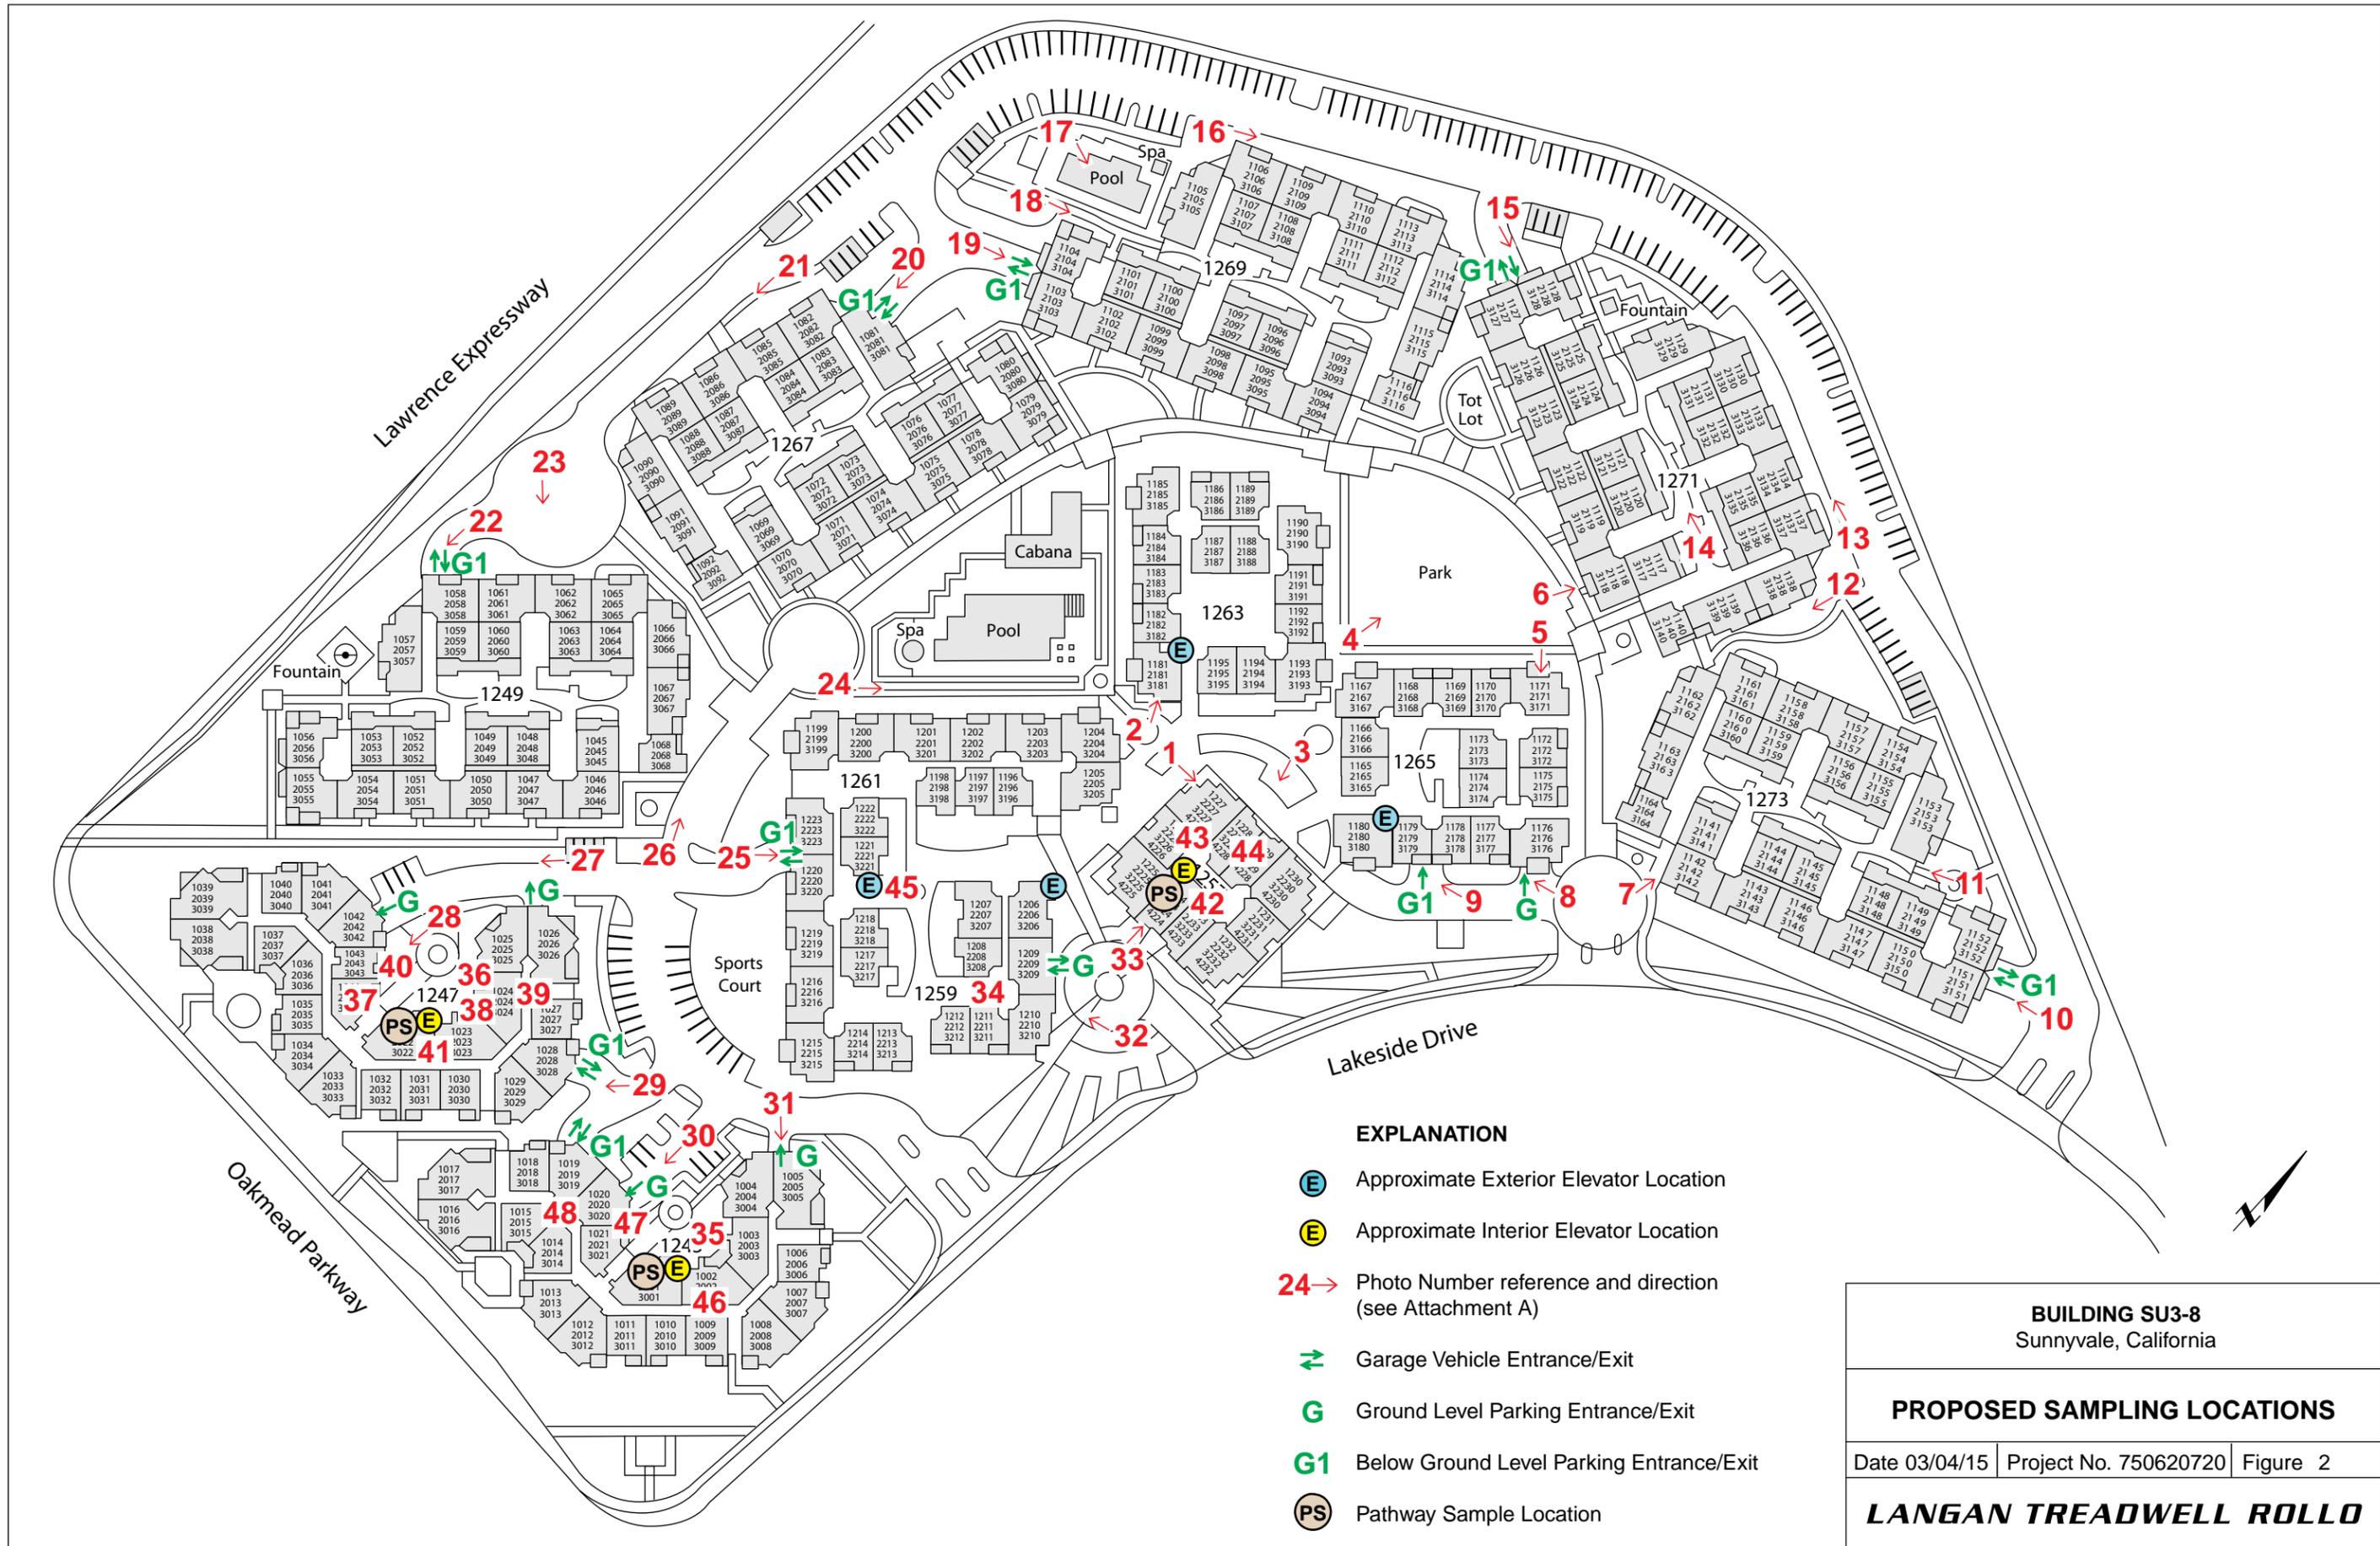
<b>BUILDING SU3-8</b> Sunnyvale, California		
<b>PROPOSED SAMPLING LOCATIONS</b>		
Date 03/04/15	Project No. 750620720	Figure 2
<b>LANGAN TREADWELL ROLLO</b>

Based on building surveys, only pathway and ambient air samples are proposed. Pathway sample locations (identified on Figure 2 with a 'PS' in the sample designation) are samples collected to evaluate potential vapor intrusion in areas that are either not accessed by residents or are not normally occupied over the course of a full day, such as storage areas and elevator lobbies. Pathway sample locations were selected to evaluate the potential pathway associated elevators in Buildings 1245, 1247, and 1257, as described below.

Based on the results of the building survey, the above sample locations were identified and are summarized in Table 1 and are illustrated on Figure 2. A total of nine pathway sample locations are proposed.

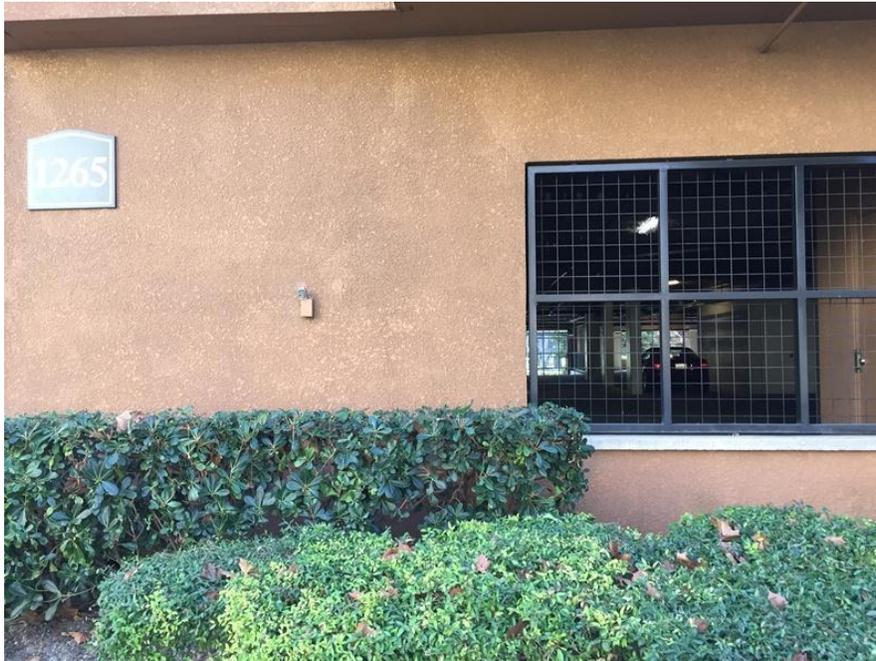
**Photograph 5 – Looking southeast at ground level parking associated with Bldg 1265 (open grated windows allow for ventilation)**

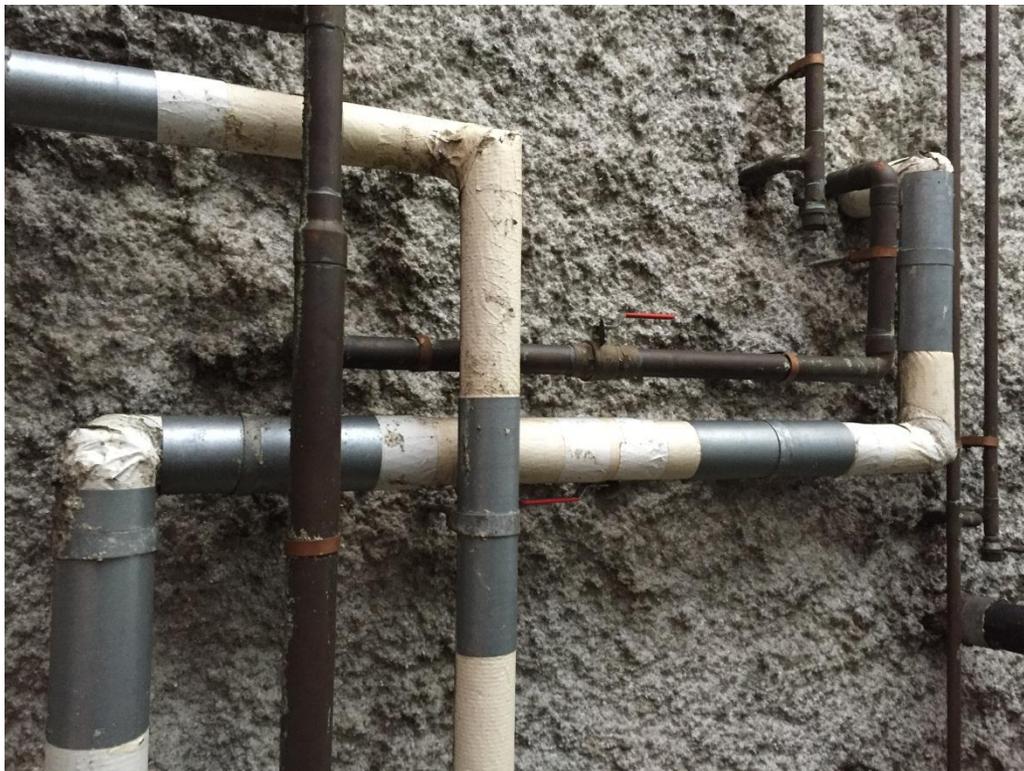
**Photograph 34 – Bldg 1259 - Ceiling of ground level parking garage showing penetrations**

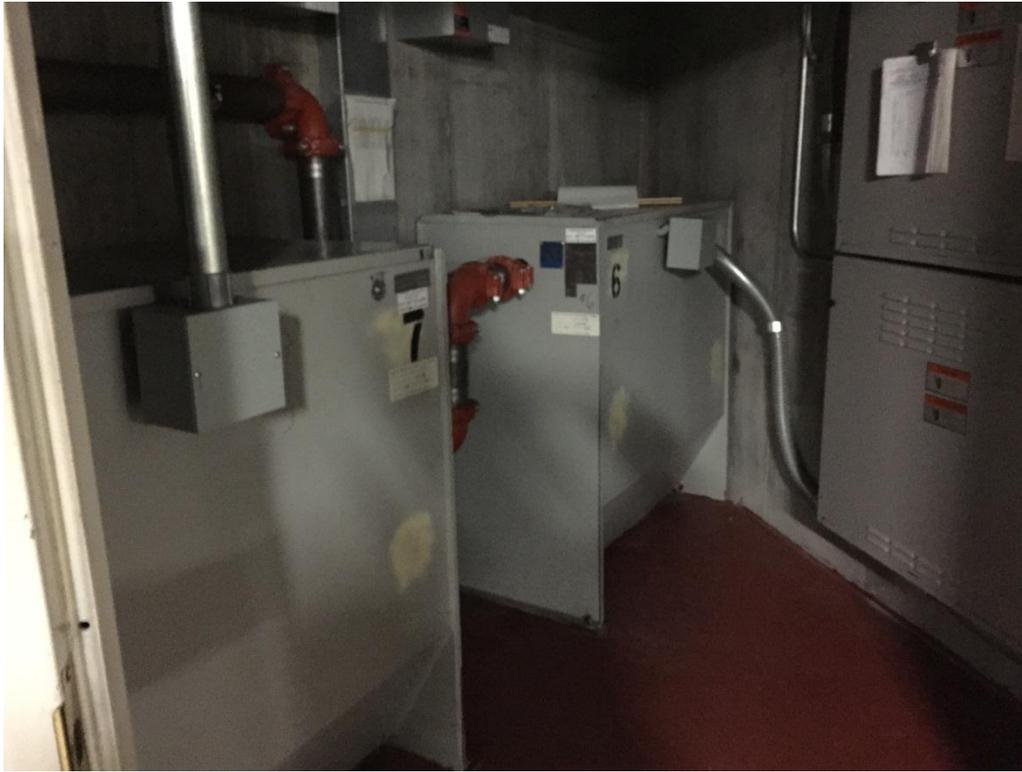
**Photograph 37 – Bldg 1247 – G1 Level Elevator Room (no penetrations)**

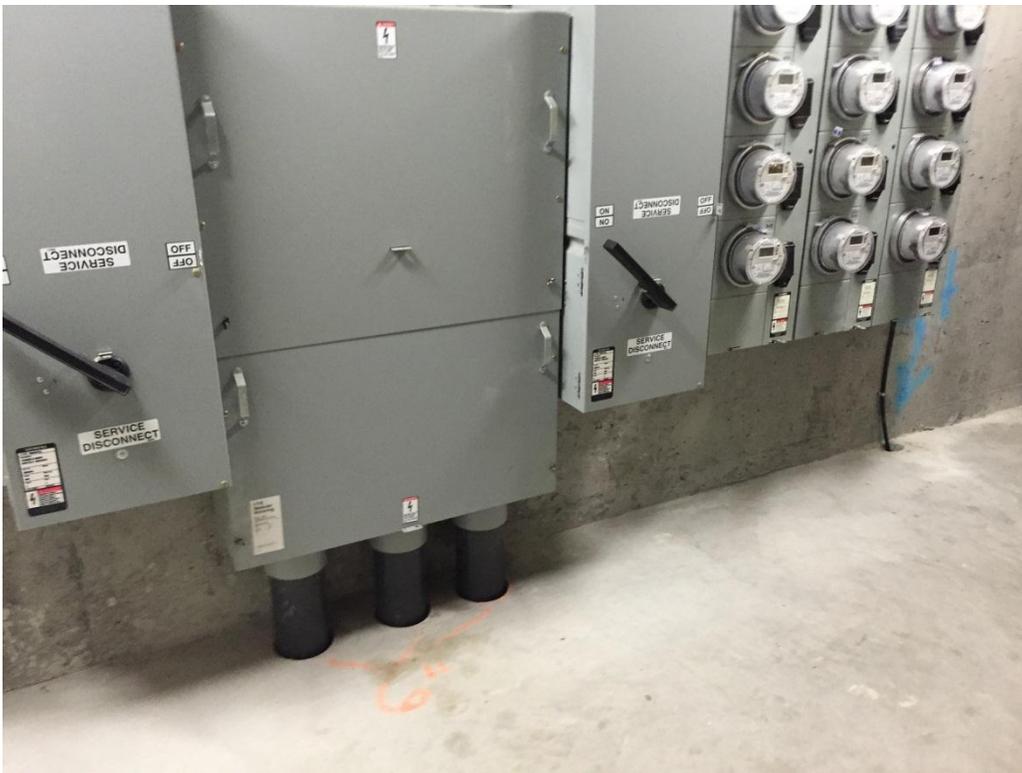
**Photograph 38 – Bldg 1247 – Ground level Electrical Room. This room is above the lower garage level (no subsurface penetrations).**

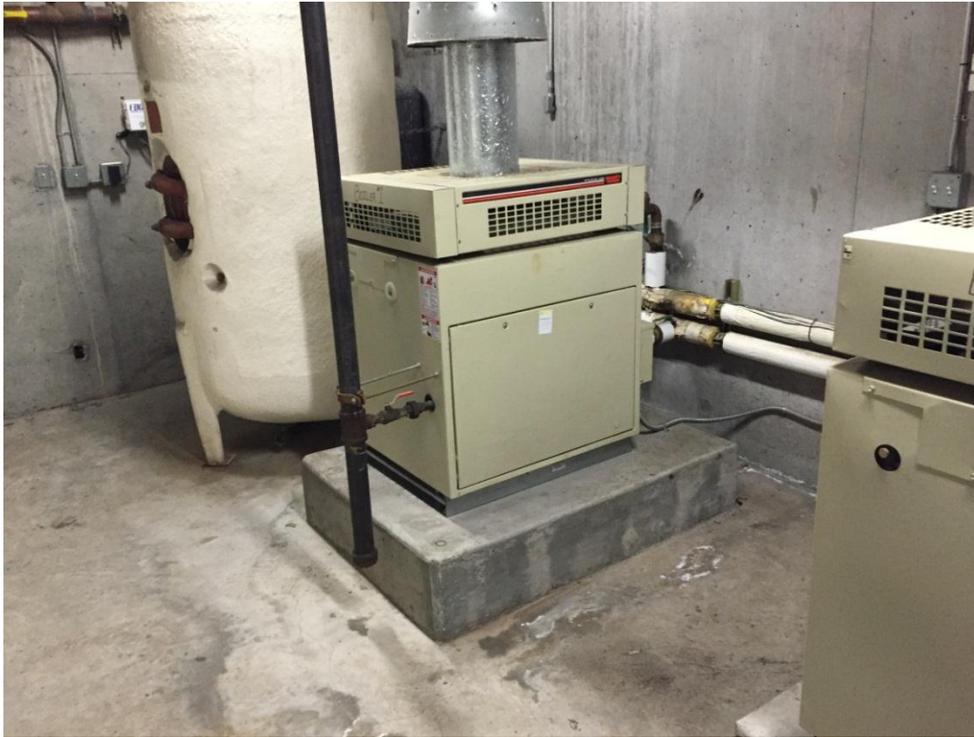
**Photograph 39 – Bldg 1247 – Ground level Boiler Room (no subsurface penetrations)**

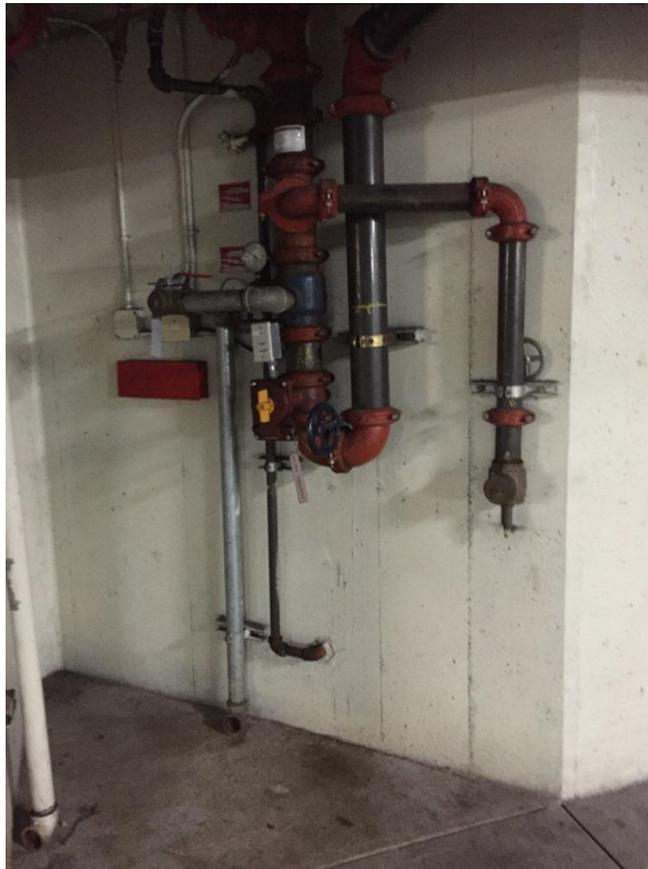
**Photograph 40 – Bldg 1247 – G1 level fire suppression (no subsurface penetrations)**

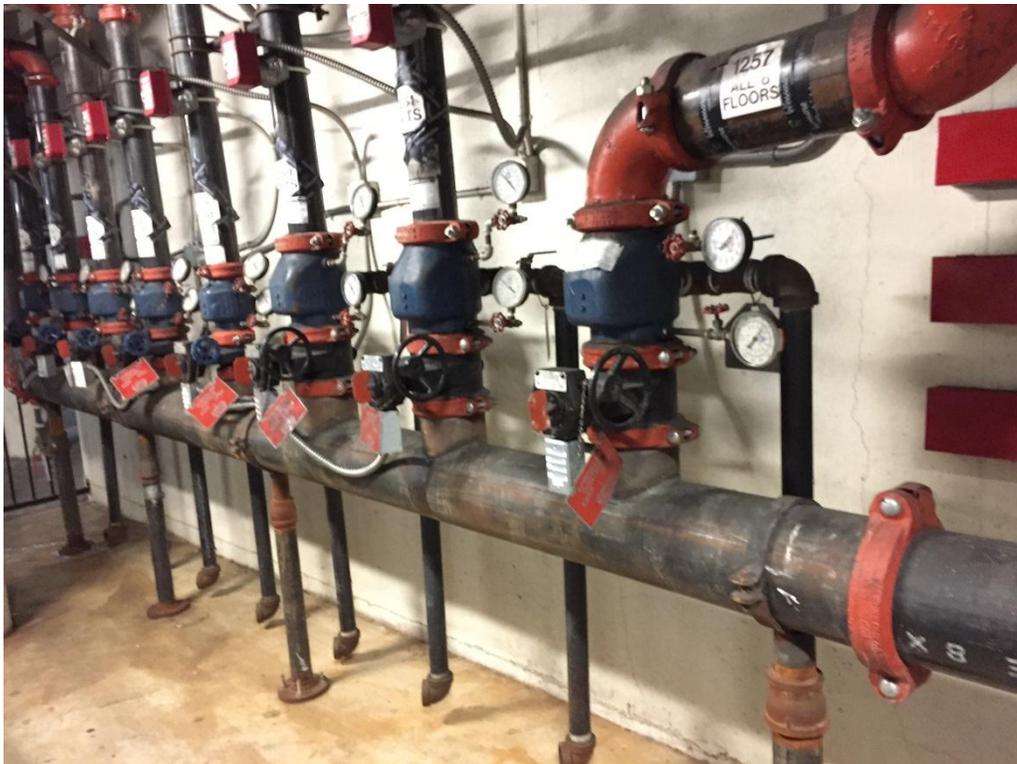
**Photograph 42 – Bldg 1257 – Fire suppression for Bldgs 1257, 1259, 1261, 1263, 1265 (no subsurface slab penetrations)**

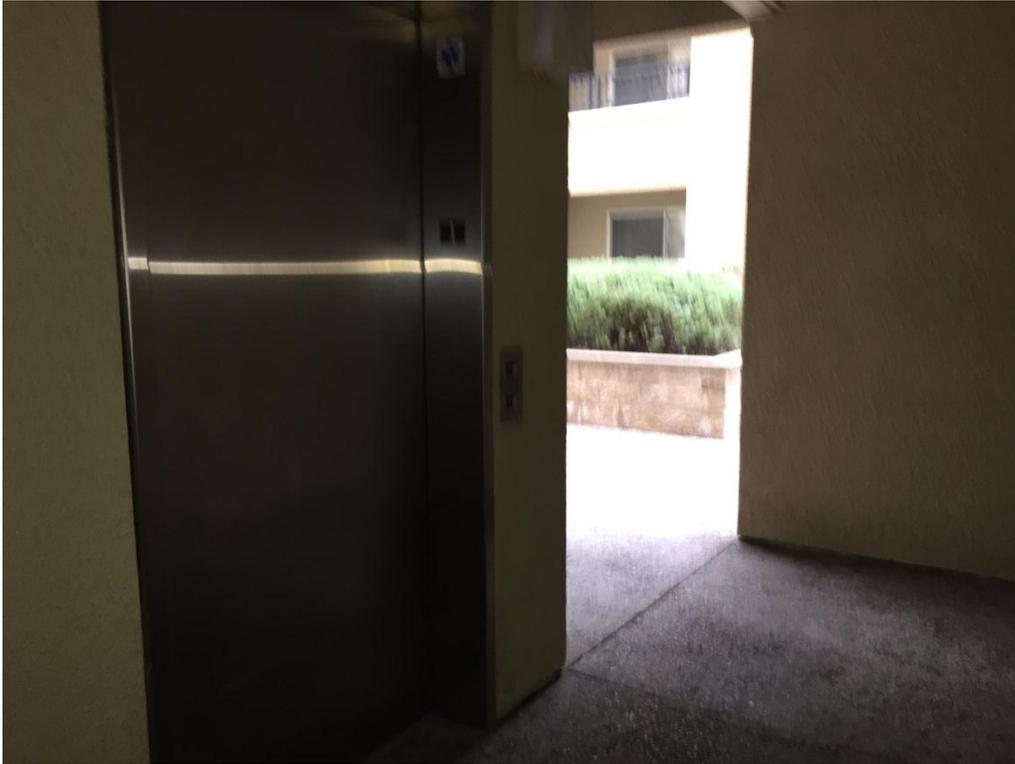
**Photograph 45 – Bldg 1259 – First floor elevator lobby (open to outside air)**

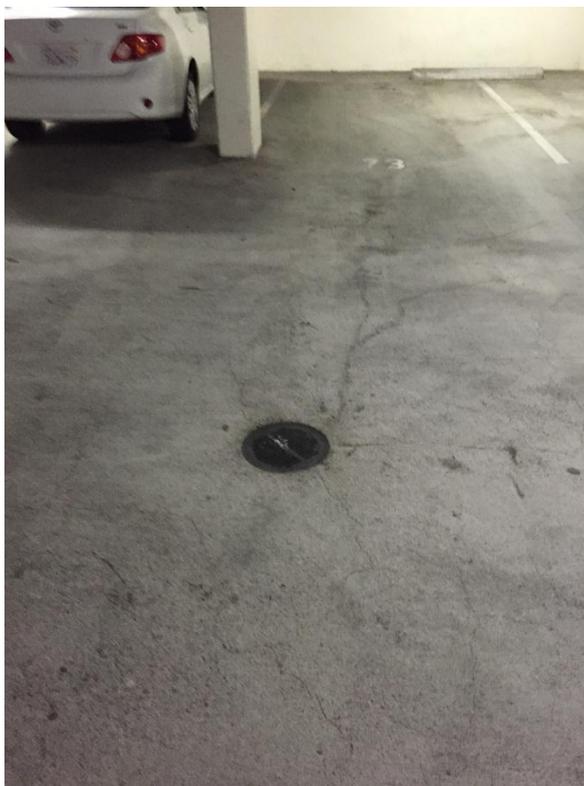
Storm drains were observed in the parking garage areas. PID readings at the floor drains were equivalent to background readings measured at the Site. No other slab penetrations were observed in the areas evaluated.

**Photograph 47 – Bldg 1245 – G1 level garage drain (no elevated PID readings)**

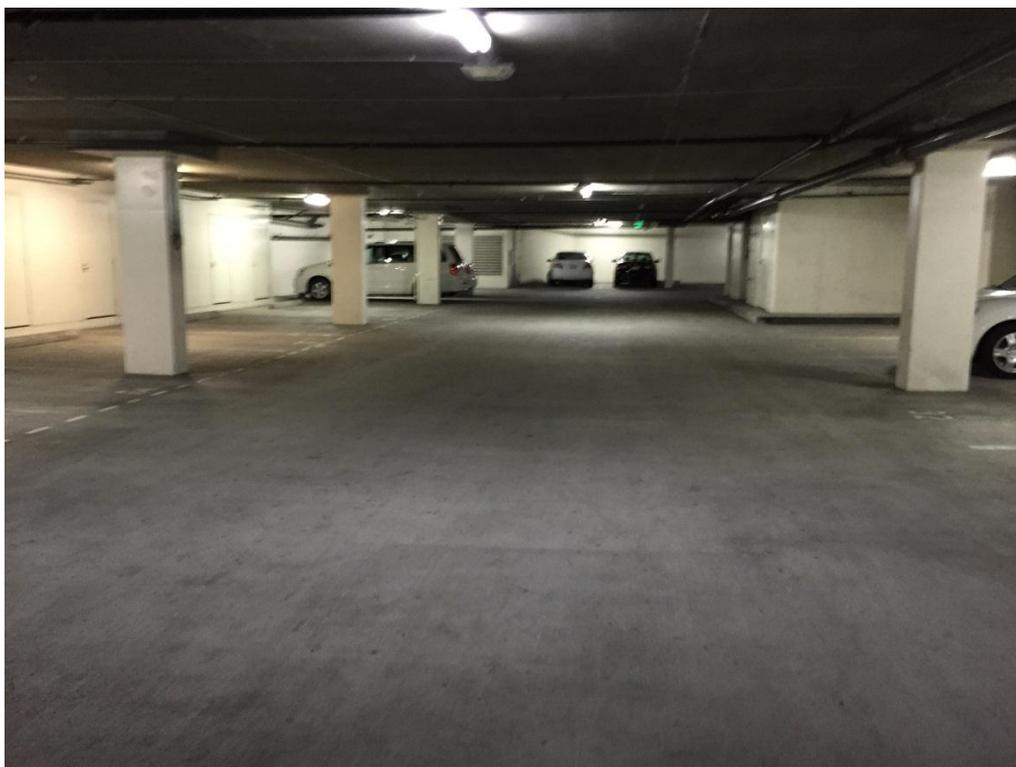
**Photograph 48 – Bldg 1245 – G1 level garage (no elevated PID readings)**
