2004 Contingency Monitoring Report and Third Five-Year Overview and 15-Year Review

for the
St. Paul Waterway Area
Sediment Remedial Action
and Habitat Restoration Project

August 2004

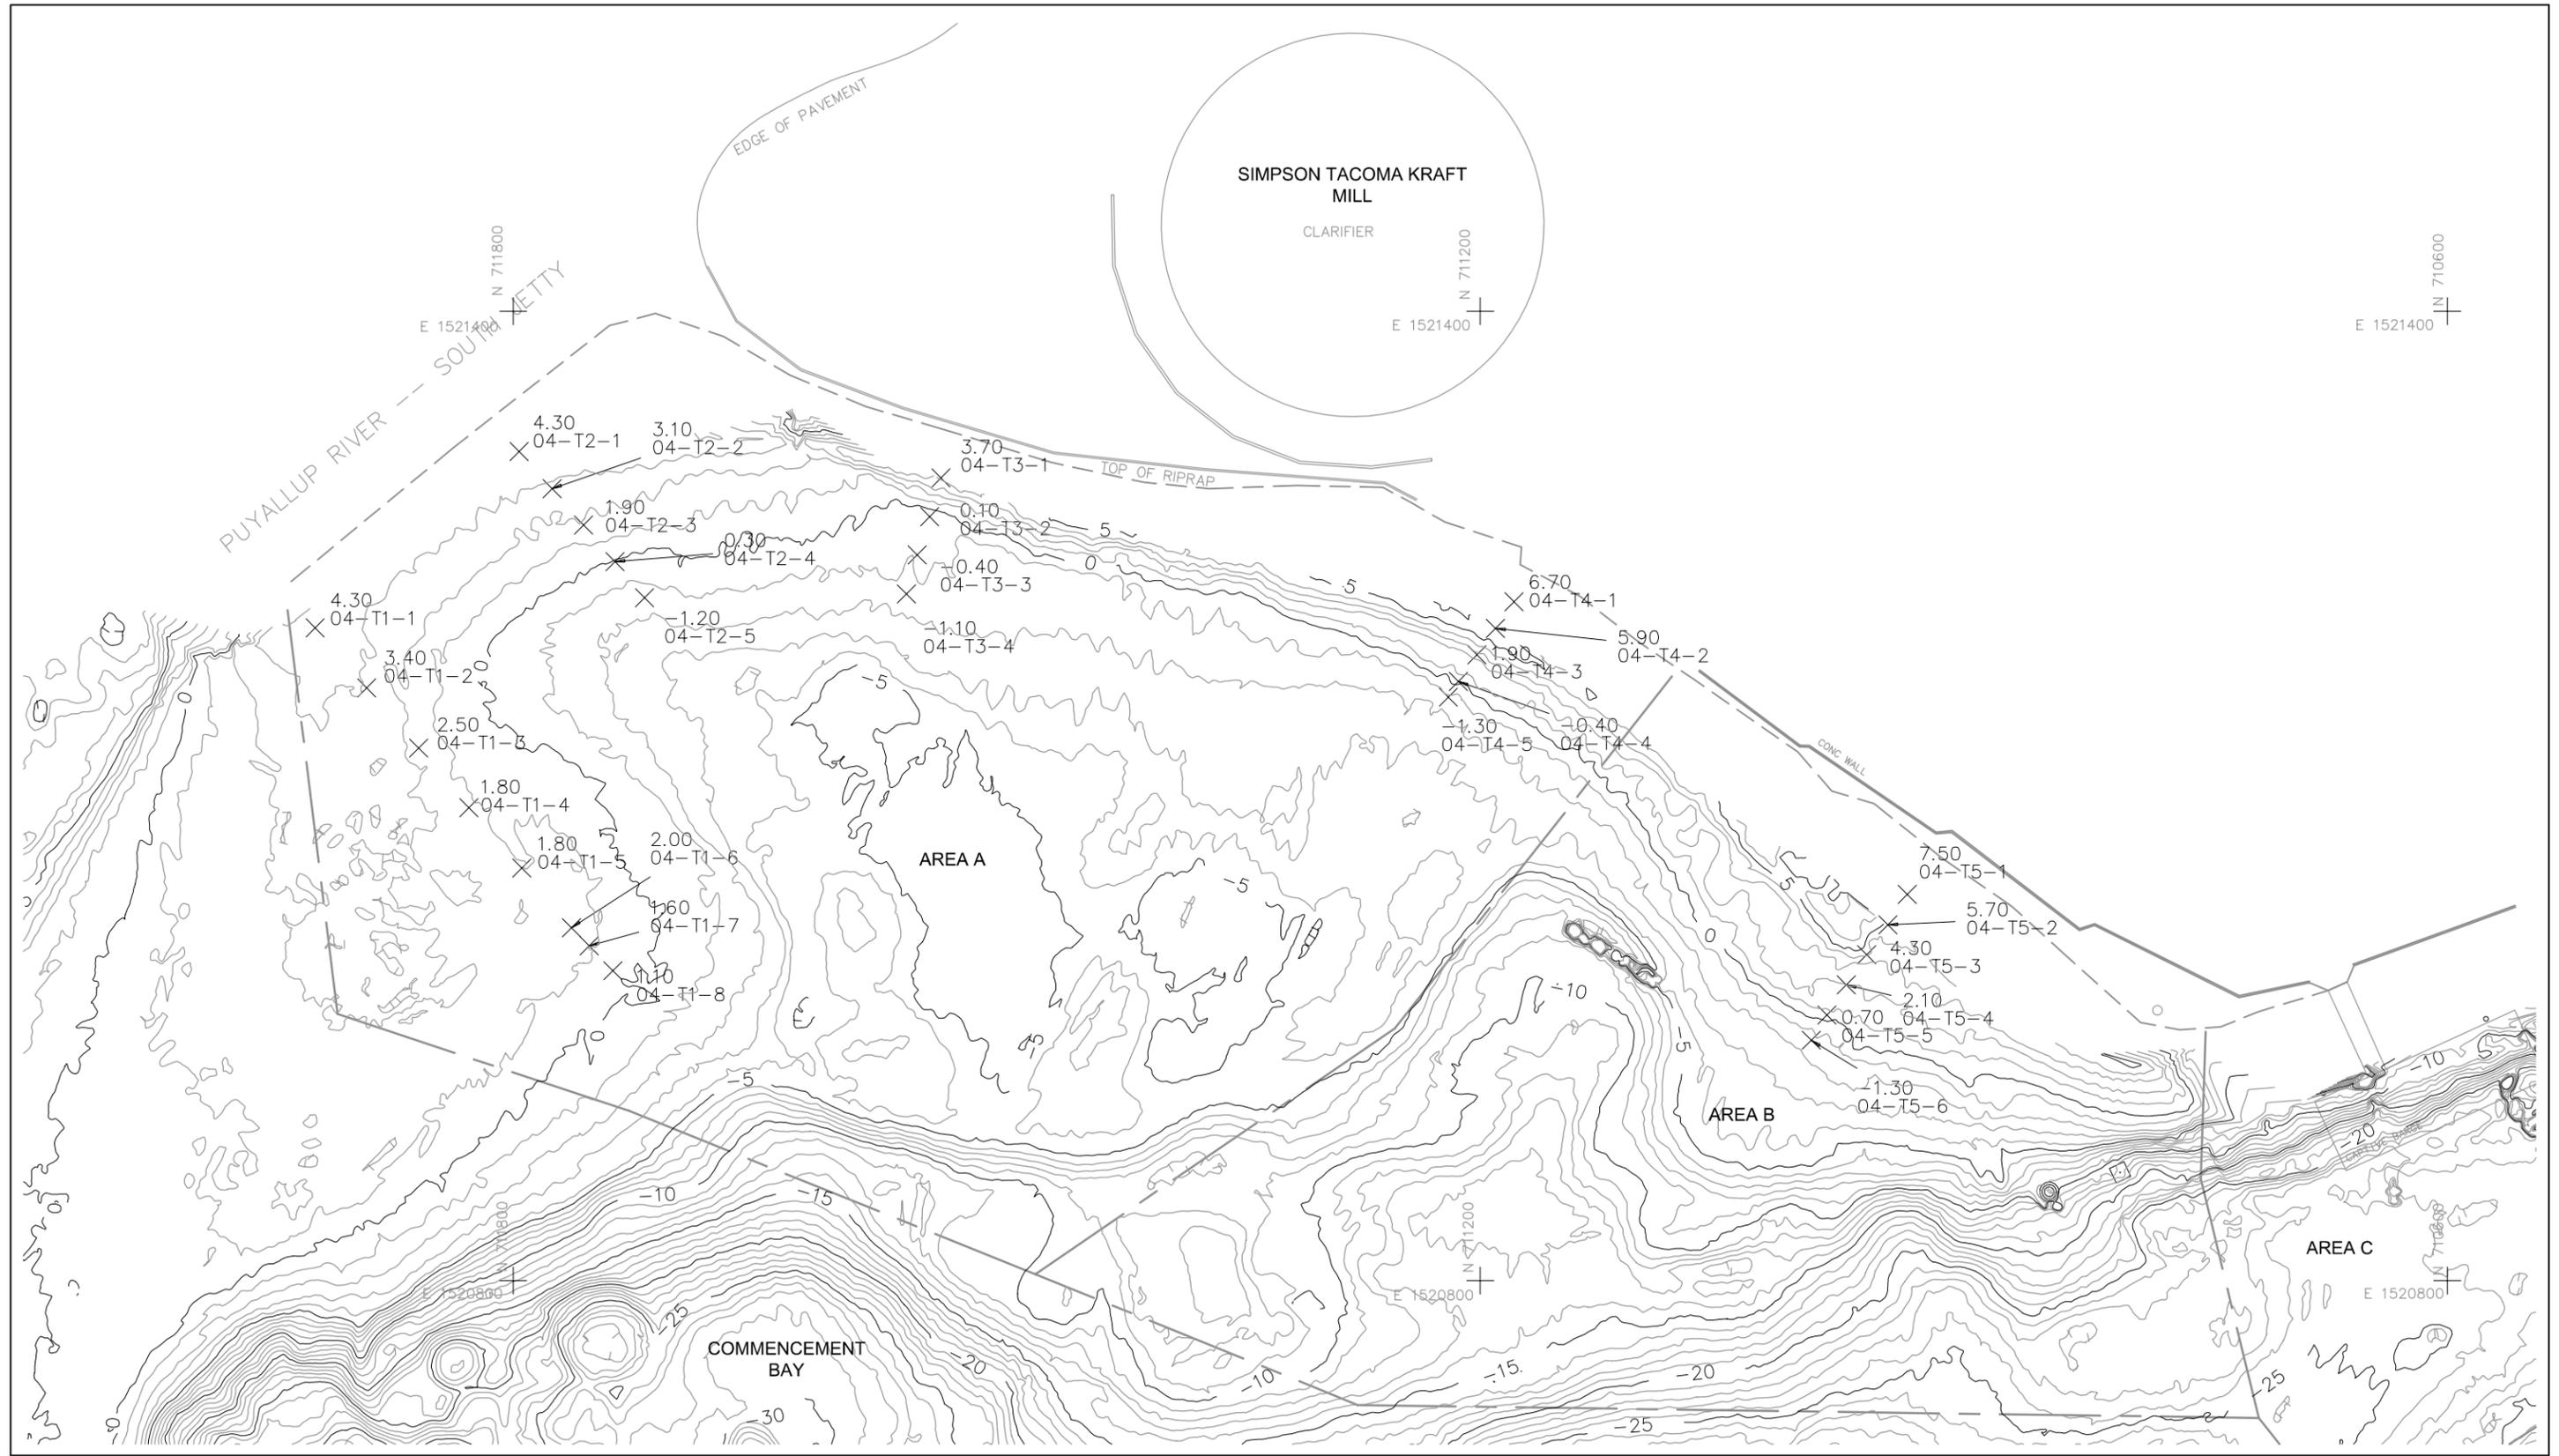
Figure 1
Project Site Topography (June 2004)
and Location of Intertidal
Transect Stations

The transects survey involved determining elevations along five transect lines, each containing four to eight monitoring stations (Figure 1). The June 2004 and cumulative (1988 through 2004) transects survey data are provided in Table 1 and Figure 2.

The survey was conducted by boat using multi-beam surveying equipment. The bathymetric contour map is provided in Figure 1. The field techniques and data processing used to create the bathymetric map are provided in the Bathymetric Survey Report (Attachment B). In summary, the bathymetric survey results match the elevations determined by the intertidal transects survey for the intertidal portions of Area A and B, and provide detailed elevation contours for the all deeper (sub-tidal) portions areas of Areas A and B. Comparison of bathymetry maps indicates that overall the primary features of the 1988 as-built map are readily visible in the 2004 map, with some smoothing of contours evident in the intertidal portions of the cap due to anticipated sediment redistribution.

Elevation changes in the two-year period since the transects were last surveyed as part of the contingency monitoring (June 2002) ranged from +2.6 ft (Station 4-2) to -0.5 ft (Station 1-2). All survey results were below the applicable contingency screening trigger level (1.0 ft elevation decrease over one year at one station, or 1.67 ft elevation decrease over two years at one station). Overall, 19 stations were unchanged or showed net elevation increases in the two-year period, and 9 stations had net elevation decreases. The elevations of the upper/middle intertidal stations on Transect 4 (stations 4-1 through 4-3), and to a lesser extent some of the upper/middle intertidal stations on Transect 5 (stations 5-1 through 5-3), were increased by the February 2004 Transect 4 area beach nourishment. This small-scale preventive beach nourishment was conducted as an adaptive management action at the constructed intertidal habitat at the Simpson Tacoma Kraft Mill to deal with naturally differential movement of sediment at middle intertidal levels of the restored habitat.

In addition to the intertidal transects survey and visual examination, the 2004 monitoring included a one-time final bathymetric survey covering all of areas A and B. This bathymetric survey was included in the monitoring plan to provide a final detailed bathymetric contour map to bookend the pre- and post-cap surveys conducted in 1987 (preconstruction) and 1988 (as-built) surveys that were performed when the project was constructed.

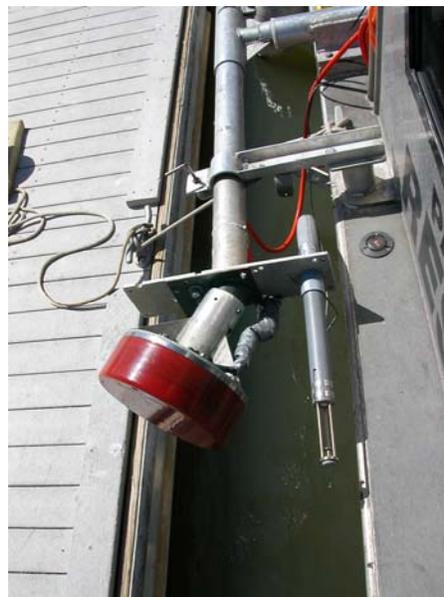
Figure 1-1. Multi-beam System Mount

Parametrix' 26-foot custom-built ALMAR survey vessel was utilized for all bathymetric data acquisition. The vessel was mobilized prior to the survey with the appropriate equipment as well as a custom mounting bracket for the transducer attached amidship on the starboard side of the vessel, as shown in Figure 1-1.

The mounting bracket for the multi-beam (see Figure 1-1) was meticulously positioned to provide minimal operational offsets of the transducer head relative to vessel attitude. Actual transducer attitude was determined during calibration of the system.

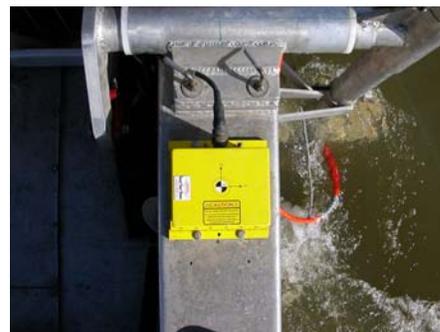
Figure 1-2. Sensor Alignment

The multi-beam sonar transducer and RTK GPS antennae were mounted along the acoustic (vertical) axis of the sonar as shown in Figure 1-2. The attitude sensor was mounted along the starboard gunnel, adjacent to the acoustic axis. This configuration was designed to minimize the introduction of attitude and positioning errors due to instruments offset from the acoustic axis. The transducer head was mounted with a fixed starboard rotation of approximately 30 degrees (see Figure 1-1) to overcome surveying limitations in shallow waters along the shore by allowing the outer beams to approach 90 degrees (horizontal) from vertical.

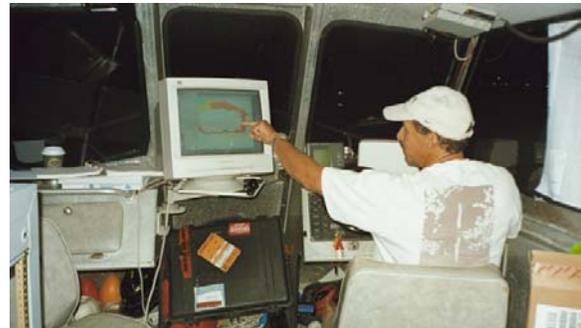
Figure 1-3. Real-time Acquisition Mapping

The TEI Isis data acquisition and processing system was used to acquire and store all multi-beam data. Data from all sensors were sent directly to Isis and integrated within the data packet for each sonar ping. Real-time acquisition displays provided data quality control and assessments during surveys. A real-time digital terrain model (DTM) of bathymetric conditions was used during the survey, as shown in Figure 1-3, via TEI's Delphmap and BathyRT programs to assure data quality and full bottom coverage. All data were stored in TEI's XTF data format for post-processing, analysis, and archiving.

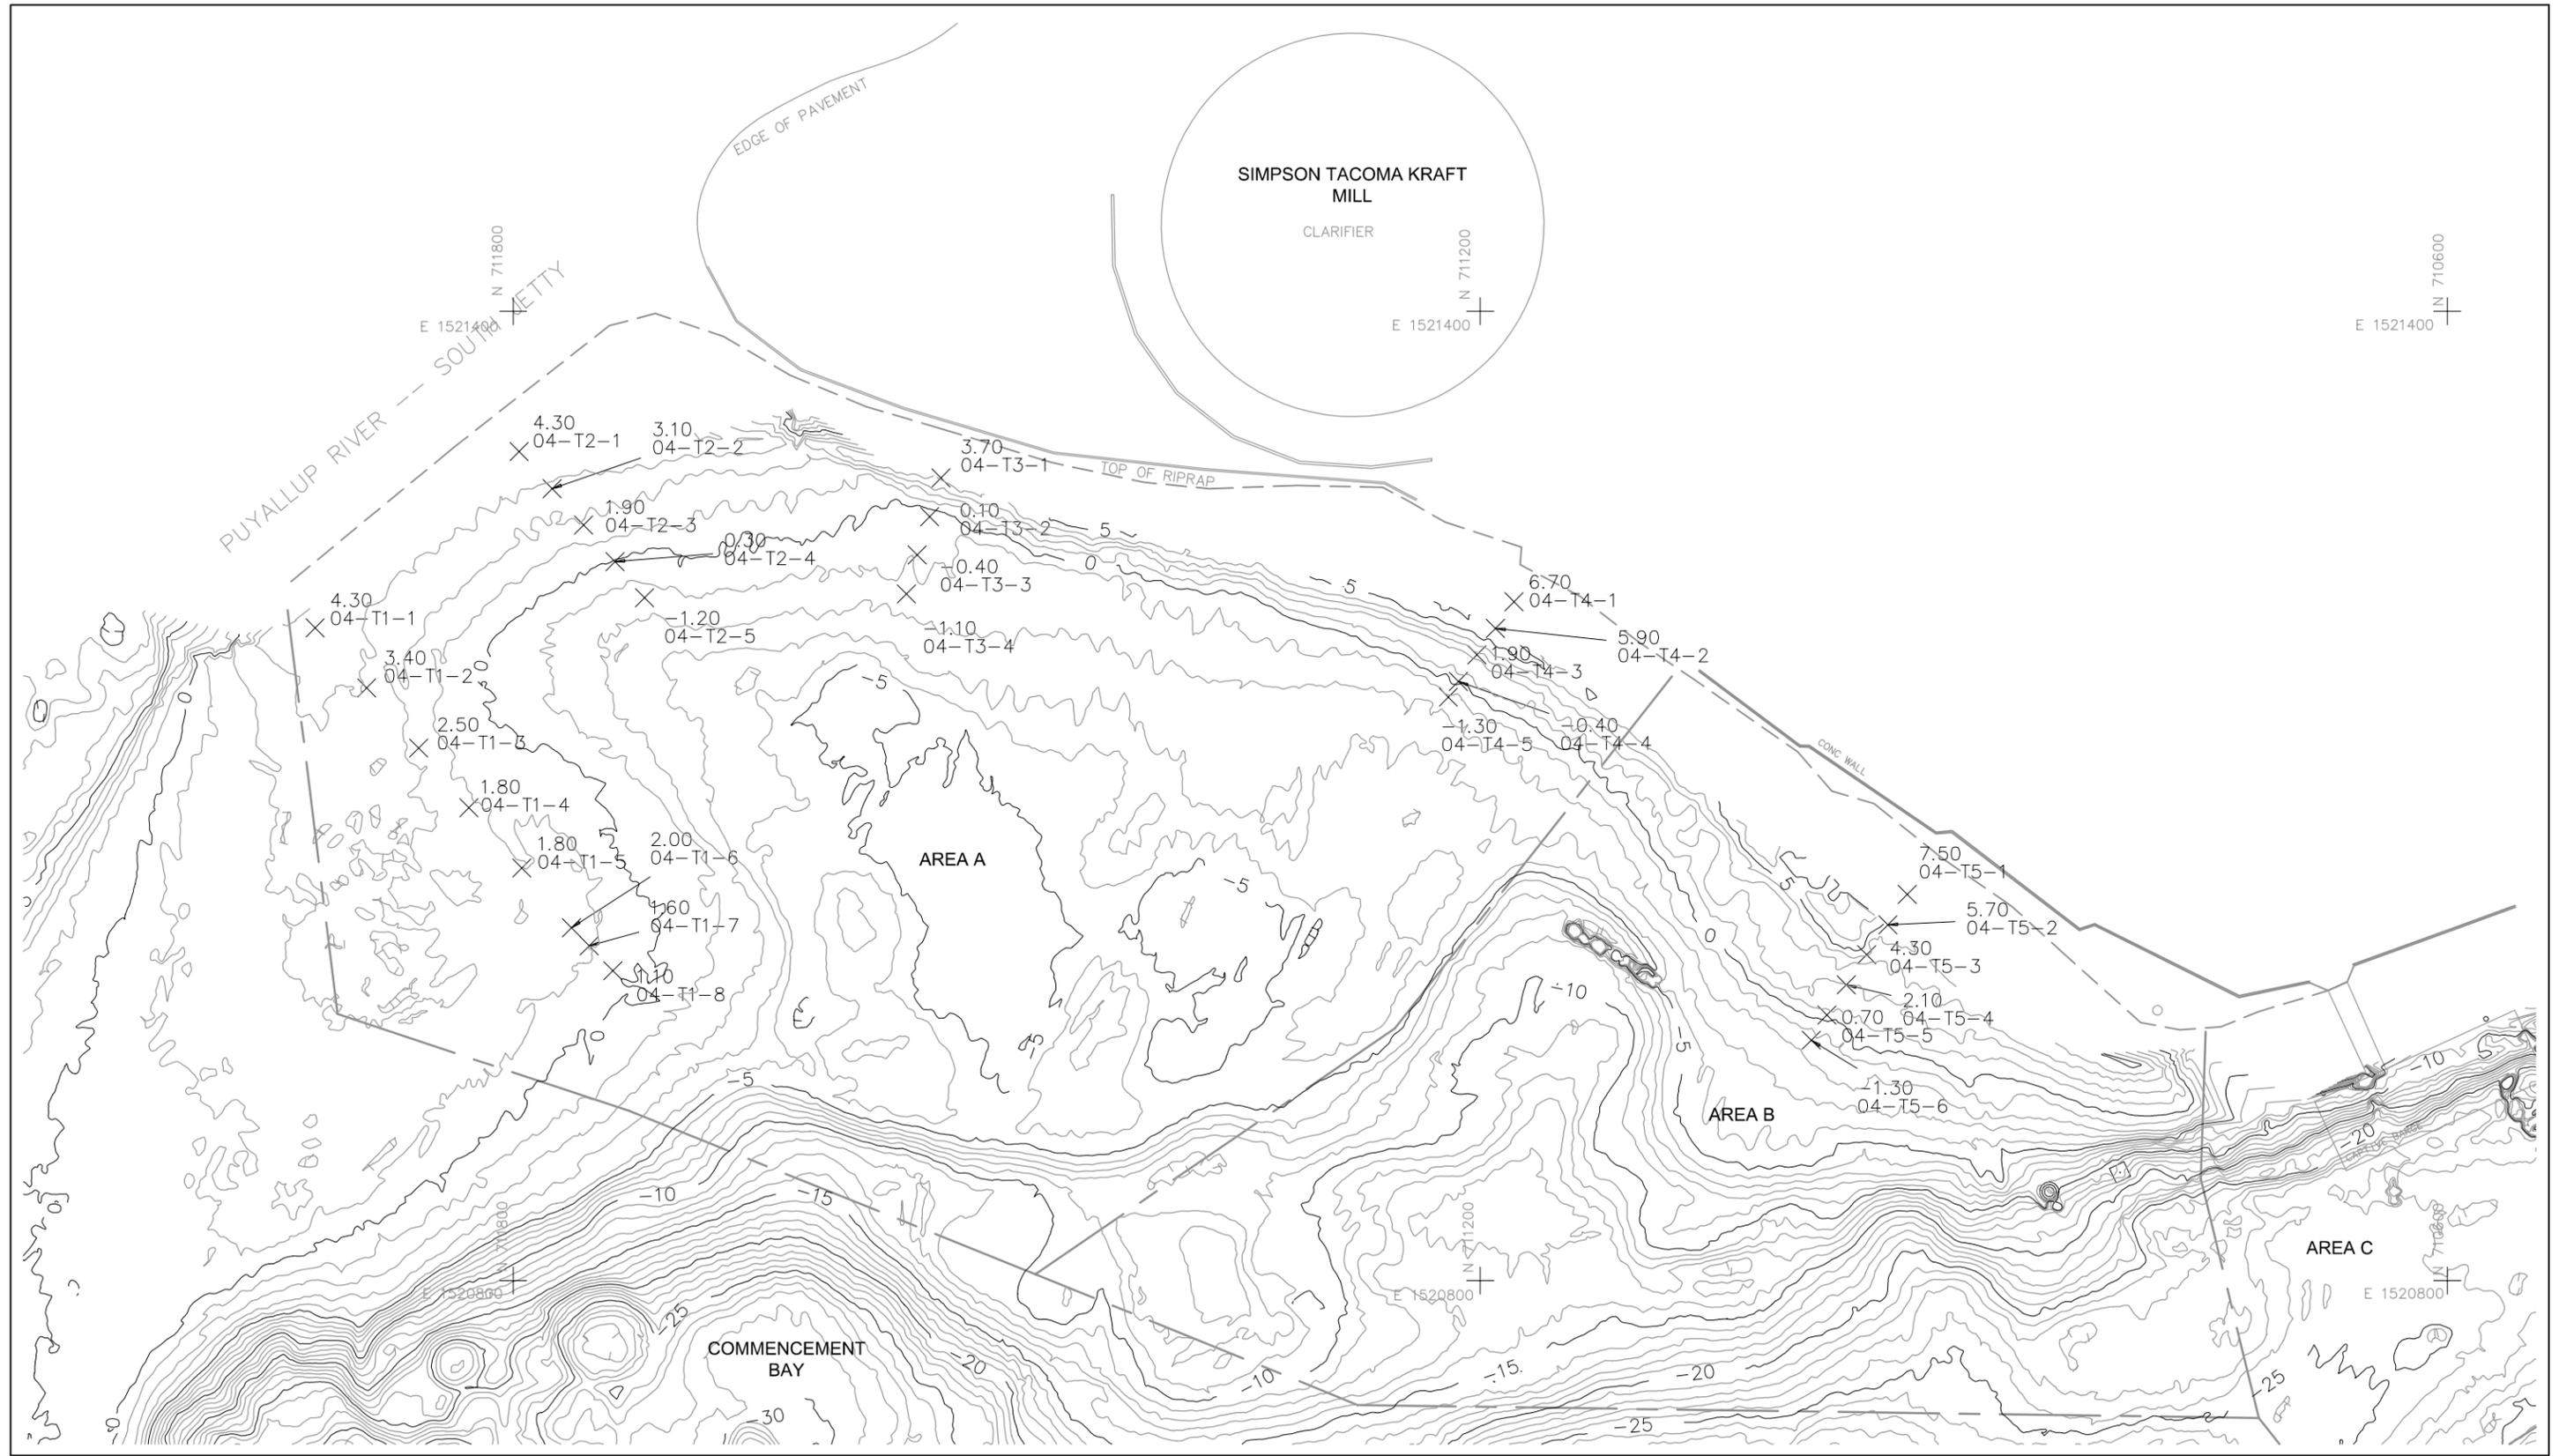
**Figure A-1
Project Site Topography (June 2004)
and Location of Intertidal
Transect Stations**

Intertidal transects over the five-year period were conducted in 2000, 2001, 2002, and 2004. (The Post-Ten Year Contingency Monitoring and Adaptive Management Plan specified intertidal transects surveys for 2000, 2002, and 2004; one was also performed in 2001 due to the February 28, 2001 Nisqually earthquake [Parametrix 1999b]) The five intertidal elevation transects that were surveyed consisted of four to eight monitoring stations (Figure A-1). In addition, a bathymetric survey covering all portions of Areas A and B was conducted in 2004 (Figure A-1) to provide a final detailed reference survey of the site to accompany the pre- and post-cap surveys conducted in 1987 (preconstruction) and 1988 (as-built) surveys that were performed when the project was constructed (Weiner 1991).

As anticipated, surface features of the Project have changed as cap material has been redistributed over the site. The greatest changes of elevation occurred within two years following Project construction, however, both increases and decreases have continued over time. In general, redistribution of the materials appears to have become less rapid and the magnitude of change has become smaller within the past 10 to 13 years (Table A-1).

Transect surveys in years 10-to-15 indicate minor change (Table A-1). The overall changes in elevation between 2000 and 2004 across all stations other than the nourishment area averaged only 0.2 ft. (mean and median elevation change, regardless of whether the change was an increase or decrease); the net change on these stations over the past five years was approximately -0.1 ft (which is close to the level of accuracy for the transect monitoring method).
