**REVISED DRAFT
TECHNICAL MEMORANDUM
SUBAREA HSA-5C
HISTORICAL SITE ASSESSMENT
SANTA SUSANA FIELD LABORATORY SITE
AREA IV RADIOLOGICAL STUDY
VENTURA COUNTY, CALIFORNIA**

**EPA Contract Number: EP-S7-05-05
Task Order Number: 0038**

**HydroGeoLogic, Inc.
Northway 10 Executive Park
313 Ushers Road
Ballston Lake, New York 12019**

August 2010

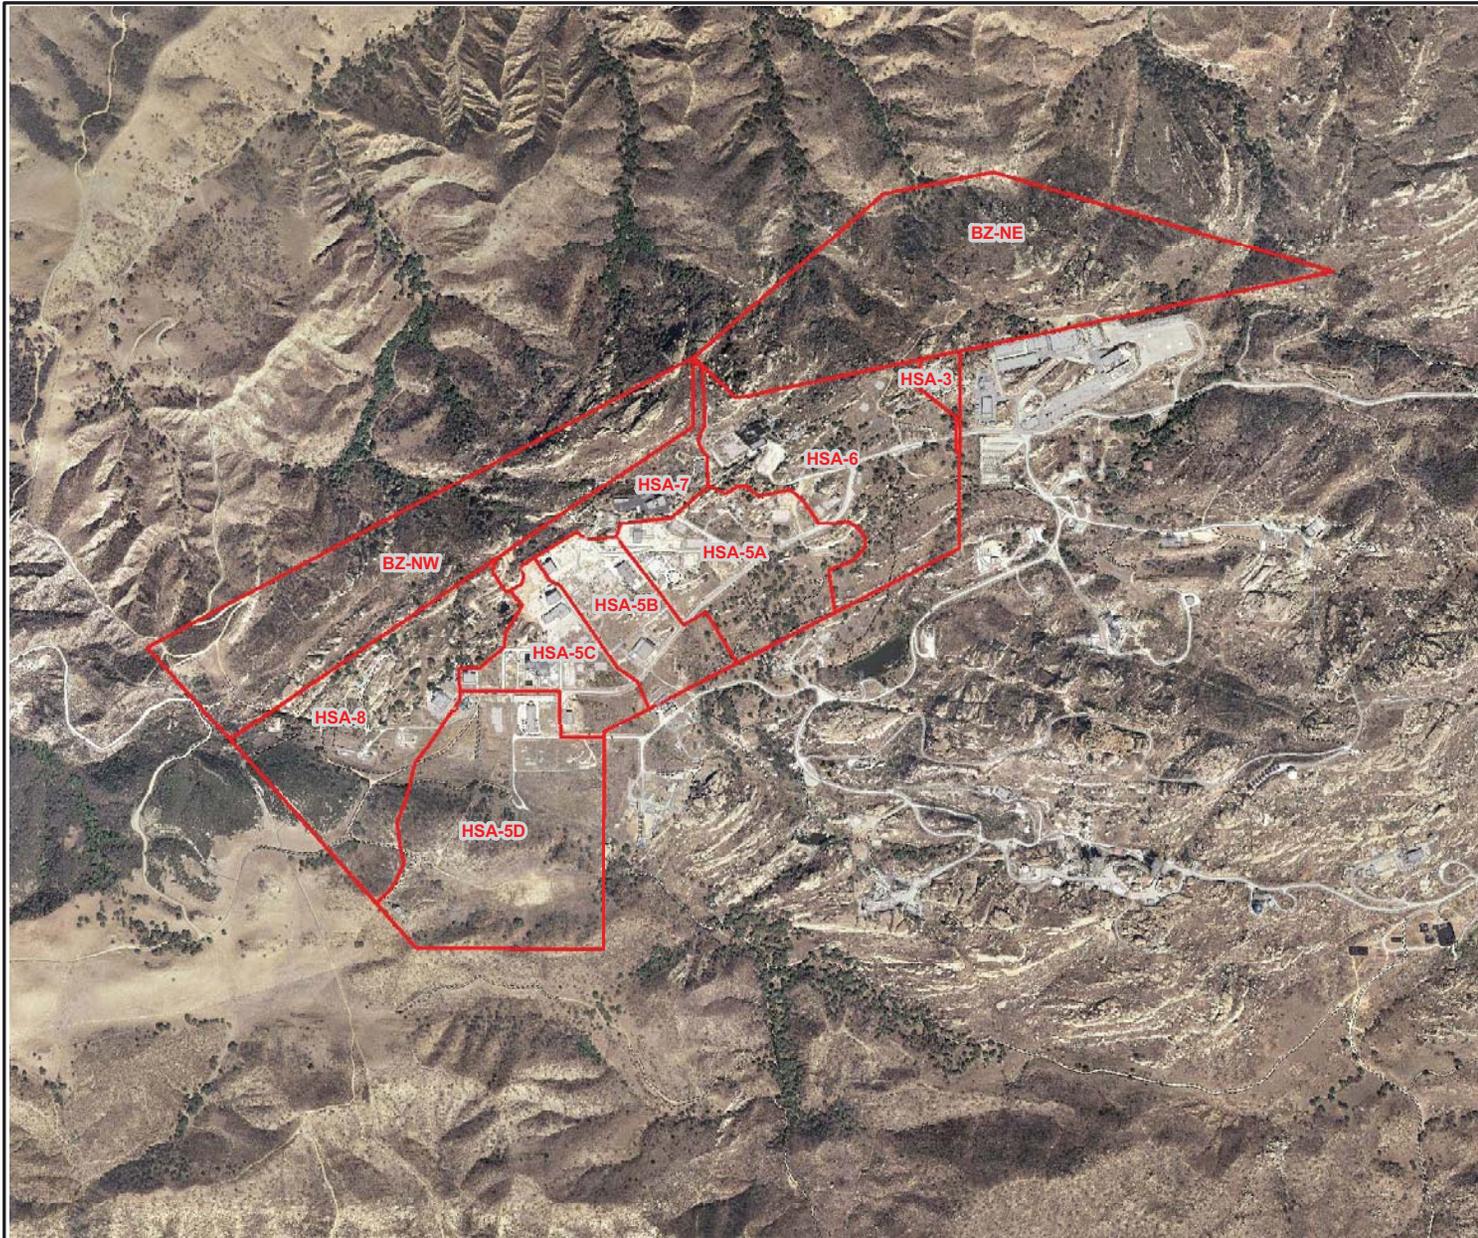
Figure 1.3
Subarea HSA-5C
Santa Susana Field Laboratory

This TM is focused on radiological information within subarea HSA-5C and the drainage channels that lead to and from this area. The location of subarea HSA-5C is shown on Figure 1.3. Plate 1 presents a summary of the features related to potential radiological sources identified within the HSA-5C subarea. Detailed information pertaining to the use of radioactive materials and the potential release of radionuclides at sites and buildings within HSA-5C are provided in Sections 2 and 3 of this TM. Preliminary findings specific to HSA-5C are presented as follows:

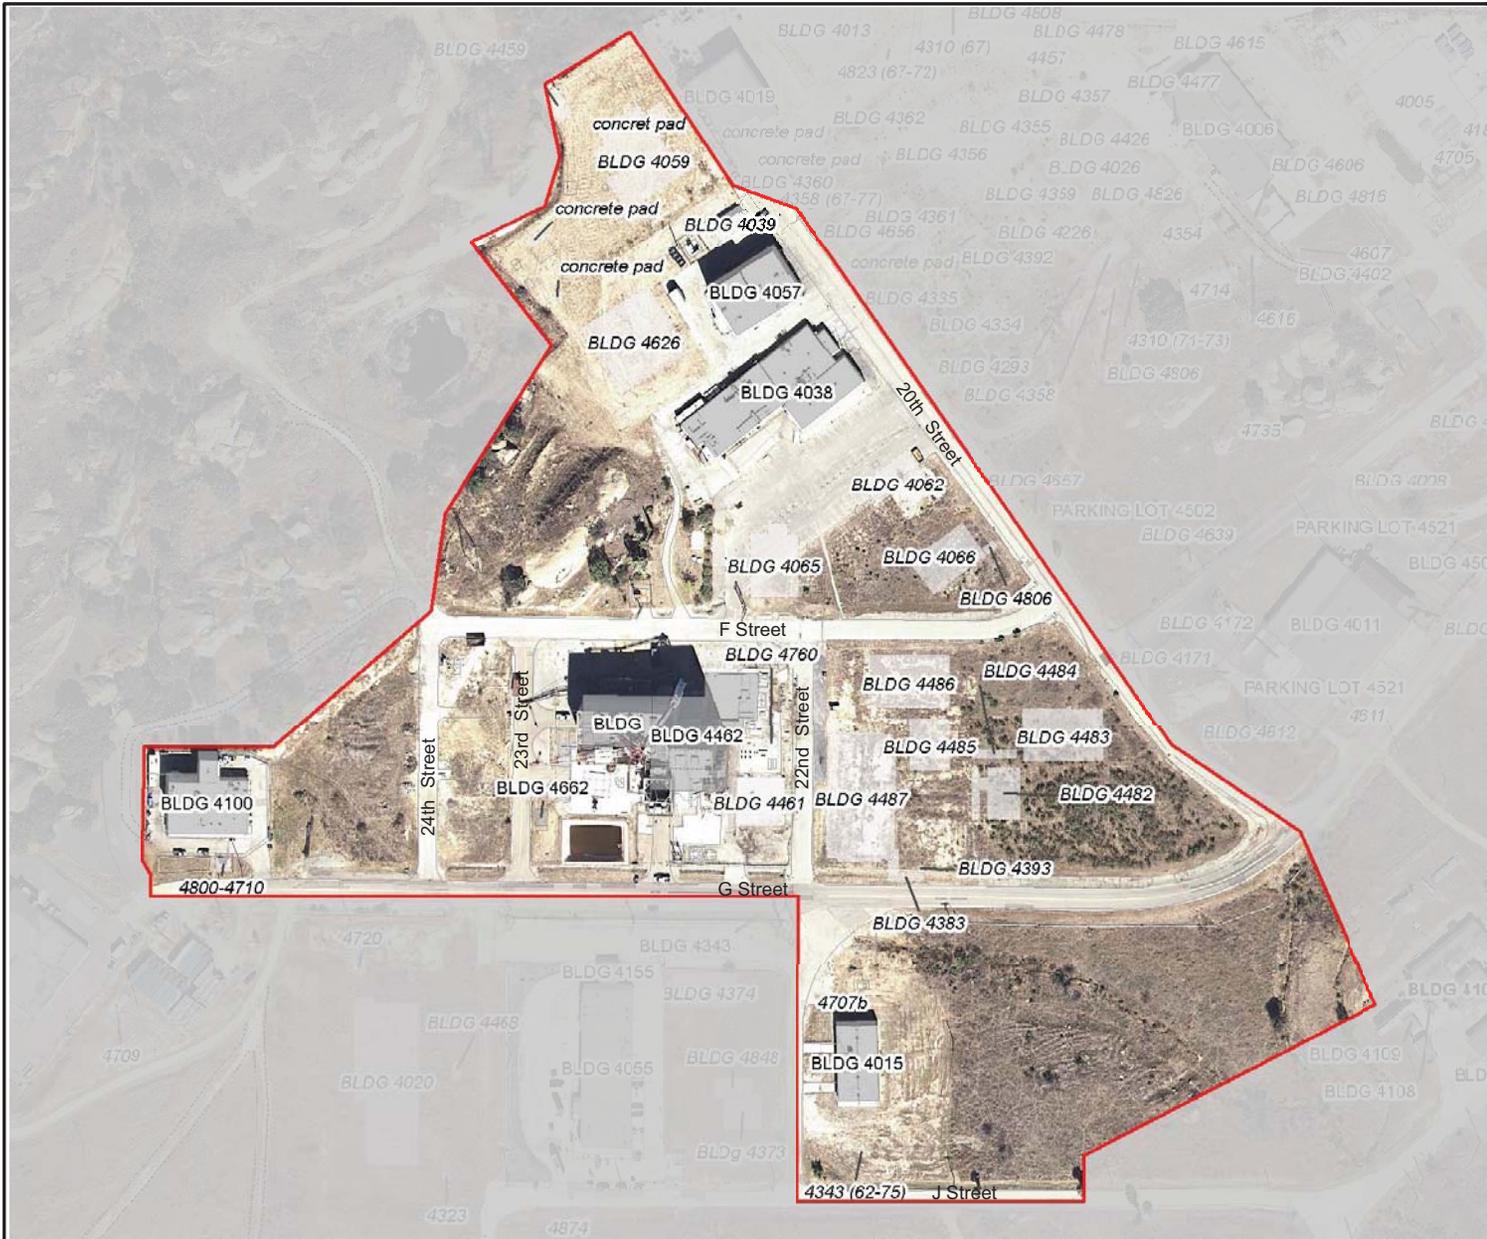
Figure 2.1
Area IV Subarea 5C-1
Santa Susana Field Laboratory

Plate 1 and Figure 2.1 provide a convenient reference for the following recommendations.

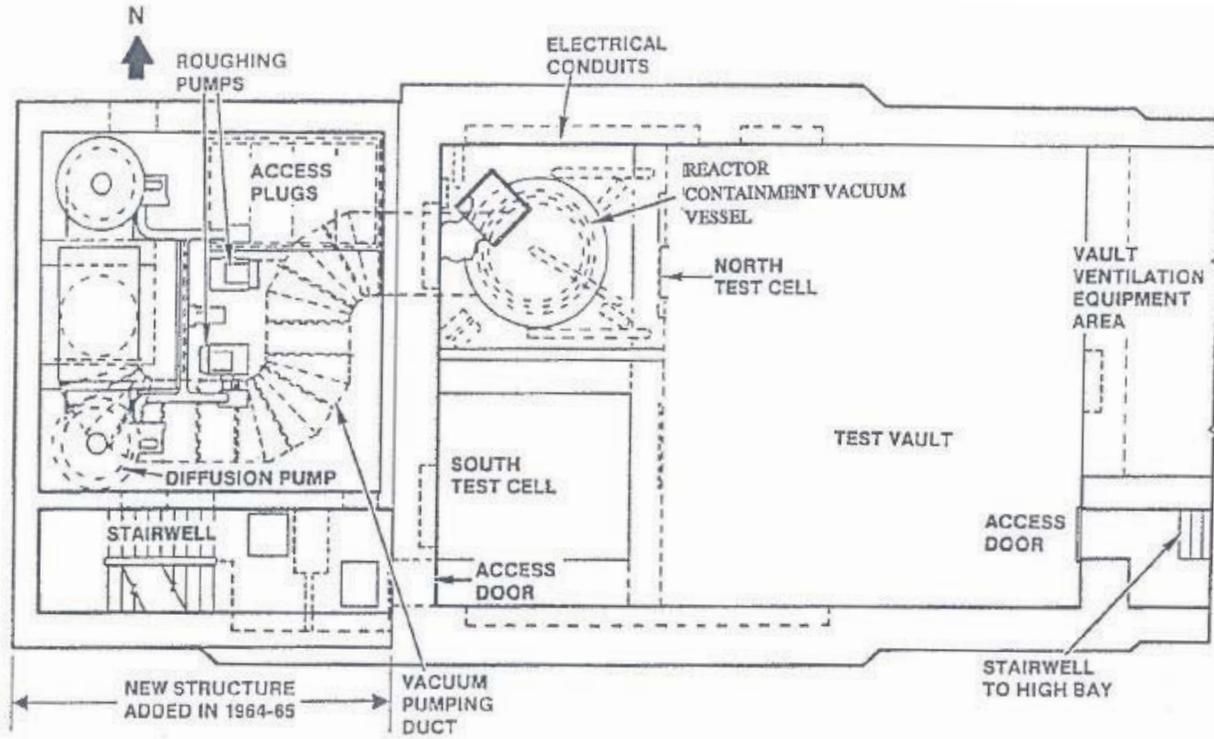
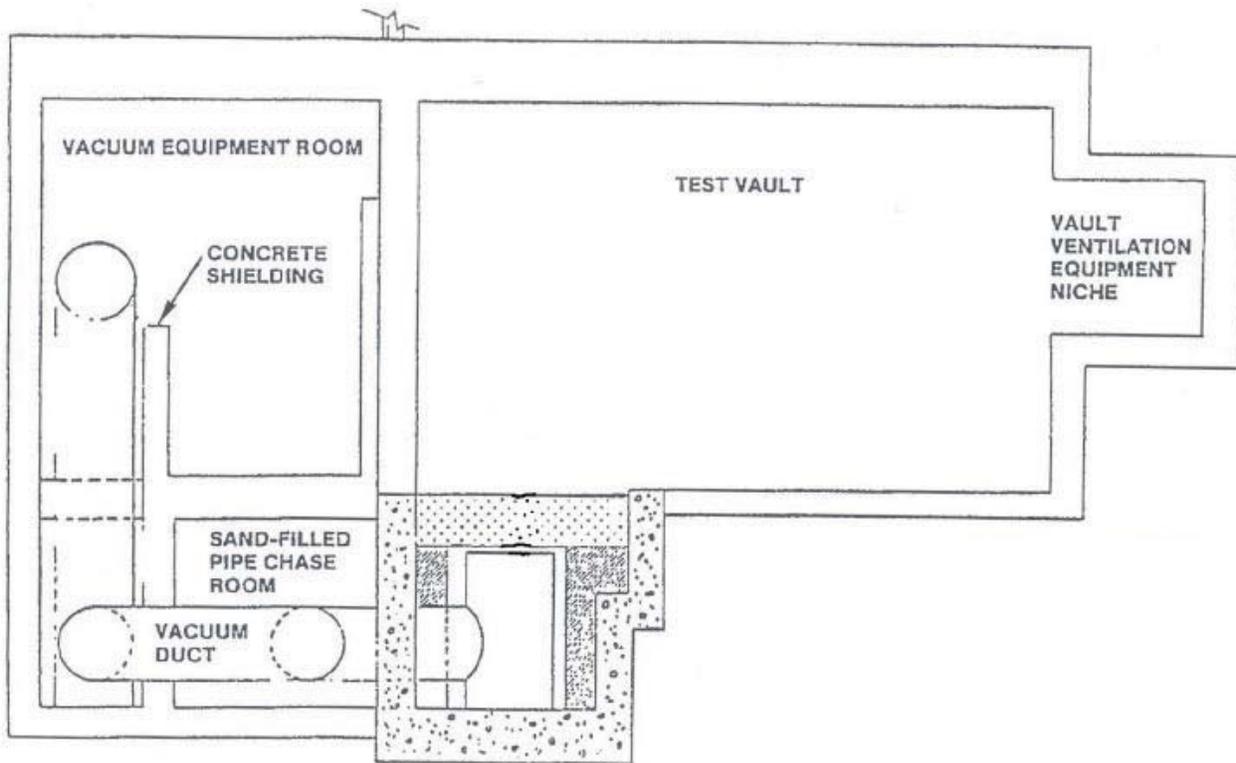
Figure 2.1.2b
Building 4059
Floor Plan

Elevation View

- ORDINARY CONCRETE
 $\rho = 2.3 \text{ g/cm}^3$
- ORDINARY CONCRETE
 1% BORON
- HIGH DENSITY CONCRETE
 $\rho = 3.2 \text{ g/cm}^3$ 0.25% BORON
- HIGH DENSITY CONCRETE
 0.5% BORON

Former Use(s): Building 4059 housed the SNAP 8 prototype reactor, S8DR, Large Leak Test Rig, and Ground Prototype Test Facility. By January 1969, an unshielded SNAP 8 prototype reactor was operating at 600 kW in the north cell. It continued operating until December 1969 at 600 kW with a short period at 1MW. In 1970, the reactor and associated equipment were removed and the facility became inactive. In 1973, the Liquid Metal Engineering Center (LMEC) occupied the building, removed the shielding and remote handling equipment, and erected the Large Leak Test Rig (LLTR) in the test vault and high bay areas.⁴

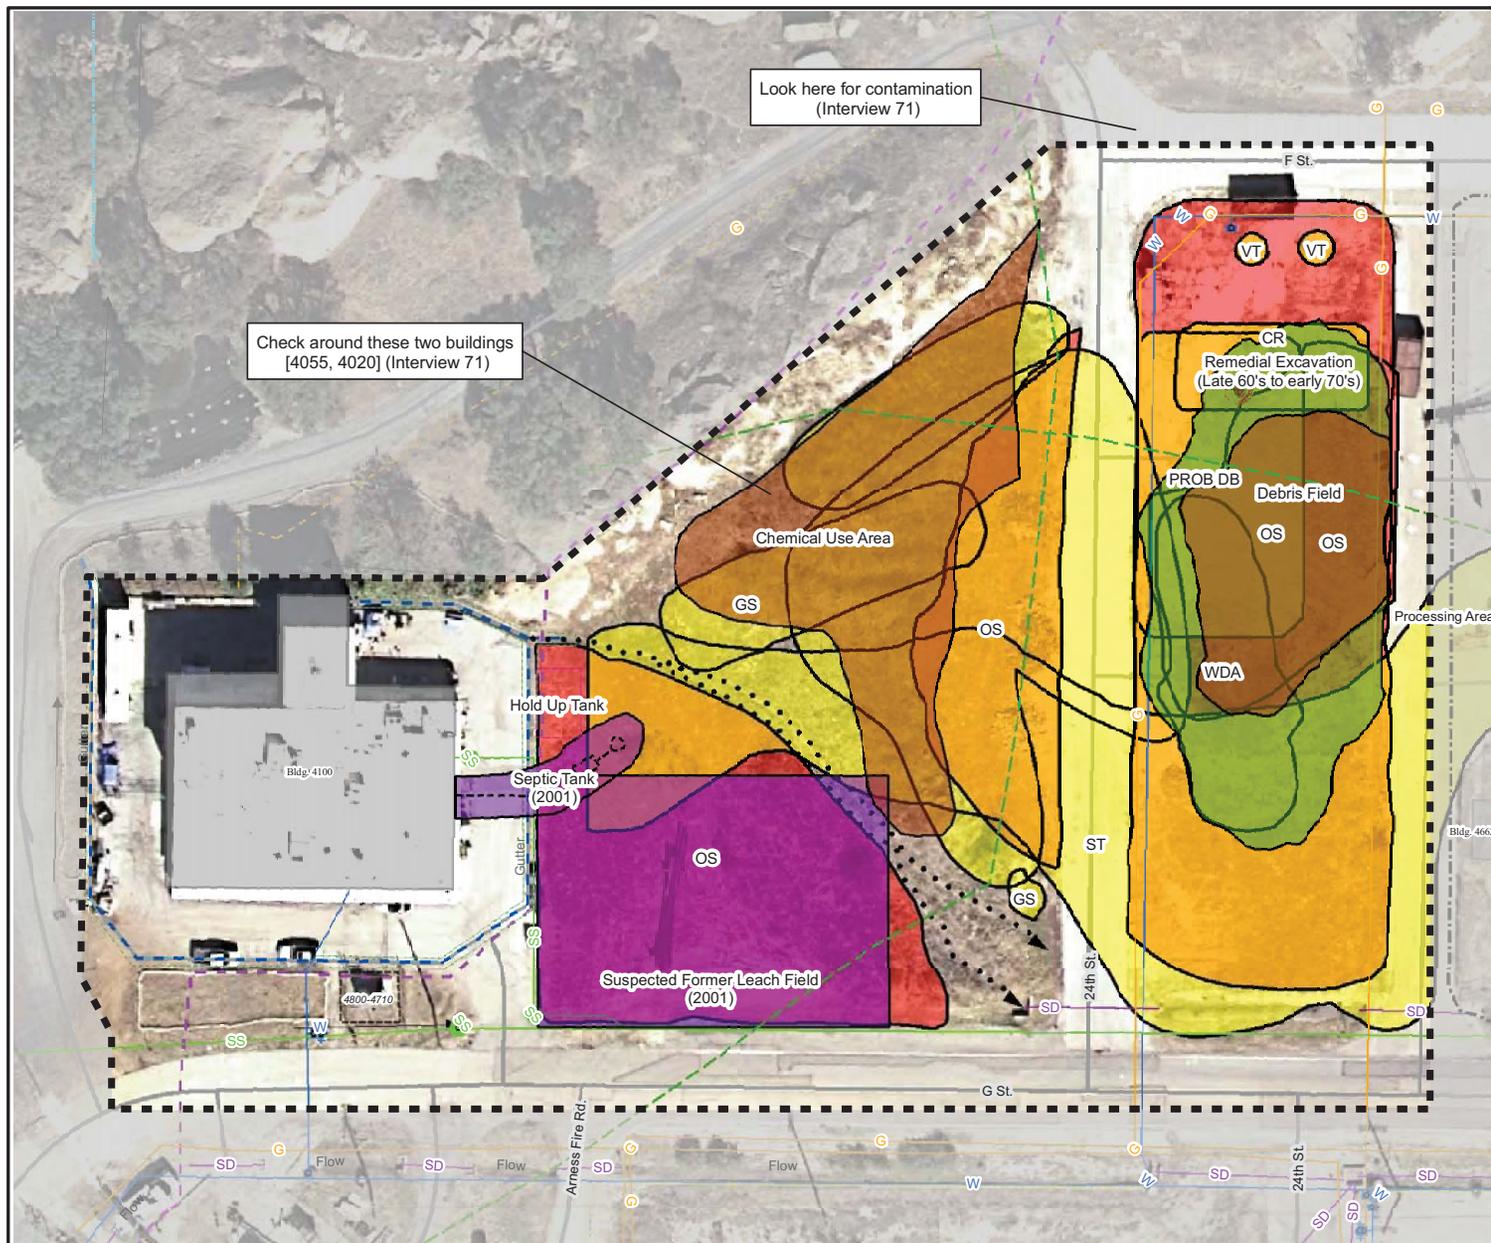
Figure 2.3
Area IV Subarea 5C-3
Santa Susana Field Laboratory

The Group 3 index map is presented in Figure 2.3. Following Figure 2.3, the site photograph and layout drawings for the building area within HSA-5C Group 3 are presented. HSA-5C Group 3 includes one building area containing criticality test facilities as well as adjacent disposal areas including trenches.

Plate 1 and Figure 2.3 provide a convenient reference for the following recommendations.
