**UNITED STATES
ENVIRONMENTAL PROTECTION AGENCY
REGION 8**

**ADMINISTRATIVE ORDER
ON CONSENT**

Docket No. **CWA-08-2014-0024**

SECOND RESTORATION PLAN FOR SHEEP CREEK RANCH FOR FINDINGS OF VIOLATION AND ADMINISTRATIVE ORDER FOR COMPLIANCE, DOCKET No. CWA-08-2011-0015

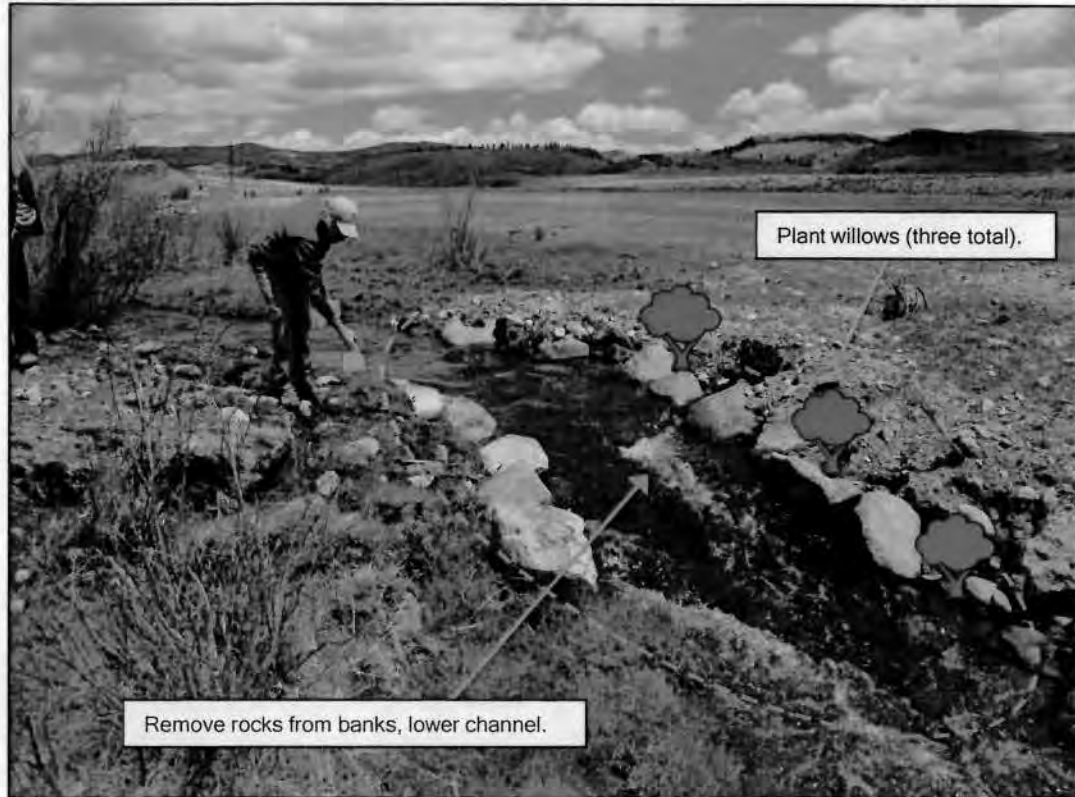
Figure B-12 . Work plan for site 12.

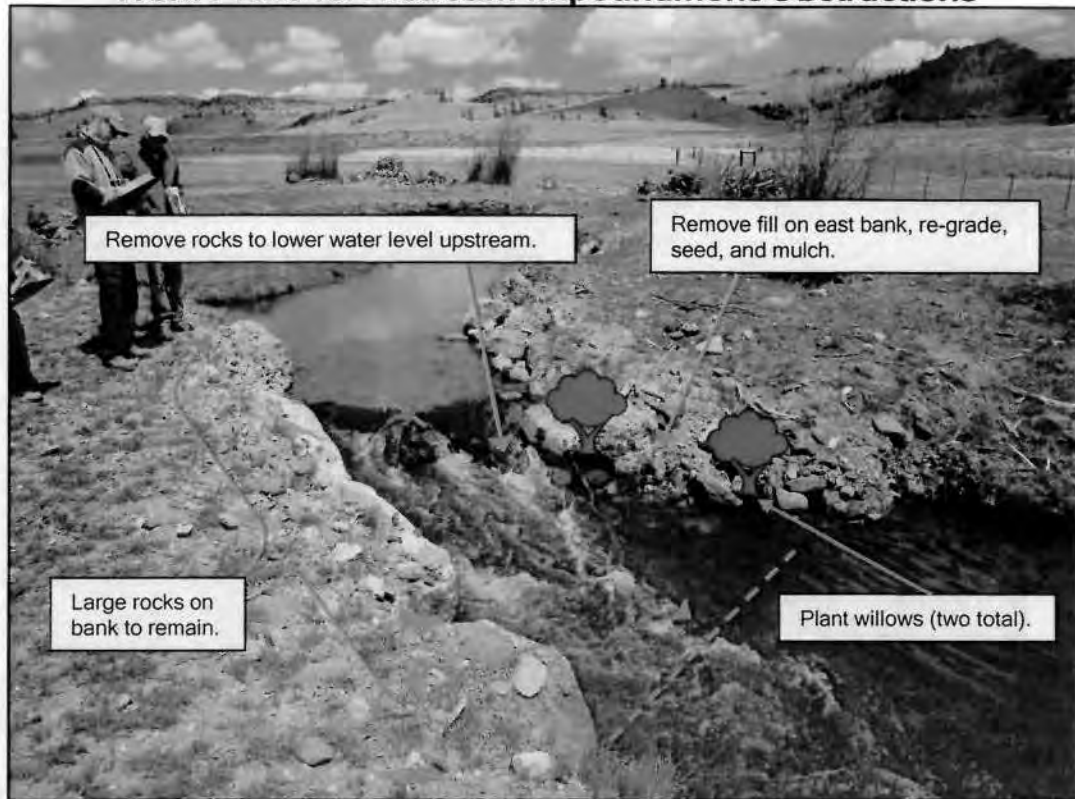
Figure B-23. Work plan for site 23.

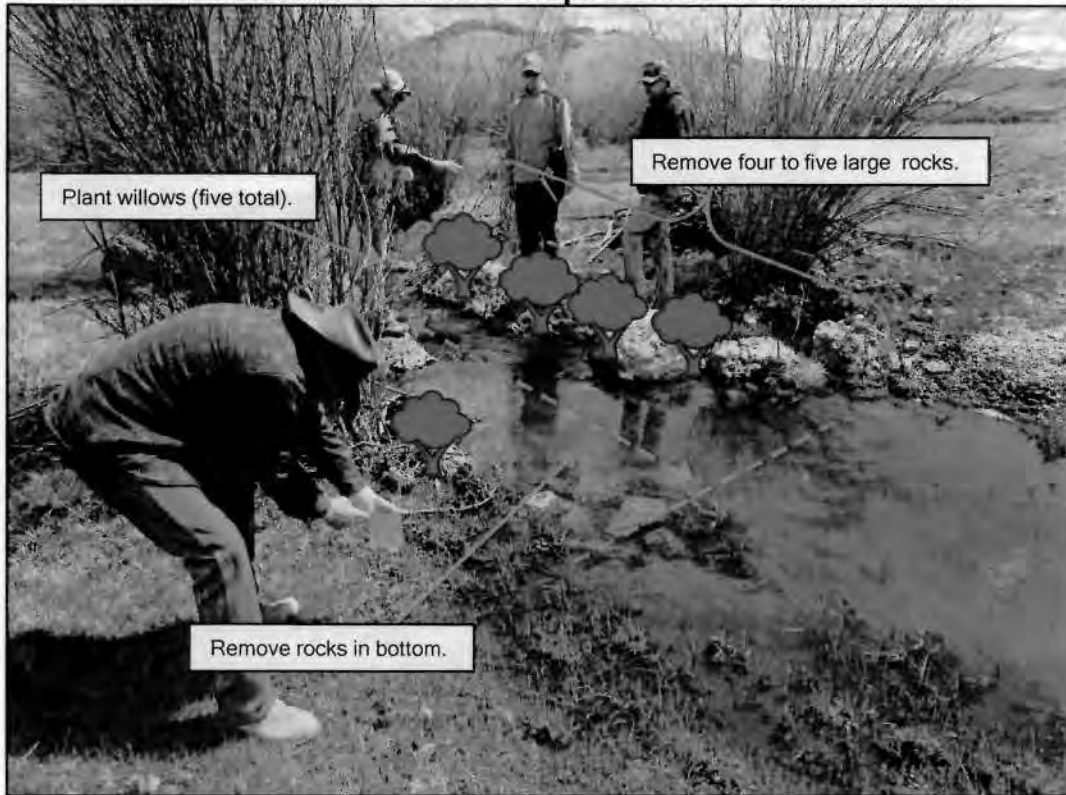
Figure B-25B. Work plan for site 25B.

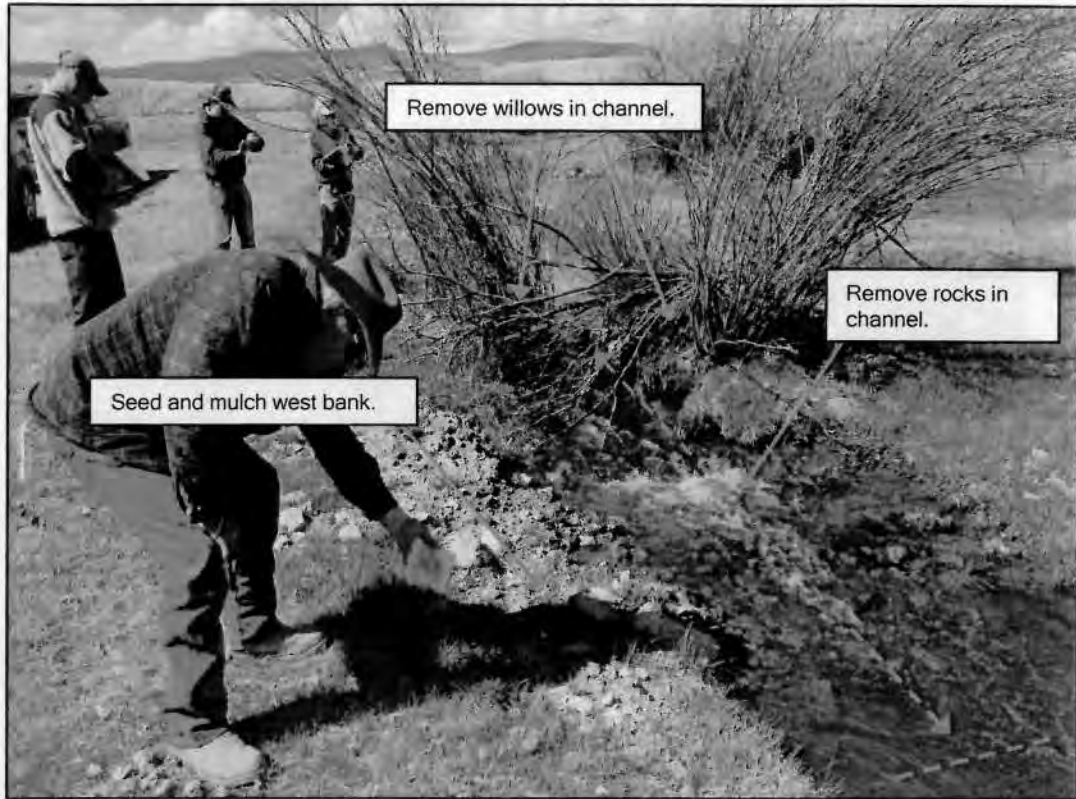
Figure B-27. Work plan for site 27.

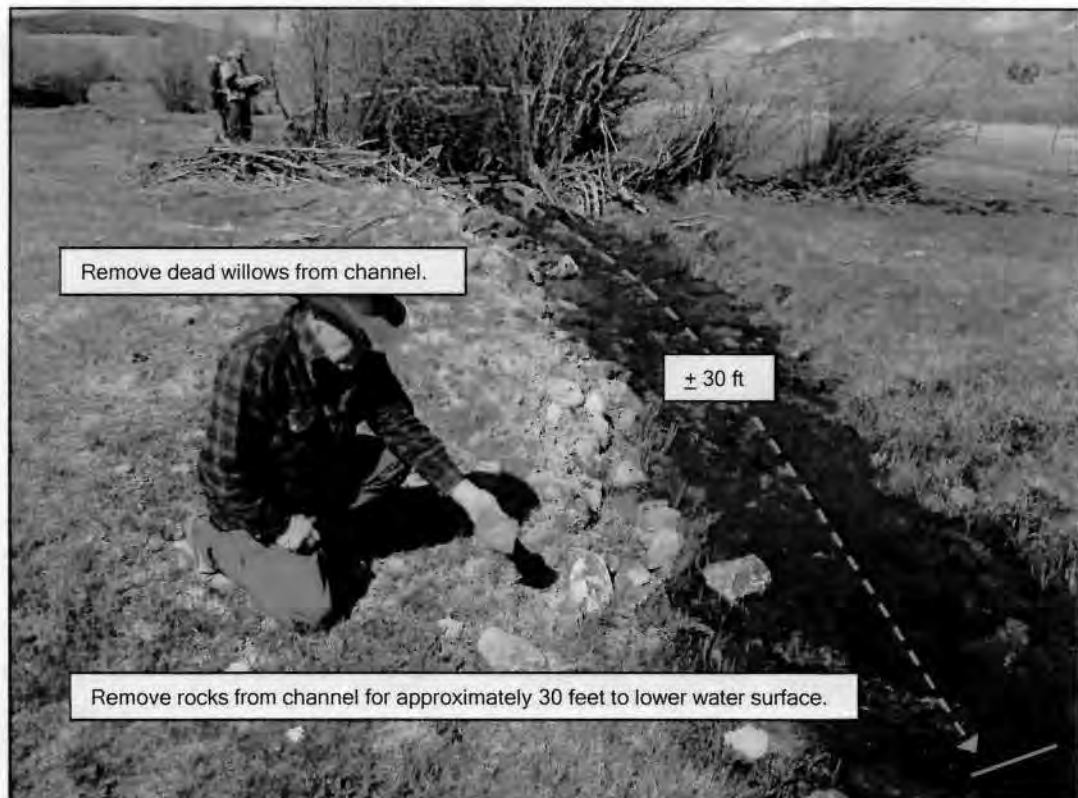
Figure B-28. Work plan for site 28.

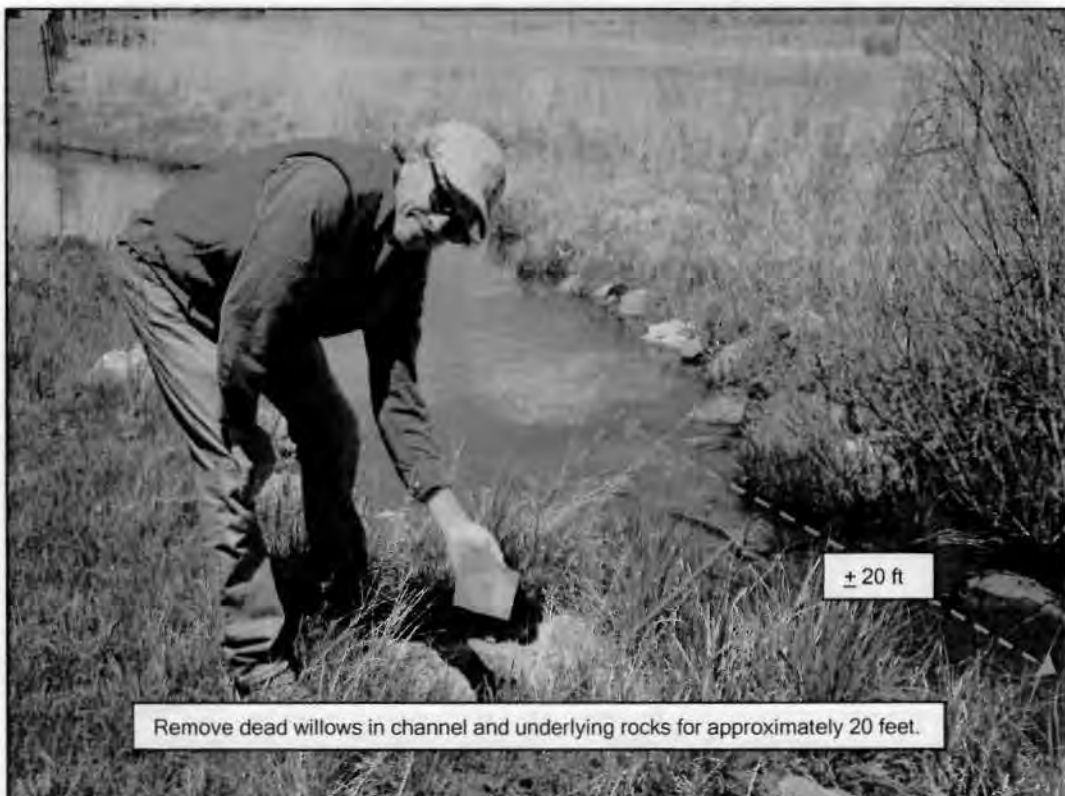
Figure B-30. Work plan for site 30.

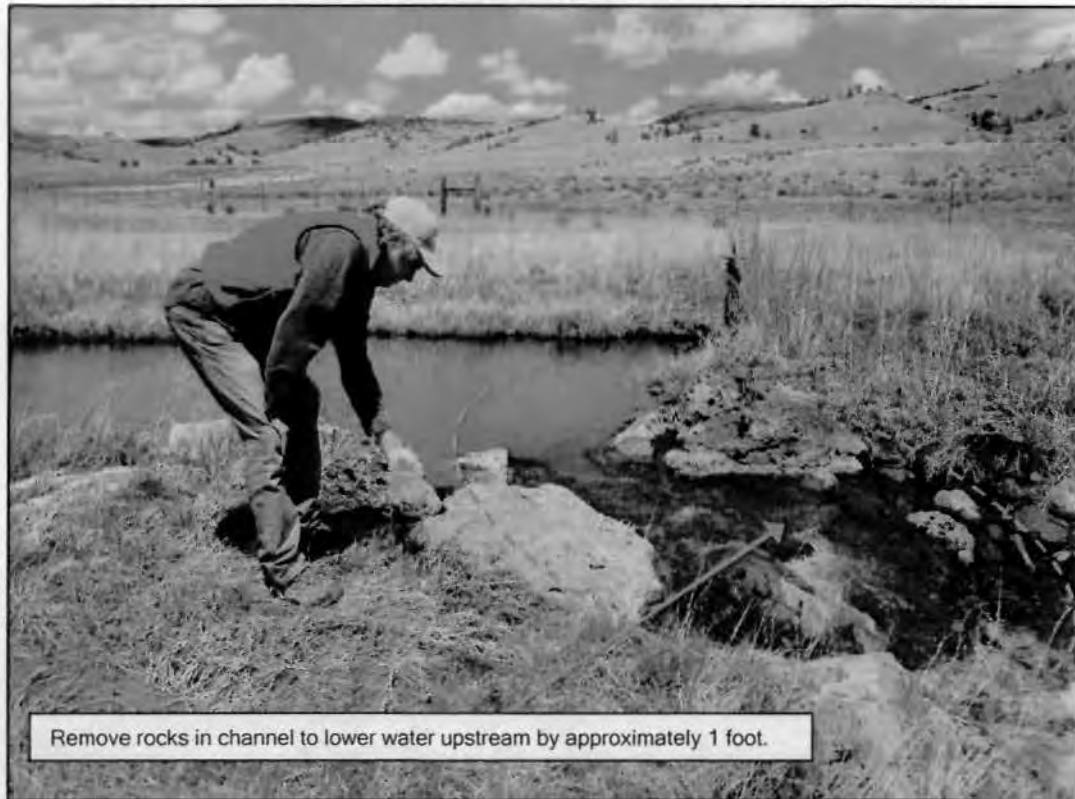
Figure B-31. Work plan for site 31.

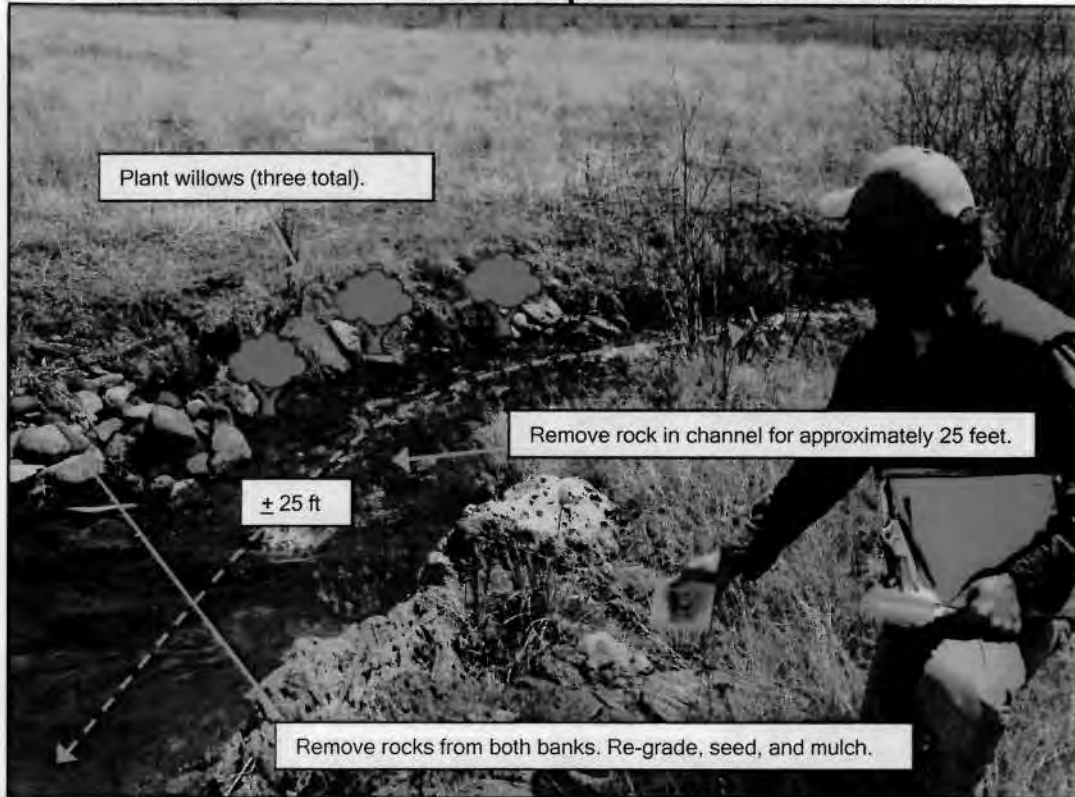
Figure B-35. Work plan for site 35.

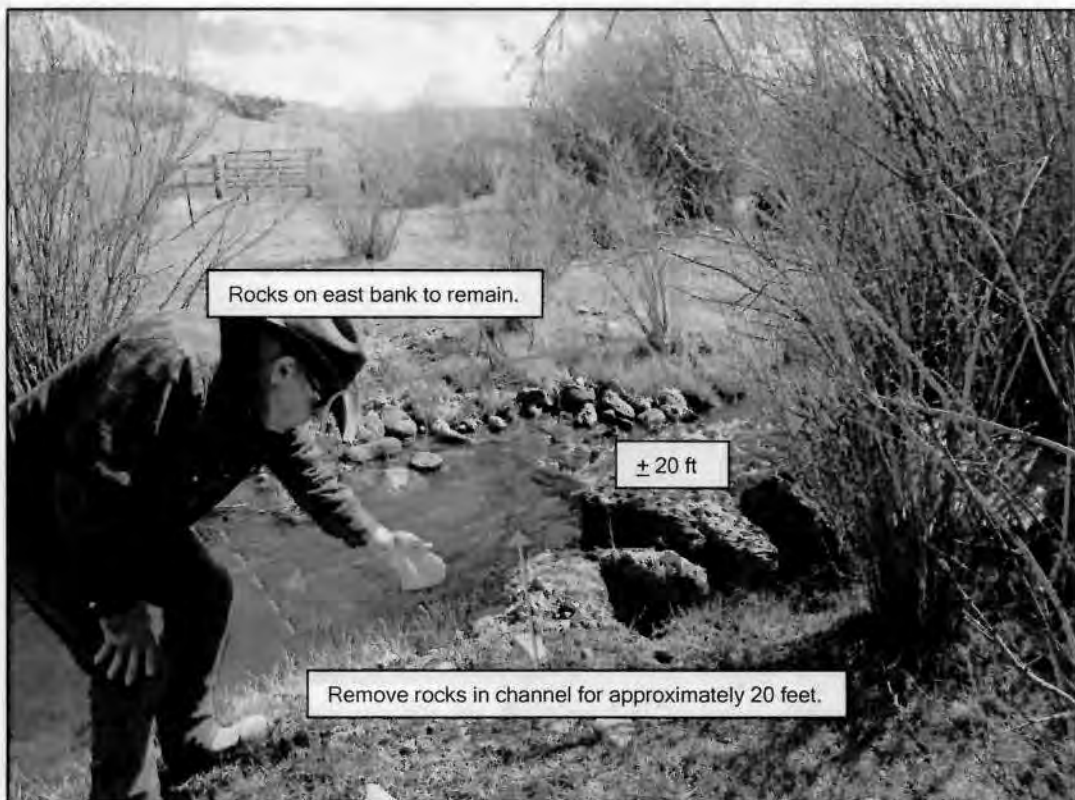
Figure B-36. Work plan for site 36.

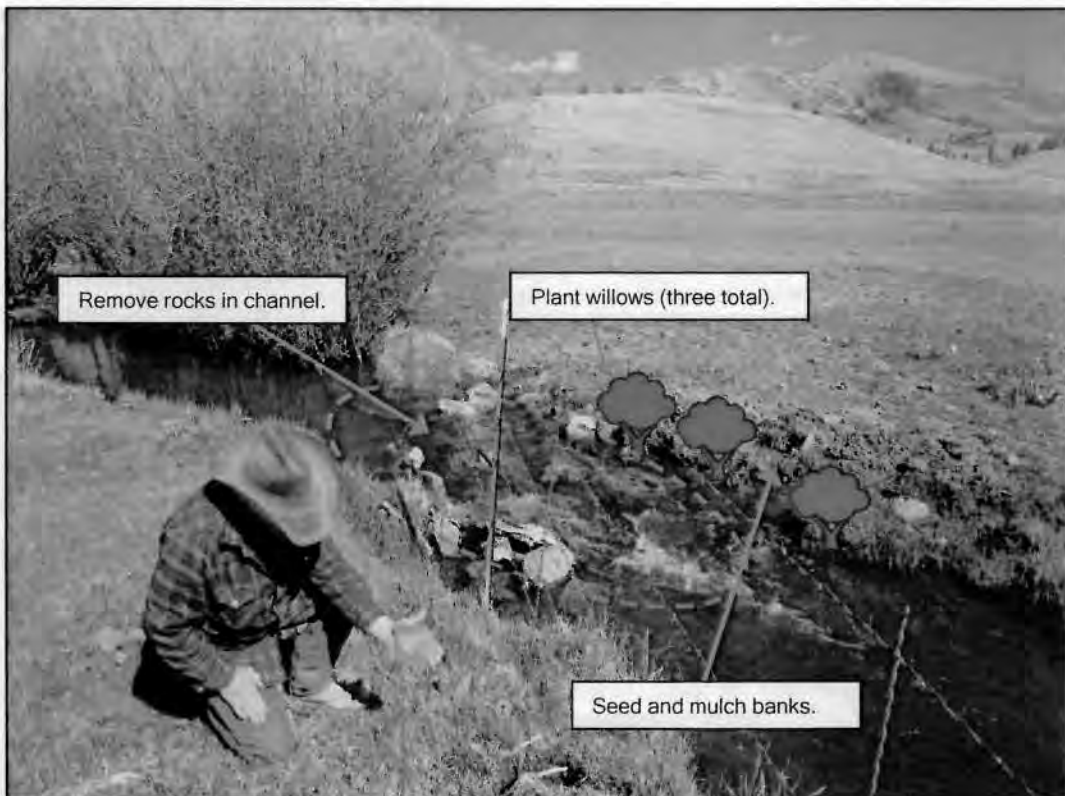
Figure B-38. Work plan for site 38.

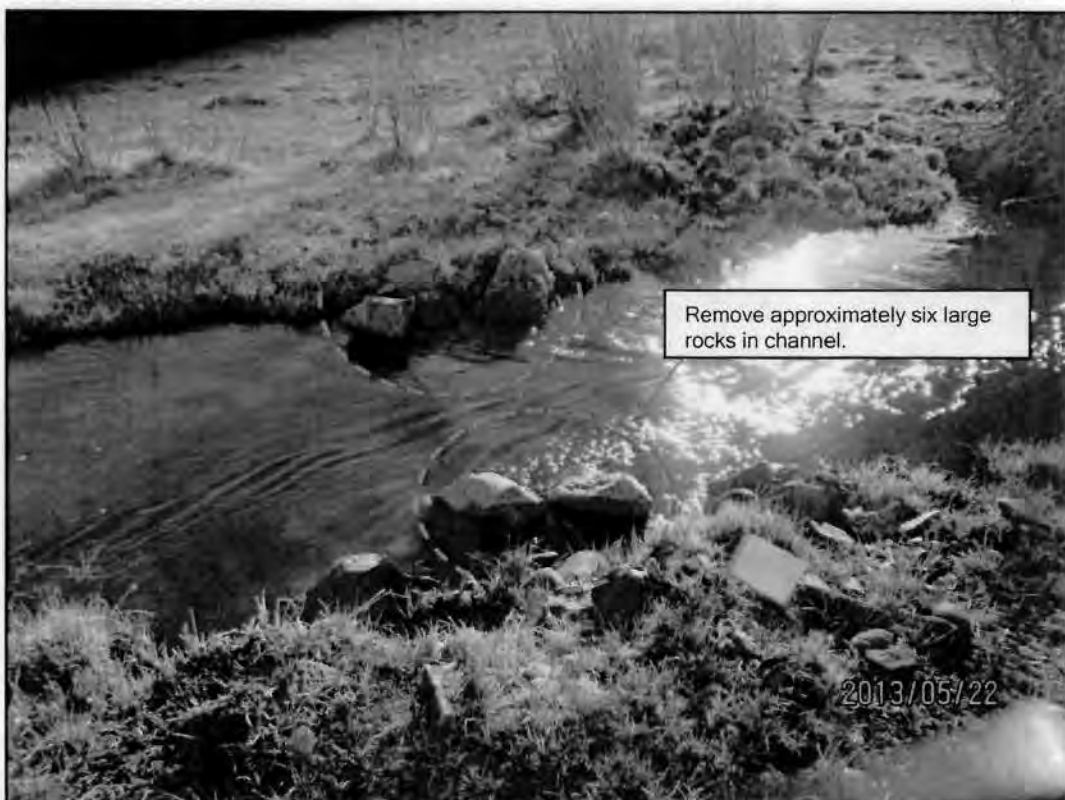
Figure B-45. Work plan for Sites 45.

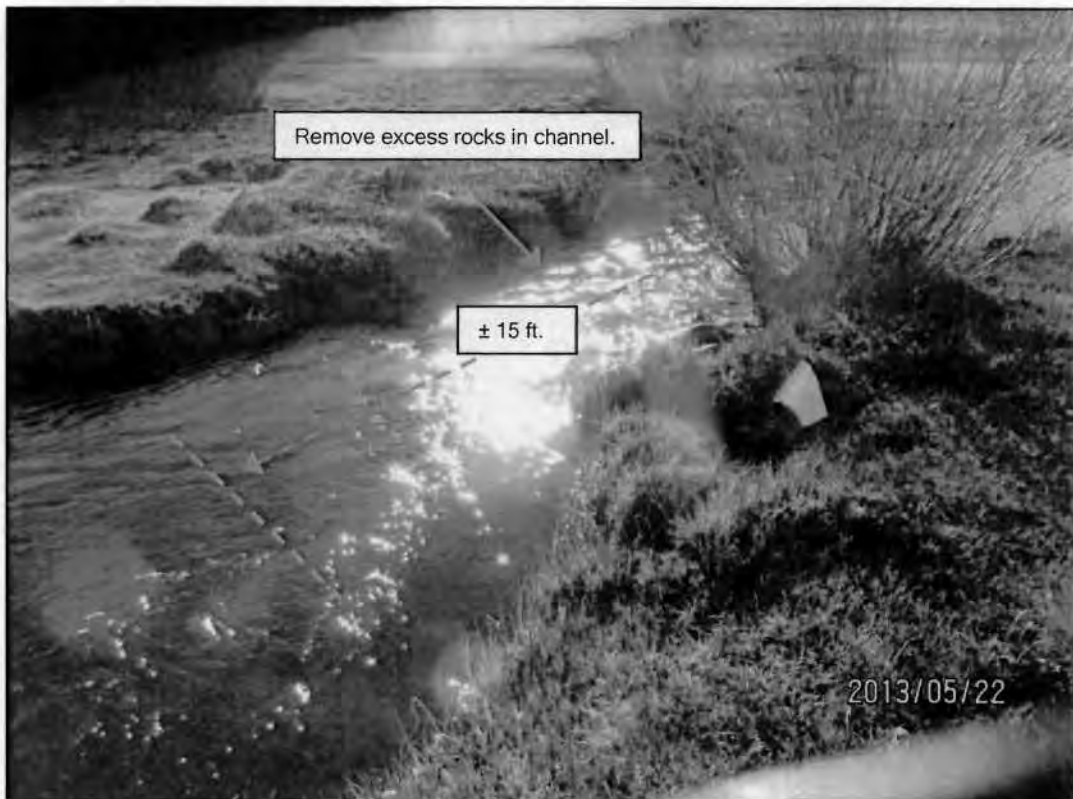
Figure B-48. Work plan for Site 48.

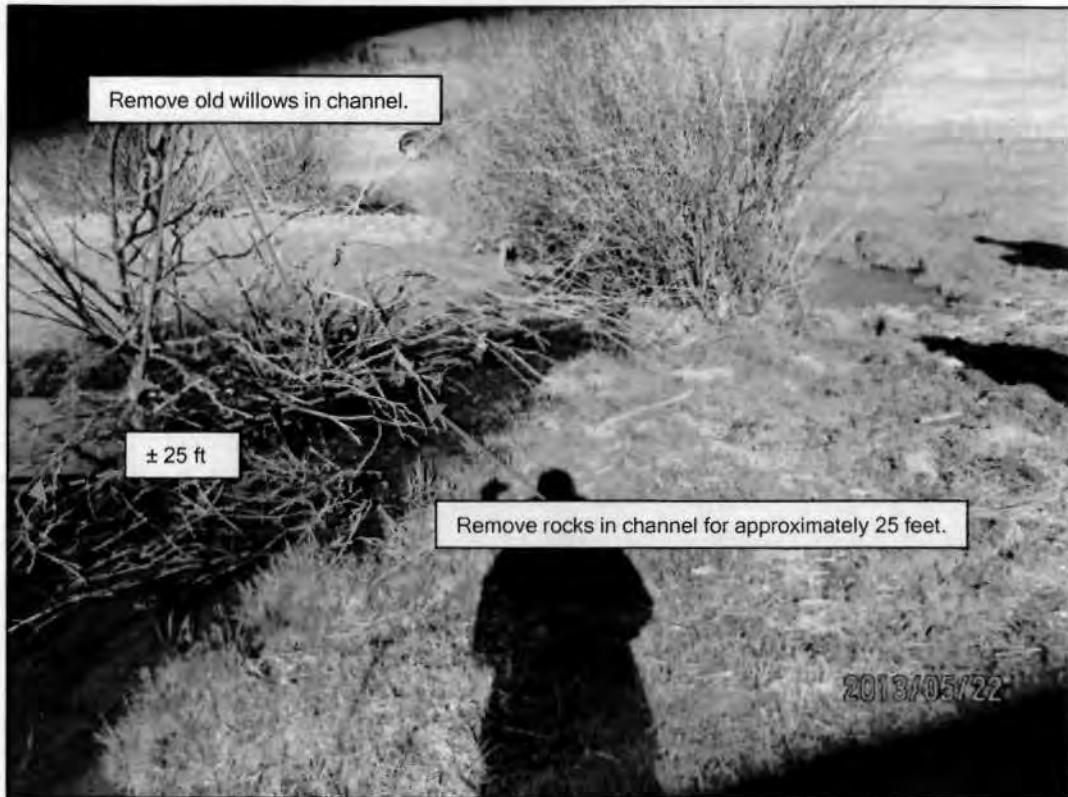
Figure B-60. Work plan for Site 60.

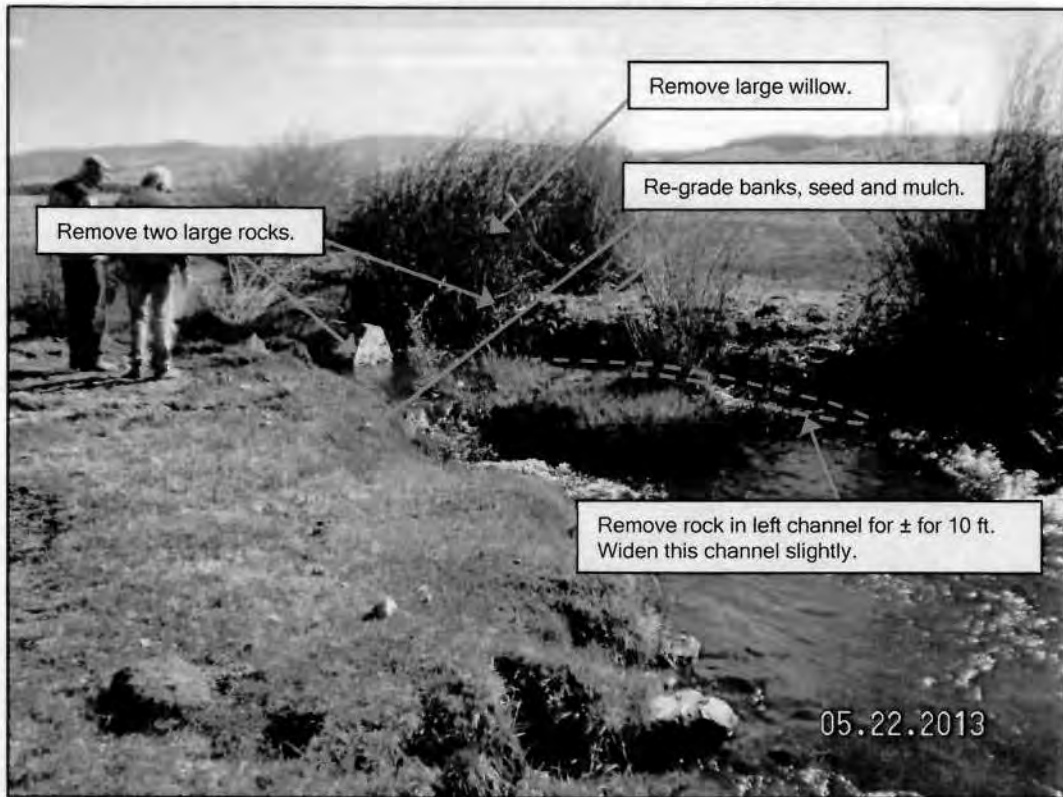
Figure B-64. Work plan for site 64.

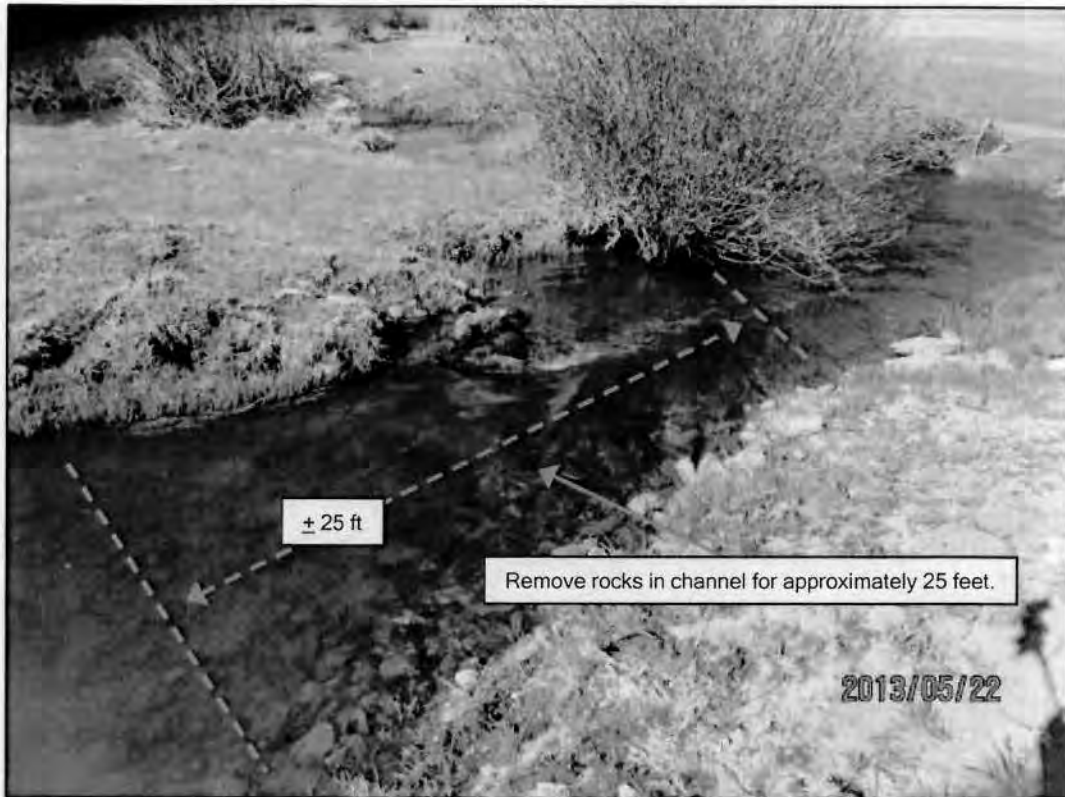
Figure B-68. Work plan for site 68.

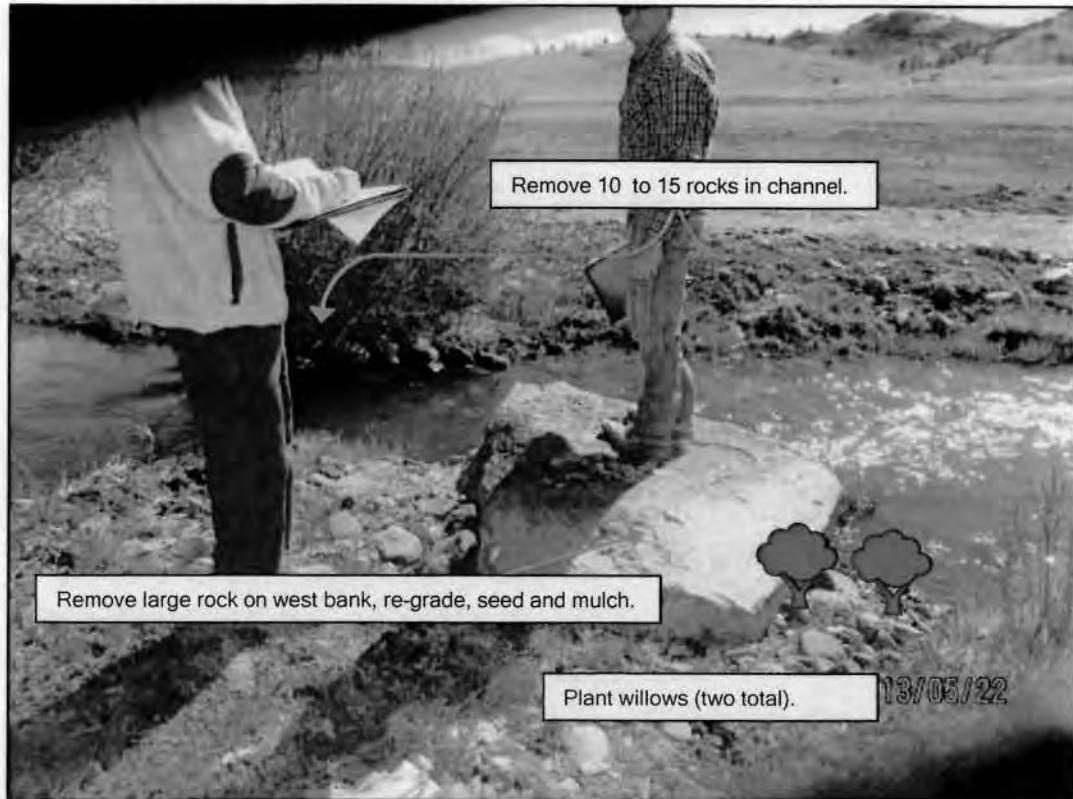
Figure B-70. Work plan for site 70.

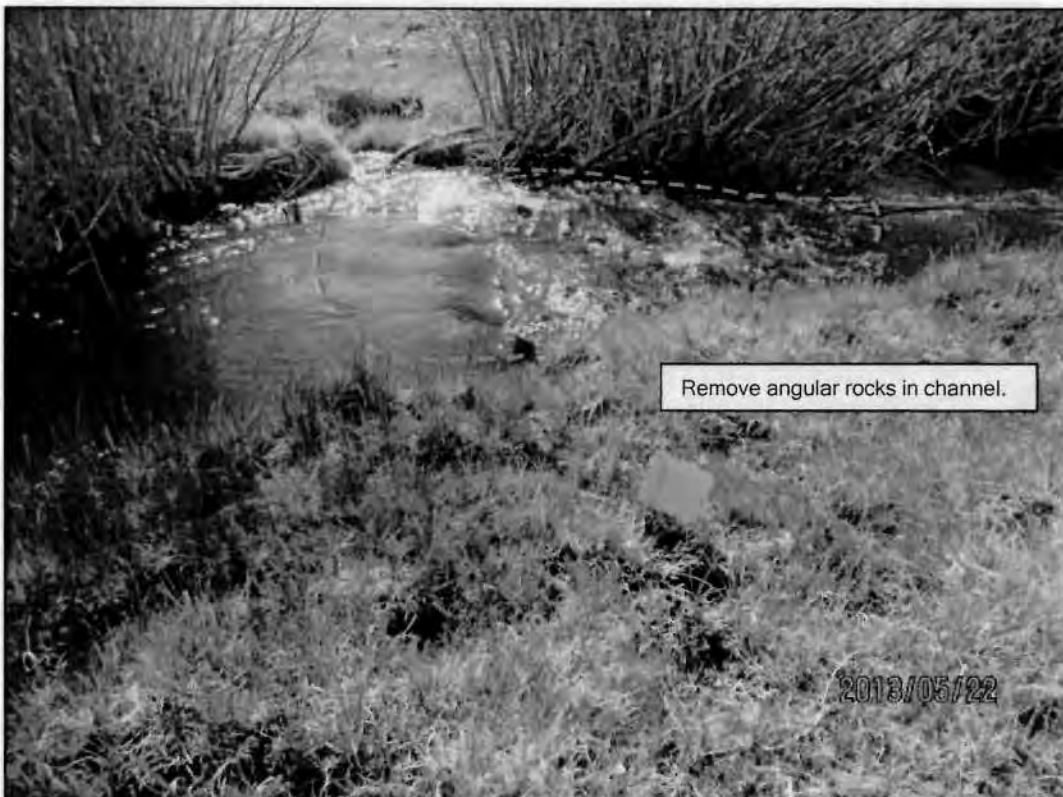
Figure B-75B. Work plan for site 75B.

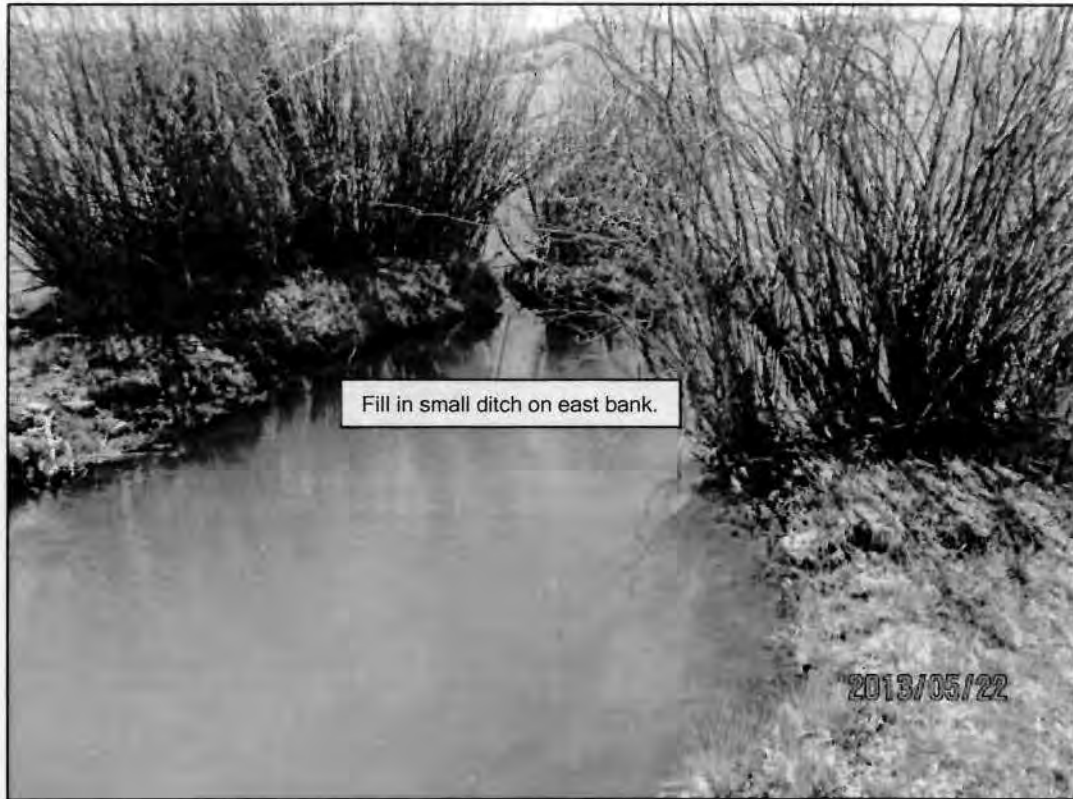
Figure B-76. Work plan for site 76.

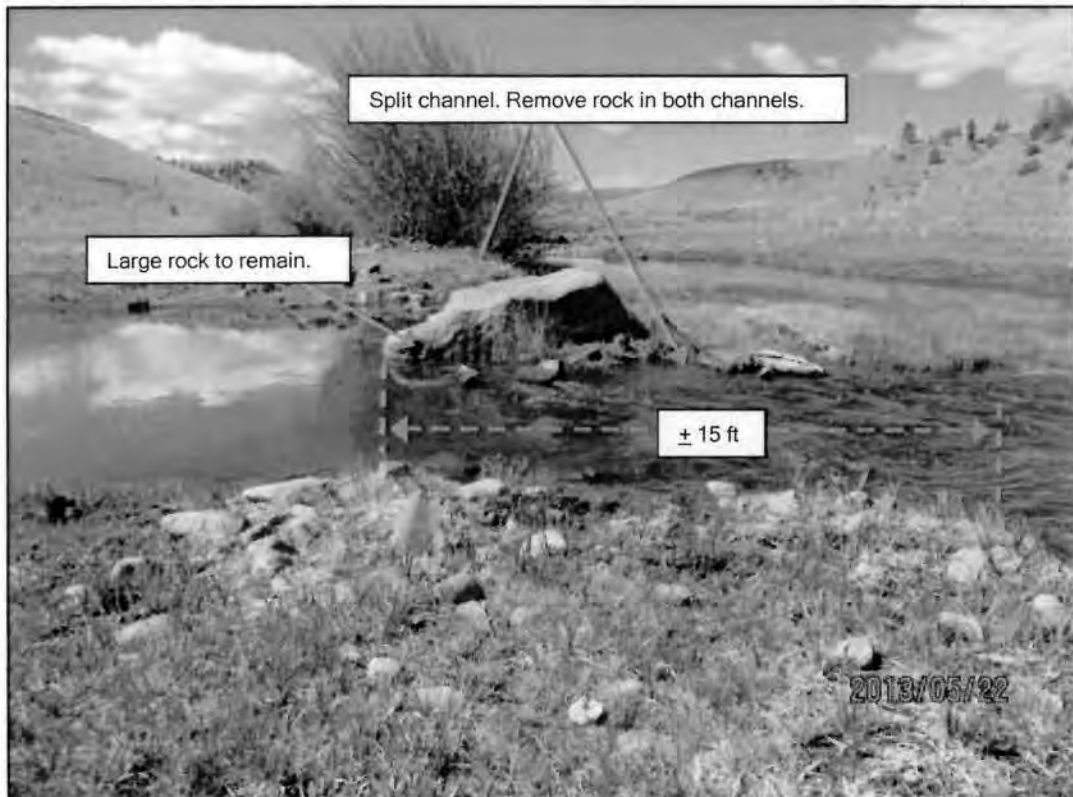
Figure B-77. Work plan for site 77.

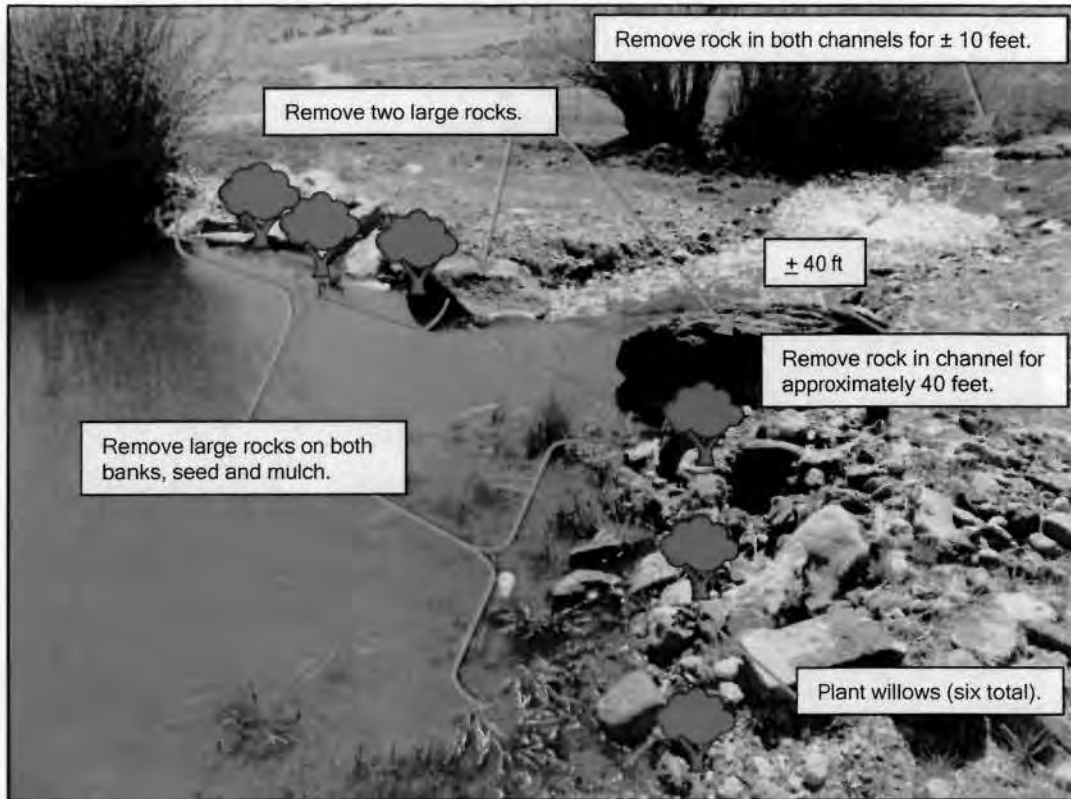
Figure B-79. Work plan for site 79.

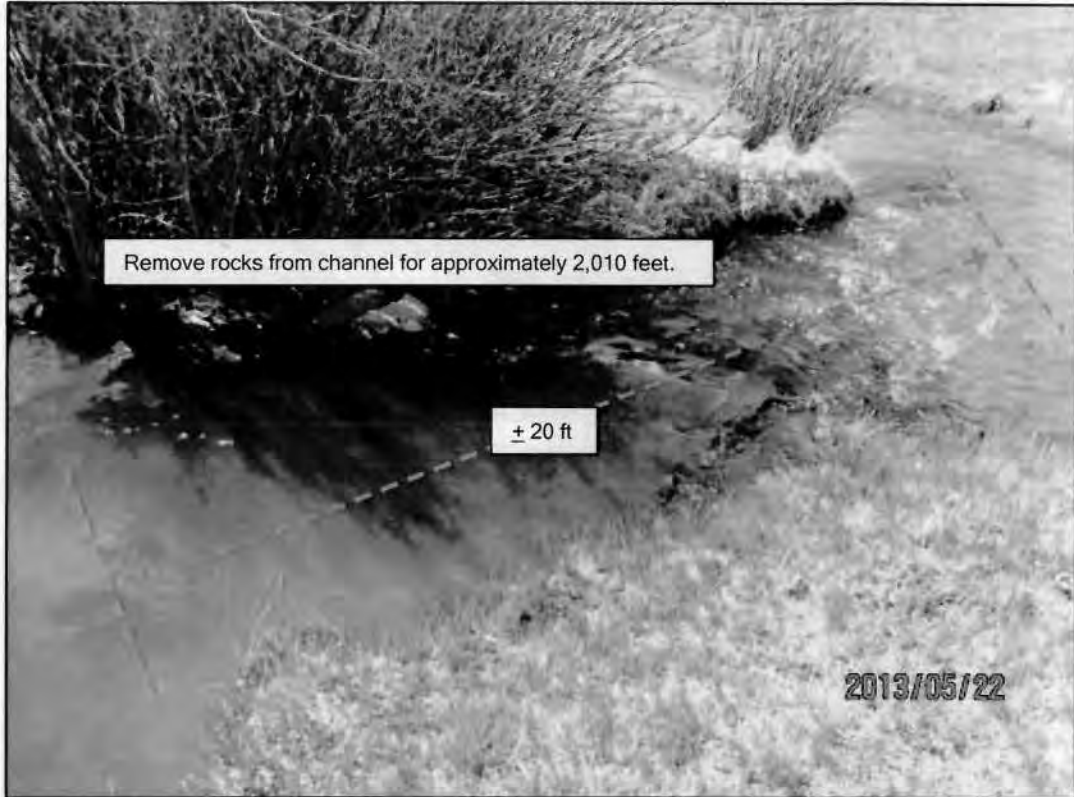
Figure B-83. Work plan for site 83.

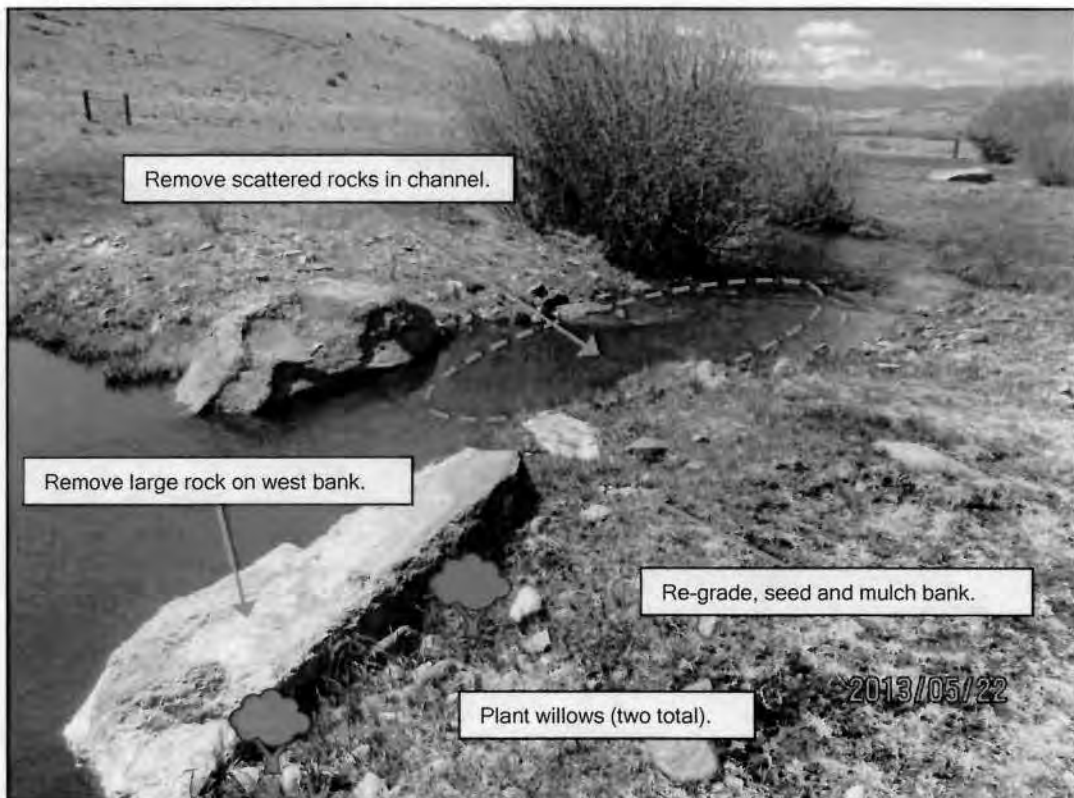
Figure B-84. Work plan for site 84.

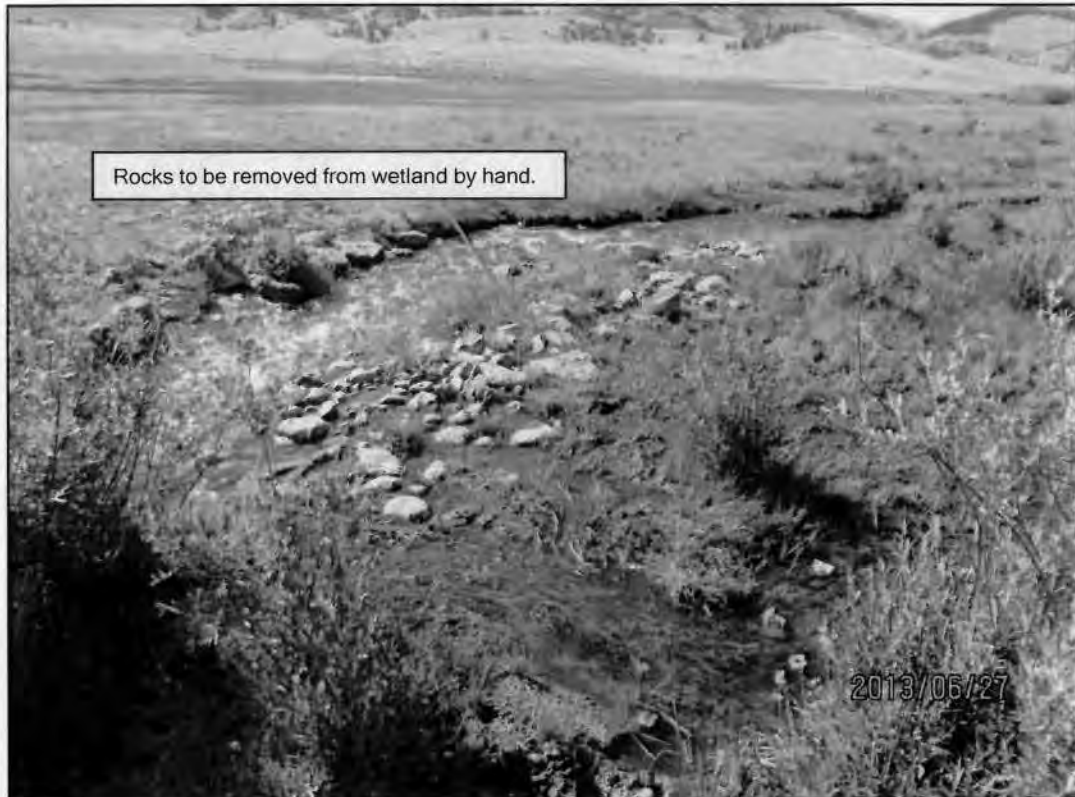
Figure D-2. Work plan for Site B (near CDWR Site 11).

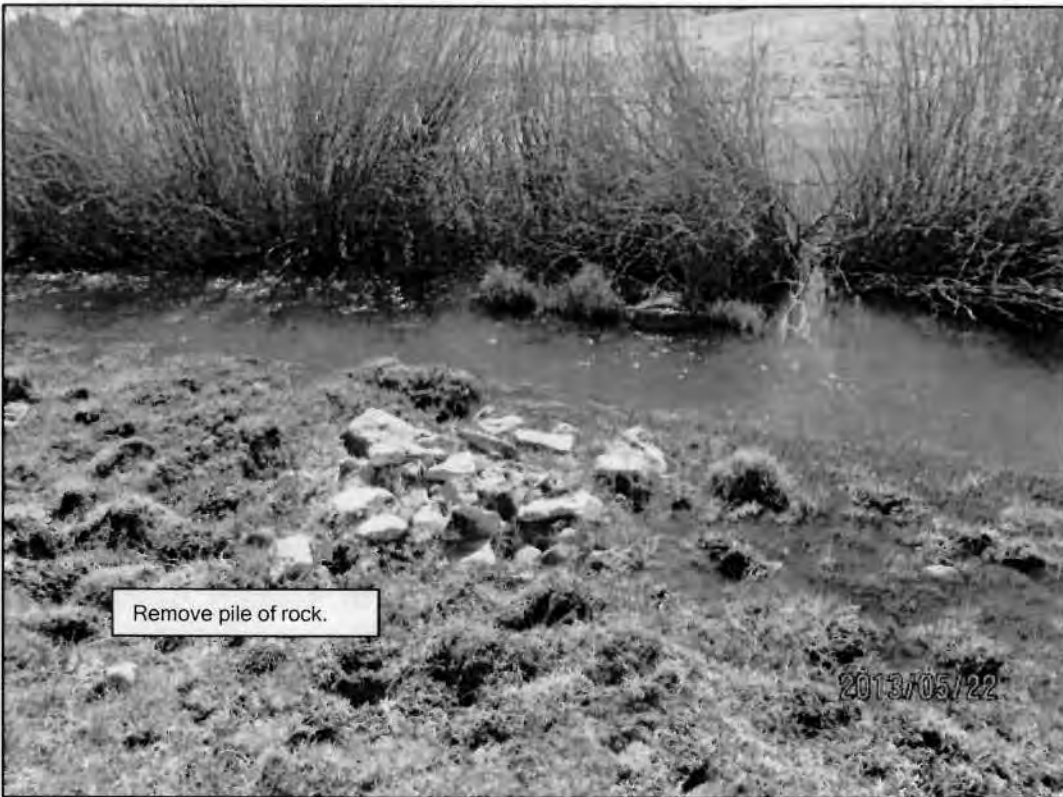
Figure D-78A. Work plan for site 78A.

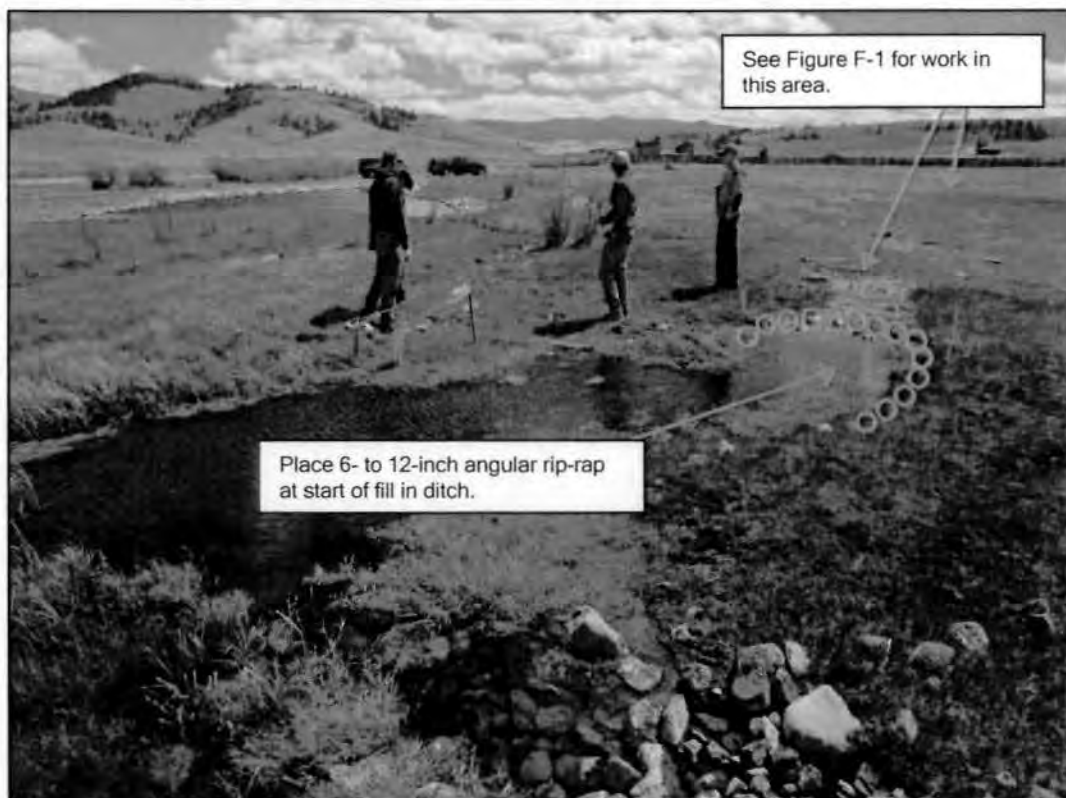
Figure F-2. Work plan for Feeder Ditch.

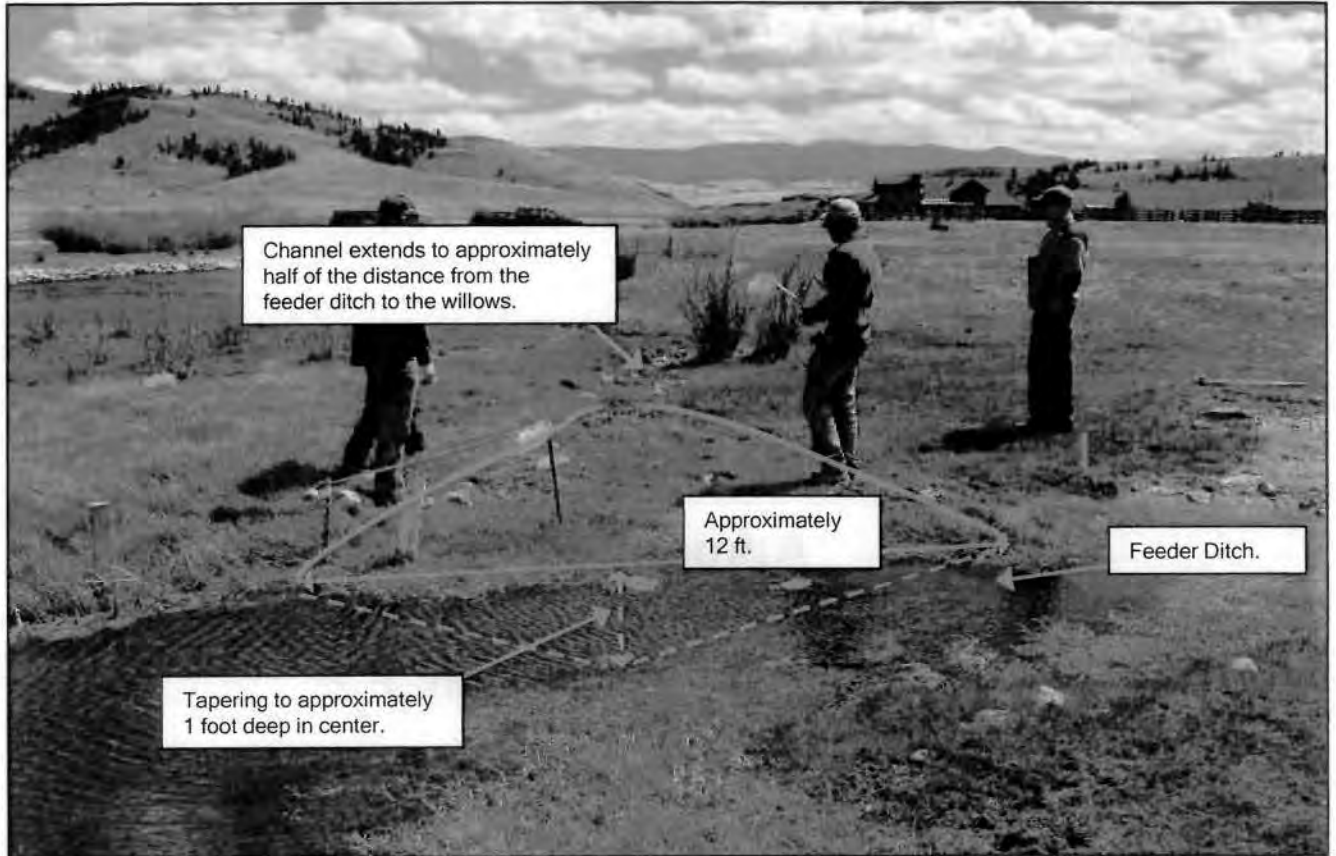
Figure F-3. Work plan for Feeder Ditch.
