Re: CKW Properties, LLP; Administrative Order for Compliance under Section 309(a) of the
Clean Water Act
Docket No. **CWA-08-2014-0031**

IN THE MATTER OF:)
)
CKW Properties, LLP) Docket No. **CWA-08-2014-0031**
via Vogel Law Firm, Ltd.)
as Registered Agent) **ADMINISTRATIVE ORDER**
P.O. Box 1389) **FOR COMPLIANCE**
Fargo, ND 58107)
)
Respondent.) Proceeding under Section 309(a) of the
) Clean Water Act, 33 U.S.C. § 1319(a)

Inspection Type: Stormwater - Construction

Photographs for South Park Comm. Development - unpermitted

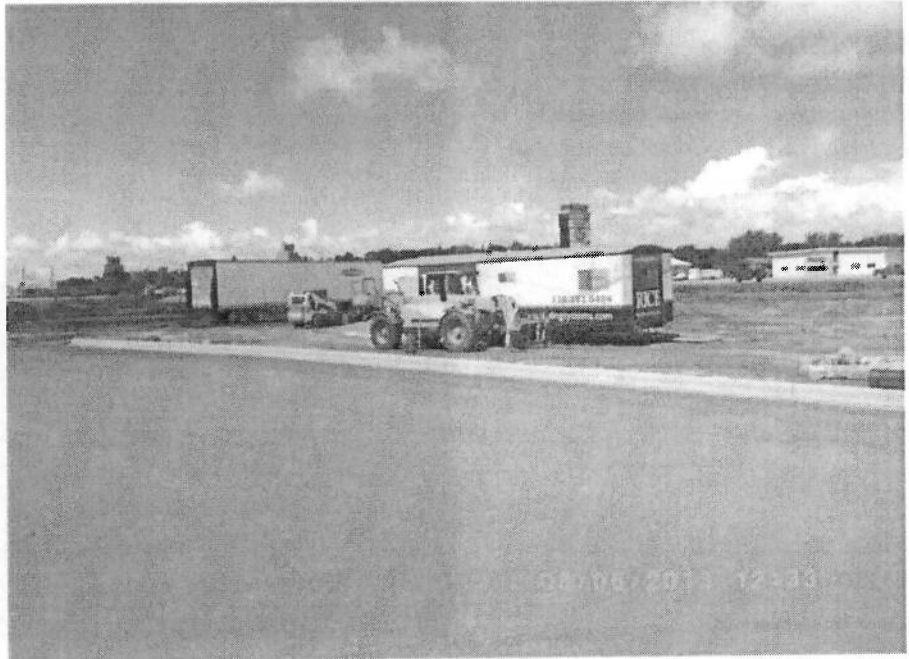
Photo Number 703
Inspection Date 8/6/2013
Photographer Stephanie Gieck
Description Rice Building Systems, Inc. trailer on the north part of the site. Construction storage area.

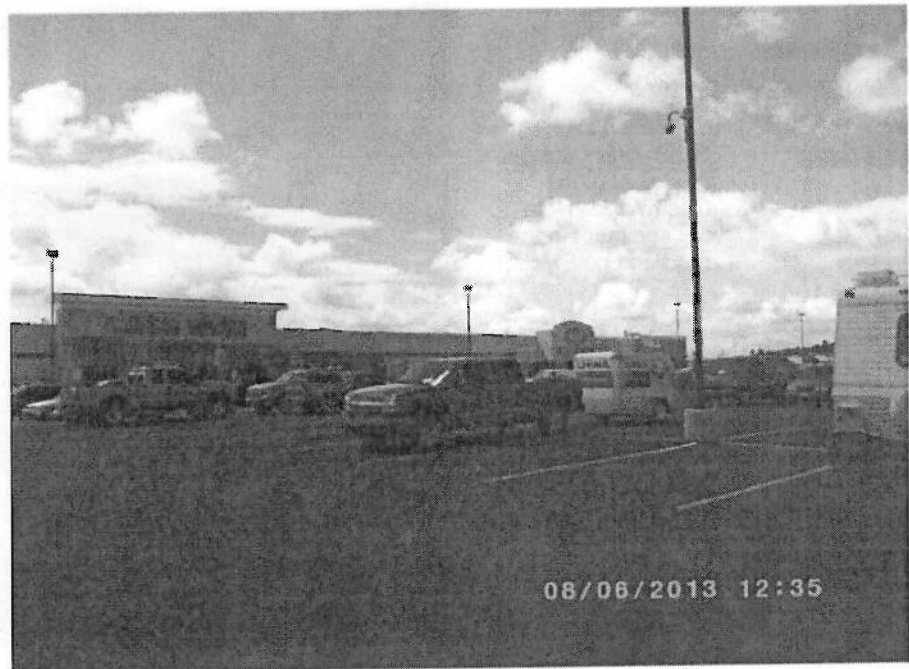
Photo Number 704
Inspection Date 8/6/2013
Photographer Stephanie Gieck
Description Cash Wise Foods and Alco constructed at the site in the central portion.

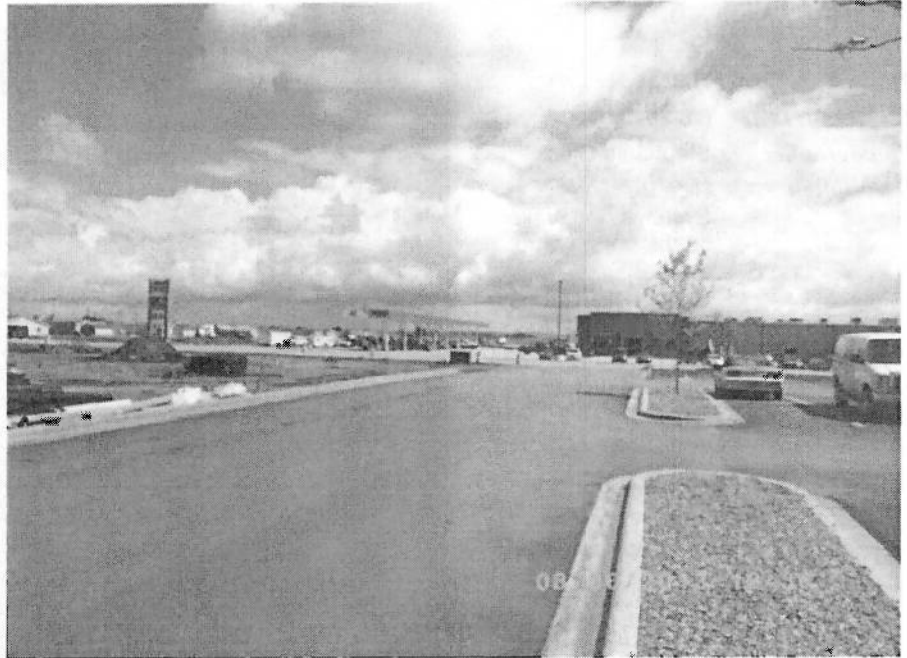
Photo Number 705
Inspection Date 8/6/2013
Photographer Stephanie Gieck
Description Cenex constructed on the northeast corner of the site. Construction storage area.

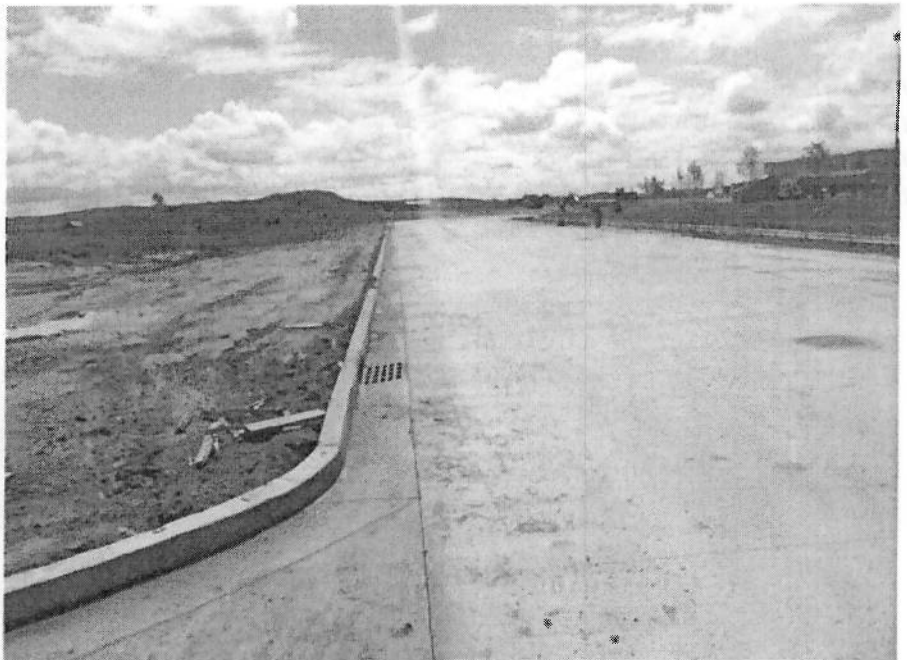
Photo Number 706
Inspection Date 8/6/2013
Photographer Stephanie Gieck
Description Storm drain along a road east of the Cash Wise. Note the sediment in the road and no BMPs.

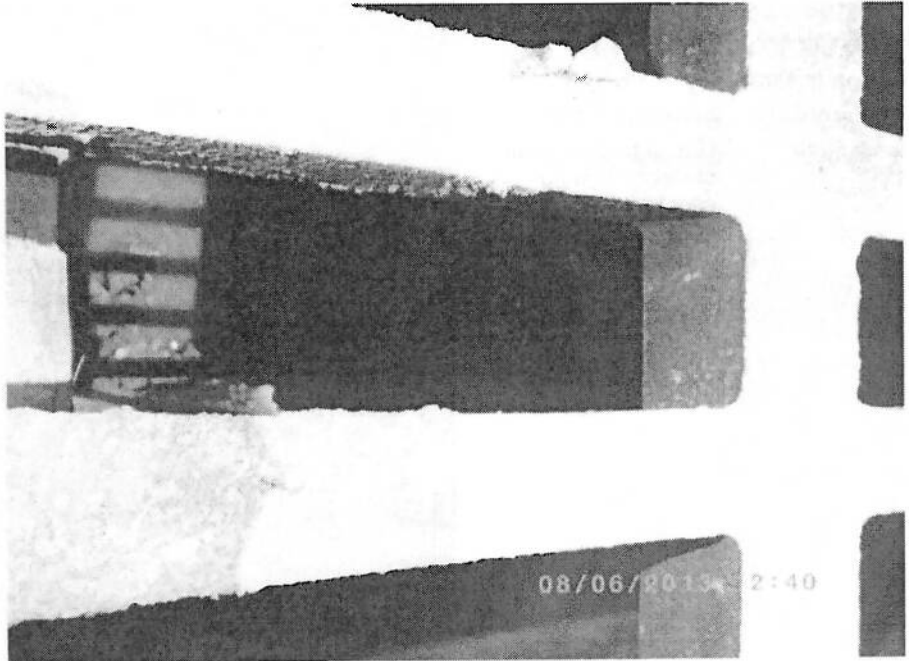
Photo Number 707
Inspection Date 8/6/2013
Photographer Stephanie Gieck
Description View inside the storm drain in photo 706. Note the sediment inside.

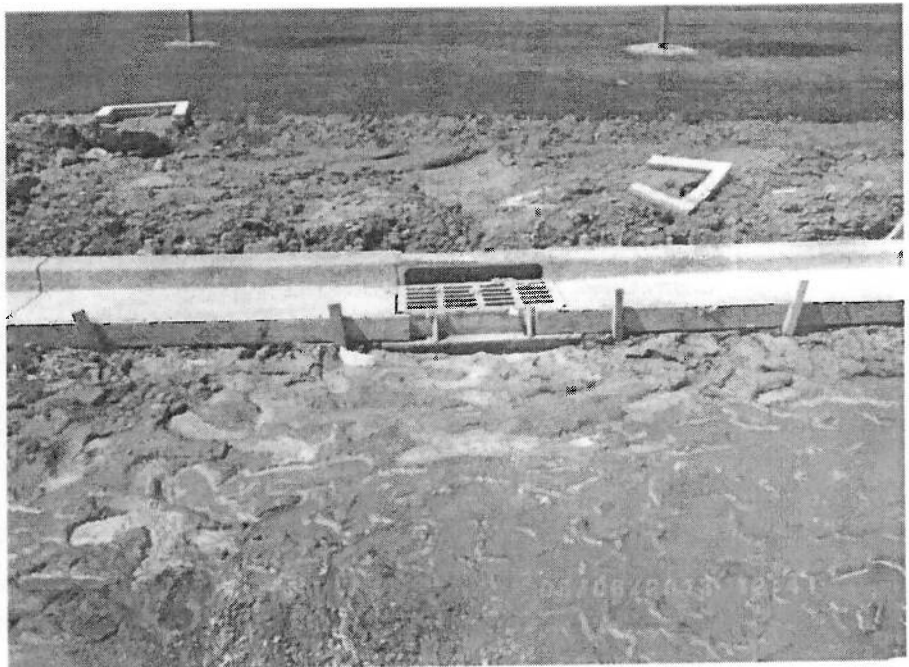
Photo Number 708
Inspection Date 8/6/2013
Photographer Stephanie Gieck
Description New storm drain along a road east of the Cash Wise across from the storm drain in photo 706.

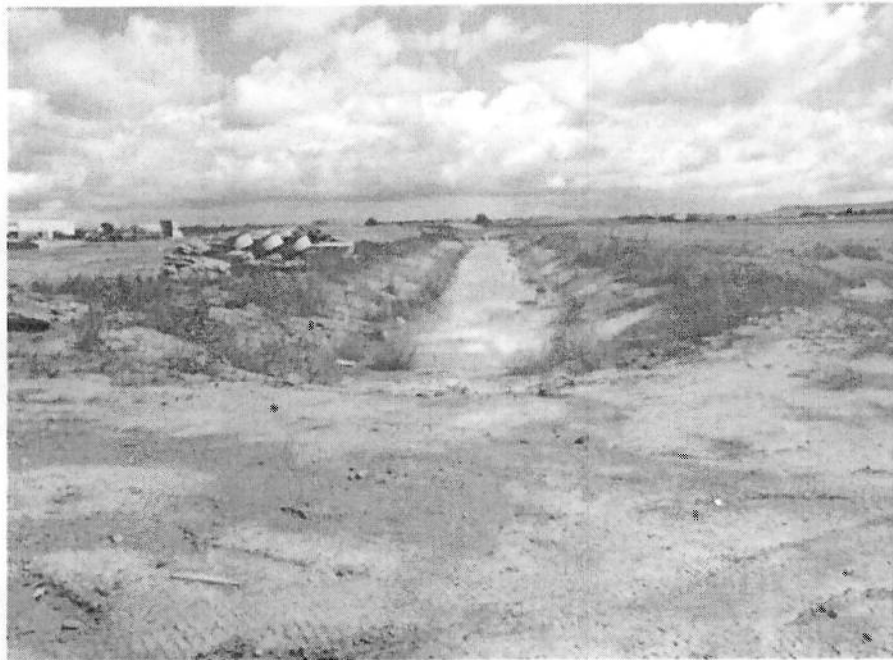
Photo Number 709
Inspection Date 8/6/2013
Photographer Stephanie Gieck
Description Drainage ditch south of Cenex flowing east toward Cherry Creek.

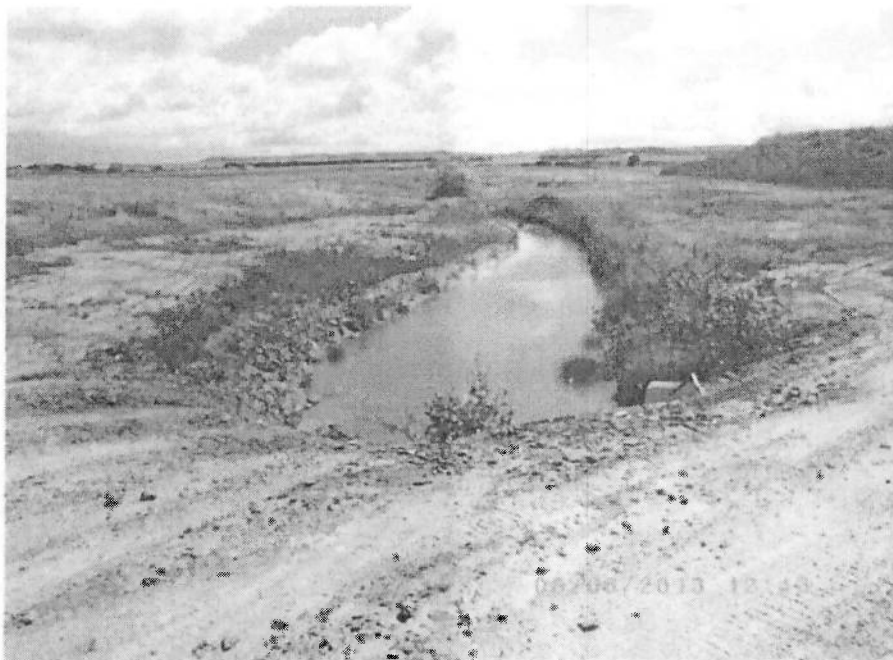
Photo Number 710
Inspection Date 8/6/2013
Photographer Stephanie Gieck
Description Second drainage ditch south of the drainage ditch in photo 709 flowing southeast toward Cherry Creek.

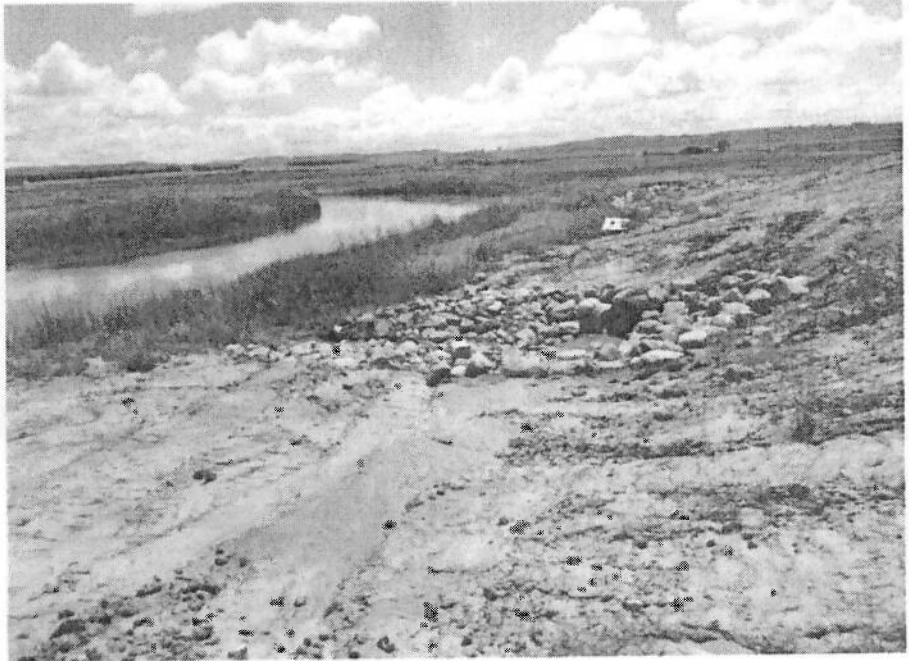
Temporary soil stock piles have effective sediment controls and are not placed in surface waters, including curb and gutter systems? Appendix I.A.4	Y		A soil stockpile observed on the site has a vegetative buffer between the stockpile and a wetland-like area (photo 729).
Is the normal wetted perimeter of any temporary or permanent drainage ditch that drains water from the site or diverts water around the site, is stabilized within 200 lineal feet from the property edge, or from the point of discharge to any surface water? Stabilization is to occur within 24 hours of connecting to a surface water. Appendix I.A.5		N	The normal wetted perimeter of the two drainage ditches south of the Cenex was not stabilized within 200 feet from the point of discharge to Cherry Creek (photos 709 and 710).
Were pipe outlets provided with temporary or permanent energy dissipation within 24 hours of connection to a surface water? Appendix I.A.6	Y		The drainage ditch outlets had rip rap above Cherry Creek (photo 711).

Photo Number 711
Inspection Date 8/6/2013
Photographer Stephanie Gieck
Description Drainage ditch outlet area for the drainage ditch shown in photo 709 (foreground) and in photo 710 (background). Cherry Creek is on the left. Note the sediment in the rip rap and no BMPs on the disturbed soil in the area.

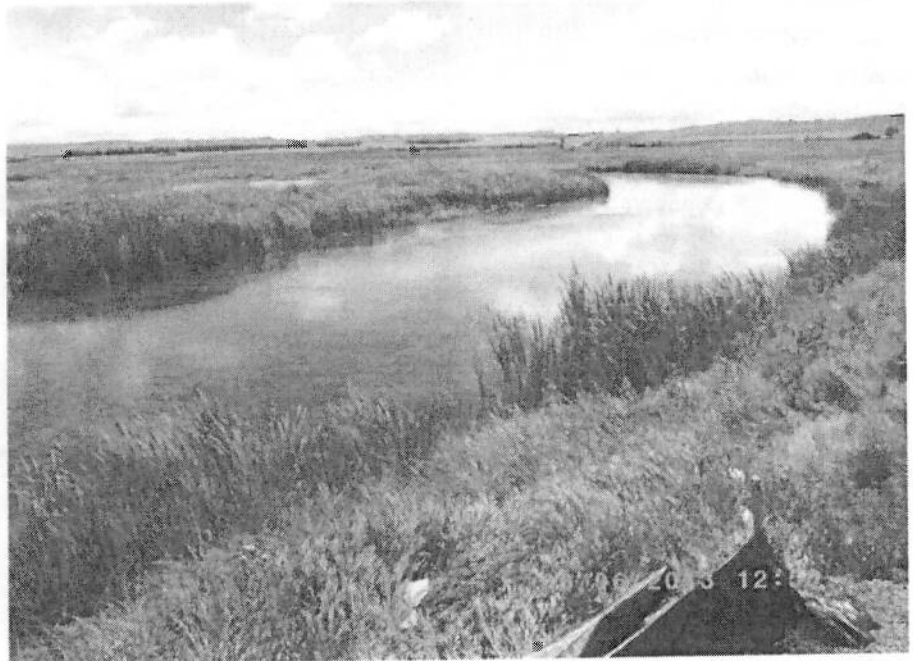
<p>4. Sediment had escaped the site, and off-site sediment had not been removed. The BMPs were not adequate to prevent sediment deposition off-site. Sediment was observed in Cherry Creek (photos 712 and 713). The site had silt fence along the eastern edge of the Cenex property; the silt fence was damaged</p>	<p>Part II.C.3.c of the permit states, “All control measures must be properly selected, installed, and maintained in accordance with the manufacturer’s specifications and good engineering practices. If periodic inspections or other information indicates a control has been used inappropriately, or incorrectly, the permittee must replace or modify the control for site situations. The permittee may deviate from the manufacturer’s specifications and erosion and</p>

Photo Number 712
Inspection Date 8/6/2013
Photographer Stephanie Gieck
Description Sediment was visible in Cherry Creek below the drainage ditch outlet shown in photo 711.

Findings	Permit Requirements, Corrective Actions, Recommended Actions and Additional Information Requested
<p>and had sediment more than halfway up the side of the silt fence in areas. There was sediment that appeared to have flowed under the silt fence into Cherry Creek (photos 713 and 714). Storm drains through the site were unprotected and had sediment inside of them, and sediment track-out was on the roads throughout the site (photos 706, 707, 708, 718, 719, 722, 723, 724, 725, 727, and 728).</p>	<p>sediment control guidelines in Appendix 1 if they provide justification for the deviation and document the rationale for the deviation in the SWPP plan.”</p> <p>Part II.C.3.d of the permit states, “If sediment escapes from the site, off-site accumulations of sediment must be removed in a manner and at a frequency sufficient to minimize off-site impacts. The plan must be modified to prevent further sediment deposition off-site.”</p> <p>Part II.B.5 of the permit states, “Maintenance. All erosion and sediment control measures and other protective measures identified in the plan must be maintained in effective operating condition. The plan must indicate, as appropriate, the maintenance or clean out interval for sediment controls. If site inspections, required in Part III of this permit, identify BMPs that are not operating effectively, maintenance shall be arranged and accomplished as soon as practicable.”</p> <p>Part II.C.3 of the permit states, “The erosion and sediment control plan must conform to the guidelines provided in Appendix 1.”</p> <p>Appendix 1, Part I.B.4 of the permit states, “If sediment escapes the construction site, off-site accumulations of sediment must be removed in a manner and at a frequency sufficient to minimize off-site impacts (e.g., fugitive sediment in streets could be washed into storm sewers by the next rain and/or pose a safety hazard to users of public streets).”</p> <p>Corrective Actions: Remove sediment in a manner and at a frequency sufficient to minimize off-site impacts, and address this in the SWPP plan in accordance with permit requirements. Ensure the SWPP plan prevents further sediment deposition off-site, and ensure all control measures are properly selected, installed, and maintained in effective operating</p>

Findings	Permit Requirements, Corrective Actions, Recommended Actions and Additional Information Requested
	condition. Implement the SWPP plan.
<p>5. No sediment basin or equivalent sediment control was observed on-site. More than 10 acres drain through the drainage ditches observed on-site.</p>	<p>Part II.C.3 of the permit states, "The erosion and sediment control plan must conform to the guidelines provided in Appendix 1."</p> <p>Appendix 1, Part I.A of the permit states, "Temporary (or permanent) sediment basins, or equivalent control, must be provided where ten (10) or more acres of disturbed area drain to a common location prior to the runoff leaving the site or entering surface waters. The permittee is encouraged, but not required, to install temporary sediment basins where appropriate in areas with steep slopes or highly erodible soils even if less than ten (10) acres drains to one area. The basins must provide at least the following:</p> <p>The basins shall be sized to provide 3,600 cubic feet of storage below the outlet pipe per acre drained to the basin. Alternative designs may be used which provide storage below the outlet for a calculated volume of runoff from a 2 year, 24 hour storm and provides not less than 1800 cubic feet of storage below the outlet pipe from each acre drained to the basin.</p> <p>Basin outlets must be designed to avoid short-circuiting and the discharge of floating debris. The basin must be designed with the ability to allow complete basin drawdown (e.g., perforated riser pipe wrapped with filter fabric and covered with crushed gravel, pumps or other means) for maintenance activities. The drawdown should be designed to release the storage volume in a 24 hour or longer period. The basin must have a stabilized emergency overflow to prevent failure of pond integrity. Energy dissipation must be provided for the basin outlet.</p> <p>2. Where the temporary sediment basin is not practical due to site limitations or nature of disturbance (such as developing a roadway, pipeline,</p>

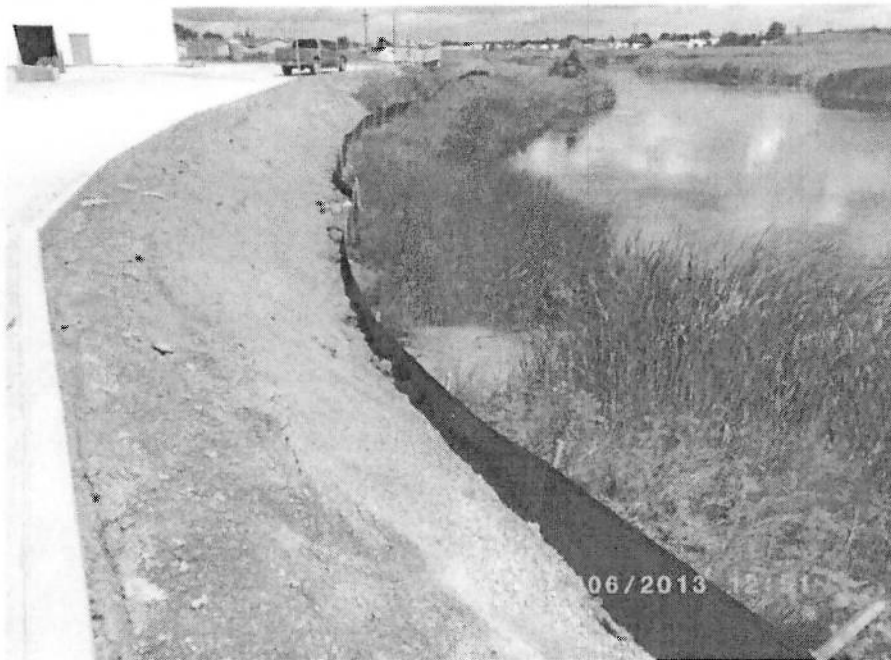
SWPP Plan Implementation (Site review)							
Structural and Stabilization Practices							
List and describe structural and stabilization practices							
	SWPP Plan / Site Map			Used On-Site			Comments
Silt Fence			N/A	Y			The site had silt fence along the eastern edge of the Cenex property; the silt fence was damaged and had sediment more than halfway up the side of the silt fence in areas. There was sediment that appeared to have flowed under the silt fence into Cherry Creek (photos 713 and 714).
Sedimentation pond			N/A		N

Are control devices similar to silt fence or fiber rolls repaired, replaced or supplemented within 24 hours of discovery when they become nonfunctional or the sediment reaches 1/3 of the height of the device? Appendix 1.B.1		Un-known	The site had silt fence along the eastern edge of the Cenex property; the silt fence was damaged and had sediment more than halfway up the side of the silt fence in areas. There was sediment that appeared to have flowed under the silt fence into Cherry Creek (photos 713 and 714).

Photo Number 713
Inspection Date 8/6/2013
Photographer Stephanie Gieck
Description View along the east side of the Cenex property. Cherry Creek is on the right. Note the sediment in the creek that flowed under the silt fence and the sediment is more than 1/3 the height of the silt fence.

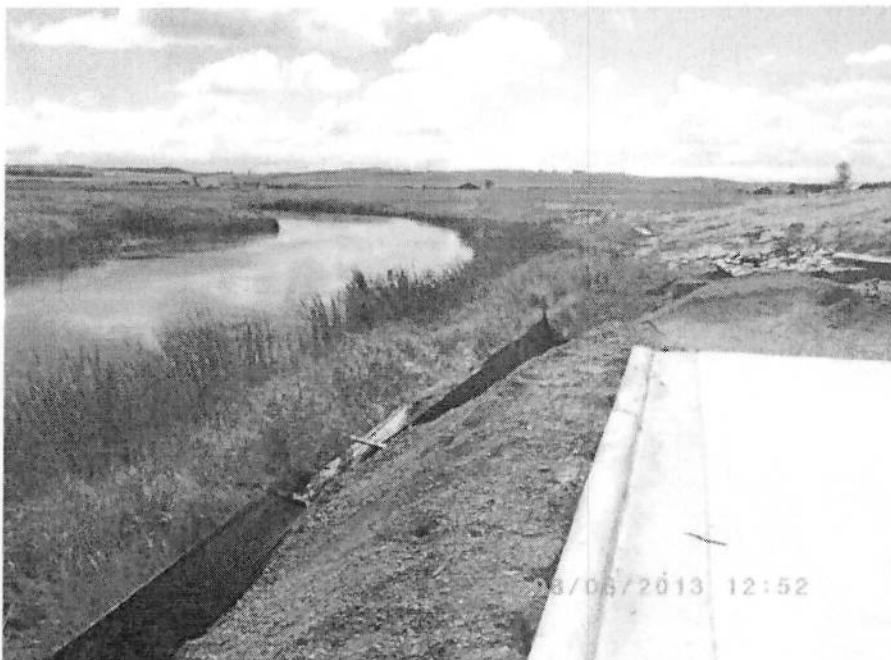
Photo Number 714
Inspection Date 8/6/2013
Photographer Stephanie Gieck
Description View to the south along Cherry Creek showing broken silt fence.

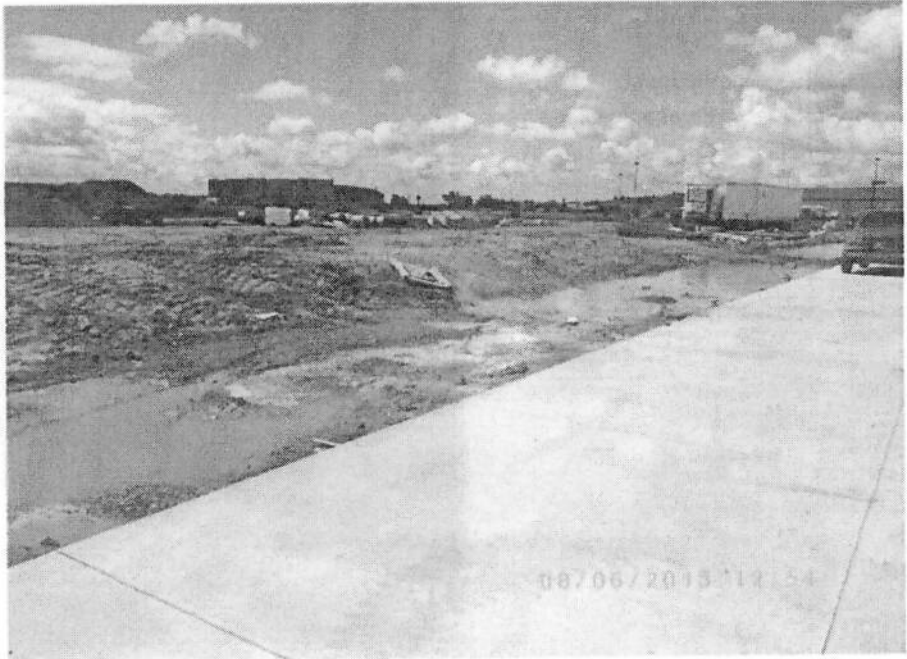
Concrete wash out was visible on the ground in multiple areas south of the Cenex (photos 715 and 717) and inside one storm drain (photo 725). A spilled substance was observed west of the hotel under construction (photo 726). An equipment storage area was located south of the Cenex (photo 716), on the north central portion of the site by the Rice Building Systems, Inc. trailer (photos 703 and 705), and near the hotels on the south side of the site (photo 721).

Concrete washout area			N/A		N	Concrete wash out was visible on the ground in multiple areas south of the Cenex (photos 715 and 717) and inside one storm drain (photo 725).
Port-o-lets			N/A	Y		Port-o-lets were observed on-site.

Photo Number 715
Inspection Date 8/6/2013
Photographer Stephanie Gieck
Description Concrete washout
on the ground south
of the Cenex.

Findings	Permit Requirements, Corrective Actions, Recommended Actions and Additional Information Requested
	<p>the site by wind or water. Collected material shall be taken to the appropriate facility for disposal or recycling.</p> <p>2. Concrete wash water shall not be discharged to any waters of the state, storm sewer systems or allowed to drain onto adjacent properties. Wash water disposal must be limited to a defined area of the site or to an area designated for cement washout. The area(s) must be sufficient to contain the wash water and residual cement.”</p> <p><u>Corrective Actions:</u> Address these issues in the SWPP plan in accordance with permit requirements, and implement the SWPP plan.</p>
<p>3. The normal wetted perimeter of the two drainage ditches south of the Cenex was not stabilized within 200 feet from the point of discharge to Cherry Creek (photos 709 and 710).</p>	<p>Part II.C.3 of the permit states, “The erosion and sediment control plan must conform to the guidelines provided in Appendix 1.”</p> <p>Appendix 1, Part A.5 of the permit states, “The normal wetted perimeter of any temporary or permanent drainage ditch that drains water from a construction site, or diverts water around a site, must be stabilized at least 200 lineal feet from the property edge, or from the point of discharge to any surface water. Stabilization should be completed within 24 hours of connecting to a surface water.”</p> <p><u>Corrective Actions:</u> Stabilize the normal wetted perimeter of the drainage ditches and address this in the SWPP plan in accordance with permit requirements.</p>

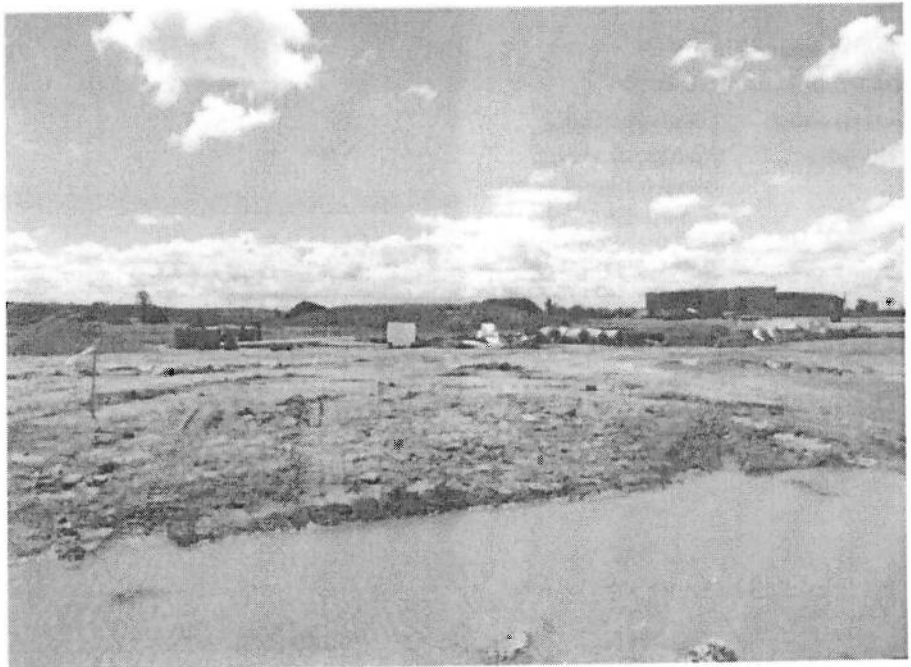
Photo Number 716
Inspection Date 8/6/2013
Photographer Stephanie Gieck
Description Equipment storage
south of the Cenex.

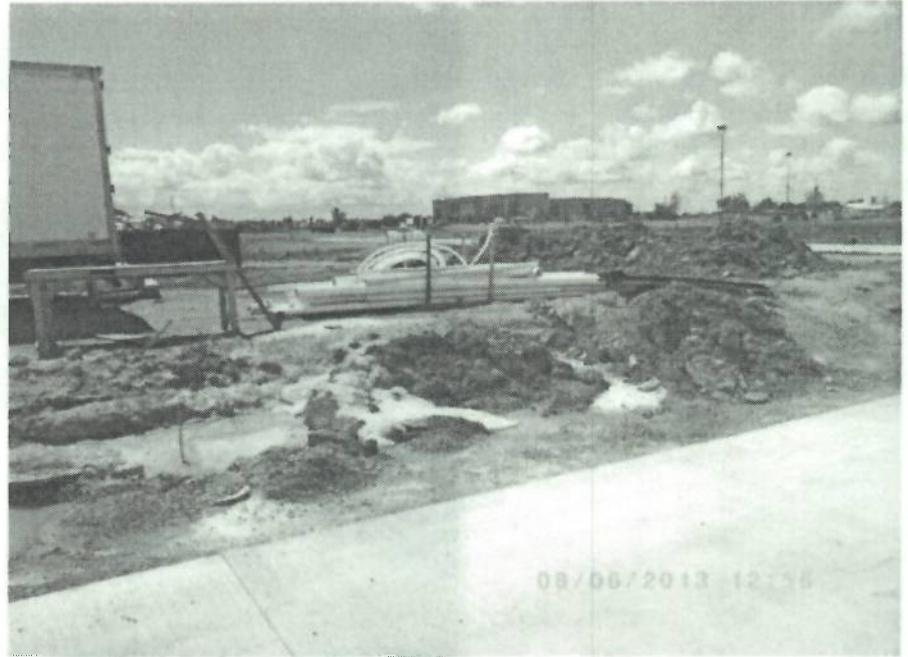
Photo Number 717
Inspection Date 8/6/2013
Photographer Stephanie Gieck
Description Concrete washout on the ground south of the Cenex.

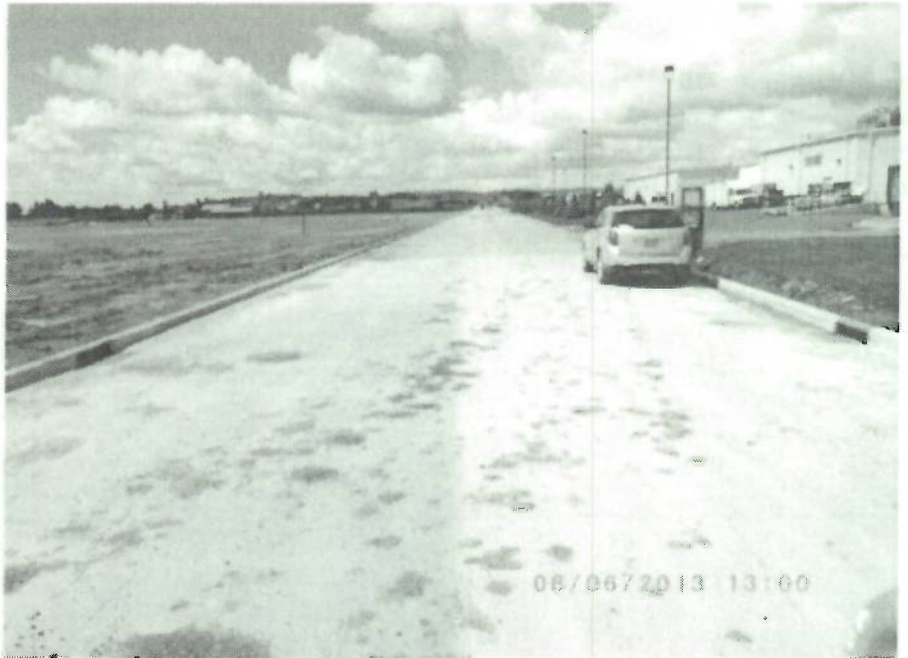
Photo Number 718
Inspection Date 8/6/2013
Photographer Stephanie Gieck
Description Two storm drains along the road south of the Cash Wise. Note there are no BMPs and there is sediment in the road.

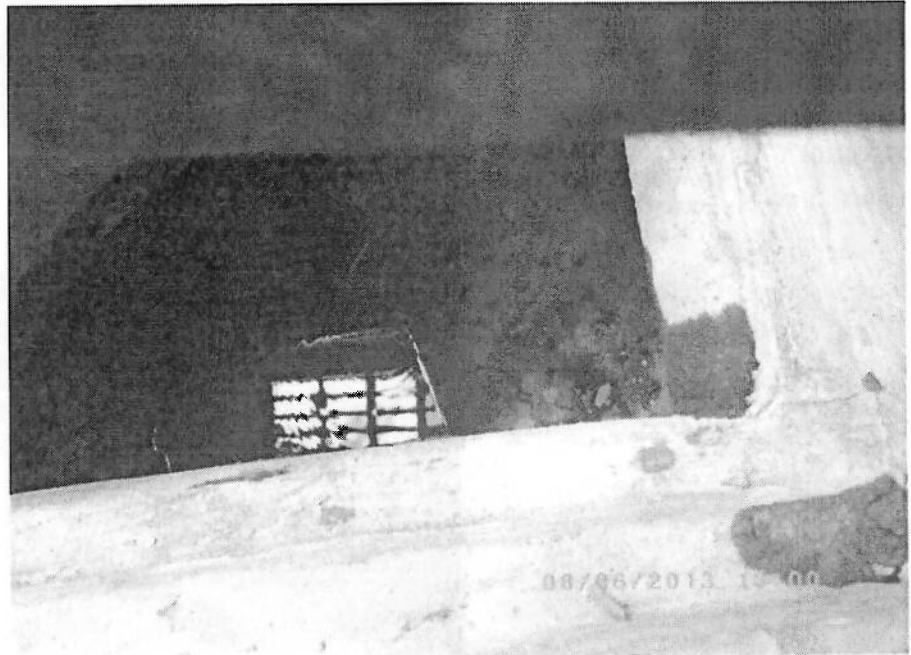
Photo Number 719
Inspection Date 8/6/2013
Photographer Stephanie Gieck
Description View inside the storm drain on the right in photo 718. Note the sediment inside.

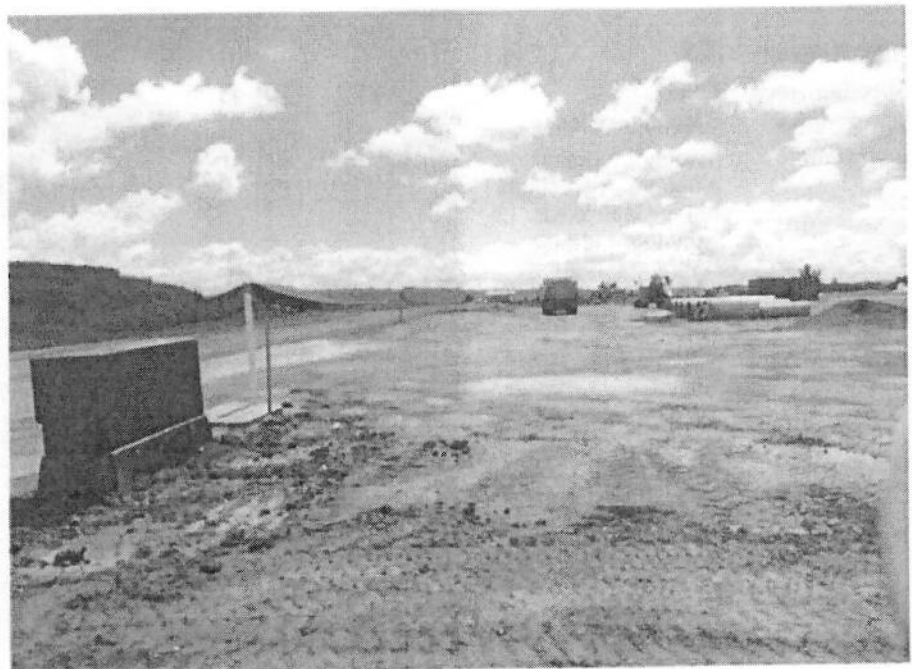
Photo Number 720
Inspection Date 8/6/2013
Photographer Stephanie Gieck
Description View south of the Cash Wise.

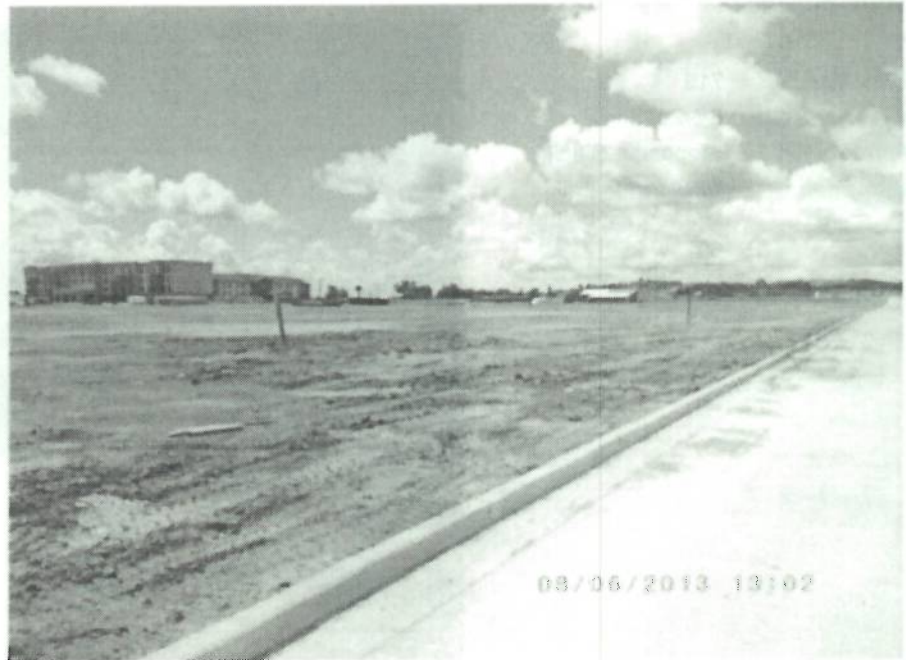
Photo Number 721
Inspection Date 8/6/2013
Photographer Stephanie Gleck
Description View southwest of the Cash Wise. Equipment storage by the hotels.

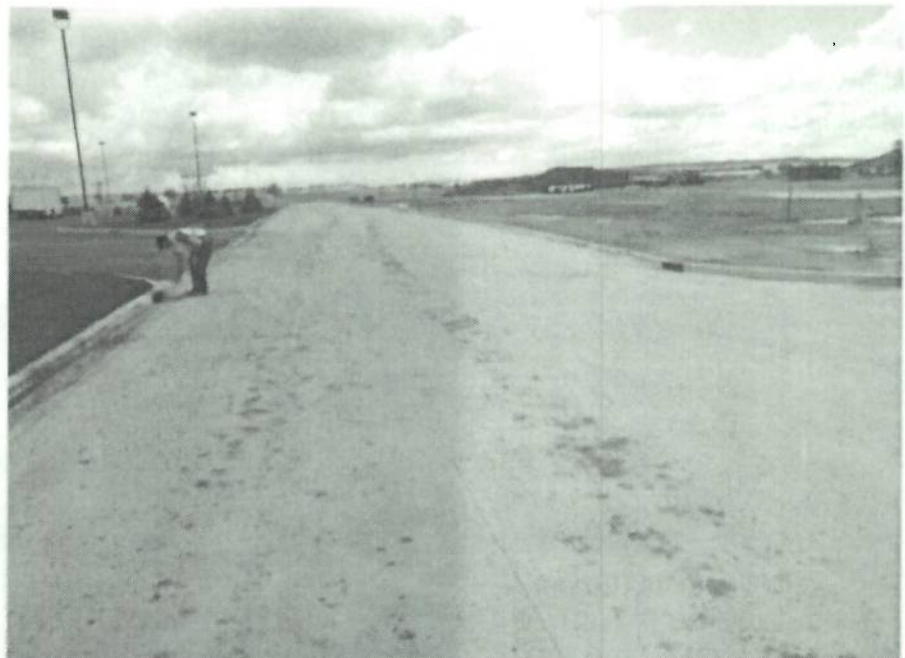
Photo Number 722
Inspection Date 8/6/2013
Photographer Stephanie Gleck
Description Two storm drains along the road south of the Cash Wise. Note there are no BMPs and there is sediment in the road.

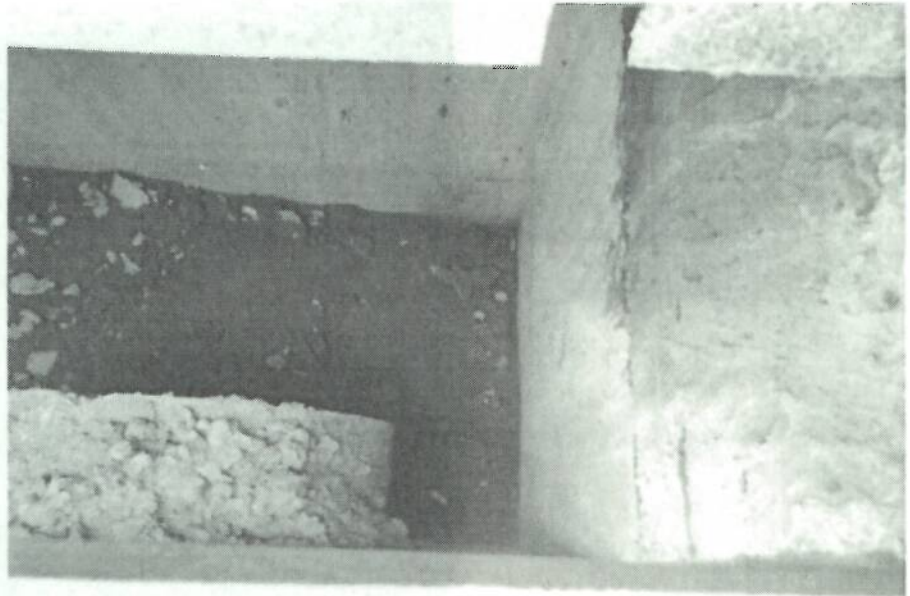
Photo Number 723
Inspection Date 8/6/2013
Photographer Stephanie Gieck
Description View inside the storm drain on the right in photo 722. Note the sediment inside.

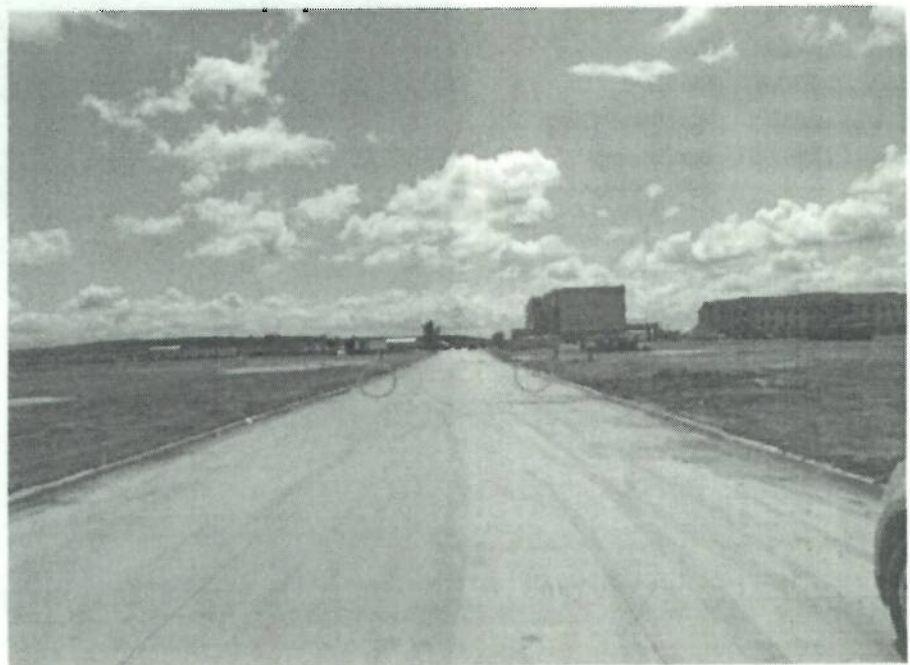
Photo Number 724
Inspection Date 8/6/2013
Photographer Stephanie Gieck
Description View east of the Cash Wise. There are two storm drains, one on each side of the road, inside of the red circles. Note there are no BMPs and there is sediment in the road.

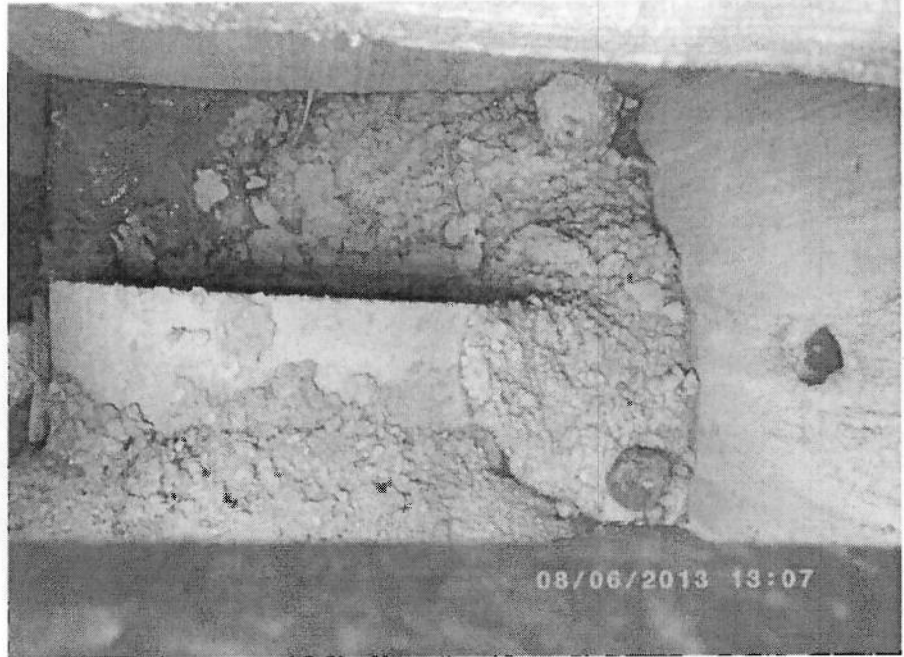
Photo Number 725
Inspection Date 8/6/2013
Photographer Stephanie Gieck
Description View inside the storm drain on the right in photo 725. Note the sediment and concrete washout inside.

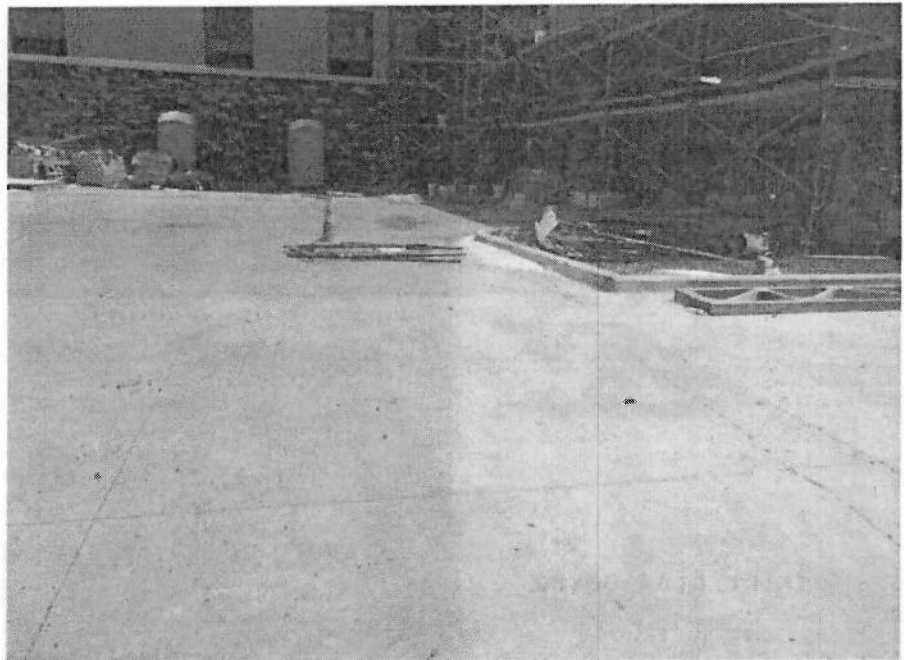
<p>2. The following housekeeping and waste management issues were identified:</p> <p>a. A spilled substance was observed west of the hotel under construction (photo 726), and trash was observed on a storm drain near the hotels (photo 728); and</p> <p>b. Concrete wash out was visible on the ground in multiple areas south of the Cenex (photos 715 and 717) and inside one storm drain (photo 725).</p>	<p>Part II.C.2.b of the permit states, “Good housekeeping practices to maintain a clean and orderly site. Litter, debris, chemicals and parts must be handled properly to minimize the exposure to stormwater.”</p> <p>Part II.C.2.f of the permit states, “Concrete wash water, grindings and slurry, shall not be discharged to waters of the state, storm sewer systems or allowed to drain onto adjacent properties.”</p> <p>Part II.C.3 of the permit states, “The erosion and sediment control plan must conform to the guidelines provided in Appendix 1.”</p> <p>Appendix 1, Part C of the permit states: “1. Properly handle construction debris and waste materials. Provide appropriate container(s) on site (or centrally located at several sites) for storing debris and other wastes until disposal. Litter and debris shall be picked-up regularly to reduce the chance for materials to be carried off</p>

Photo Number 726
Inspection Date 8/6/2013
Photographer Stephanie Gieck
Description Spill of white substance on the east side of a hotel being built on the south end of the site.

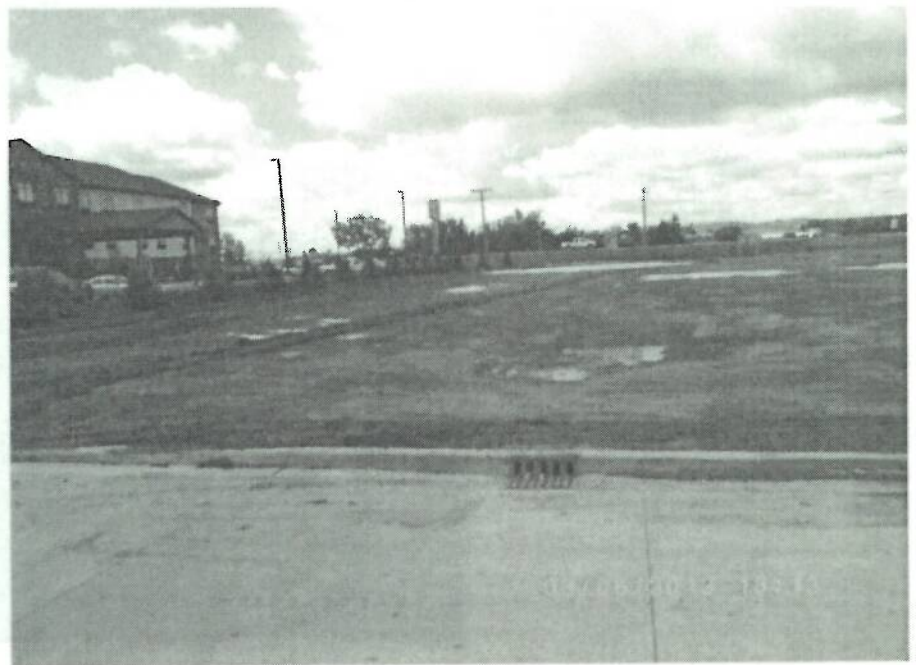
Photo Number 727
Inspection Date 8/6/2013
Photographer Stephanie Gieck
Description Storm drain west of a hotel being built on the south end of the site. Note the sediment in the road and lack of BMPs around the storm drain.

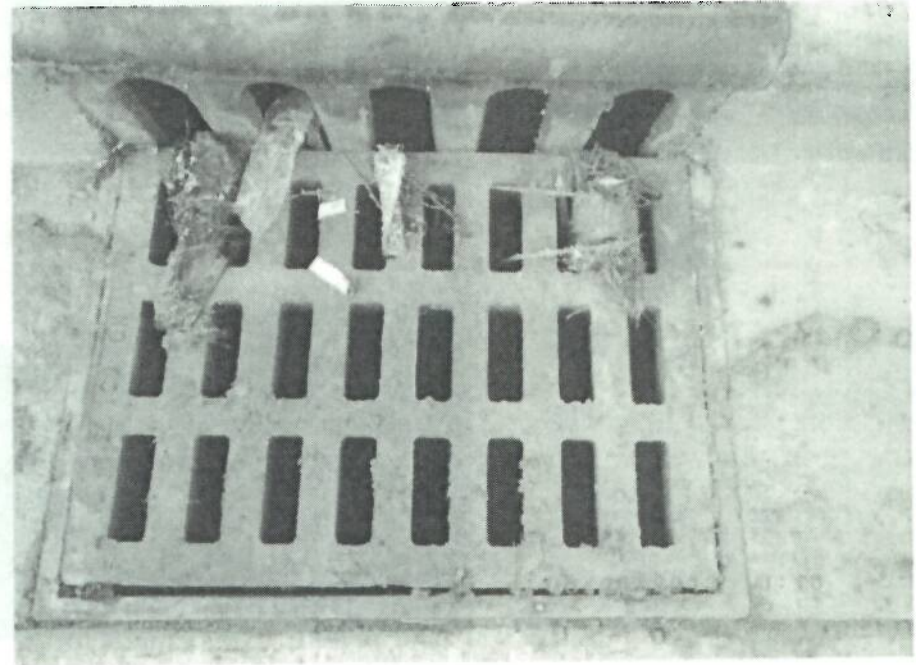
Photo Number 728
Inspection Date 8/6/2013
Photographer Stephanie Gieck
Description Close-up of storm drain in photo 727. Note the trash and sediment.

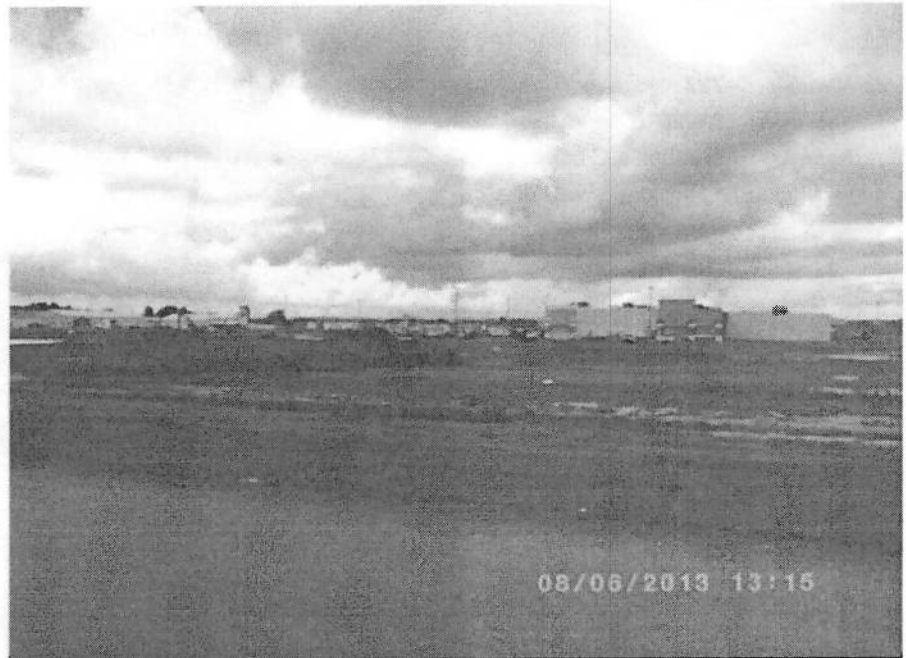
Photo Number 729
Inspection Date 8/6/2013
Photographer Stephanie Gieck
Description View of the west side of the site looking north.

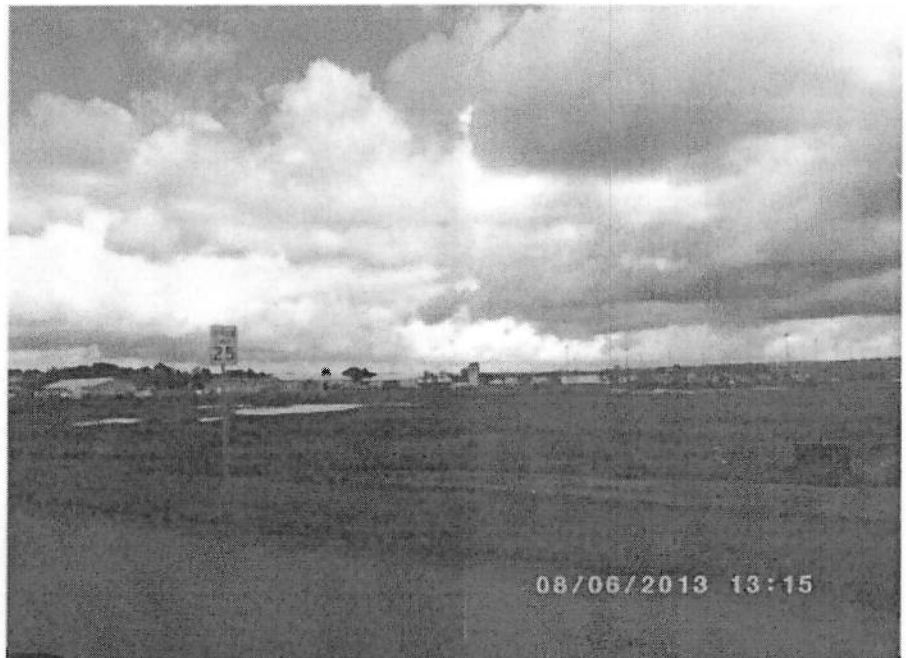
Photo Number 730
Inspection Date 8/6/2013
Photographer Stephanie Gieck
Description View of the west side of the site looking north. Note standing water and the wetland-like vegetation.

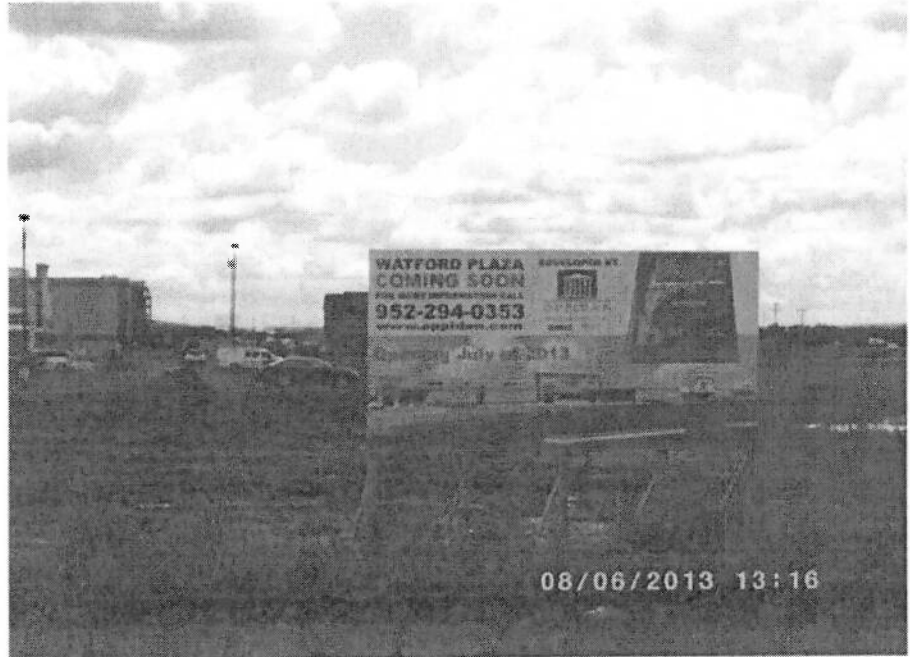
Photo Number 731
Inspection Date 8/6/2013
Photographer Stephanie Gieck
Description Watford Plaza sign on the north side of the site.
