DOCKET NO.: CWA-08-2014-0007

Re: NPDES Permit No. COR03K161 Inspection Report and Notice of Proposed Expedited Settlement Agreement

Water Compliance Inspection Report

Photographs for Windsor Meadows Apartments COR03K161

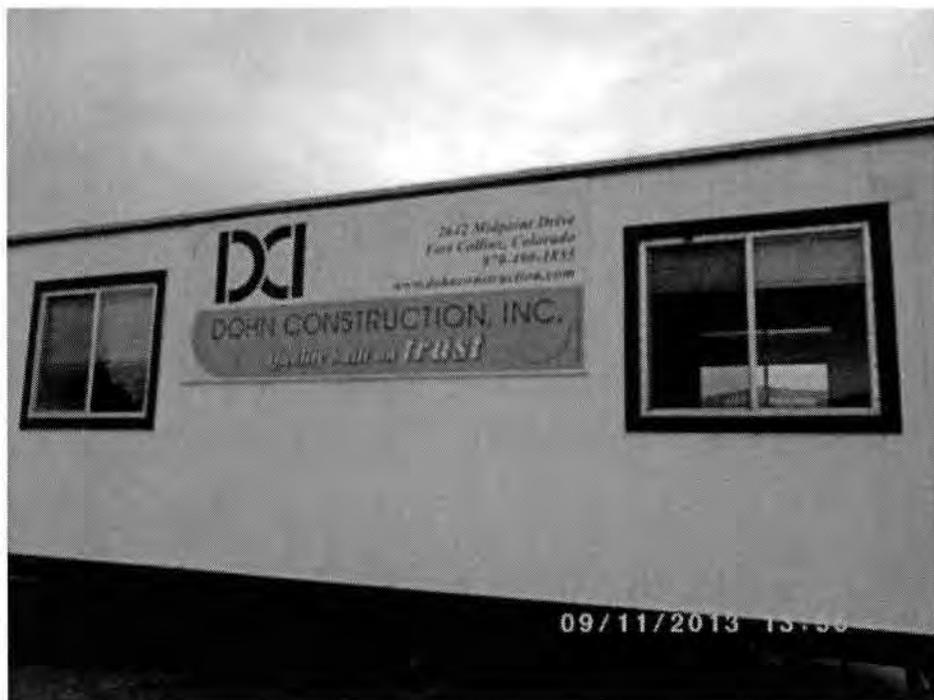
Photo Number 742
Inspection Date 9/11/2013
Photographer N. Davis
Description The site trailer sign at Windsor Meadow Apartments.

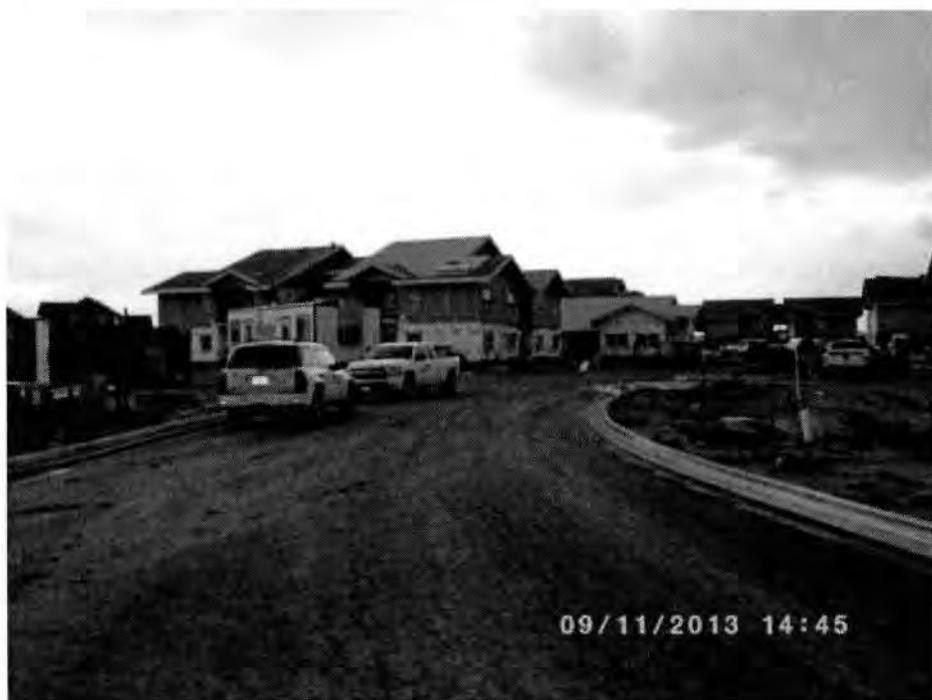
Photo Number 744
Inspection Date 9/11/2013
Photographer N. Davis
Description Overview of site. Photo is facing northwest. Note excessive sediment in road.

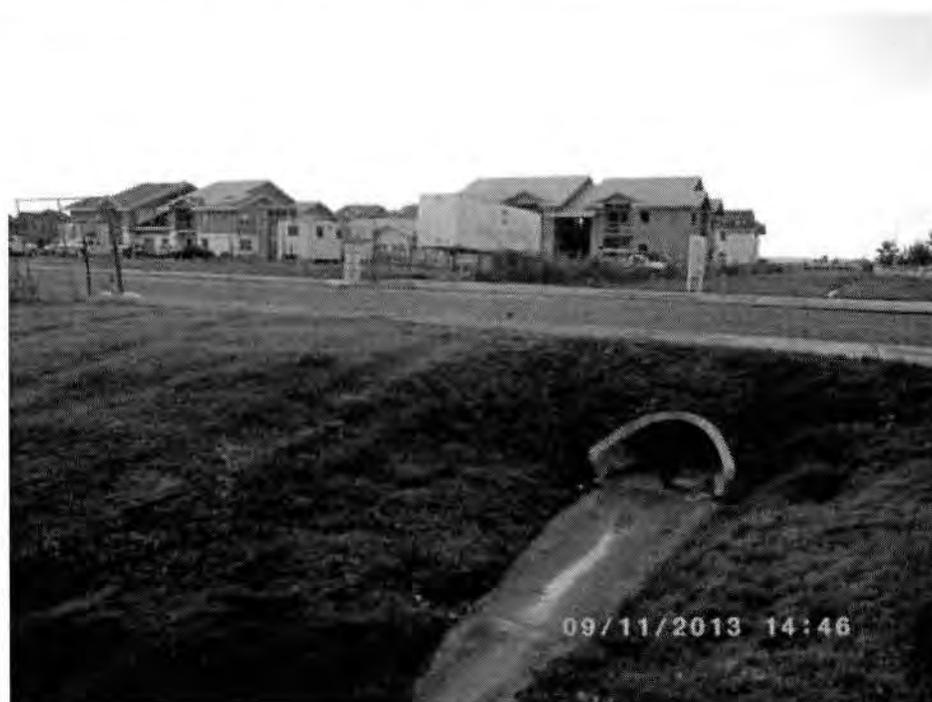
Photo Number 745
Inspection Date 9/11/2013
Photographer N. Davis
Description Outfall from eastern side of the site goes to the culvert under Tipton Drive. Photo is facing north.

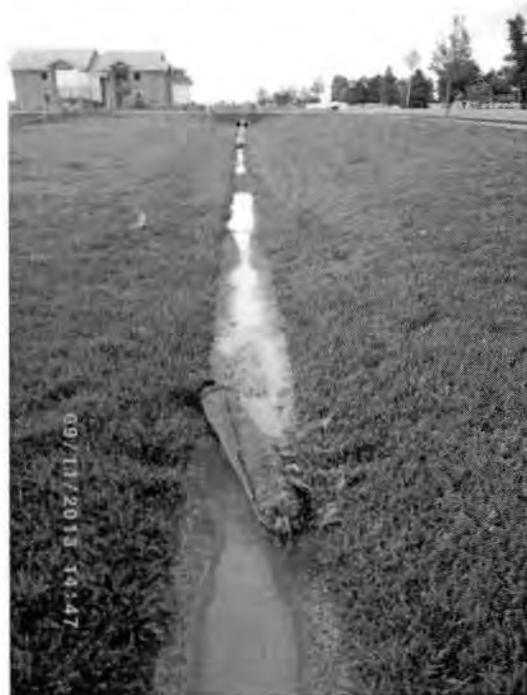
Photo Number 746
Inspection Date 9/11/2013
Photographer N. Davis
Description Rock socks and sediment in outfall downstream from photo 745. Photo is facing north. Note one rock sock had a hole and the rocks were spilling out of the bag. Sediment had accumulated around the rock socks and needed to be cleaned out.

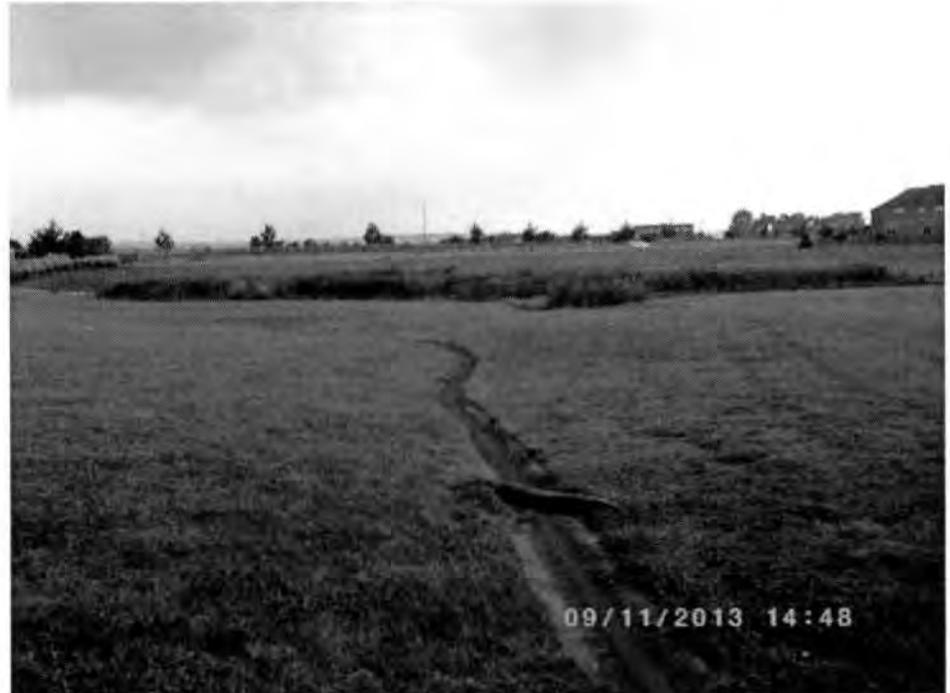
Photo Number 747
Inspection Date 9/11/2013
Photographer N. Davis
Description Receiving water downstream of from photo 746. Photo is facing south.

SWMP Implementation (Site review)							
<u>Structural and Stabilization Practices</u>							
List and describe structural and stabilization practices							
	SWMP/Site Map			Used On-Site			Comments
Silt Fence (perimeter)	Y			Y			The silt fence was knocked down at several points around the perimeter of the construction site (photos 749, 753, 754, 755, and 759). The silt fence was in need of maintenance.
Storm drain inlet protection		N			N		There were inlets close to the construction site that did not have BMP controls (photos 751, 752, 768, 769 and 773). Stormwater with sediment from the construction site was entering the inlets at the time of the inspection (photos 766 to 773).
Straw Wattles	Y			Y			The silt fence on the northeastern boundary of the site was removed and replaced with straw wattles. However, wattles were not staked or trenched into the ground (photos 760, 761 and 762).
Rock Socks	Y			Y			One rock sock had a hole and the rocks were spilling out of the bag. Sediment had accumulated around the rock socks and needed to be cleaned out (photos 746 and 747).

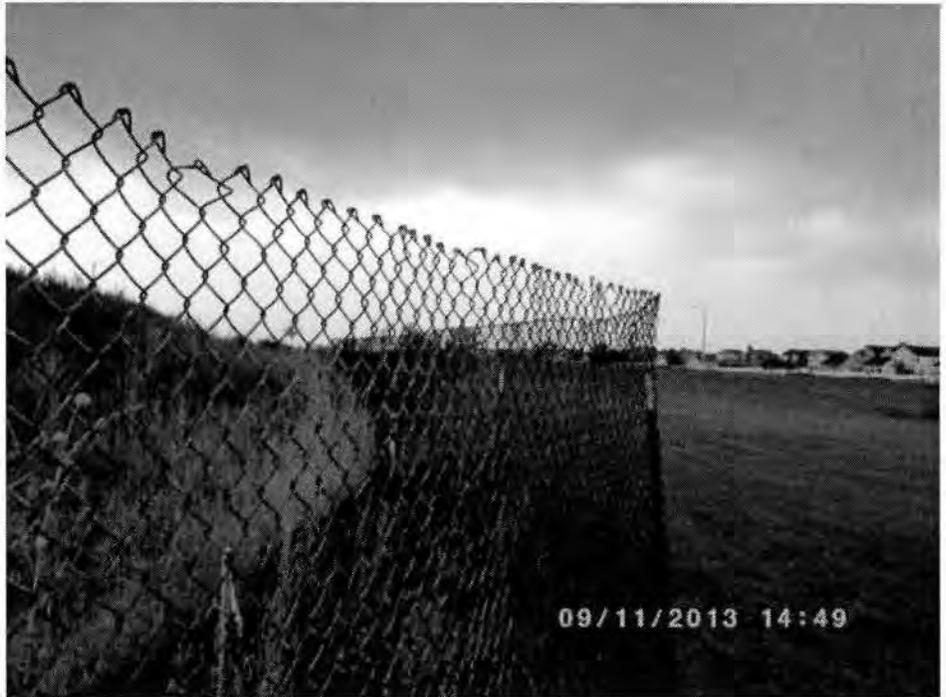
Photo Number 748
Inspection Date 9/11/2013
Photographer N. Davis
Description Stockpiles on southern section of site with silt fence along the perimeter of the site. Photo is facing east.

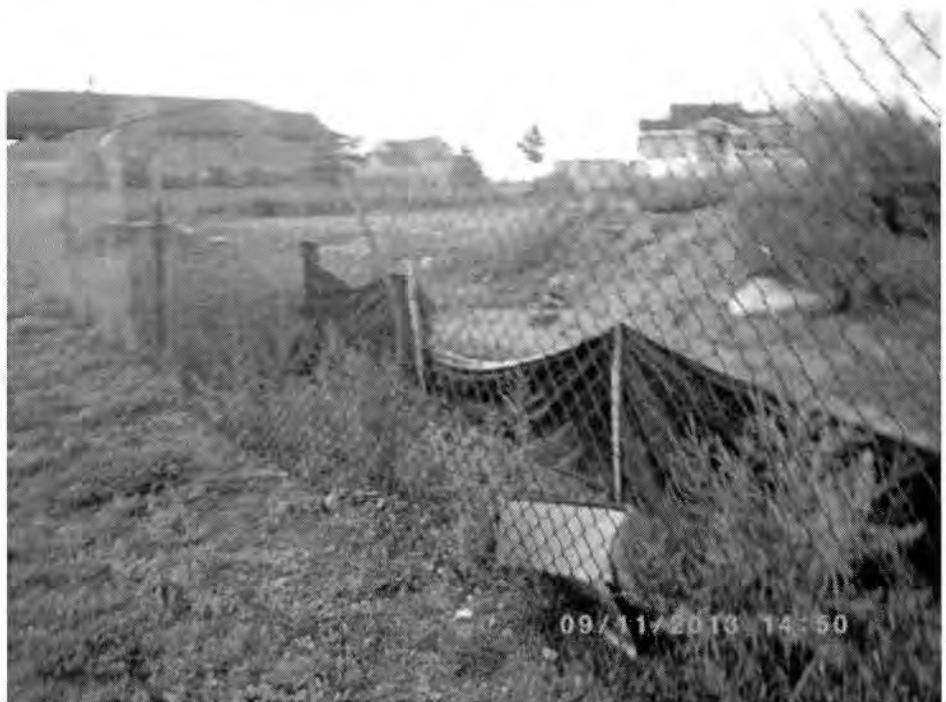
Photo Number 749
Inspection Date 9/11/2013
Photographer N. Davis
Description Silt fence on southwestern section of site was knocked down.

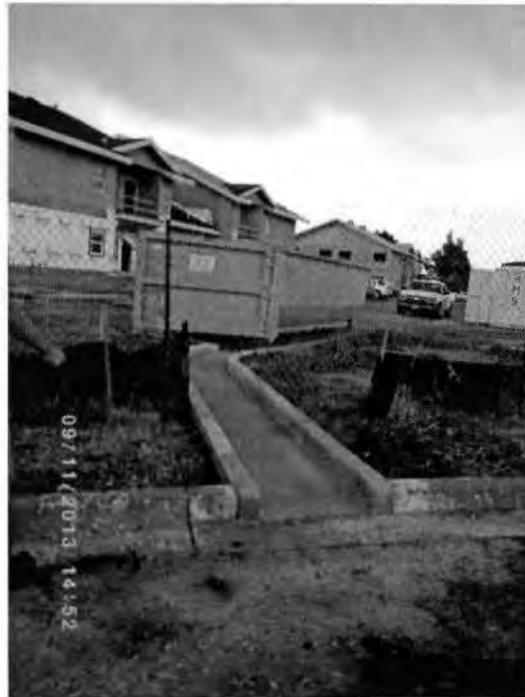
Photo Number 750
Inspection Date 9/11/2013
Photographer N. Davis
Description Stormwater outlet on western section of site. Note this outlet does not have BMPs. Photo is facing east.

B Maintenance not performed prior to next anticipated storm event (count each failure to select, install, maintain each BMP as one violation)	was a stormwater outlet on western section of site that did not have BMPs (photos 750). When it started raining stormwater with sediment was discharge from this outlet into the Millfleet Drive and into the storm water inlet (photos 770, 771, 772 and 773).	CO CGP I.D.7 & I.D.8				\$250.00	=	
43	When sediment escapes the site, it is not removed at a frequency necessary to minimize off-site impacts		CO CGP N/A				\$500.00	=	
44	Litter, construction debris, and construction chemicals exposed to storm water are not prevented from becoming a pollutant source (e.g. screening outfalls, pickup daily, etc.)		CO CGP I.C.3.c.4				\$500.00	=	
45	Stabilization measures are not initiated as soon as practicable on portions of the site where construction activities have temporarily or permanently ceased within 14 days after such cessation		CO CGP N/A				\$500.00	=

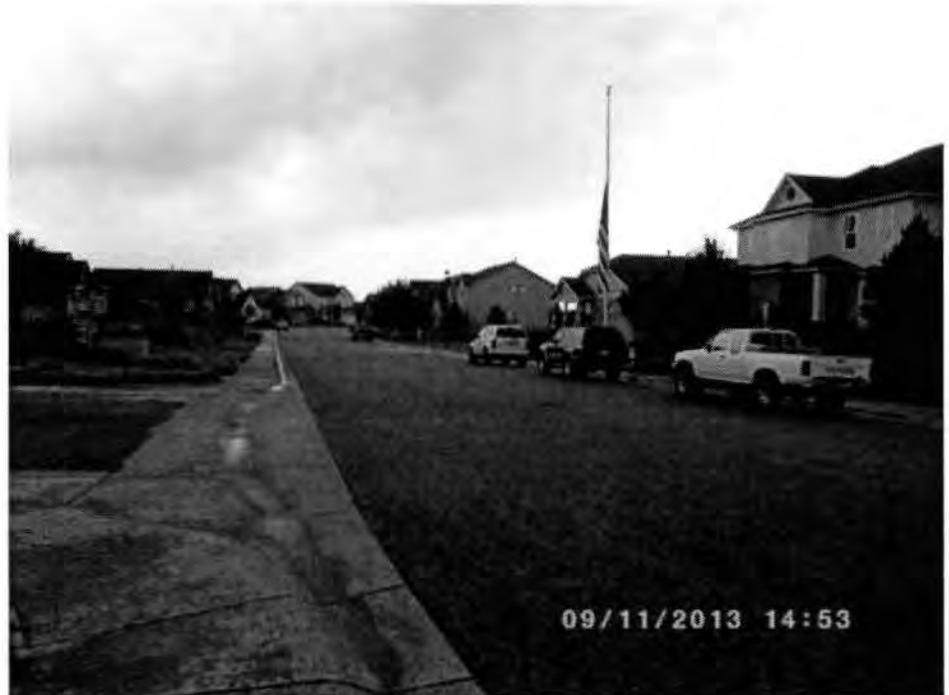
Photo Number 751
Inspection Date 9/11/2013
Photographer N. Davis
Description Overview of inlets on Millfleet Drive. Photo is facing southwest. These inlets did not have BMPs.

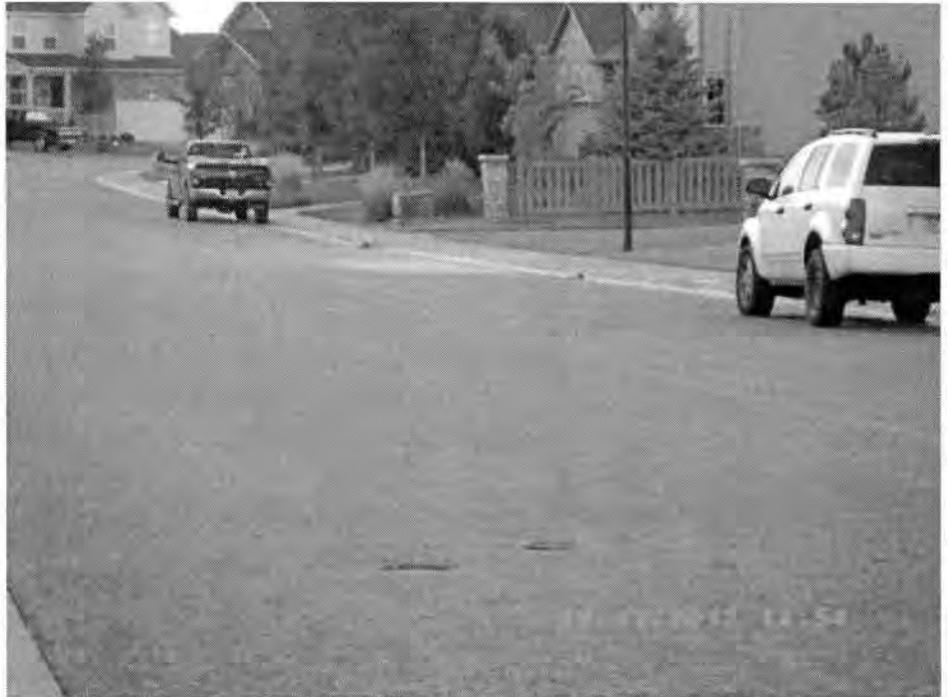
Photo Number 752
Inspection Date 9/11/2013
Photographer N. Davis
Description Close up of inlets in photo 751. Photo is facing west.

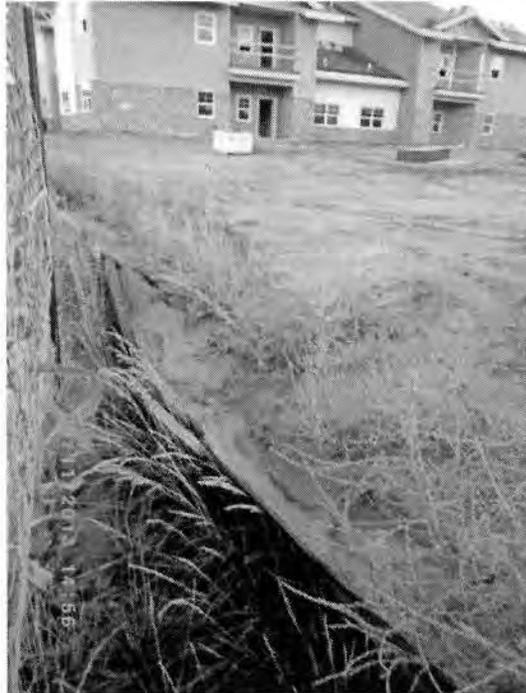
Photo Number 753
Inspection Date 9/11/2013
Photographer N. Davis
Description Damaged silt fence on the western perimeter along Millfleet Drive.

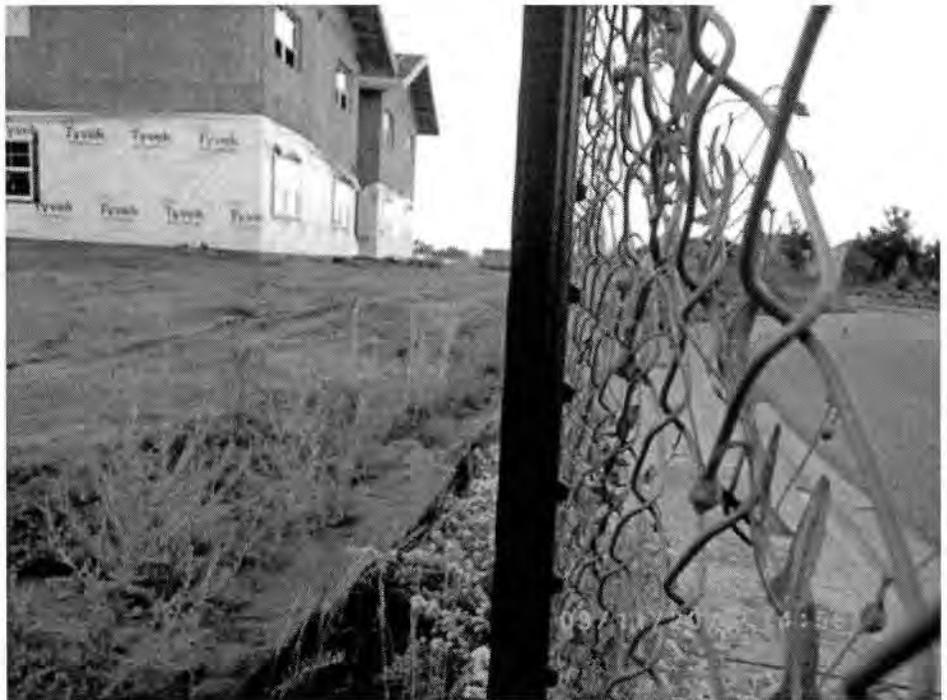
Photo Number 754
Inspection Date 9/11/2013
Photographer N. Davis
Description Damaged silt fence on the western perimeter along Millfleet Drive.

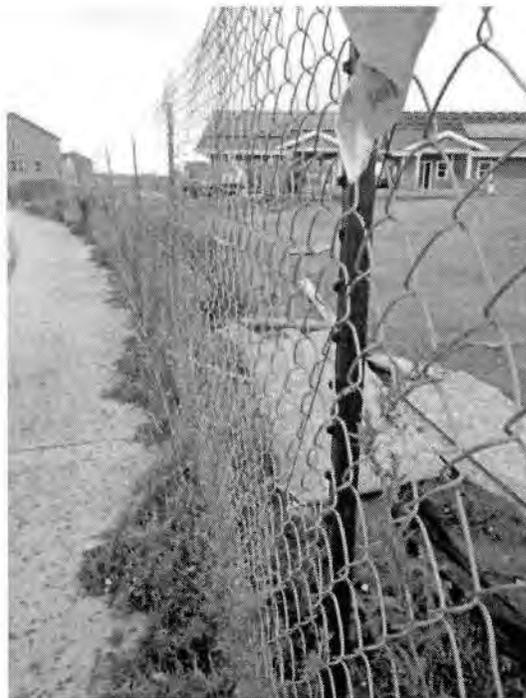
Photo Number 755
Inspection Date 9/11/2013
Photographer N. Davis
Description Damaged silt fence on the western perimeter along Millfleet Drive. Note construction materials were placed on silt fence.

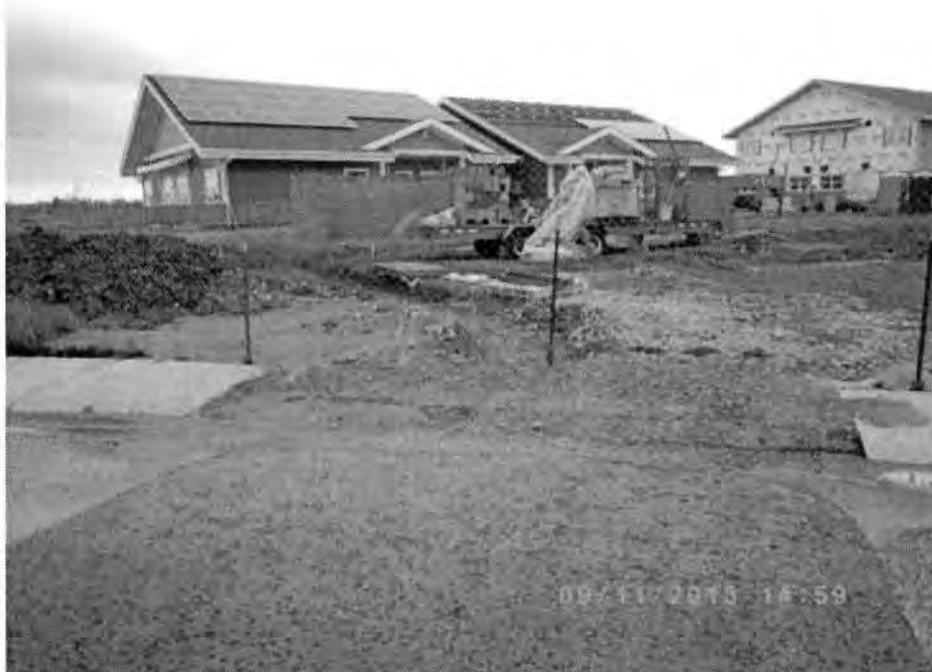
Rip rap	Y				N		Not observed on-site during the inspection.
Vehicle track-out pad	Y			Y			The VTP was no longer in use and a fence had been place around it (photo 756). However, there was sediment erosion from the vehicle track-out pad area onto the road.

Photo Number 756
Inspection Date 9/11/2013
Photographer N. Davis
Description Vehicle track-out pad onto Millfleet Drive. Photo is facing east. Note this vehicle access area was fenced off.

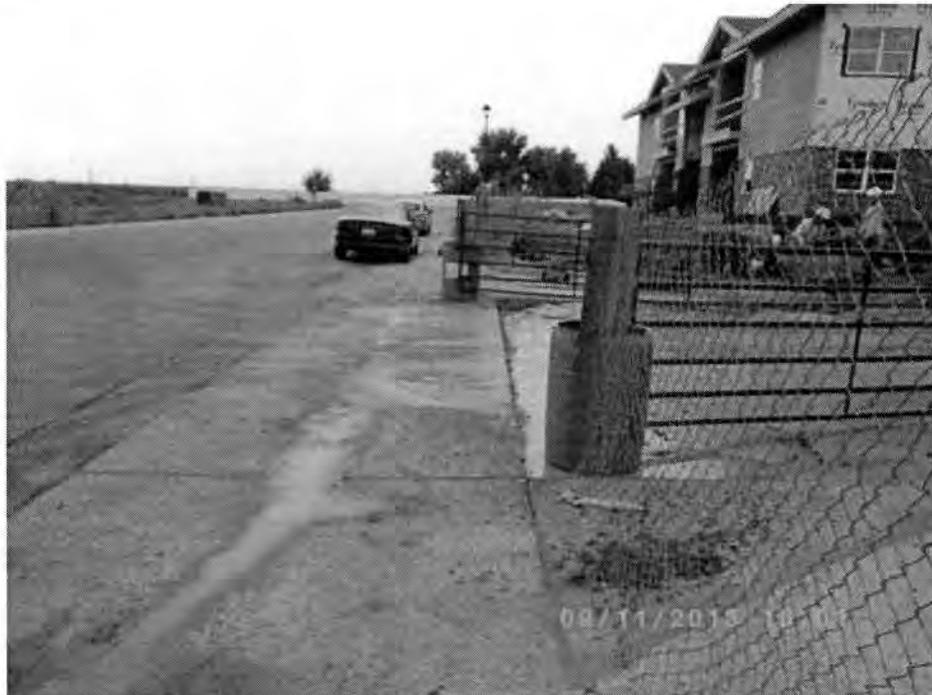
Photo Number 757
Inspection Date 9/11/2013
Photographer N. Davis
Description Vehicle access road from Tipton Drive to Windshire Dr. Note sediment track-out in road. Photo is facing northeast.

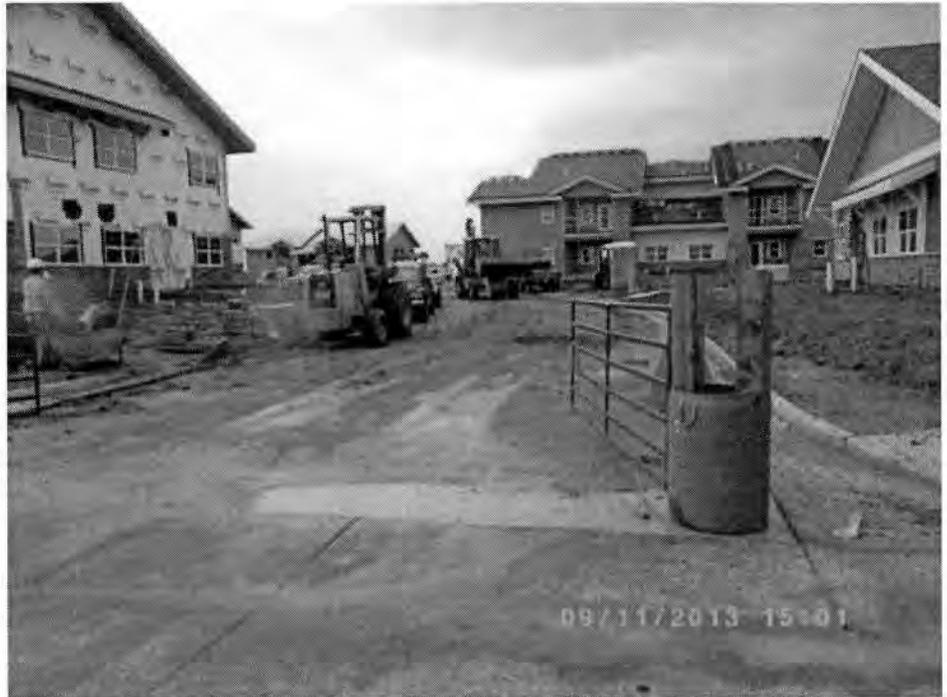
Photo Number 758
Inspection Date 9/11/2013
Photographer N. Davis
Description Vehicle access road from Tipton Drive to Windshire Dr. Note excessive sediment track-out in road. Photo is facing south.

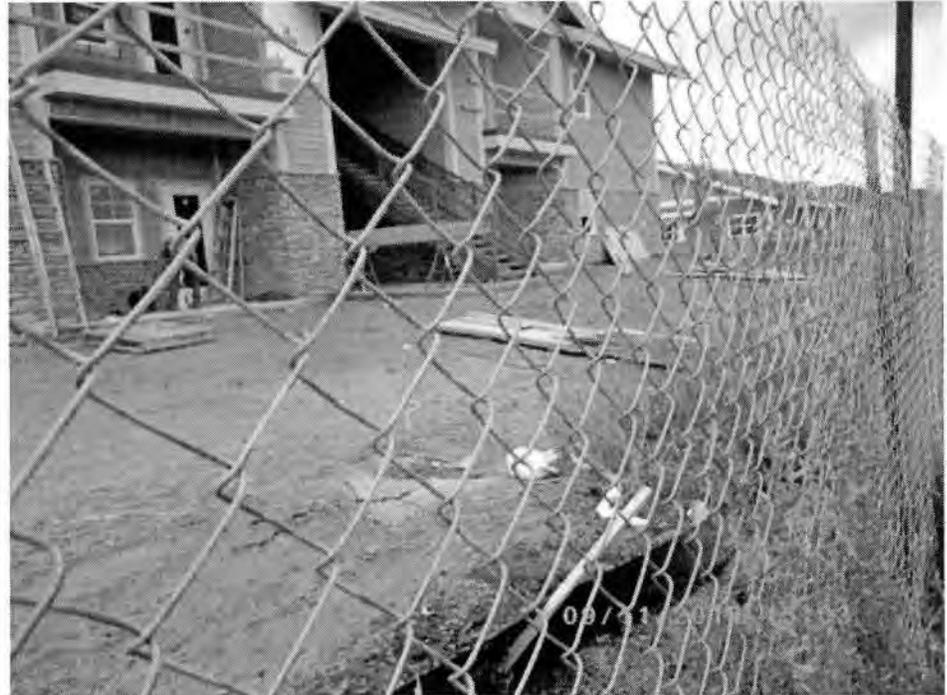
Photo Number 759
Inspection Date 9/11/2013
Photographer N. Davis
Description Damaged silt fence on the northern perimeter along Windshire Drive. Note concrete washout remnants in background.

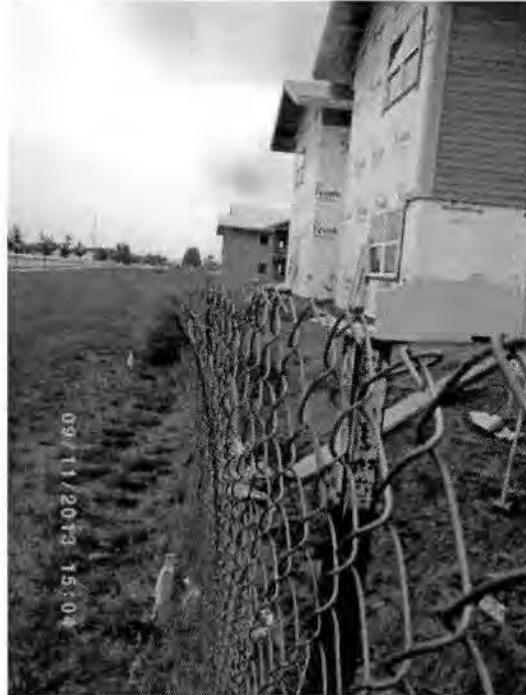
Photo Number 760
Inspection Date 9/11/2013
Photographer N. Davis
Description Eastern perimeter of site facing south. The silt fence was removed in this section of the site and replaced with straw wattles. However, wattles were not staked or trenched into the ground.

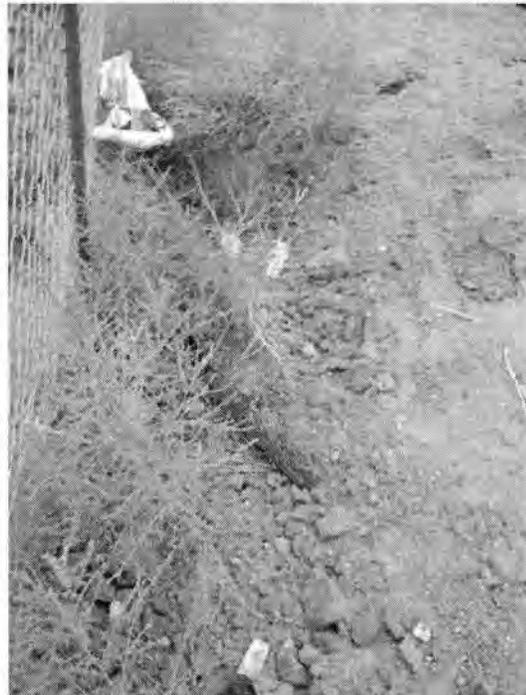
Photo Number 761
Inspection Date 9/11/2013
Photographer N. Davis
Description The silt fence was removed in the eastern section of the site and replaced with straw wattles. However, wattles were not staked or trenched into the ground.

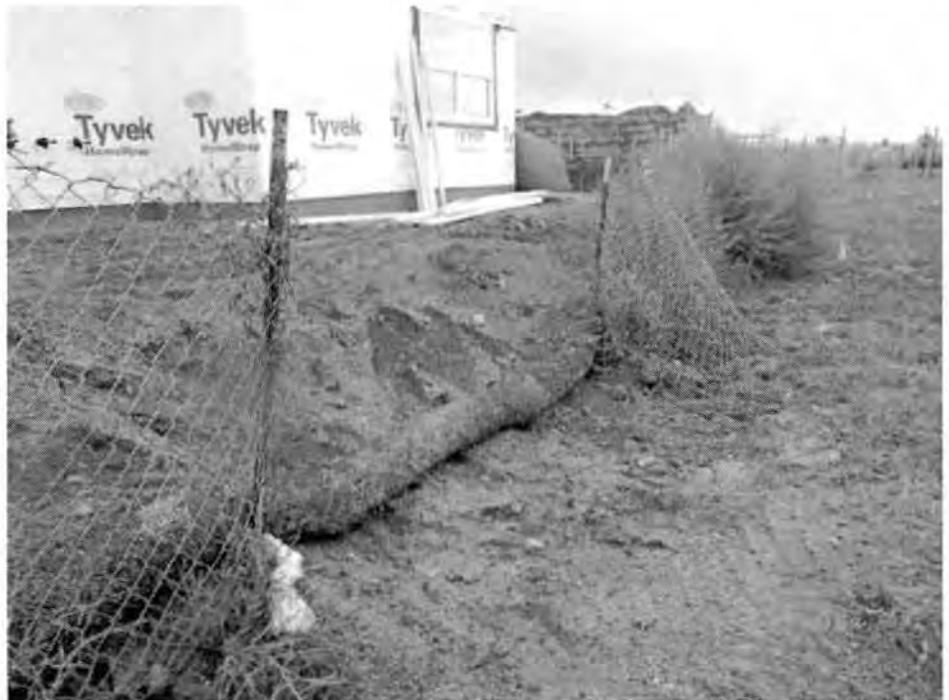
Photo Number 762
Inspection Date 9/11/2013
Photographer N. Davis
Description The silt fence was removed in the eastern section of the site and replaced with straw wattles. However, wattles were not staked or trenched into the ground.

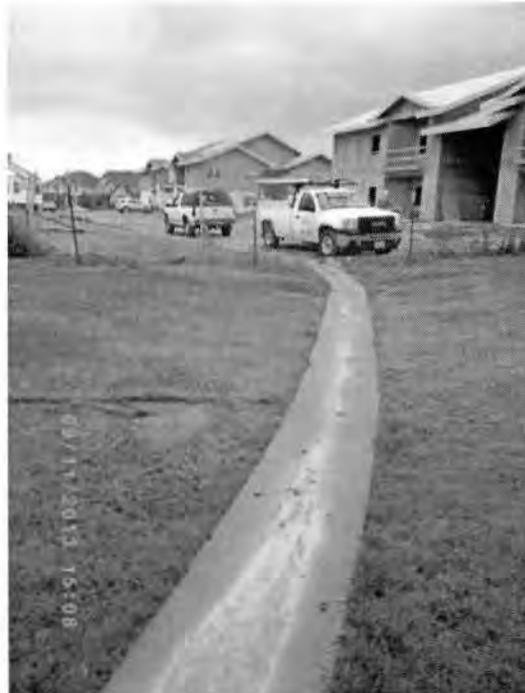
Photo Number 763
Inspection Date 9/11/2013
Photographer N. Davis
Description Outfall from eastern side of the site. Note stormwater with sediment. Photo is facing northwest.

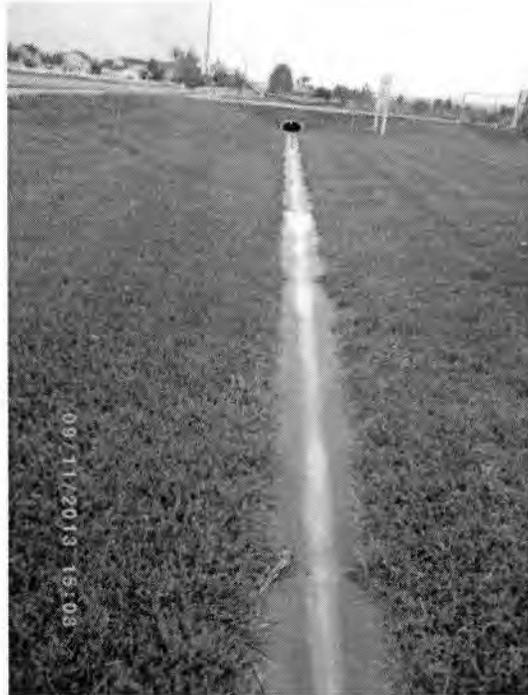
Photo Number 764
Inspection Date 9/11/2013
Photographer N. Davis
Description Swale along 15th Street facing south. The culvert under Tipton Street is in the back of the photo. Note stormwater with sediment.

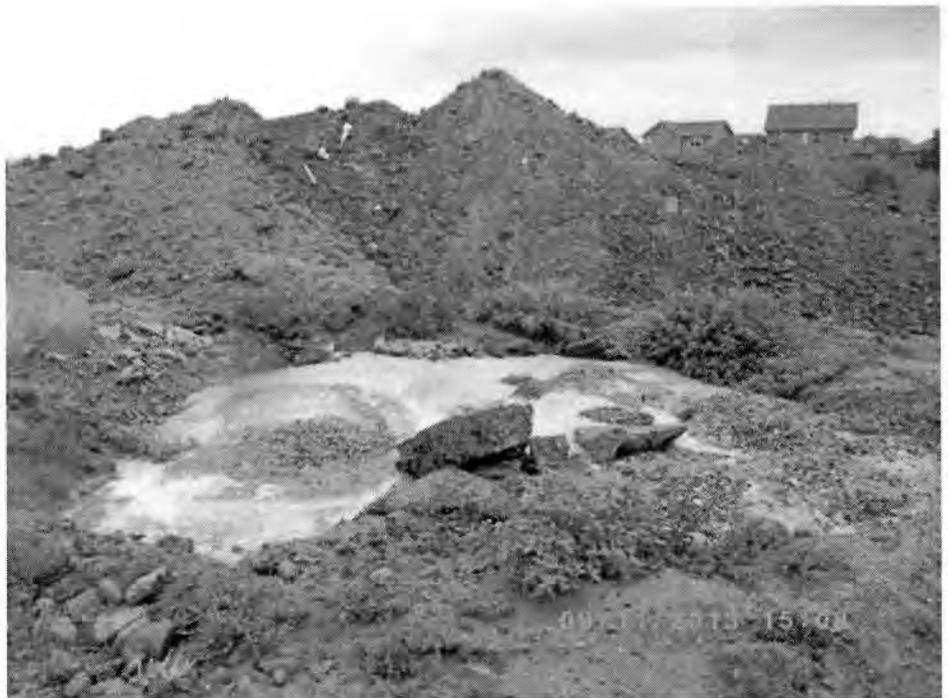
Photo Number 765
Inspection Date 9/11/2013
Photographer N. Davis
Description The concrete washout area on the southern section of the site. Note concrete washout area was almost at capacity with the berms. Photo is facing south.

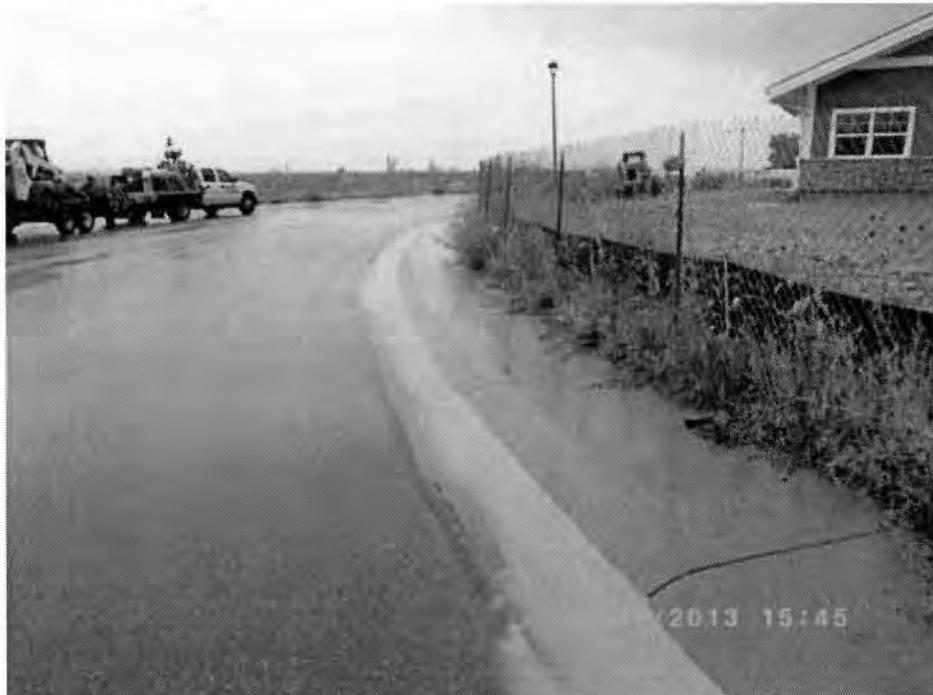
Photo Number 766
Inspection Date 9/11/2013
Photographer N. Davis
Description Stormwater with sediment coming from construction entrance at the corner of Windshire Drive and Tipton Drive. Photo is facing northeast.

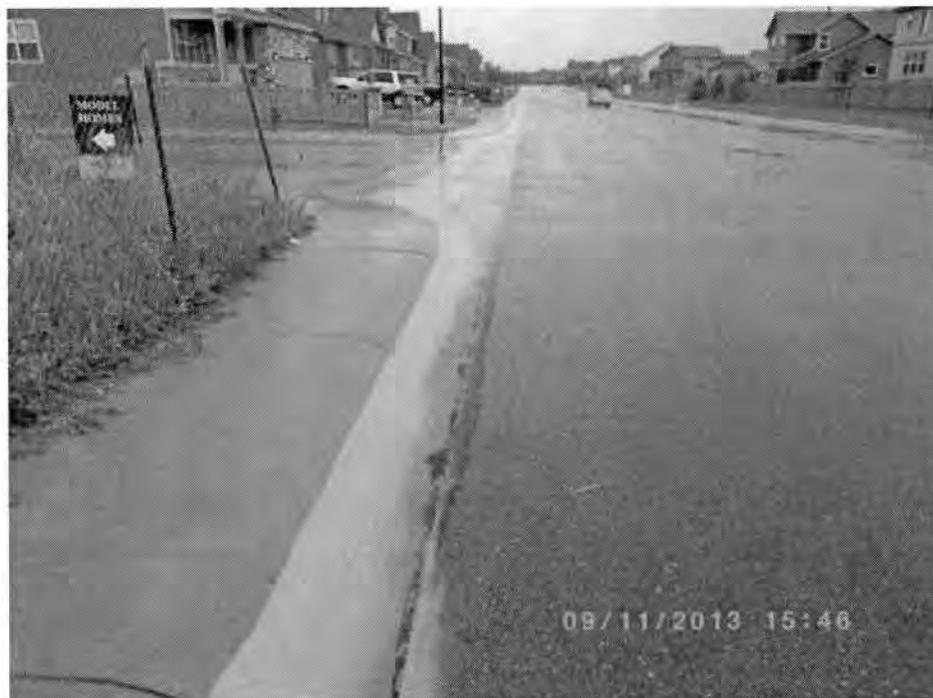
Photo Number 767
Inspection Date 9/11/2013
Photographer N. Davis
Description Stormwater with sediment shown in photo 766 flowing down Windshire Drive and the corner of Millfleet Drive. Photo is facing southwest.

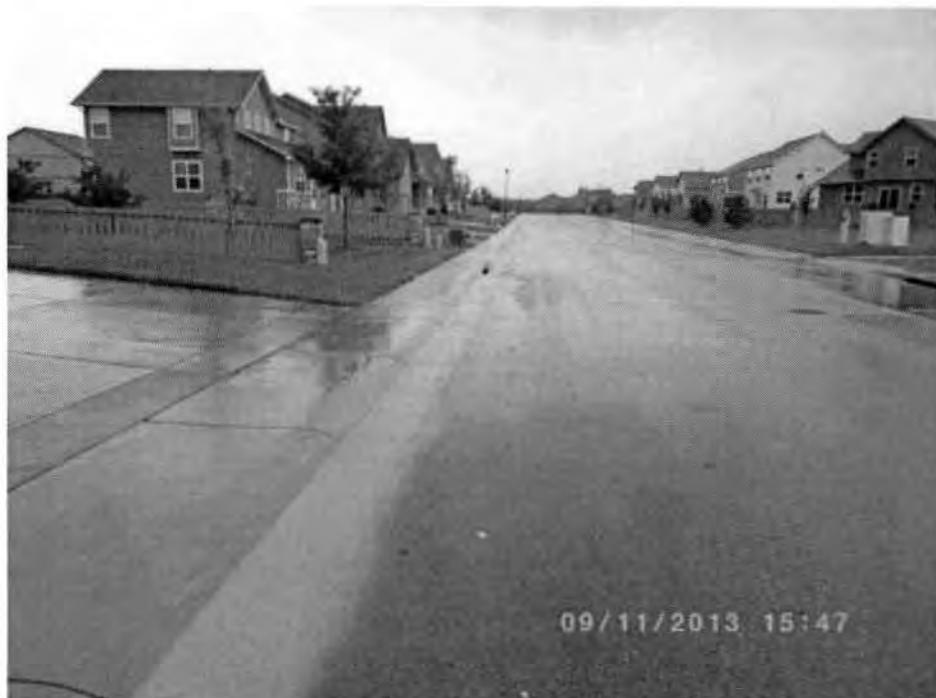
Photo Number 768
Inspection Date 9/11/2013
Photographer N. Davis
Description Stormwater with sediment shown in photos 766 and 767 flowing down Windshire Drive to the stormwater inlet. Photo is facing southwest.

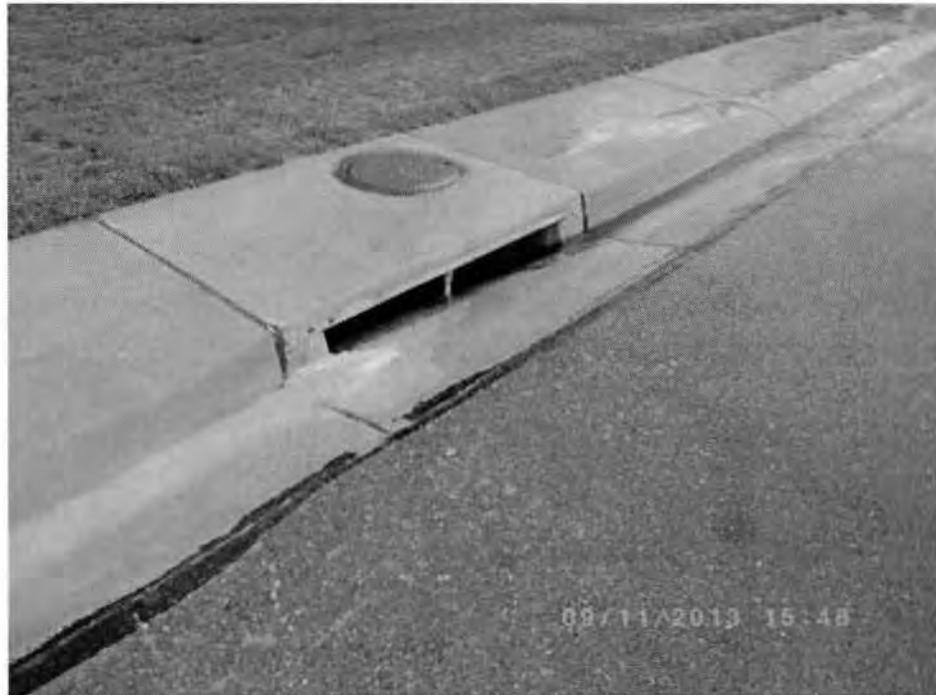
Photo Number 769
Inspection Date 9/11/2013
Photographer N. Davis
Description Close up of inlet shown in photo 768.

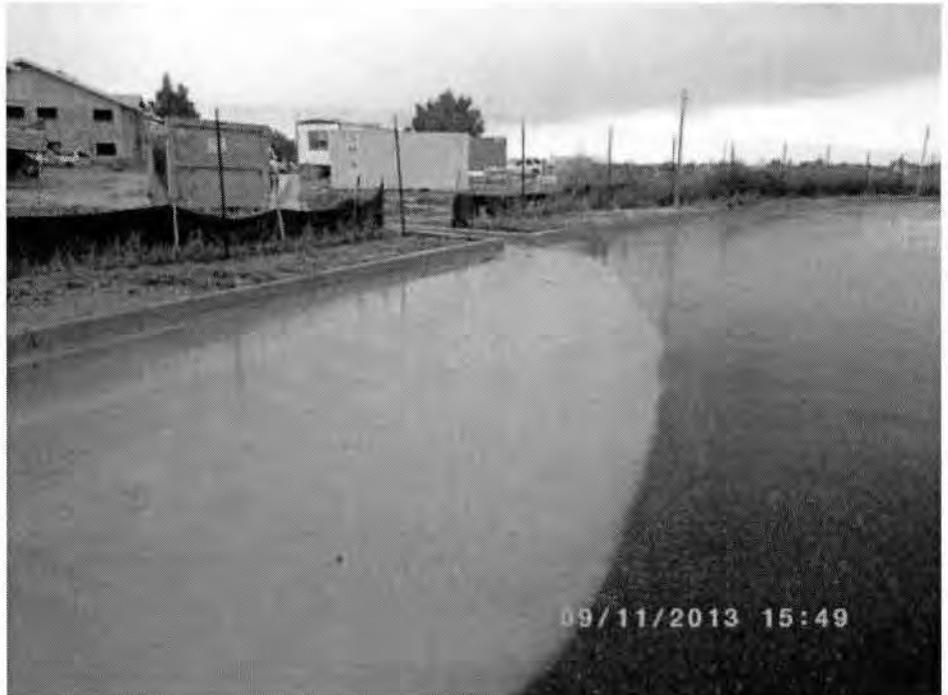
Description Stormwater drainage area on west side of the site that drains towards the Windshire Pool Parking lot. Note sediment in stormwater. Photo is facing southeast.

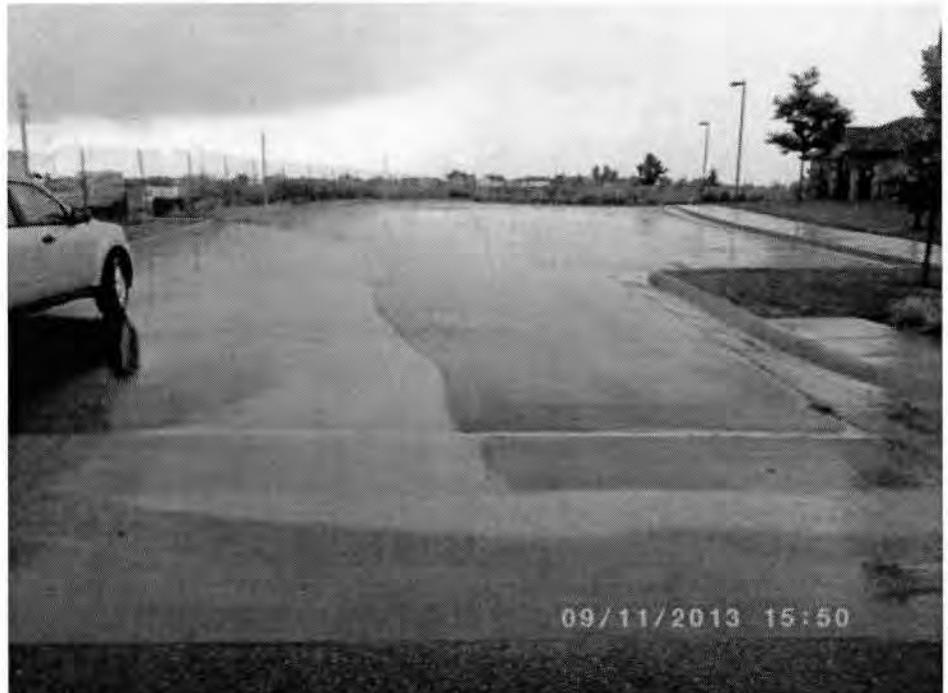
Photo Number 771

Description Stormwater drainage area on west side of the site that drains towards the Windshire Pool Parking lot. Note sediment in stormwater. Photo is facing south.

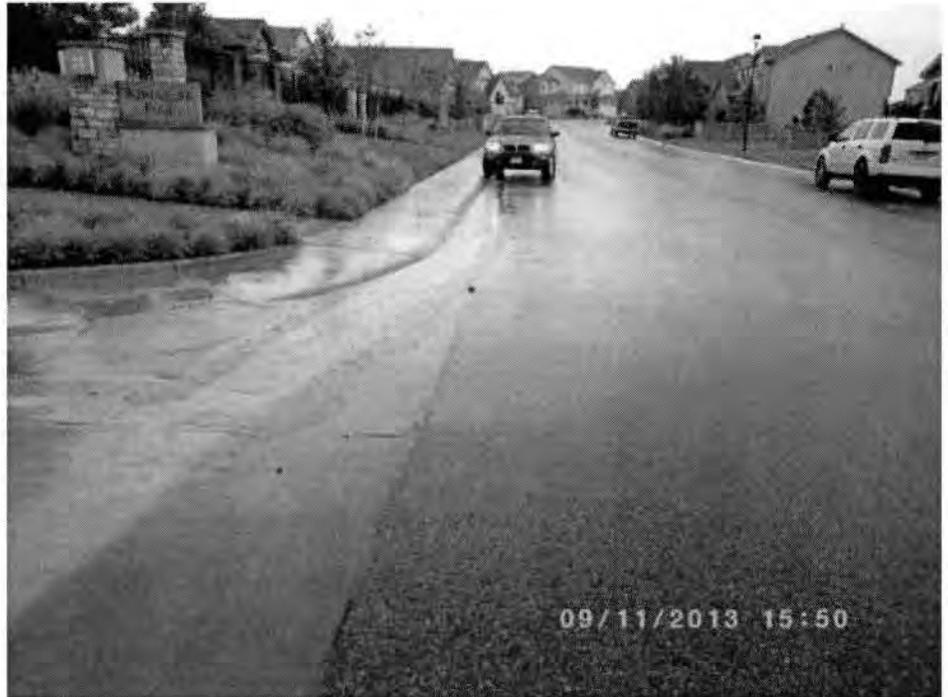
Photo Number 772
Inspection Date 9/11/2013
Photographer N. Davis
Description Stormwater with sediment shown in photos 770 and 771 flowing down Millfleet Drive. Photo is facing southwest.

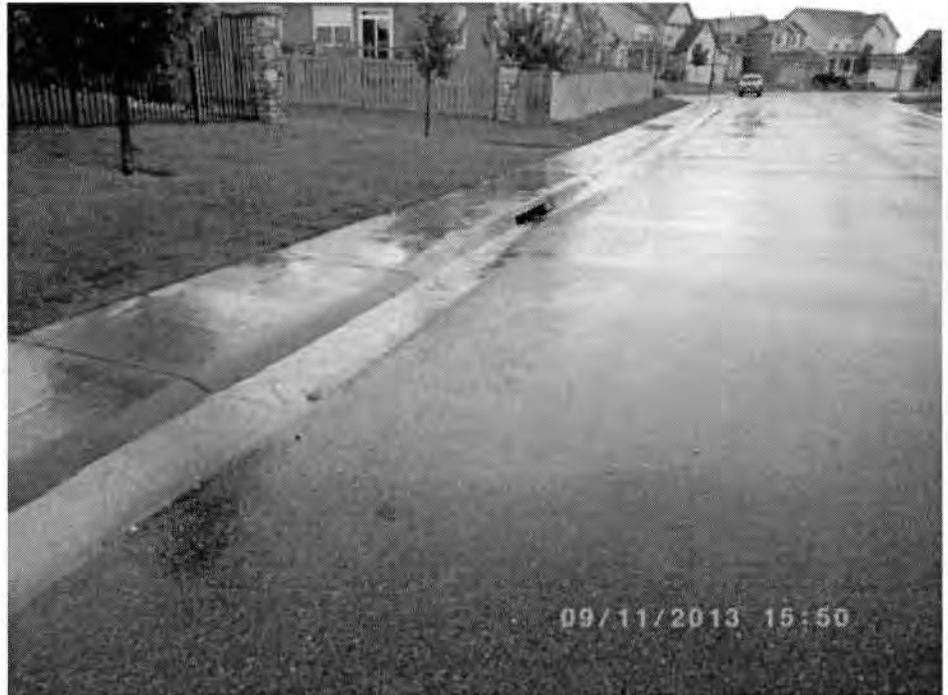
Photo Number 773
Inspection Date 9/11/2013
Photographer N. Davis
Description Stormwater with sediment shown in photos 770, 771 and 772 flowing down Millfleet Drive to stormwater inlet. Photo is facing southwest.
