Exhibit 31

Background Information

JURISDICTIONAL DETERMINATION
U.S. Army Corps of Engineers

DISTRICT OFFICE: Galveston
FILE NUMBER: D19144

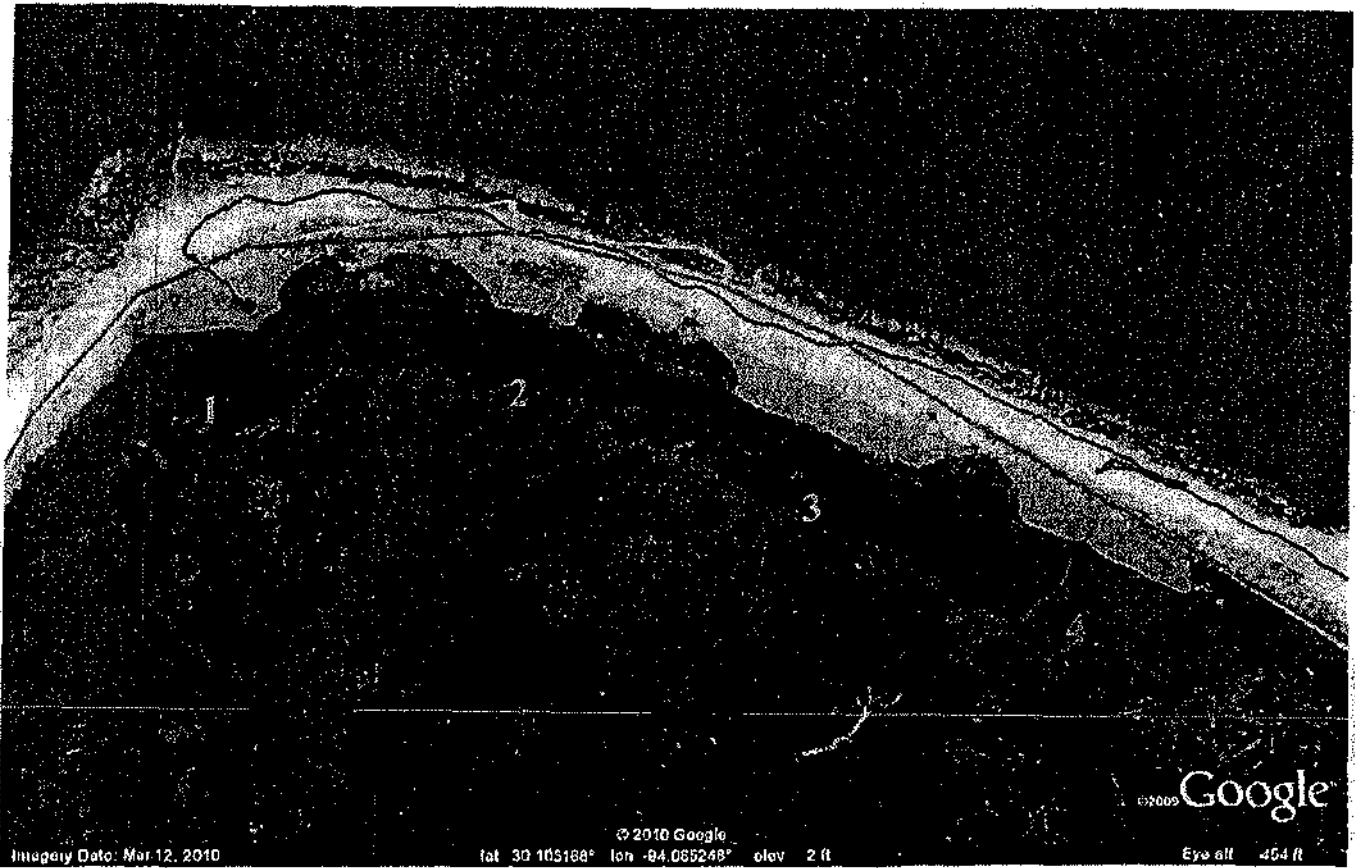
Complainant's Ex. 35
Suspected Areas of Fill

Area 3: 0.03 acre

Area 4: 0.02 acre

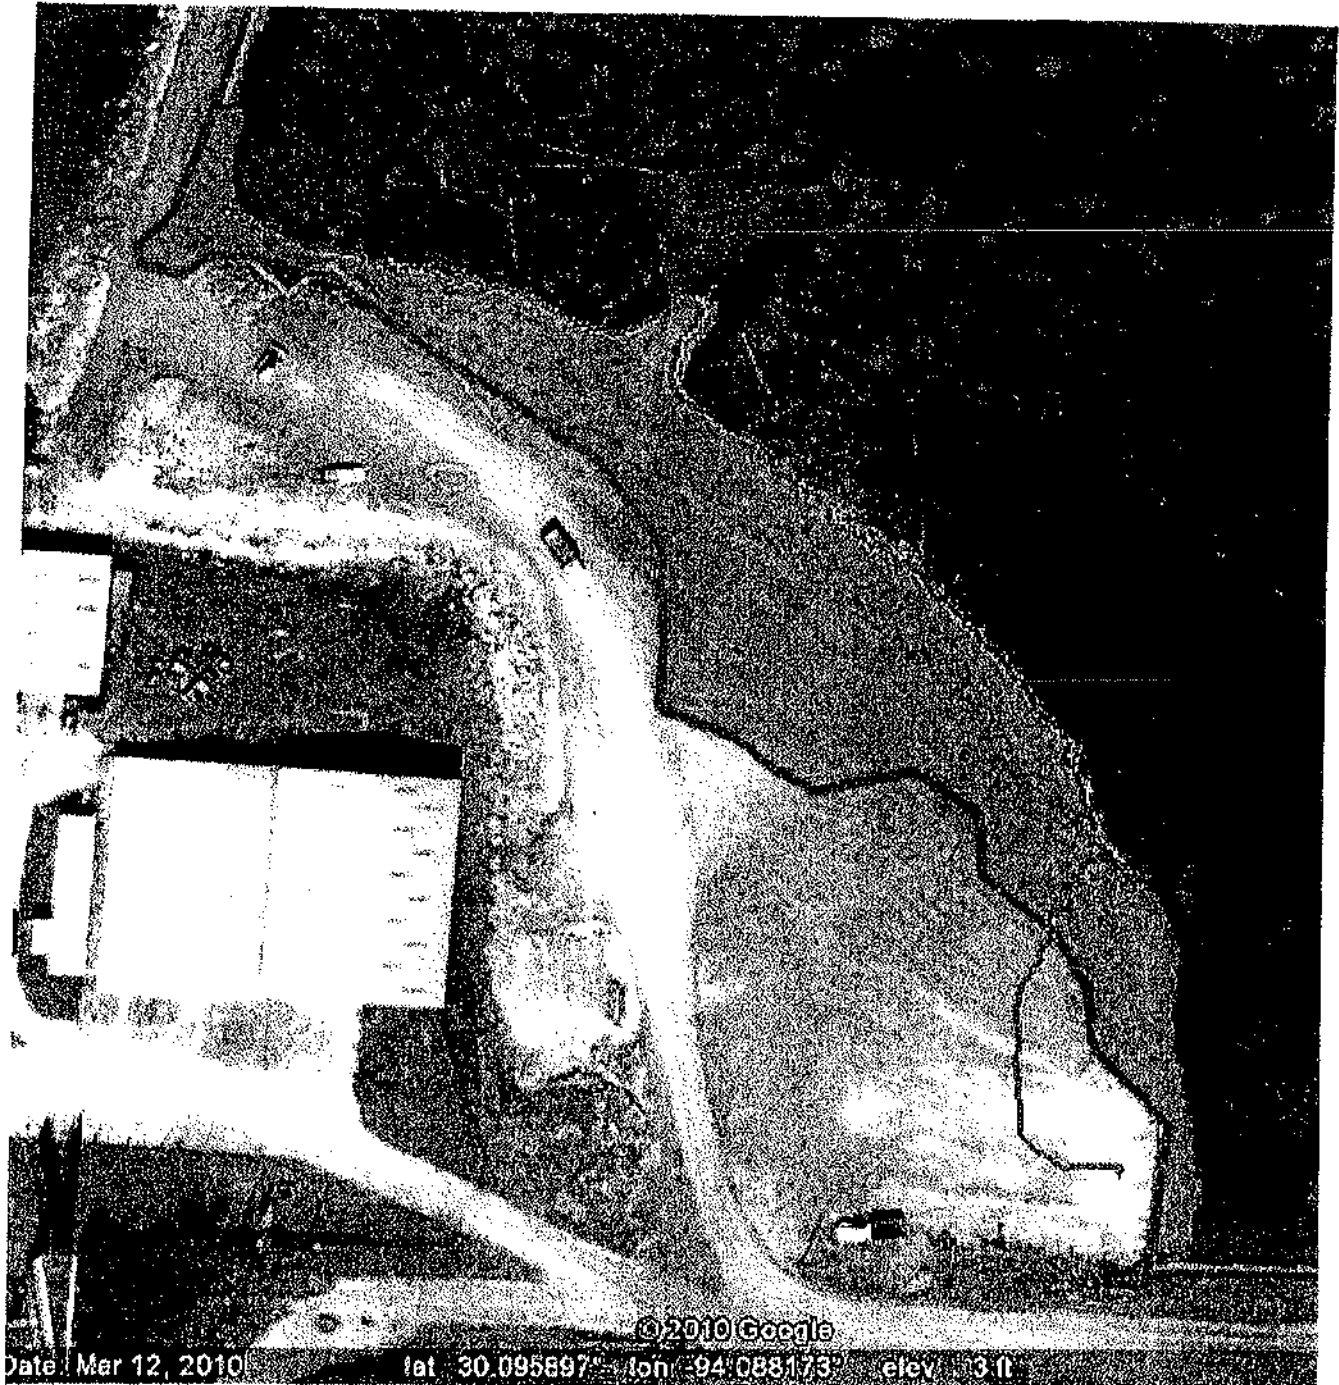
Southwest Corner

Red Line: 22 July 2010 fill line. Line curves in because remainder of area was unsafe to traverse.
