ADMINISTRATIVE ORDER
ON CONSENT

Docket No. CWA-08-2018-0013

**C-2 Construction, Inc. and Iron Man/Carroll Drilling, LLC
Wetland Mitigation Project**

Wetland Delineations and Mitigation Plan

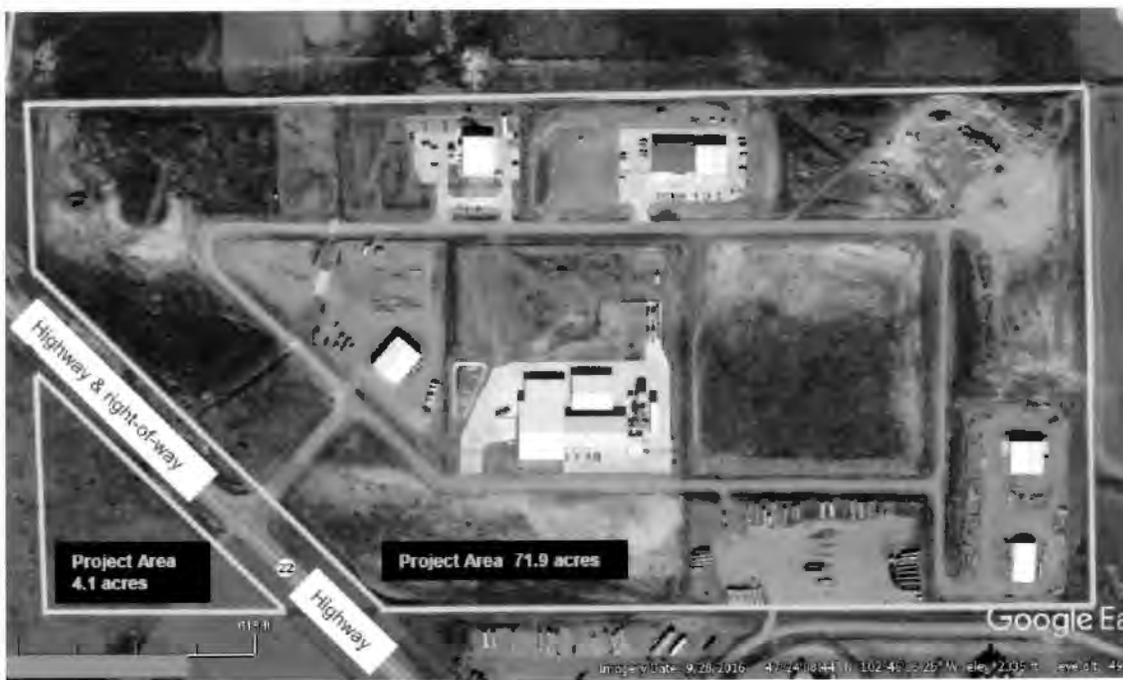
Figure 1. KIP Site Map. See also Appendix A, Location and Site Maps.

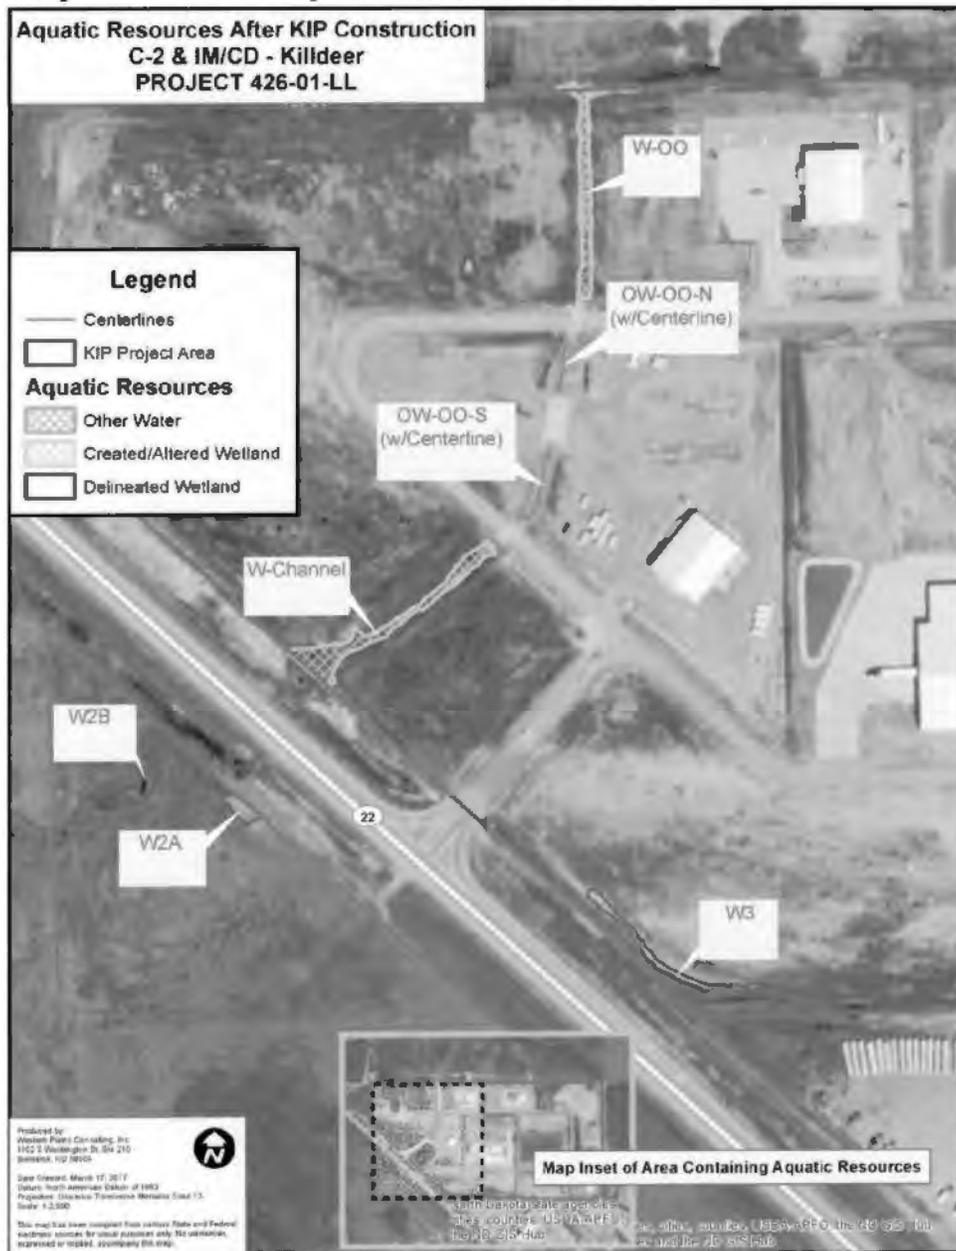
Figure 3. Aquatic Resource Map – After KIP Construction.

On-Site photographs of these areas can be found in **Appendix C, Site Photographs**.

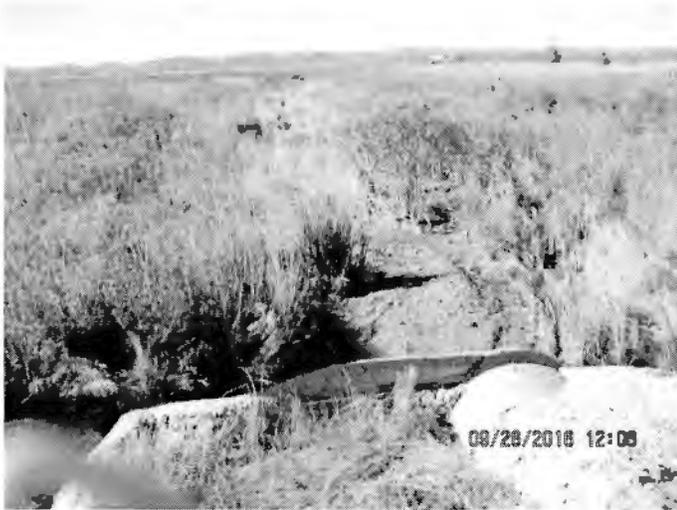
Photo 1: A view of Wetland Channel from the east end.
Direction: Southwest.

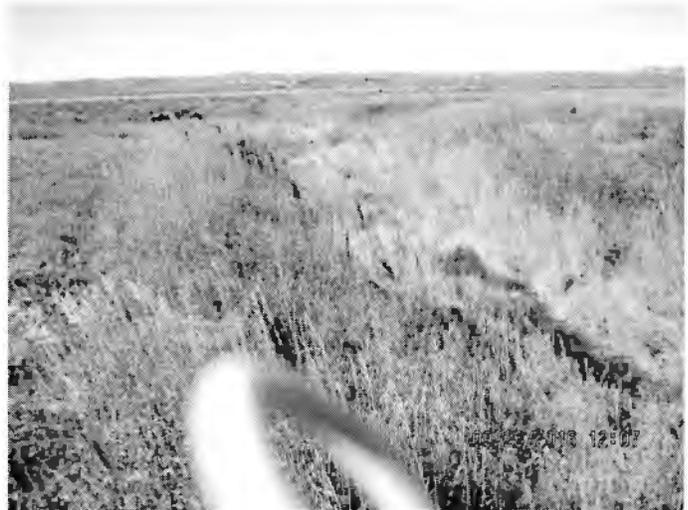
Photo 2: A view of the west half of Wetland Channel.
Direction: Southwest.

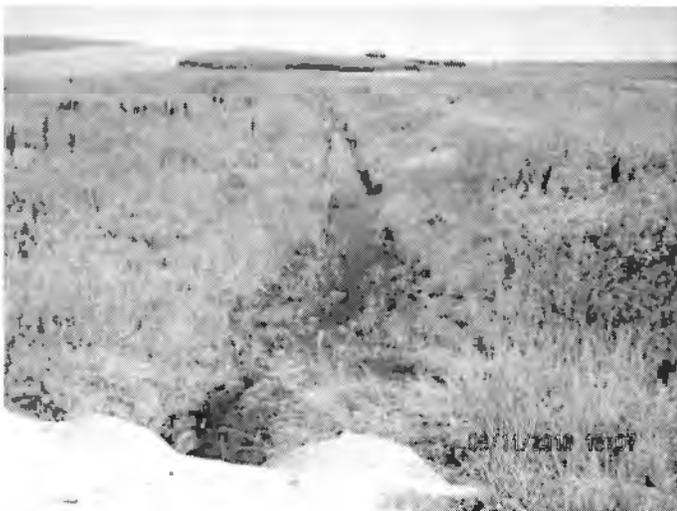
Photo 3: Wetland OO viewed from the south end.
Direction: North.

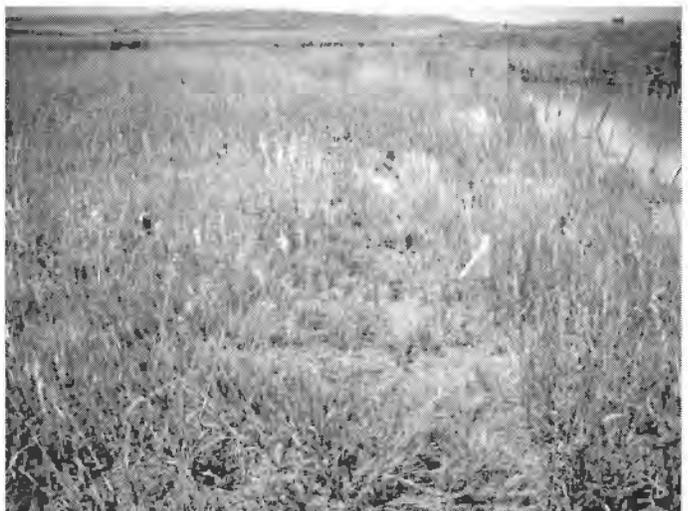
Photo 6: Wetland 2A. The open water on the right is in the ND Highway 22 west ditch.
Direction: Northwest.

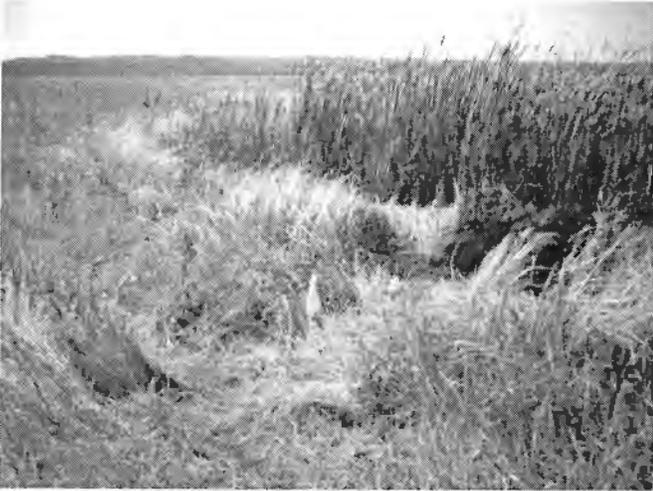
Photo 5: Wetland 2B.
Direction: West.

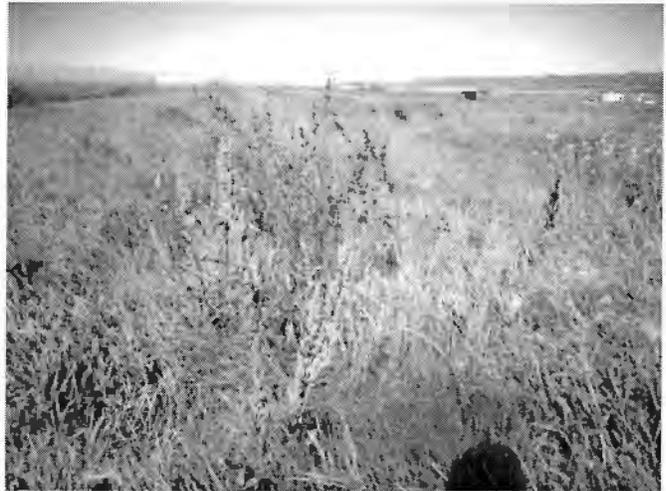
Photo 6: East end of Wetland 3.
Direction: West.

The southeast end of the wetland has a slight depression. The middle reach of the wetland is slightly gullied slope wetland. The western reach of this wetland that parallels Hwy 22 is slope wetland with sandy soil. Water was flowing westward on the surface of the eastern and middle reaches of this wetland on Aug. 10-11, 2016, but it diminished to no flow on the west reach, as it all infiltrated the sandy soil.

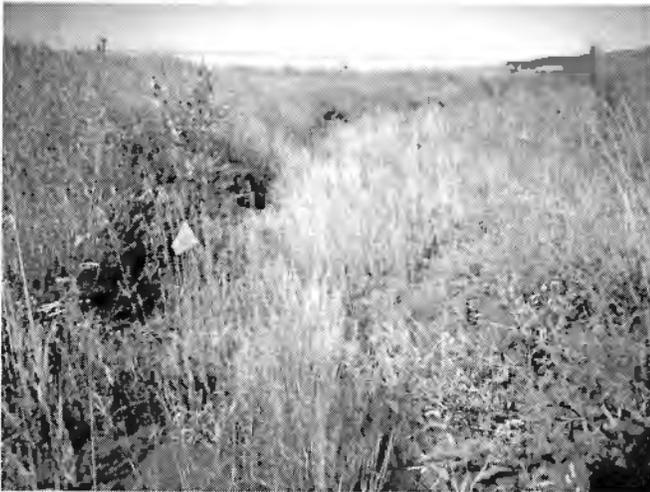
Photo 7: Middle reach of Wetland 3.
Direction: West.

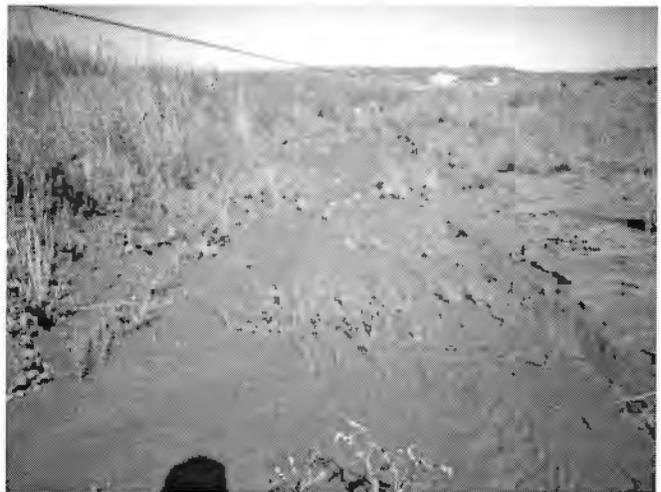
Photo 8: Northwest reach of Wetland 3. The surface flow infiltrated the sandy soil completely.
Direction: Northwest.

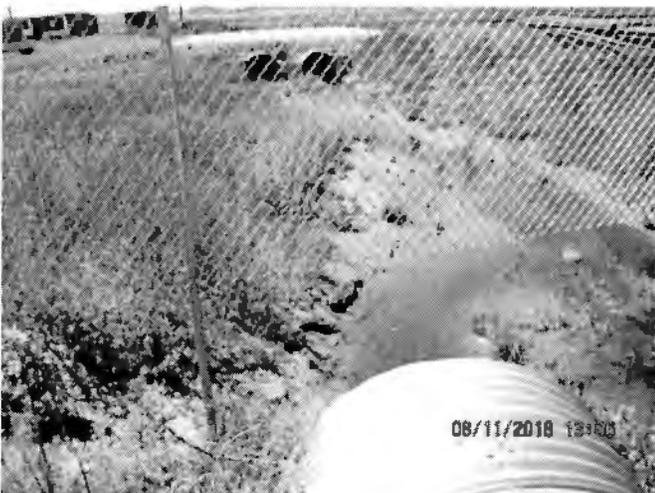
Photo 9: Other Water OO-N. It was considered to have no mitigation value.
Direction: South.

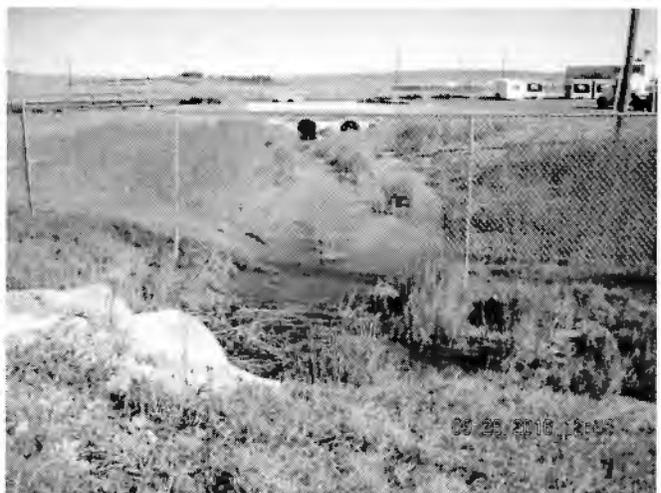
Photo 10: Other Water OO-S. It is managed to suppress all vegetation, the same as OO-N.
Direction: North.

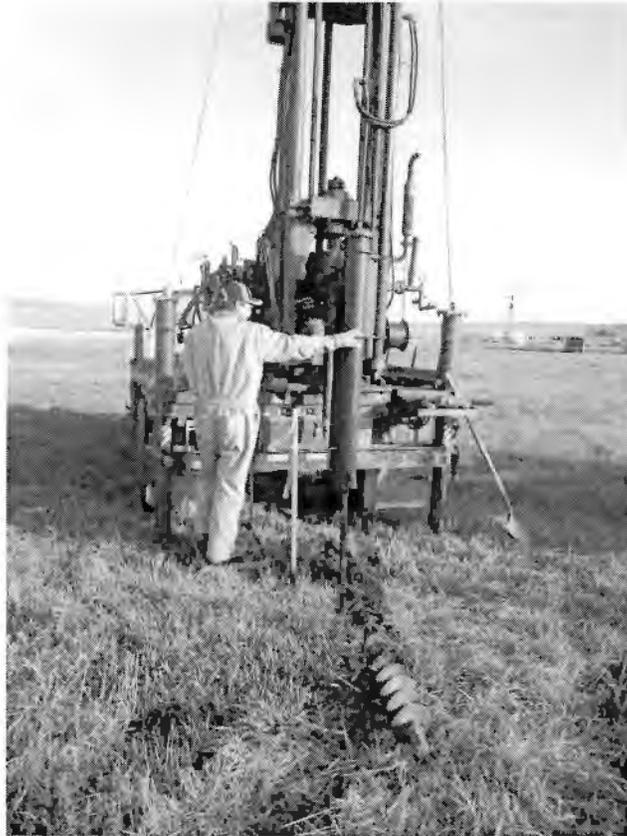
Figure 2: Soil coring efforts conducted by Western Plains (Image 121).

Concurrent with Metcalf's work, Western Plains was conducting a soil core survey (Figure 2). Observation of the soil cores indicated that intact sediments exist close to the stream that runs through the northwestern block of the APE. It appears as though sediment from the eastern side of the block were graded on top of the original ground surface near the stream to the west. Cores taken east of the road allowing access to the industrial park also showed buried soils.

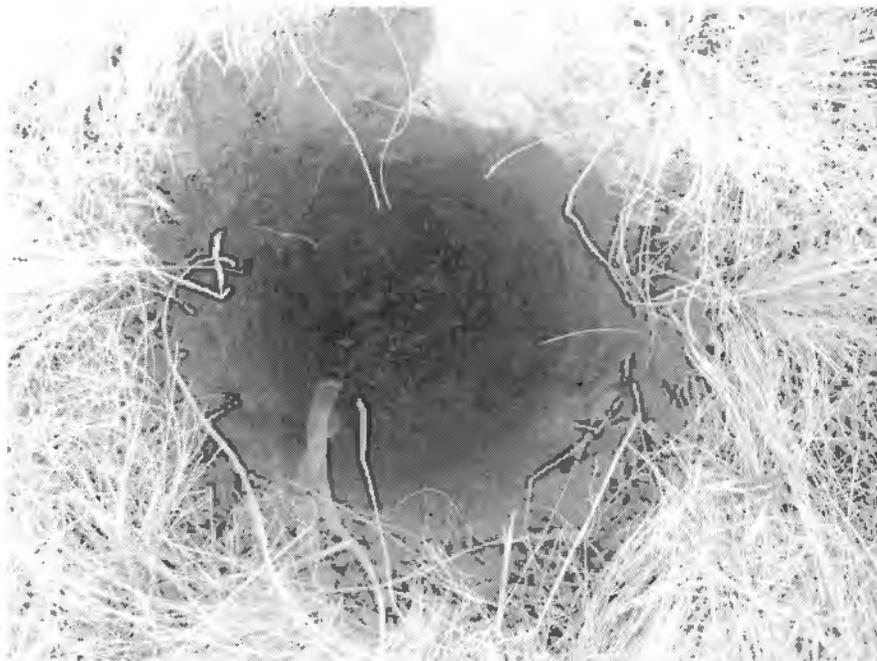
Figure 11: SP 1, 32DUx1463 (Image 122).

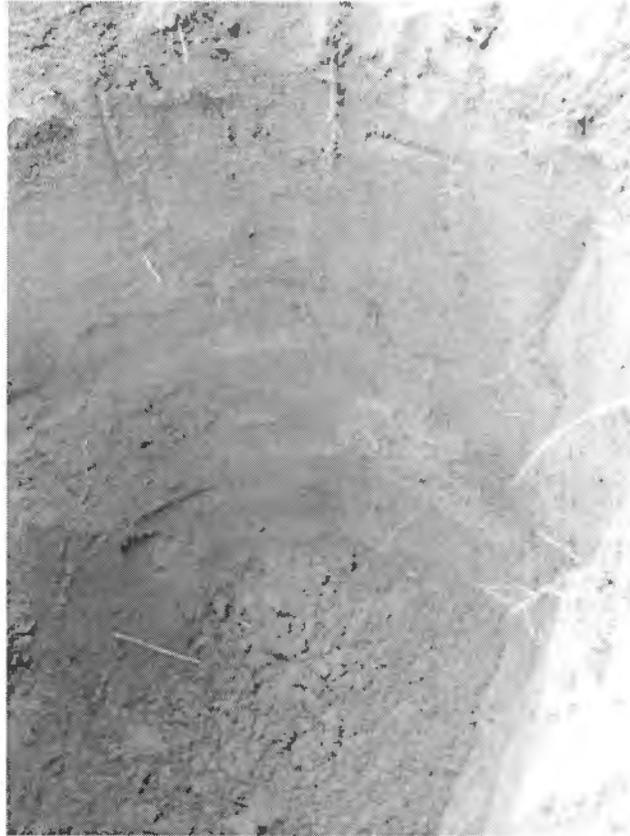
Figure 12: SP 2, 32DUx1463 (Image 124).

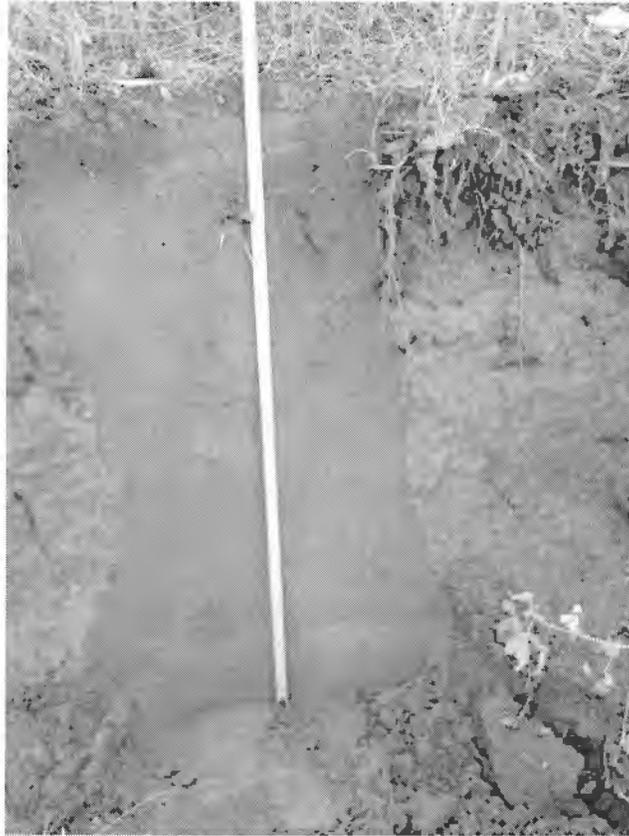
Figure 18: Soil Profile 1 (Image 126).
