GASCO: The First Portland Harbor Early Action In Review

Sean Sheldrake
EPA Region 10

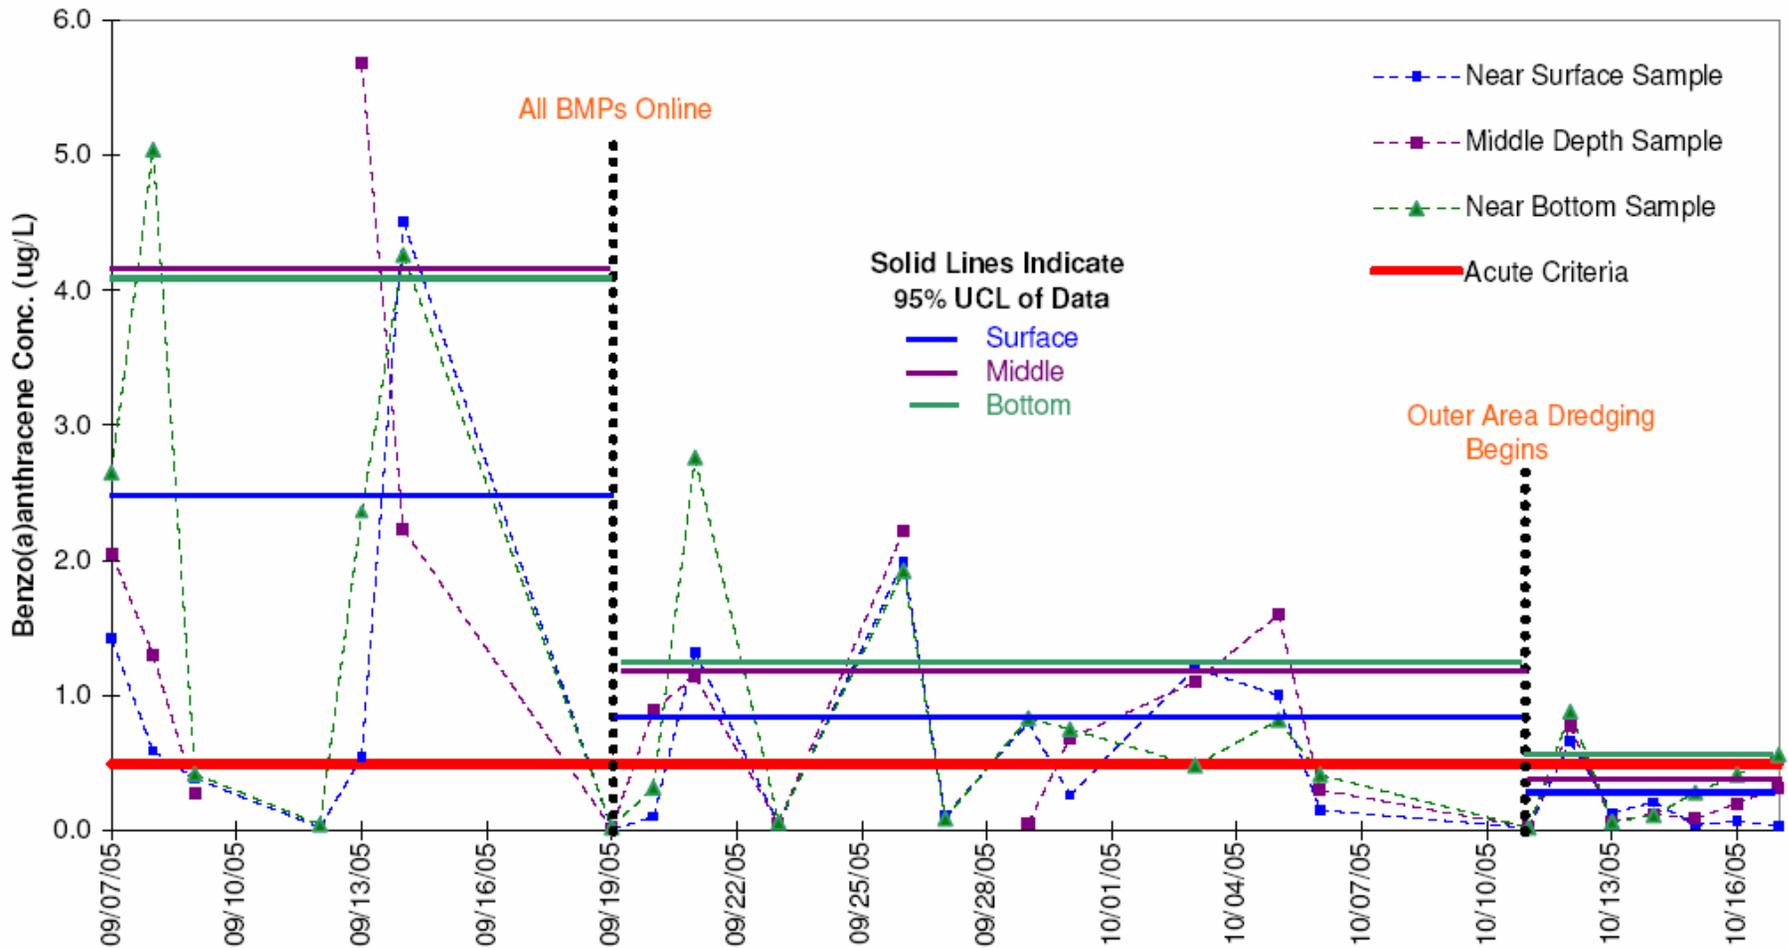
GASCO Removal Action
Benzo(a)anthracene Concentration
Approximately 150 feet Downstream of Containment

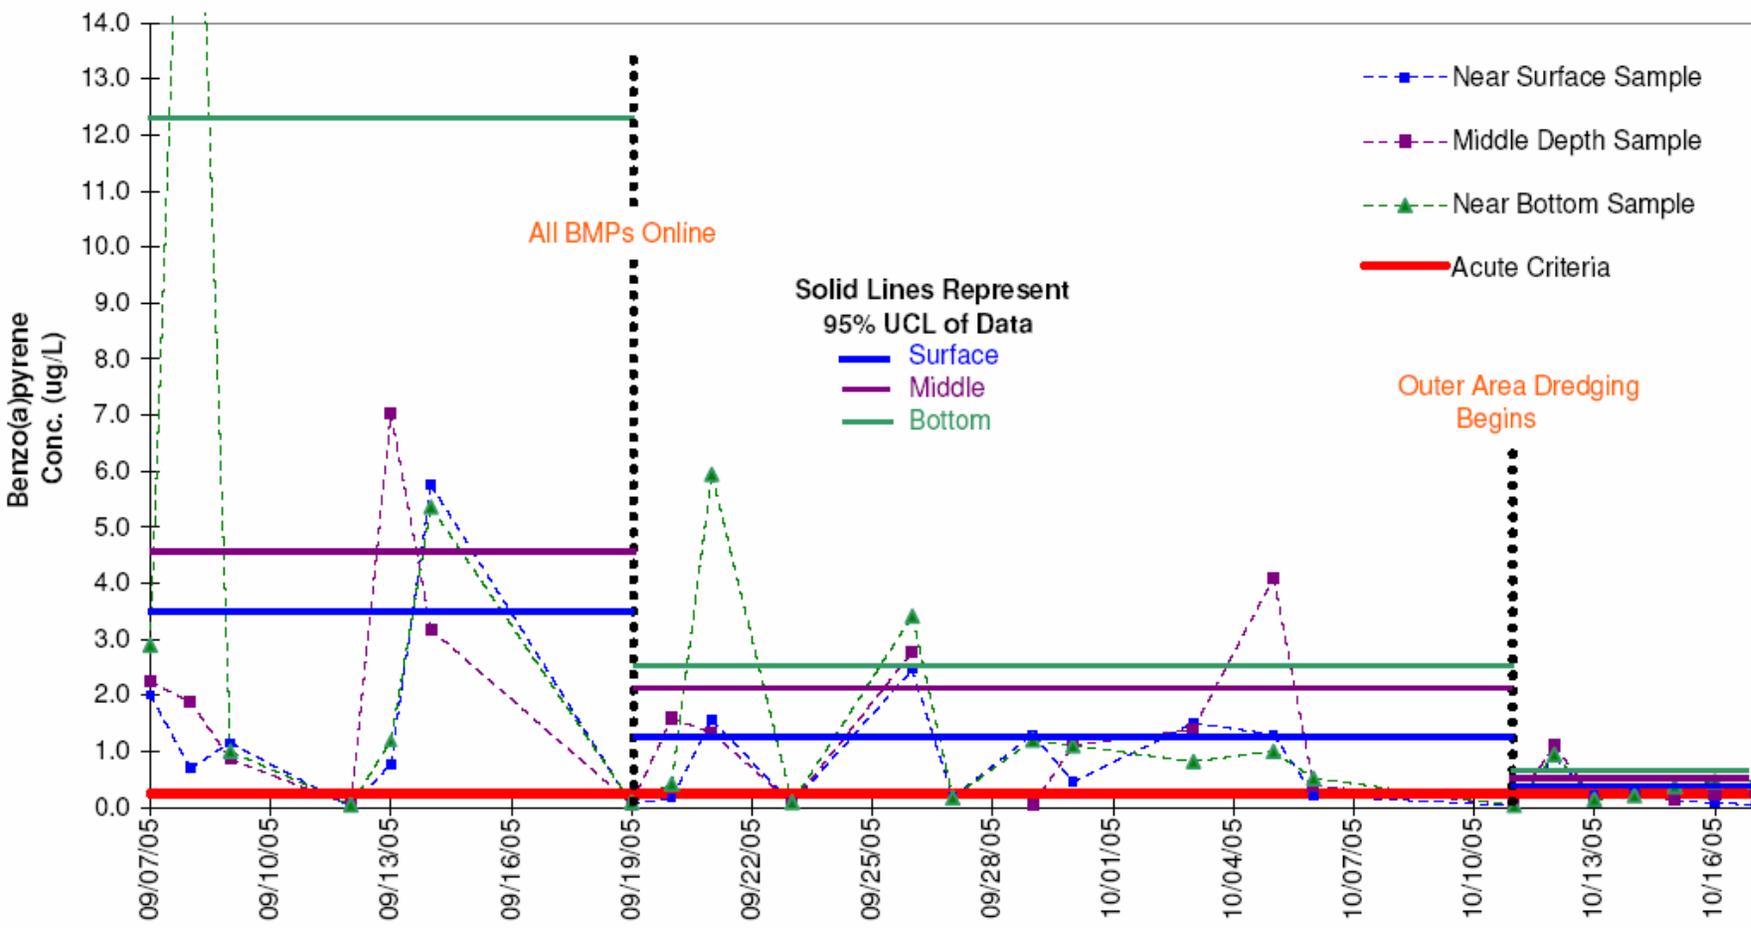
GASCO Removal Action
Benzo(a)pyrene Concentration
 Approximately 150 feet Downstream of Containment

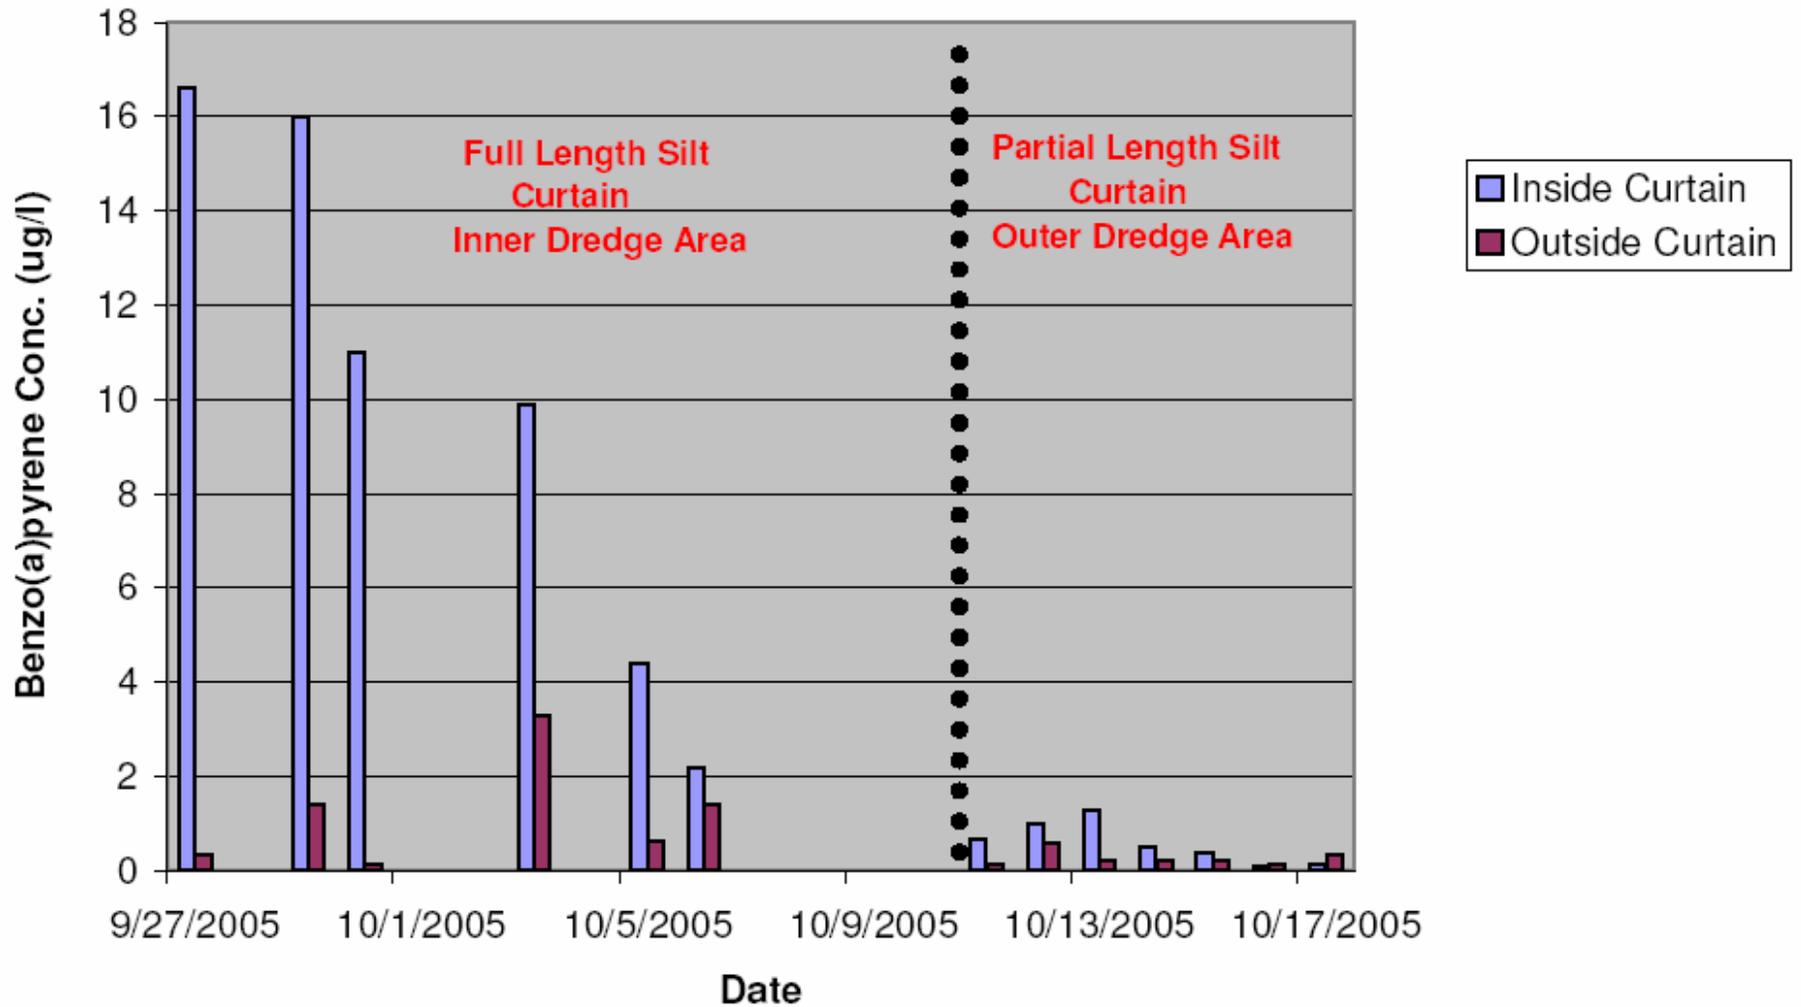
Benzo(a)pyrene Distribution Near Silt Curtain

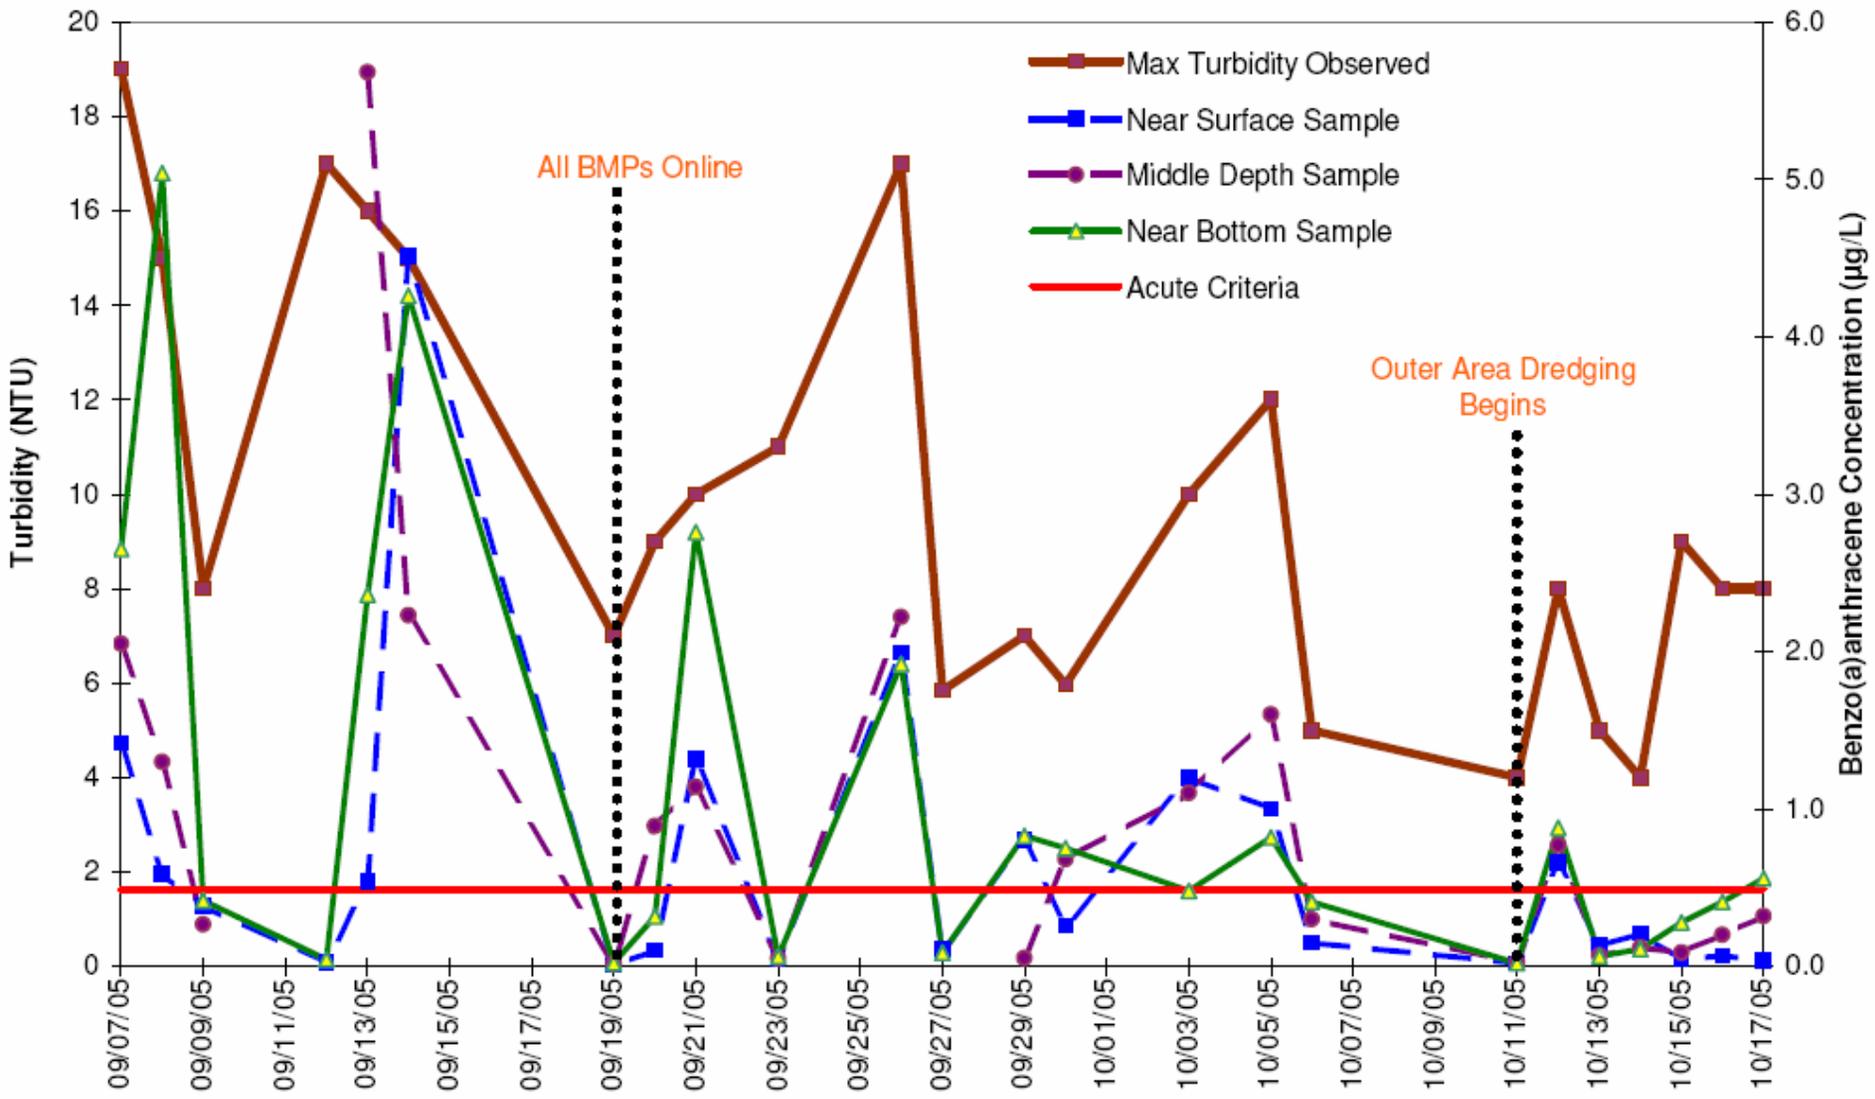
GASCO Removal Action
Daily Maximum Turbidity and Benzo(a)anthracene Concentration
Approximately 150 feet Downstream of Containment

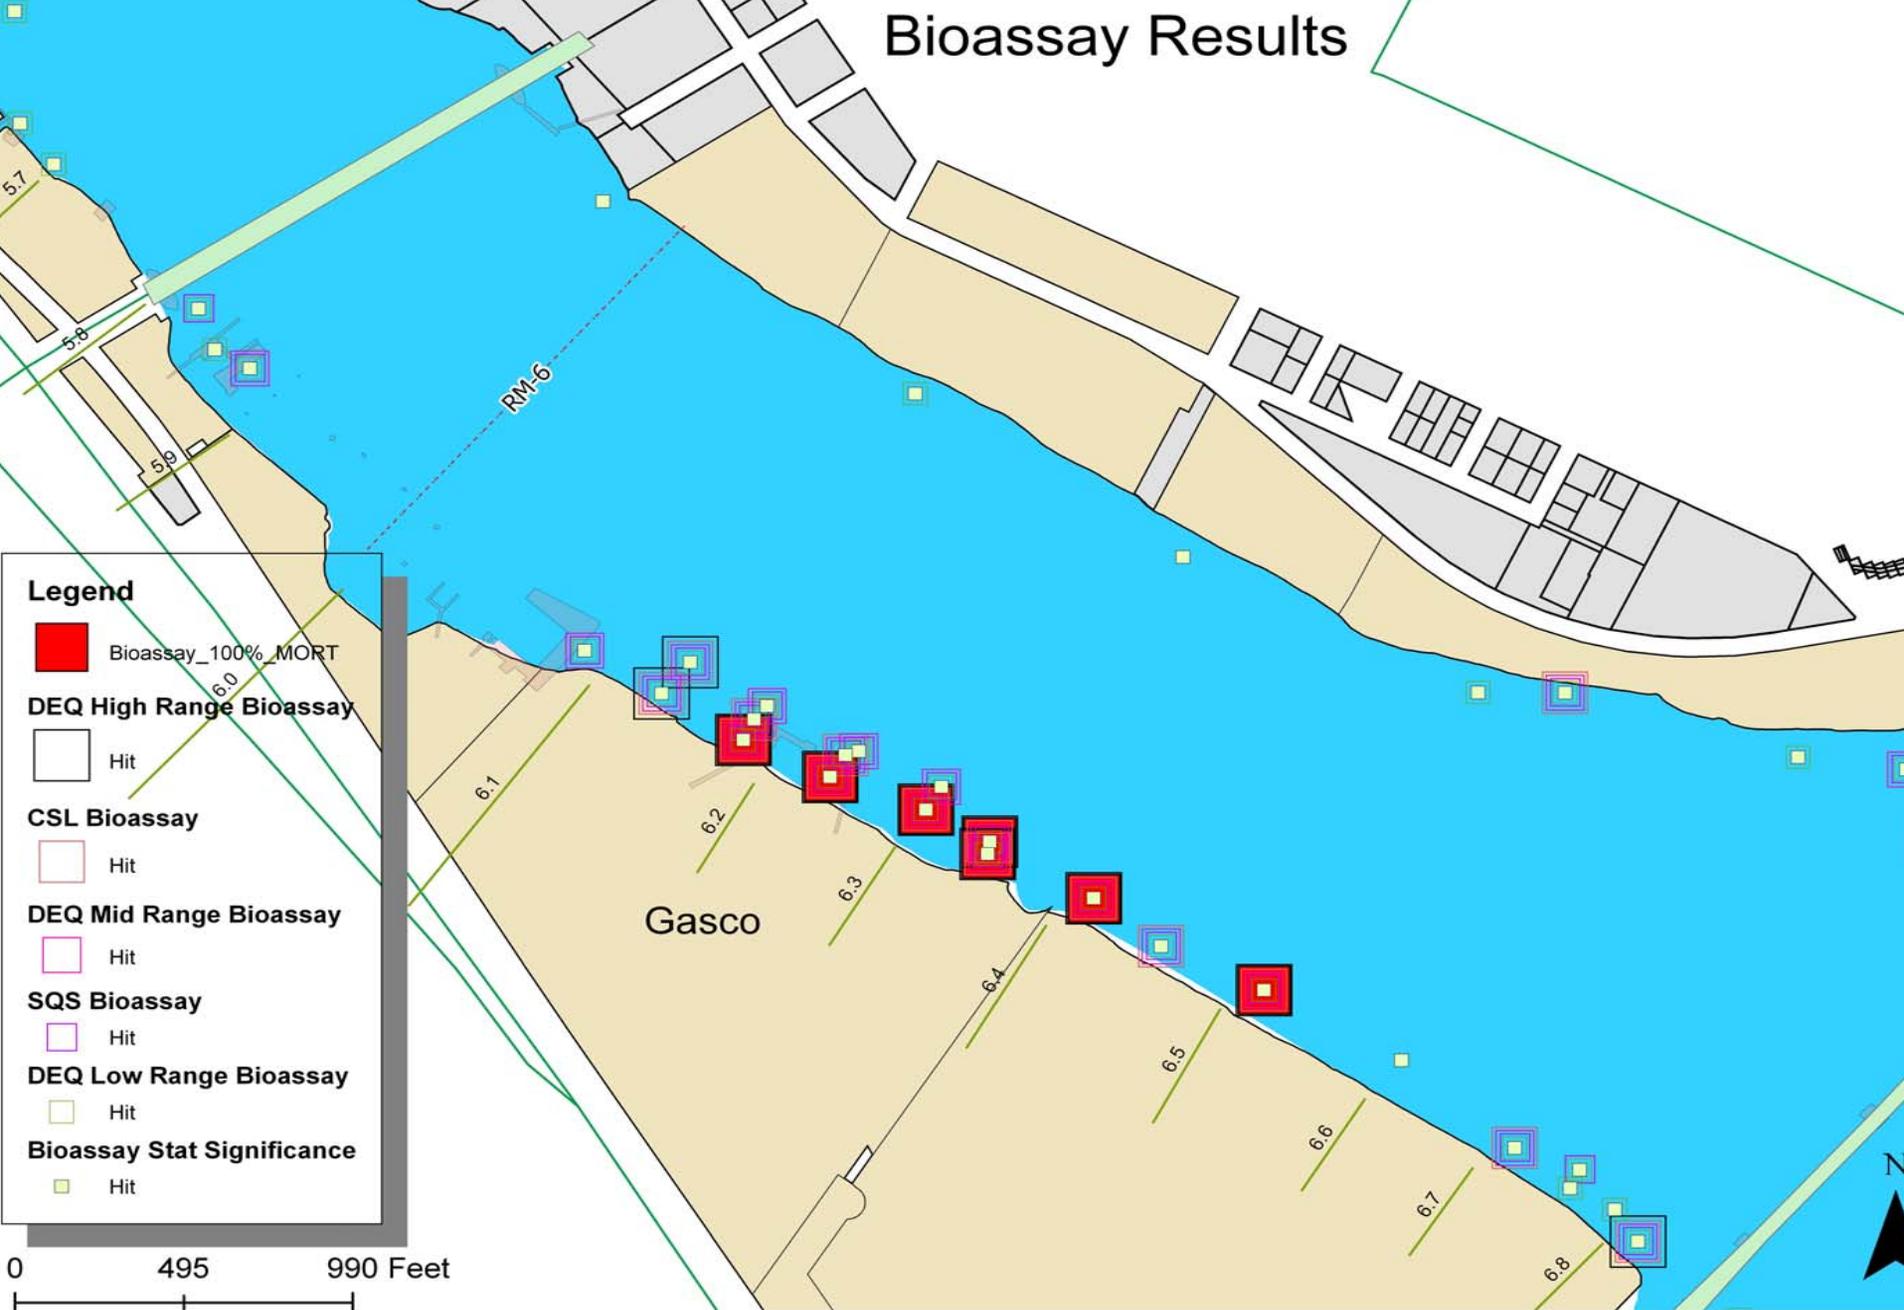
Bioassay Results

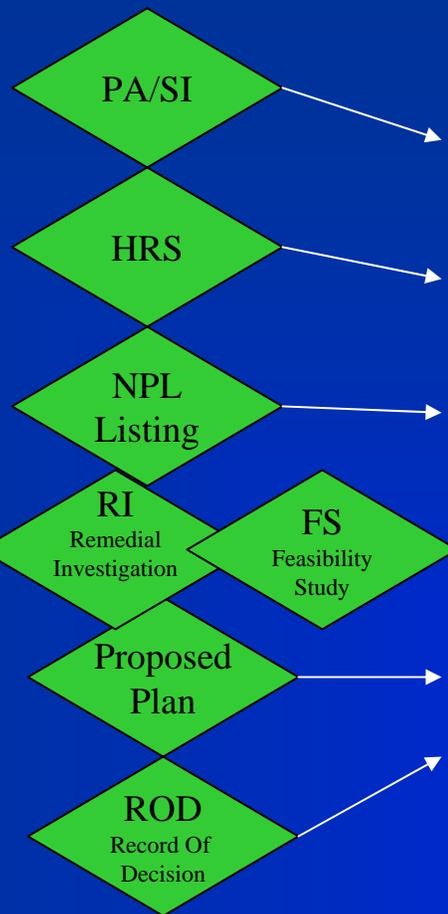
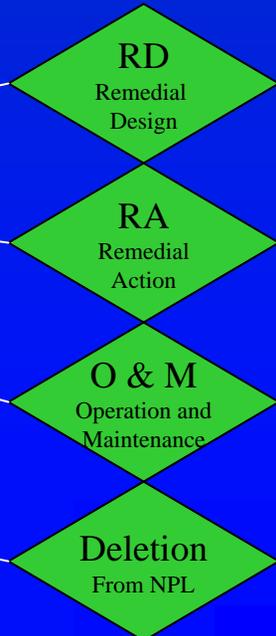
Superfund Remedial Process

Preliminary Assessment/
Site Investigation

Hazard Ranking System scoring

National Priorities List site
listing process

Remedial Investigation
/Feasibility Study

Proposed Plan

Record Of Decision

Remedial Design

Remedial Action

Operation and
Maintenance

Deletion
