Memorandum

To: Sean Sheldrake, U.S. Environmental Protection Agency
From: Ryan Barth and Carl Stivers, Anchor Environmental, L.L.C.
CC: Robert Wyatt, NW Natural
Patty Dost, Schwabe Williamson & Wyatt
Rick Wadsworth, Parametrix
Date: January 18, 2006
Re: January 3, 2006 Post-Construction Visual Monitoring Report, NW Natural Gasco Site, Portland, Oregon

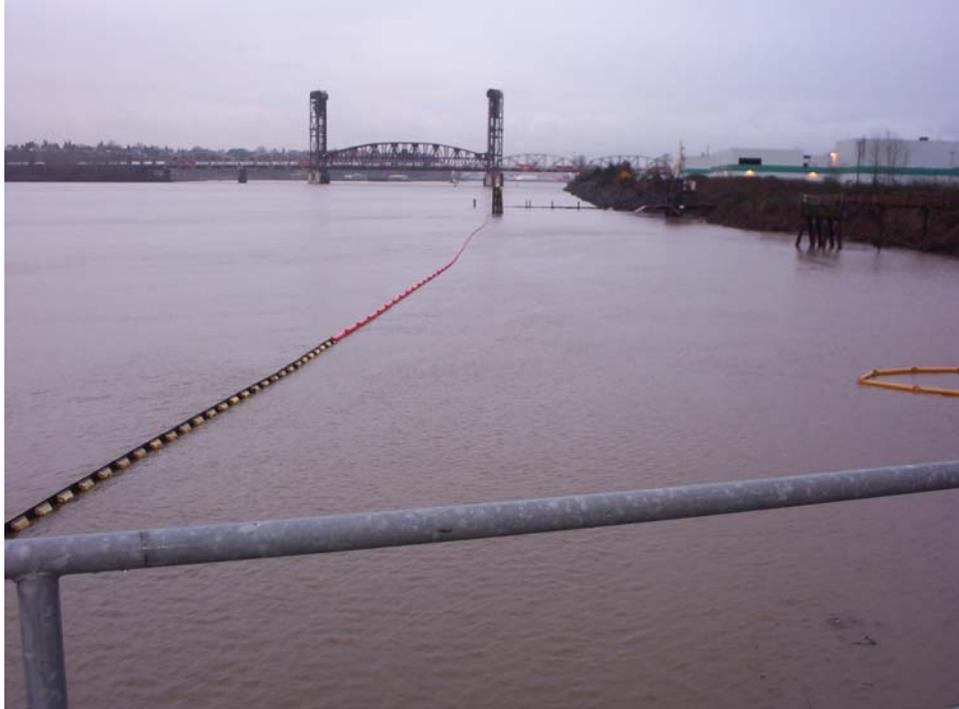
View from the pipeline walkway looking upstream toward outer removal area. Note boom placed to restrict vessel track within the tar body removal area.

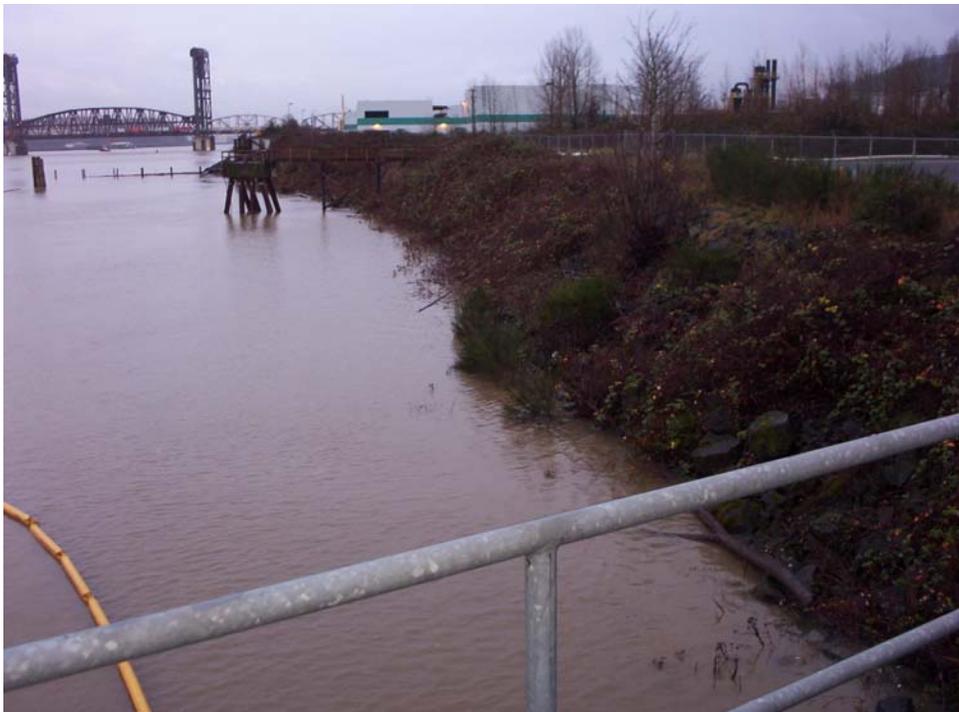
View from the pipeline walkway looking upstream along shoreline.

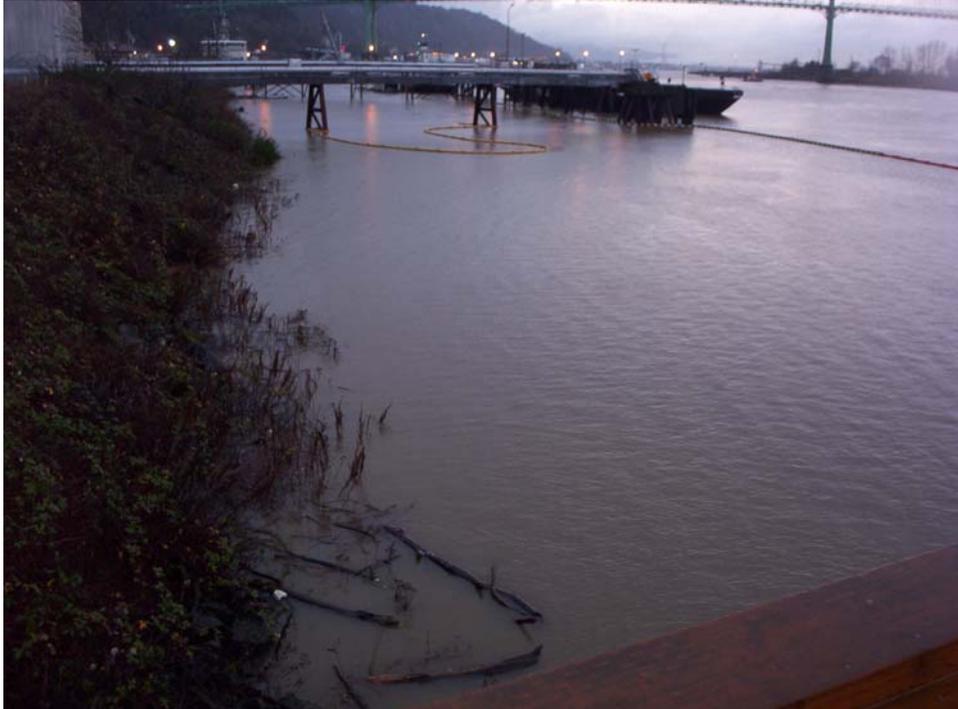
View from upstream observation deck looking downstream along shoreline.

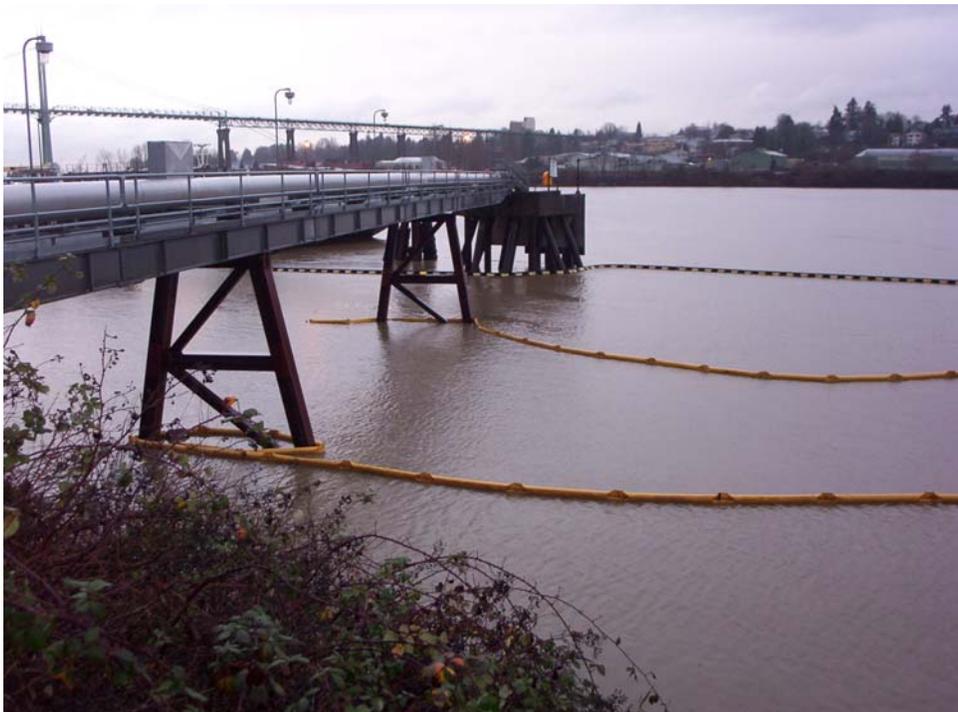
Observations of Longterm Controls (i.e., oil booms, organo-clay mat, etc.): Oil boom has become detached at one end. Organo-clay mat presumably in place underwater.

View from top of bank looking channel ward toward tar body removal area. Note oil containment boom present near the channel ward pipeline support has become detached from the shoreline.

Given the high water level, observations of erosion/deposition of the cap and fringe cover were not physically possible. Otherwise, there were no areas where sheen/product releases were observed in the project vicinity. The oil containment boom that was left in place following construction has become detached from the shoreline and floated out into the river (see Attachment B). Given there was no sheen observed, NW Natural did not see an immediate need for replacement of the boom. Leaving this segment of boom in place was not a part of the EPA-approved design and was a voluntary measure by NW Natural to assist in limiting of potential sheens should they occur. As visual observations continue in coming weeks, NW Natural will assess the need for replacing/reconnecting the boom if sheens are observed. A specific proposal for the type, configuration, and maintenance of such a boom will be submitted to EPA should this condition occur. It should be noted that the tenant currently leasing the NW Natural oil pipeline facilities has a permanent boom installed at the Site (see Attachment B). This boom would act as a second containment barrier for sheens associated with the removal action area should they occur in the short term or over the longer term.

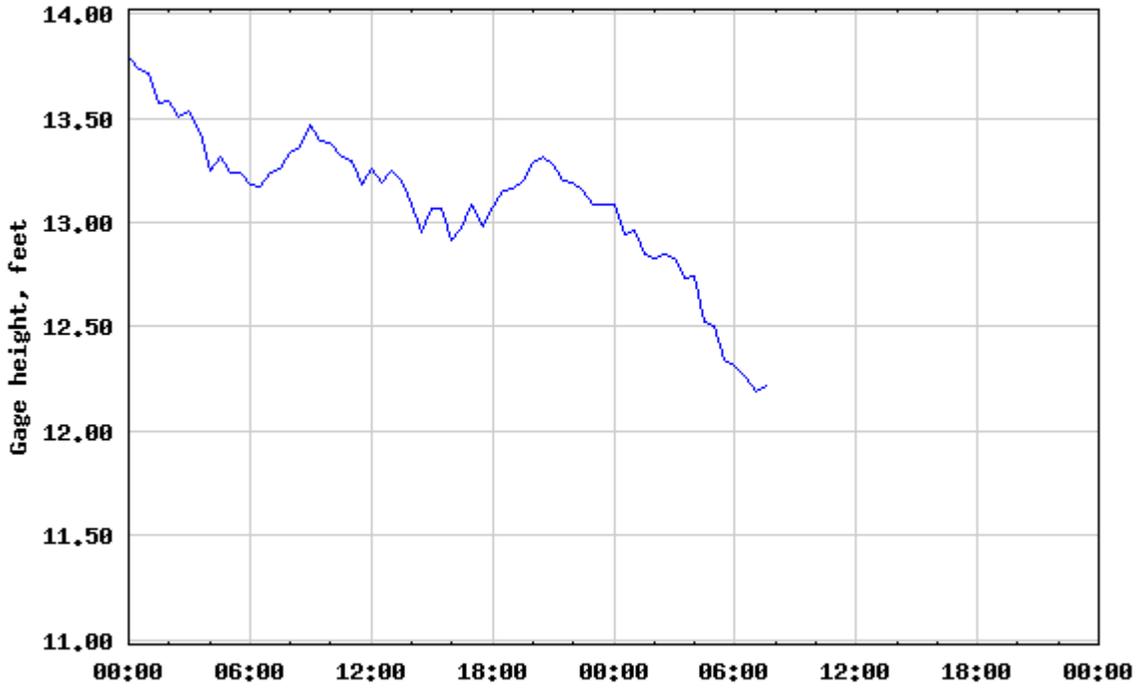
USGS 14211720 WILLAMETTE RIVER AT PORTLAND, OR

Monitoring occurred right before a daily low tide (17:07) and before, during, and after sunset (16:40). Although monitoring was conducted during a low tide, the shoreline cap extents, beach area, and riprap were completely underwater due to the high stage of the river. The water level was above the line of vegetation along the banks of the river. According to USGS real-time water data for gage 14211720 (Willamette River at Portland, OR; Attachment C), the gage height of the river at this time was approximately 13 feet NAVD 88. The river water was turbid and light brown in color. In addition, several very large logs (i.e., approximately 2 feet in diameter) and other wood debris were observed floating in the project area or otherwise snagged on pilings.
