**Explanation of Significant Differences**

**100 Area Remaining Sites Interim Remedial Action**  
**Record of Decision**

**Hanford Site**  
**Benton County, Washington**

**August 2009**

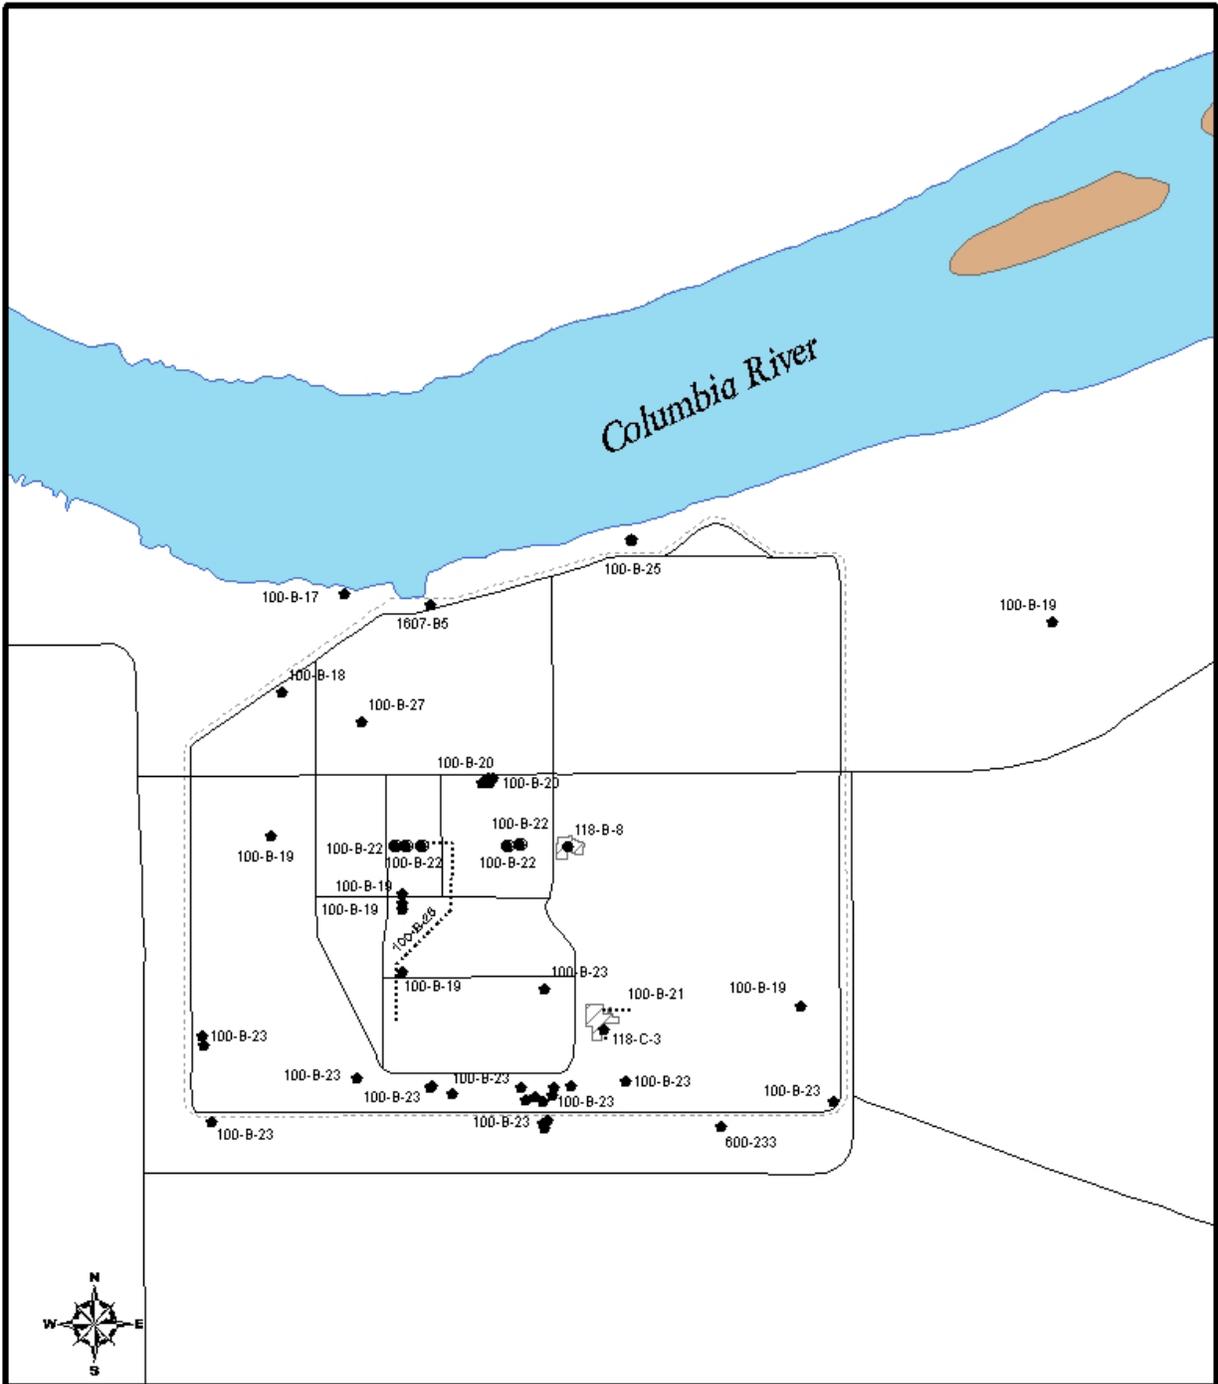
**Figure 3. Waste Sites in the 100-B/C Area to Be Added to Tables A-1 and A-2 of the Remaining Sites ROD.**

Eighty-seven additional waste sites in the 100-BC-1, 100-DR-1, 100-DR-2, 100-FR-1, 100-HR-1, 100-KR-2, 100-IU-2, and 100-IU-6 OUs (see Figures 3 through 10) requiring additional characterization are added to Table A-2 of the Remaining Sites ROD. These sites meet the “plug in” waste site profile in the ROD. If contamination levels above established cleanup levels are indicated, the waste sites will be remediated in accordance with the selected ROD remedy and an approved RD/RA work plan. Details of the sites are given in Table 2; these waste sites have been determined by the Tri-Parties to be candidate waste sites for remediation due to hazardous substances that may be present at concentrations that pose a threat to human health and the environment. The Tri-Parties also have determined that these sites are similar to the other candidate waste sites listed in Table A-2 of the Remaining Sites ROD because they have similar contaminants, similar waste characteristics, and similar contaminated media; this determination is based on historical information and records, as well as analogous data from other similar waste sites.

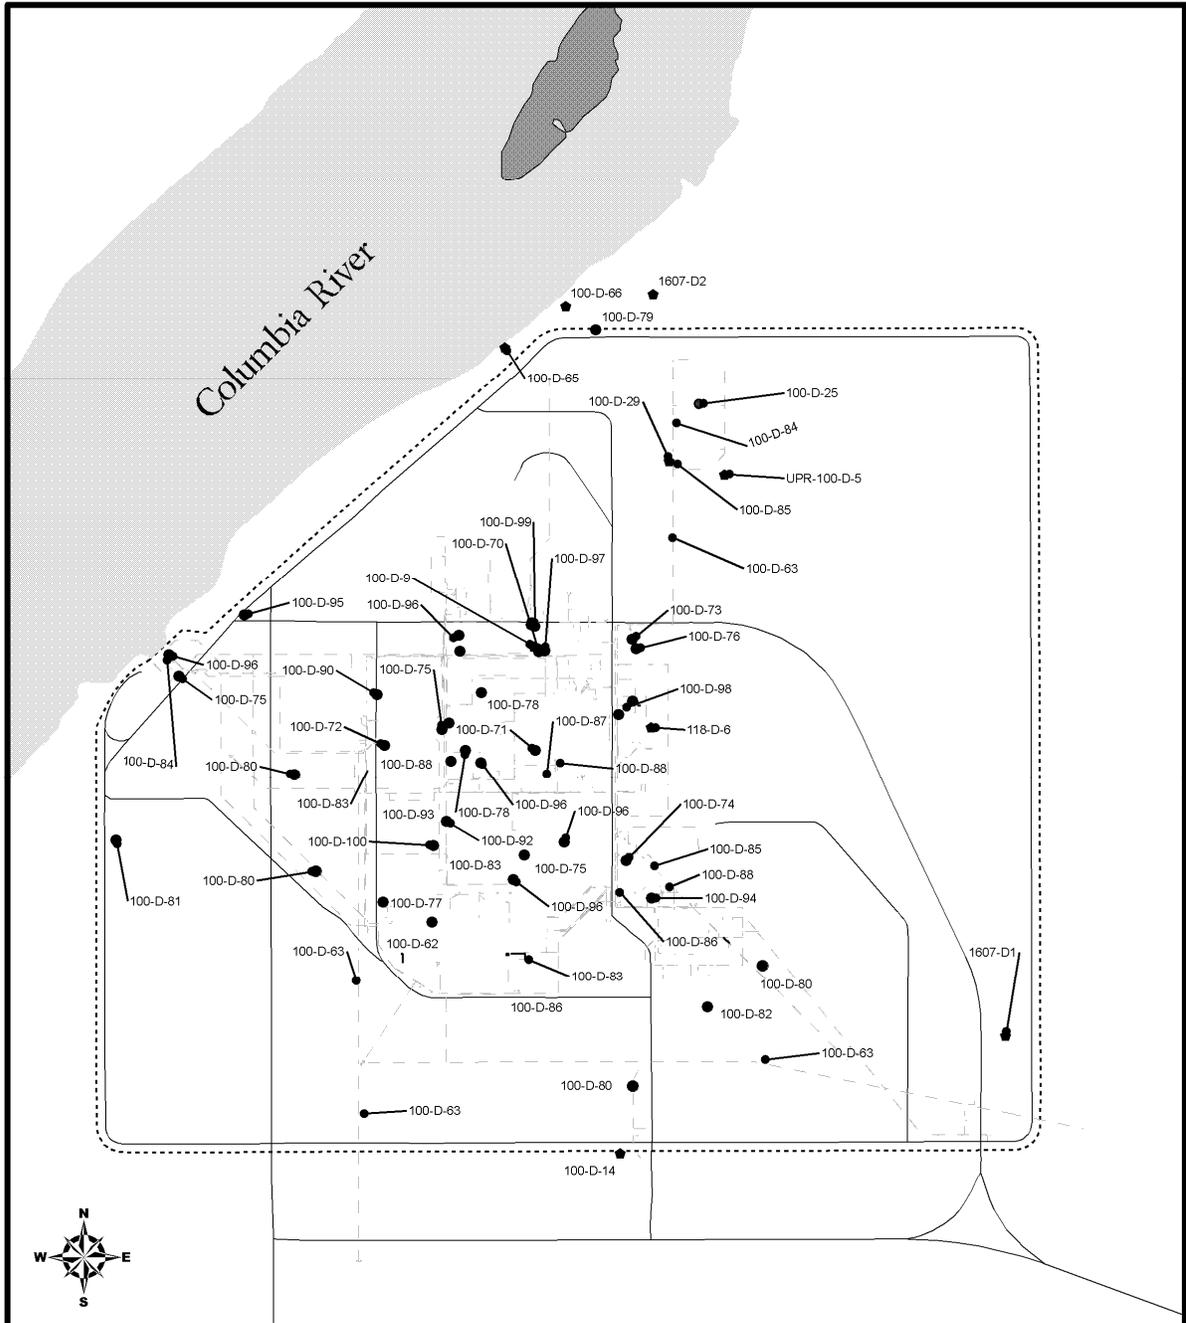
**Figure 4. Waste Sites in the 100-D Area to Be Added to Tables A-1 and A-2 of the Remaining Sites ROD.**

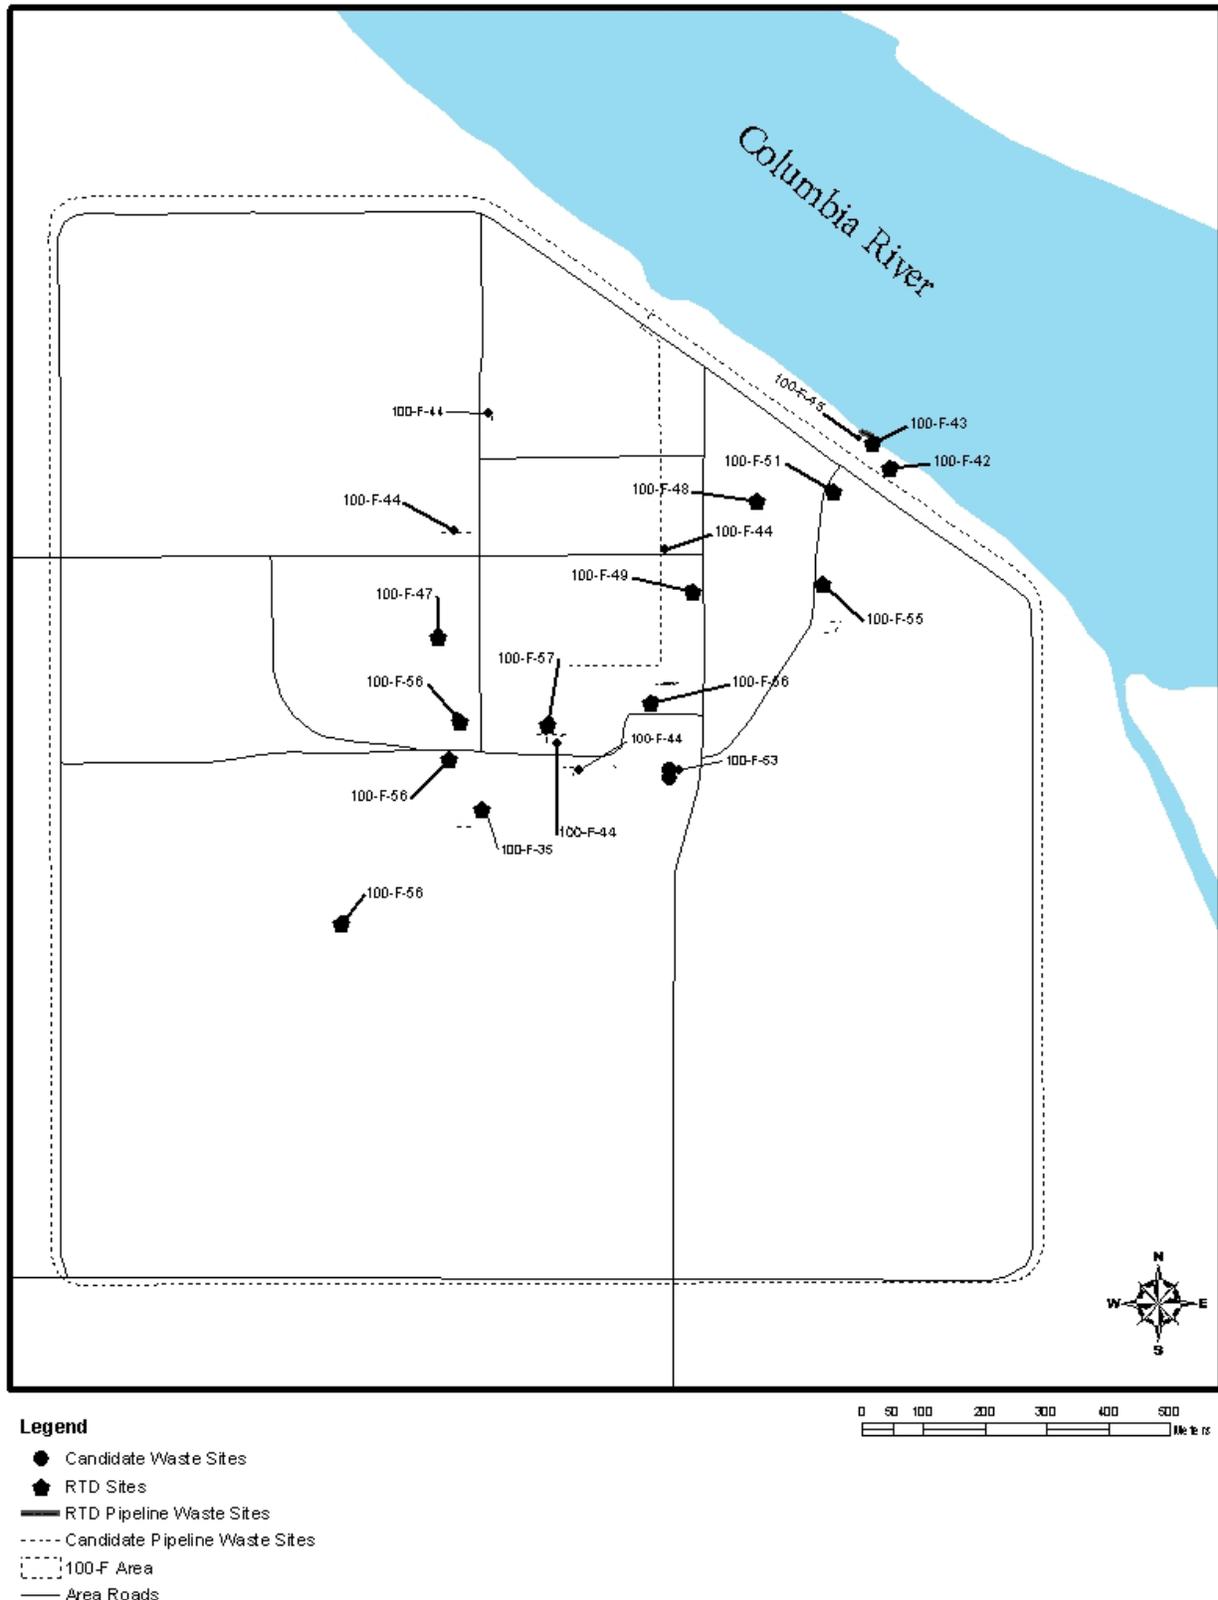
**Figure 5. Waste Sites in the 100-F Area to Be Added to Tables A-1 and A-2 of the Remaining Sites ROD.**

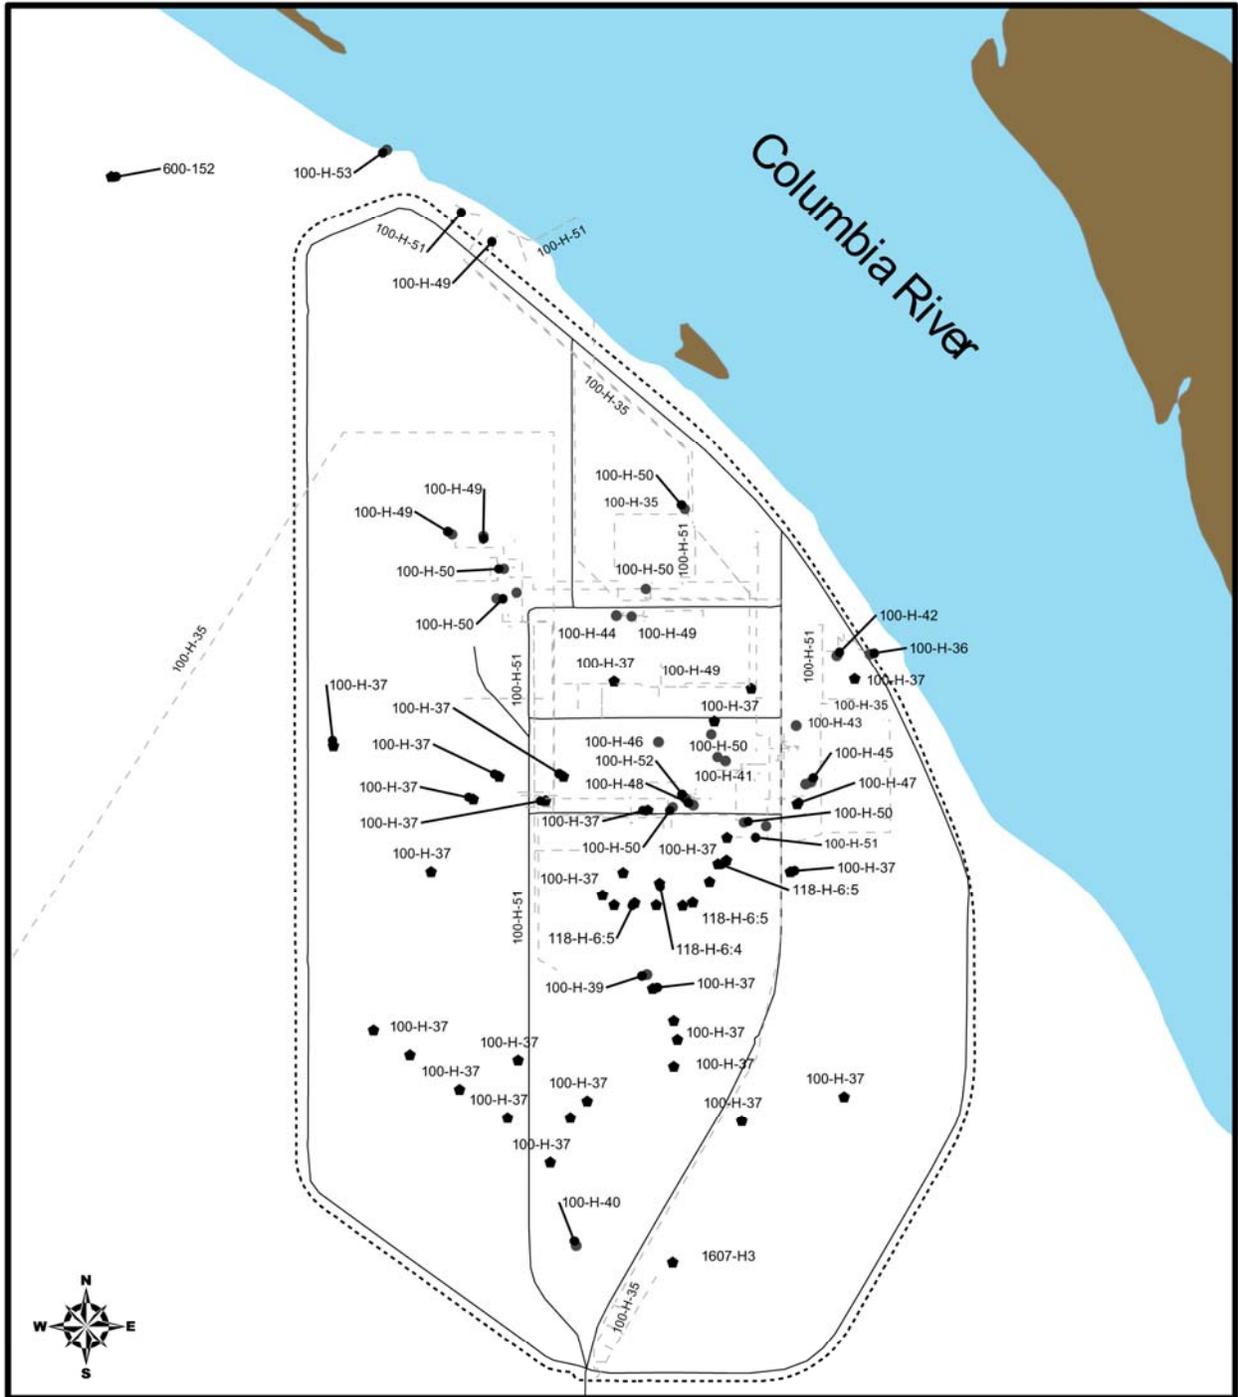
**Figure 6. Waste Sites in the 100-H Area to Be Added to Tables A-1 and A-2 of the Remaining Sites ROD.**

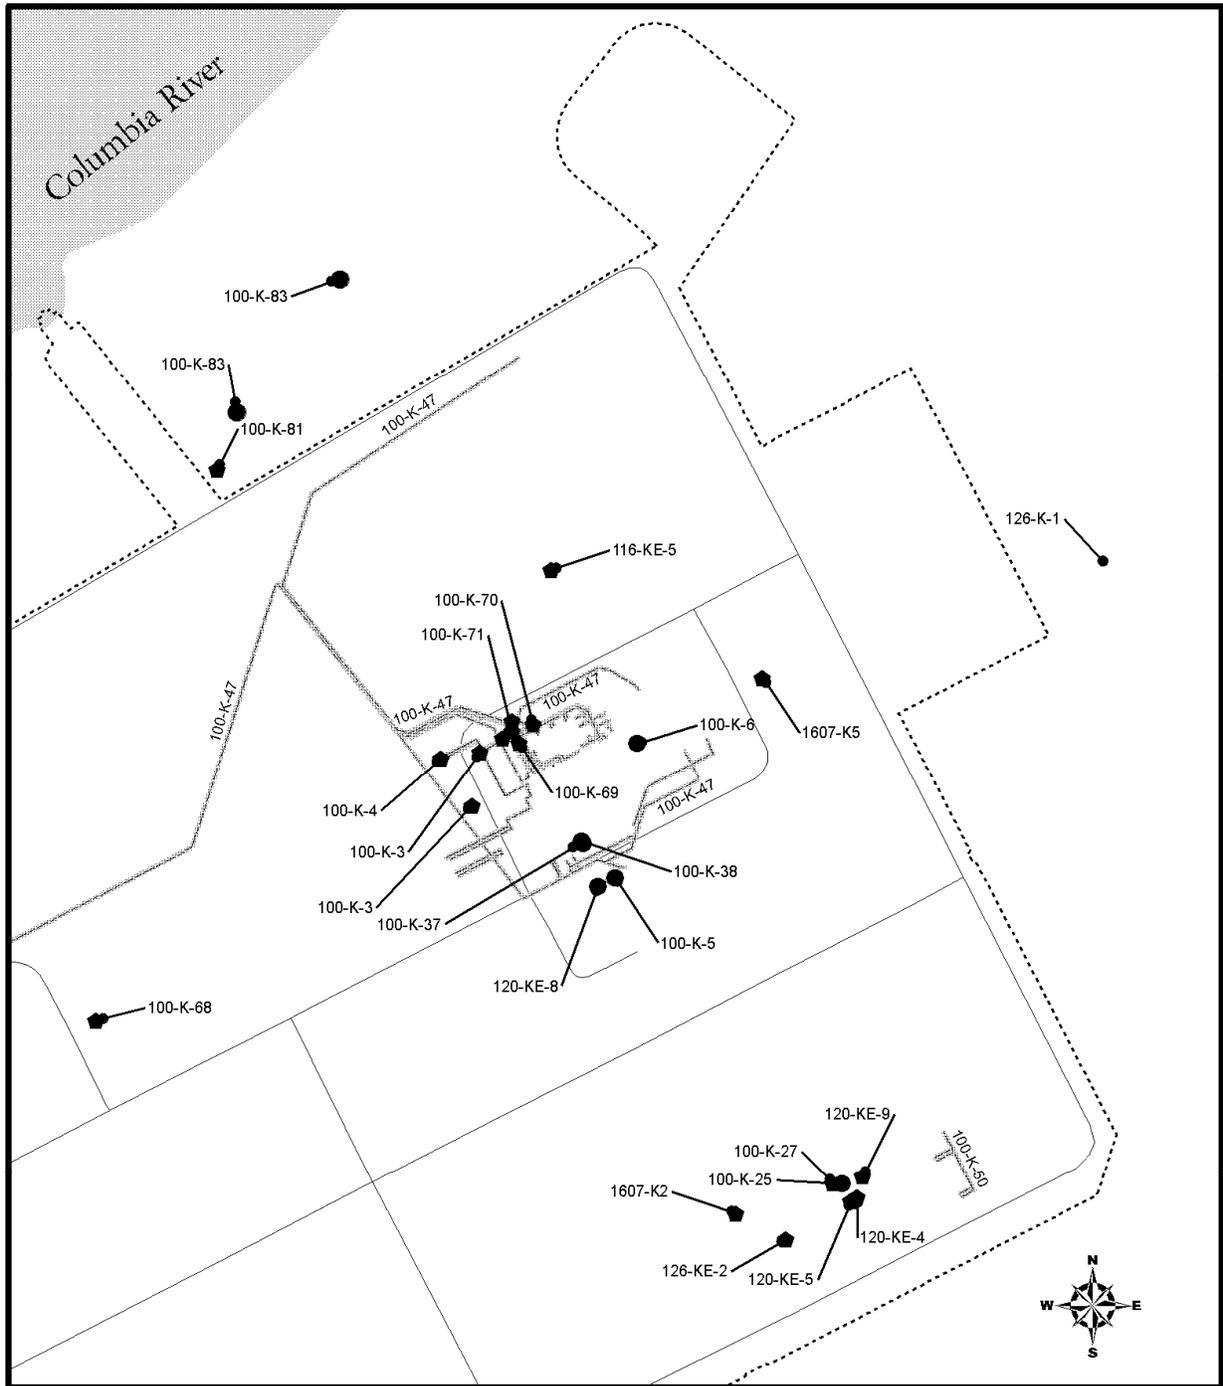
**Figure 7. Waste Sites in the 100-K East Area to Be Added to Tables A-1 and A-2 of the Remaining Sites ROD.**

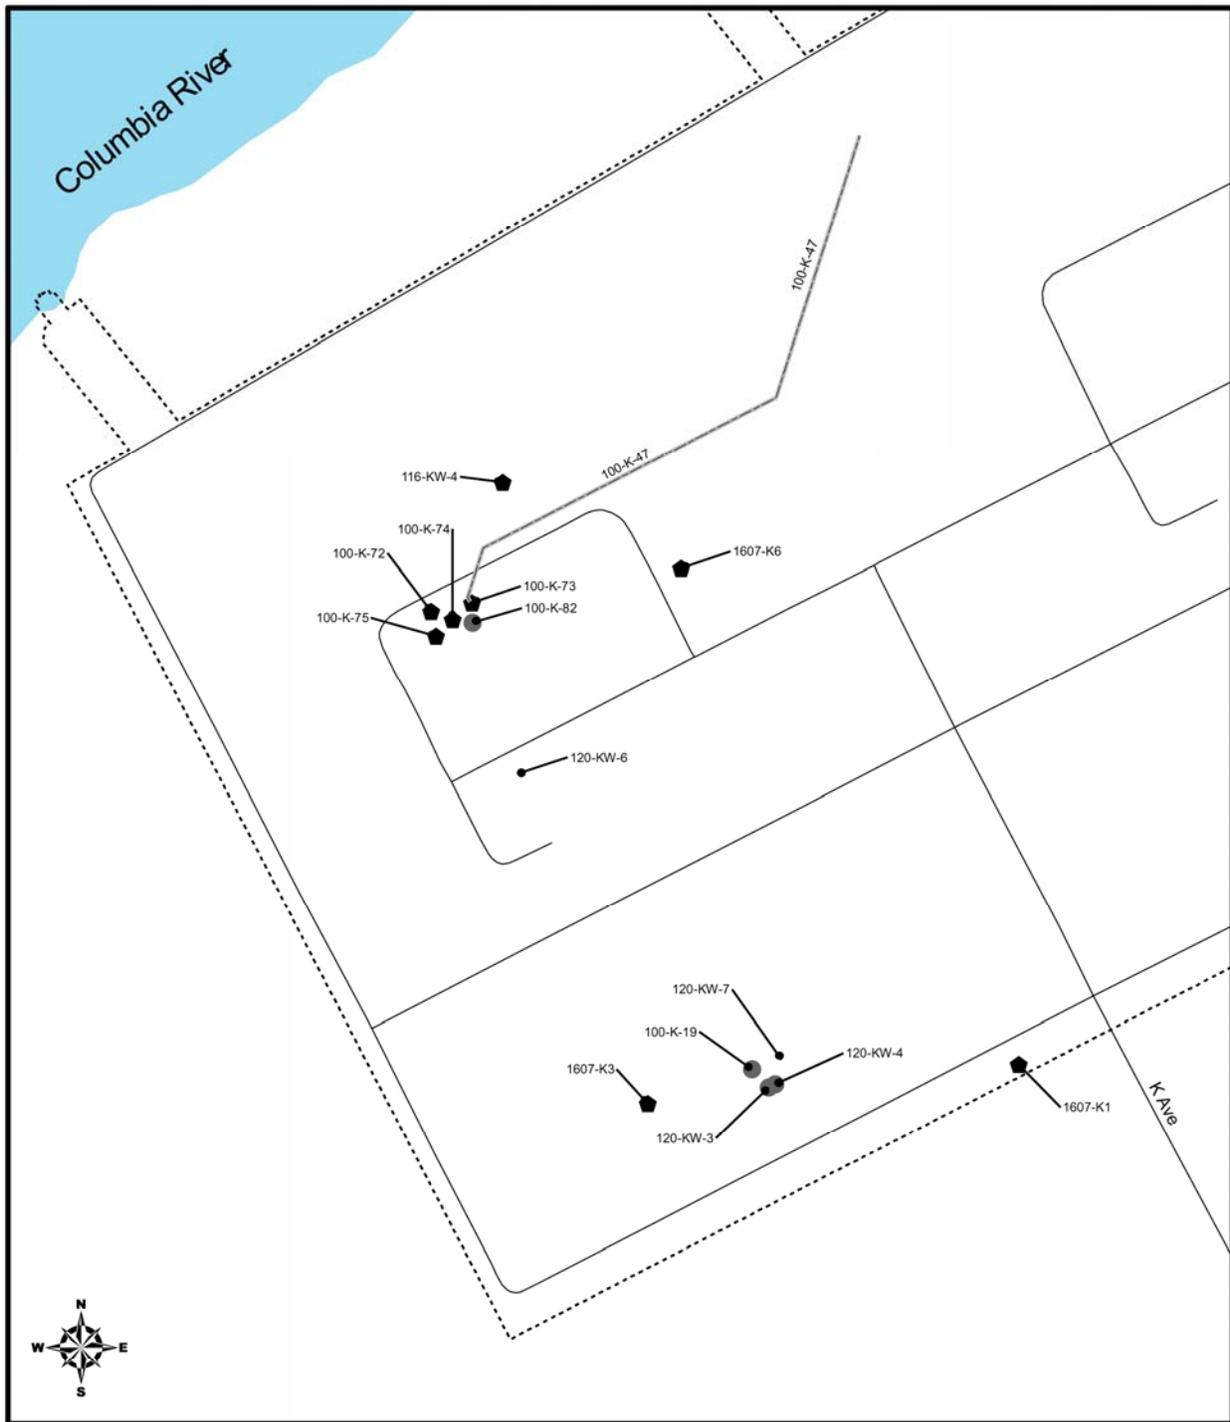
**Figure 8. Waste Sites in the 100-K West Area to Be Added to Tables A-1 and A-2 of the Remaining Sites ROD.**

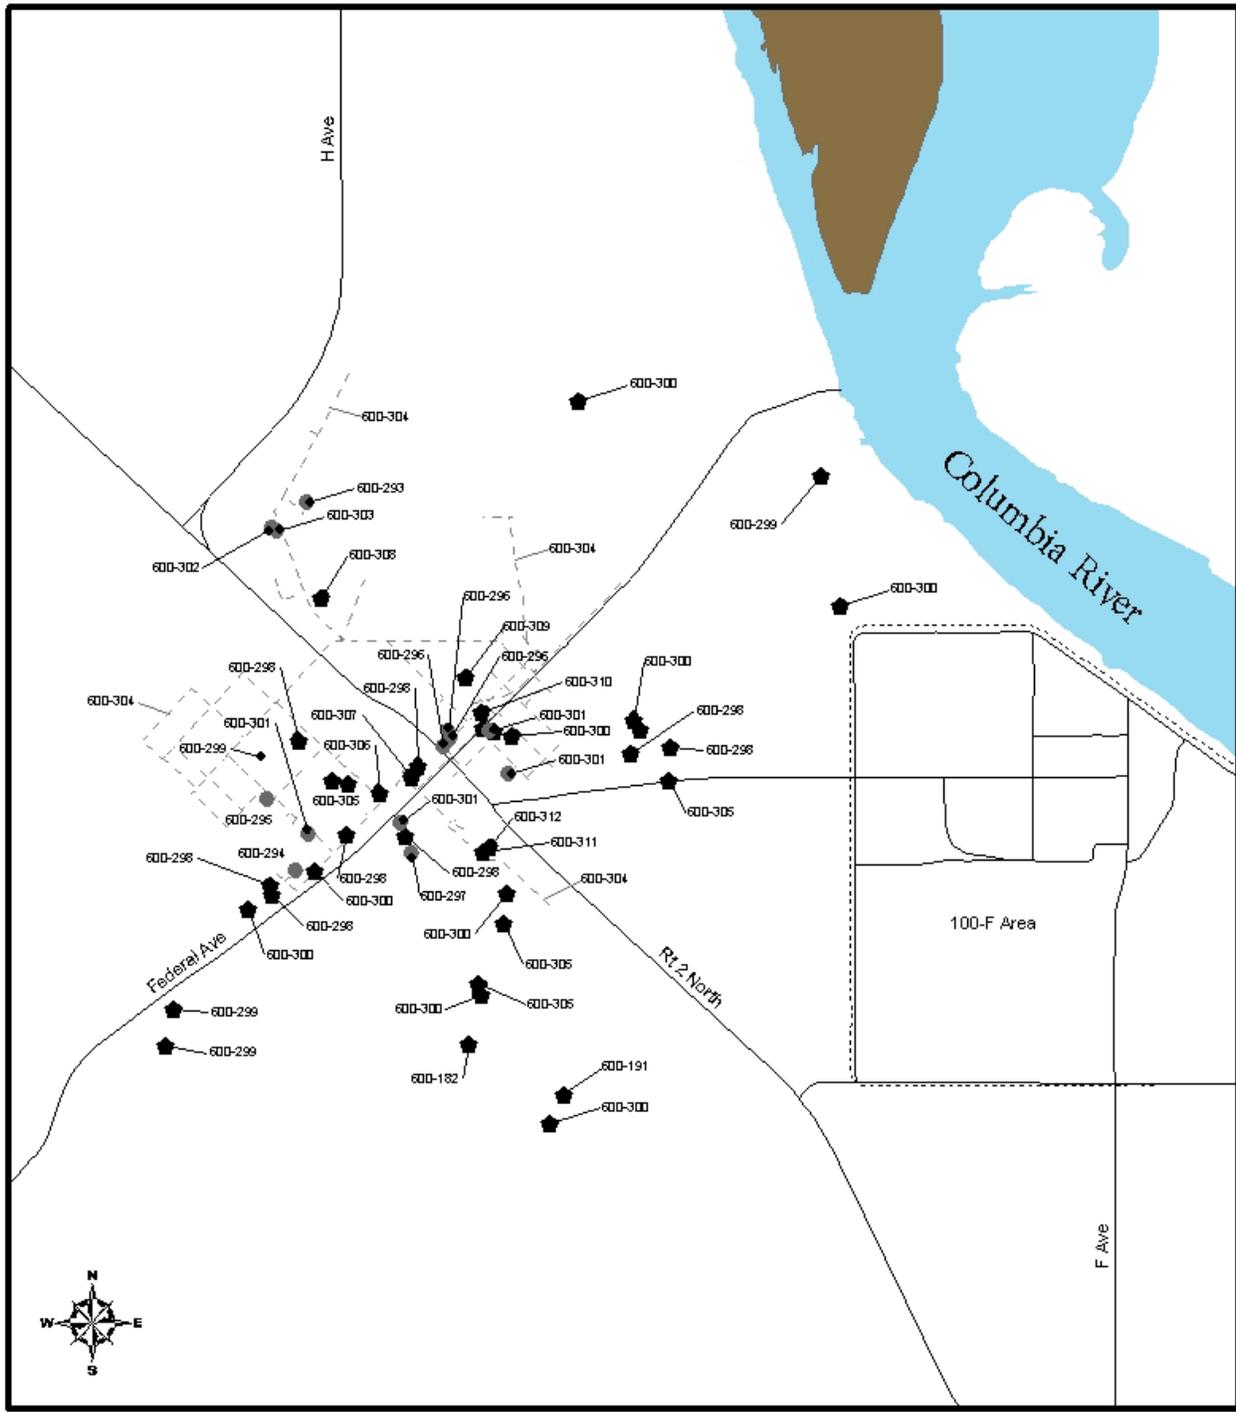
**Figure 9. Waste Sites in the 100-IU-2 Area to Be Added to Tables A-1 and A-2 of the Remaining Sites ROD.**

**Note:**  
 1) Sites may have multiple locations.  
 2) The 600-178 RTD waste site is located to the south and shown on Figure 10.

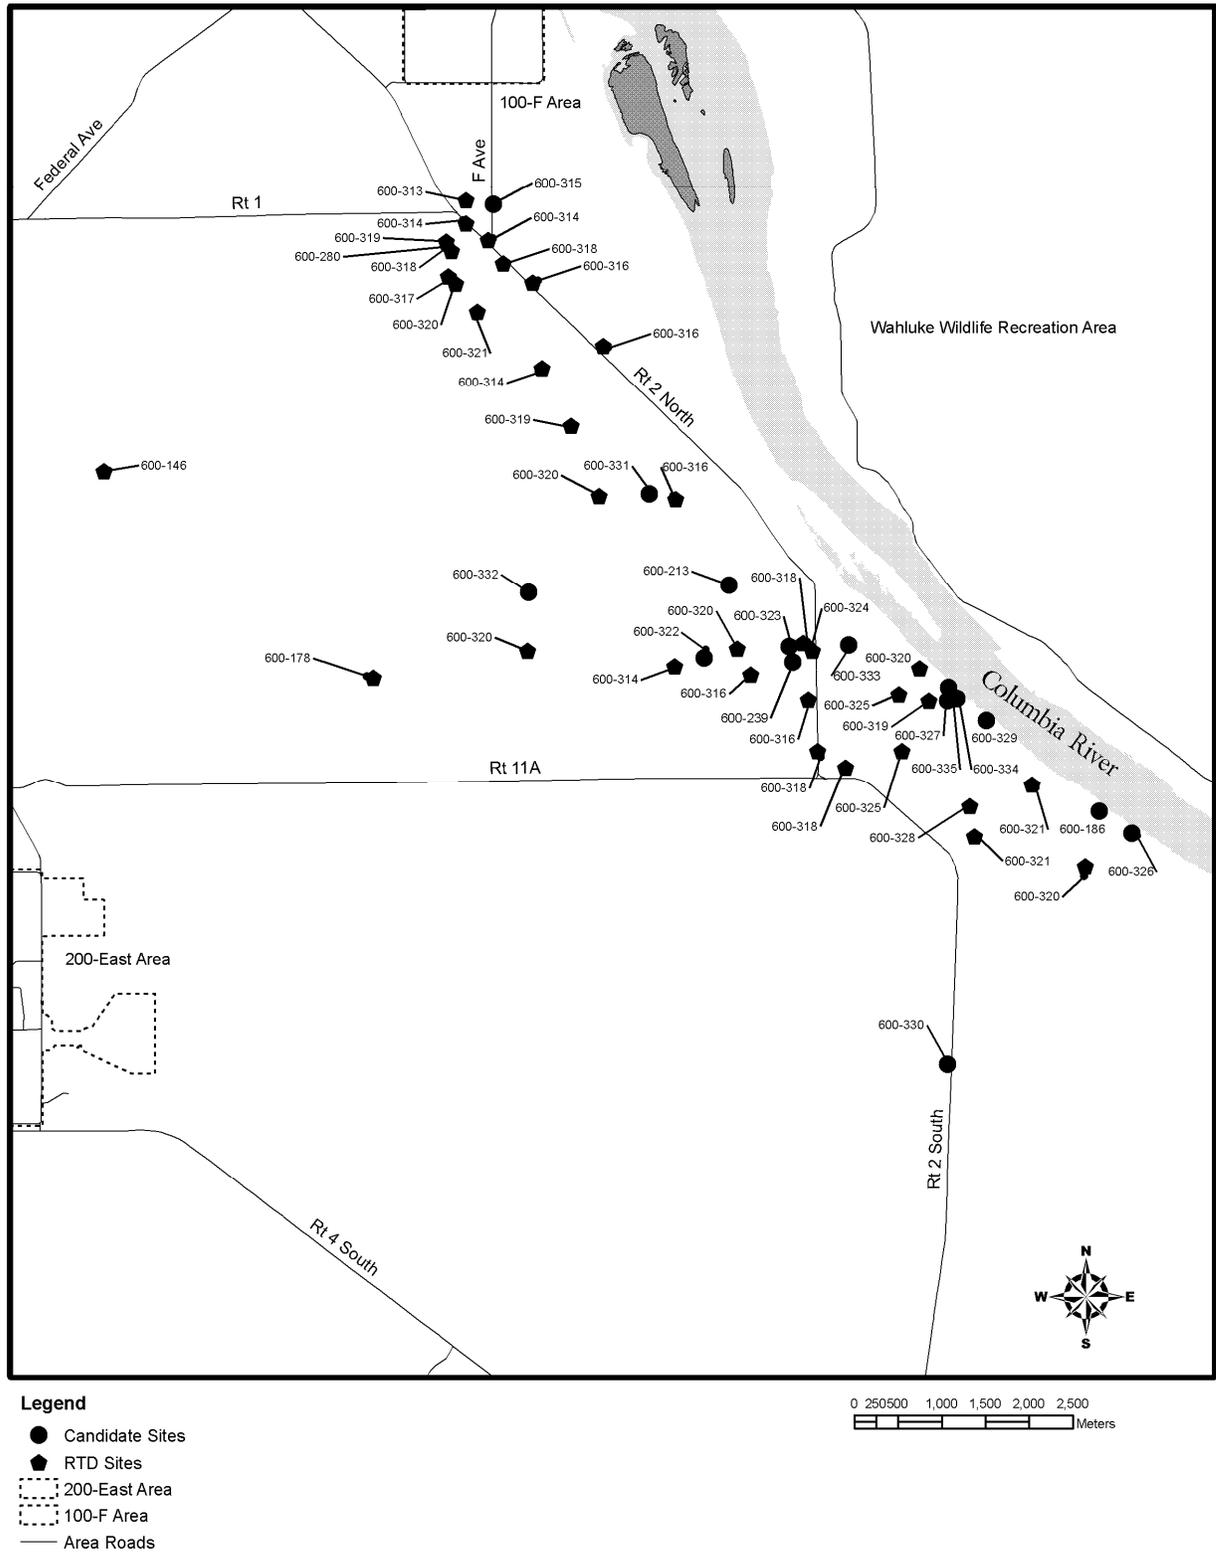
**Figure 10. Waste Sites in the 100-IU-6 Area to Be Added to Tables A-1 and A-2 of the Remaining Sites ROD.**

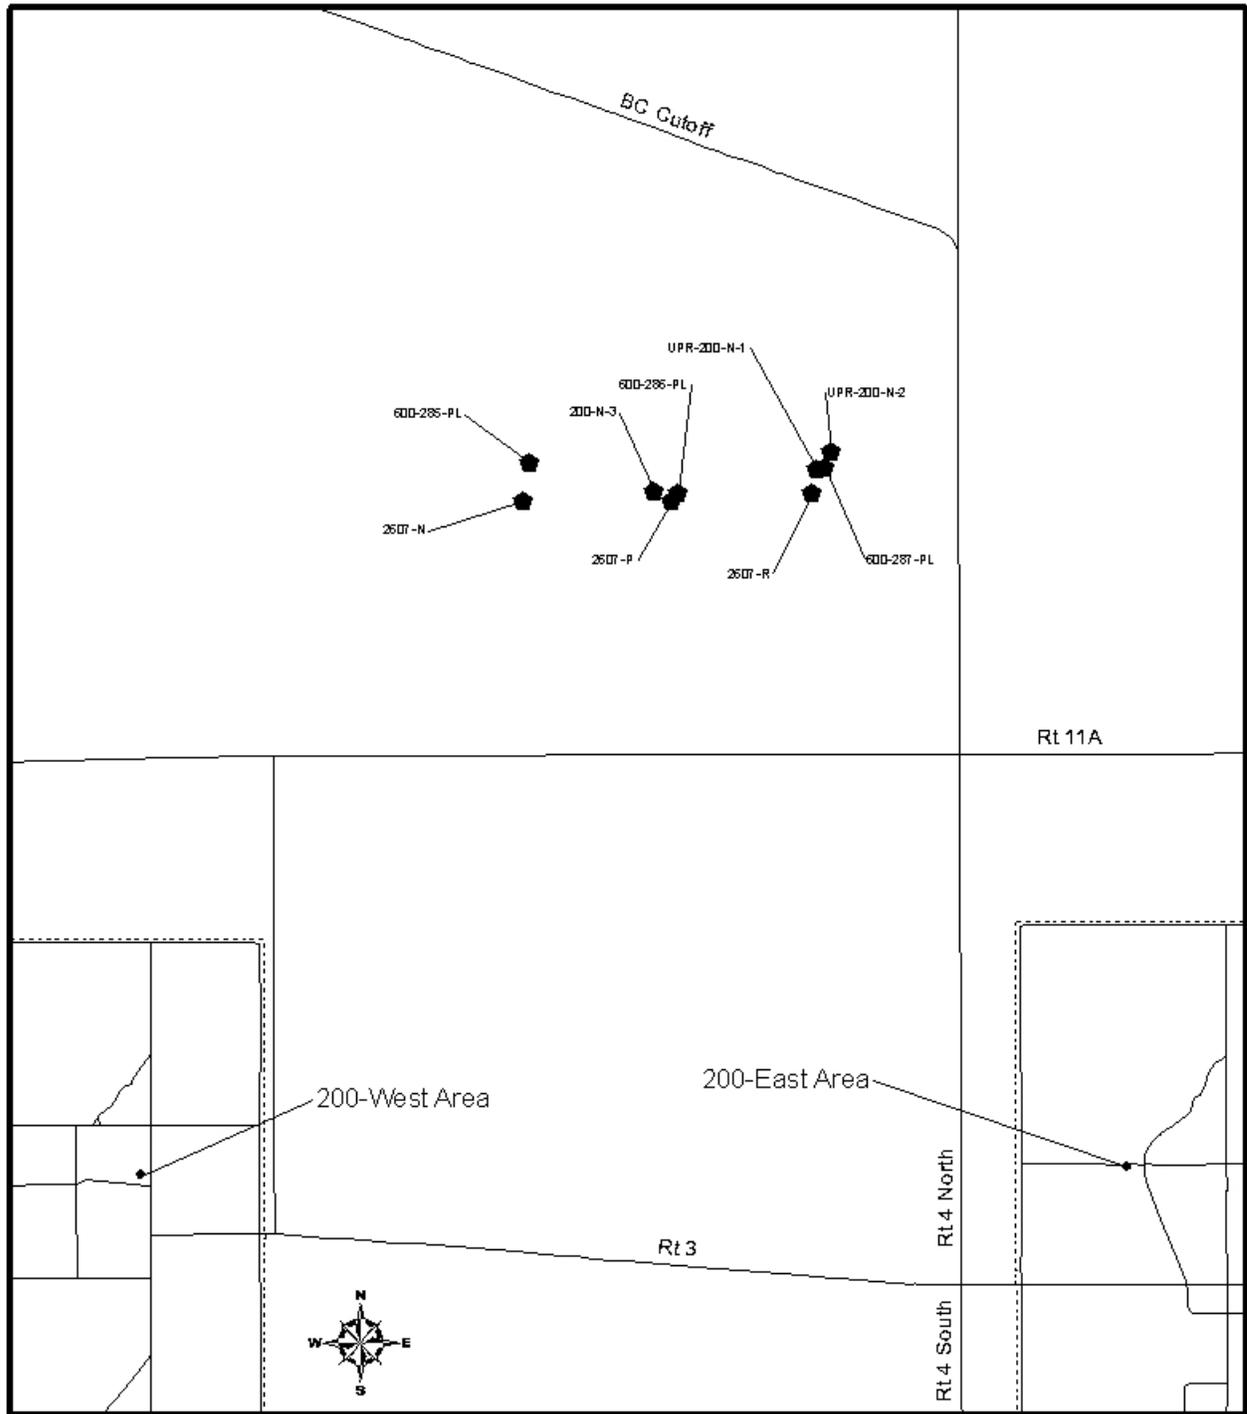
**Figure 11. Waste Sites in the 200-CW-3 Area to Be Added to Tables A-1 and A-2 of the Remaining Sites ROD.**

The Remaining Sites ROD did not provide for the use of the “plug-in” approach for the 200-CW-3 OU, even though 200-CW-3 waste sites are included in the Remaining Sites ROD. Since the remaining Sites ROD was issued, additional 200-CW-3 sites have been identified that are similar to the waste sites in the Remaining Sites ROD in terms of contaminants, contaminated media and contaminated waste material. The Remaining Sites ROD is being revised to allow sites in the 200-CW-3 OU that share common physical and contamination characteristics with sites listed in the Remaining Sites ROD to be added as plug-in and candidate sites in accordance with ROD requirements.
