OLYMPIC VIEW RESOURCE AREA

**YEAR 5
ANNUAL MONITORING REPORT
2007**

City of Tacoma
October 30, 2007

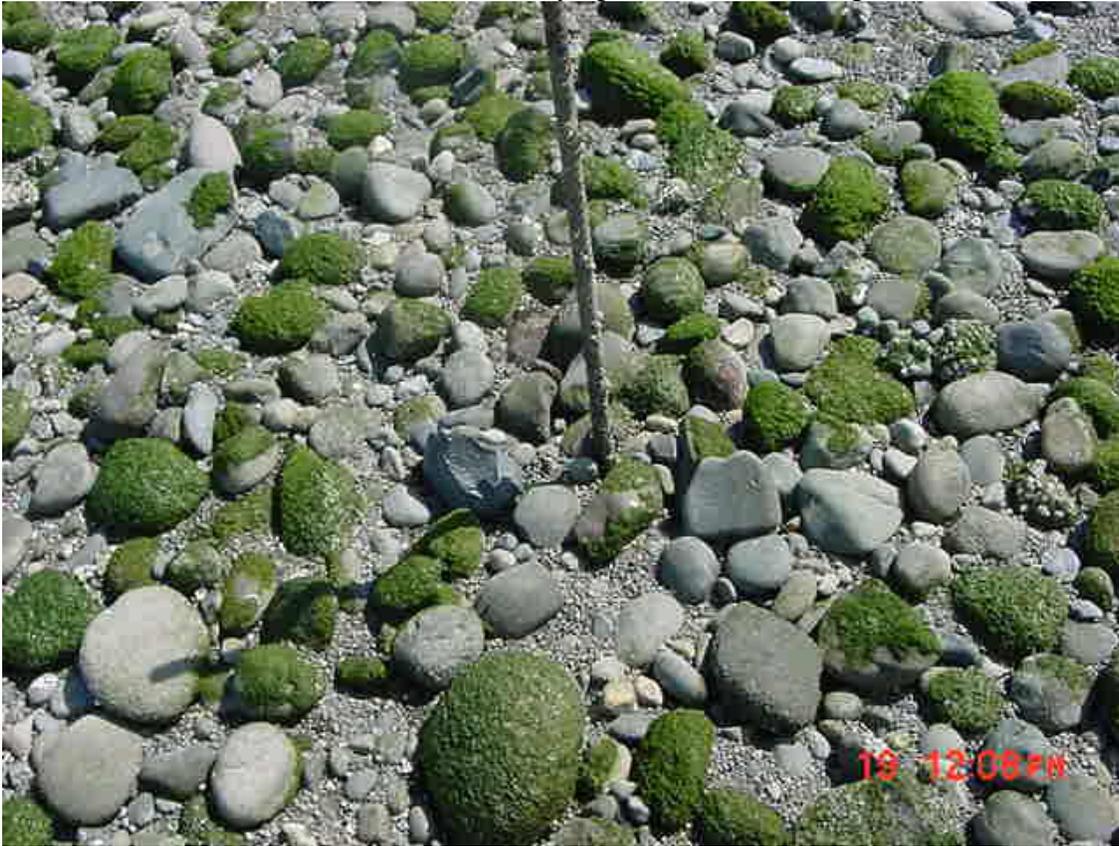
Close up of Erosion Protection Material A

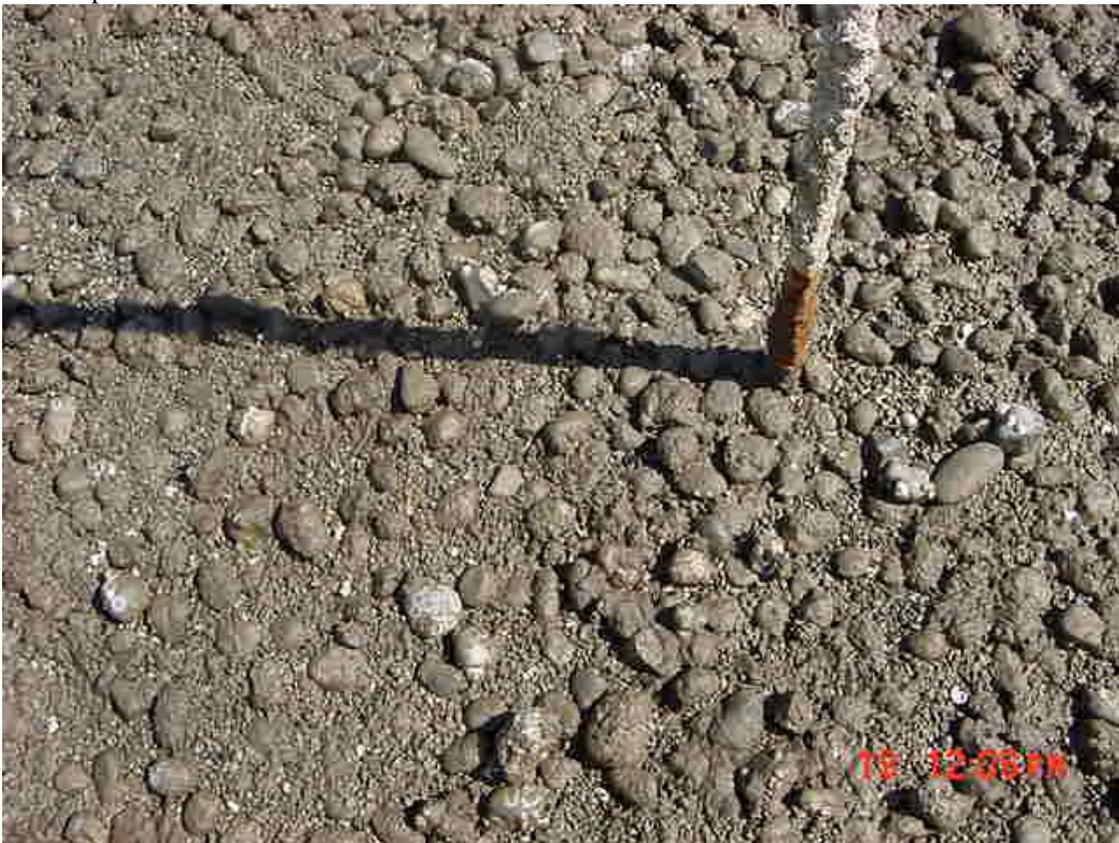
Close up of Erosion Protection Material B
