UNITED STATES ENVIRONMENTAL PROTECTION AGENCY

MEMORANDUM

TO: Denise Baker, Site Assessment Manager
Office of Environmental Cleanup
FROM: Jed Januch, David Frank, and Lorraine Edmond
Office of Environmental Assessment
SUBJECT: Trip report and X-ray diffraction analysis of samples collected April 6, 2006
Project Code ESD-122A, Swift Creek Asbestos project

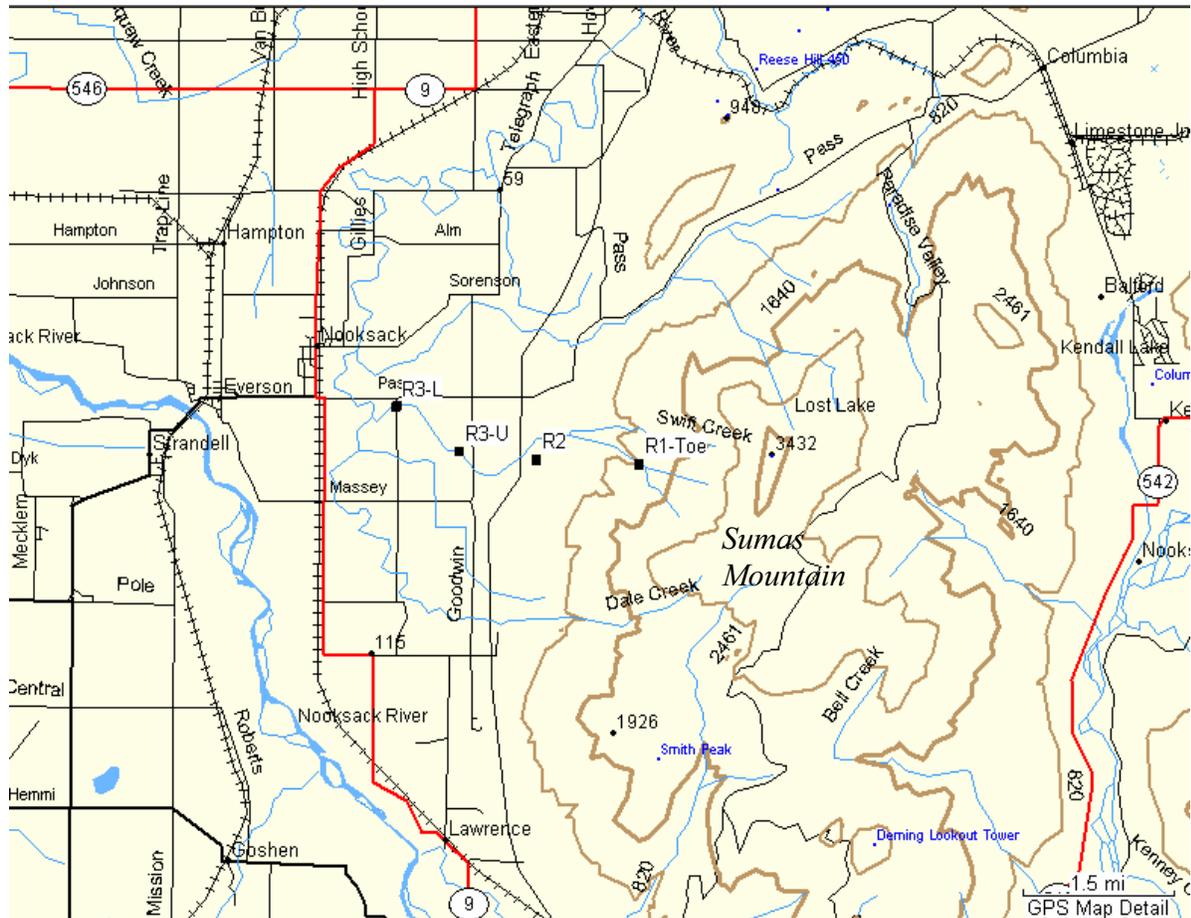
Figure 1. Location of four reaches of Swift Creek from which samples were collected April 6, 2006. Reaches are designated as follows:

- R1-Toe - toe of the Swift Creek landslide on west slope of Sumas Mountain.
- R2 - Swift Creek channel near forest land at wooden bridge.
- R3-U - upper reach of Swift Creek in farmland near Goodwin Road.
- R3-L - lower reach of Swift Creek in farmland near Oat Coles Road.

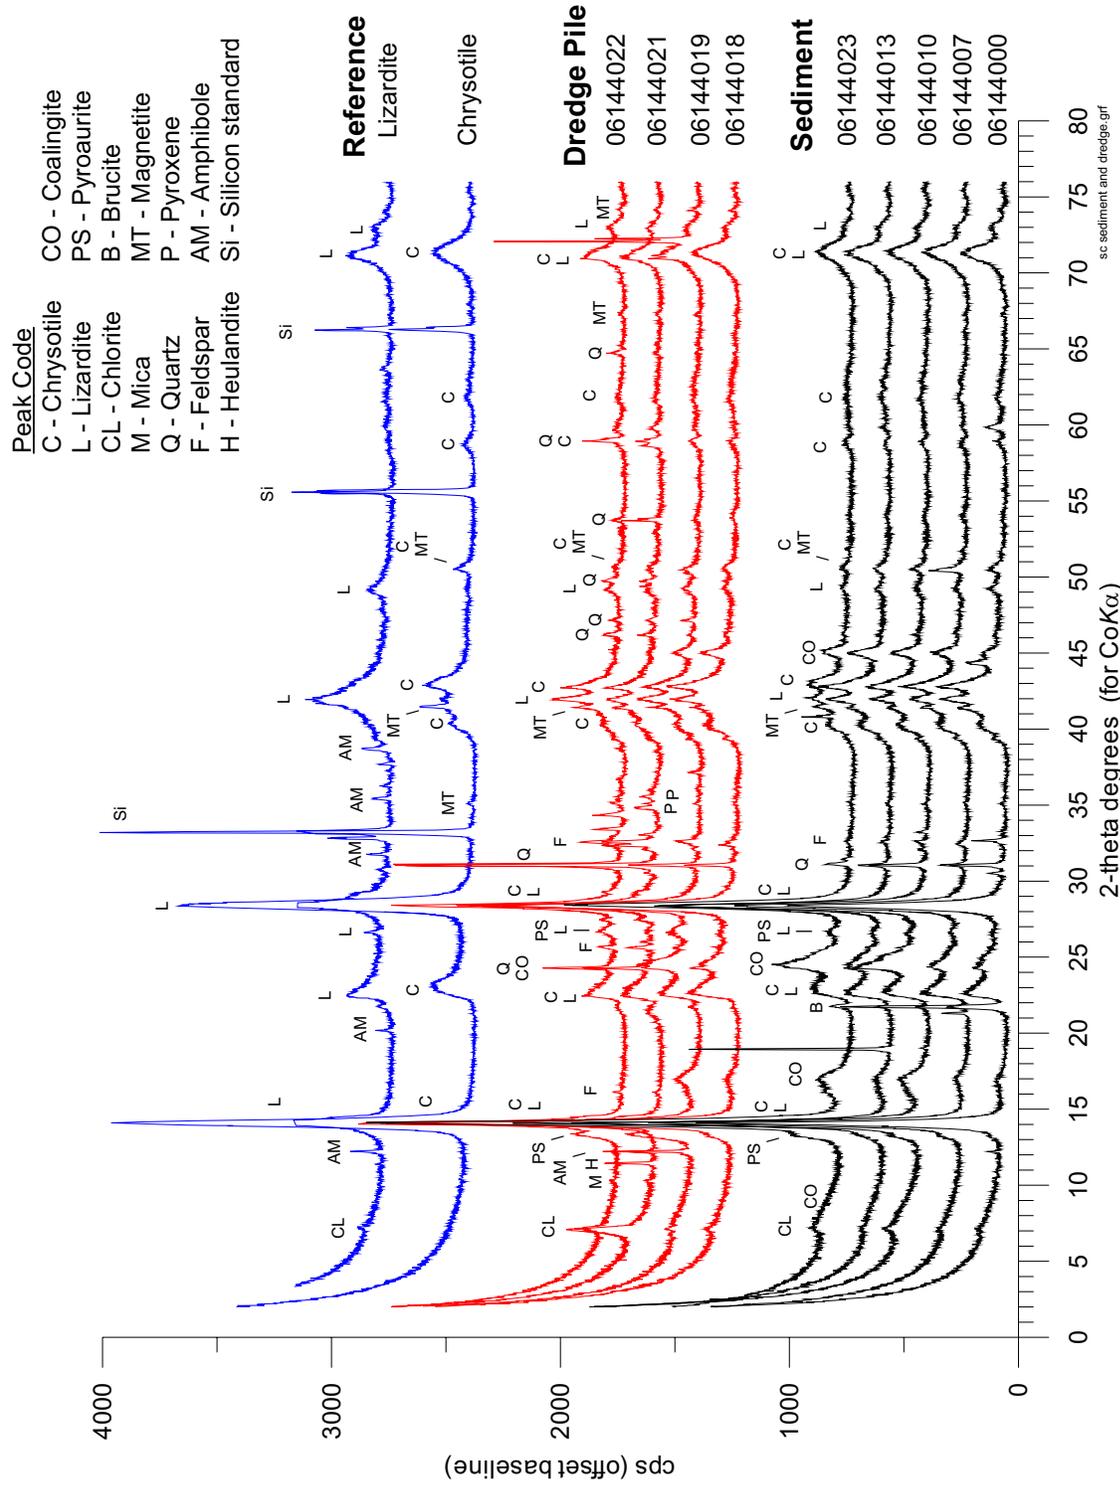
Figure 2. XRD patterns of chrysotile and lizardite reference materials, and bottom sediment and dredge pile material from Swift Creek.

The diffraction characteristics for chrysotile and lizardite indicate that most of the chrysotile in the bottom sediment samples occurs as clinochrysotile with a smaller component of orthochrysotile, and most of the lizardite occurs as lizardite-1T. Other structural types of chrysotile and lizardite may be present. Coalingite (a magnesium iron hydroxy carbonate) has broad diffraction peaks indicating it is a poorly crystallized phase. The hydroxy minerals, coalingite, pyroaurite (another magnesium iron hydroxy carbonate) and brucite (magnesium hydroxide) have peak positions that indicate element substitutions for the metal content in their ideal formulae. The phase identified as pyroaurite may also include sjoegrenite (a third magnesium iron hydroxy carbonate). The phase identified as magnetite (iron oxide) by XRD also includes chromite (iron chromium oxide).

XRD results for the bottom sediment yield a similar mineral suite from all four areas (Table 2, Figure 2 - bottom five XRD patterns). All bottom sediment samples contain major amounts of chrysotile and lizardite and lesser amounts of coalingite, brucite, chlorite, quartz and magnetite. In addition, pyroaurite and feldspar were identified in three sediment samples and amphibole in two samples. See Table 2 for the chemical formulae for the minerals.

XRD results for the dredge-pile samples yield a similar mineral suite to that found in the bottom sediments, but with the occurrence of some additional minerals in small amounts (Table 2, Figure 2 - middle four XRD patterns). XRD patterns for chrysotile and lizardite reference materials are also shown for comparison in Figure 2 (top two patterns). All dredge-pile samples contain major amounts of chrysotile and lizardite and lesser amounts of chlorite, quartz, feldspar and magnetite. In addition, pyroaurite and amphibole were identified in three dredge-pile samples, coalingite and mica in two samples, and brucite, calcite, heulandite (a zeolite), and pyroxene in one sample. See Table 2 for the chemical formulae for the minerals.

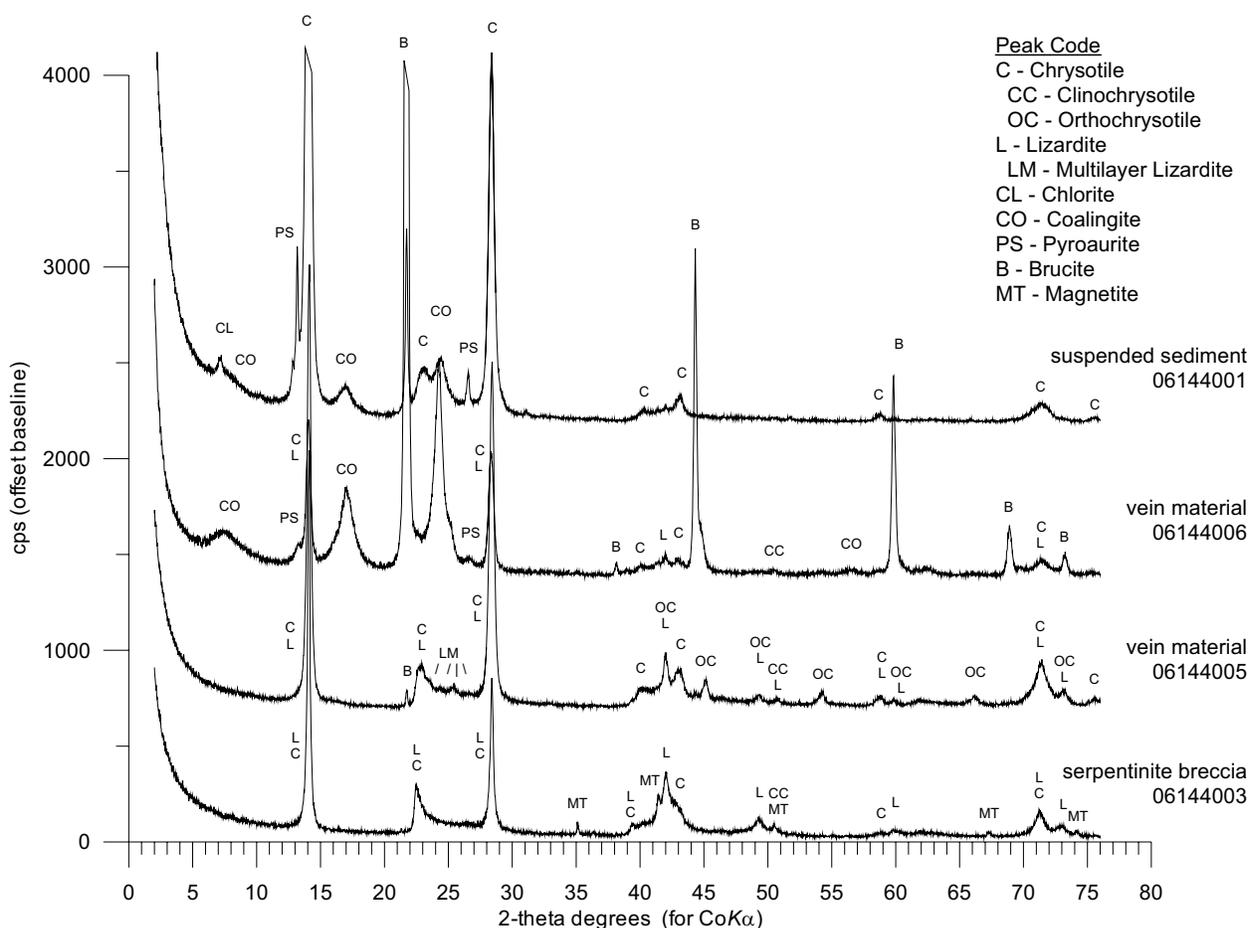
Figure 3. XRD patterns for source materials for sediment in Swift Creek. Collected from the toe of the Swift Creek landslide on Sumas Mountain.

XRD results for suspended sediment and other source materials yield a similar mineral suite to that found in the downstream bottom sediments and dredge piles, but with concentrated occurrences of particular minerals in the different types of materials (Table 2). Figure 3 shows patterns of some of the source materials. A light fraction of the suspended sediment (Figure 3 - top XRD pattern) contains major chrysotile with lesser amounts of coalingite, pyroaurite, brucite, and chlorite. Vein material (Figure 3 - middle two patterns) also contains major chrysotile with lesser lizardite and pyroaurite. Chrysotile-rich vein material in the coating on sample 06144006 is well mixed with major brucite and coalingite. In contrast, the clayey boulder breccia (Figure 3 - bottom pattern) contains primarily lizardite in both the clayey matrix and the greenish black pebble clasts, and very little chrysotile.

The diffraction characteristics and microscopic observations for the minerals in the source materials are generally similar to those described for the bottom sediments and dredge-pile materials. Two samples of source material (06144001, 06144006) were treated with hydrochloric acid to concentrate the serpentine phases to aid identification of types in the chrysotile and lizardite mineral subgroups. Most of the chrysotile in the limited set of source materials examined occurs as clinochrysotile, and most of the lizardite as lizardite-1T. However, one sample of vein material (06144005) was particularly abundant in other members of these mineral subgroups, including orthochrysotile and multilayer lizardite (Figure 3). The acid treatment, in addition, indicated all of the hydroxy minerals are acid soluble.

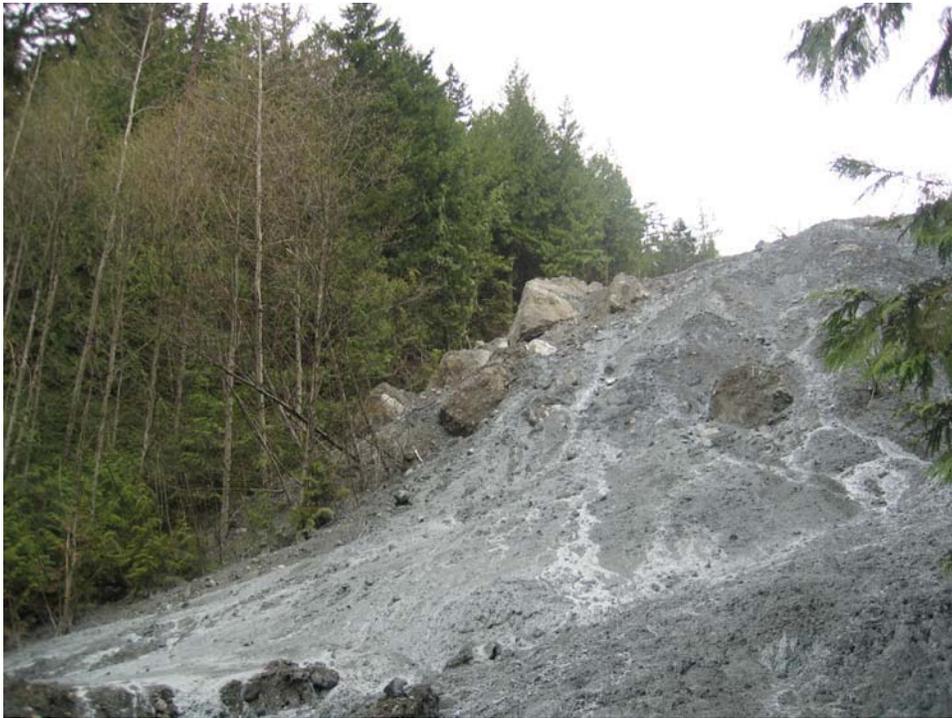
IMG_1301 - Toe of Swift Creek landslide in altered serpentinite, north edge.

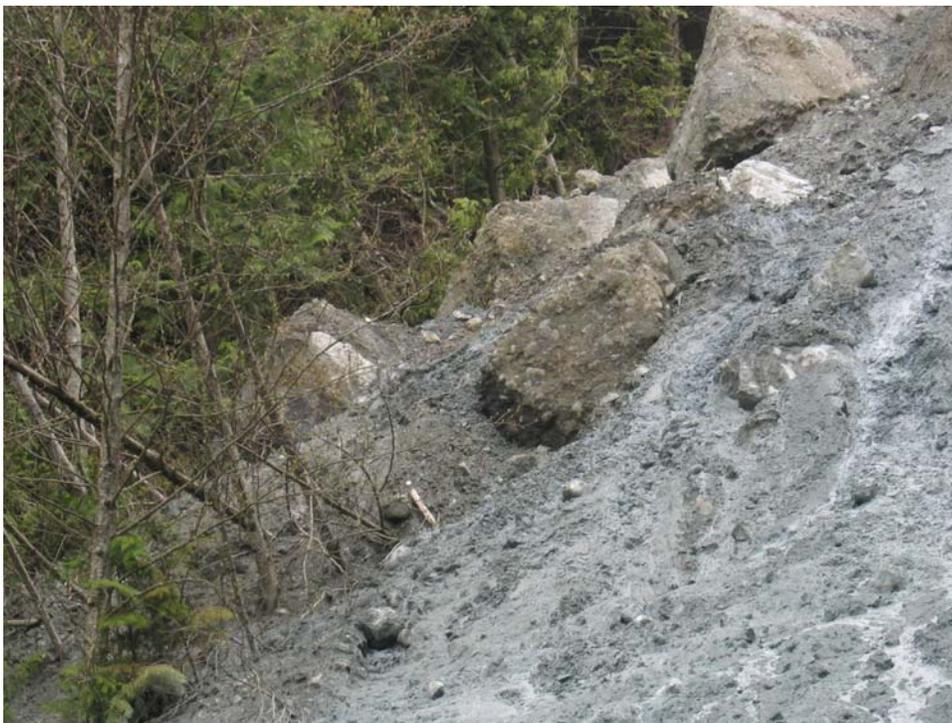
IMG_1302 - Toe of Swift Creek landslide in altered serpentinite, north edge close-up.

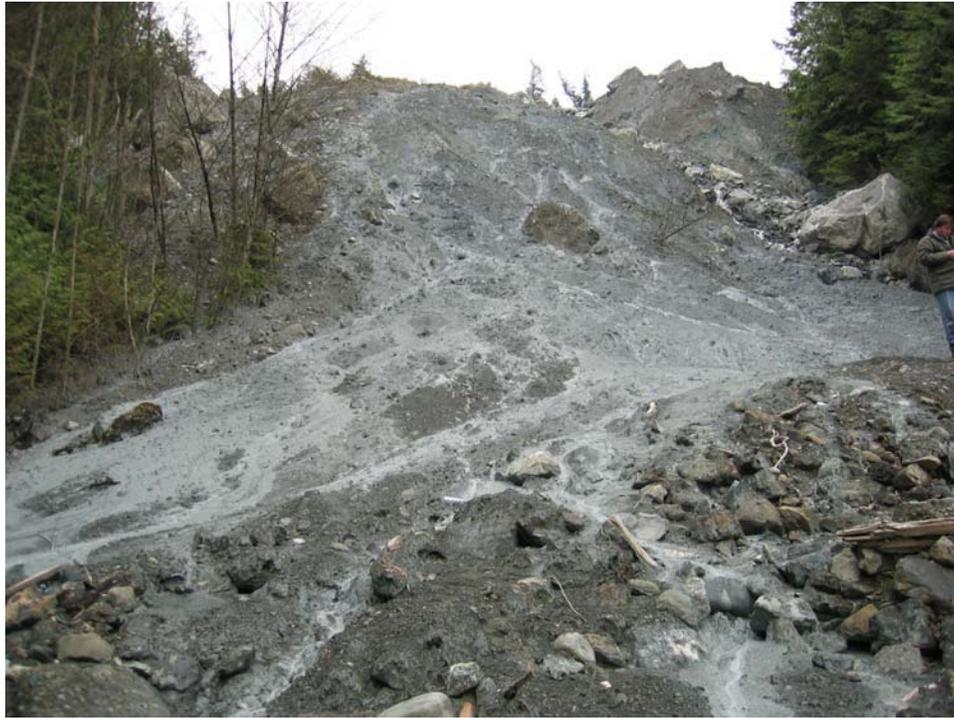
IMG_1305 - Toe of Swift Creek landslide in altered serpentinite, general locality for samples 06144000-06144006.

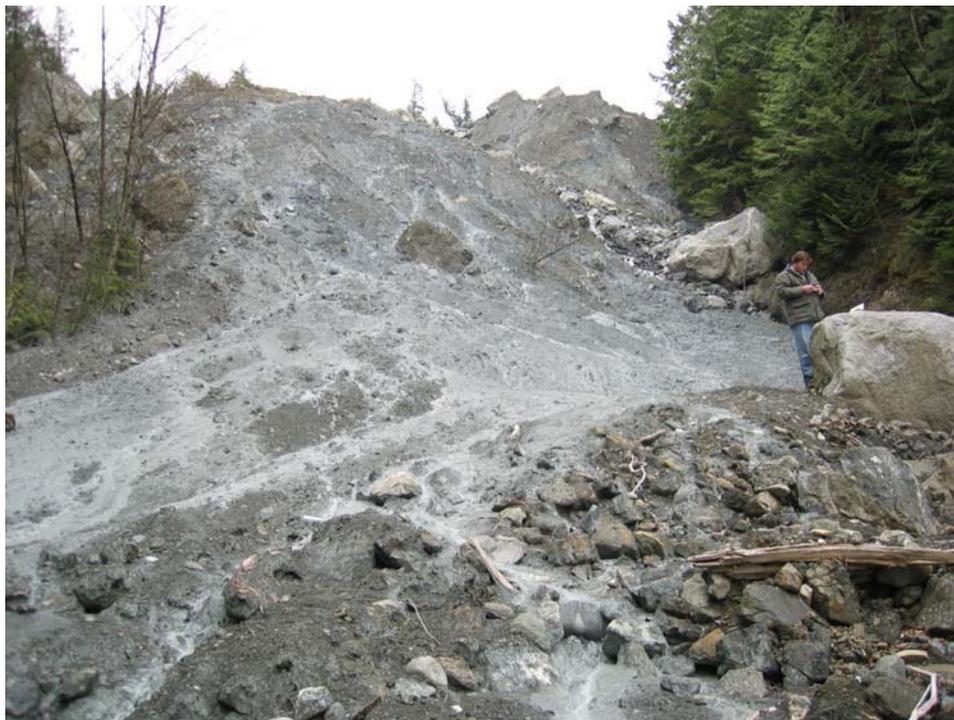
IMG_1306 - Toe of Swift Creek landslide in altered serpentinite, general locality for samples 06144000-06144006.

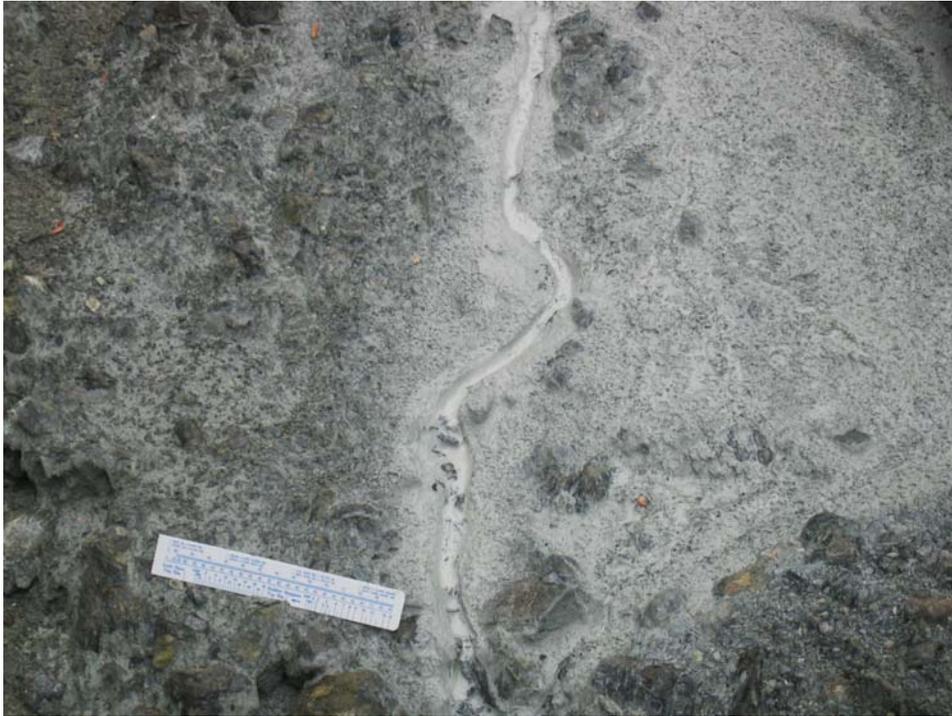
IMG_1310 - Rivulet of chrysotile-laden water from toe of Swift Creek landslide, site for sediment sample 06144000. 16-cm ruler for scale.

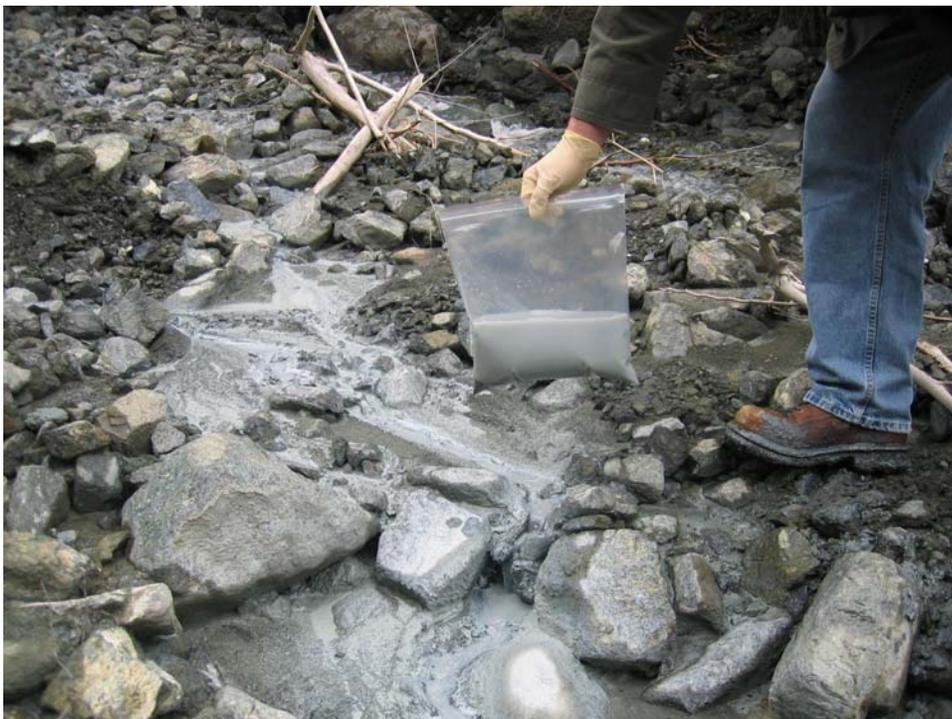
IMG_1311 - Stream of chrysotile-laden water from toe of Swift Creek landslide, water sample 06144001.

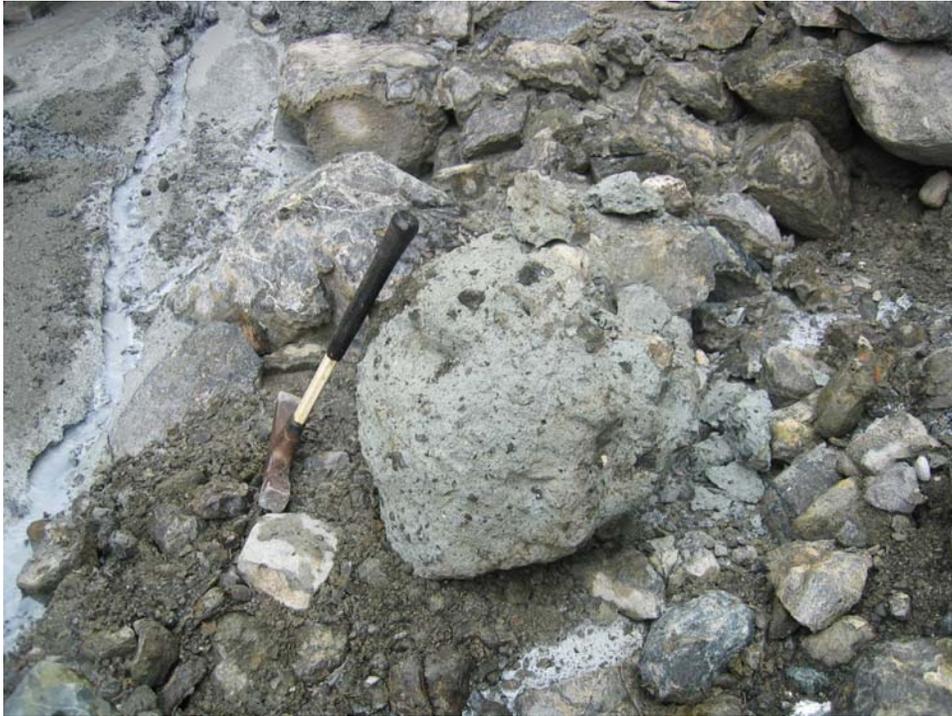
IMG_1312 - Block of serpentinitic landslide gouge at toe of Swift Creek landslide, source of rock sample 06144003. Rock hammer for scale.

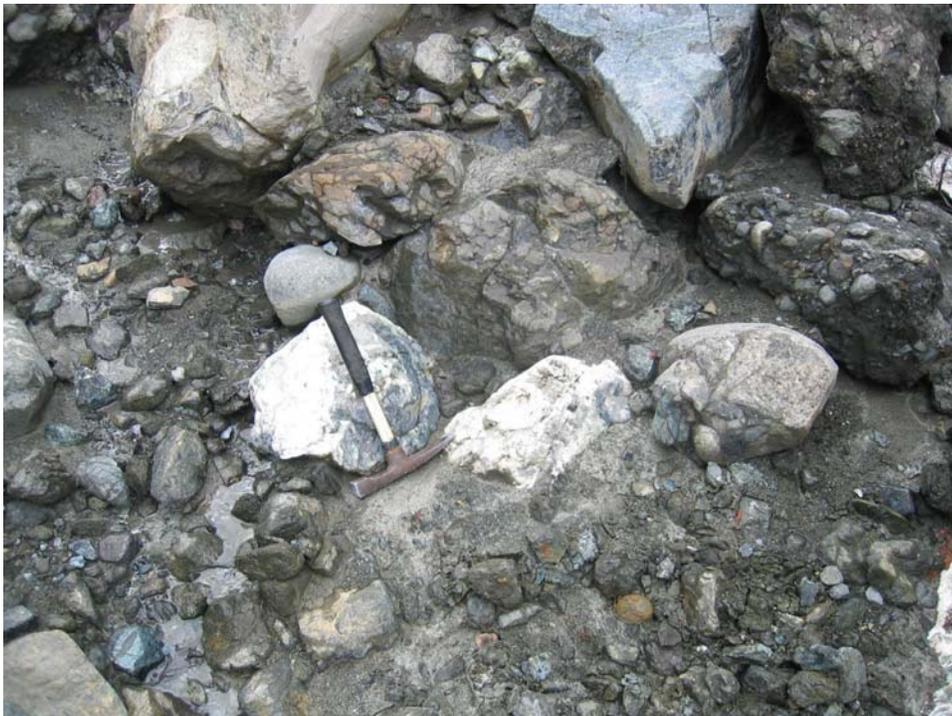
IMG_1313 - Serpentinite blocks with pale bluish green fibrous coatings, at toe of Swift Creek landslide. Rock hammer for scale.

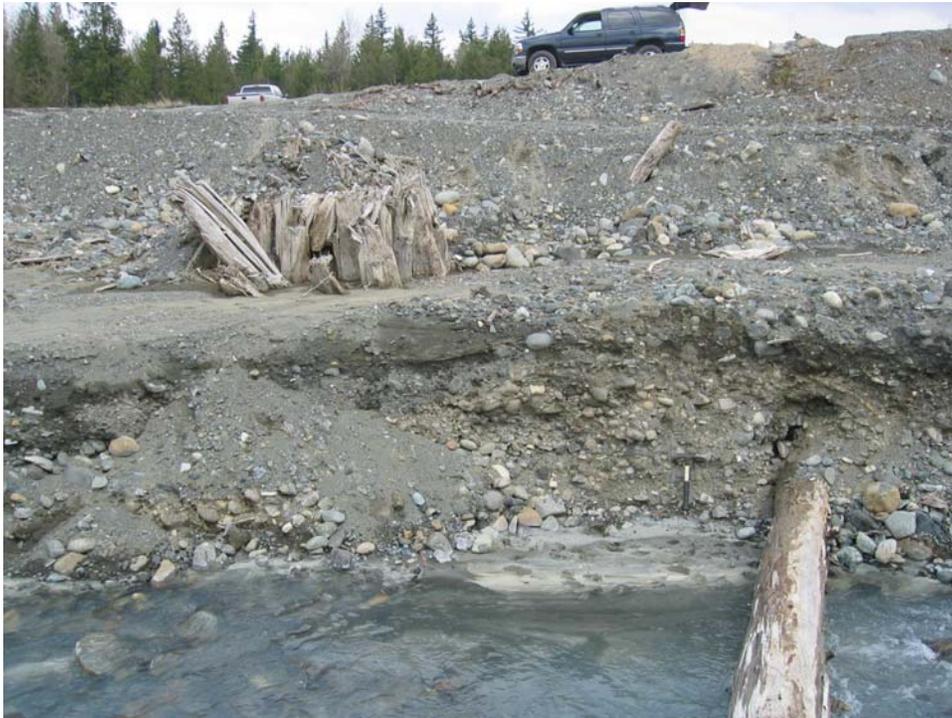
IMG_1314 – Northwest bank of Swift Creek near bridge at Great Western Lumber property. Brown serpentinite-poor sandy gravel occurs in lower part of bank. Medium-grey serpentinite-rich gravelly sand occurs in upper part of bank and in debris cones that have sloughed into the creek (lower left of image). Serpentinite-rich material also makes up the roadbed. Recent deposits of pale grey serpentine-rich mud occur along the water line and side bars of Swift Creek (below hammer). Near locality for samples 06144007-06144009.

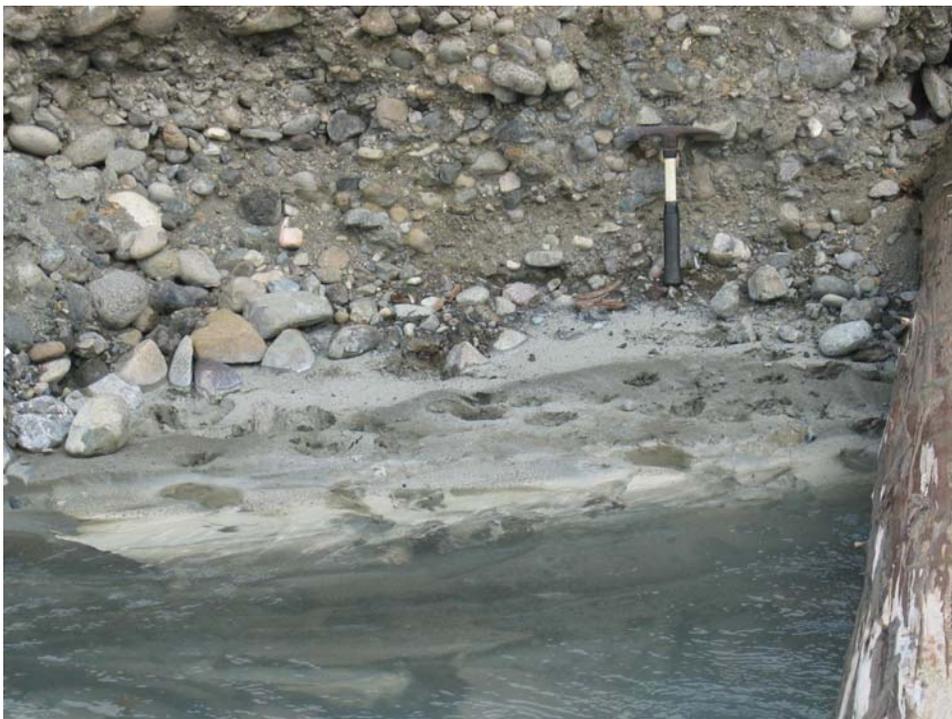
IMG_1315 - Northwest bank of Swift Creek near bridge at Great Western Lumber property. Close-up of recent deposits of pale grey serpentine-rich mud along the water line and side bar of Swift Creek (below hammer). Near locality for samples 06144007-06144009.

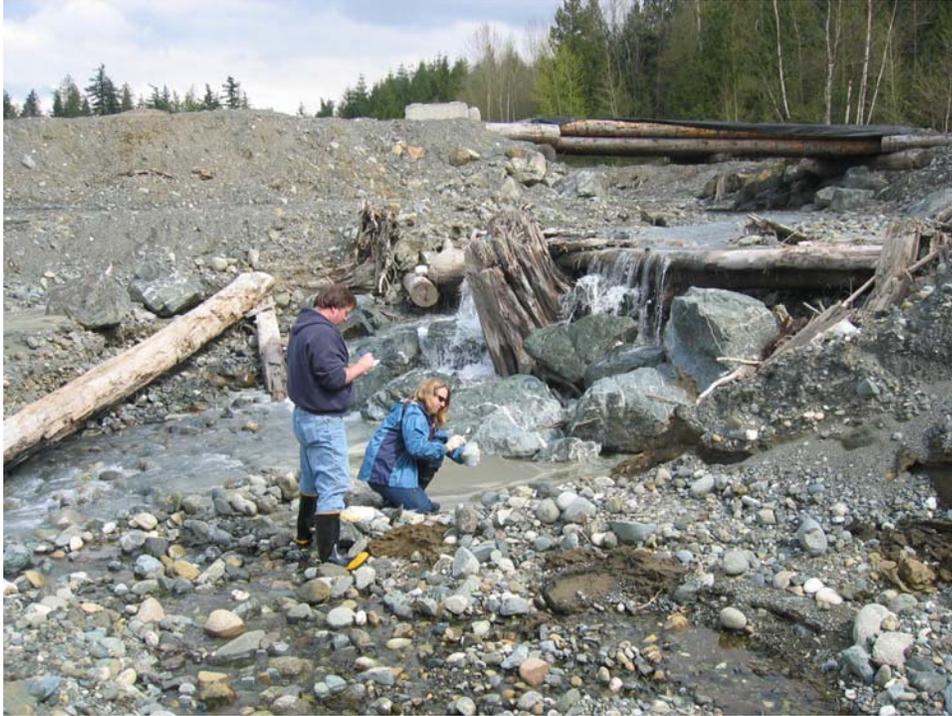
IMG_1316 - Collecting pale grey sediment sample 06144007 from channel of Swift Creek near bridge at Great Western Lumber property.

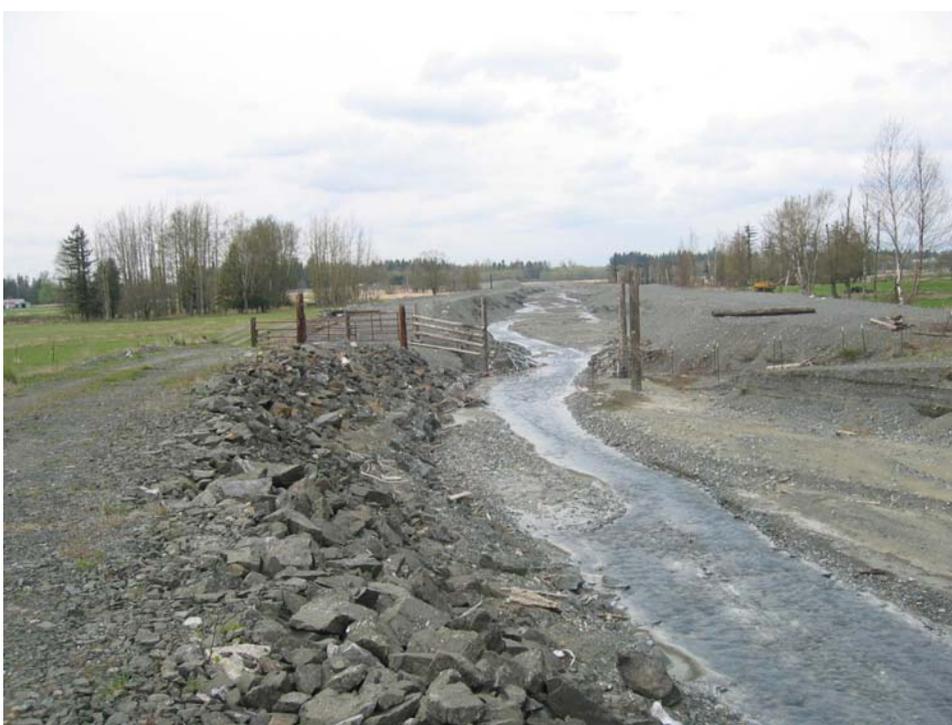
IMG_1317 - Swift Creek and adjacent dredge piles near fence at west edge of Gimmaka property near Goodwin Road, looking downstream to the northwest. Locality of pale brownish grey, mud-cracked sediment sample 06144017 on far side of creek.

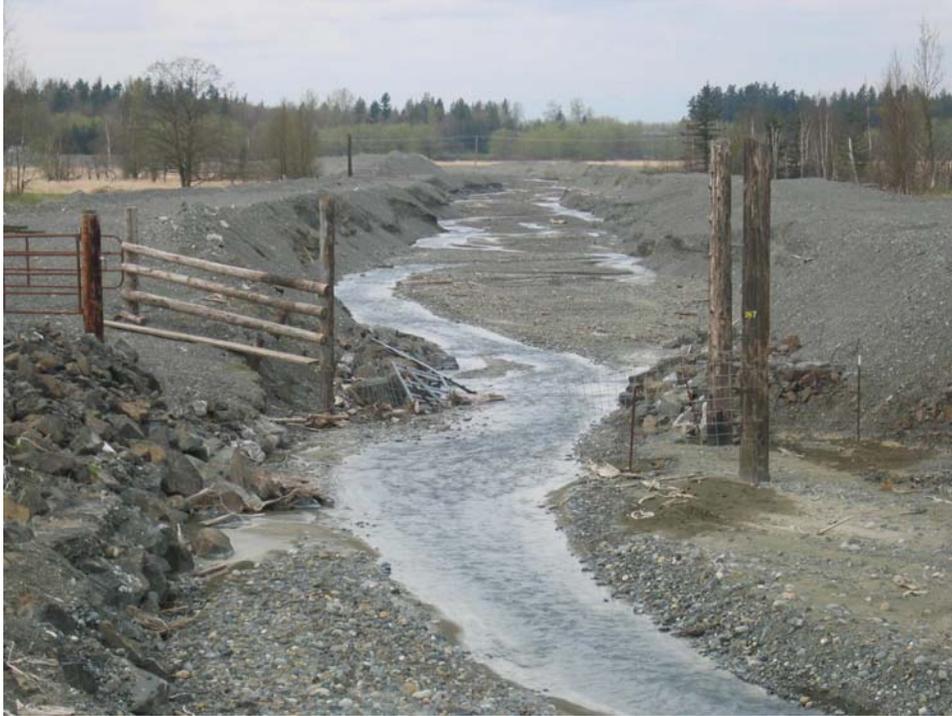
IMG_1318 - Swift Creek and adjacent dredge piles near fence at west edge of Gimmaka property near Goodwin Road, looking downstream to the northwest. Close-up of locality of pale brownish grey, mud-cracked sediment sample 06144017 on far side of creek.

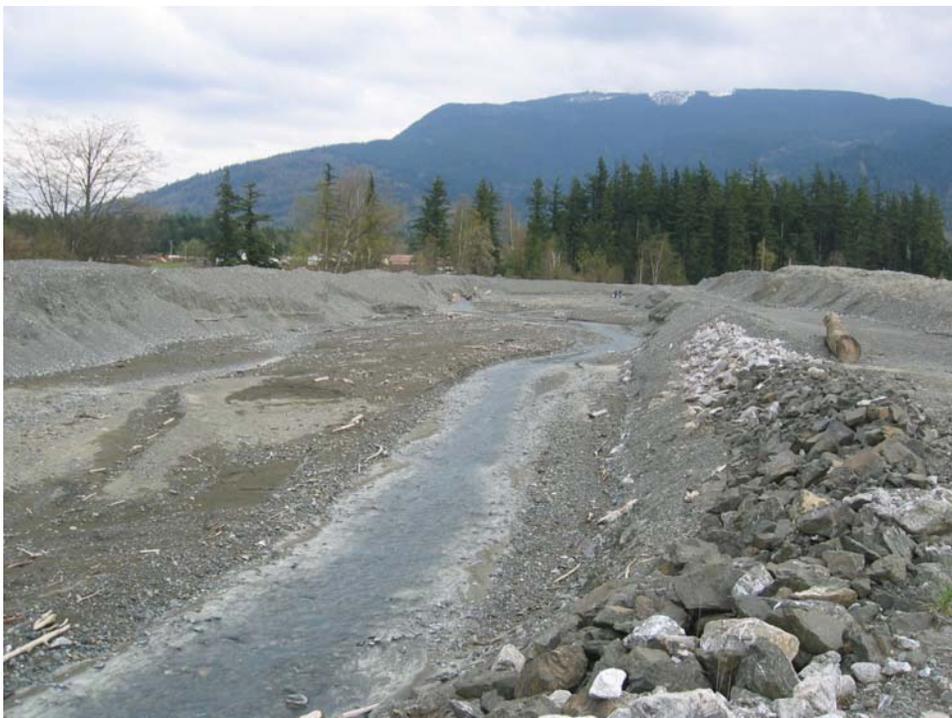
IMG_1319 - Swift Creek and adjacent dredge piles at Gimmaka property near Goodwin Road, looking upstream to the east toward Sumas Mountain. General locality of samples 06144010-06144019.

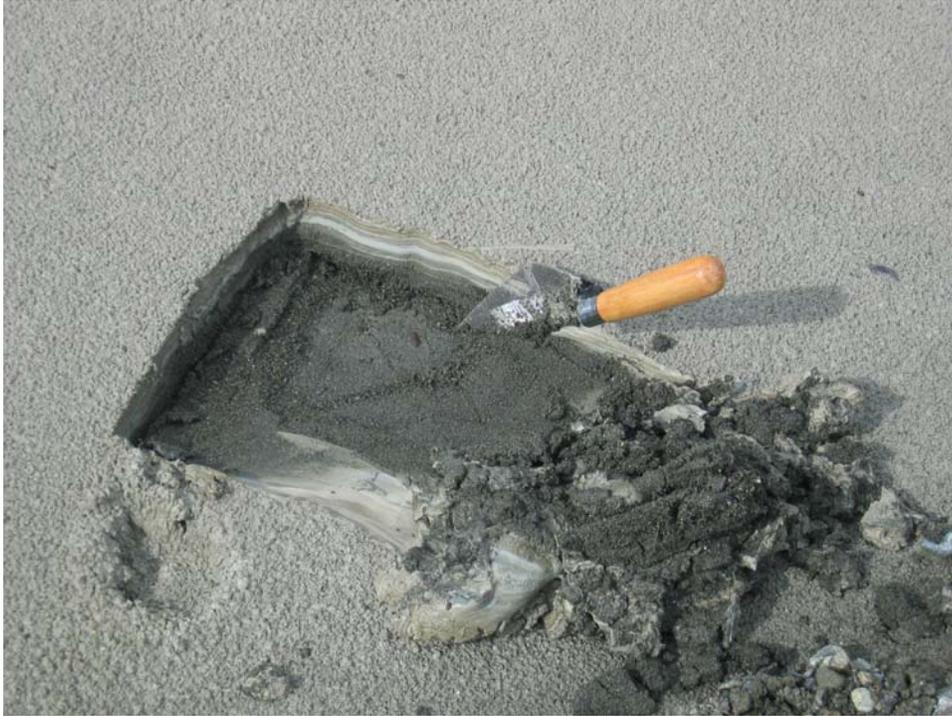
IMG_1321 - Excavation in damp laminated sediment in channel of Swift Creek at Gimmaka property near Goodwin Road. Samples 06144011-06144013 taken from lamination sequence, respectively, from top to bottom.

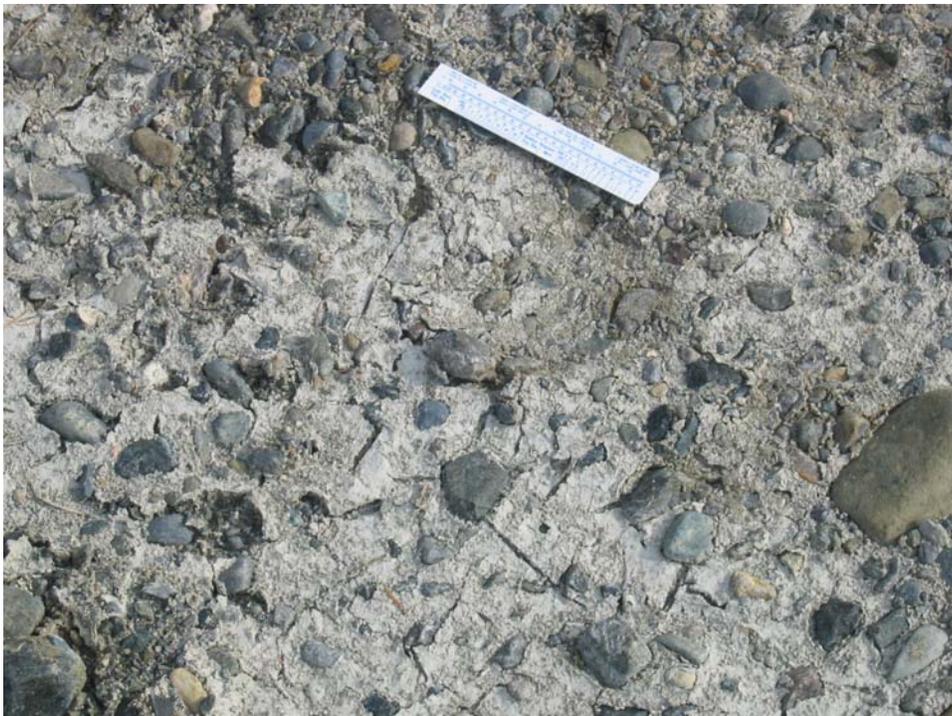
IMG_1327 - Dry, mud-cracked sediment in channel of Swift Creek at Gimmaka property near Goodwin Road. Caked fines collected as sediment sample 06144010.

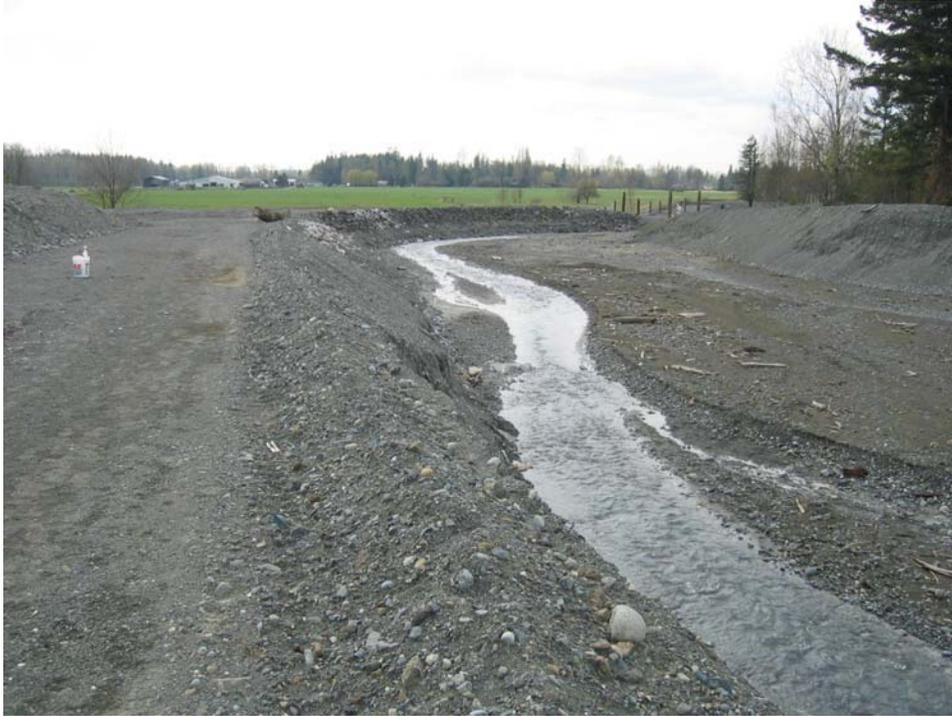
IMG_1328 - Swift Creek and adjacent dredge piles at Gimmaka property near Goodwin Road, looking downstream to the west. Water samples 06144015-06144016 collected in the rippled reach (middle of image).

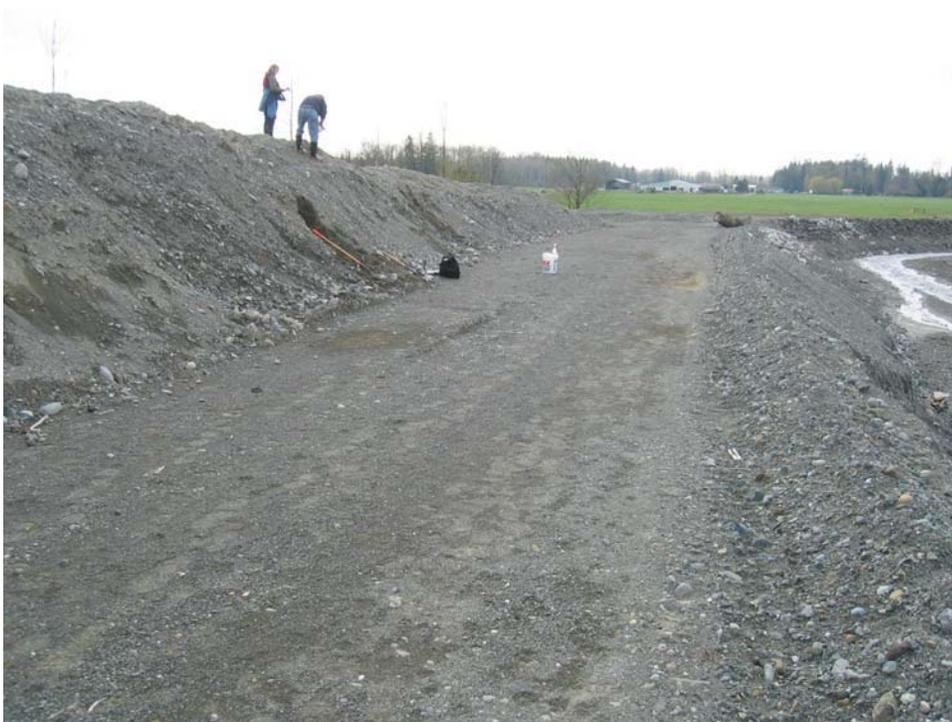
IMG_1329 - Sampling of dredge pile on the south side of Swift Creek at Gimmaka property near Goodwin Road, looking downstream to the west. Surface sample 06144018 taken from the top of the pile. Interior sample 06144019 taken from the interior of the pile at the excavation.

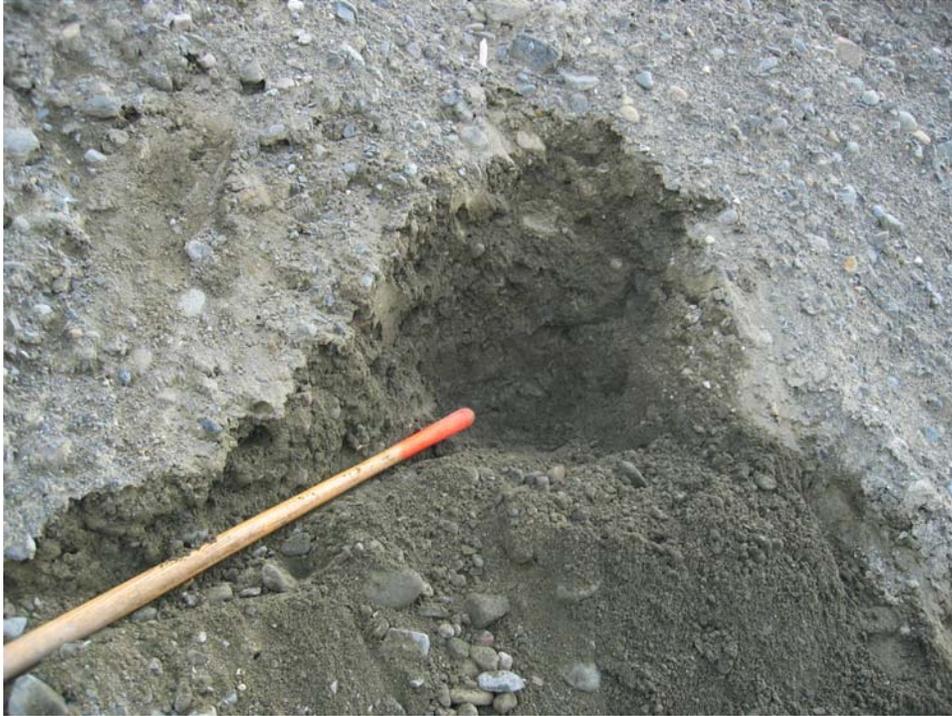
IMG_1330 - Excavation for sample 06144019 taken from the interior of the dredge pile, Gimmaka property near Goodwin Road. Shovel handle points to brown, fine-grained clump used for the sample.

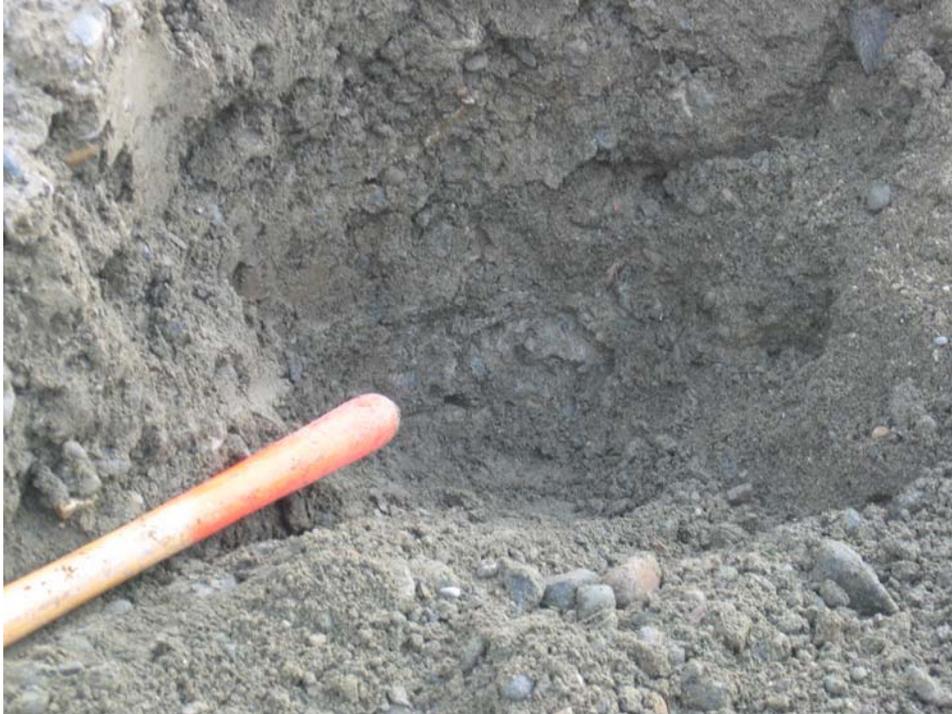
IMG_1331 - Close-up of excavation for sample 06144019 taken from the interior of the dredge pile, Gimmaka property near Goodwin Road. Shovel handle points to brown, fine-grained clump used for the sample.

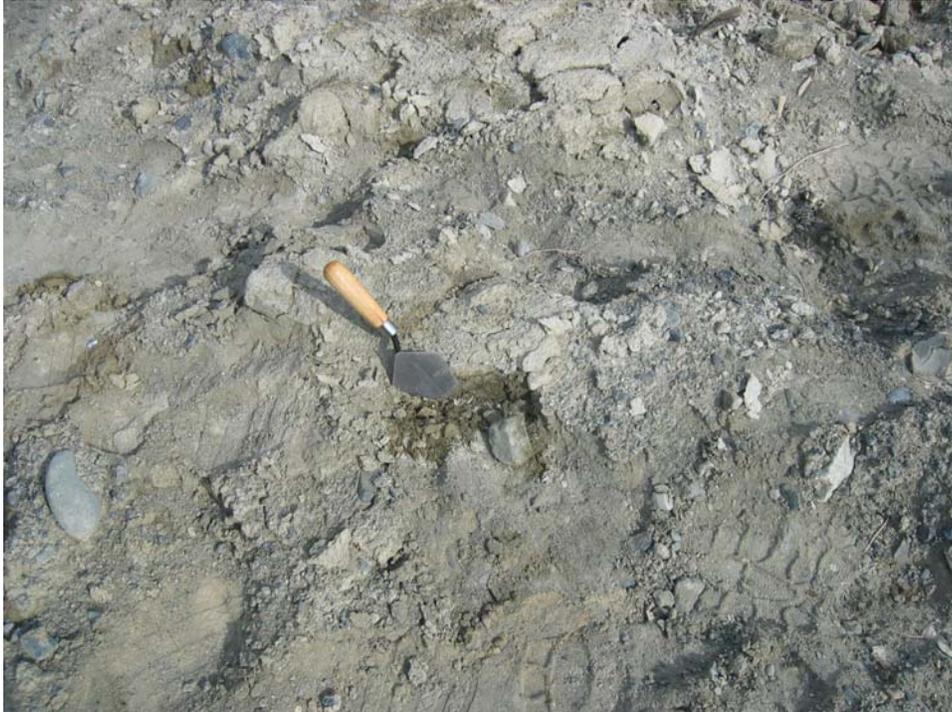
IMG_1332 - Close-up of fine-grained clumps similar to sample 06144018 taken from the surface of the top of the dredge pile, Gimmaka property near Goodwin Road.

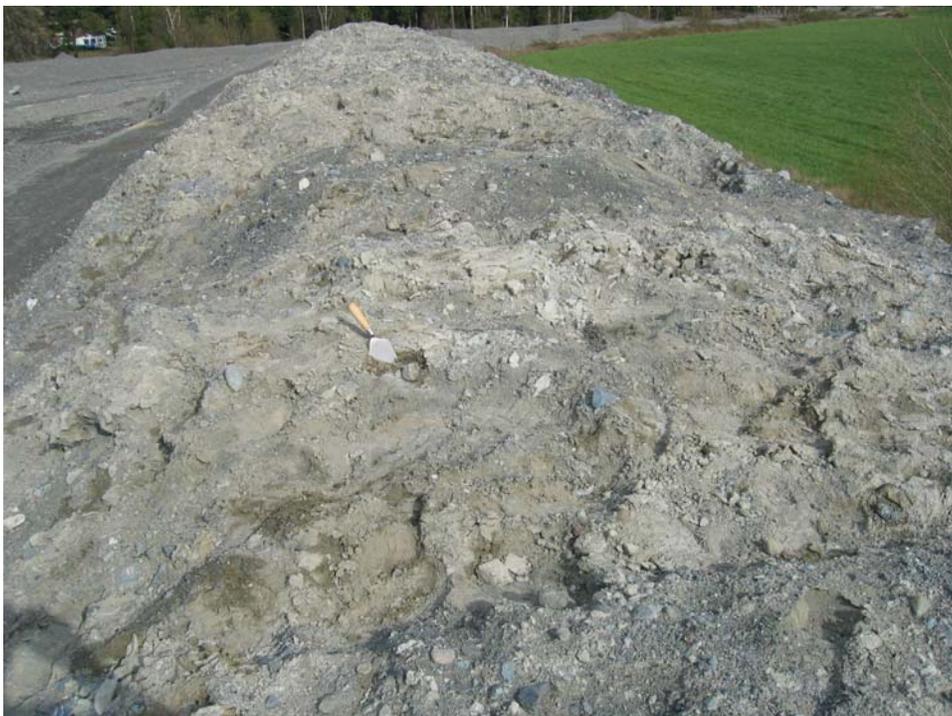
IMG_1333 – Fine-grained clumps, in area of sample 06144018, scattered across the top of the dredge pile, Gimmaka property near Goodwin Road, looking upstream to the east.

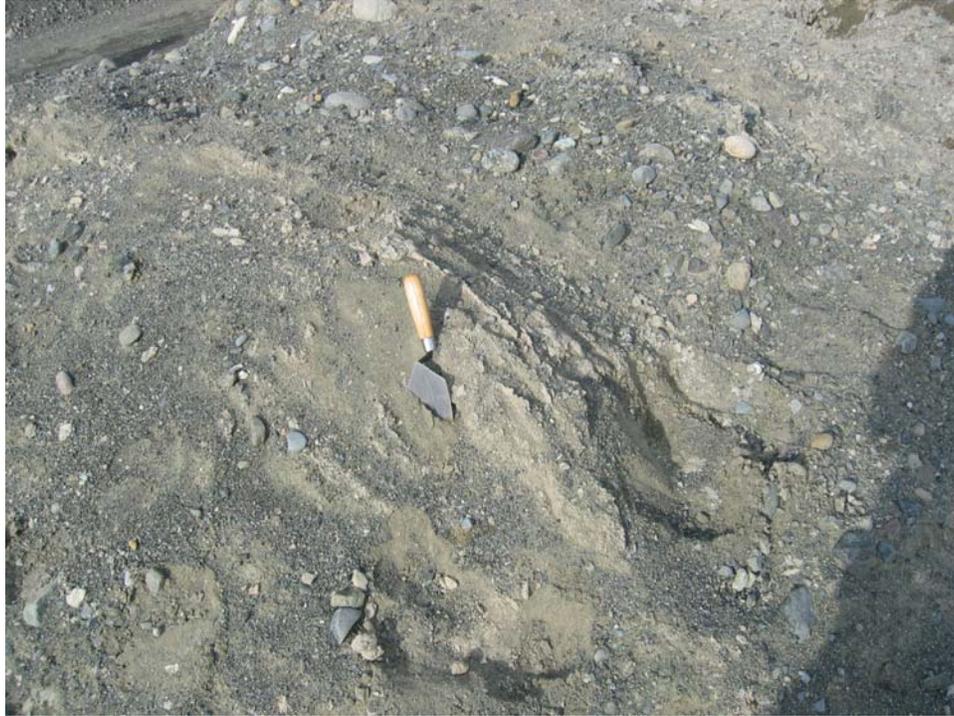
IMG_1334 - Close-up of an upturned block of clumpy, laminated fine-grained bottom sediment (to the right of the trowel) exposed on the top of the dredge pile, Gimmaka property near Goodwin Road. Near locality of dredge-pile sample 06144018.

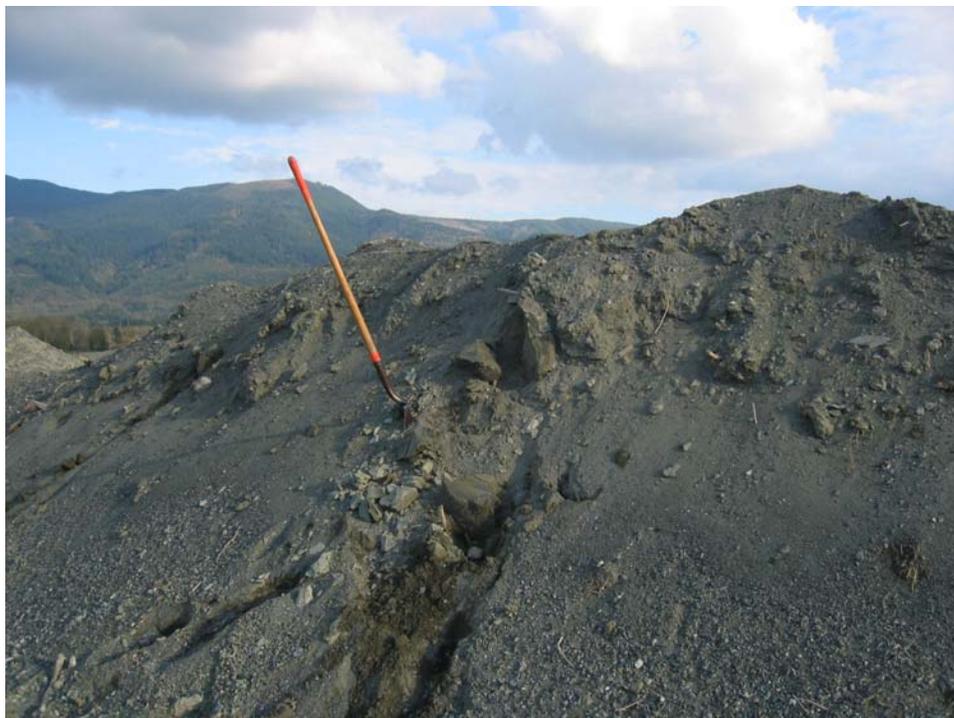
IMG_1335 - Excavation for sample 06144020 taken from the side of one of several blocks of laminated fine-grained bottom sediment exposed near the top of the dredge pile, Parker property near Oat Coles Road, looking southeast toward Sumas Mountain.
