UNITED STATES ENVIRONMENTAL PROTECTION AGENCY

MEMORANDUM

TO: Denise Baker, Site Assessment Manager
Office of Environmental Cleanup
FROM: Jed Januch, David Frank, and Lorraine Edmond
Office of Environmental Assessment
SUBJECT: Trip report and X-ray diffraction analysis of samples collected April 6, 2006
Project Code ESD-122A, Swift Creek Asbestos project

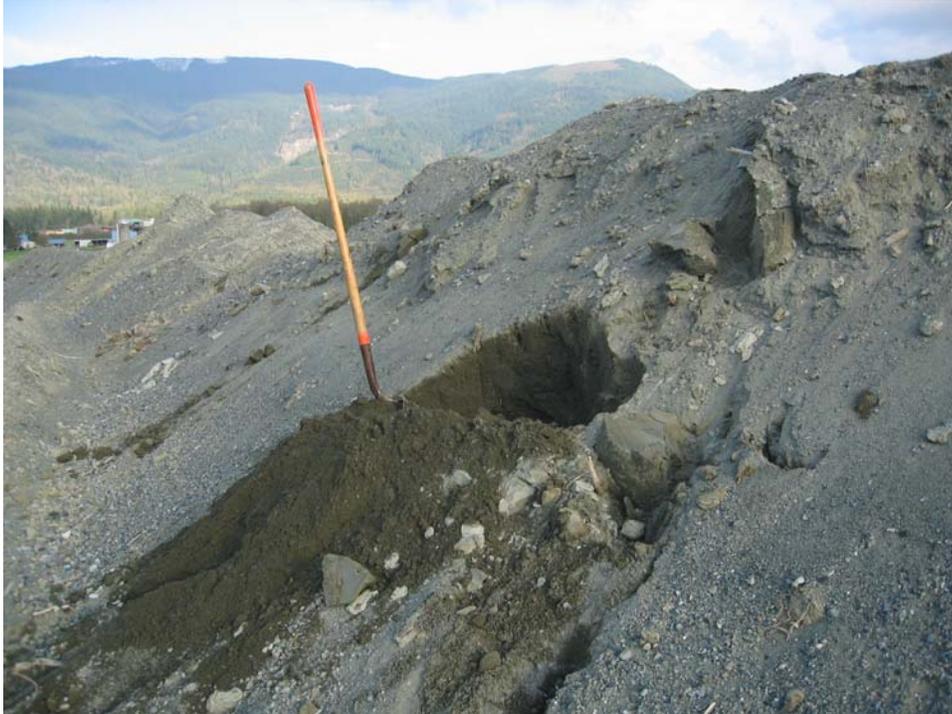
IMG_1336 - Excavation for sample 06144021 taken from a fine-grained clump in the interior of the dredge pile, Parker property near Oat Coles Road, looking east toward Sumas Mountain, with Swift Creek landslide appearing behind the shovel handle.

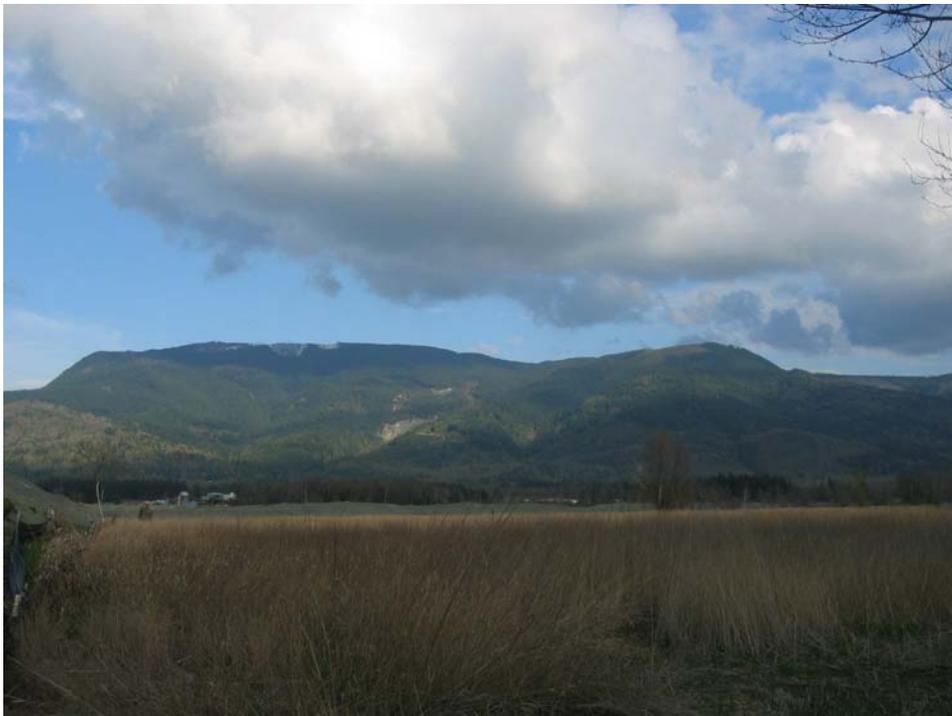
IMG_1337 - Eastward view across pastureland from Oat Coles Road toward Sumas Mountain and the Swift Creek landslide. Dredge piles along Swift Creek cross the lower middle of the image.

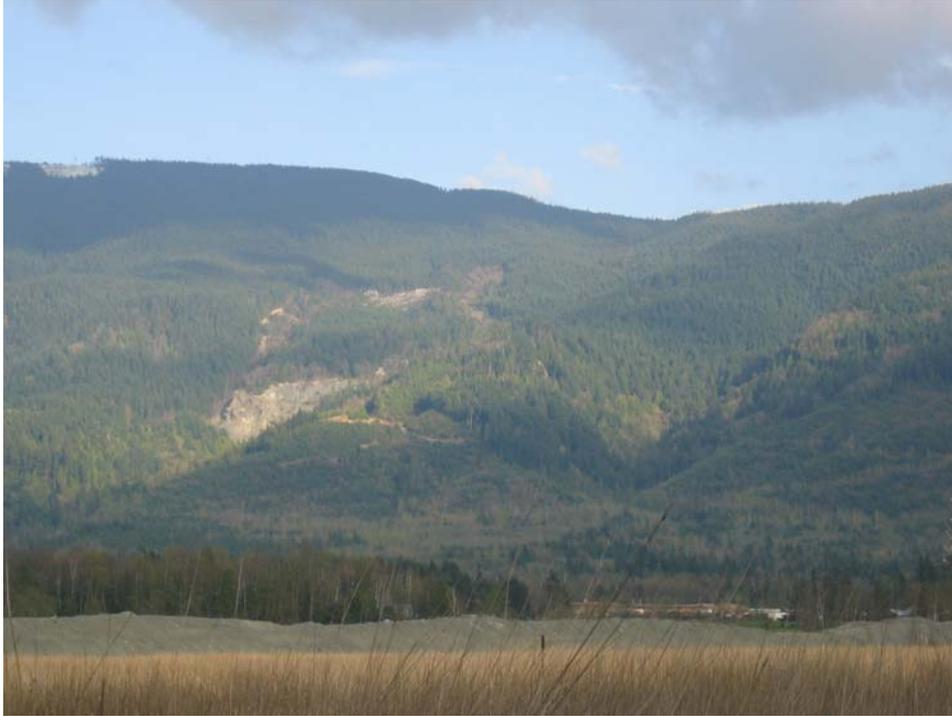
IMG_1338 - Close-up of eastward view from Oat Coles Road toward Sumas Mountain and the Swift Creek landslide. The toe of the landslide is the light grey barren slope in the left of middle in the image. Newly constructed logging roads crisscross the ridge adjacent to the landslide toe. Dredge piles along Swift Creek cross the lower middle of the image.

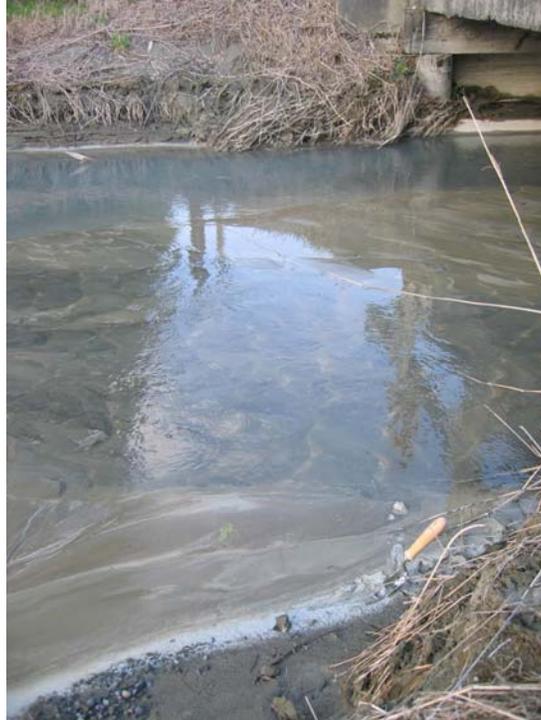
IMG_1339 - Brown to light-grey, fine-grained bottom sediment in Swift Creek, west of Oat Coles Road bridge. Sample 06144023 collected at trowel. Bridge abutment at upper right.

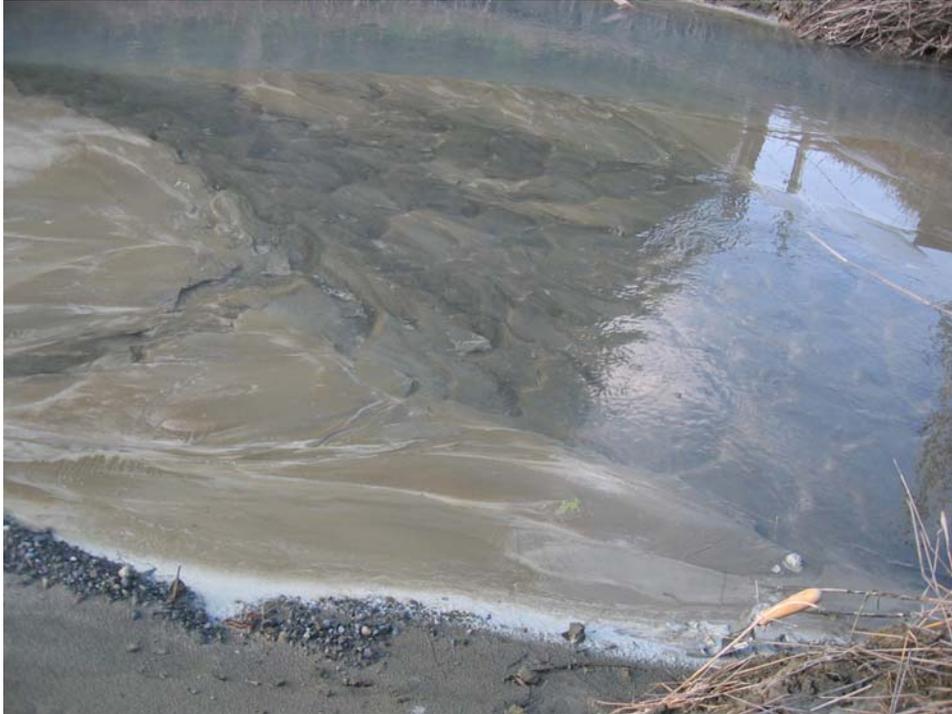
IMG_1340 - Brown to light-grey, fine-grained bottom sediment in Swift Creek, west of Oat Coles Road bridge. Sample 06144023 collected at trowel.

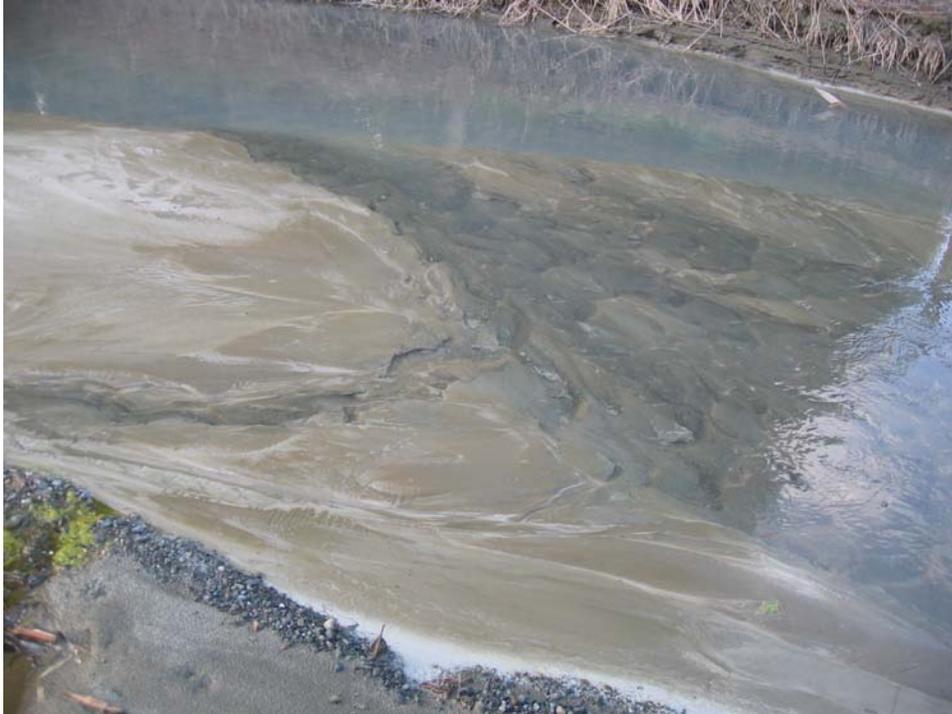
IMG_1341 - Brown to light-grey, fine-grained bottom sediment in Swift Creek, west of Oat Coles Road bridge. Near site for sample 06144023, downstream extension of image 1340.

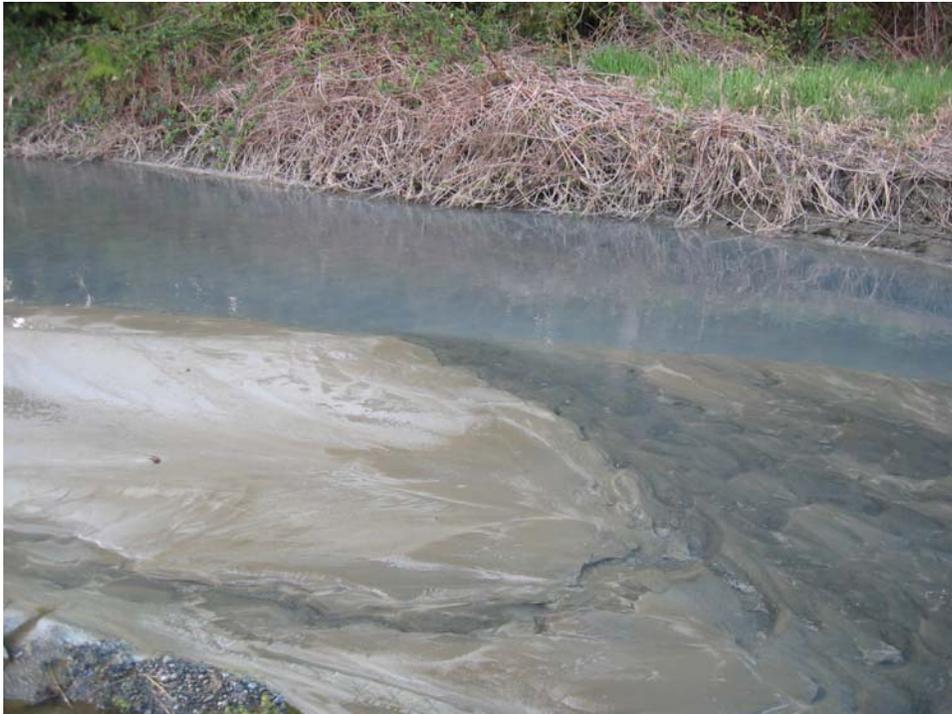
IMG_1342 - Brown to light-grey, fine-grained bottom sediment in Swift Creek, west of Oat Coles Road bridge. Near site for sample 06144023, downstream extension of images 1340-1341.

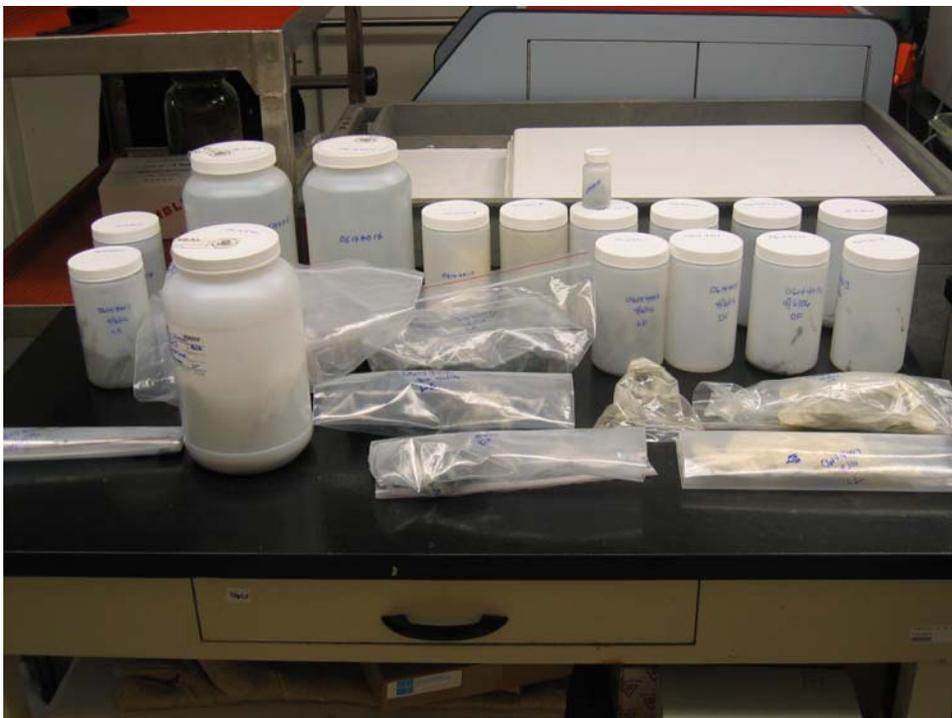
IMG_1344 - Samples 06144000-06144023 collected April 6, 2006 at Swift Creek Asbestos site, near Sumas, Washington. April 10, USEPA Region 10 Manchester Environmental Laboratory.
